## Expertise

Protocol number: 46272568  
Order No. / Reference: 26490291  
Inspection date: 1 Jul 2026

Model: Transit Custom 320 L1H1 LKW VA Trend

VIN: WF0YXXTTGYLT50913

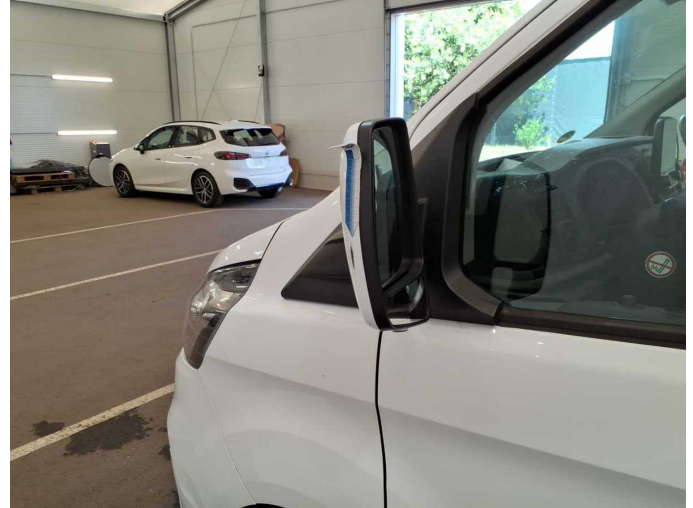
Damage 1: Wing mirror - left side: Cap - Scratched - Smart repair

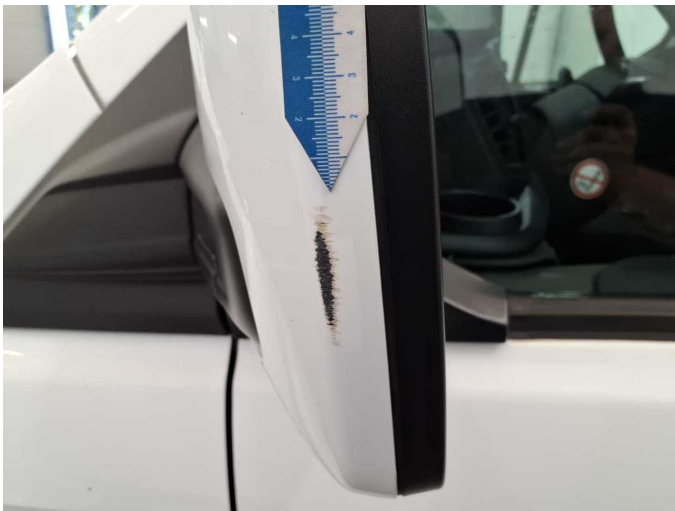
Damage 1: Wing mirror - left side: Cap - Scratched - Smart repair

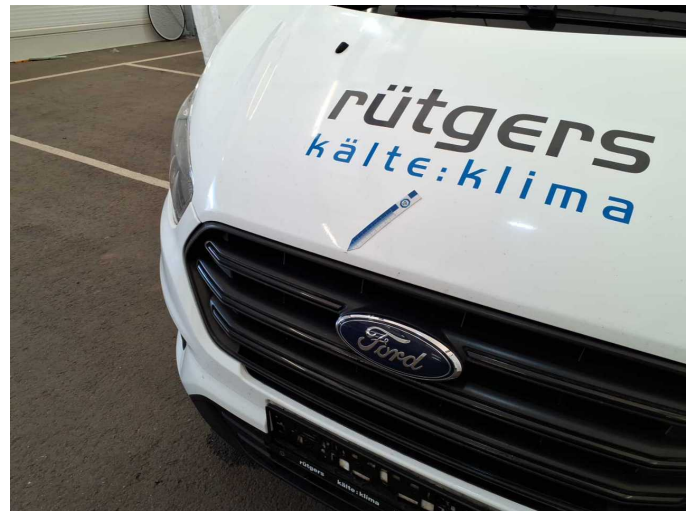
Damage 2: Bonnet: Bonnet - Scratched - Smart repair

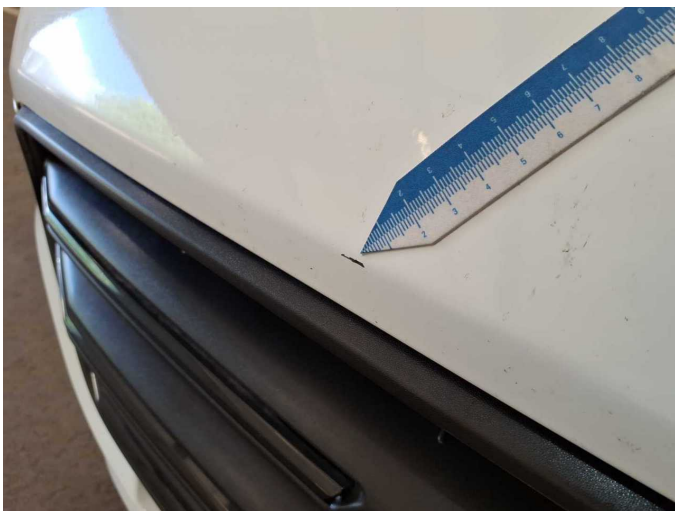
Damage 2: Bonnet: Bonnet - Scratched - Smart repair

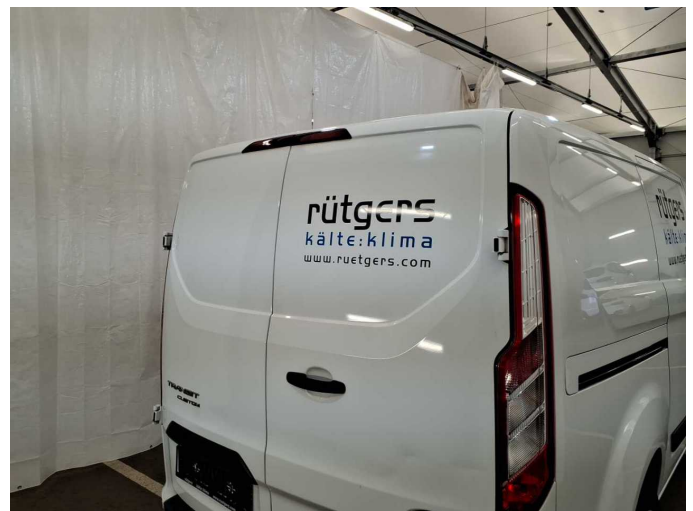
Damage 3: Body: Body - Glued / labelled - De-glue / neutralise

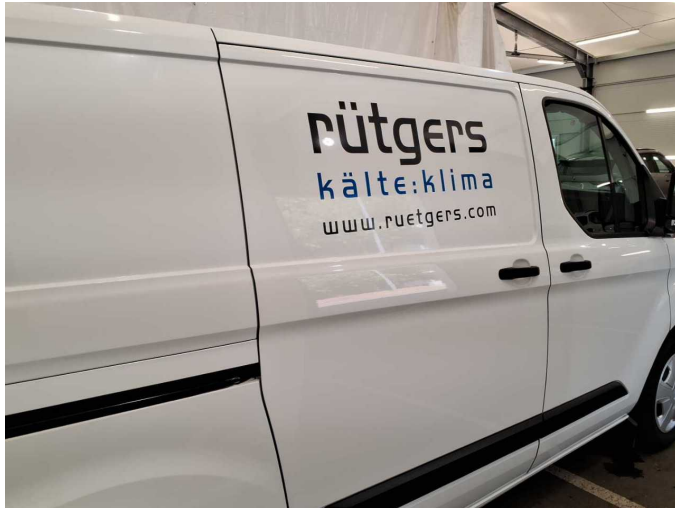
**Damage 3:** Body: Body - Glued / labelled - De-glue / neutralise

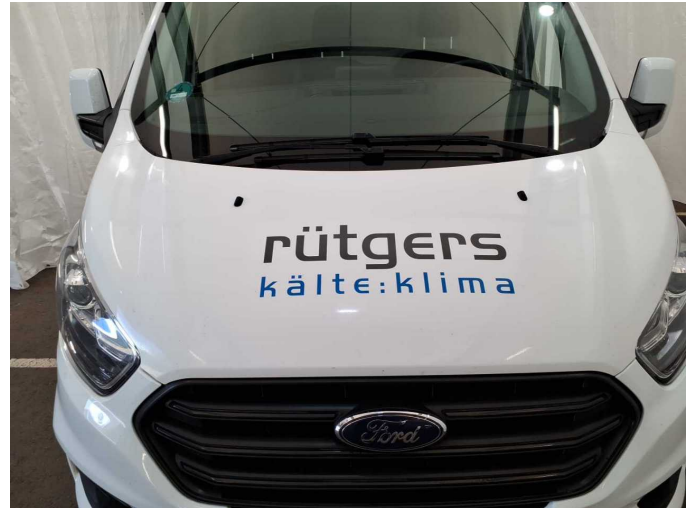
**Damage 3:** Body: Body - Glued / labelled - De-glue / neutralise

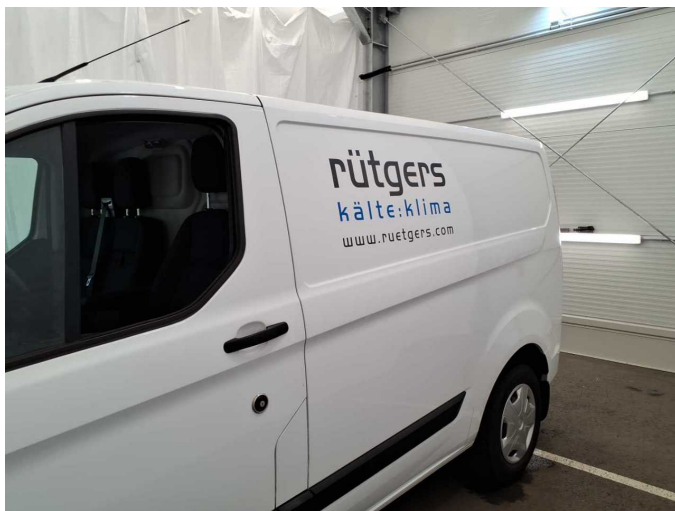
**Damage 3:** Body: Body - Glued / labelled - De-glue / neutralise

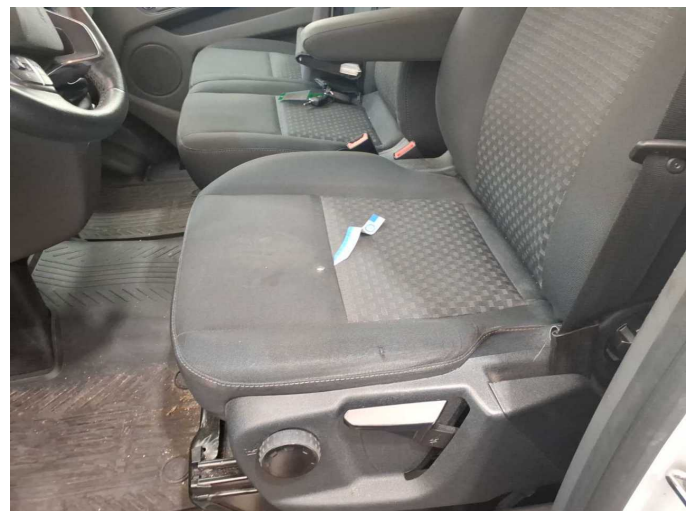
**Damage 4:** Seat - front: Seat cover - left side - Damaged - Replace

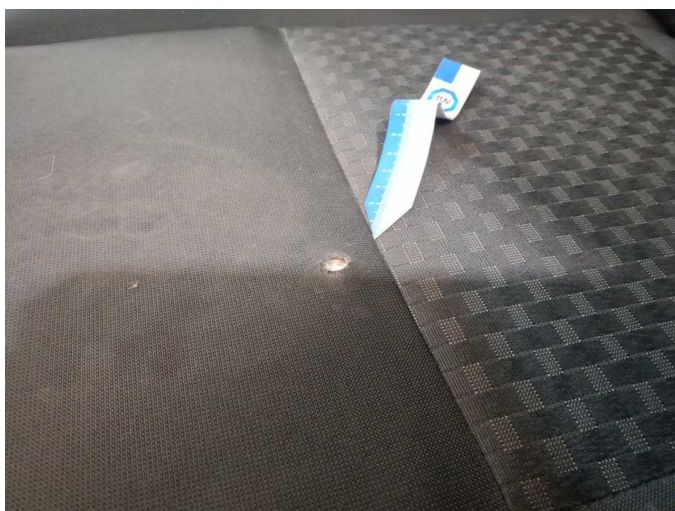
**Damage 4:** Seat - front: Seat cover - left side - Damaged - Replace

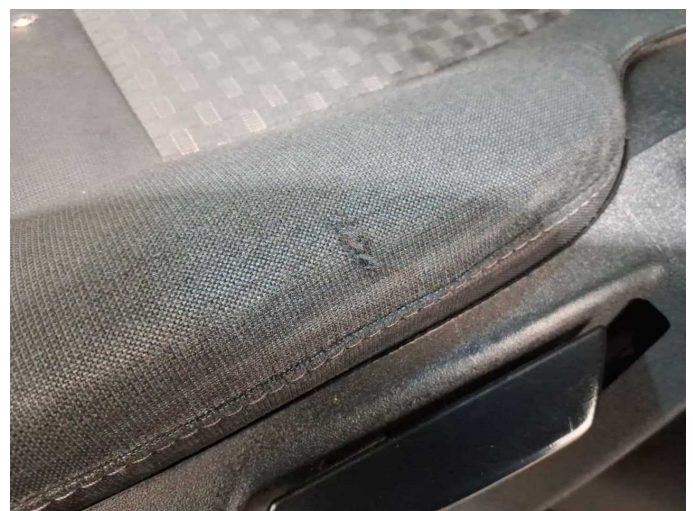
**Damage 4:** Seat - front: Seat cover - left side - Damaged - Replace

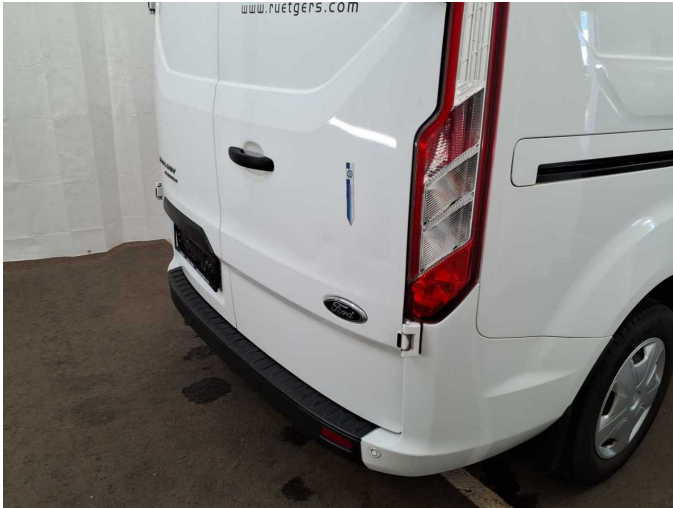
**Damage 5:** Boot lid / rear door: Rear door - right side - Deformed - Repair and paint

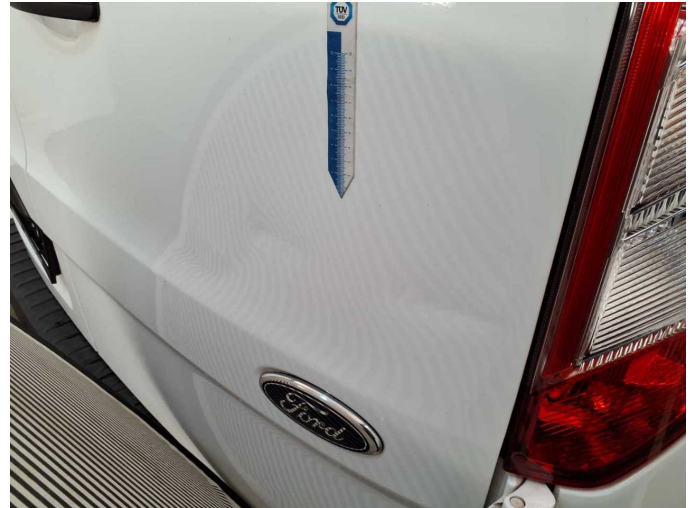
**Damage 5:** Boot lid / rear door: Rear door - right side - Deformed - Repair and paint

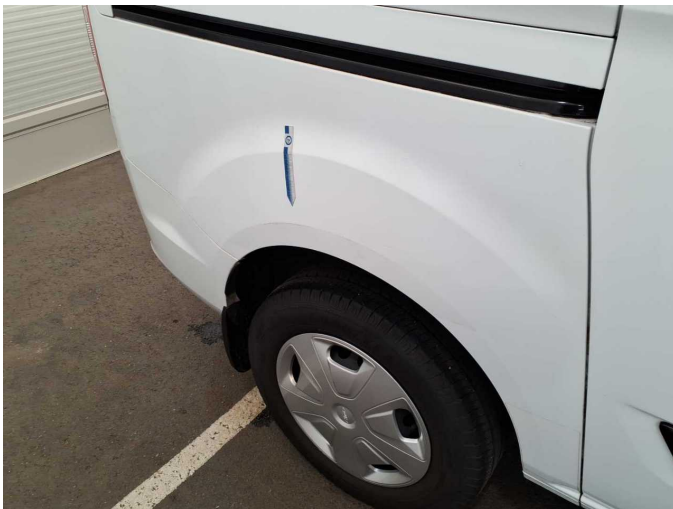
**Damage 6:** Side panel - rear right side: Side panel (& Lackschaden) - Deformed - Repair and paint

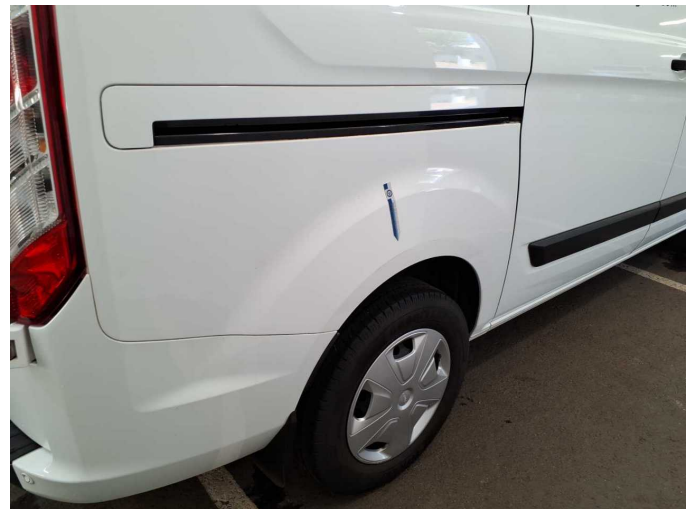
**Damage 6:** Side panel - rear right side: Side panel (& Lackschaden) - Deformed - Repair and paint

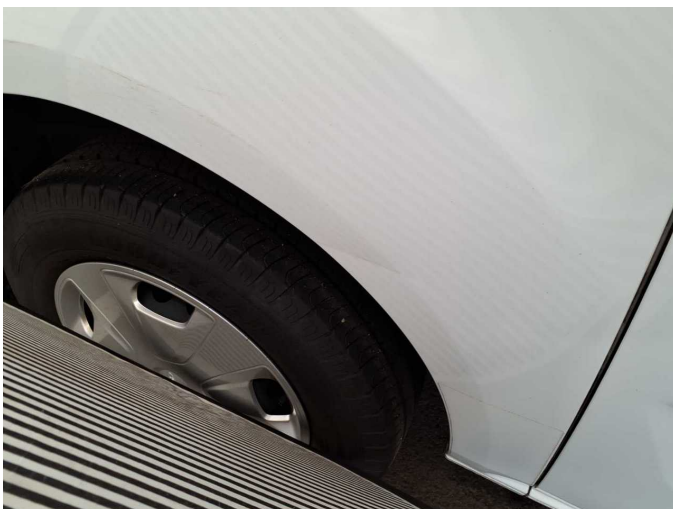
**Damage 6:** Side panel - rear right side: Side panel (& Lackschaden) - Deformed - Repair and paint

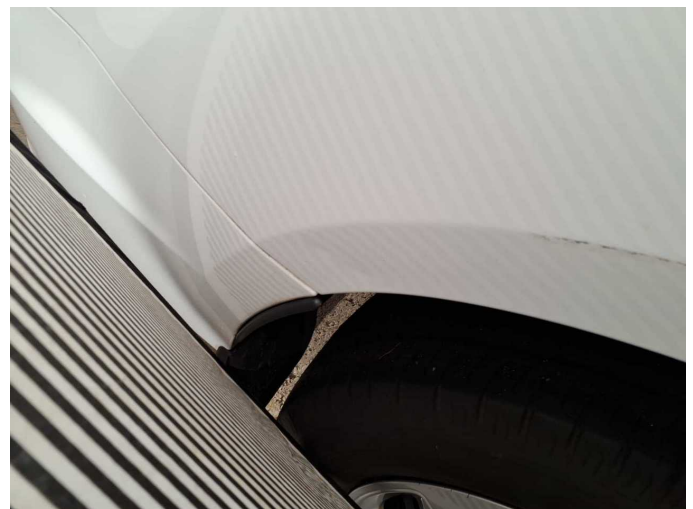
**Damage 6:** Side panel - rear right side: Side panel (& Lackschaden) - Deformed - Repair and paint

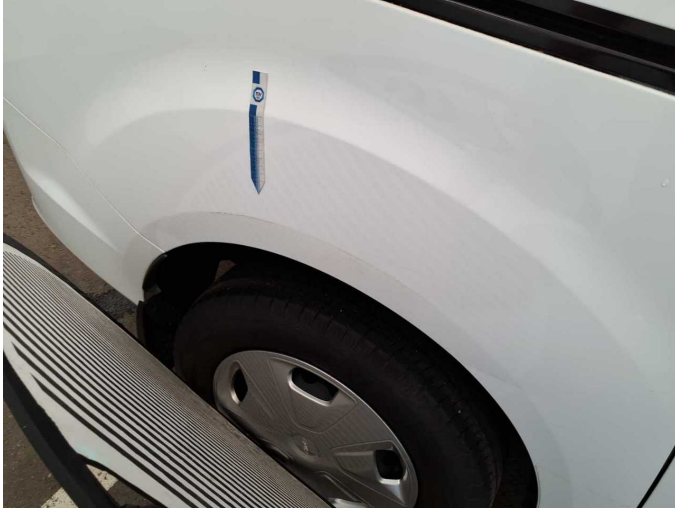
**Damage 6:** Side panel - rear right side: Side panel (& Lackschaden) - Deformed - Repair and paint

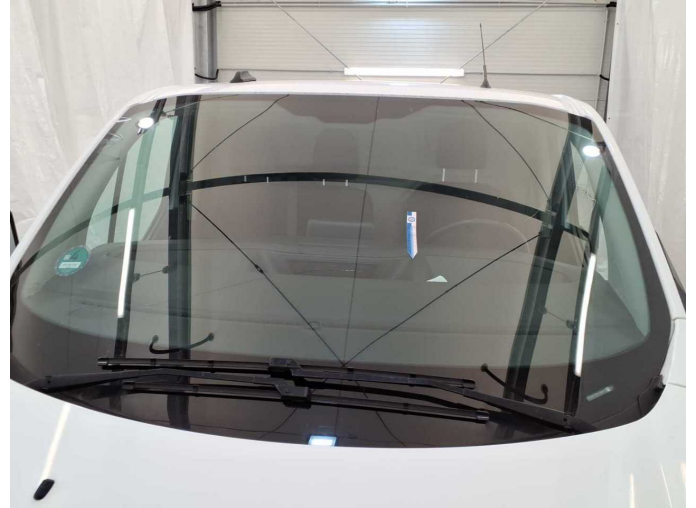
**Damage 7:** Vehicle glazing: Windscreen - Broken / torn - Replace

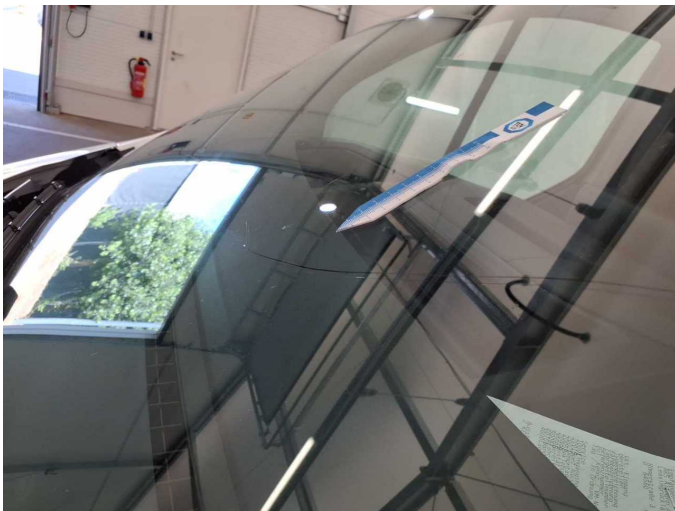
**Damage 7:** Vehicle glazing: Windscreen - Broken / torn - Replace

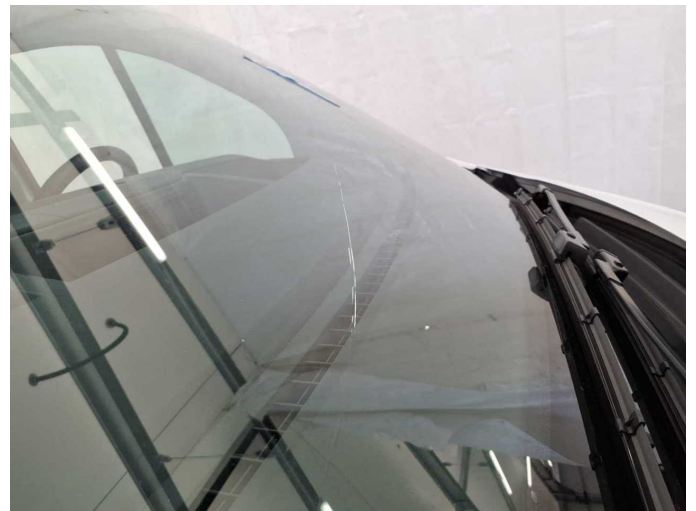
**Damage 7:** Vehicle glazing: Windscreen - Broken / torn - Replace
