Expertise

Protocol number: 46163330
Order No. / Reference: 26002512
Inspection date: 22 Jun 2026

Model: Vito 110 CDI Lang VA Kasten

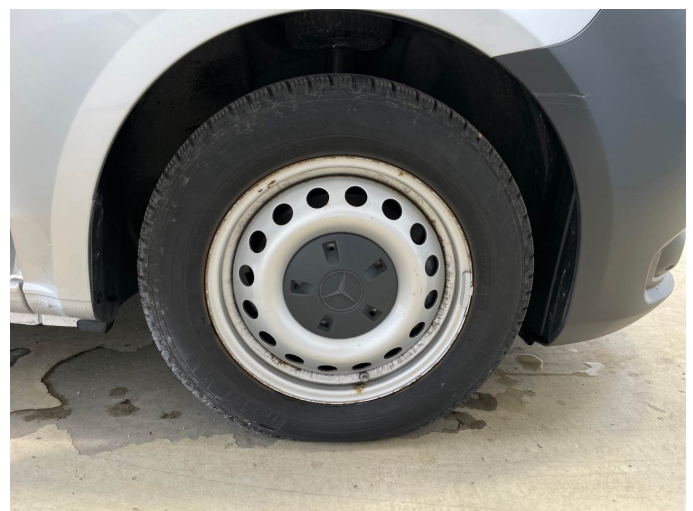
Figure 12: Mounted tyres

- Der montierte Winterradsatz ist kein Bestandteil des Auslieferungsumfangs.
- Für den montierten Radsatz wurde kein Nachweis erbracht.
- Winterradsatz ist kein Bestandteil des Auslieferungsumfangs.

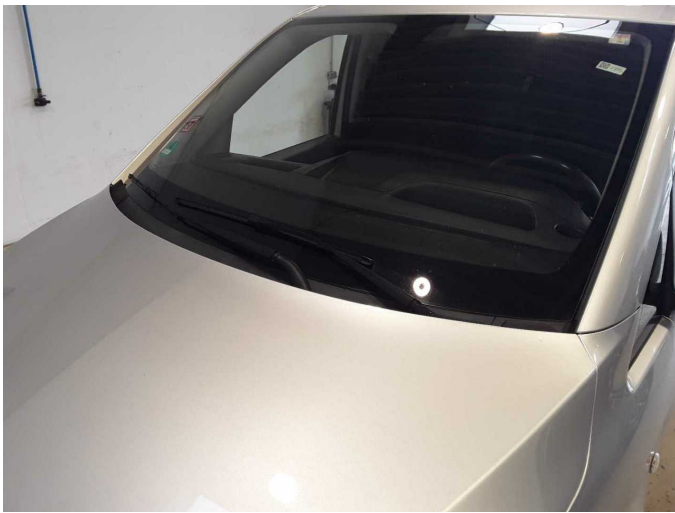
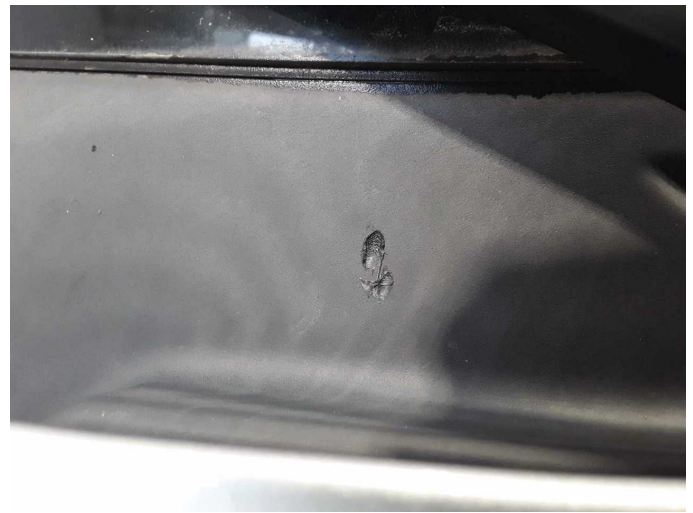
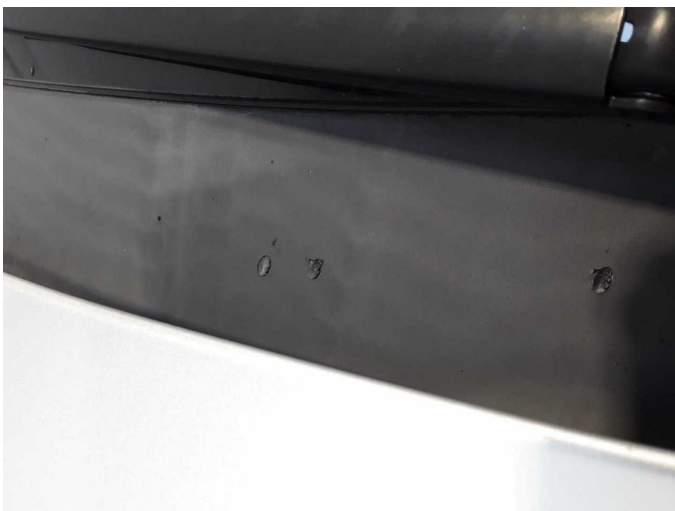
Damage 1: Trim / covers: Trim / covers (Dichtung) - Scratch(es) - Replace

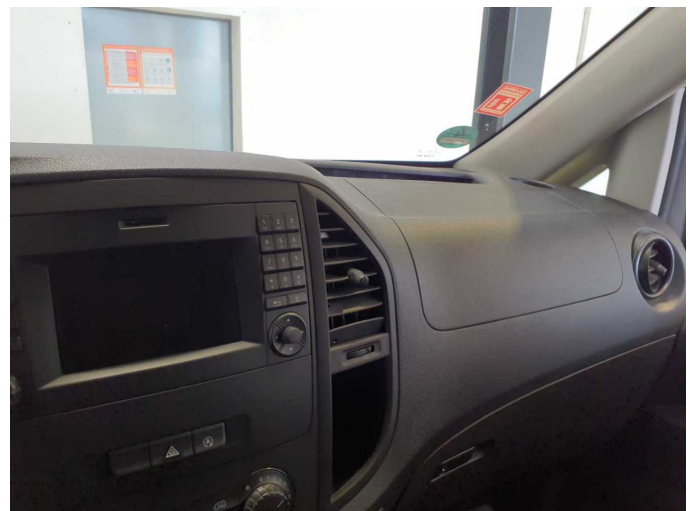
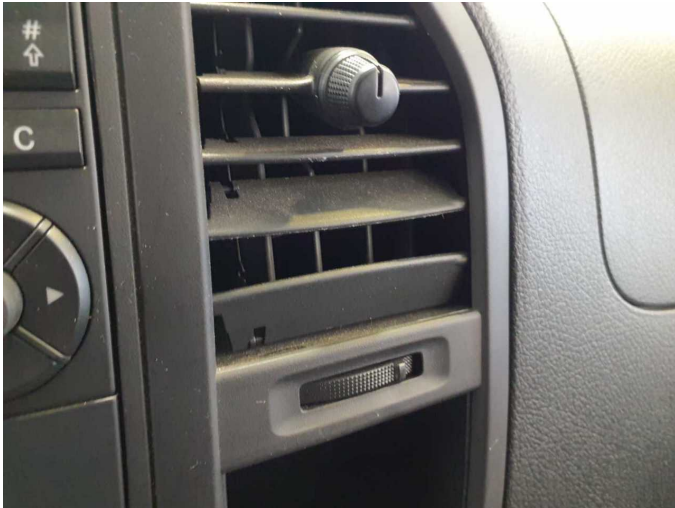
Damage 2: Instrument panel: Air nozzle - centre - Broken / torn - Replace

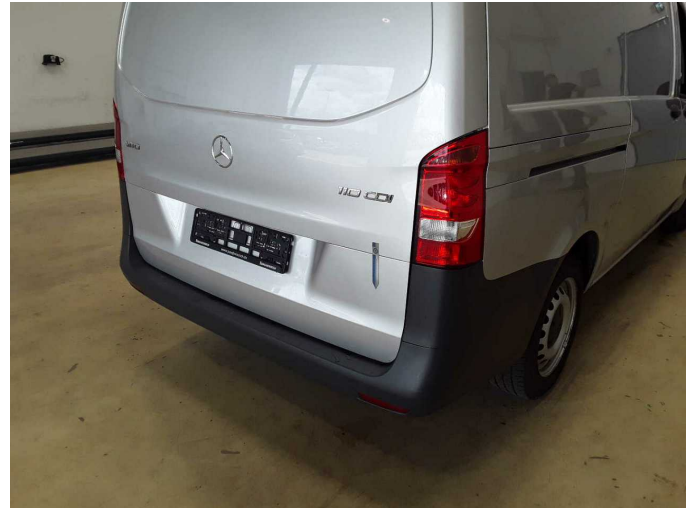
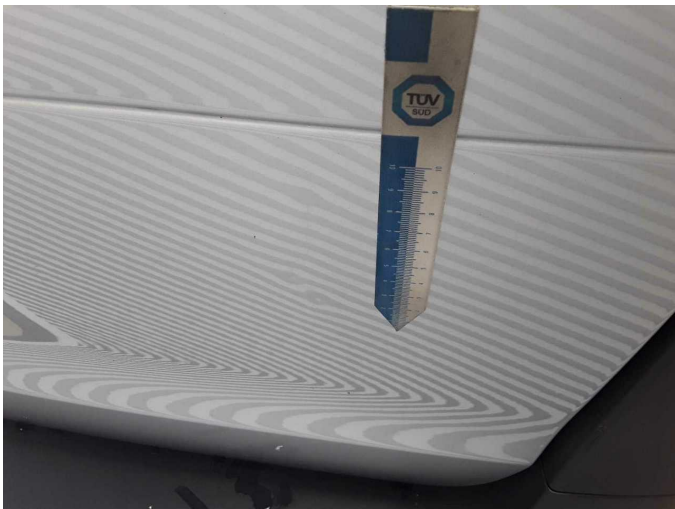
Damage 3: Boot lid / rear door: Boot lid - Dent / paintcoat damage - Smart repair

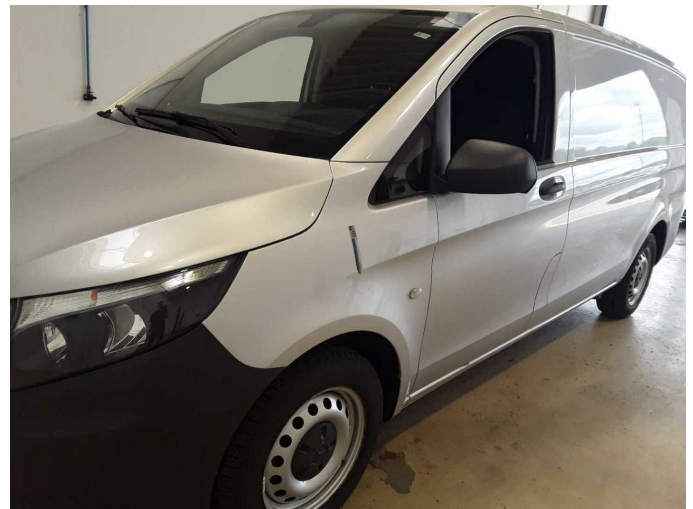
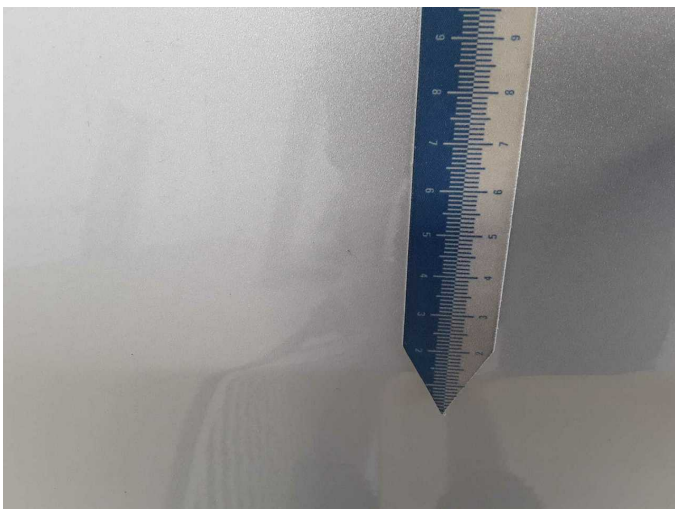
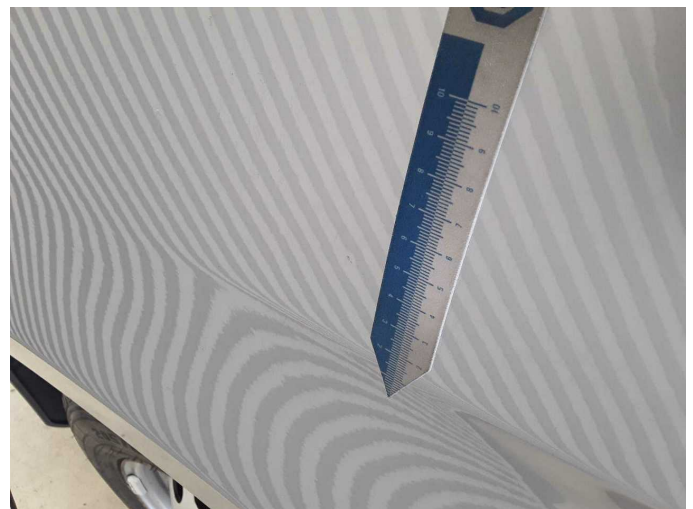
Damage 4: Mudguard - left side: Mudguard - left side - Dent / paintcoat damage - Smart repair

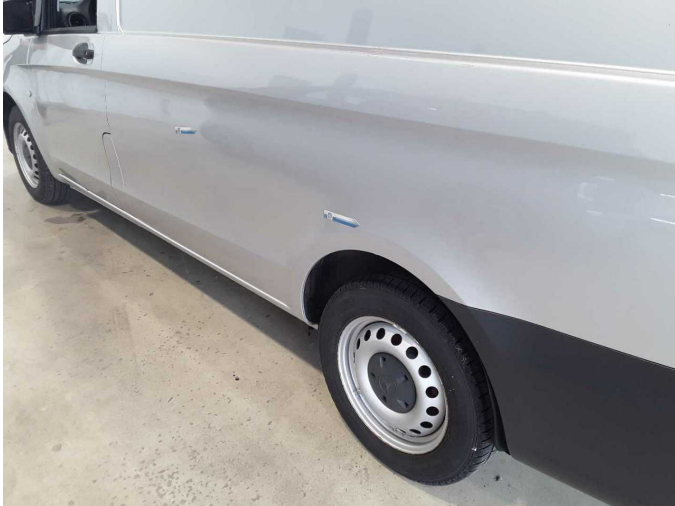
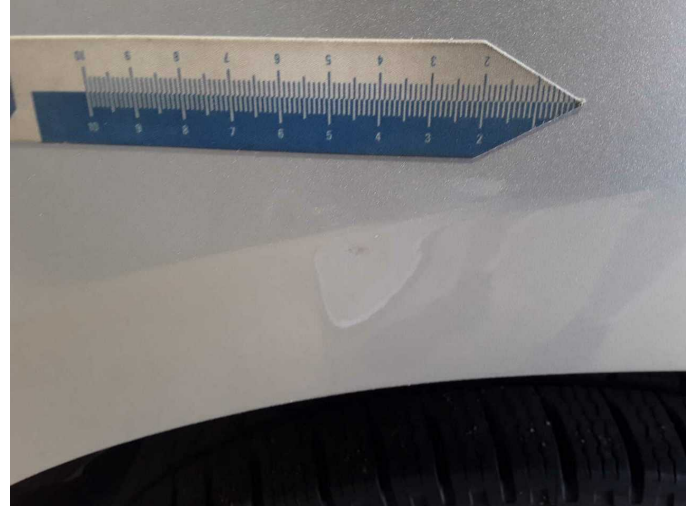
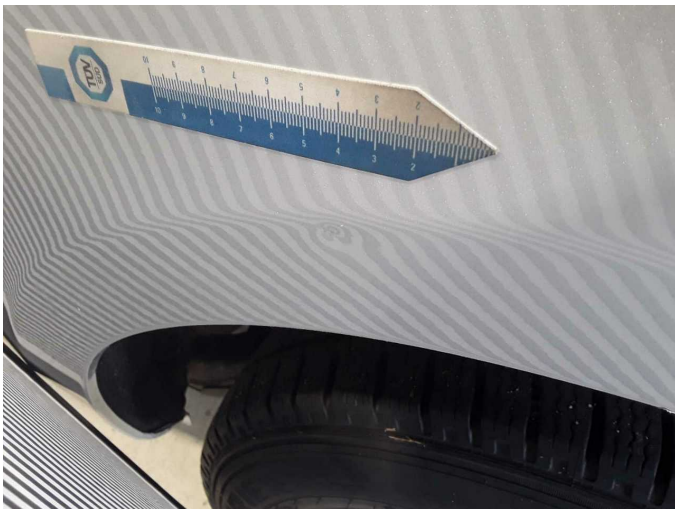
Damage 5: Side panel - rear left side: Side panel - Dent / paintcoat damage - Smart repair

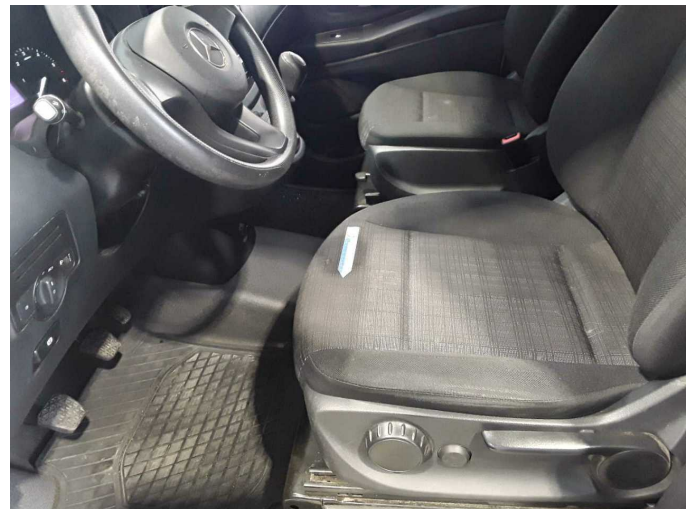
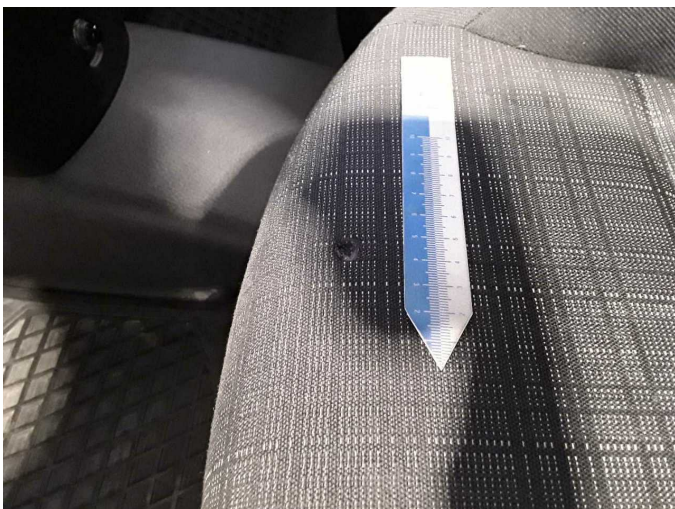
Damage 6: Seat - front: Seat cover - left side - Burn hole (cigarettes) - Smart repair

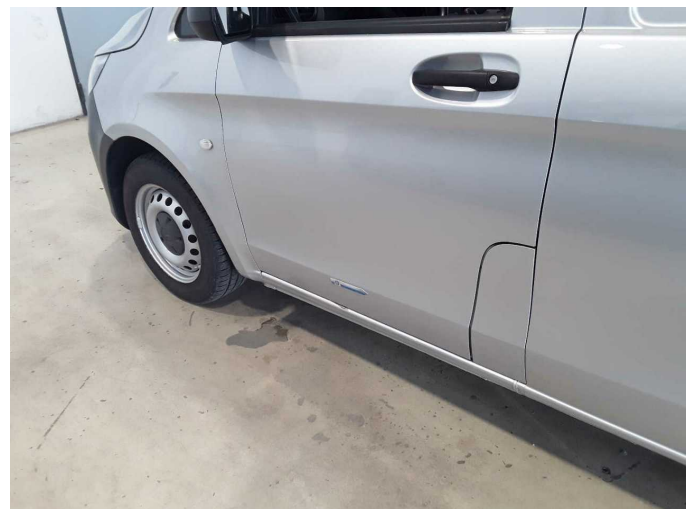
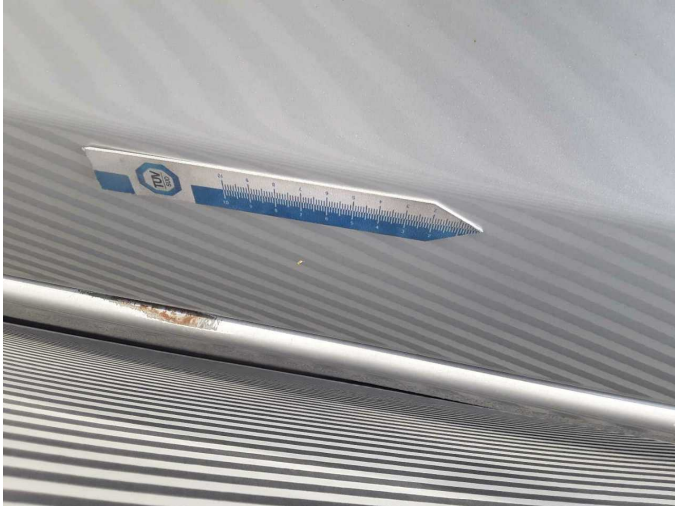
Damage 7: Door - front left side: Door - Dent / paintcoat damage - Smart repair

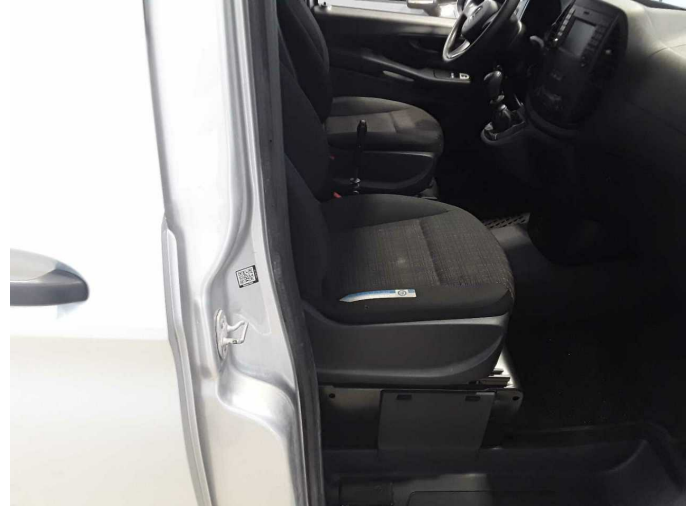
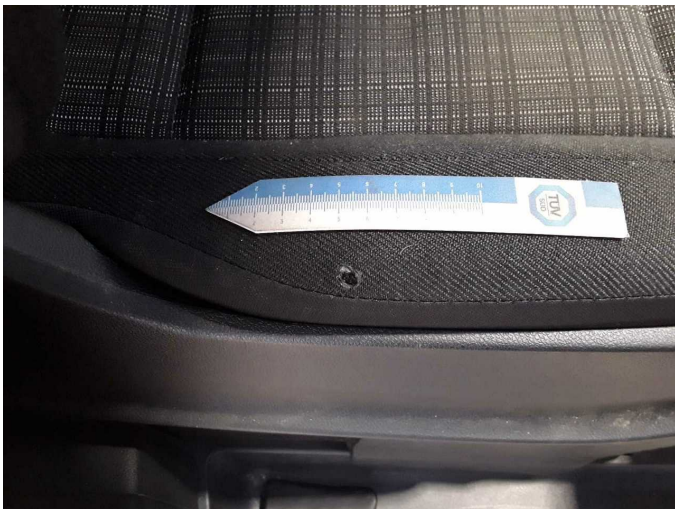
Damage 8: Seat - front: Seat cover - right side - Broken / torn - Smart repair

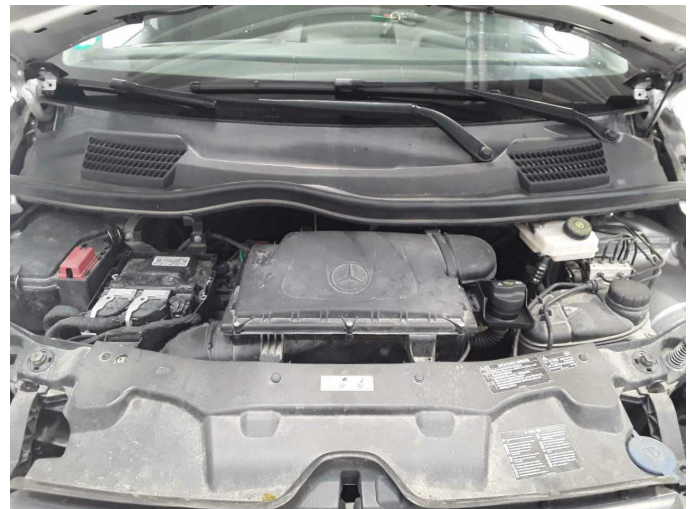
Damage 10: Engine: Engine (Schleifen, unsauber) - Noise - Perform diagnosis

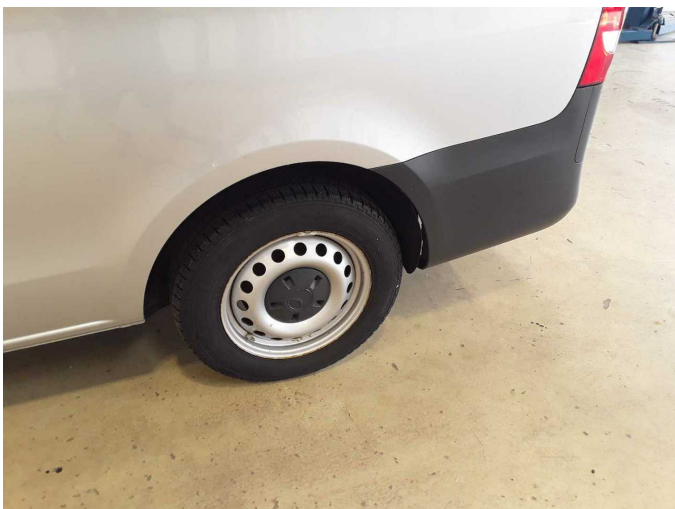
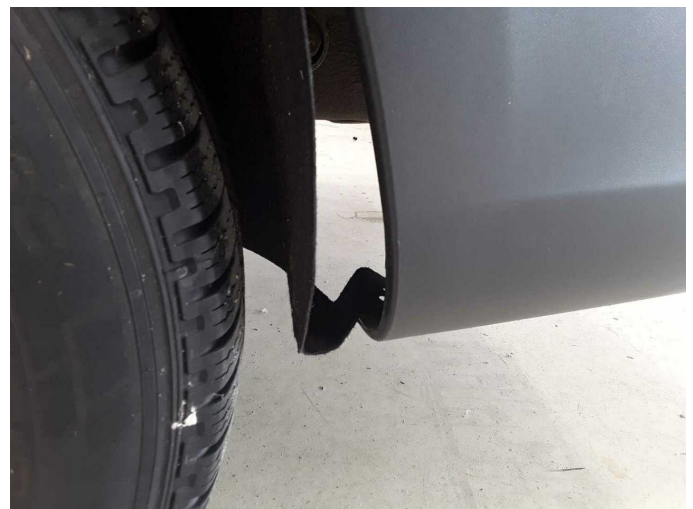
Damage 11: Body: Wheel well - rear left side - Malposition - Replace

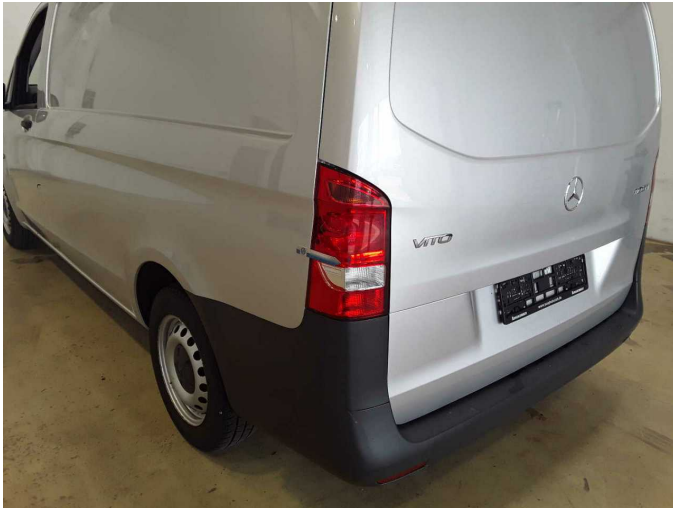
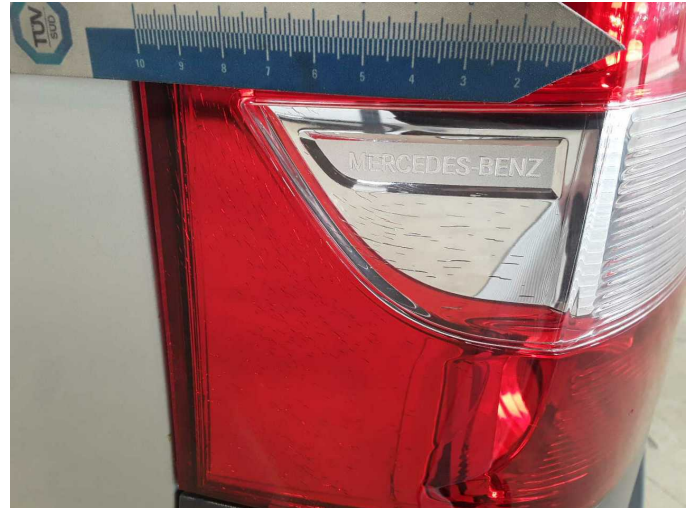
Damage 12: Tail light: Tail lamp - left side - Broken / torn - Replace

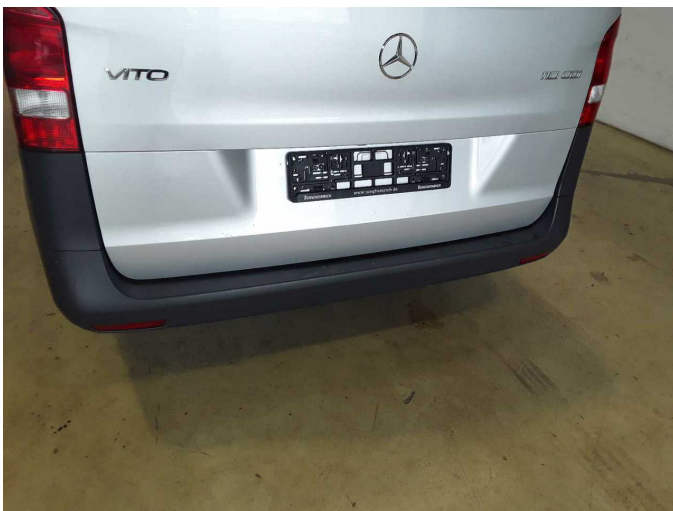
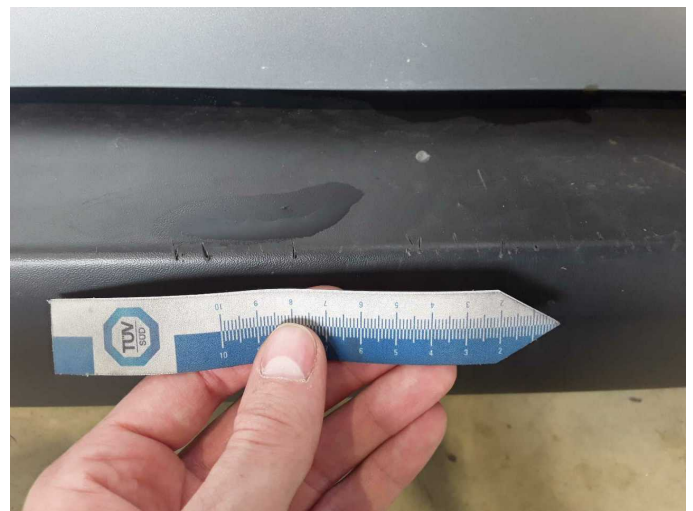
Damage 13: Rear bumper: Rear bumper (unpainted) - Scratch(es) - Loss in value

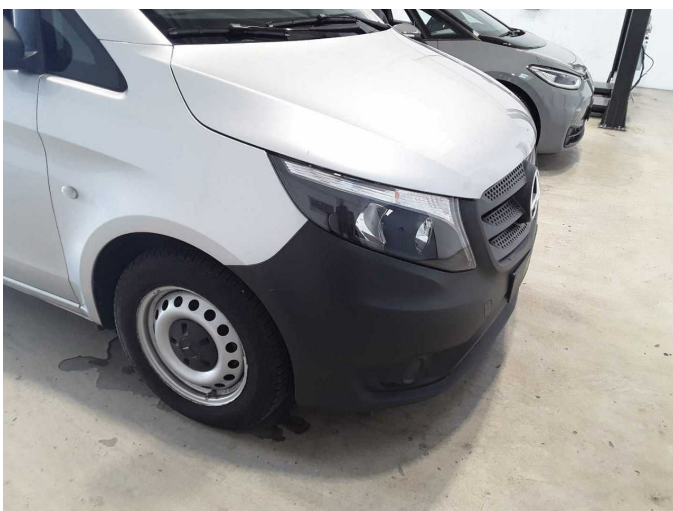
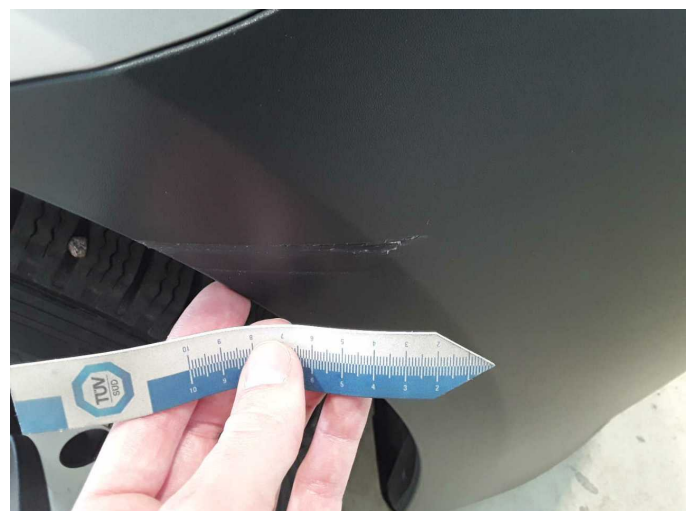
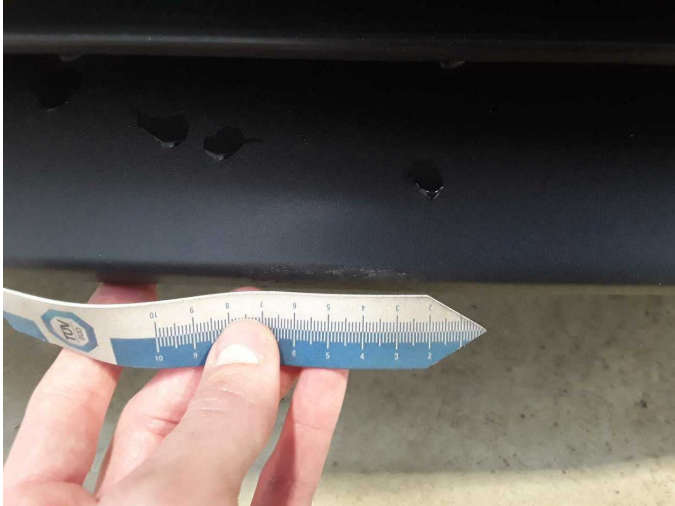
Damage 14: Front bumper: Front bumper (unpainted) - Scratch(es) - Loss in value

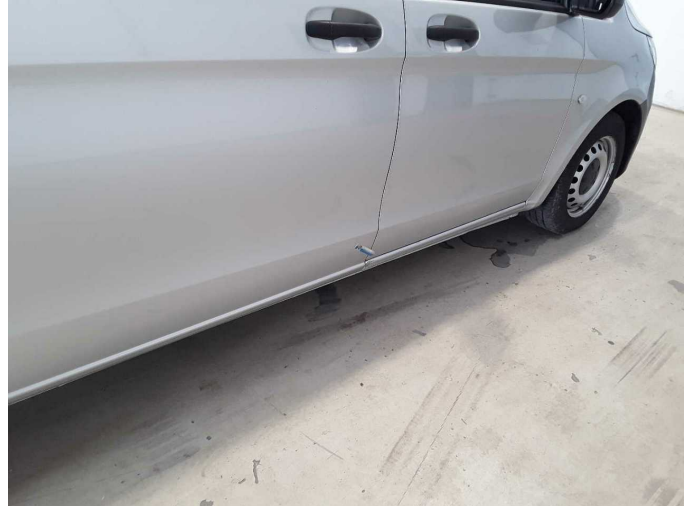
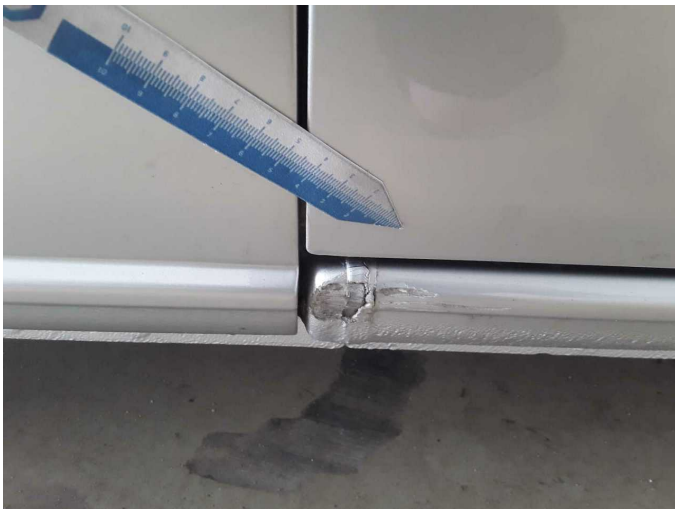
Damage 15: Sill - right side: Sill - Dent / paintcoat damage - Repair and paint

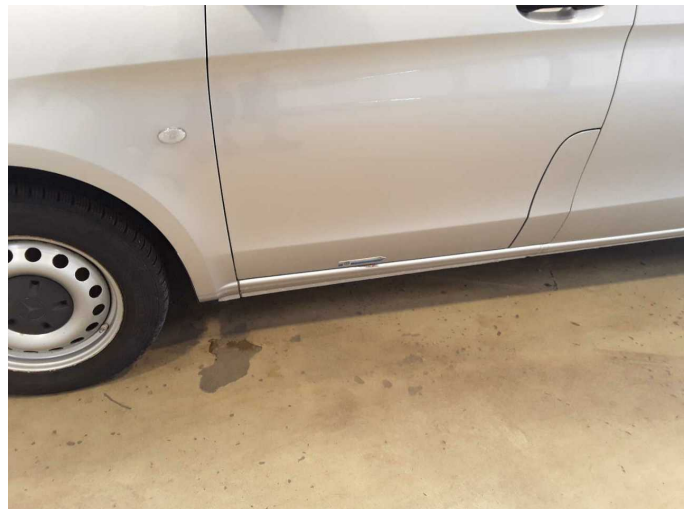
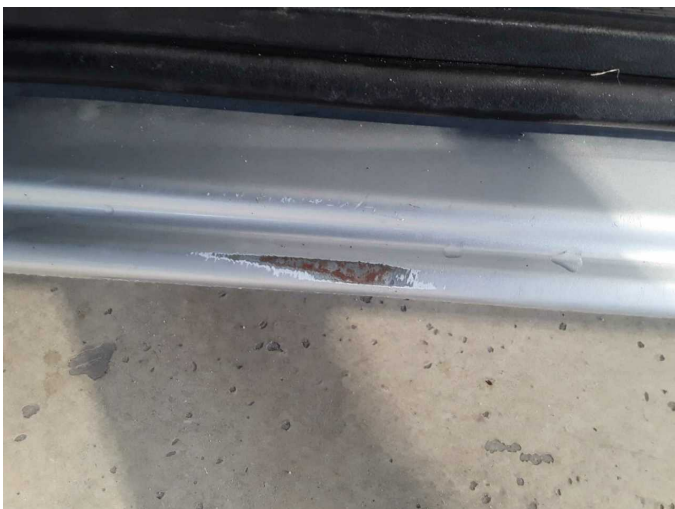
Damage 16: Sill - left side: Sill - Corrosion - Repair and paint

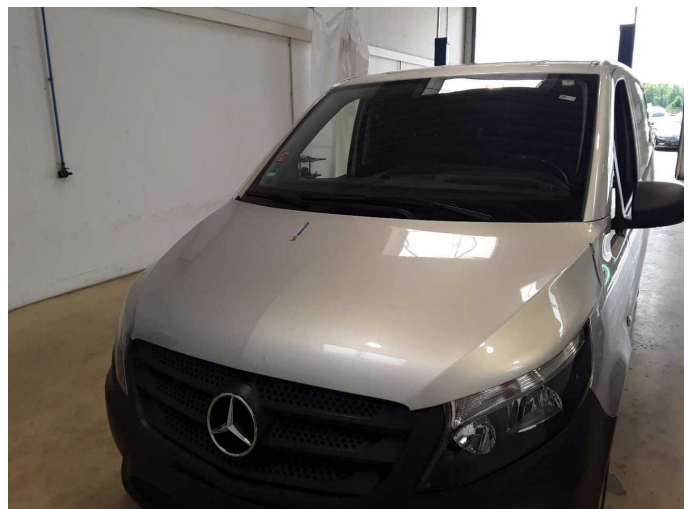
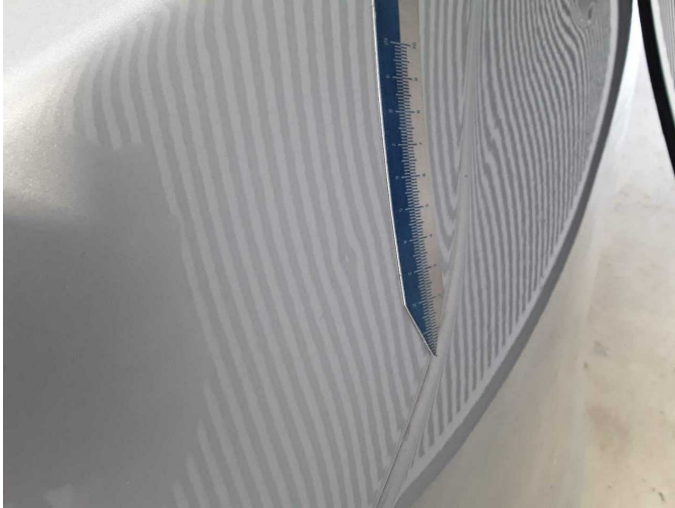
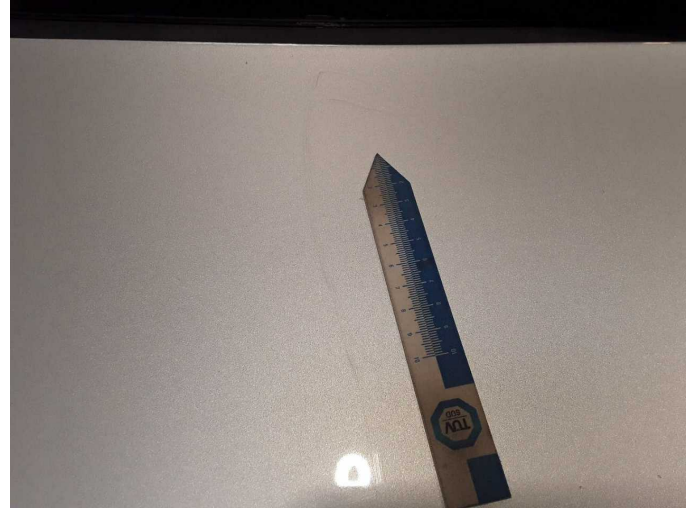
Damage 17: Bonnet: Bonnet - Dent / paintcoat damage - Paint

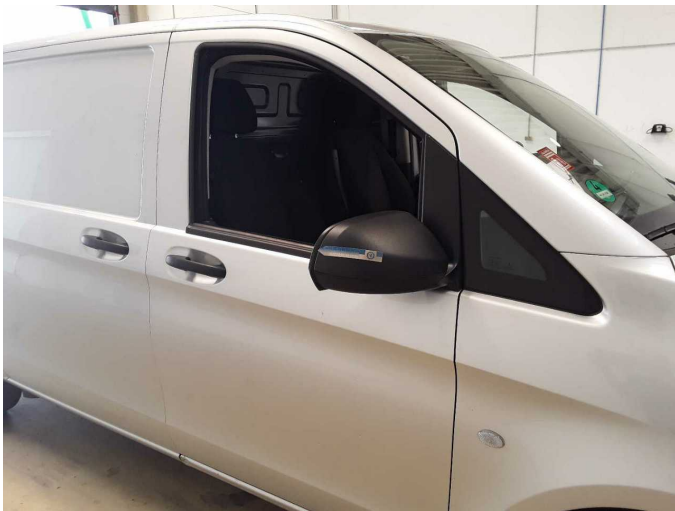
Wear and tear 4: Wing mirror - right side: Cap - Scratch(es) - No deduction

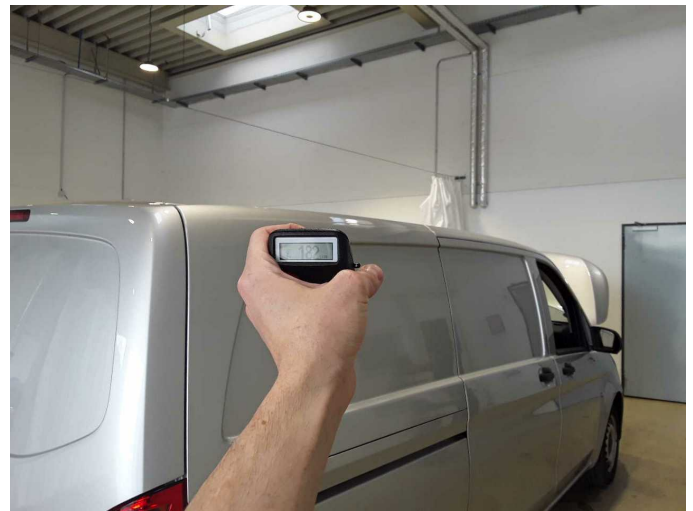
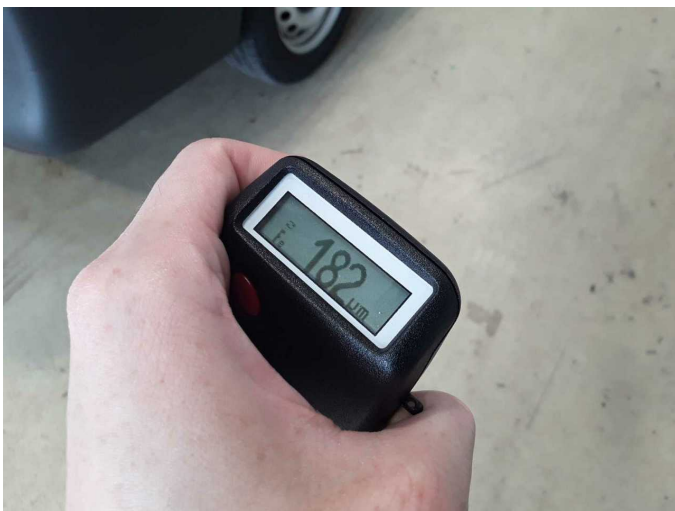
Repainting 1: Roof rail - right side

No.	Repainting
1	Roof rail - right side, Professionally carried out, Invoice of repair done Non-existent
2	Side panel - rear right side, Professionally carried out, Invoice of repair done Non-existent
3	Door - rear right side, Professionally carried out, Invoice of repair done Non-existent

Roof rail - right side	182 µm	Side panel - rear right side	182 µm
Door - rear right side	180 µm
