Expertise

Protocol number: 45701431
Order No. / Reference: 26373117
Inspection date: 29 May 2026

Model: Kodiaq 2.0 TDI DSG Tour

VIN: TMBJJ7NSXP8038822

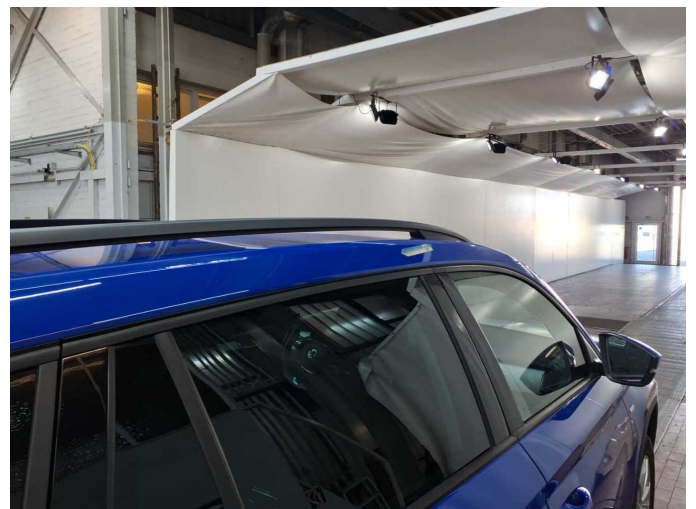
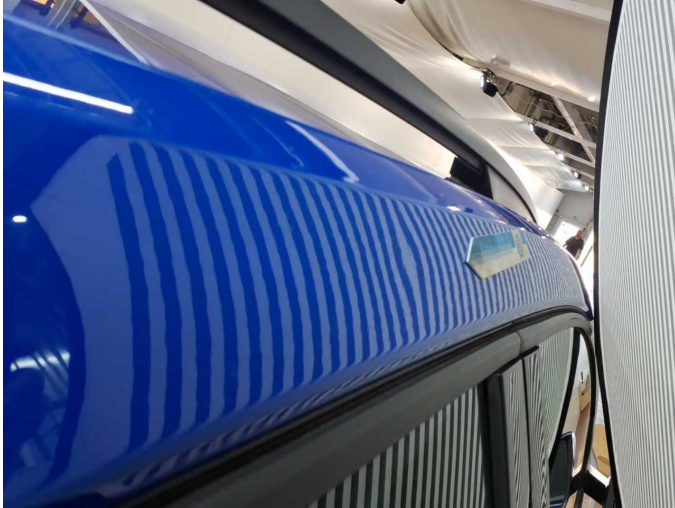
Damage 1: Roof: Roof rail - right side - dent(s) - Smart repair

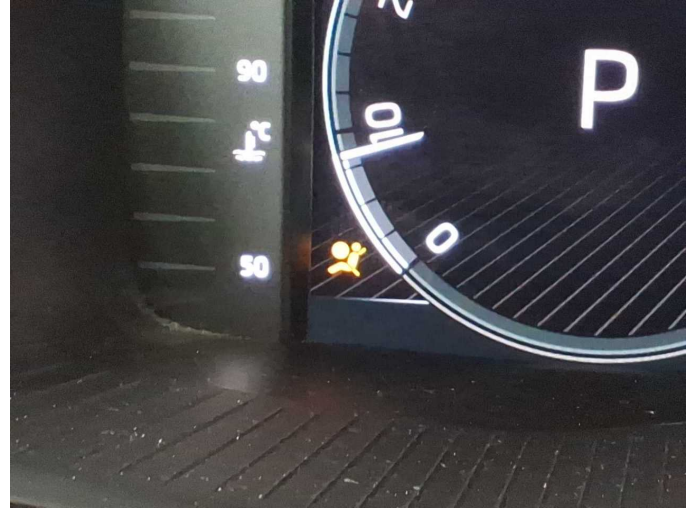
Damage 2: Instrument panel: Indicator light (Airbag) - on - Perform

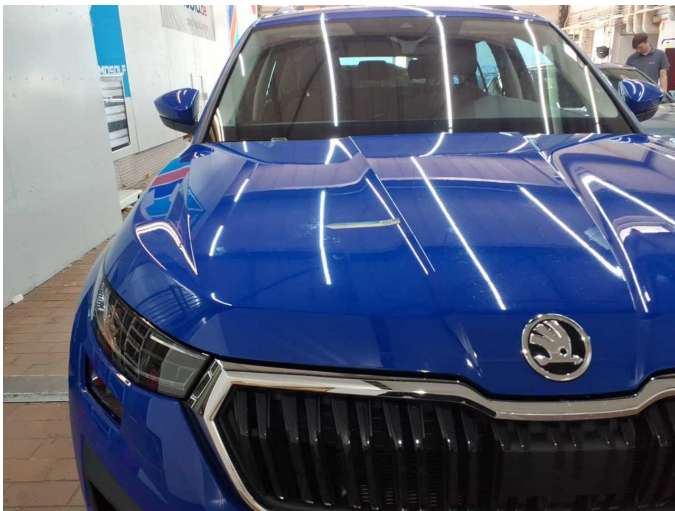
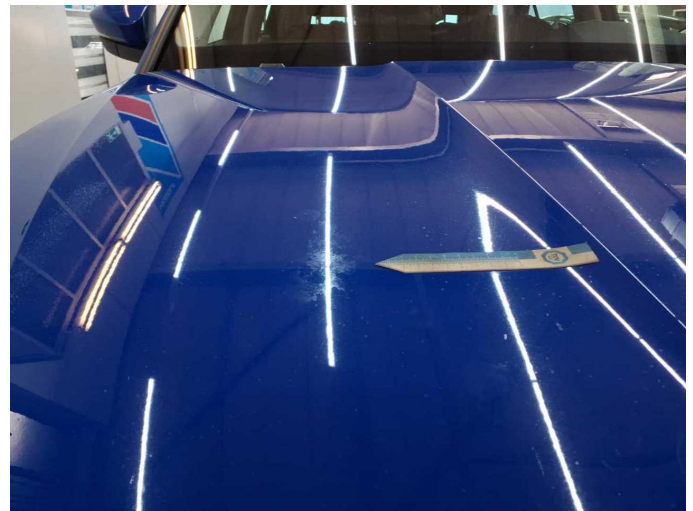
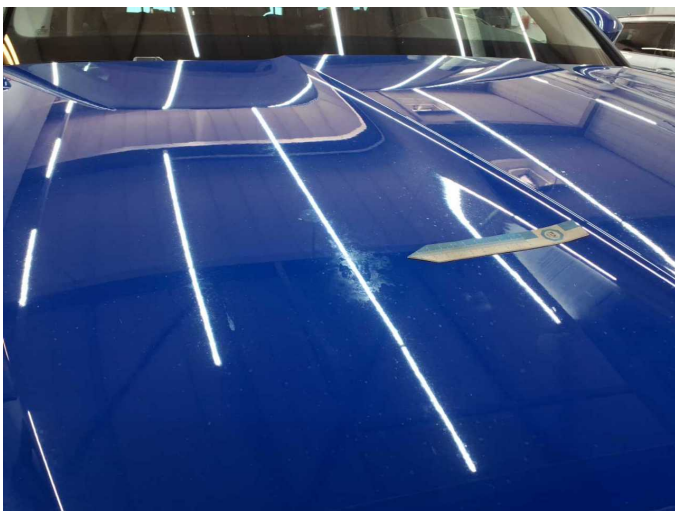
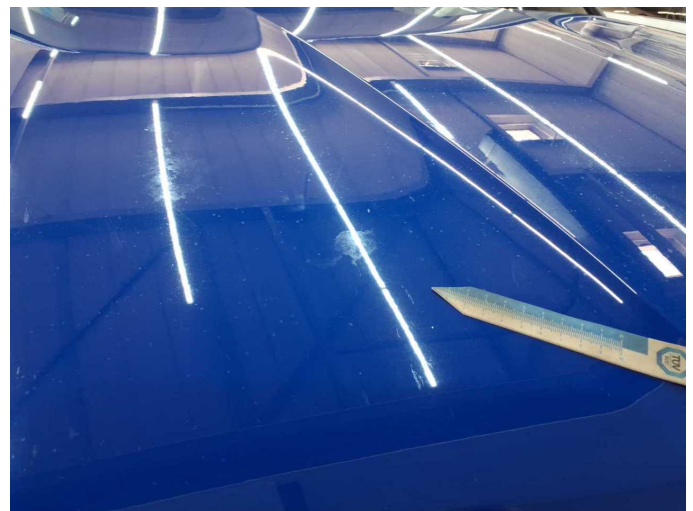
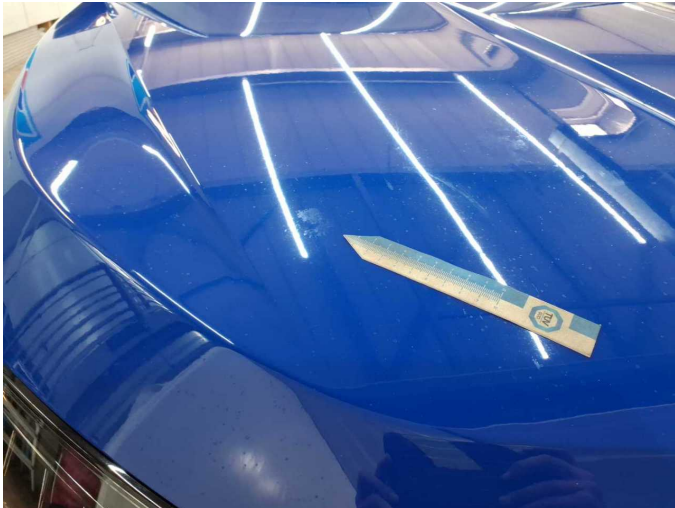
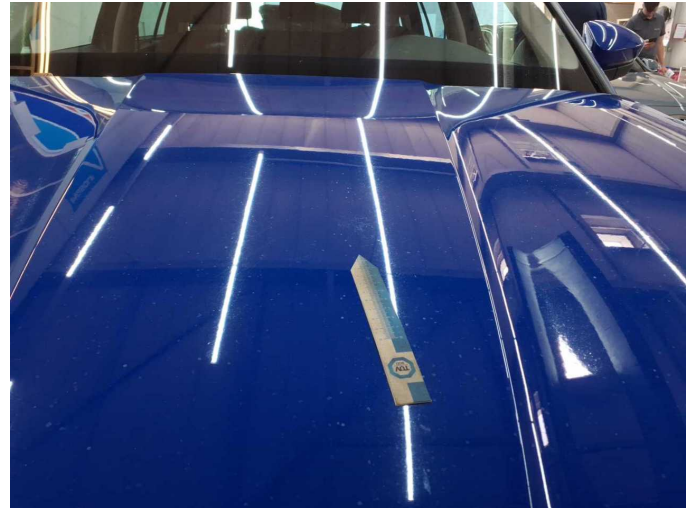
Damage 3: Bonnet: Bonnet (Verätzungen) - Paint defect - Paint

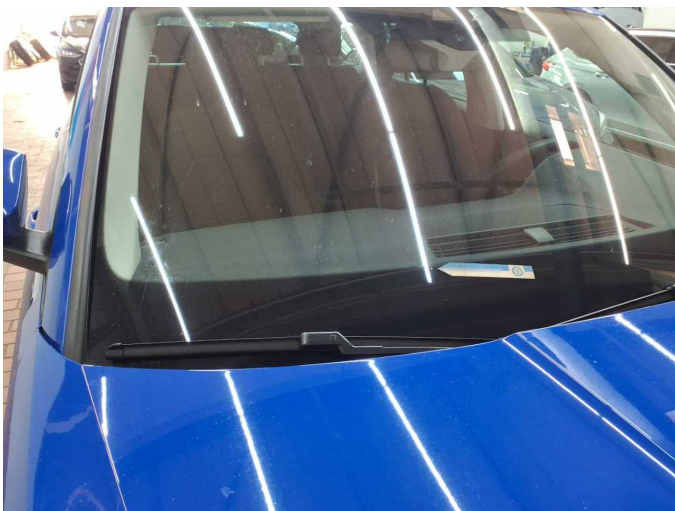
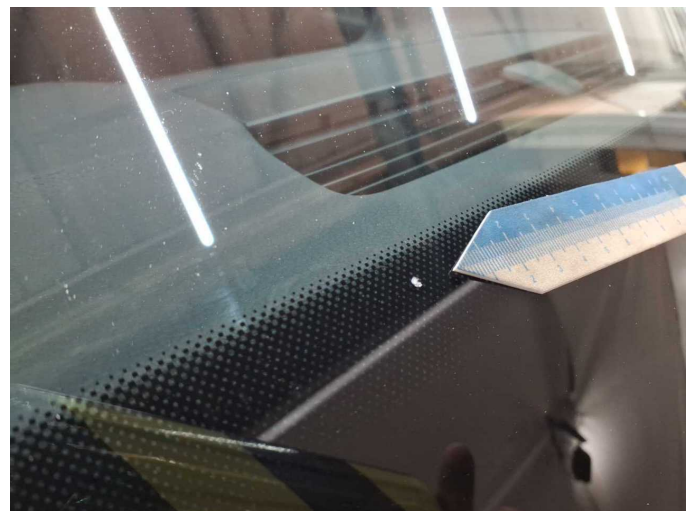
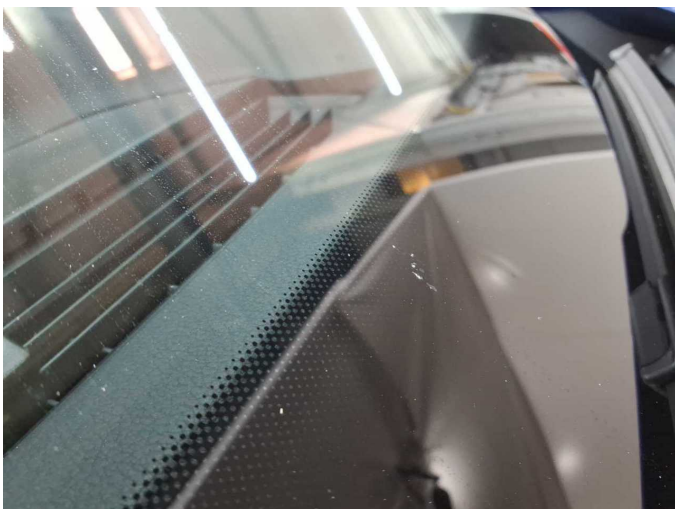
Damage 4: Vehicle glazing: Windscreen - Stone chips - Replace

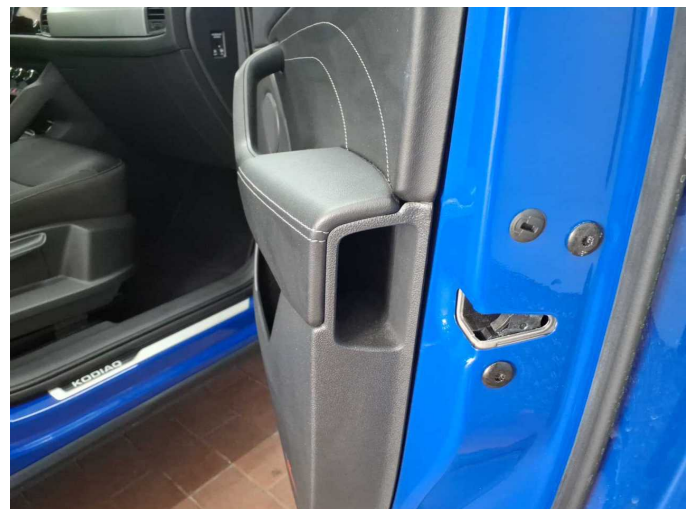
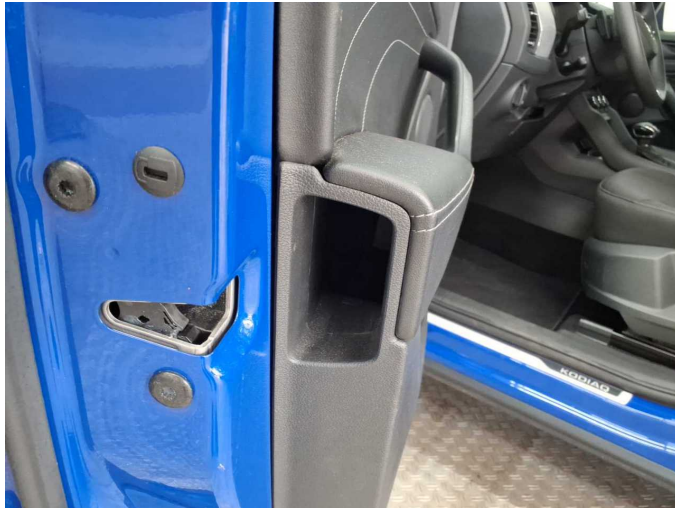
Missing part 1: Equipment: Umbrella - Missing - Replace

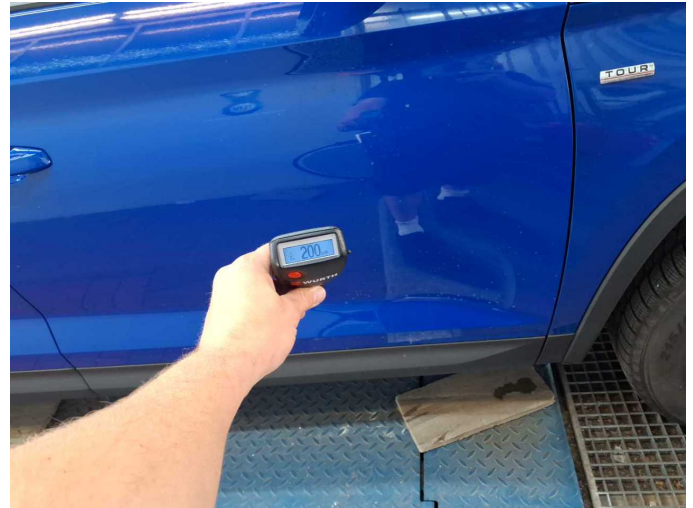
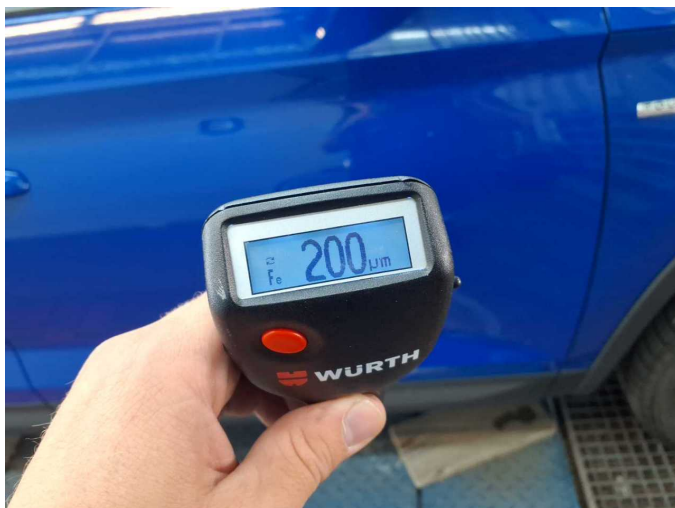
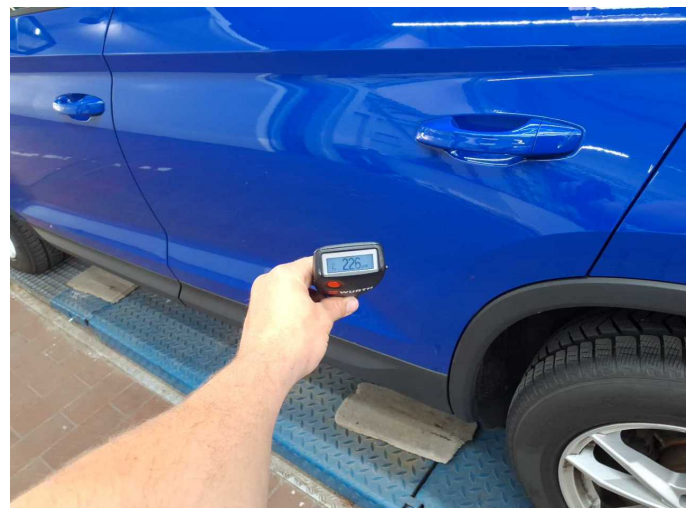
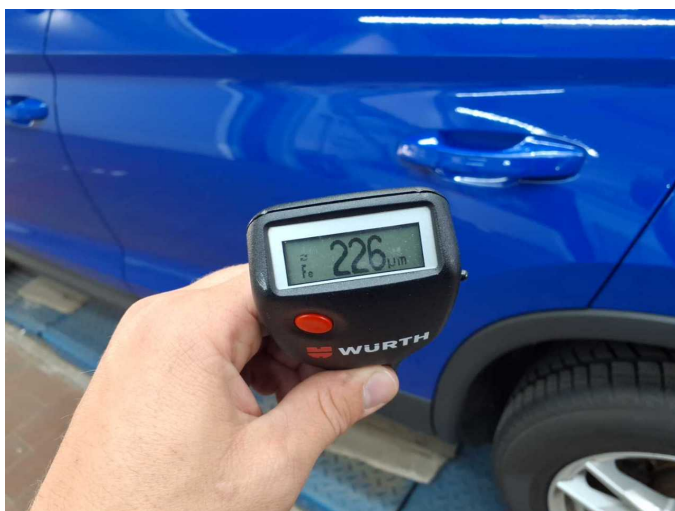
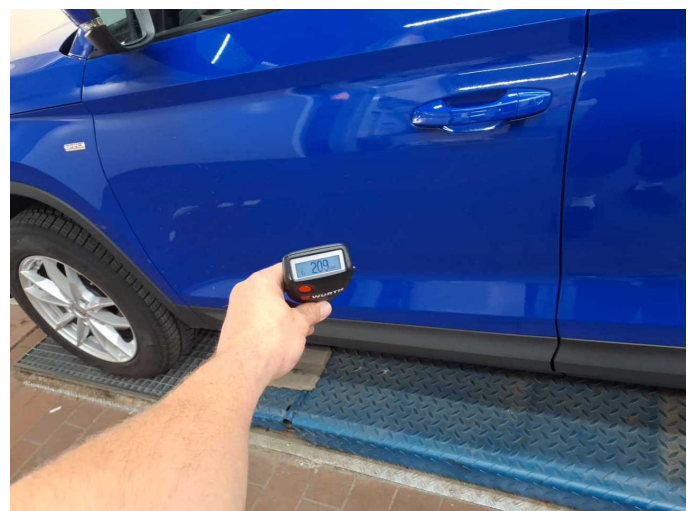
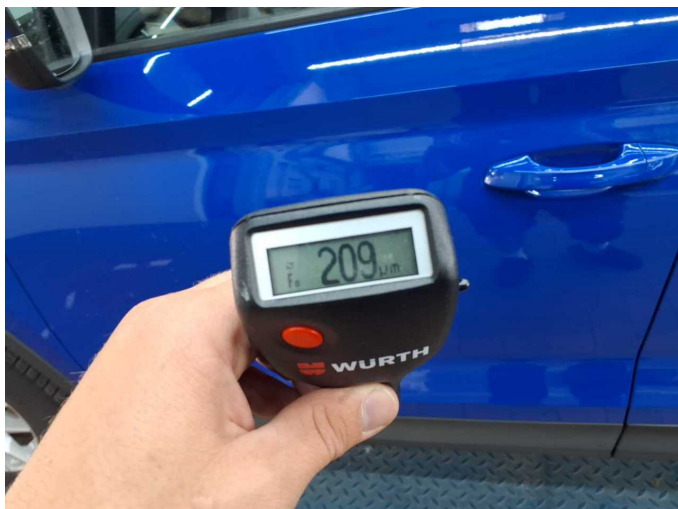
Door - rear left side	226 µm	Door - front left side	209 µm
Door - front right side	200 µm

Repainting 1: Door - rear left side, Door - front left side, Door - front right side
