Expertise

Protocol number: 46179411
Order No. / Reference: 26535047
Inspection date: 24 Jun 2026

Model: S-Max 2.0 EcoBlue Aut. Trend

VIN: WF0JXXWPCJNP22598

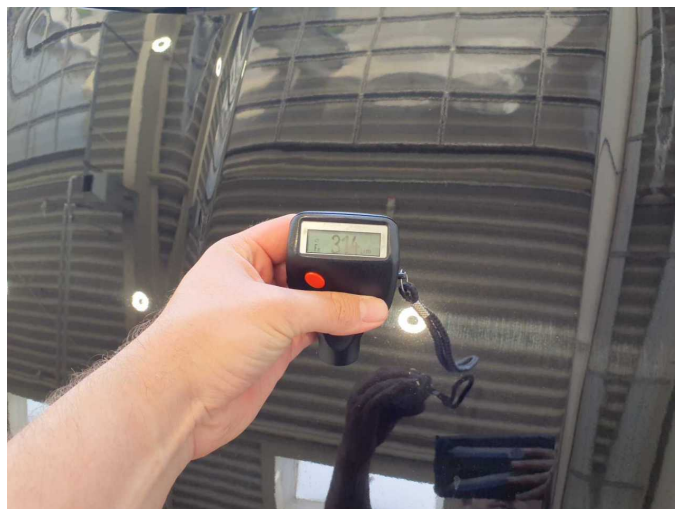
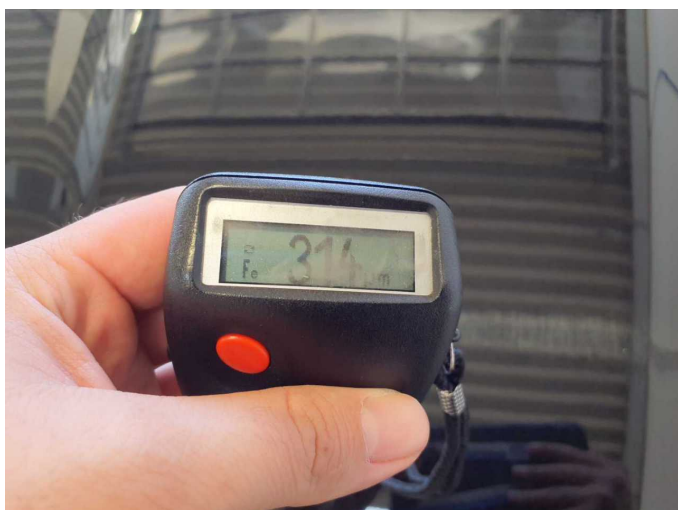
No.	Repainting
1	Bonnet, Professionally carried out

Bonnet	314 μm
--------	-------------------

Repainting 1: Bonnet
