Expertise

Protocol number: 45928457
Order No. / Reference: 26412293
Inspection date: 12 Jun 2026

Model: Focus Turnier 1.5 EcoBlue Start-Stopp-System Aut. TITANIUM

VIN: WF0PXXGCHPPL83828

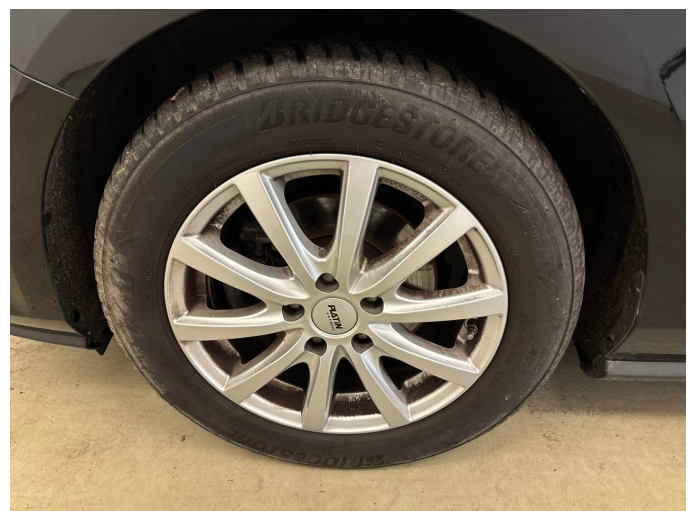
Figure 12: Mounted tyres

Mounted tyres				
#	Tyre size	Type of tyre	Manufacturer	Tread depth
1)	205/60 R16 92H	Winter tyres on Light alloy	Bridgestone	3mm / 3mm
2)	205/60 R16 92H	Winter tyres on Light alloy	Bridgestone	4mm / 4mm

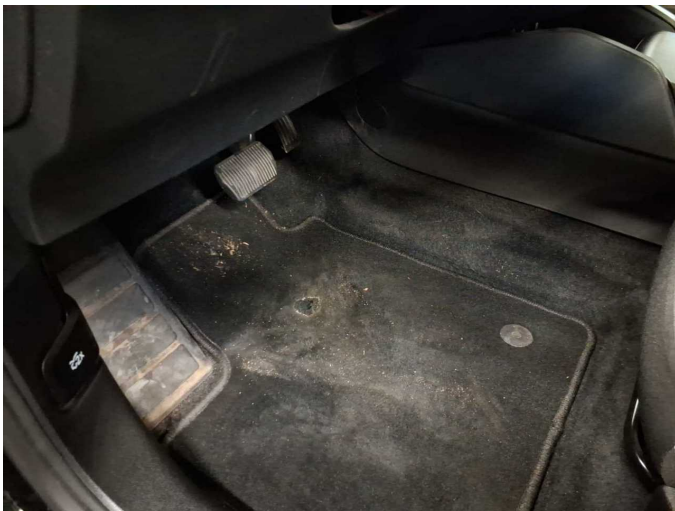
Damage 3: Trim / covers: Floor mats - Holes - Replace

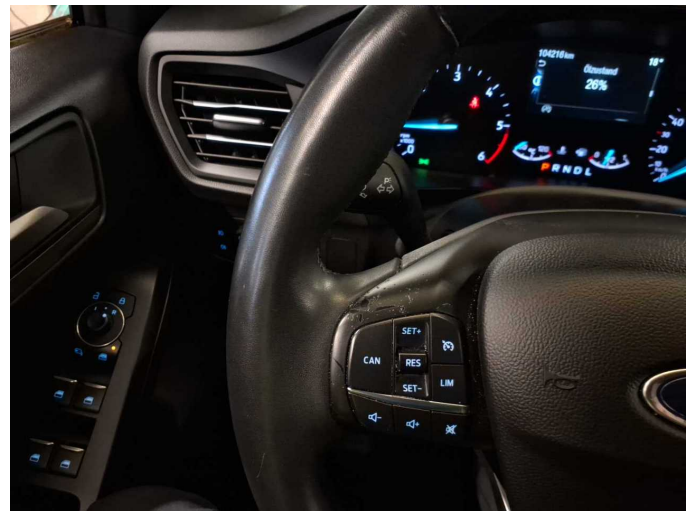
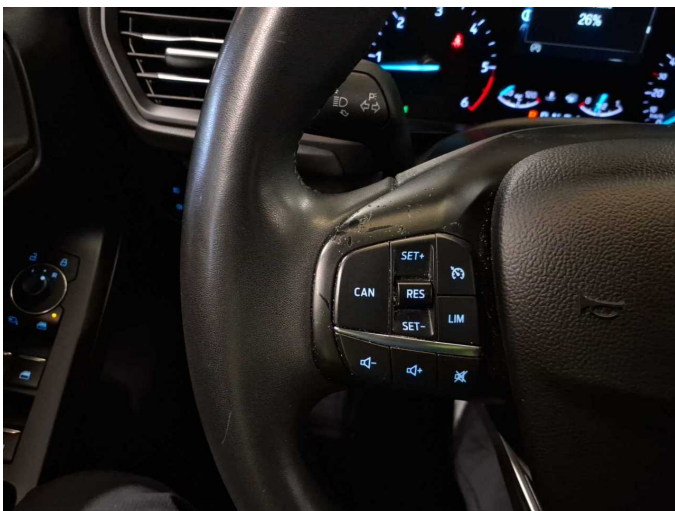
Damage 4: Steering system: Steering wheel (Abdeckung) - Scratch(es) - Loss in value

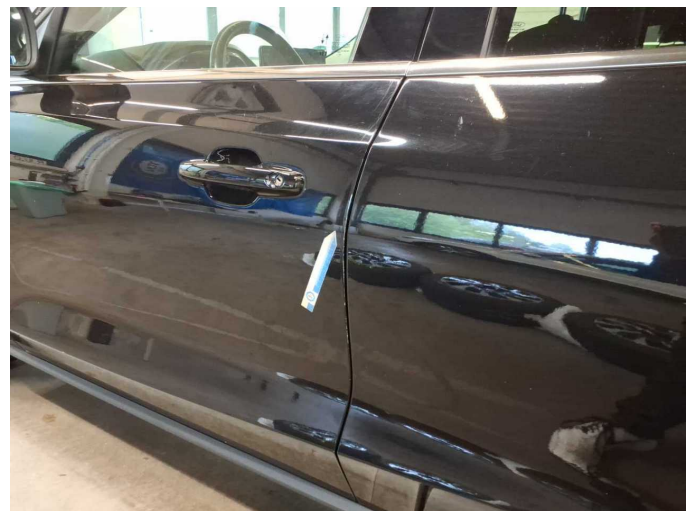
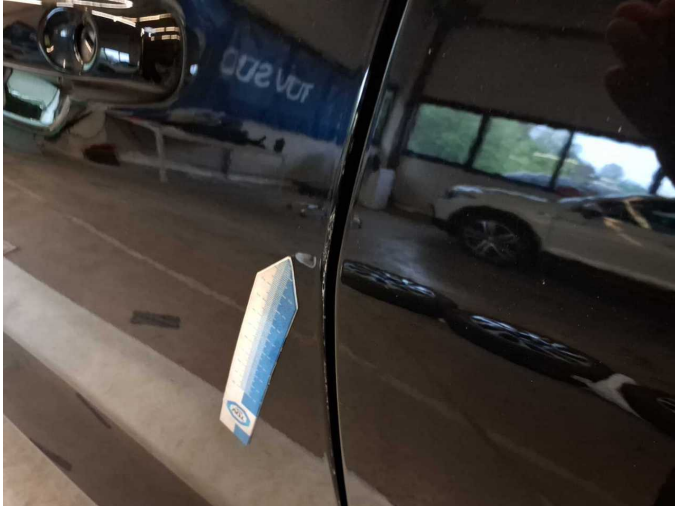
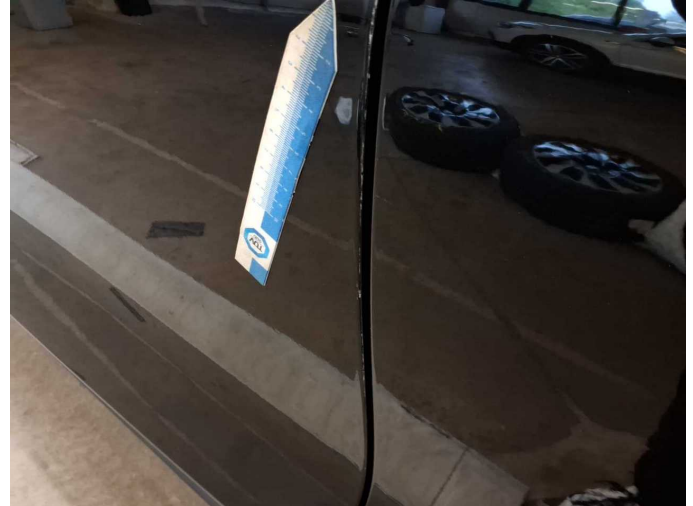
Damage 5: Door - front left side: Door edge - Scratch(es) - Smart repair

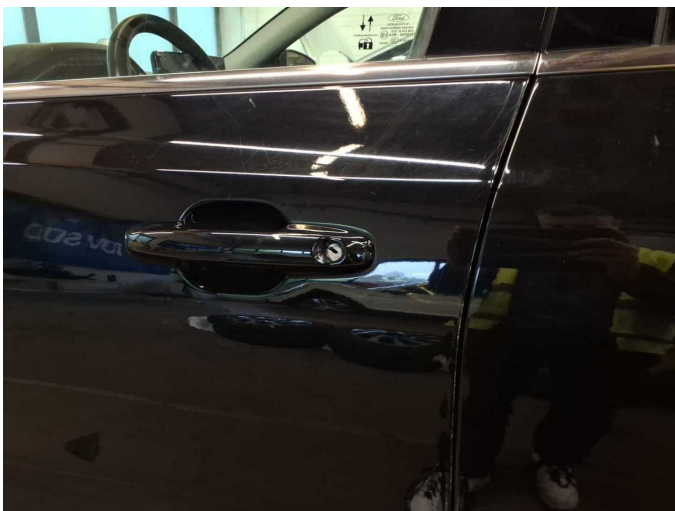
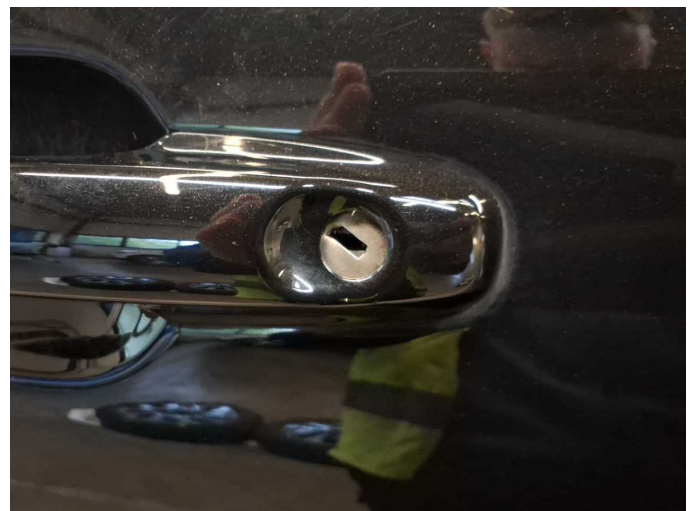
Damage 7: Door - front left side: Lock / Locking mechanism - Damaged - Replace

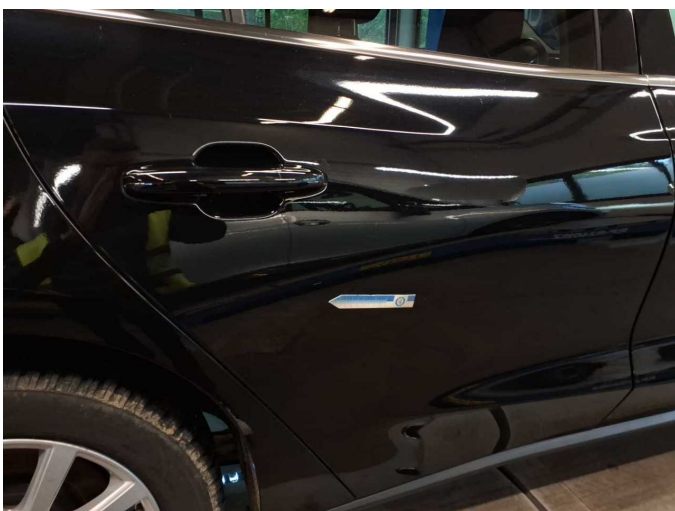
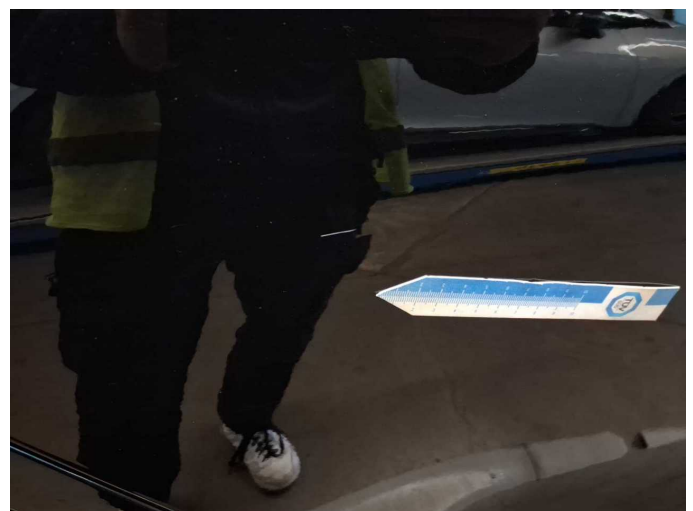
Damage 8: Door - rear right side: Door - Scratch(es) - Paint

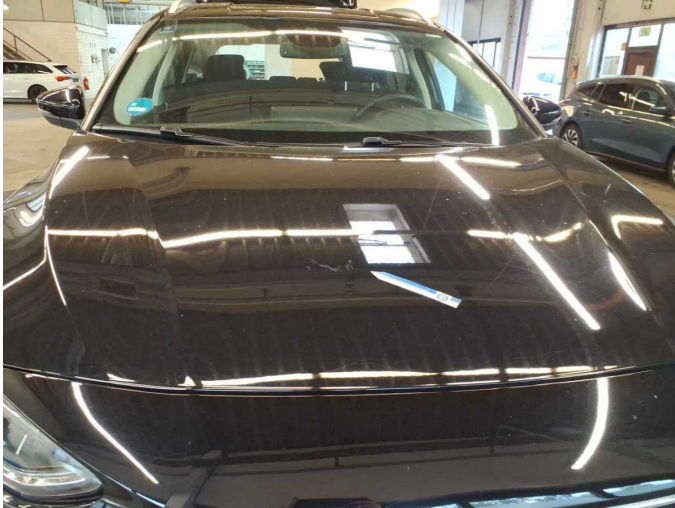
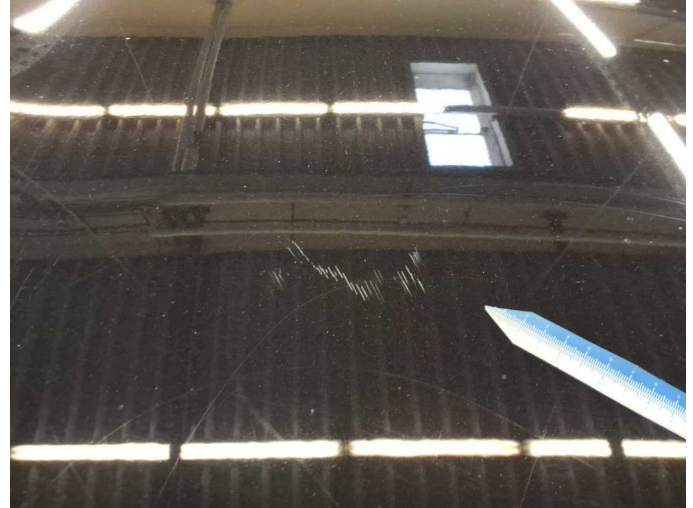
Damage 9: Bonnet: Bonnet - Scratched - Paint

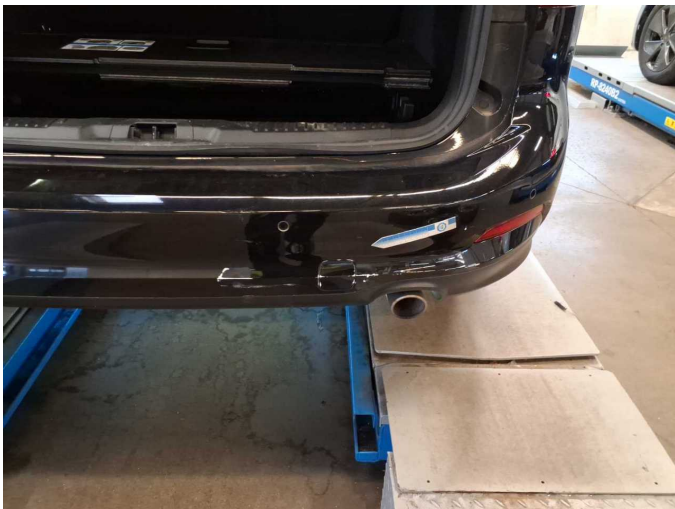
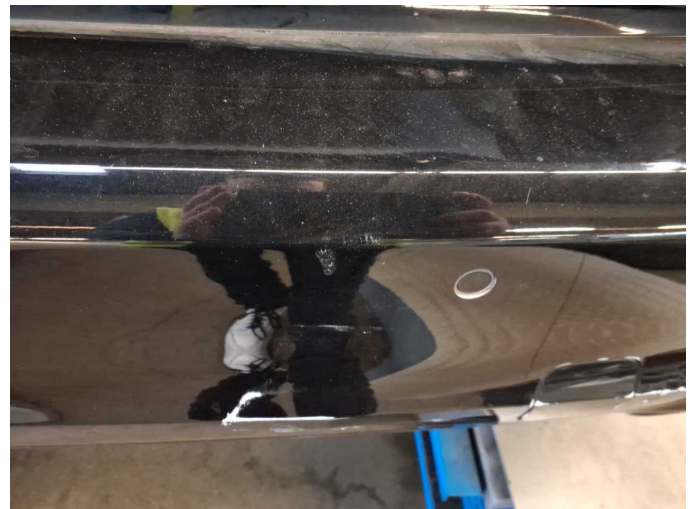
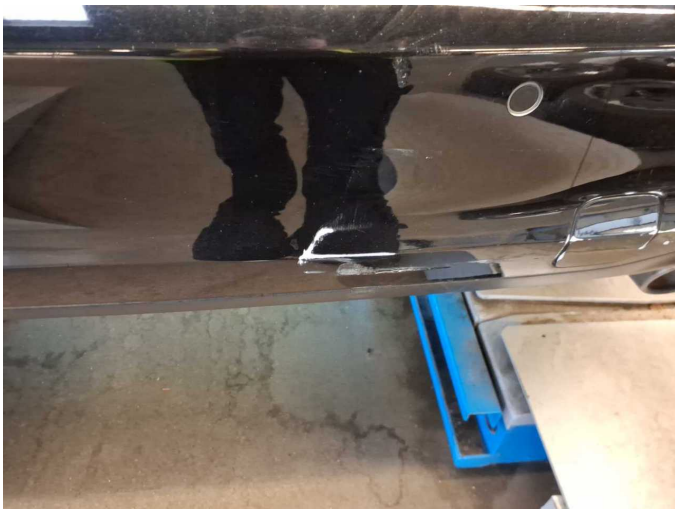
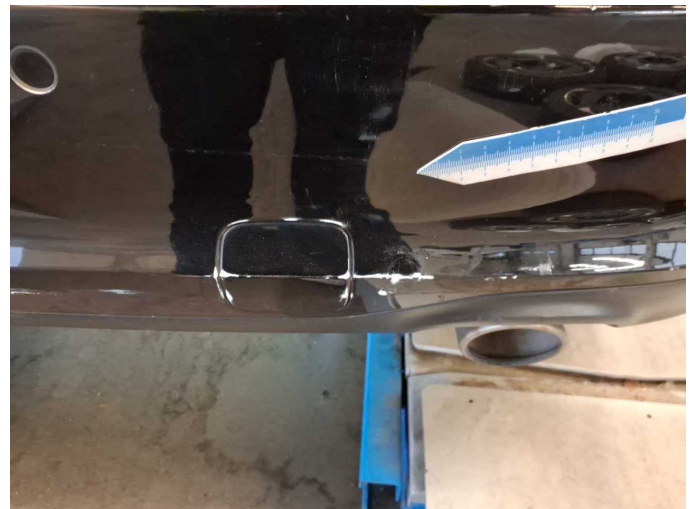
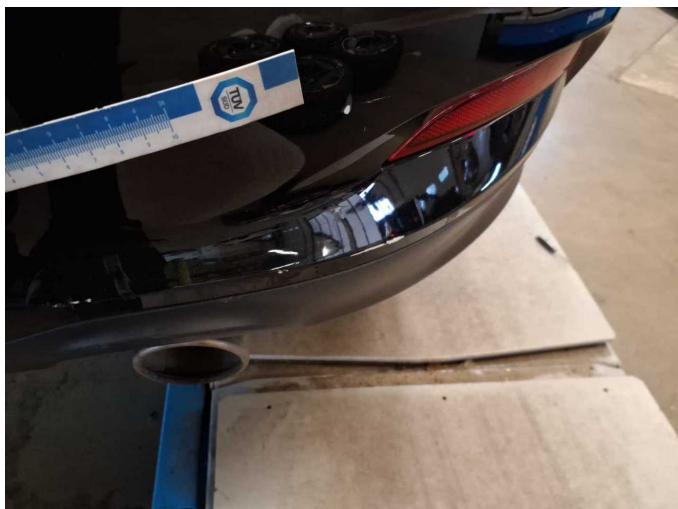
Damage 10: Rear bumper: Rear bumper (inkl. Abdeckung) - Scratched - Repair and paint
