Expertise

Protocol number: 45905125
Order No. / Reference: 26487907
Inspection date: 11 Jun 2026

Manufacturer: Volvo

Model: XC60 T8 AWD Recharge Geartronic R-Design

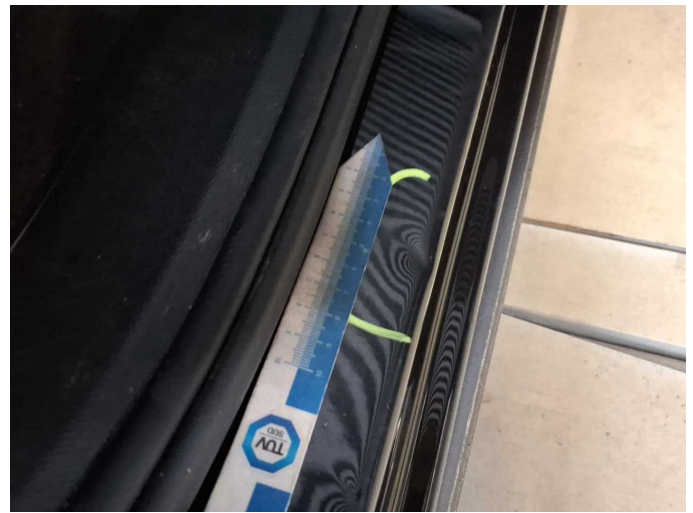
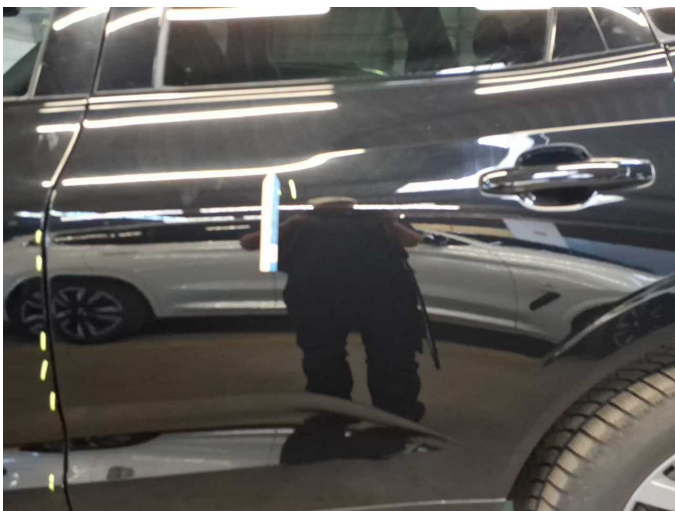
Damage 2: Side panel - rear right side: Sill - dent(s) - Smooth repair work

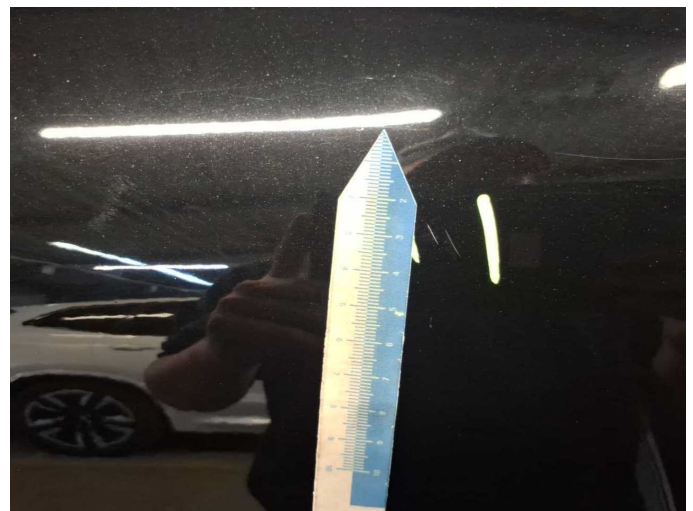
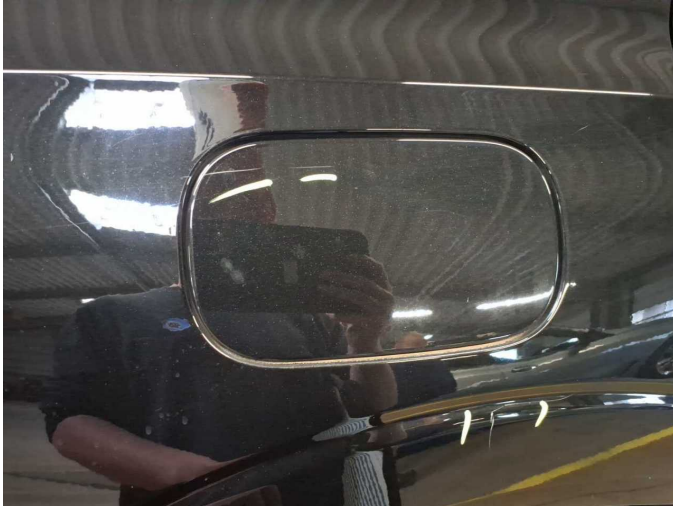
Damage 3: Door - rear left side: Door - Scratch(es) - Smart repair

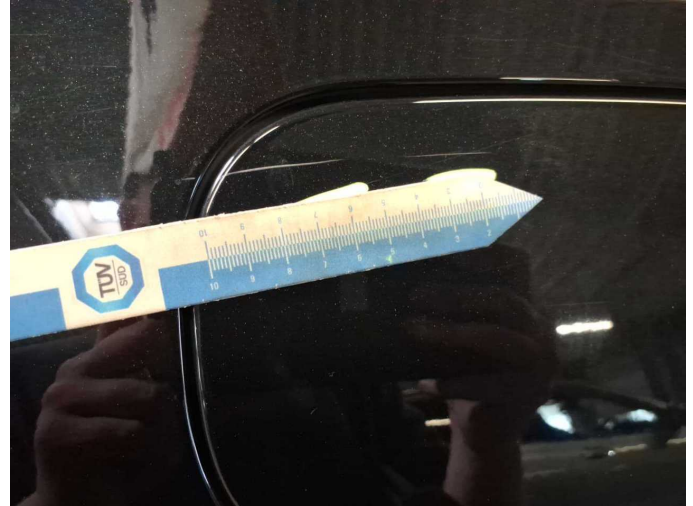
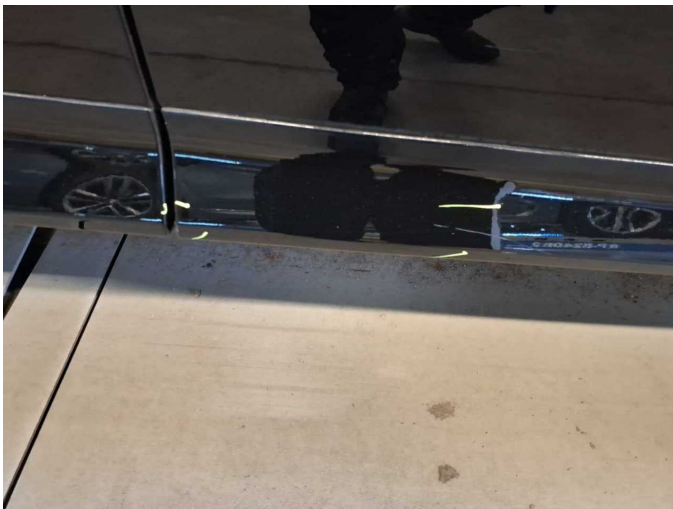
Damage 4: Fuel system: Tank cap - Scratch(es) - Smart repair

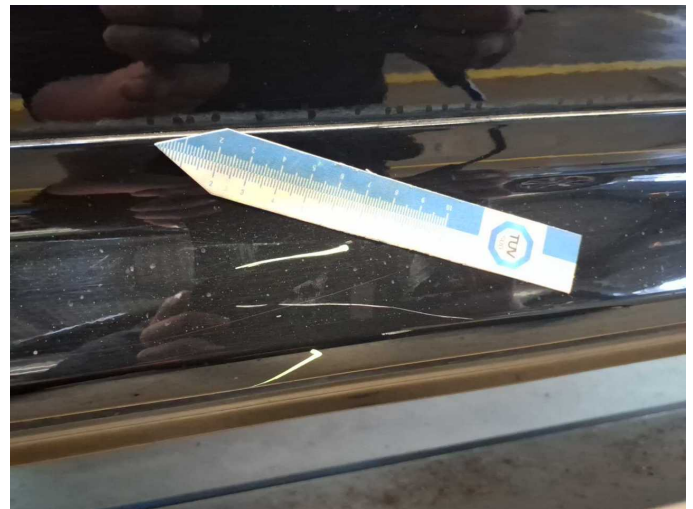
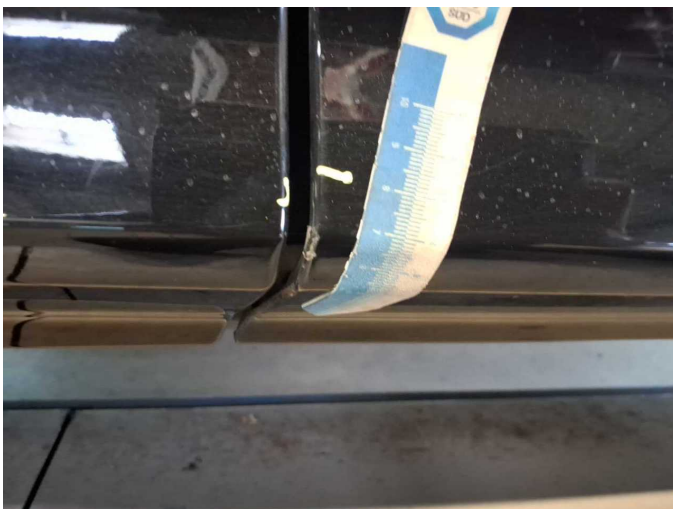
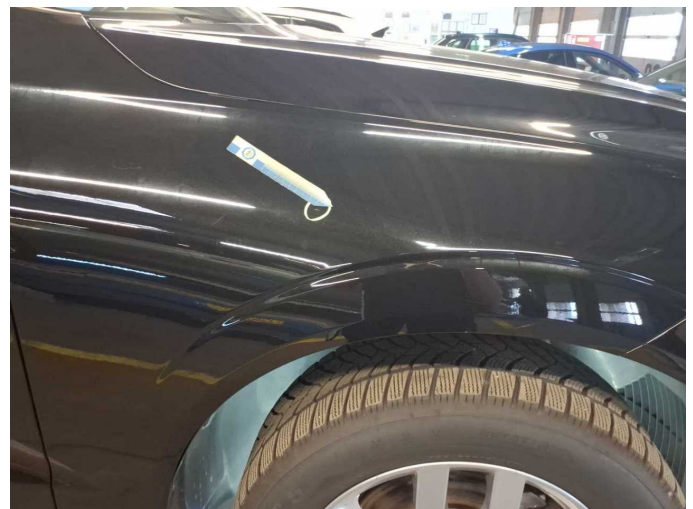
Damage 5: Door - front right side: Brightware - lower - Scratch(es) - Smart repair

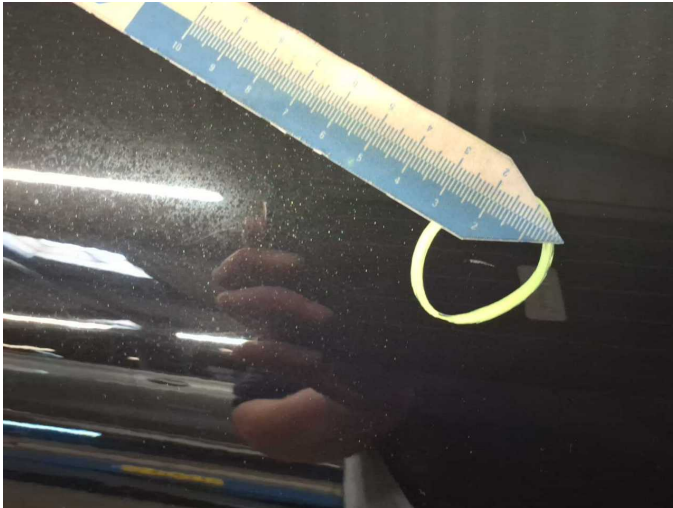
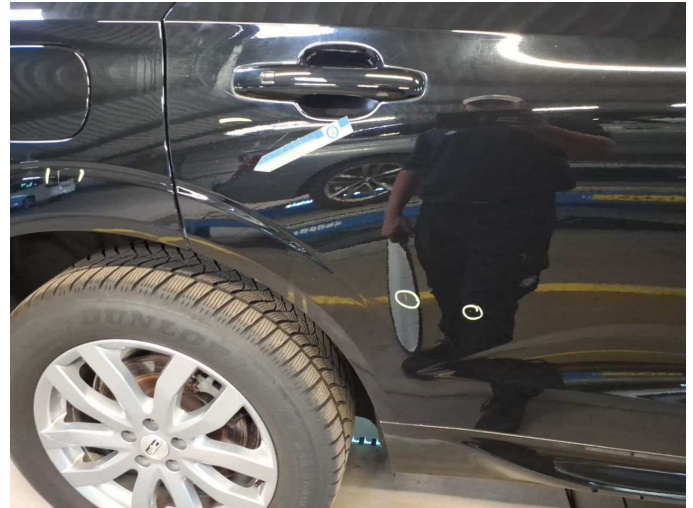
Damage 6: Mudguard - right side: Mudguard - right side - Scratch(es) - Smart repair

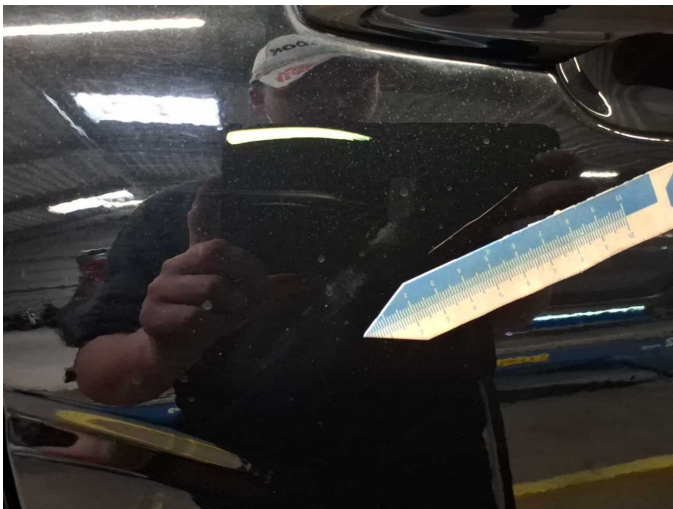
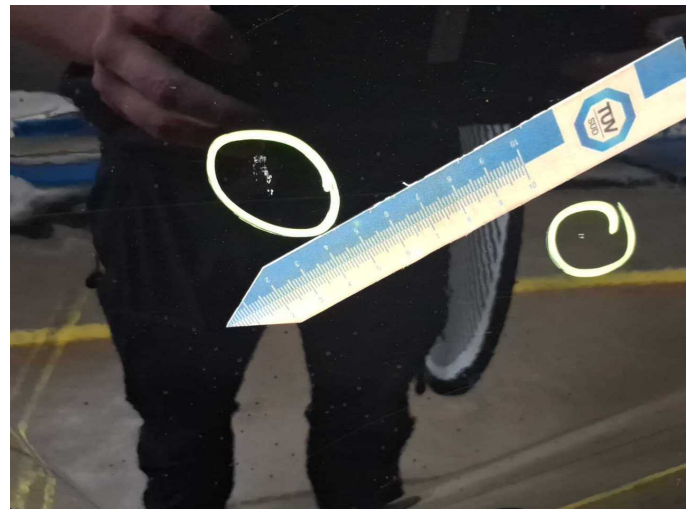
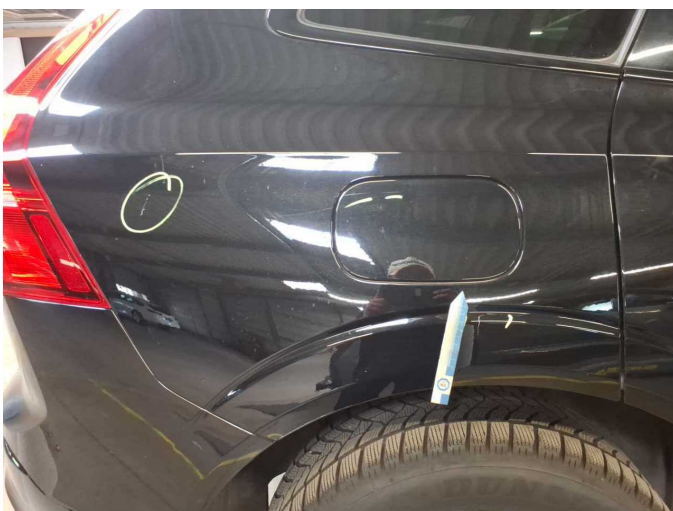
Damage 7: Door - rear right side: Door - Scratch(es) - Paint

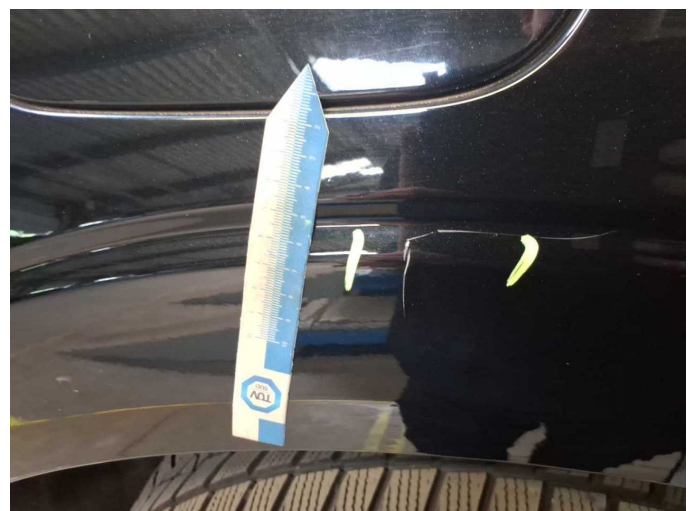
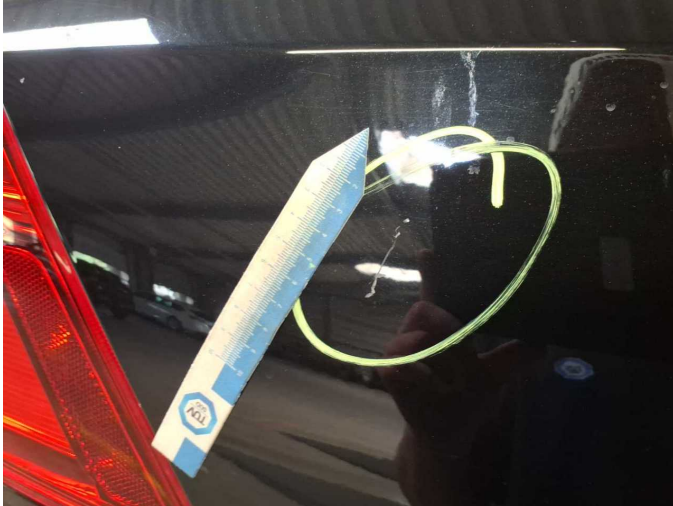
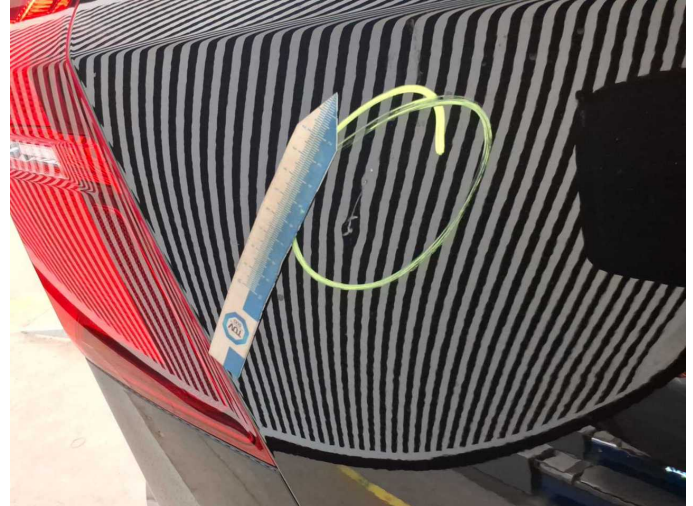
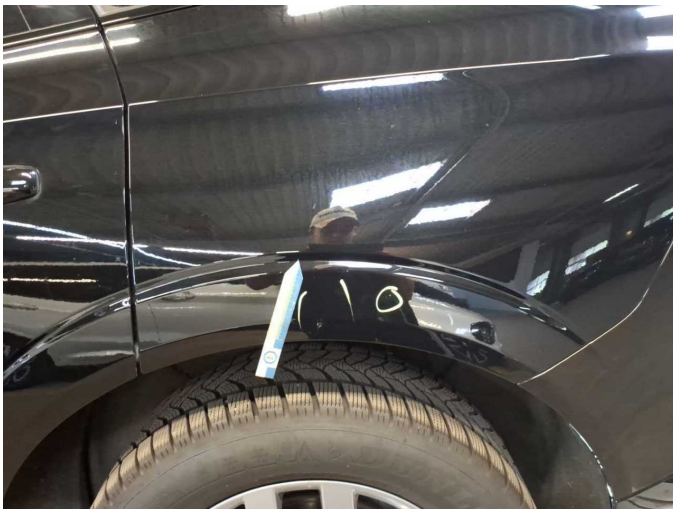
Damage 8: Side panel - rear right side: Side panel - Dent / paintcoat damage - Repair and paint

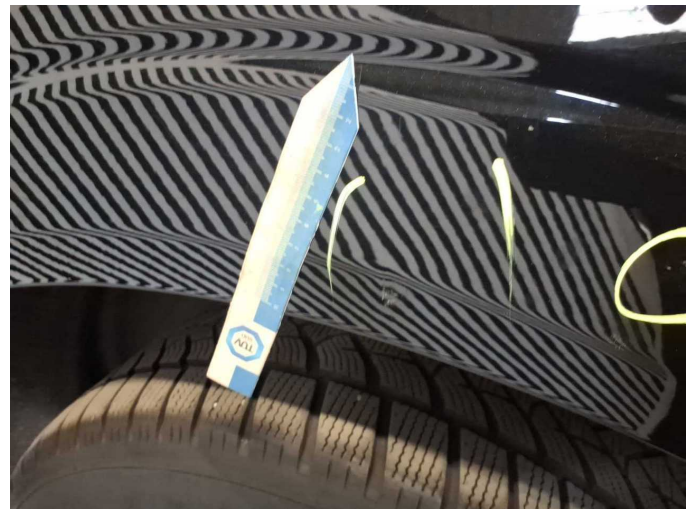
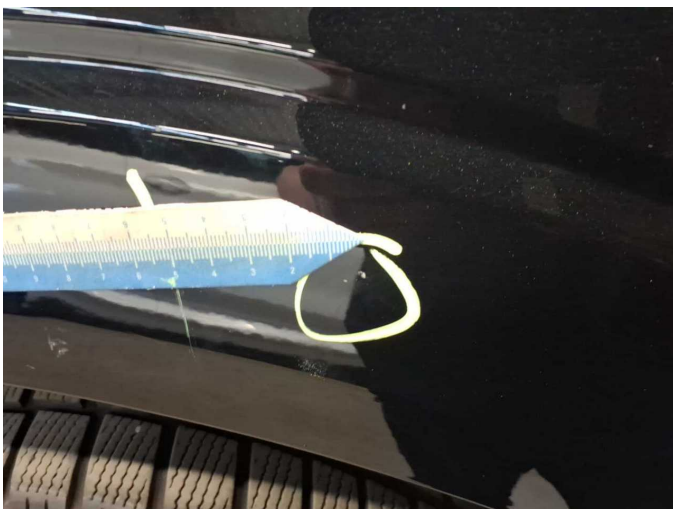
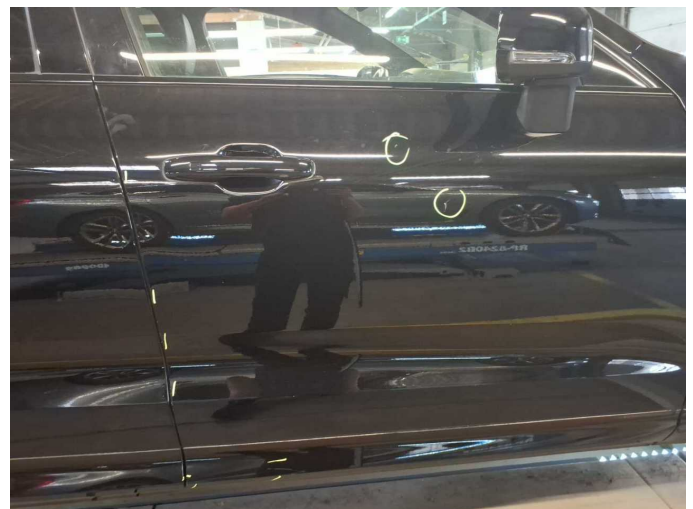
Damage 9: Side panel - rear left side: Side panel - Dent / paintcoat damage - Repair and paint

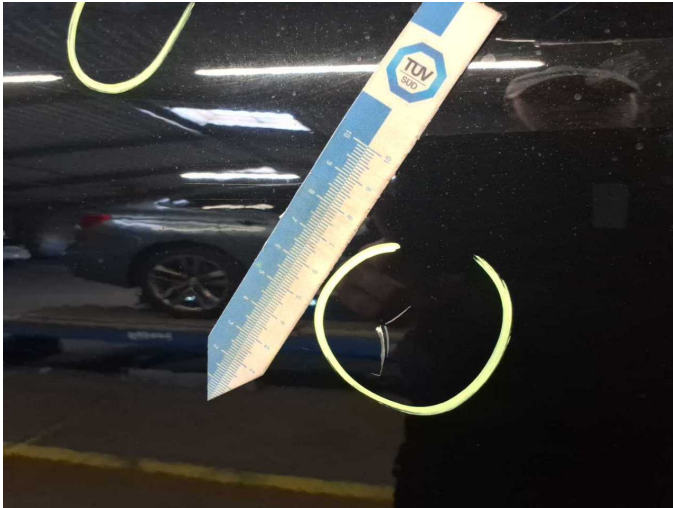
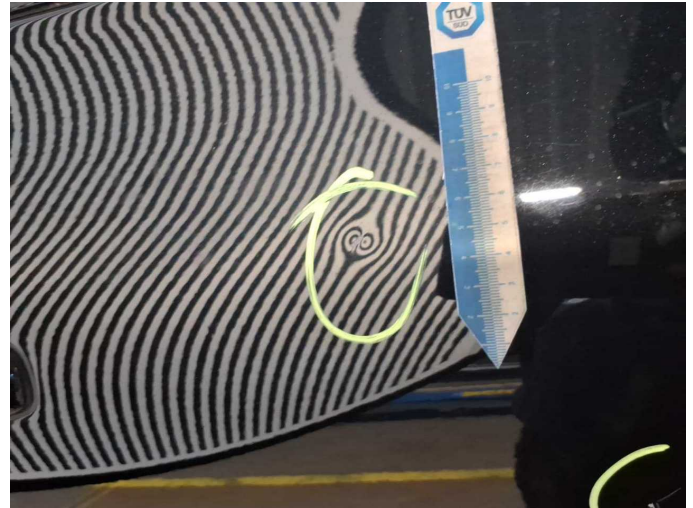
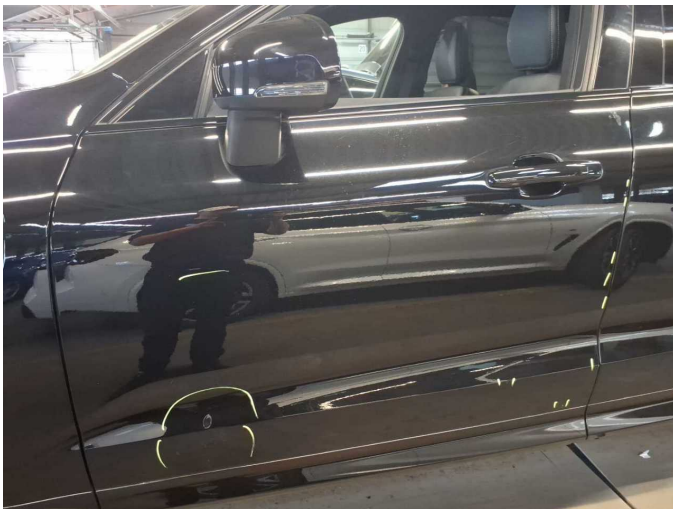
Damage 10: Door - front right side: Door - Dent / paintcoat damage - Repair and paint

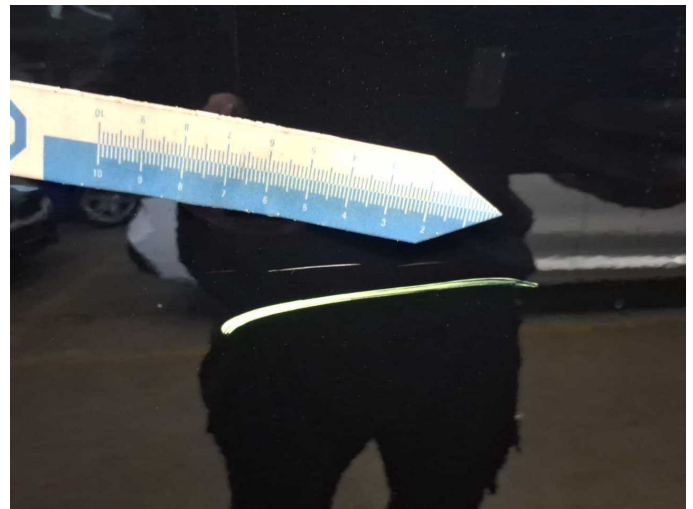
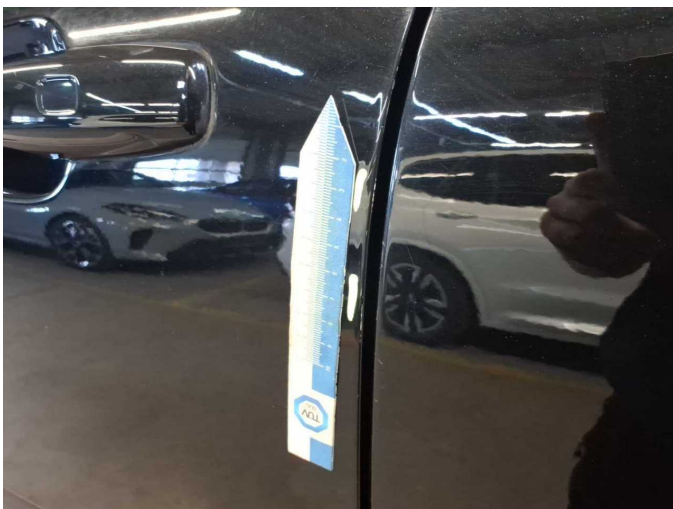
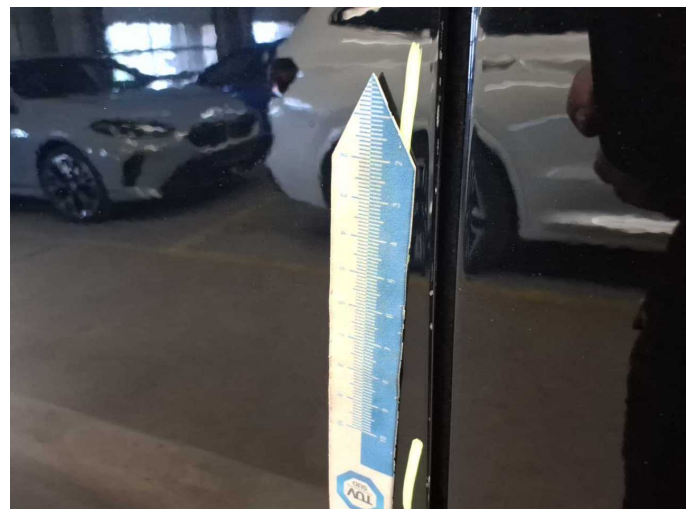
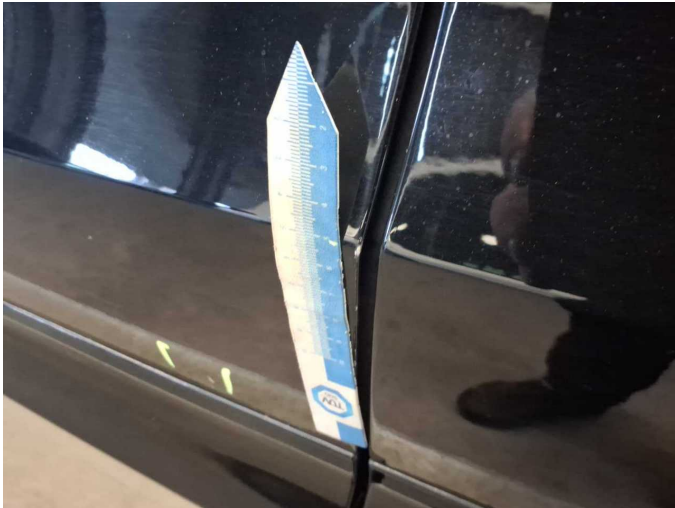
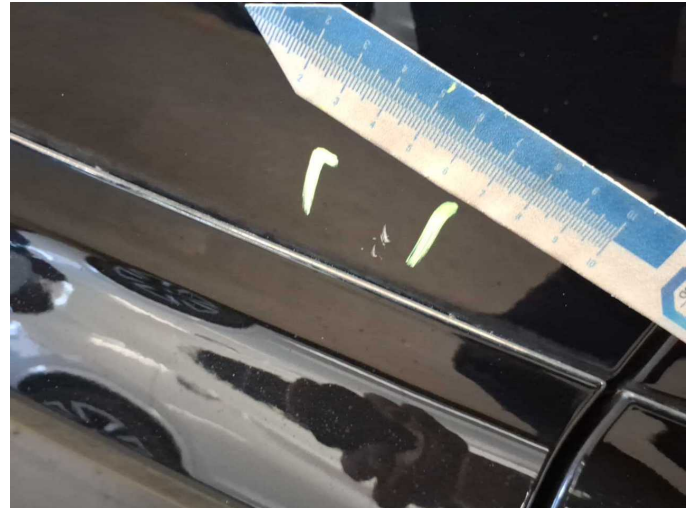
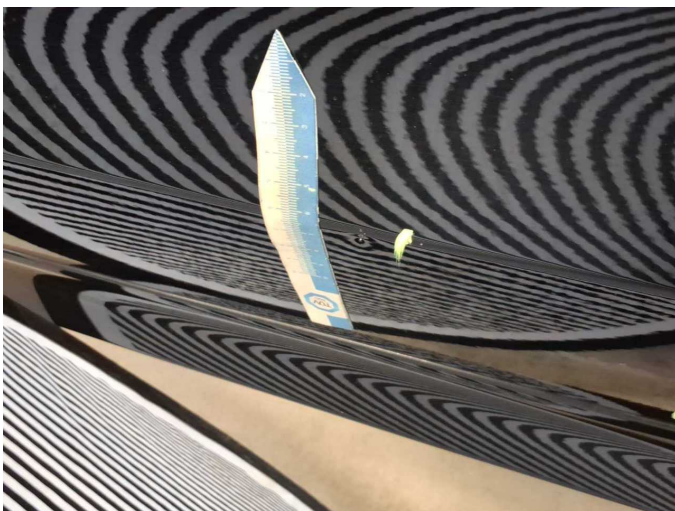
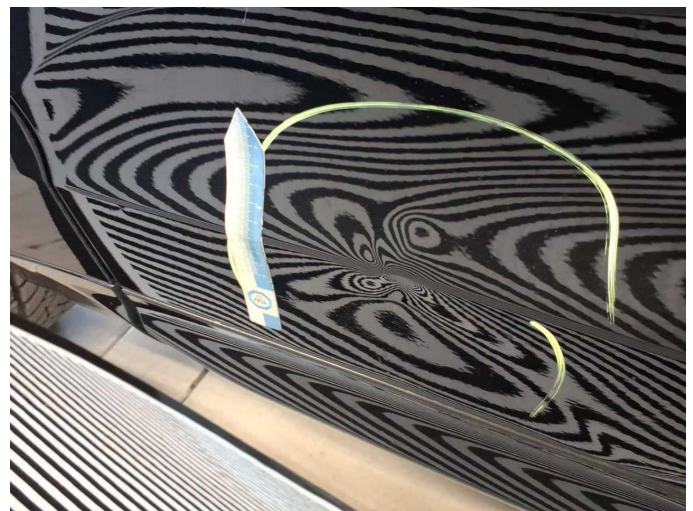
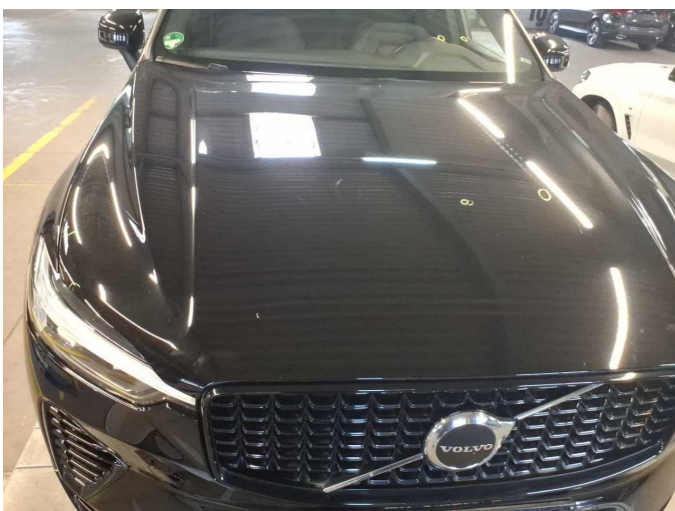
Damage 11: Door - front left side: Door - Dent / paintcoat damage - Repair and paint

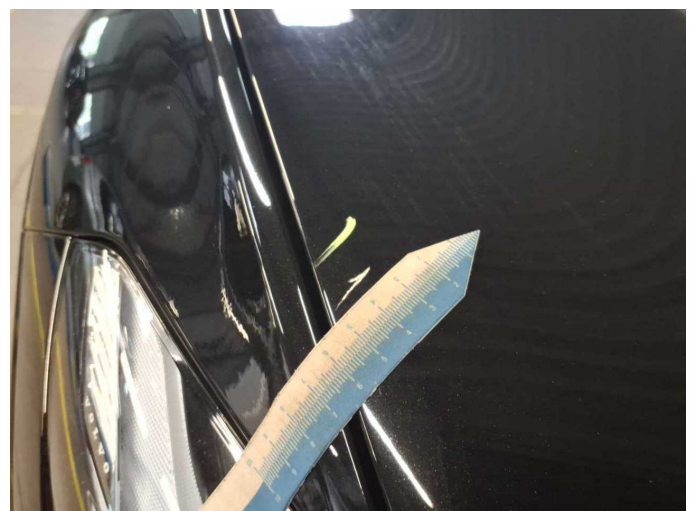
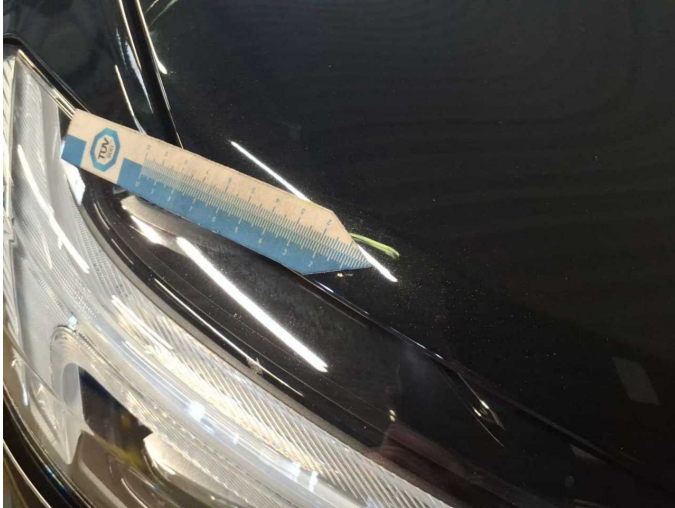
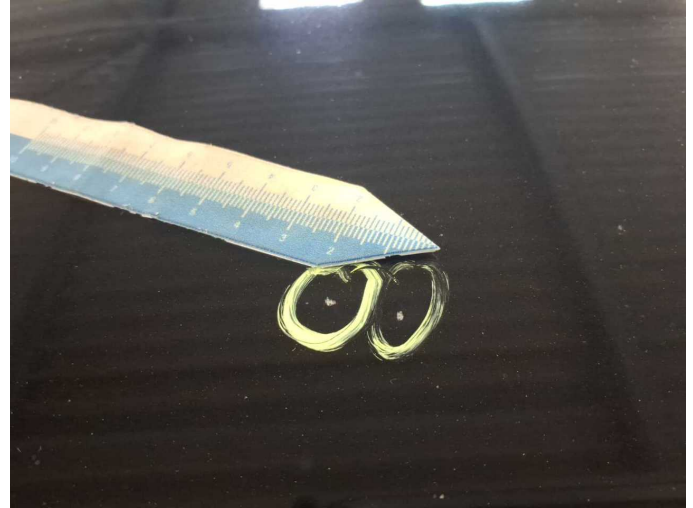
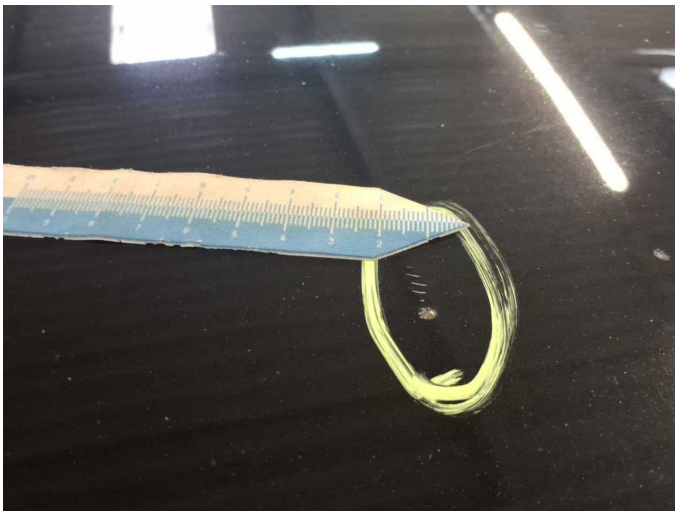
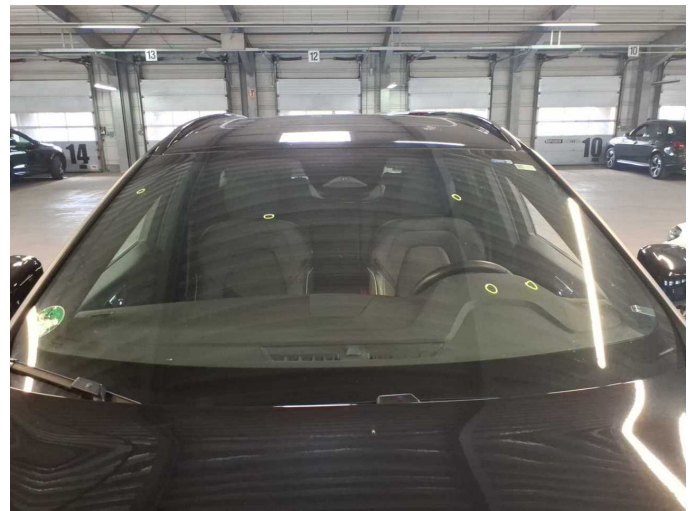
Damage 12: Bonnet: Bonnet - Dent / paintcoat damage - Repair and paint

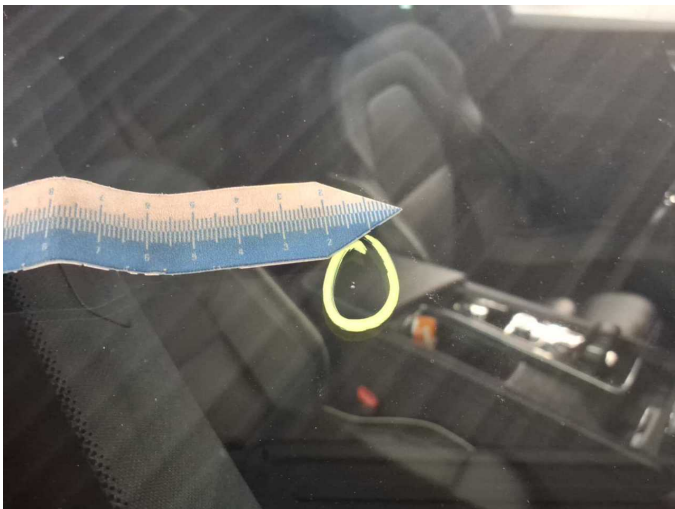
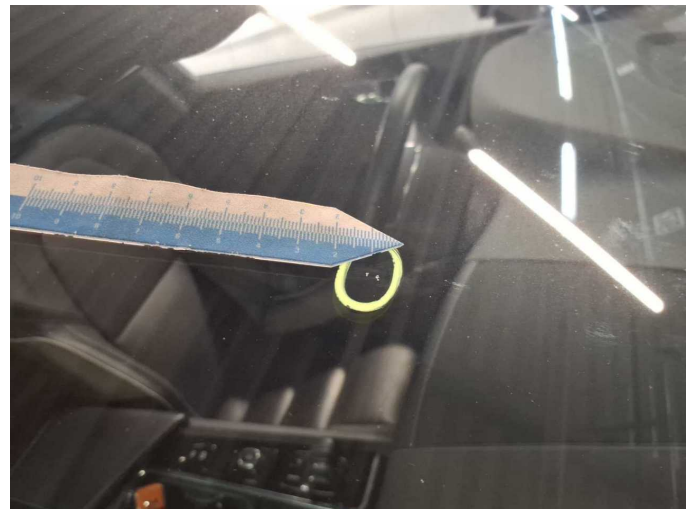
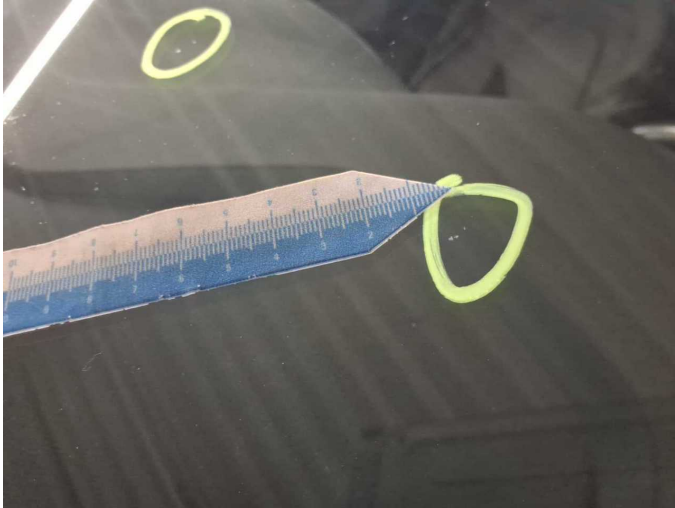
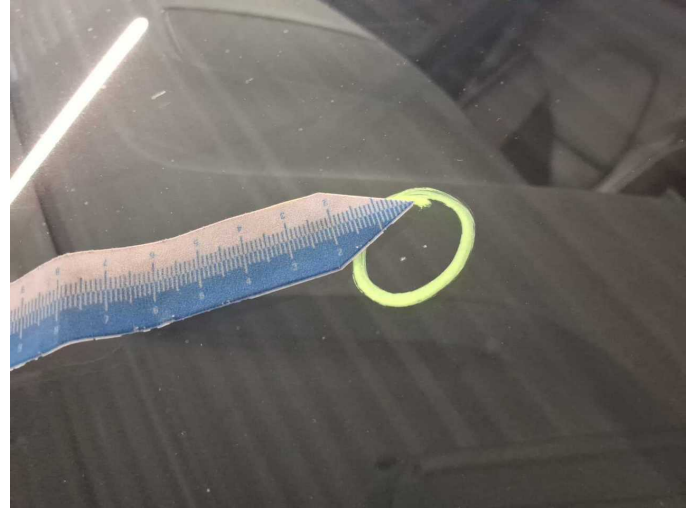
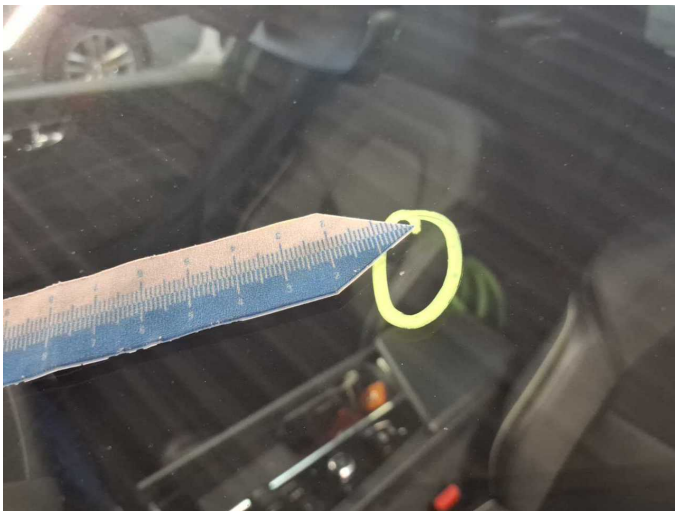
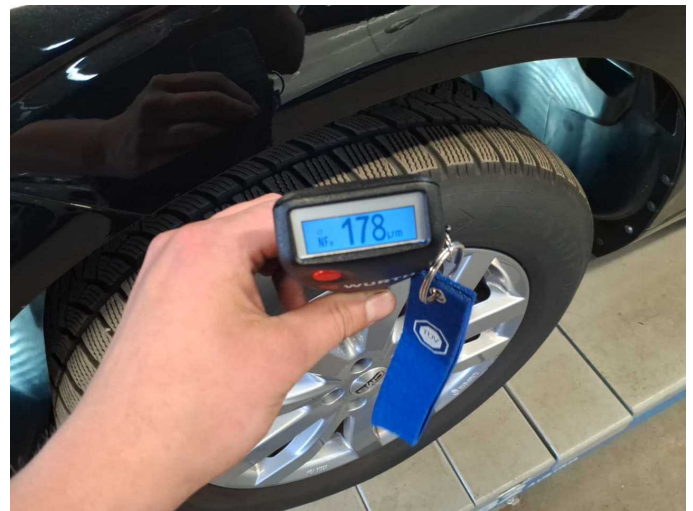
Wear and tear 2: Vehicle glazing: Windscreen - Stone chips - No deduction

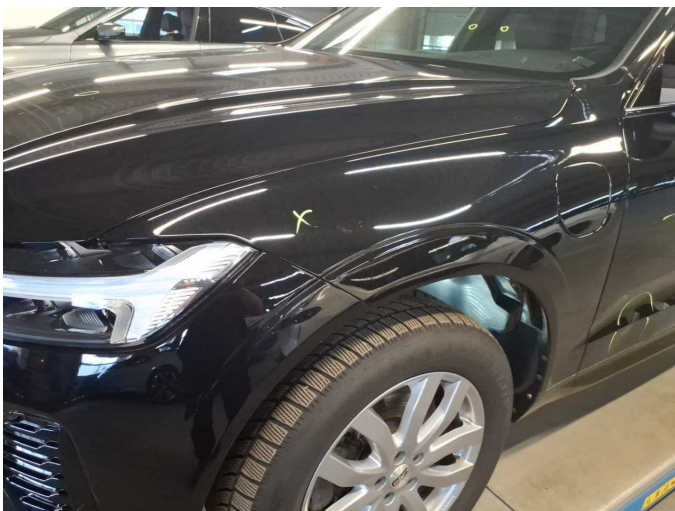
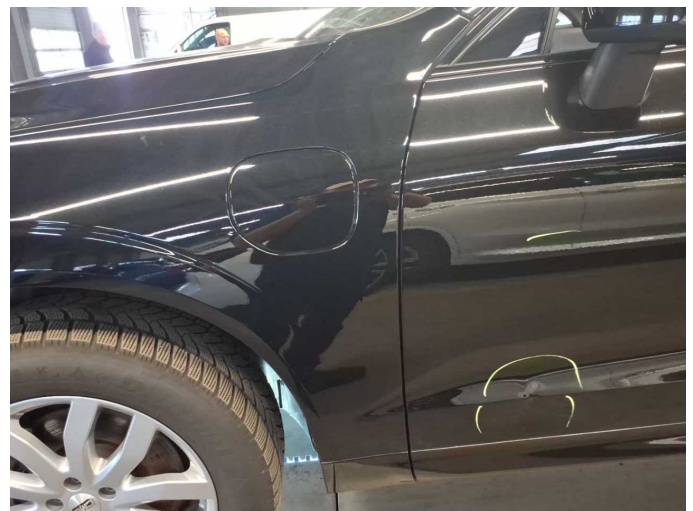
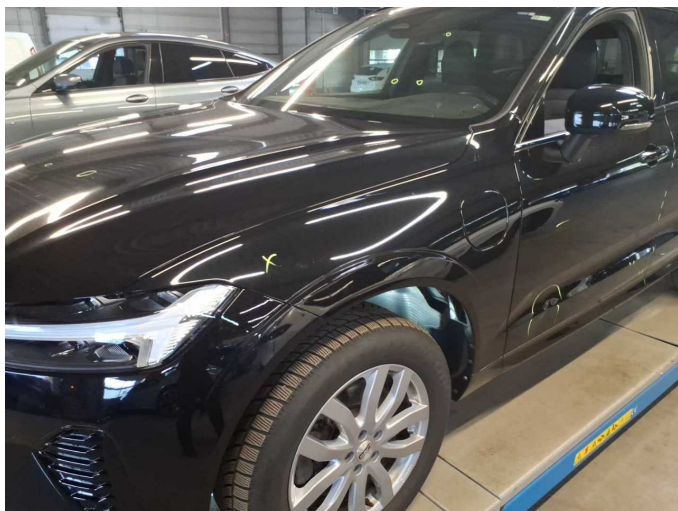
Repainting 1: Mudguard - left side

Mudguard - left side: 178 μm
