Expertise

Protocol number: 46505472  
Order No. / Reference: 26601168  
Inspection date: 14 Jul 2026

Manufacturer: Opel

Model: Combo Cargo XL 1.5 D EHZ Edition

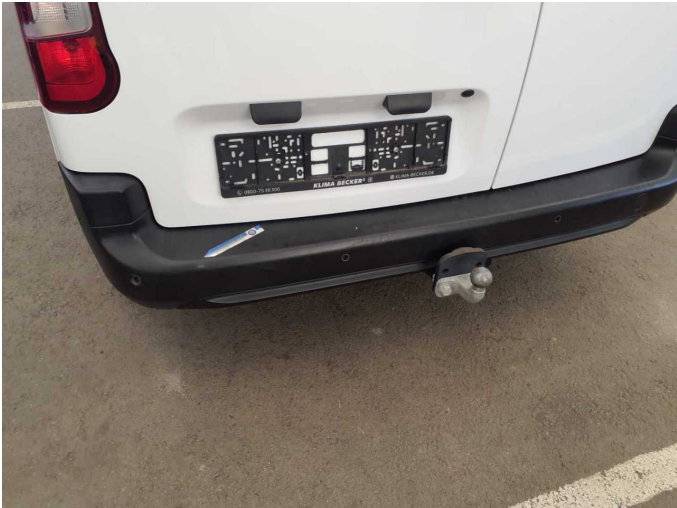
| No. | Component group | Description |
|---|---|---|
| 1 | Rear bumper | Rear bumper - Deformed - Loss in value |

Damage 1: Rear bumper: Rear bumper - Deformed - Loss in value

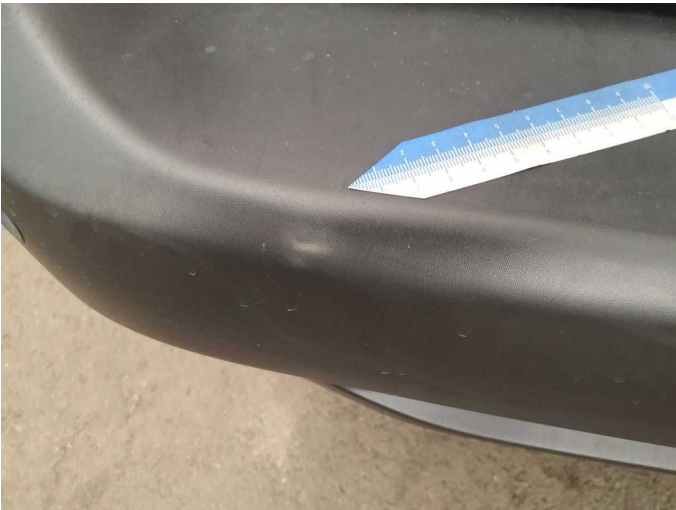
Damage 1: Rear bumper: Rear bumper - Deformed - Loss in value

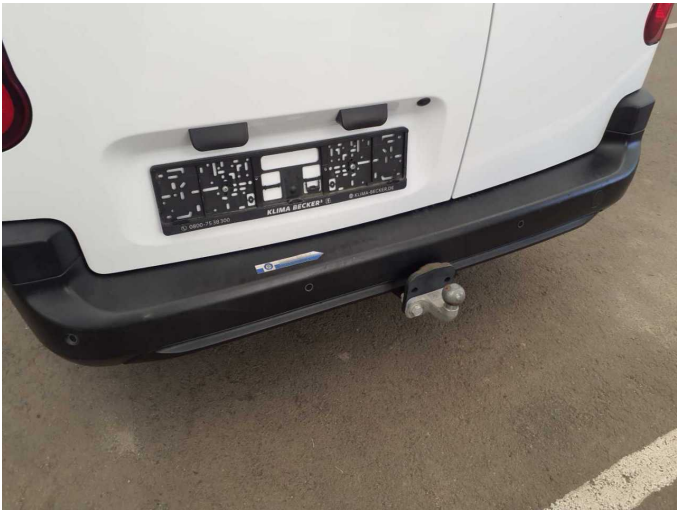
Damage 1: Rear bumper: Rear bumper - Deformed - Loss in value

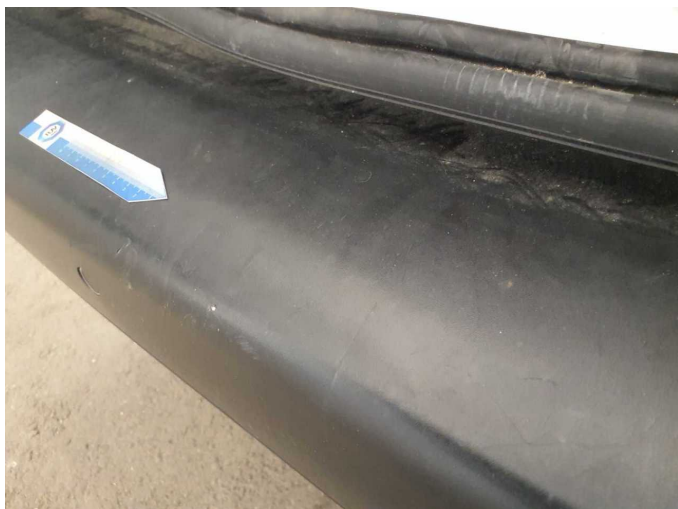
**Damage 1:** Rear bumper: Rear bumper - Deformed - Loss in value

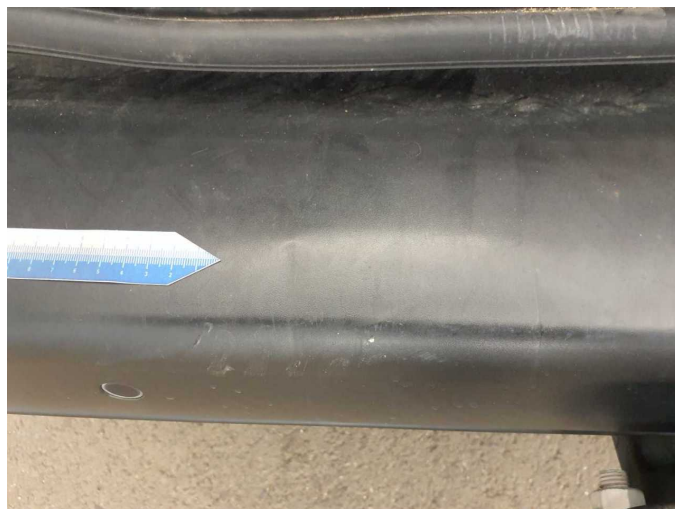
**Damage 1:** Rear bumper: Rear bumper - Deformed - Loss in value

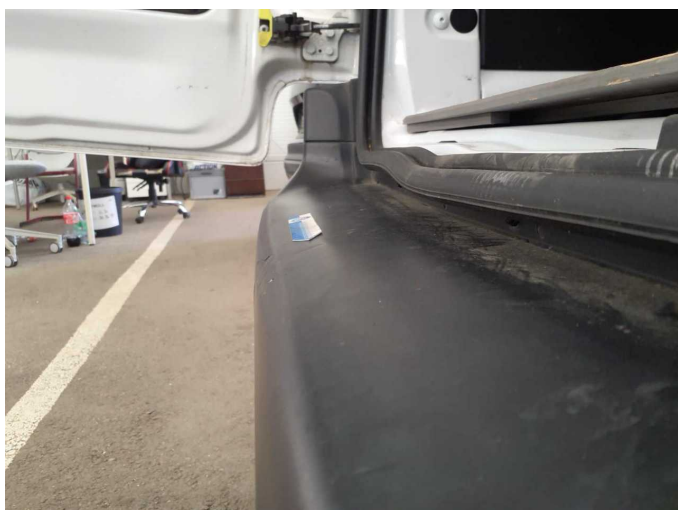
**Damage 1:** Rear bumper: Rear bumper - Deformed - Loss in value

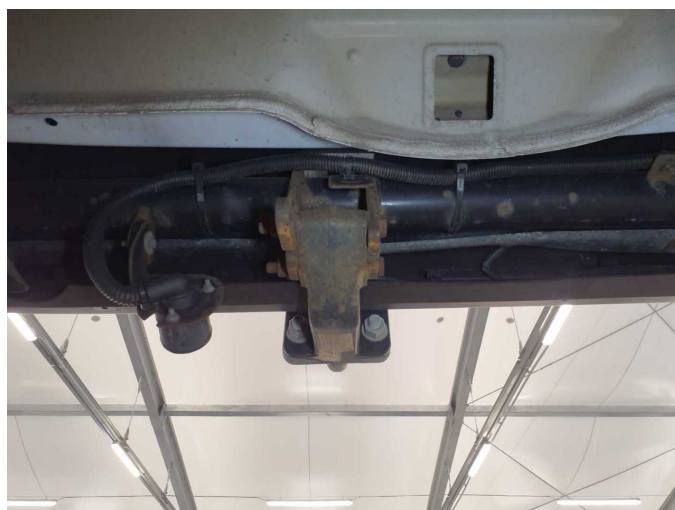
**Damage 1:** Rear bumper: Rear bumper - Deformed - Loss in value

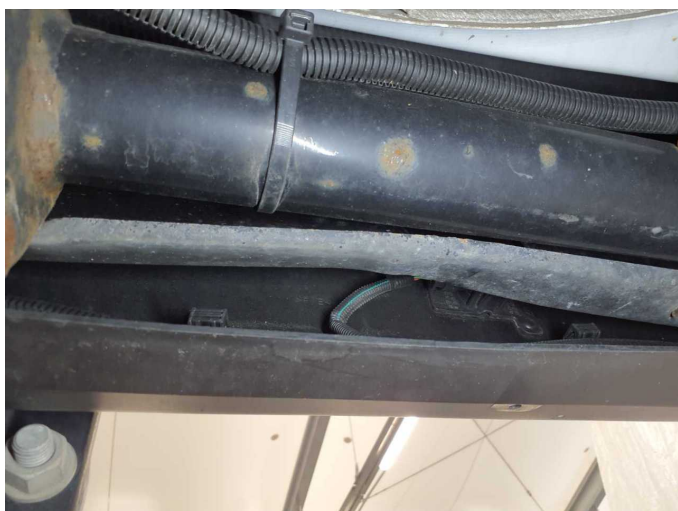
**Damage 1:** Rear bumper: Rear bumper - Deformed - Loss in value

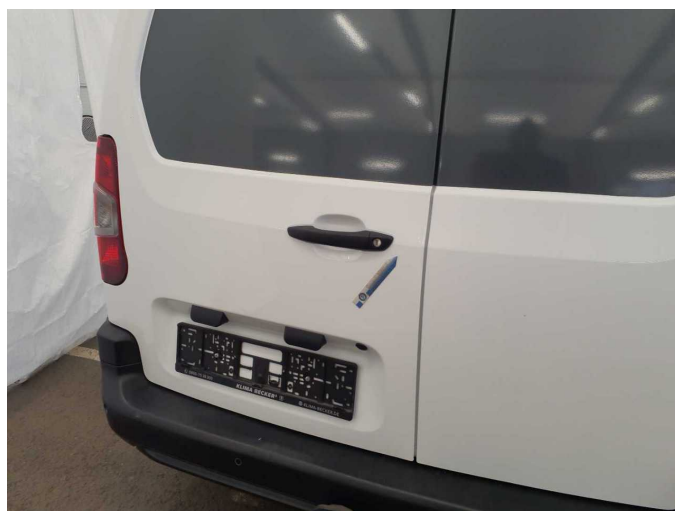
| No. | Component group | Description |
|---|---|---|
| 2 | Boot lid / rear door | Rear door - left side - dent(s) - Smart repair |

**Damage 2:** Boot lid / rear door: Rear door - left side - dent(s) - Smart repair

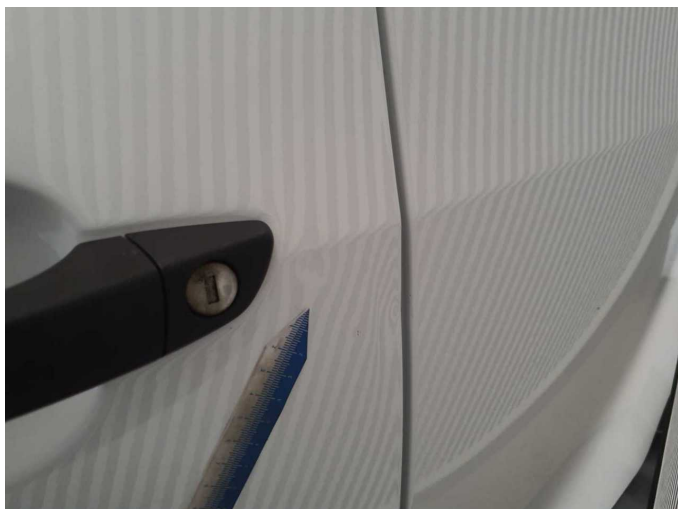
**Damage 2:** Boot lid / rear door: Rear door - left side - dent(s) - Smart repair

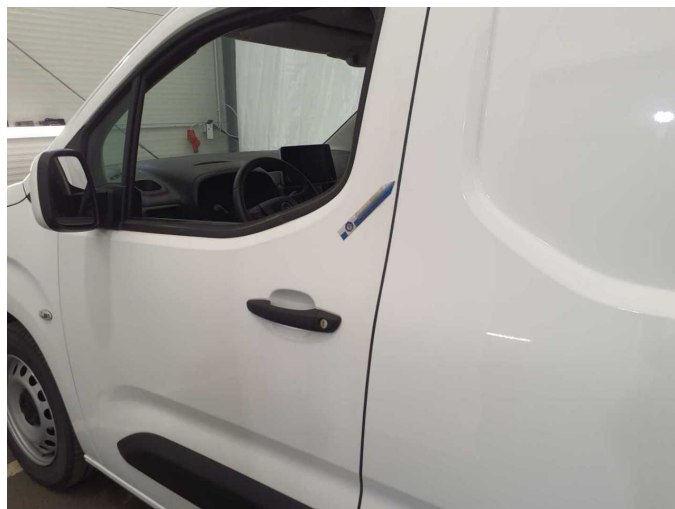
| No. | Component group | Description |
|---|---|---|
| 3 | Door - front left side | Door edge - Scratch(es) - Smart repair |

**Damage 3:** Door - front left side: Door edge - Scratch(es) - Smart repair

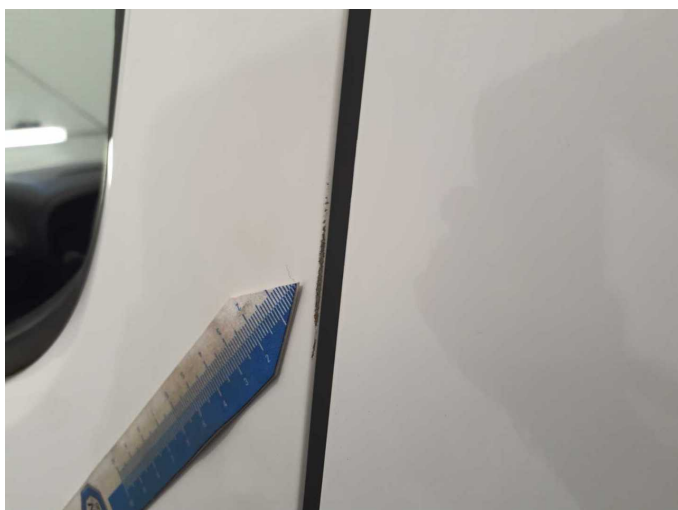
**Damage 3:** Door - front left side: Door edge - Scratch(es) - Smart repair

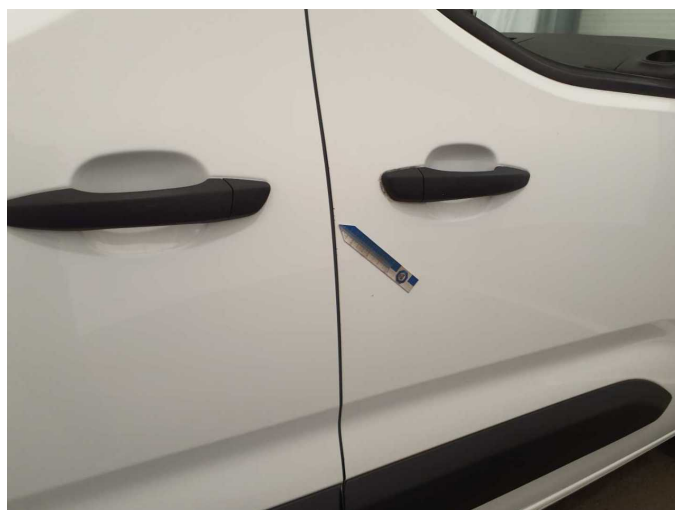
| No. | Component group | Description |
|---|---|---|
| 4 | Door - front right side | Door edge - Scratch(es) - Smart repair |

**Damage 4:** Door - front right side: Door edge - Scratch(es) - Smart repair

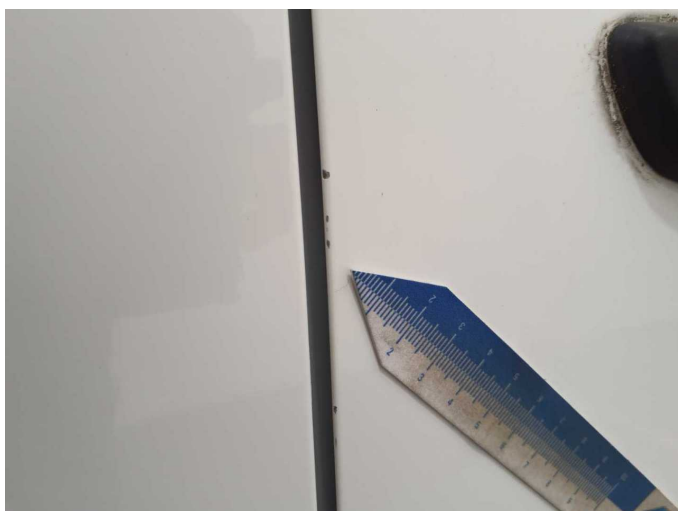
**Damage 4:** Door - front right side: Door edge - Scratch(es) - Smart repair

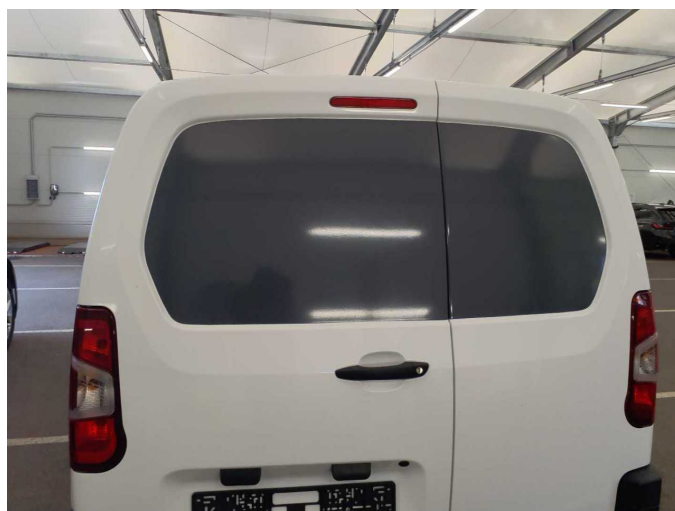
| No. | Component group | Description |
|---|---|---|
| 5 | Boot lid / rear door | Boot lid - Glued / labelled - De-glue / neutralise |

**Damage 5:** Boot lid / rear door: Boot lid - Glued / labelled - De-glue / neutralise

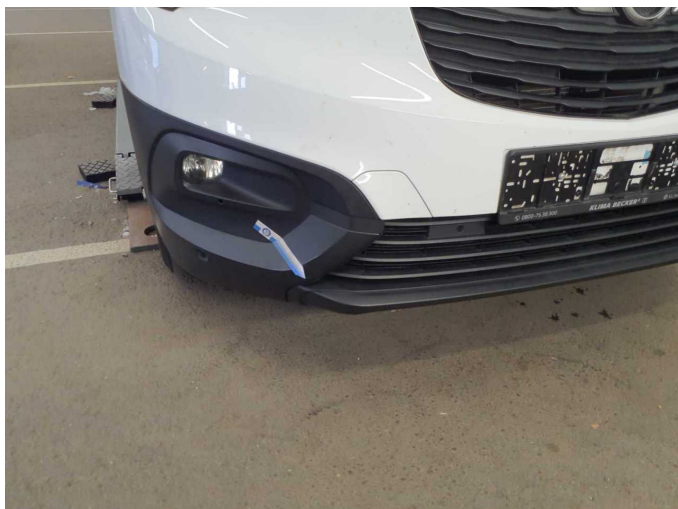
| No. | Component group | Description |
|---|---|---|
| 6 | Front bumper | Front bumper - Broken / torn - Replace |

**Damage 6:** Front bumper: Front bumper - Broken / torn - Replace

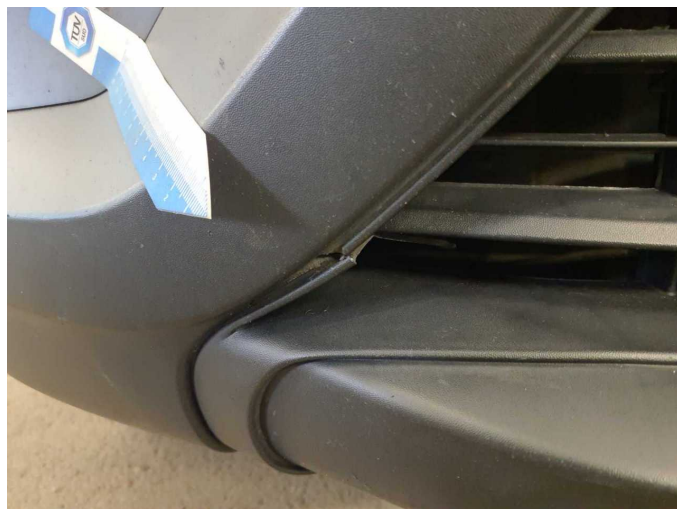
**Damage 6:** Front bumper: Front bumper - Broken / torn - Replace

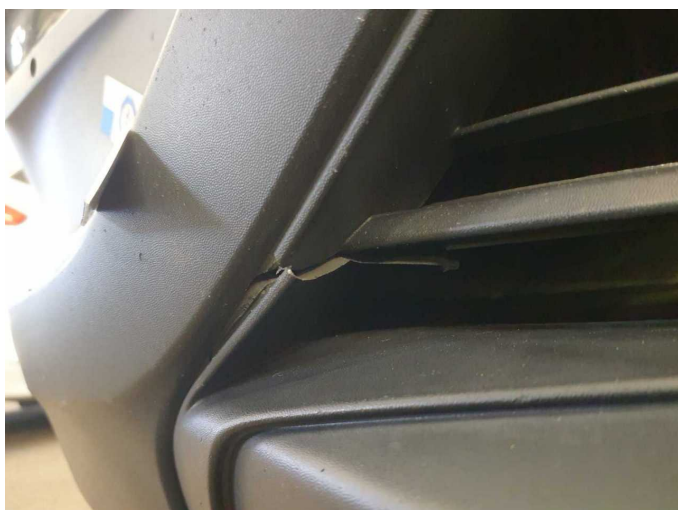
**Damage 6:** Front bumper: Front bumper - Broken / torn - Replace

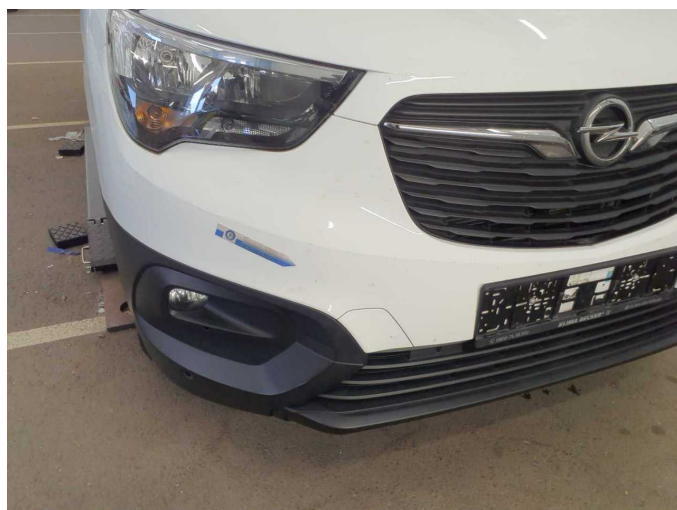
| No. | Component group | Description |
|---|---|---|
| 7 | Front bumper | Front bumper - Scratch(es) - Paint |

**Damage 7:** Front bumper: Front bumper - Scratch(es) - Paint

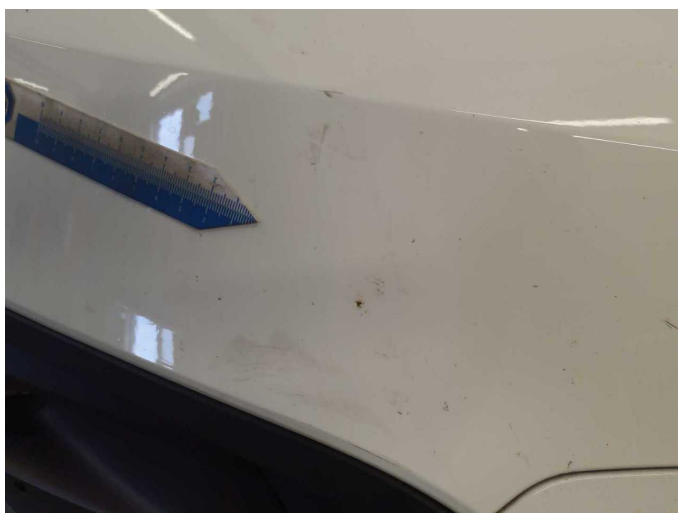
**Damage 7:** Front bumper: Front bumper - Scratch(es) - Paint

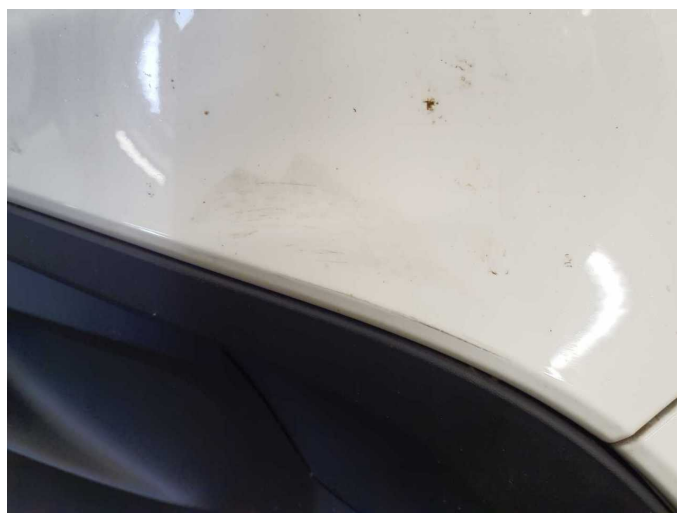
**Damage 7:** Front bumper: Front bumper - Scratch(es) - Paint

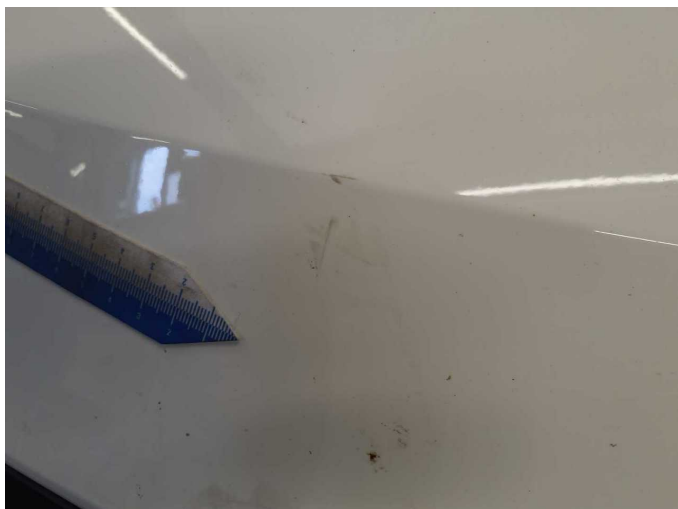
**Damage 7:** Front bumper: Front bumper - Scratch(es) - Paint
