Expertise

Protocol number: 46111658  
Order No. / Reference: 26533743  
Inspection date: 23 Jun 2026

Manufacturer: Opel

Model: Combo Cargo 1.5 D Edition

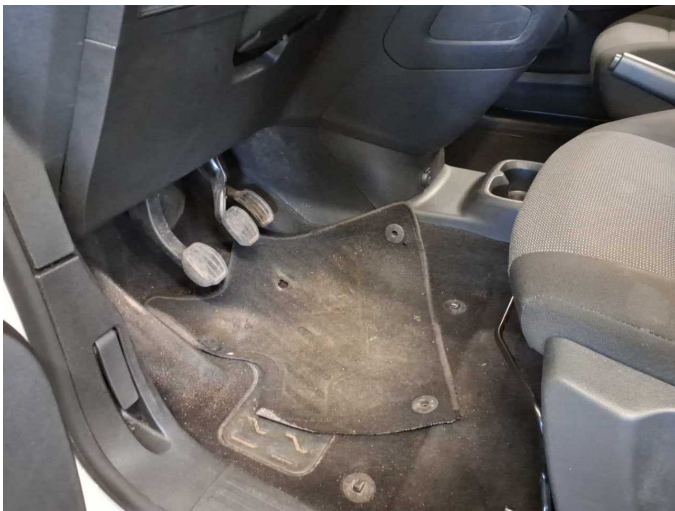
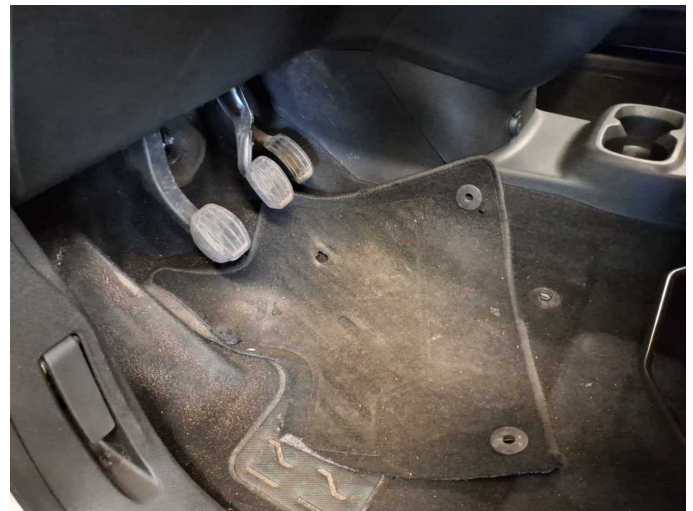
| No. | Component group | Description |
|---|---|---|
| 1 | Trim / covers | Floor mats - Damaged - Replace |

**Damage 1:** Trim / covers: Floor mats - Damaged - Replace

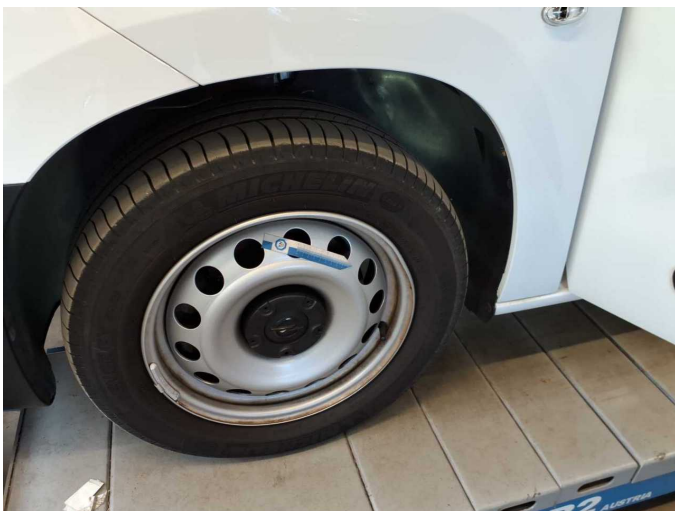
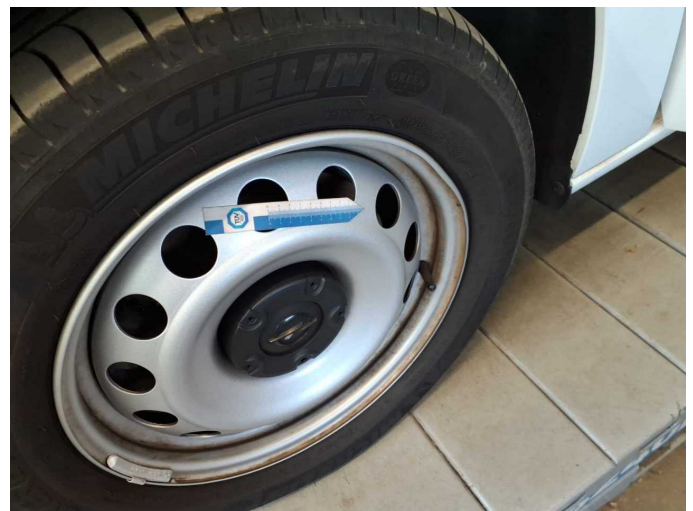
| No. | Component group | Description |
|---|---|---|
| 2 | Wheel / tyres | Wheel rim - front left side - Deformed - Replace |

**Damage 2:** Wheel / tyres: Wheel rim - front left side - Deformed - Replace

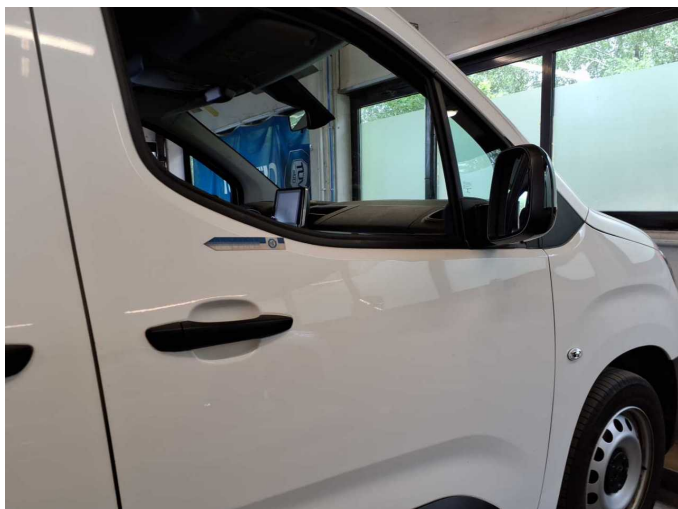
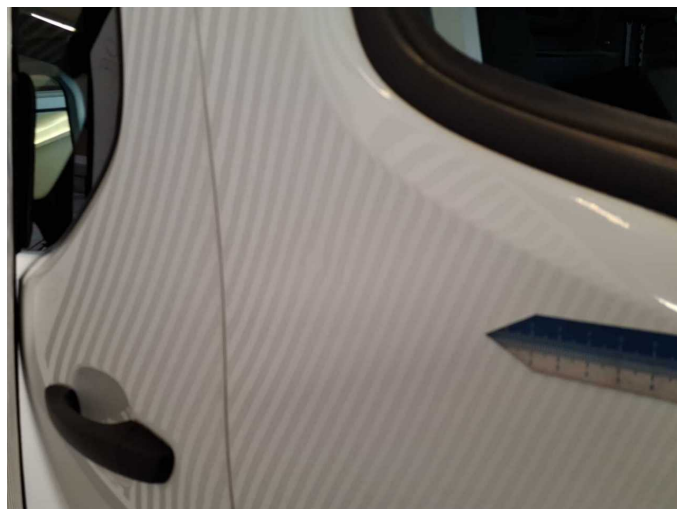
| No. | Component group | Description |
|---|---|---|
| 3 | Door - front right side | Door - dent(s) - Smooth repair work |

**Damage 3:** Door - front right side: Door - dent(s) - Smooth repair work

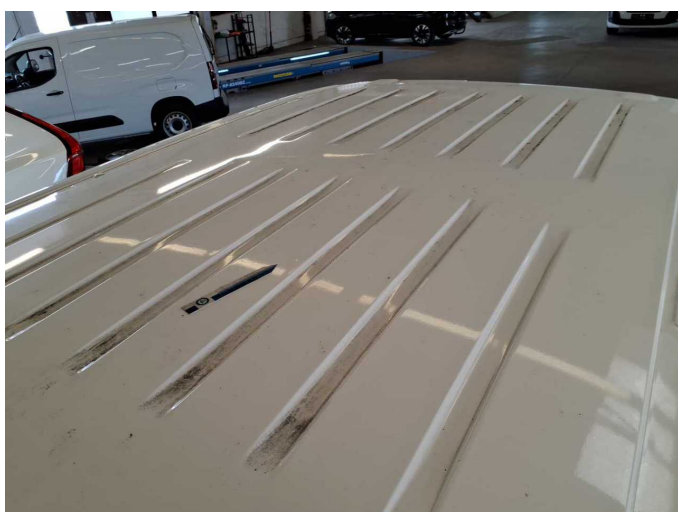
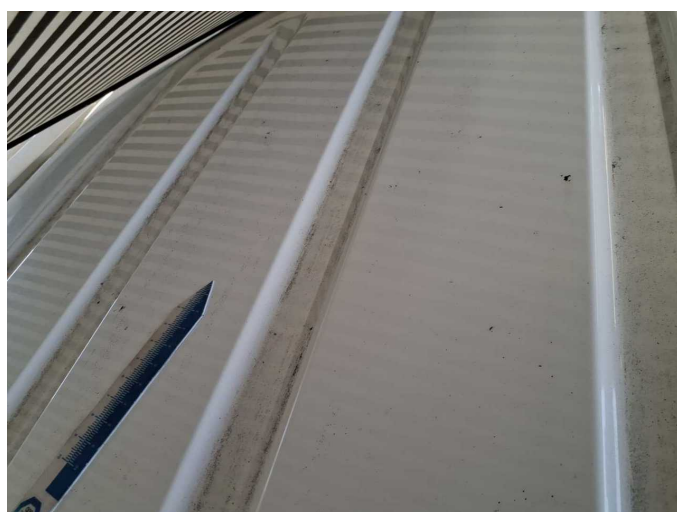
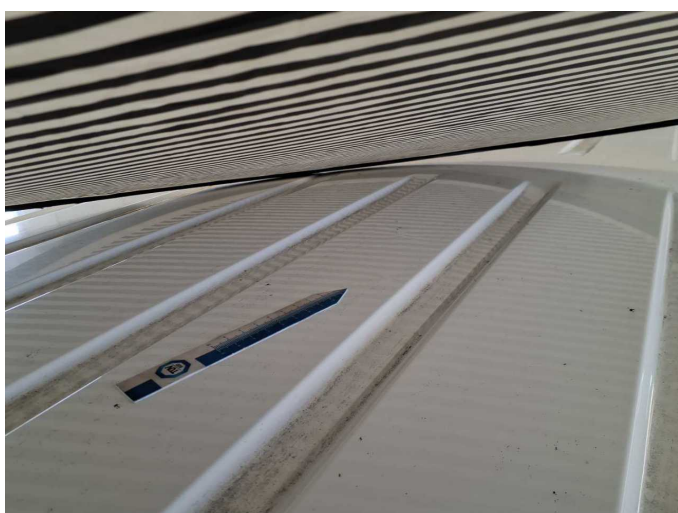
| No. | Component group | Description |
|---|---|---|
| 4 | Roof | Roof - dent(s) - Smooth repair work |

**Damage 4:** Roof: Roof - dent(s) - Smooth repair work

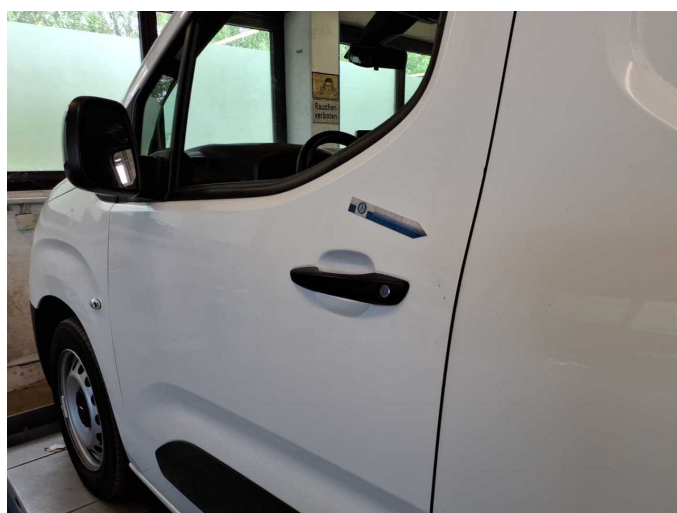
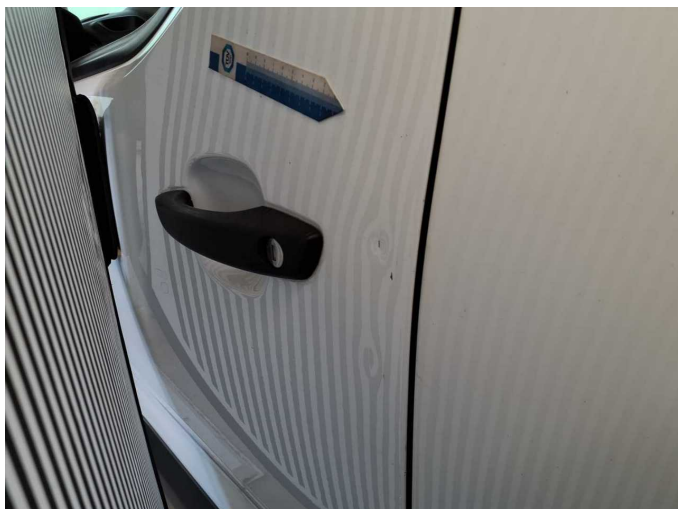
| No. | Component group | Description |
|---|---|---|
| 5 | Door - front left side | Door - Dent / paintcoat damage - Smart repair |

**Damage 5:** Door - front left side: Door - Dent / paintcoat damage - Smart repair

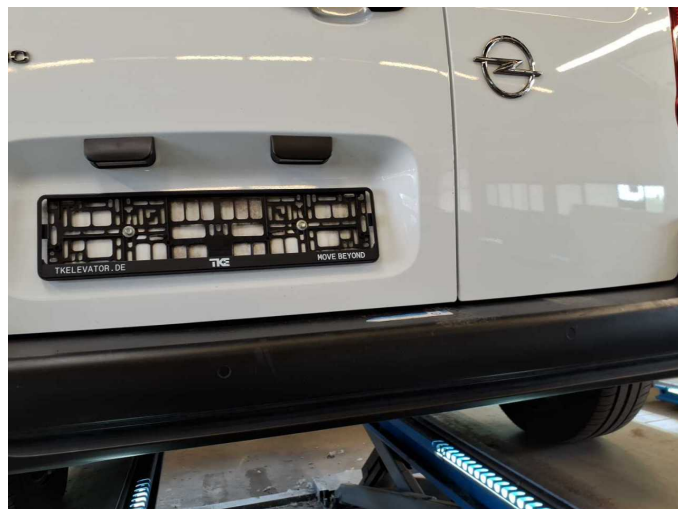
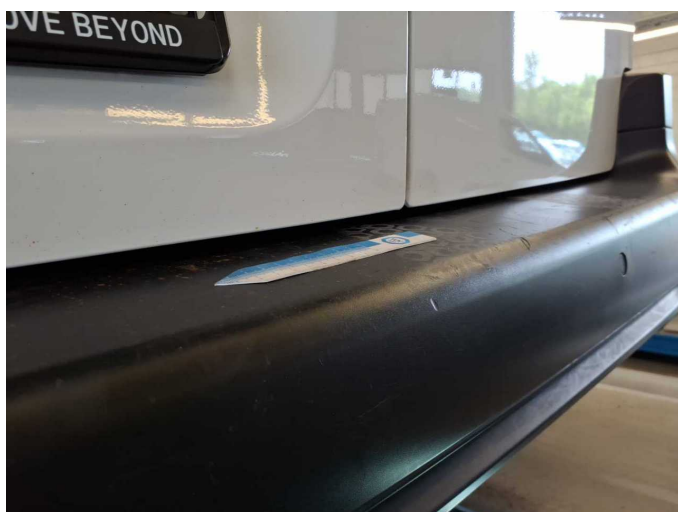
| No. | Component group | Description |
|---|---|---|
| 1 | Rear bumper | Rear bumper (unpainted) - Scratch(es) - No deduction |

**Wear and tear 1:** Rear bumper: Rear bumper (unpainted) - Scratch(es) - No deduction

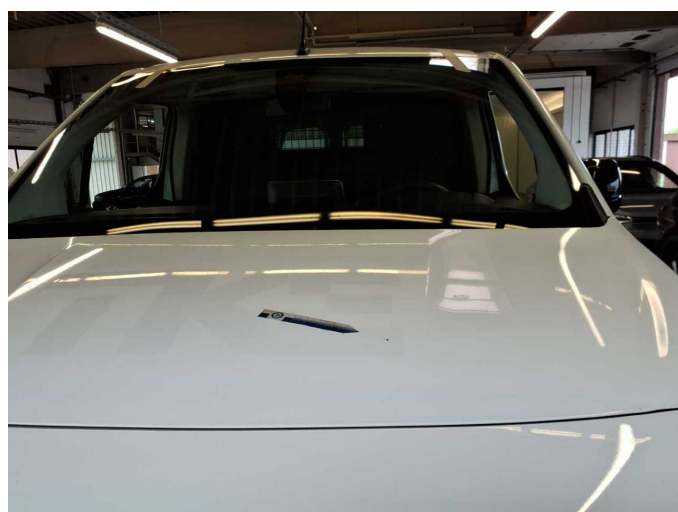
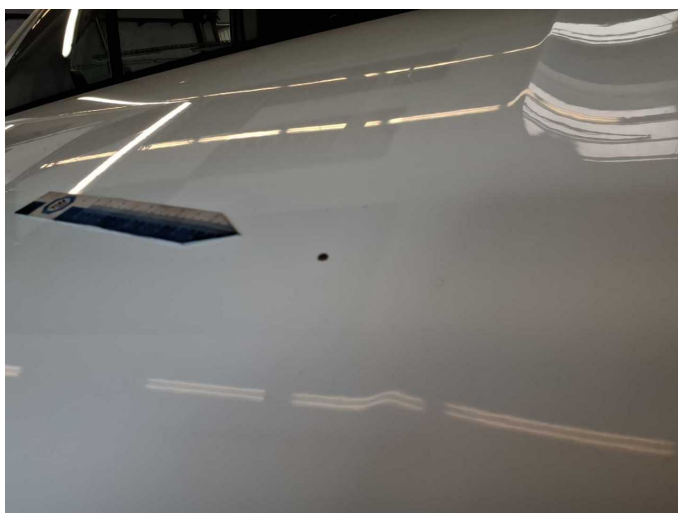
| No. | Component group | Description |
|---|---|---|
| 2 | Bonnet | Bonnet - Stone chips - No deduction |

**Wear and tear 2:** Bonnet: Bonnet - Stone chips - No deduction
