Expertise

Protocol number: 45232666  
Order No. / Reference: 26006377  
Inspection date: 14 Apr 2026

Manufacturer: Skoda  
VIN: TMBJJ8NX0PY076190

Model: Octavia Combi 2.0 TDI DSG Tour

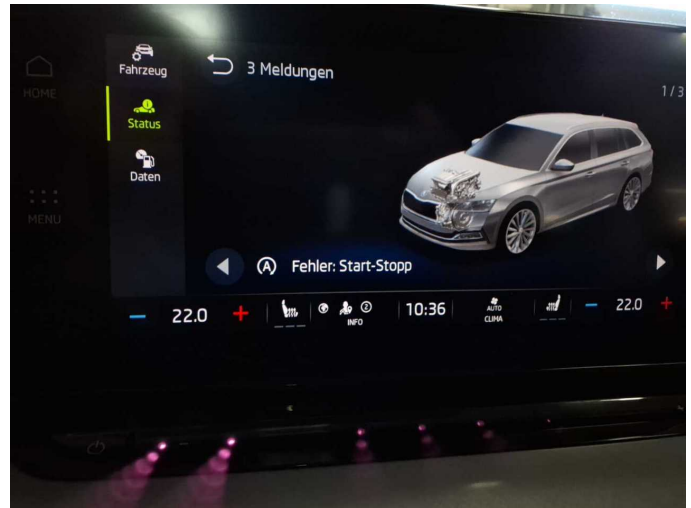
| No. | Component group | Description |
|---|---|---|
| 1 | Electronic systems | Electronic systems (Start- Stopp) - Functional / admissibility - Perform diagnosis |

**Damage 1:** Electronic systems: Electronic systems (Start- Stopp) - Functional / admissibility - Perform diagnosis

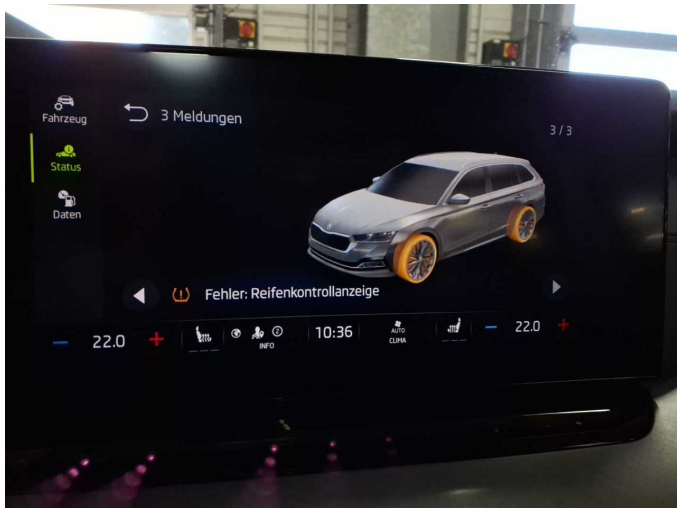
| No. | Component group | Description |
|---|---|---|
| 2 | Wheel / tyres | Pressure sensor (Reifendruck) - Functional / admissibility - Perform diagnosis |

**Damage 2:** Wheel / tyres: Pressure sensor (Reifendruck) - Functional / admissibility - Perform diagnosis

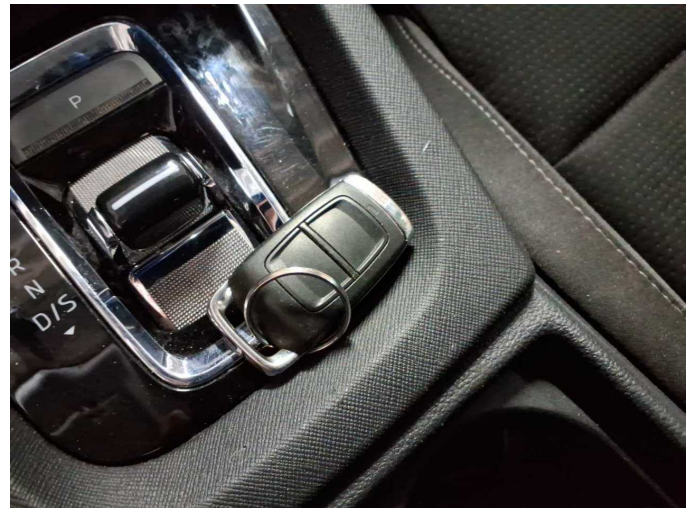
| No. | Component group | Description |
|---|---|---|
| 4 | Heating system | Remote control auxiliary heating (Abgenutzt) - Scratched - Loss in value |

**Damage 4:** Heating system: Remote control auxiliary heating (Abgenutzt) - Scratched - Loss in value

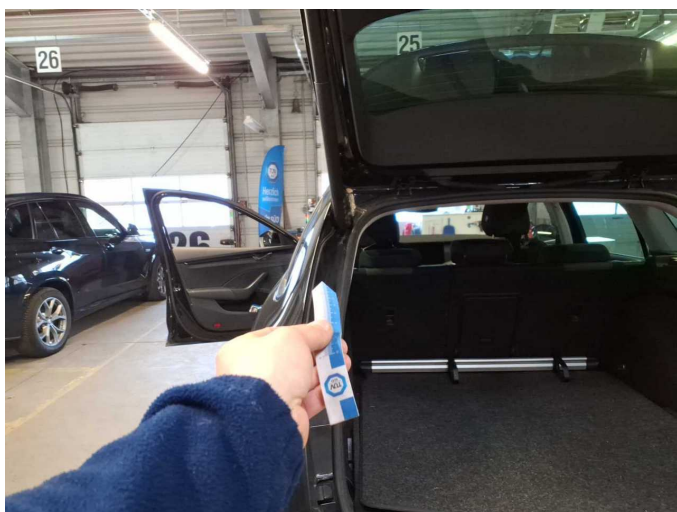
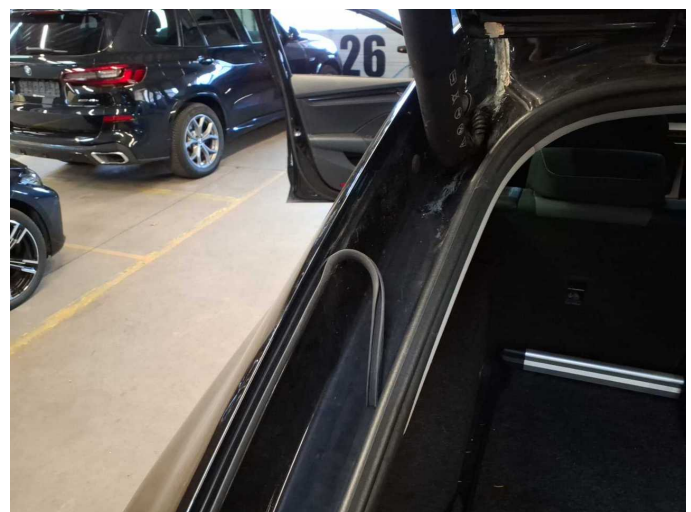
| No. | Component group | Description |
|---|---|---|
| 5 | Body | D-pillar - left side (Dichtung) - Loose - Replace |

**Damage 5:** Body: D-pillar - left side (Dichtung) - Loose - Replace

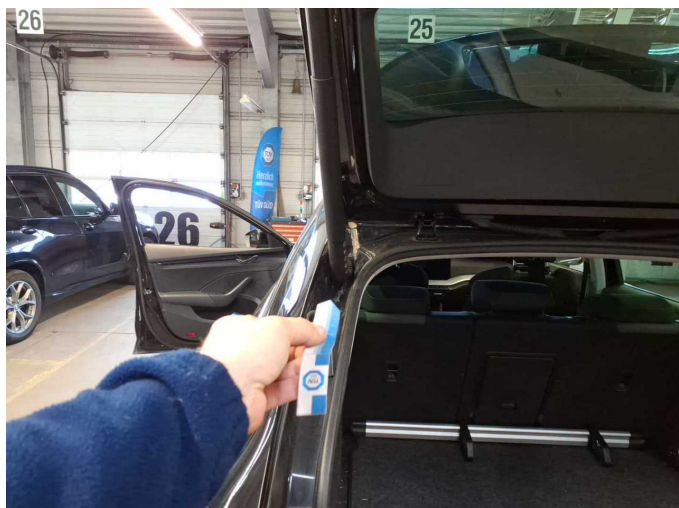
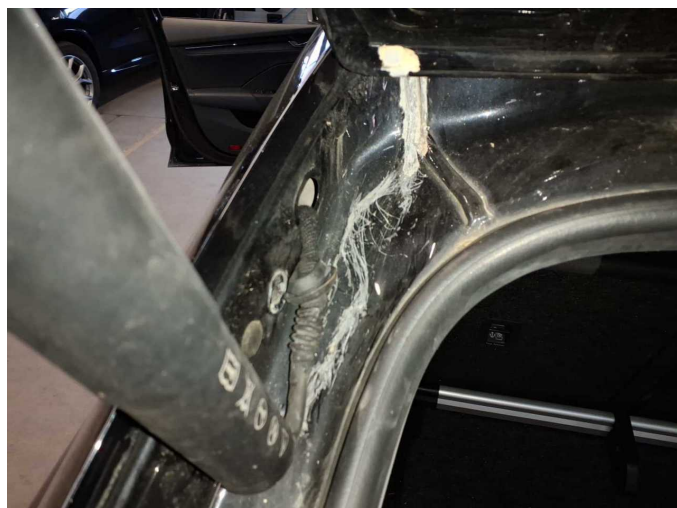
| No. | Component group | Description |
|---|---|---|
| 6 | Body | D-pillar - left side - Scratched - Smart repair |

**Damage 6:** Body: D-pillar - left side - Scratched - Smart repair

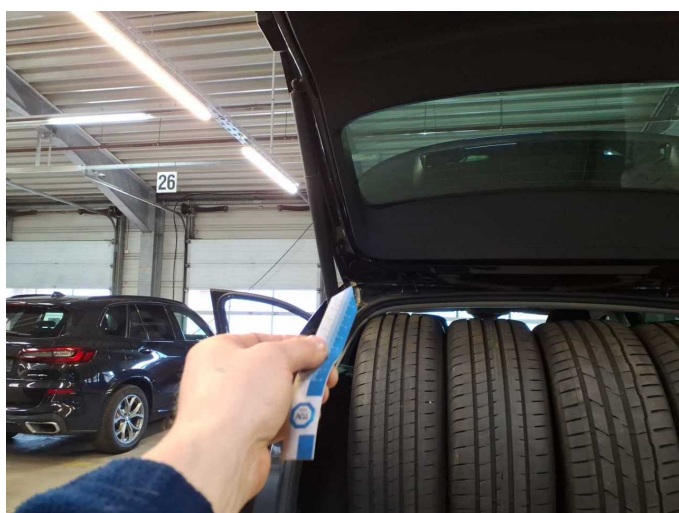
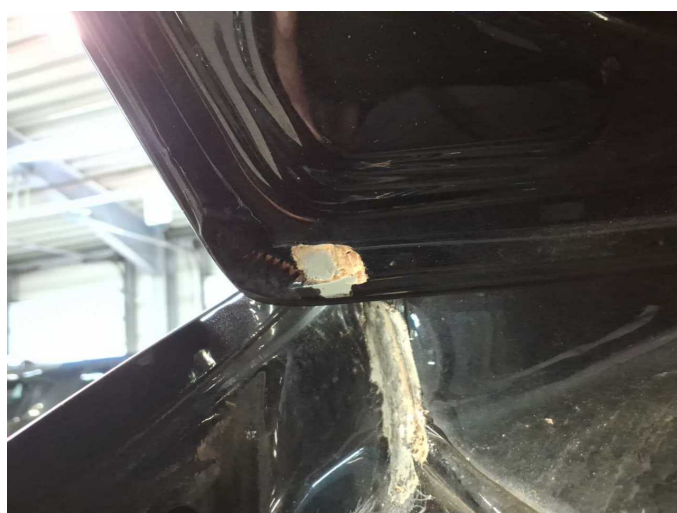
| No. | Component group | Description |
|---|---|---|
| 7 | Boot lid / rear door | Boot lid (Innen) - Paint defect - Smart repair |

**Damage 7:** Boot lid / rear door: Boot lid (Innen) - Paint defect - Smart repair

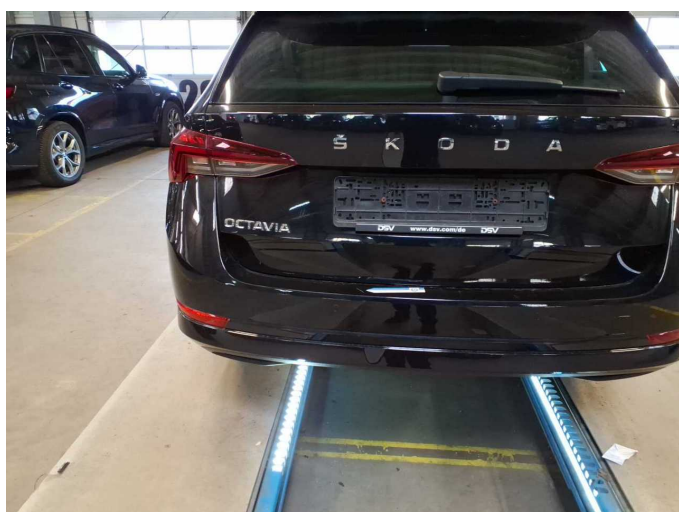
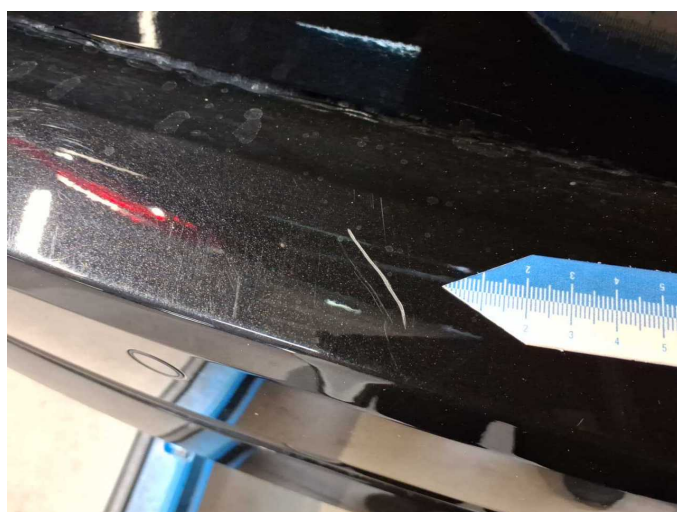
| No. | Component group | Description |
|---|---|---|
| 8 | Rear bumper | Rear bumper - Scratch(es) - Smart repair |

**Damage 8:** Rear bumper: Rear bumper - Scratch(es) - Smart repair

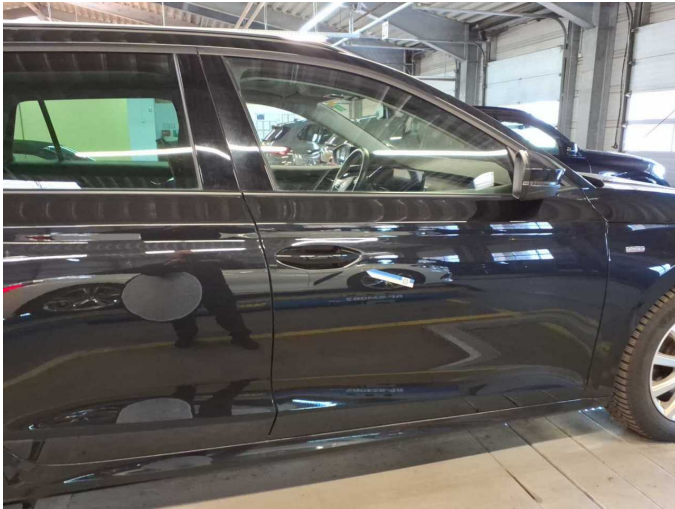
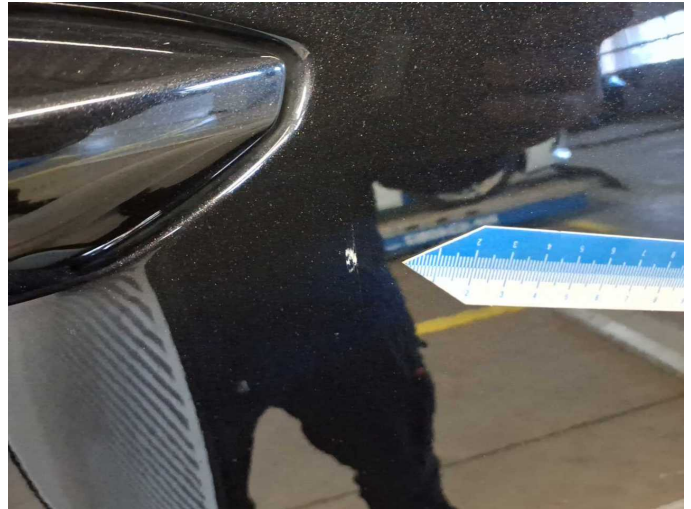
| No. | Component group | Description |
|---|---|---|
| 9 | Door - front right side | Door - Scratch(es) - Smart repair |

**Damage 9:** Door - front right side: Door - Scratch(es) - Smart repair

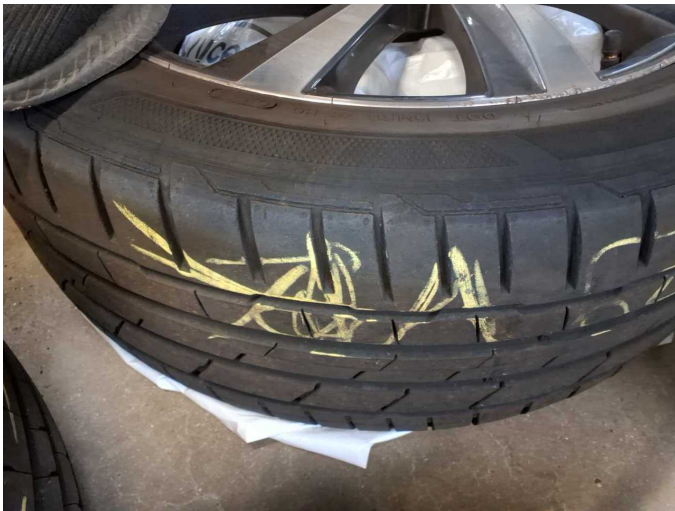
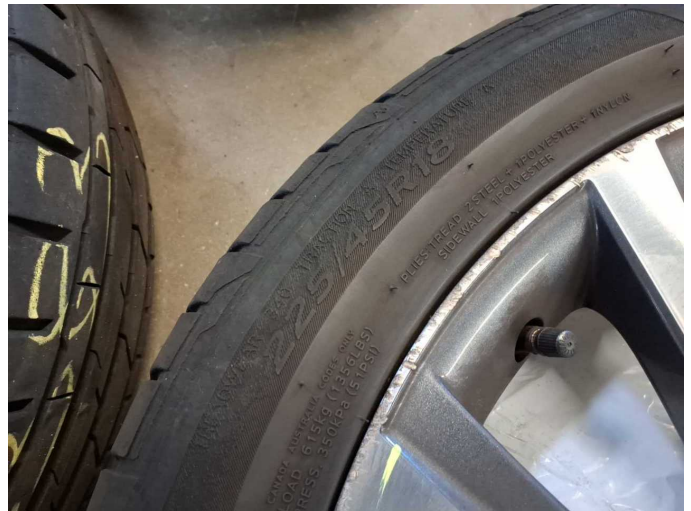
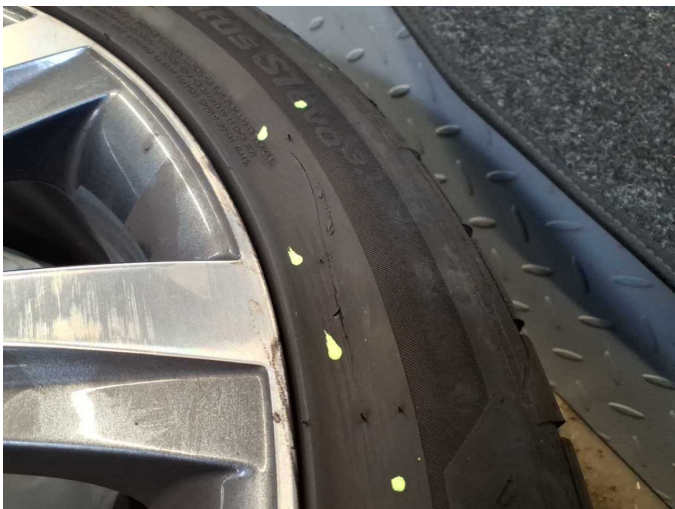
| No. | Component group | Description |
|---|---|---|
| 11 | 2nd wheel set | 1 tyre (Flanke) - Damaged - Replace |

**Damage 11:** 2nd wheel set: 1 tyre (Flanke) - Damaged - Replace

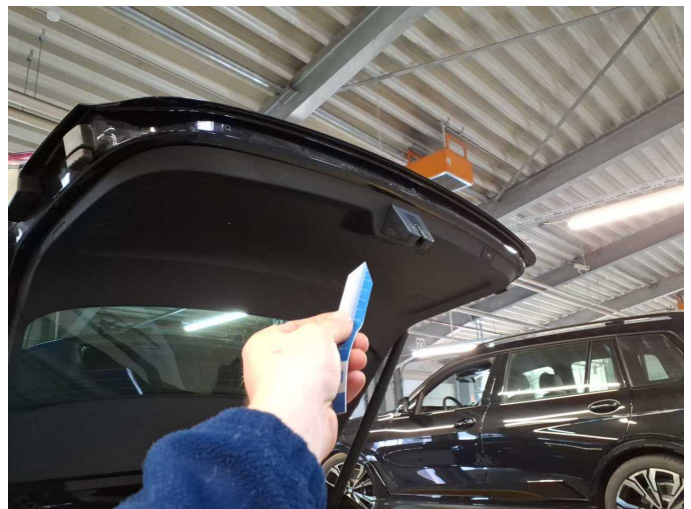
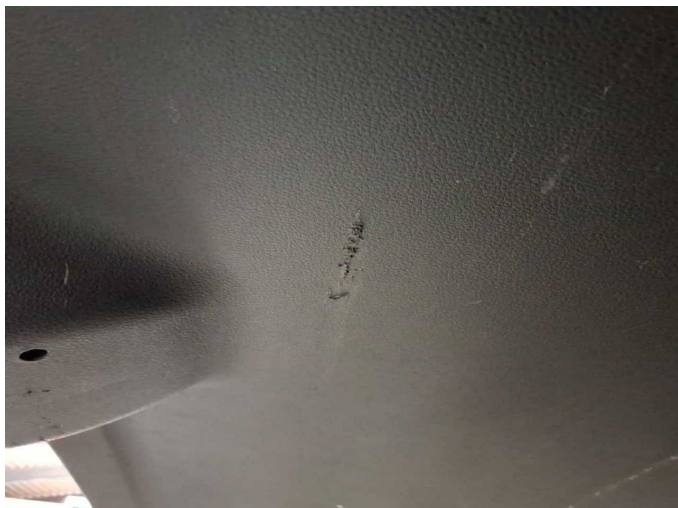
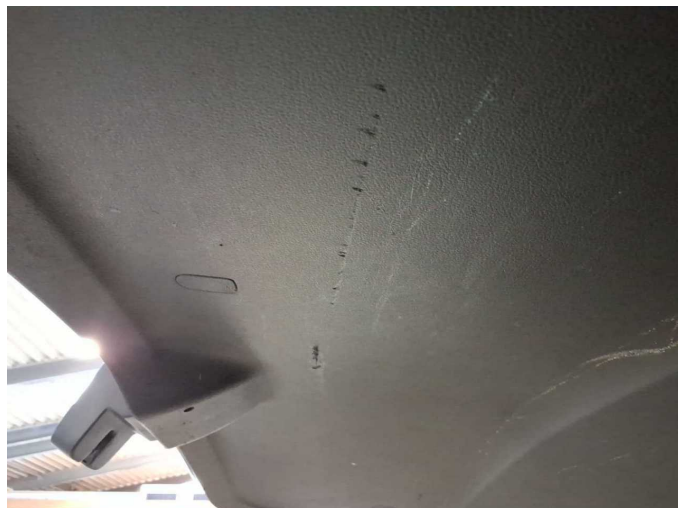
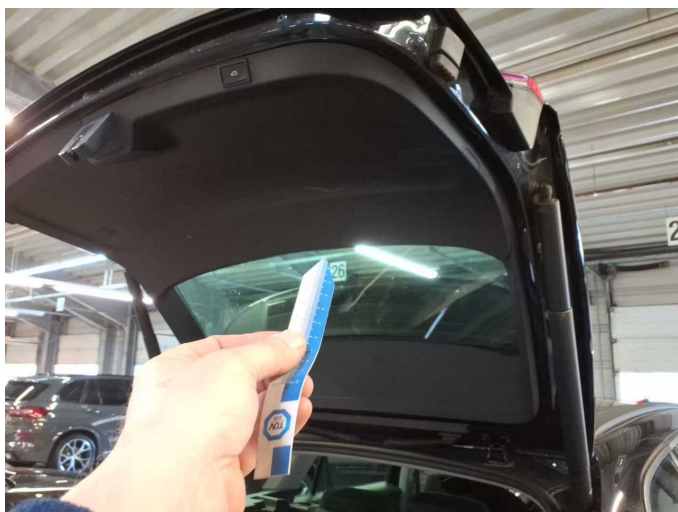
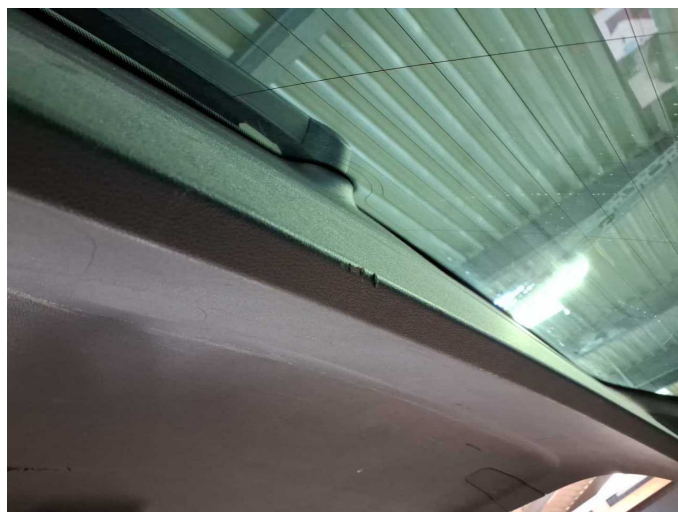
| No. | Component group | Description |
|---|---|---|
| 12 | Trim / covers | Boot lid - interior trim - Scratched - Replace |

**Damage 12:** Trim / covers: Boot lid - interior trim - Scratched - Replace

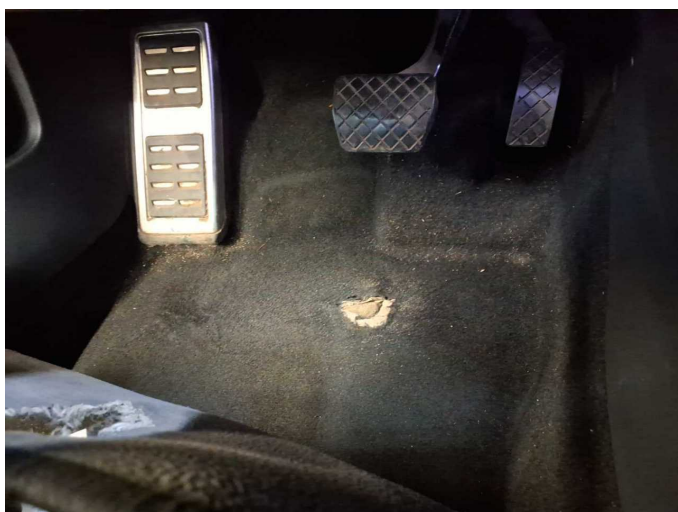
| No. | Component group | Description |
|---|---|---|
| 13 | Trim / covers | Floor covering - front left side - Broken / torn - Smart repair |

**Damage 13:** Trim / covers: Floor covering - front left side - Broken / torn - Smart repair

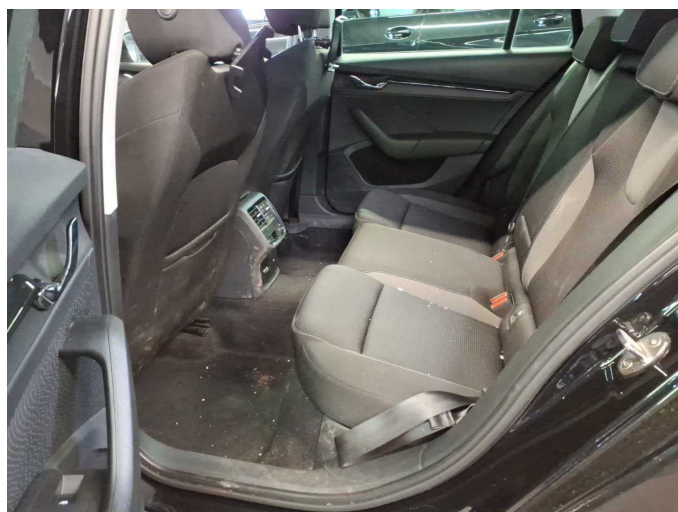
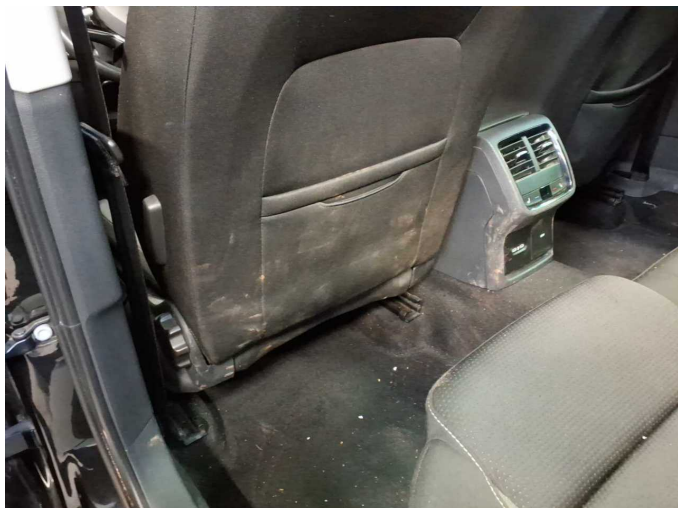
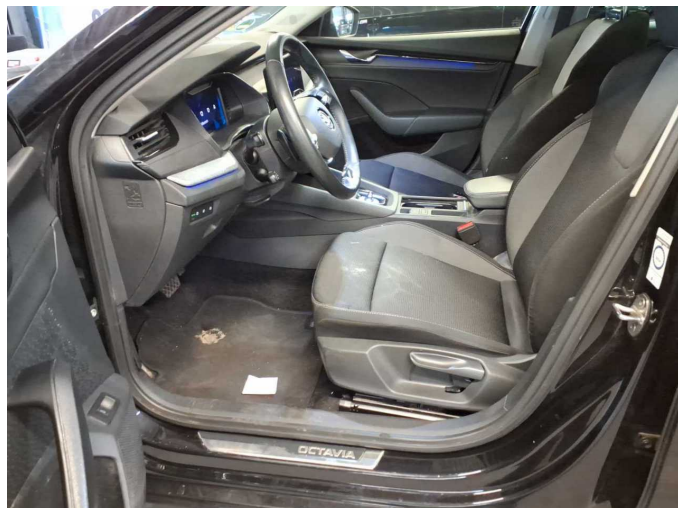
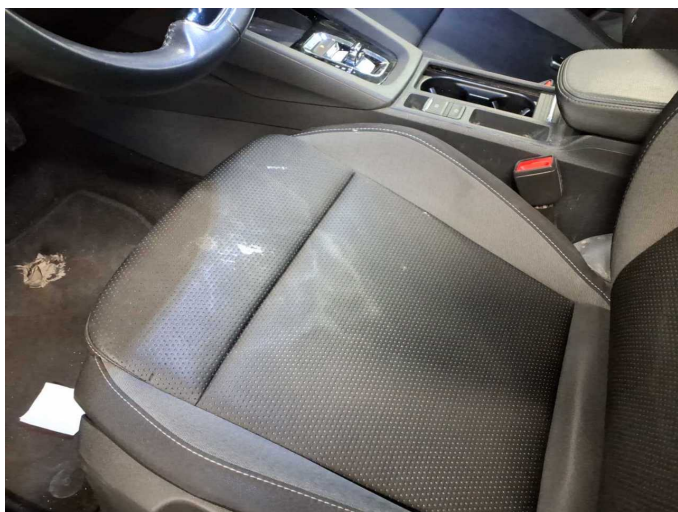
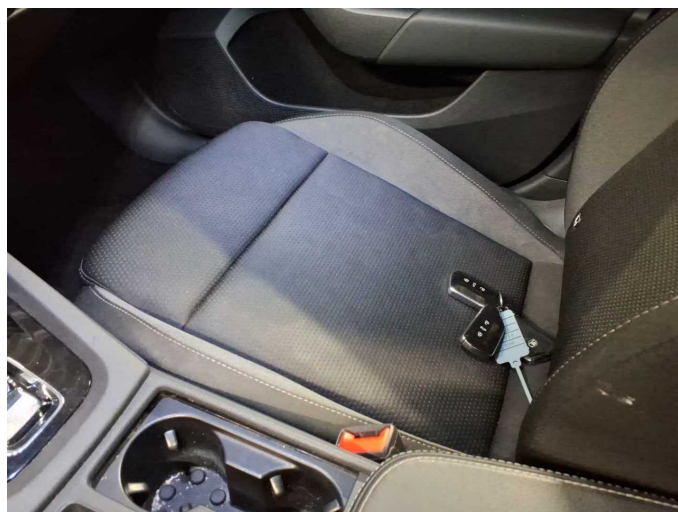
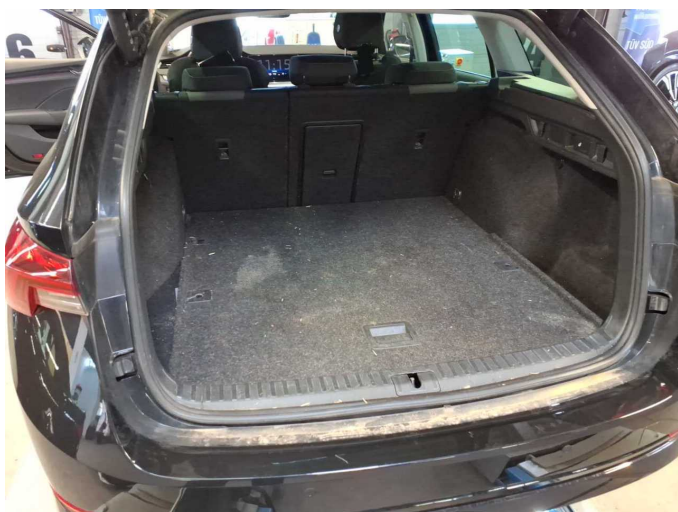
| No. | Component group | Description |
|---|---|---|
| 14 | Interior | Interior - Soiled - Clean |

**Damage 14:** Interior: Interior - Soiled - Clean

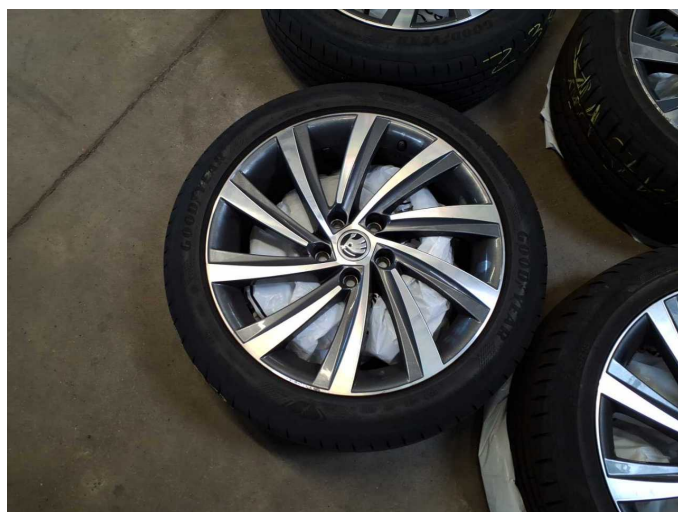
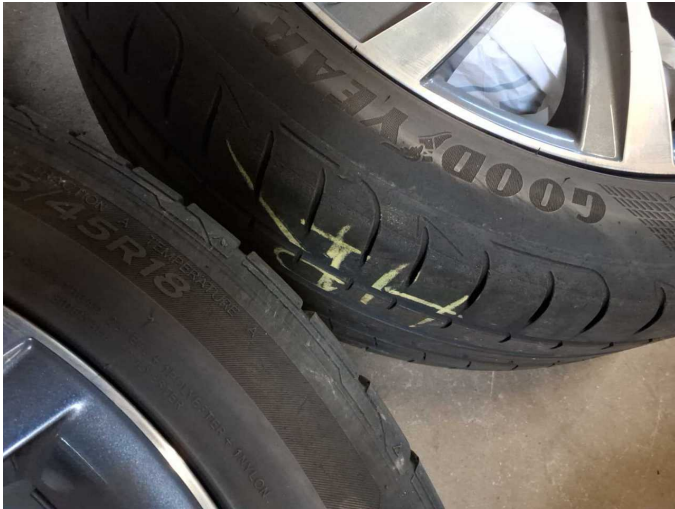
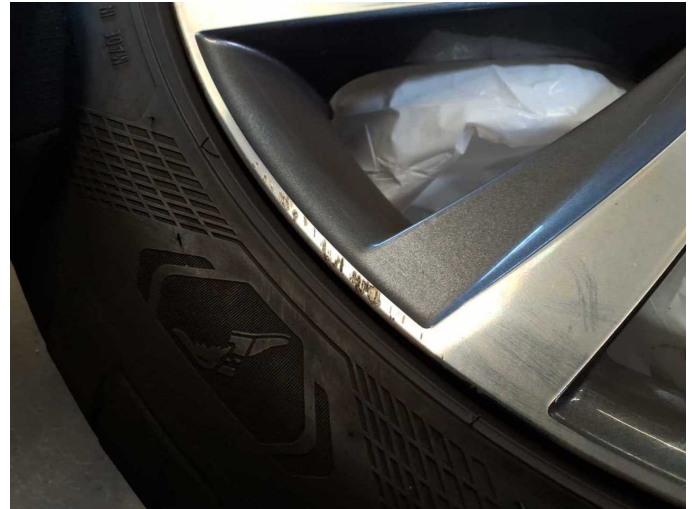
| No. | Component group | Description |
|---|---|---|
| 15 | 2nd wheel set | 1 alloy rim - Scratch(es) - Loss in value |

**Damage 15:** 2nd wheel set: 1 alloy rim - Scratch(es) - Loss in value

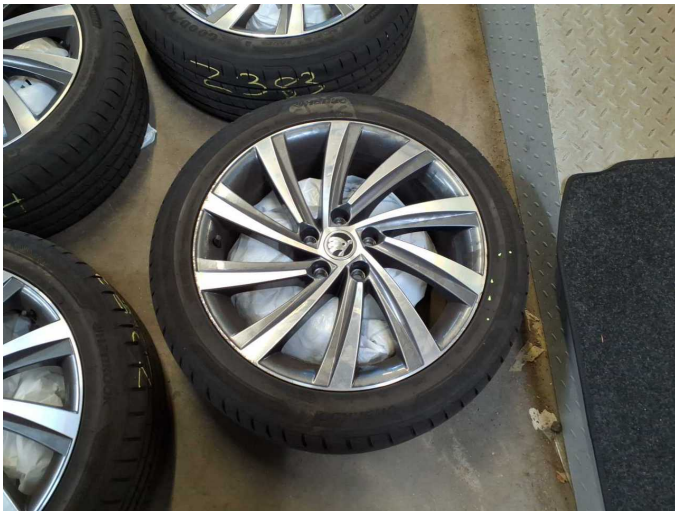
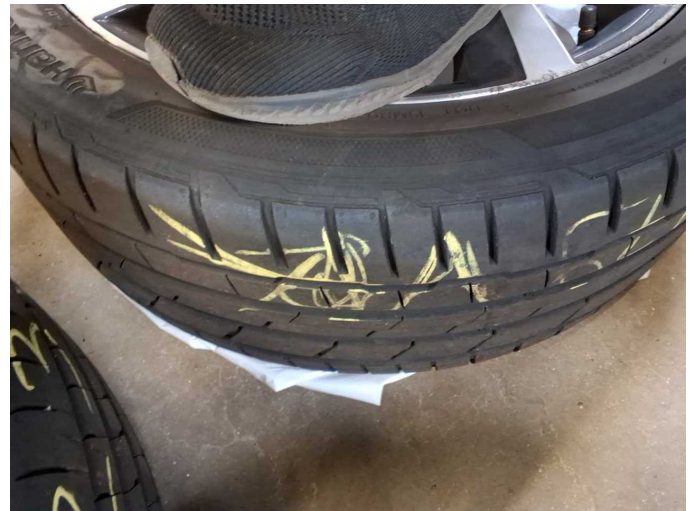
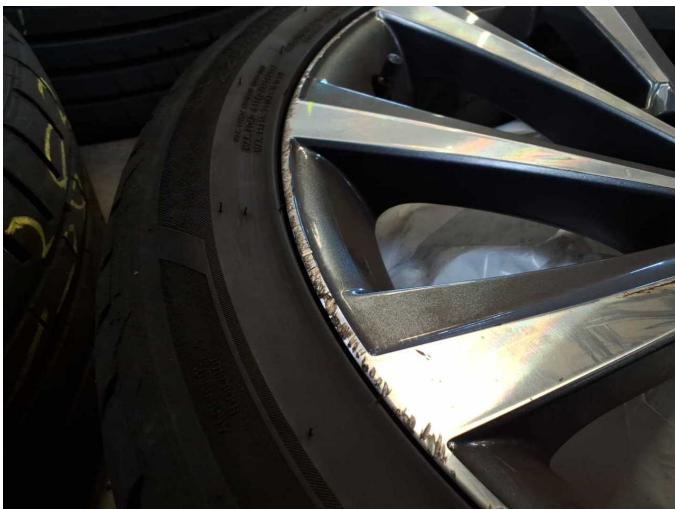
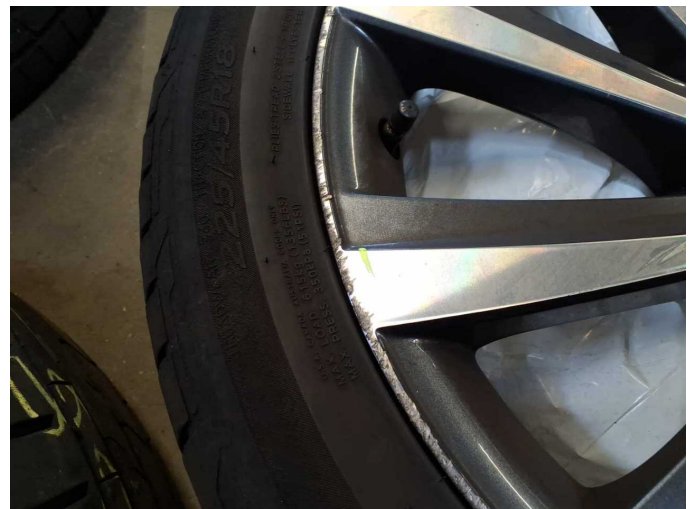
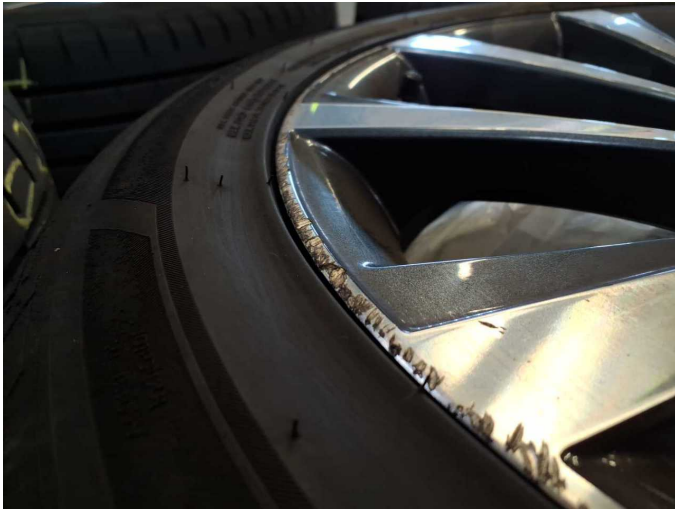
| No. | Component group | Description |
|---|---|---|
| 16 | 2nd wheel set | 1 alloy rim (Materialabtrag) - Scratched - Replace |

**Damage 16:** 2nd wheel set: 1 alloy rim (Materialabtrag) - Scratched - Replace

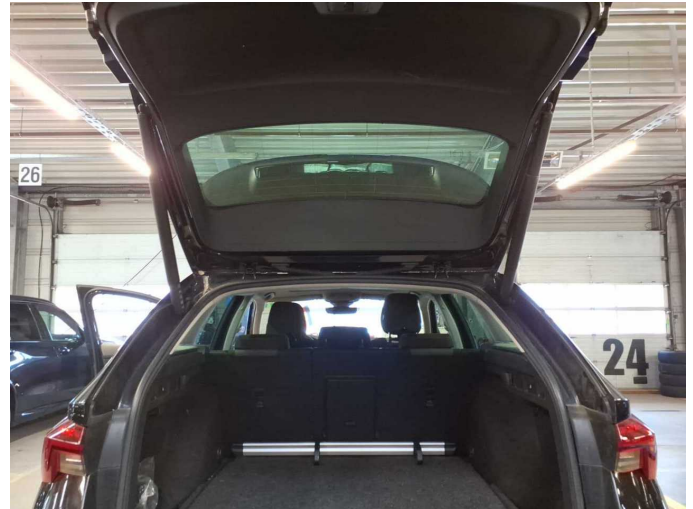
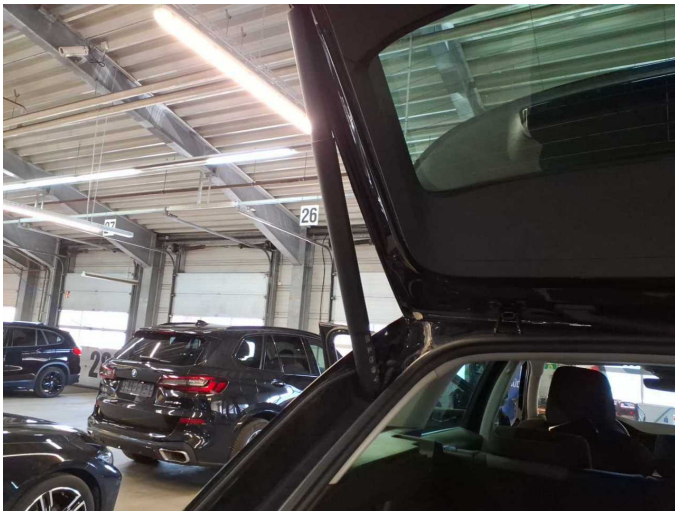
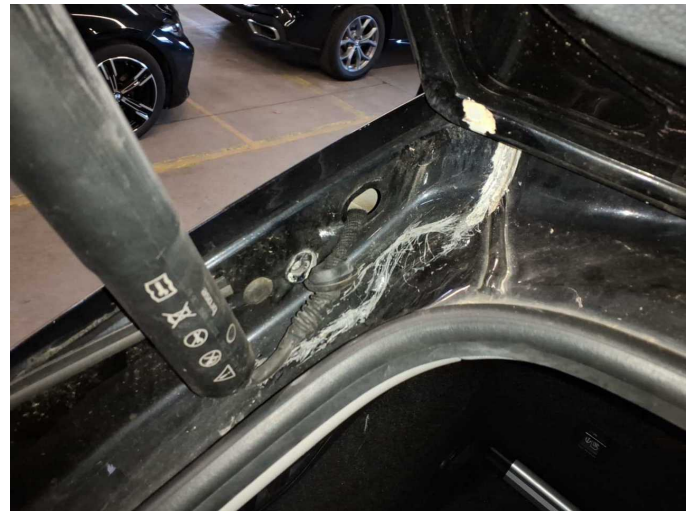
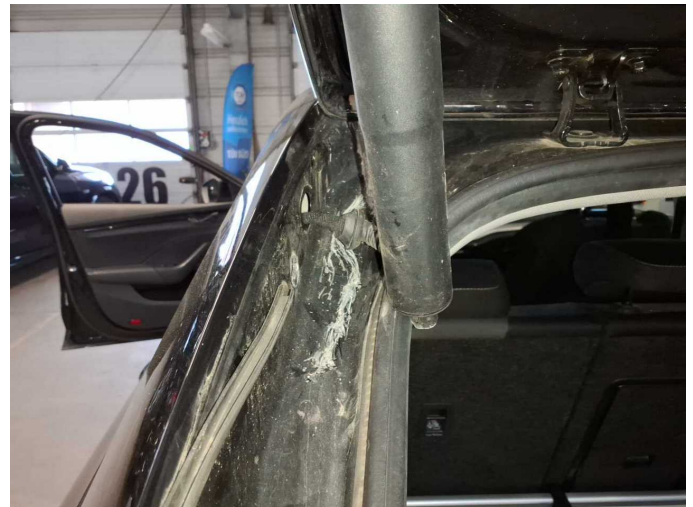
| No. | Component group | Description |
|---|---|---|
| 17 | Boot lid / rear door | Gas pressure damper (Motor, links + Halterinkl. inkl. Halter) - Loose - Replace |

**Damage 17:** Boot lid / rear door: Gas pressure damper (Motor, links + Halterinkl. inkl. Halter) - Loose - Replace

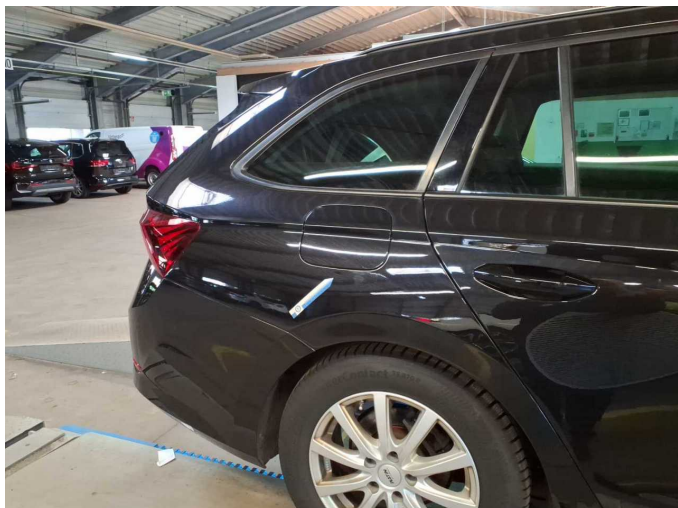
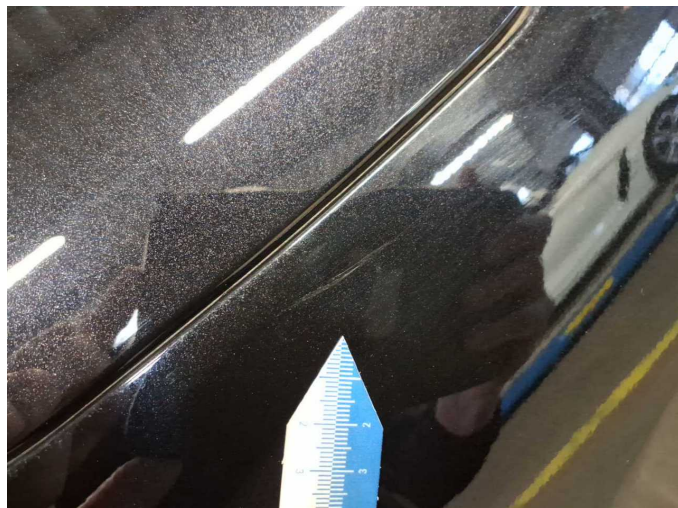
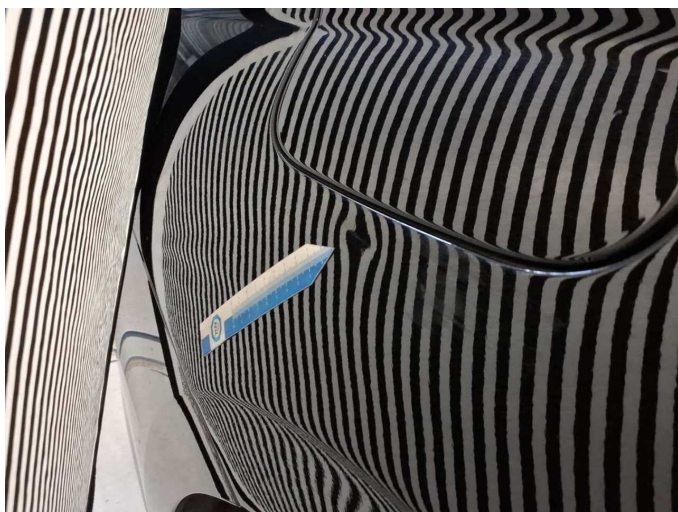
| No. | Component group | Description |
|---|---|---|
| 18 | Side panel - rear right side | Side panel - Dent / paintcoat damage - Repair and paint |

**Damage 18:** Side panel - rear right side: Side panel - Dent / paintcoat damage - Repair and paint

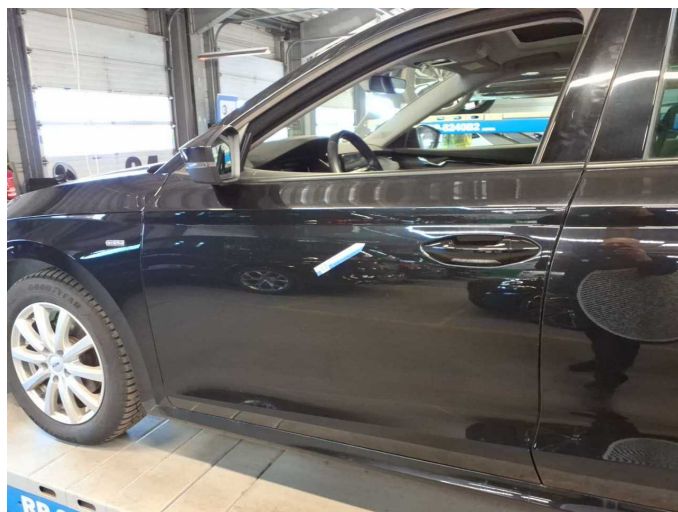
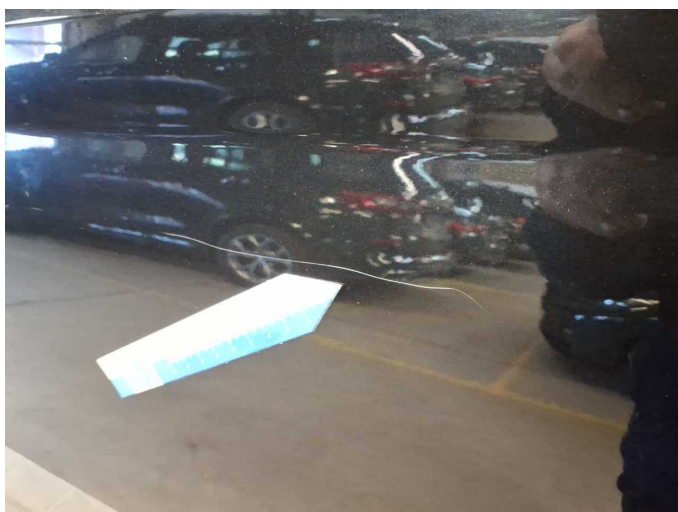
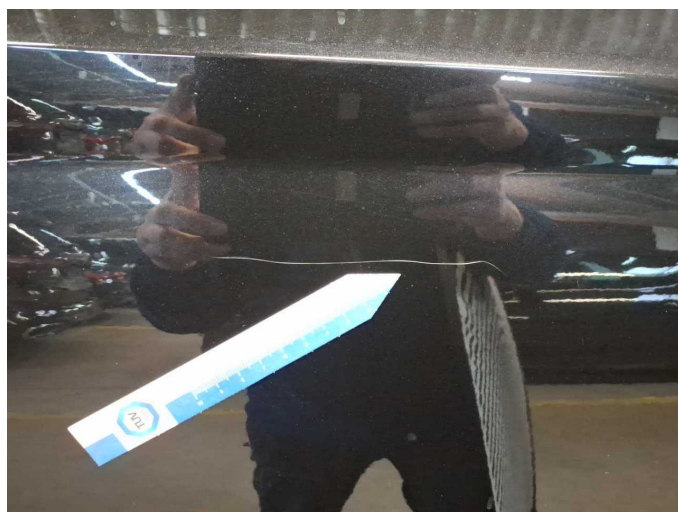
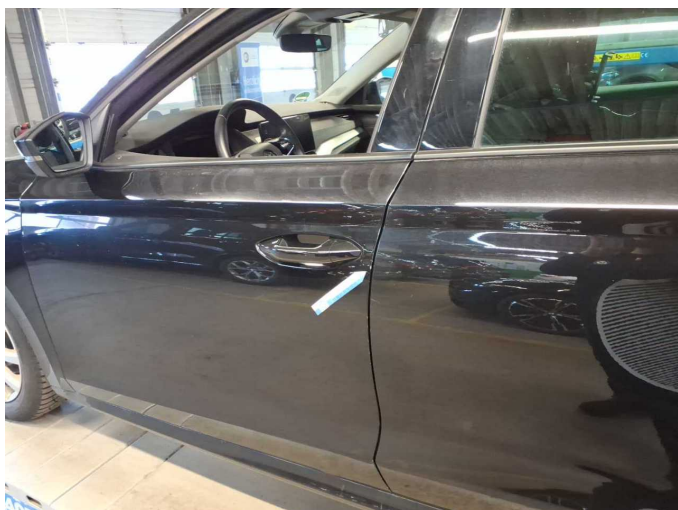
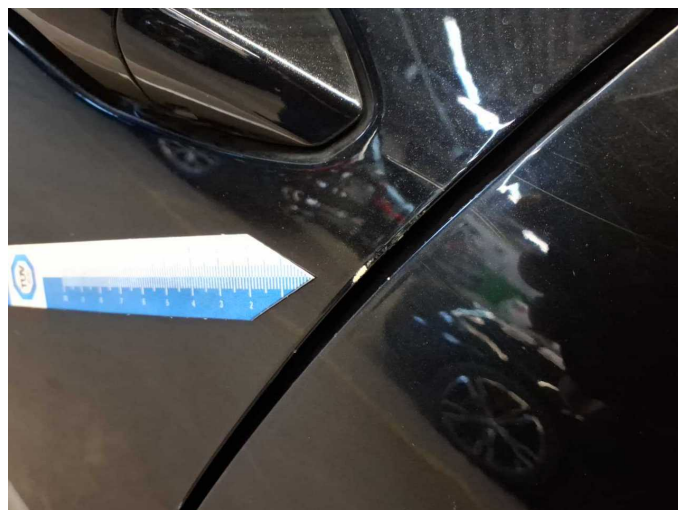
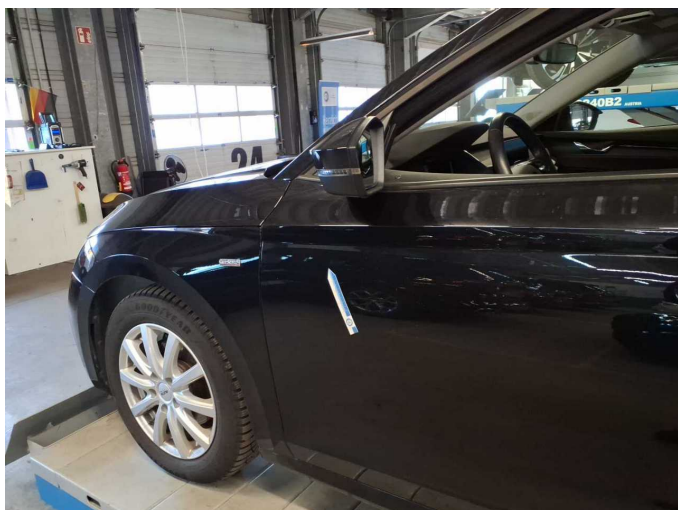
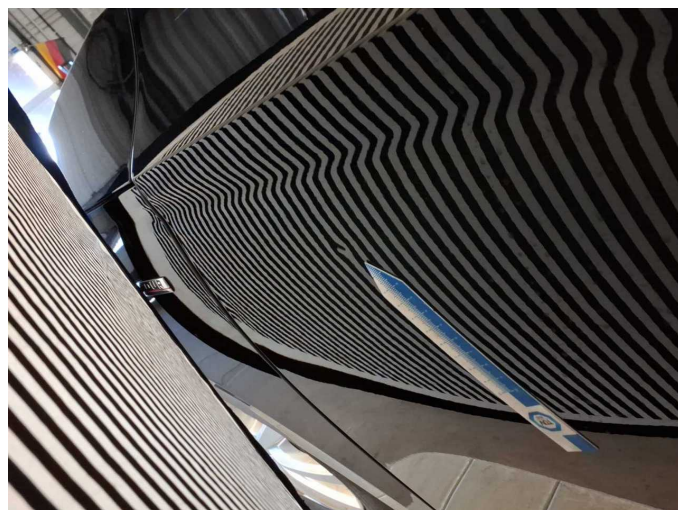
| No. | Component group | Description |
|---|---|---|
| 19 | Door - front left side | Door - Dent / paintcoat damage - Repair and paint |

**Damage 19:** Door - front left side: Door - Dent / paintcoat damage - Repair and paint

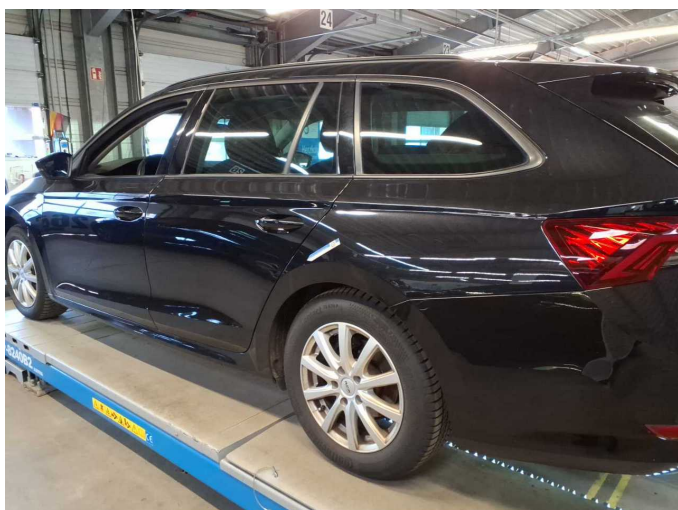
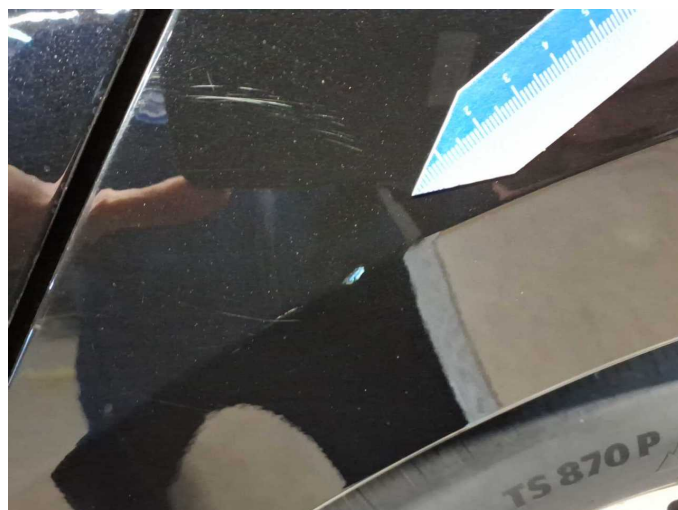
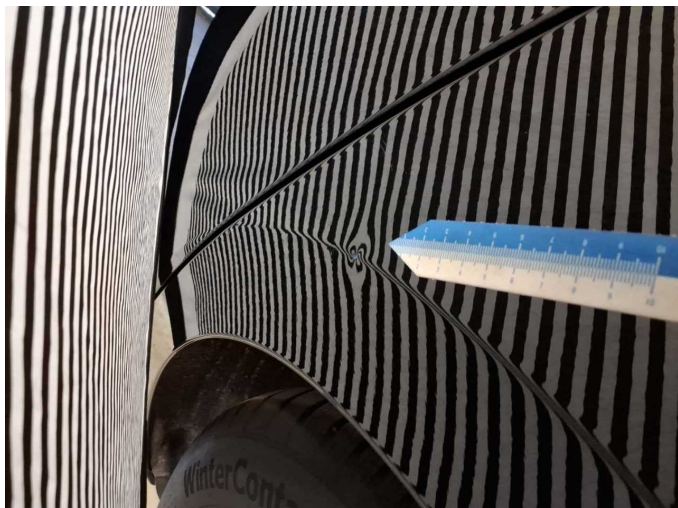
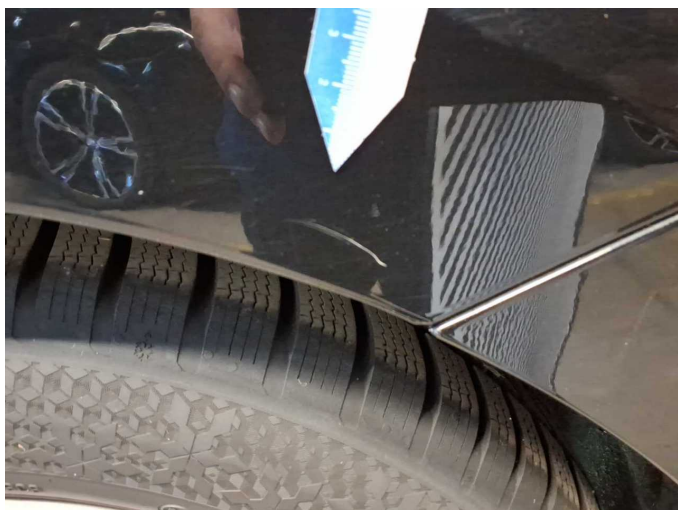
| No. | Component group | Description |
|---|---|---|
| 20 | Side panel - rear left side | Side panel - Dent / paintcoat damage - Repair and paint |

**Damage 20:** Side panel - rear left side: Side panel - Dent / paintcoat damage - Repair and paint

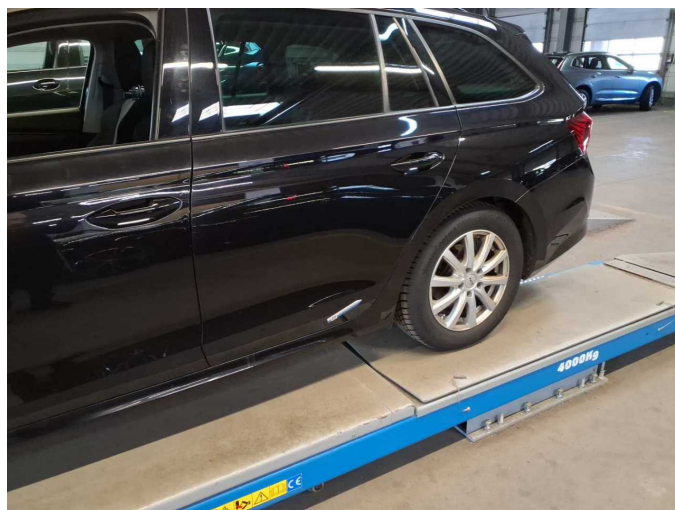
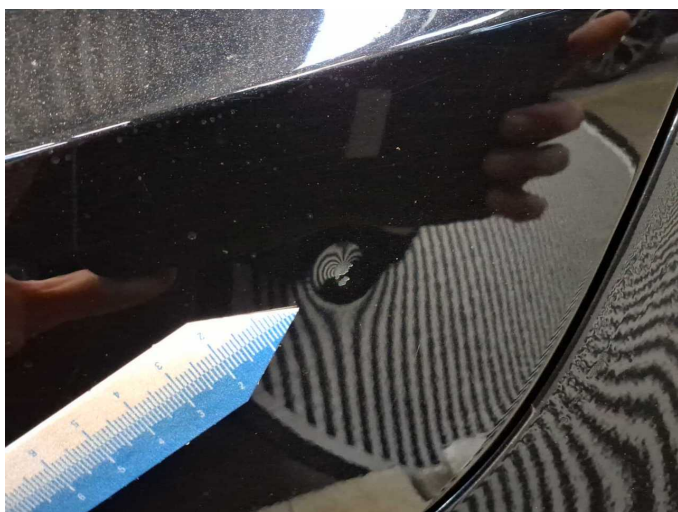
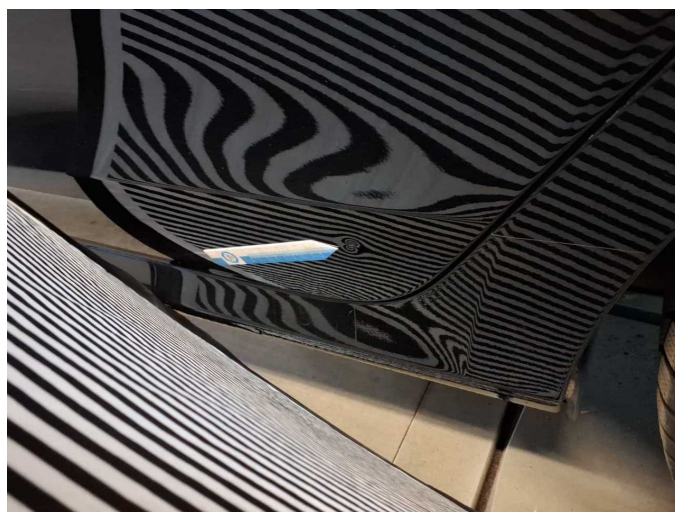
| No. | Component group | Description |
|---|---|---|
| 21 | Door - rear left side | Door - Dent / paintcoat damage - Repair and paint |

**Damage 21:** Door - rear left side: Door - Dent / paintcoat damage - Repair and paint
