Expertise

Protocol number: 45232666  
Order No. / Reference: 26006377  
Inspection date: 14 Apr 2026

Manufacturer: Skoda  
VIN: TMBJJ8NX0PY076190

Model: Octavia Combi 2.0 TDI DSG Tour

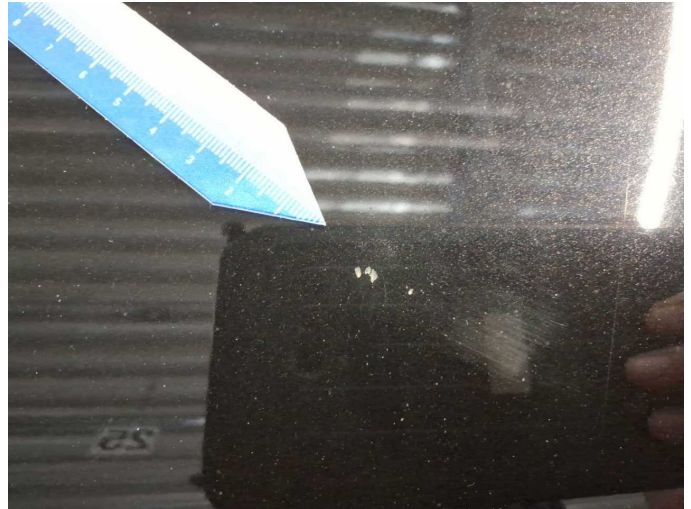
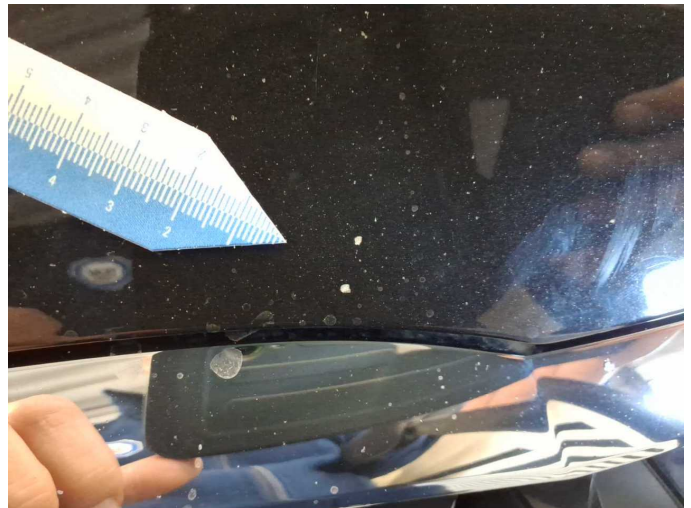
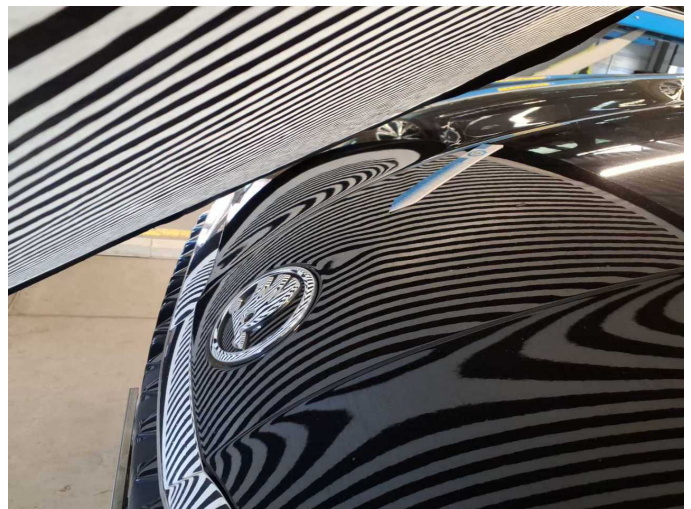
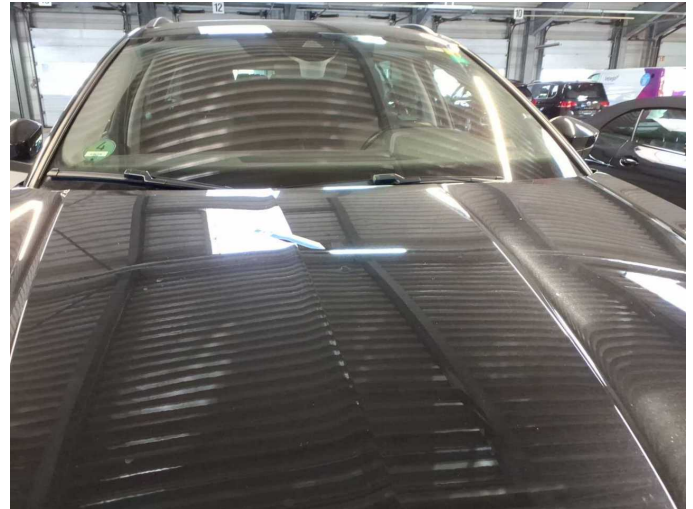
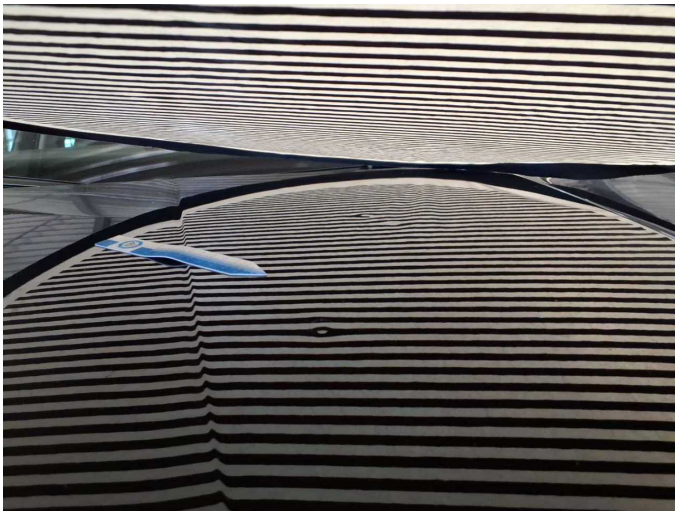
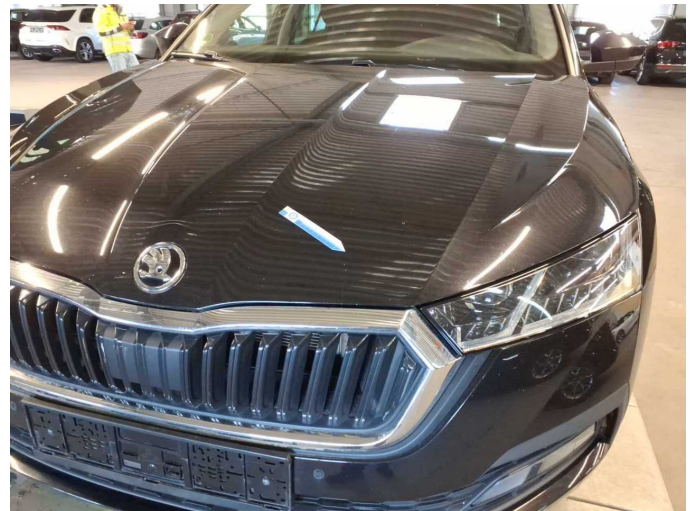
| No. | Component group | Description |
|---|---|---|
| 22 | Bonnet | Bonnet (Verformt) - Dent / paintcoat damage - Repair and paint |

**Damage 22:** Bonnet: Bonnet (Verformt) - Dent / paintcoat damage - Repair and paint

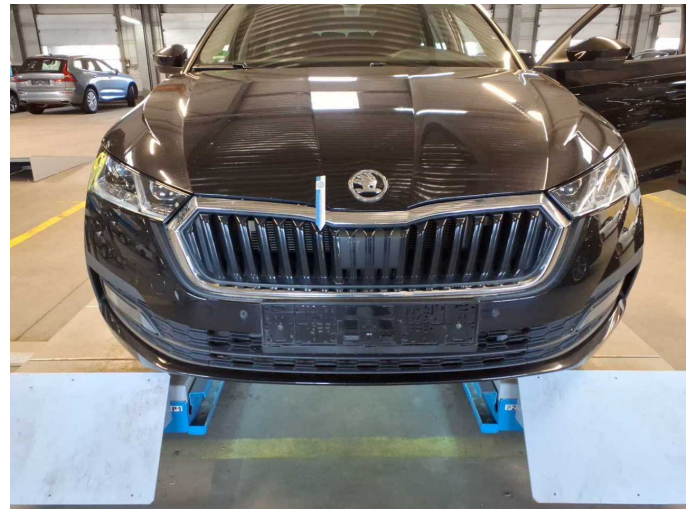
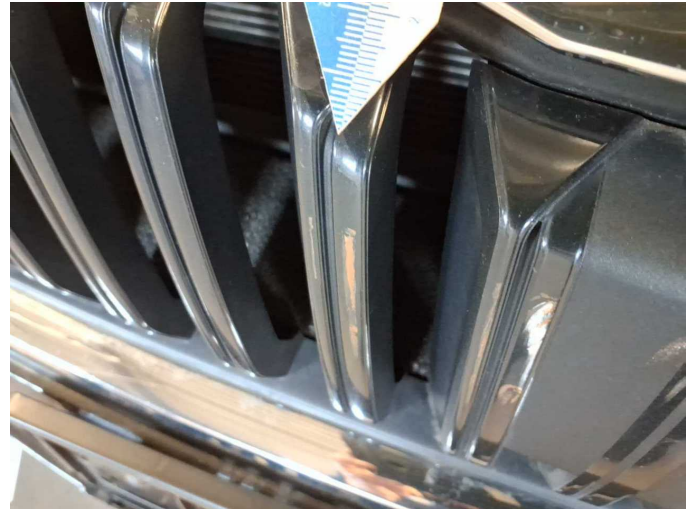
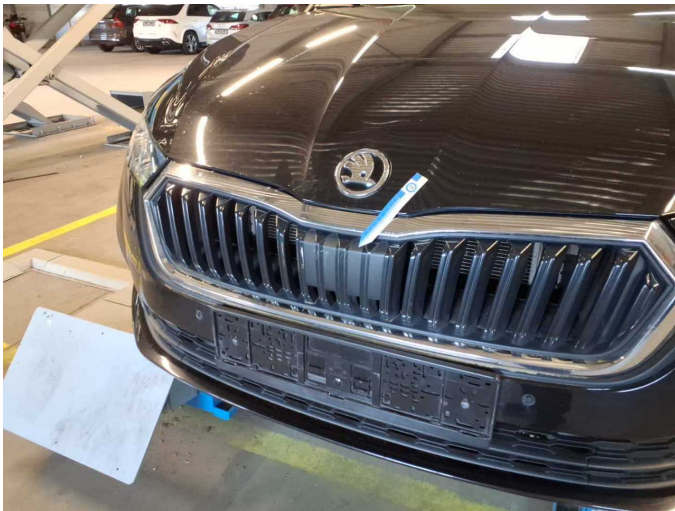
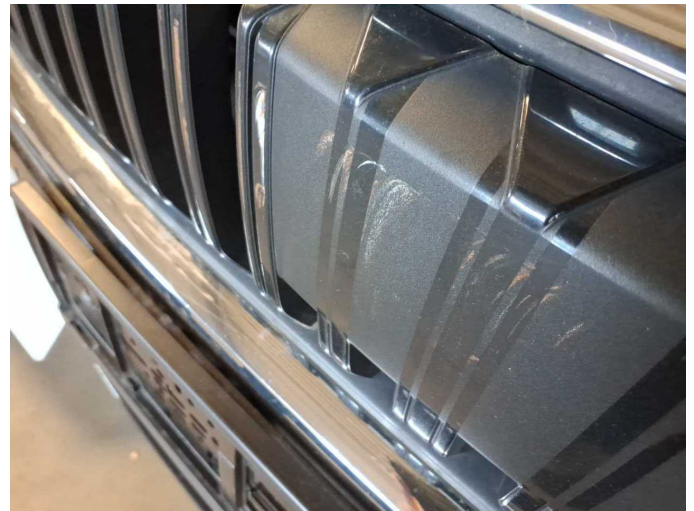
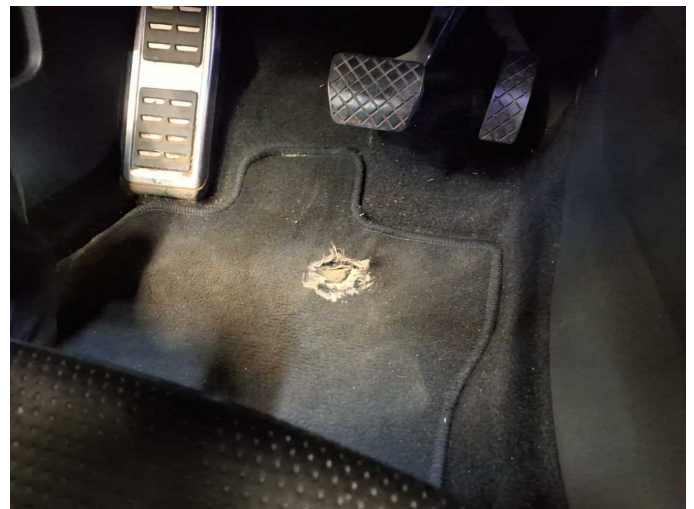
| No. | Component group | Description |
|---|---|---|
| 4 | Front bumper | Air-inlet grille - Scratched - No deduction |

**Wear and tear 4:** Front bumper: Air-inlet grille - Scratched - No deduction
