Expertise

Protocol number: 46242377  
Order No. / Reference: 26611675  
Inspection date: 29 Jun 2026

Manufacturer: Volkswagen

Model: Caddy Cargo 2.0 TDI BMT

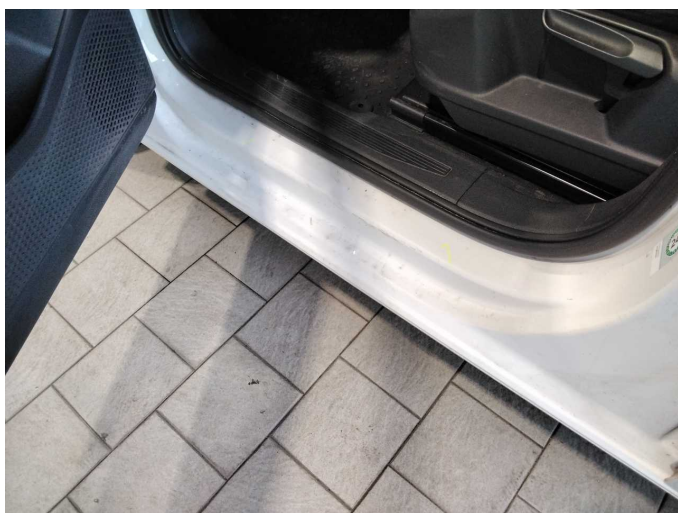
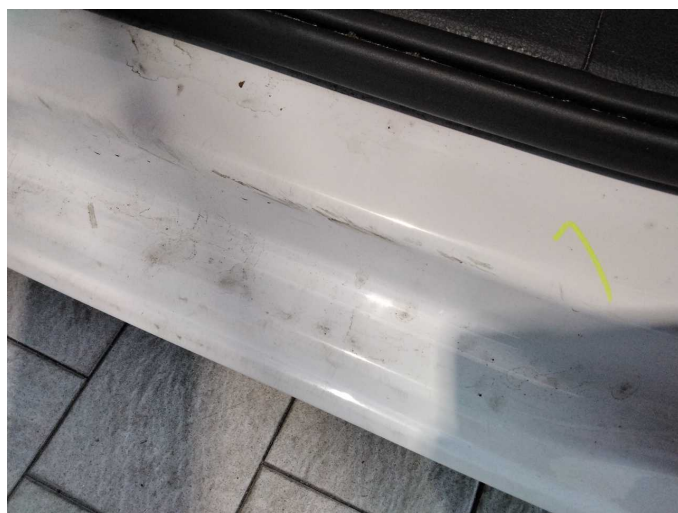
| No. | Component group | Description |
|---|---|---|
| 2 | Sill - left side | Sill - Scratch(es) - Smart repair |

Damage 2: Sill - left side: Sill - Scratch(es) - Smart repair

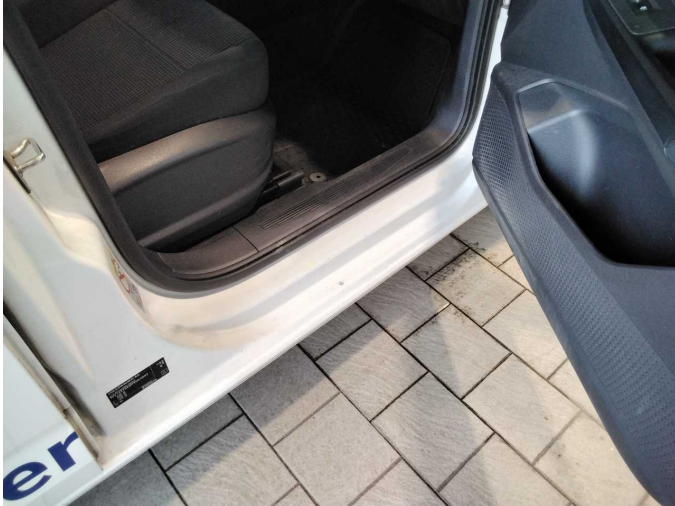
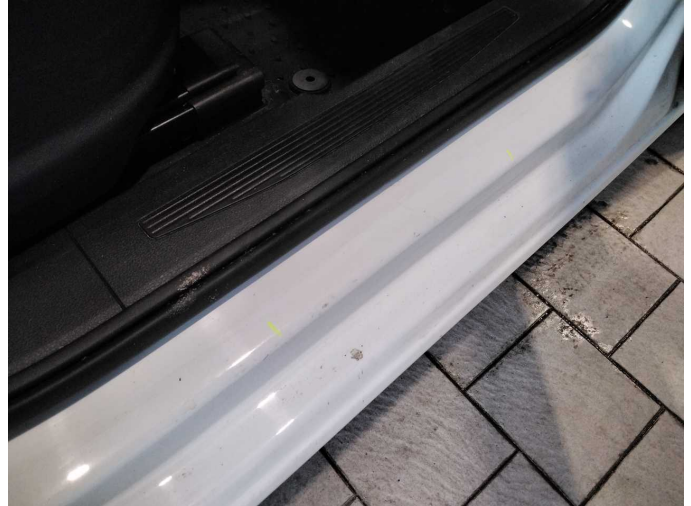
| No. | Component group | Description |
|---|---|---|
| 3 | Sill - right side | Sill - Scratch(es) - Smart repair |

**Damage 3:** Sill - right side: Sill - Scratch(es) - Smart repair

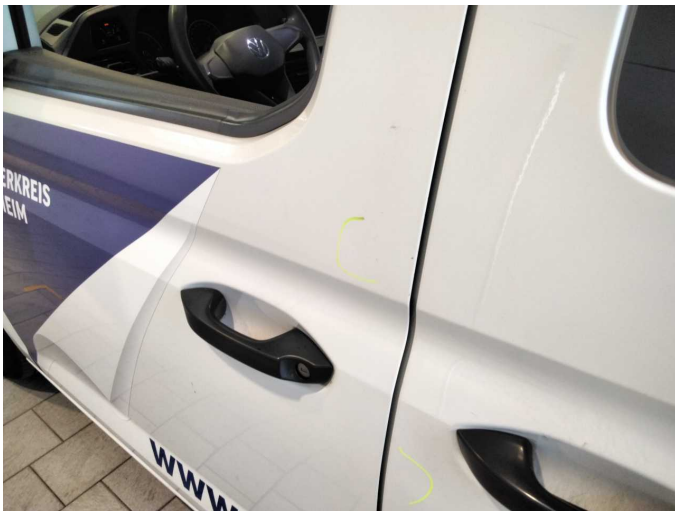
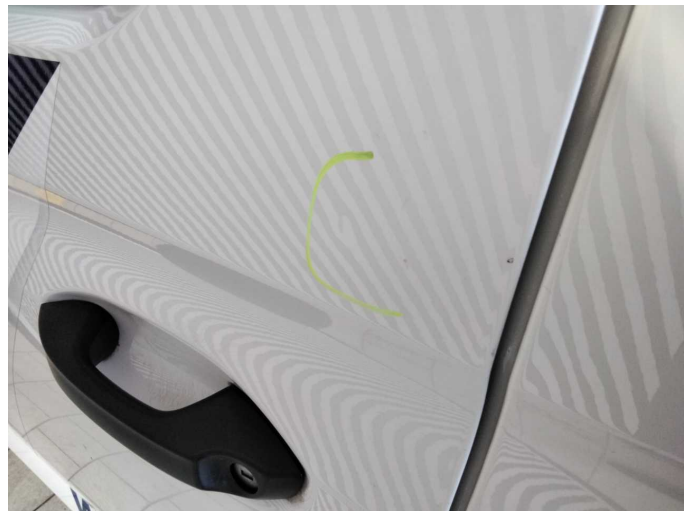
| No. | Component group | Description |
|---|---|---|
| 4 | Door - front left side | Door - dent(s) - Smooth repair work |

**Damage 4:** Door - front left side: Door - dent(s) - Smooth repair work

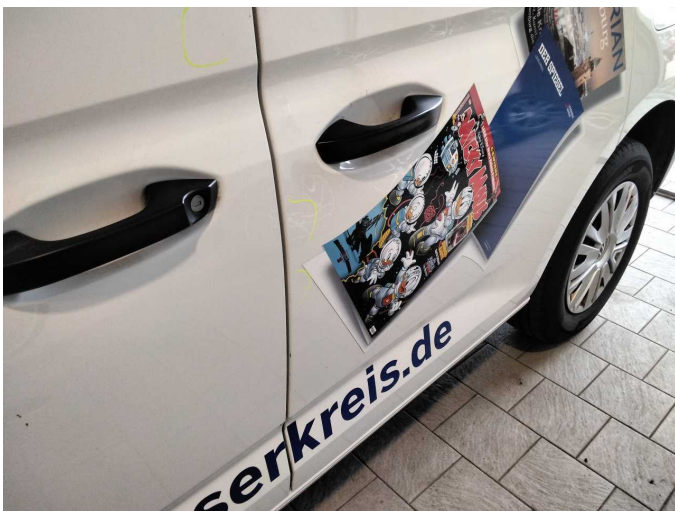
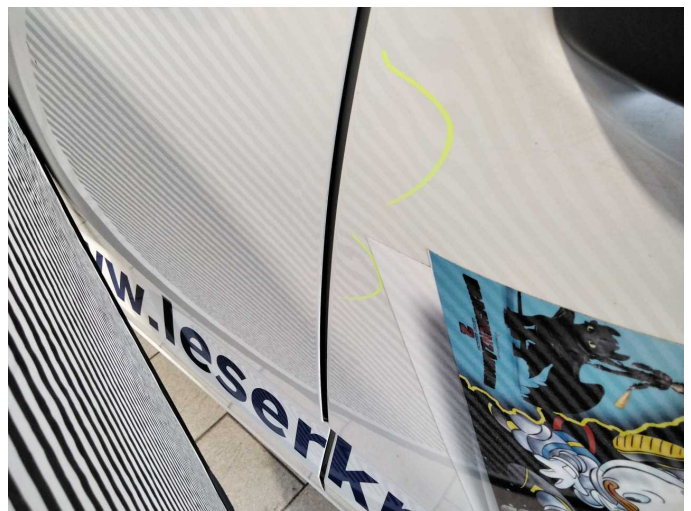
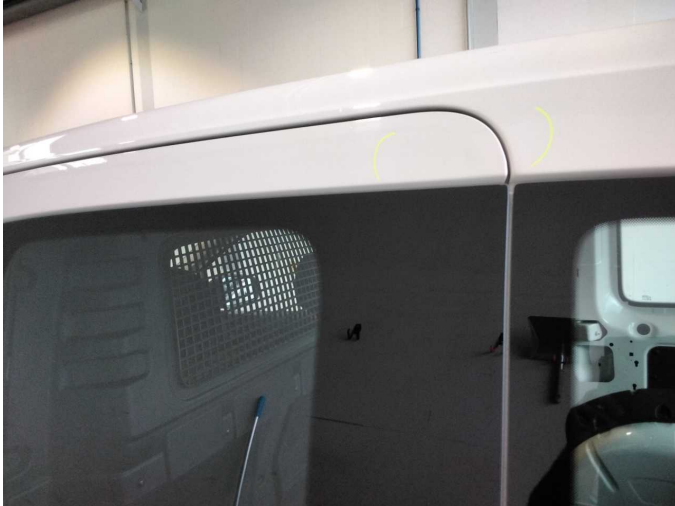
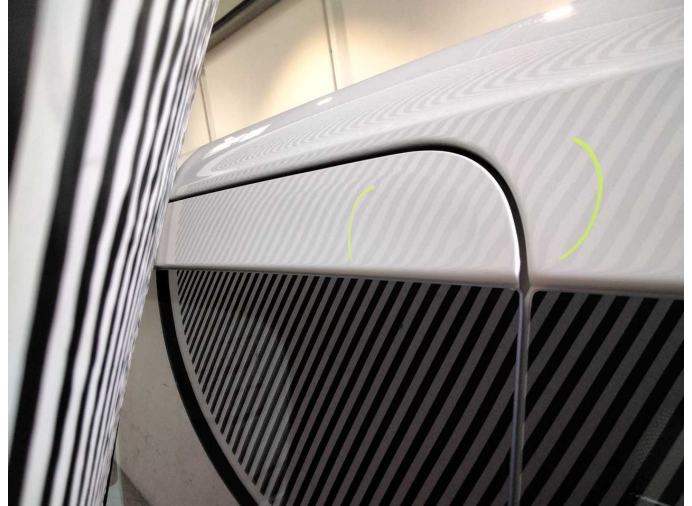
| No. | Component group | Description |
|---|---|---|
| 5 | Sliding door - left side | Sliding door with glass panel - dent(s) - Smooth repair work |

**Damage 5:** Sliding door - left side: Sliding door with glass panel - dent(s) - Smooth repair work

**Damage 5:** Sliding door - left side: Sliding door with glass panel - dent(s)  
- Smooth repair work

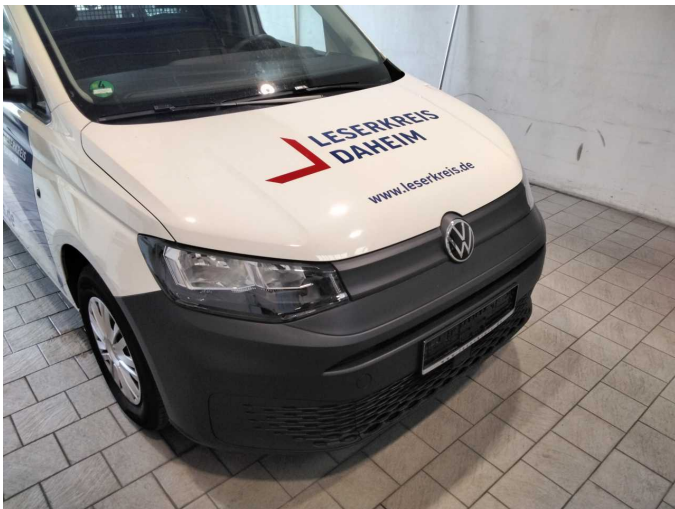
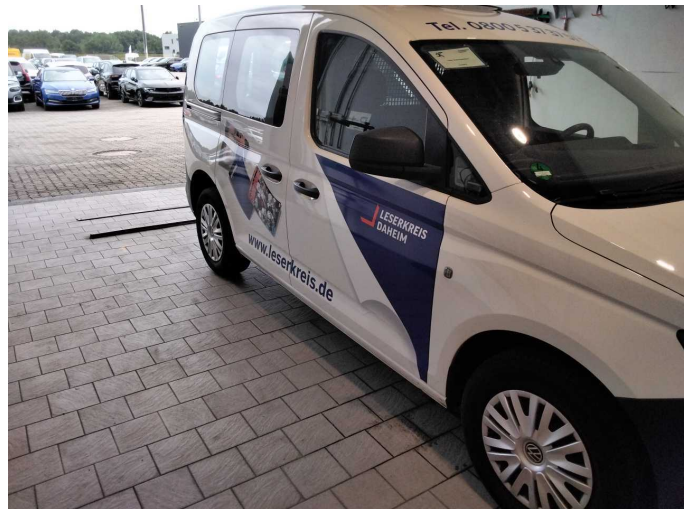
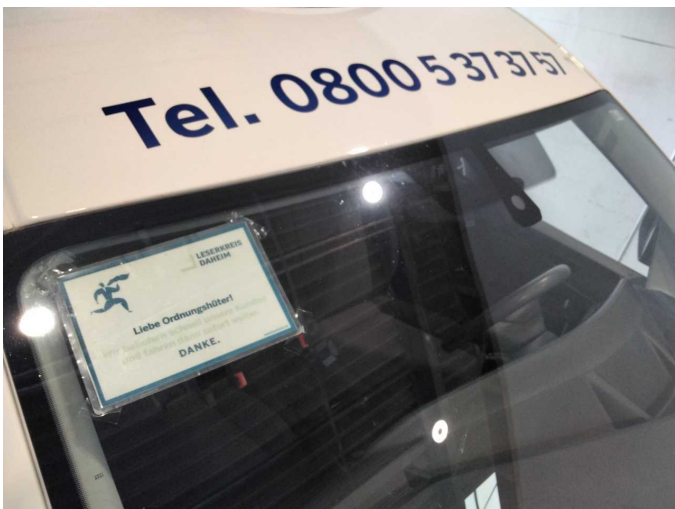
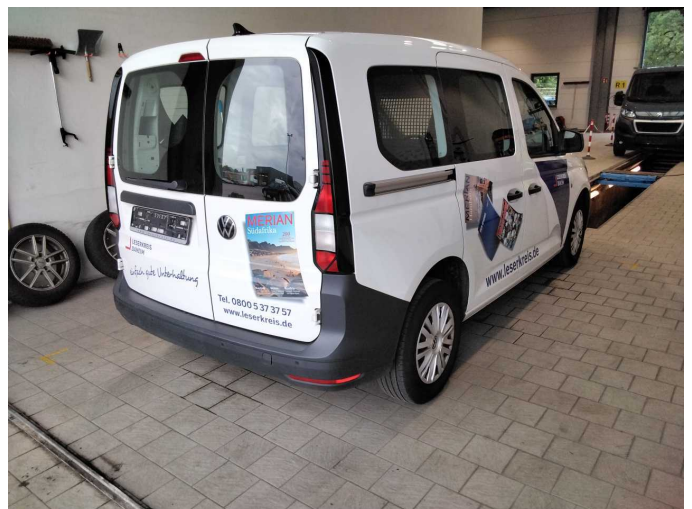
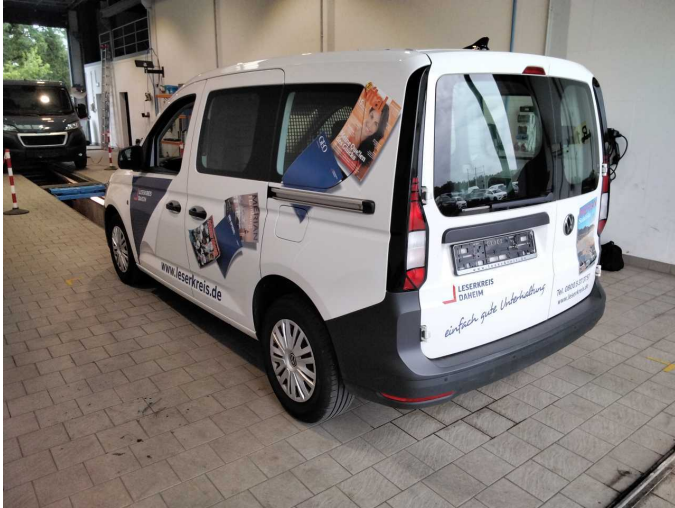
| No. | Component group | Description |
|---|---|---|
| 6 | Body | Body - Glued / labelled - De-glue / neutralise |

**Damage 6:** Body: Body - Glued / labelled - De-glue / neutralise
