Expertise

Protocol number: 46158241  
Order No. / Reference: 26576454  
Inspection date: 24 Jun 2026

Manufacturer: CUPRA

Model: Born 150kW/58kWh

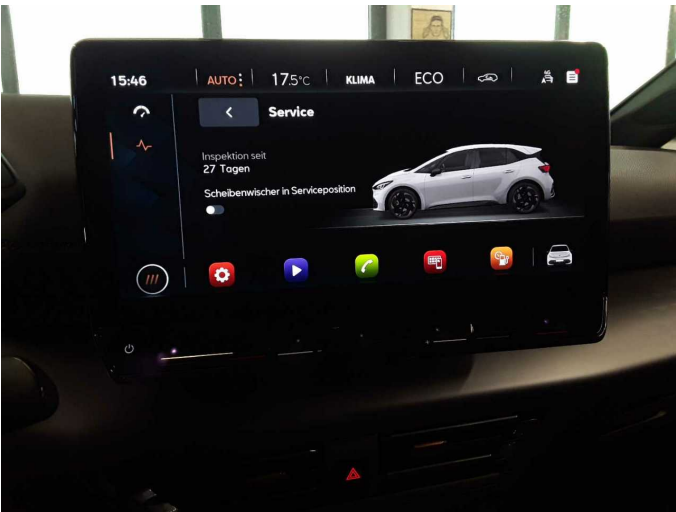
| No. | Component group | Description |
|---|---|---|
| 1 | Misc. | Inspection / maintenance - Due - Perform |

Damage 1: Misc.: Inspection / maintenance - Due - Perform

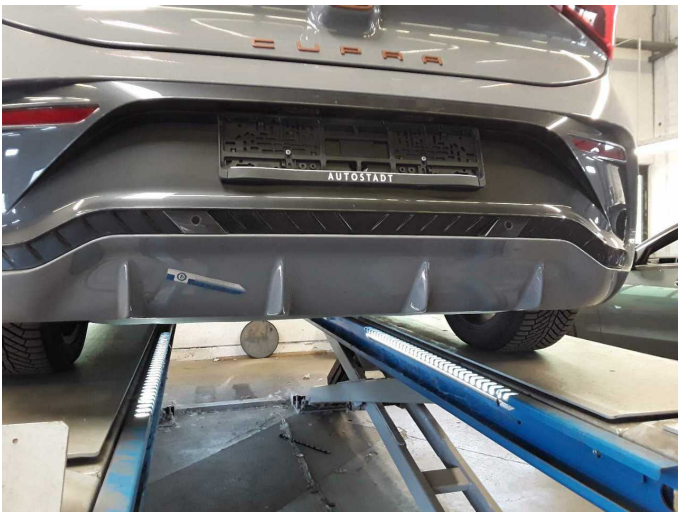
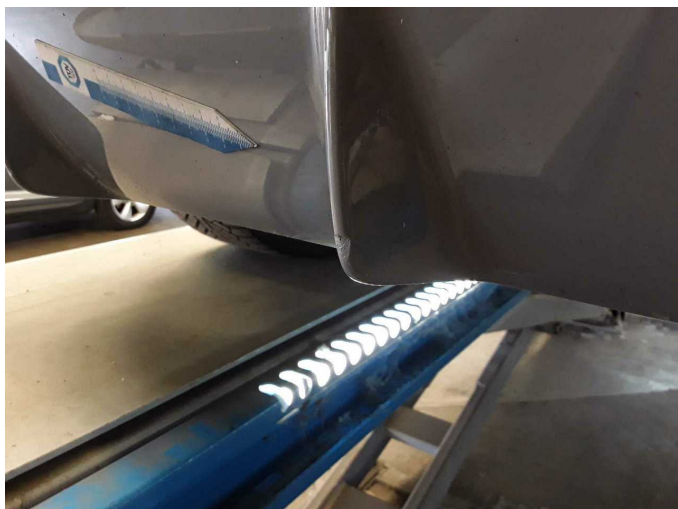
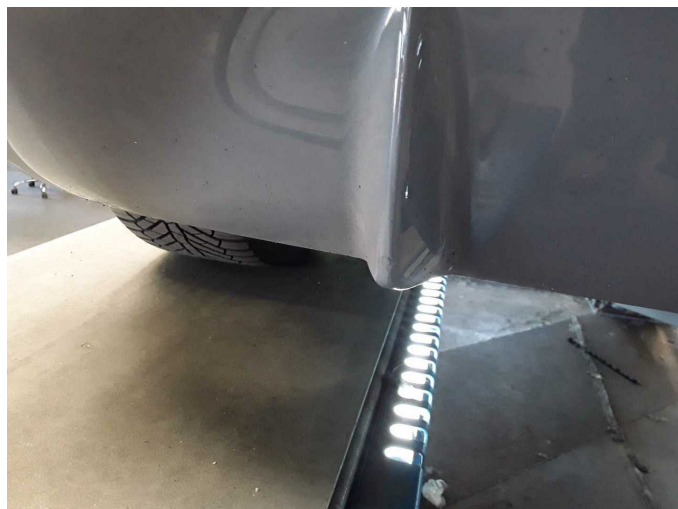
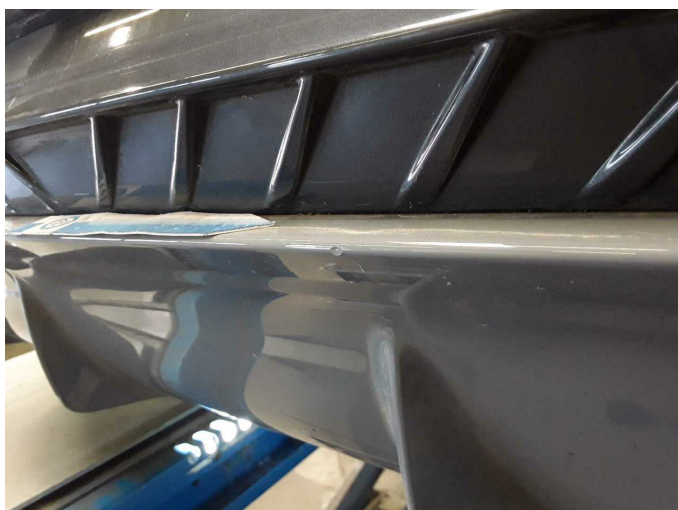
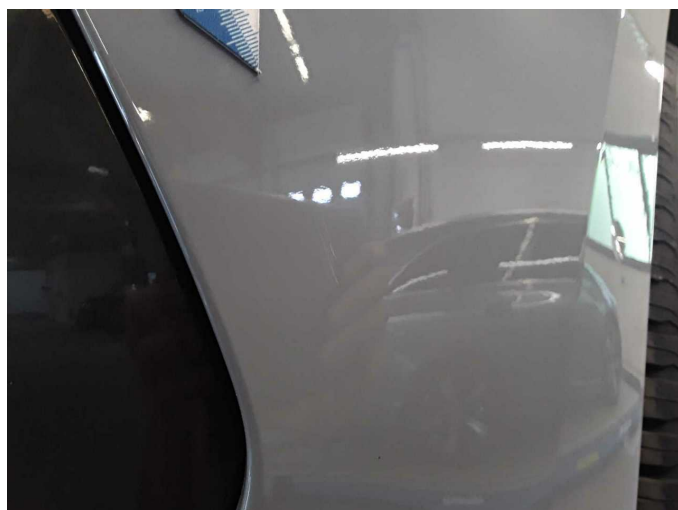
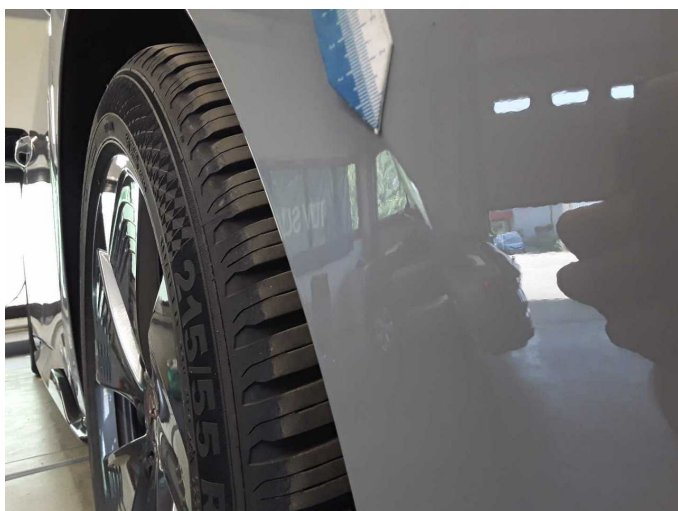
| No. | Component group | Description |
|---|---|---|
| 2 | Rear bumper | Rear bumper - Scratch(es) - Paint |

Damage 2: Rear bumper: Rear bumper - Scratch(es) - Paint

**Damage 2:** Rear bumper: Rear bumper - Scratch(es) - Paint

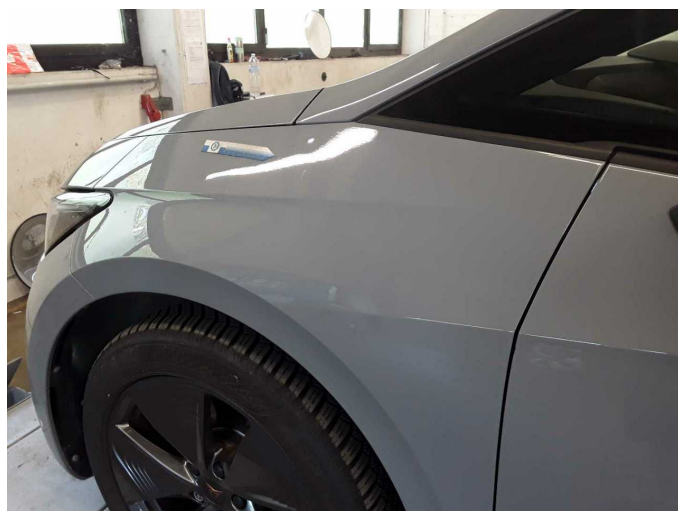
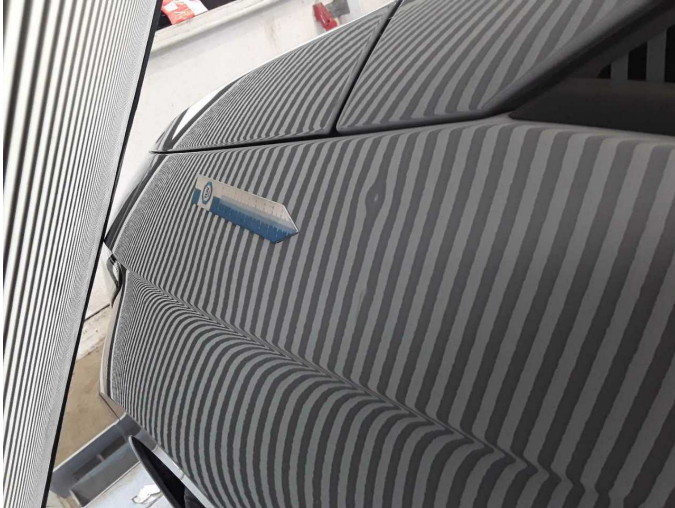
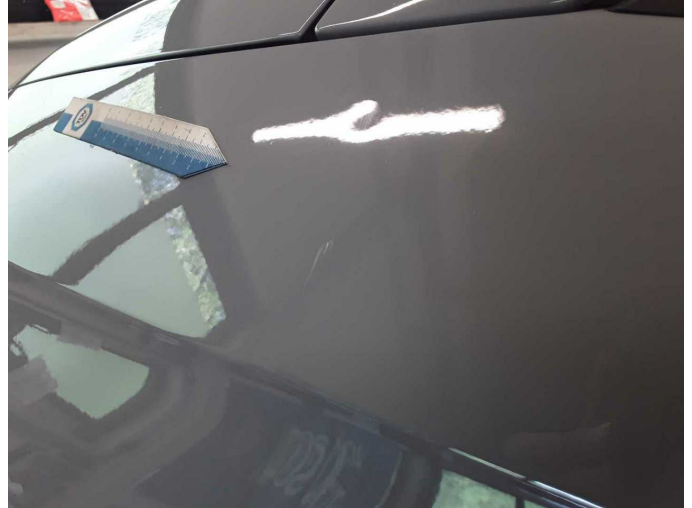
| No. | Component group | Description |
|---|---|---|
| 3 | Mudguard - left side | Mudguard - left side - Dent / paintcoat damage - Repair and paint |

**Damage 3:** Mudguard - left side: Mudguard - left side - Dent / paintcoat damage - Repair and paint

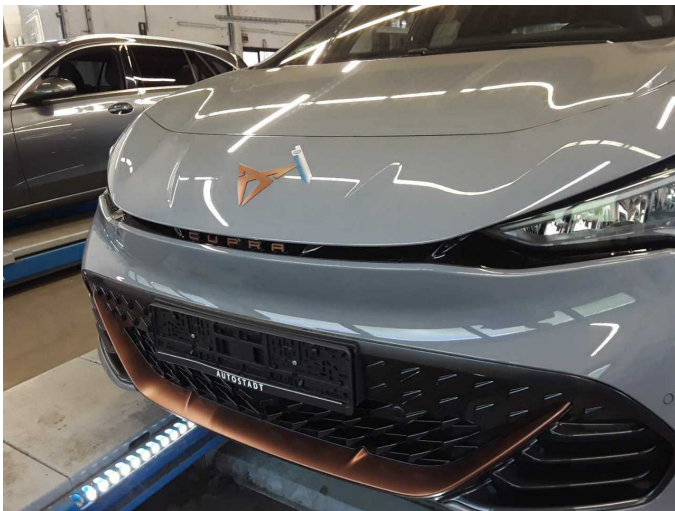
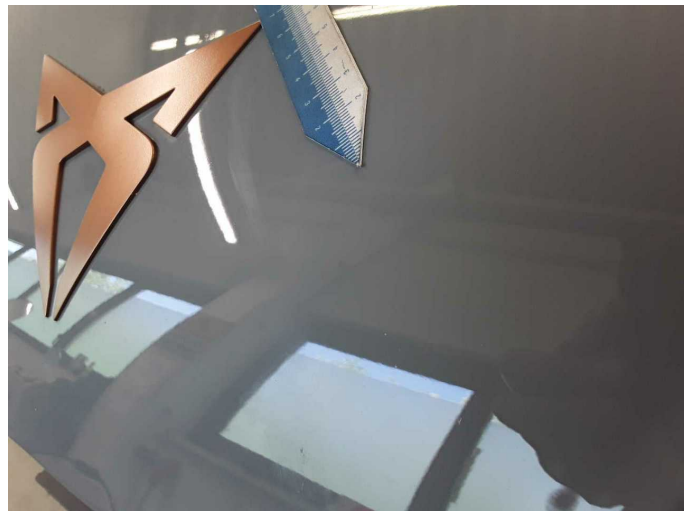
| No. | Component group | Description |
|---|---|---|
| 1 | Front bumper | Front bumper - Stone chips - No deduction |

**Wear and tear 1:** Front bumper: Front bumper - Stone chips - No deduction

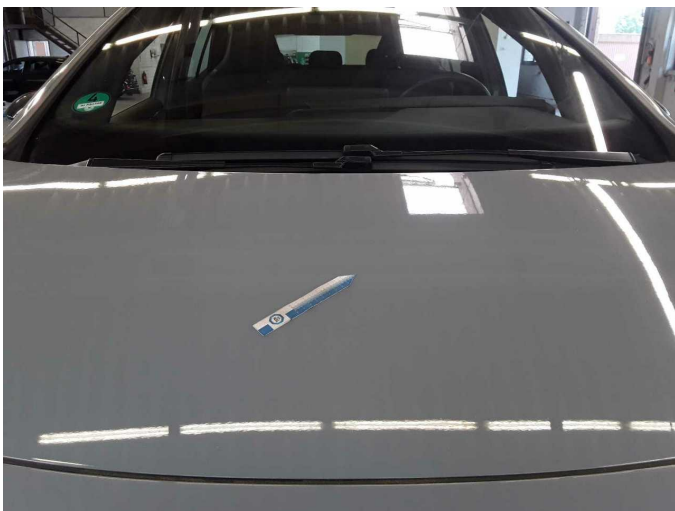
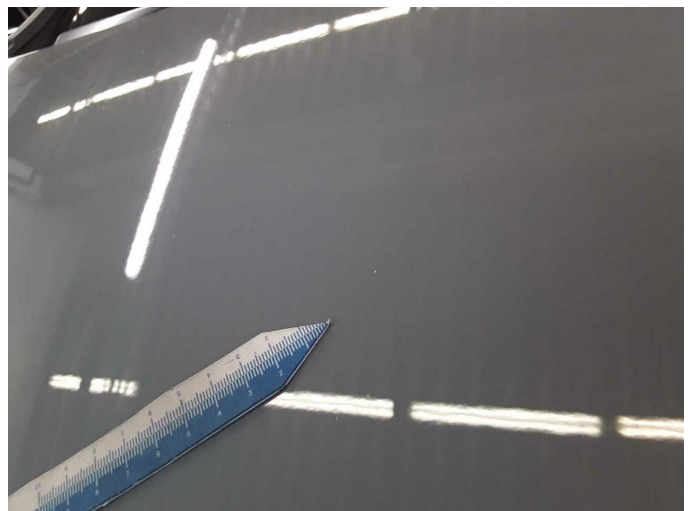
| No. | Component group | Description |
|---|---|---|
| 2 | Bonnet | Bonnet - Stone chips - No deduction |

**Wear and tear 2:** Bonnet: Bonnet - Stone chips - No deduction

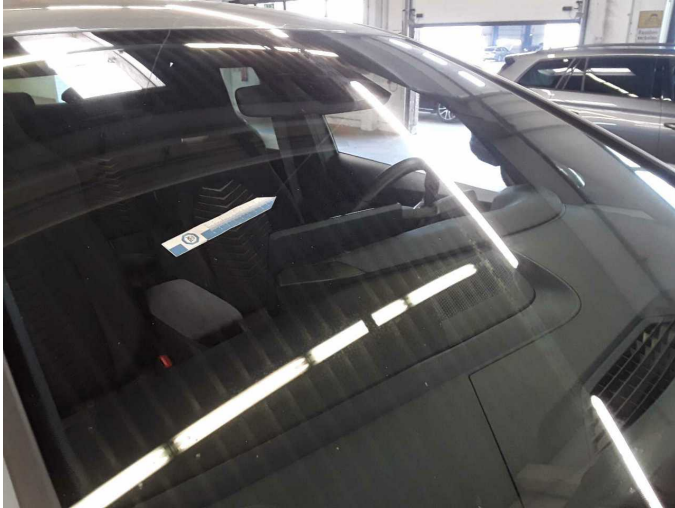
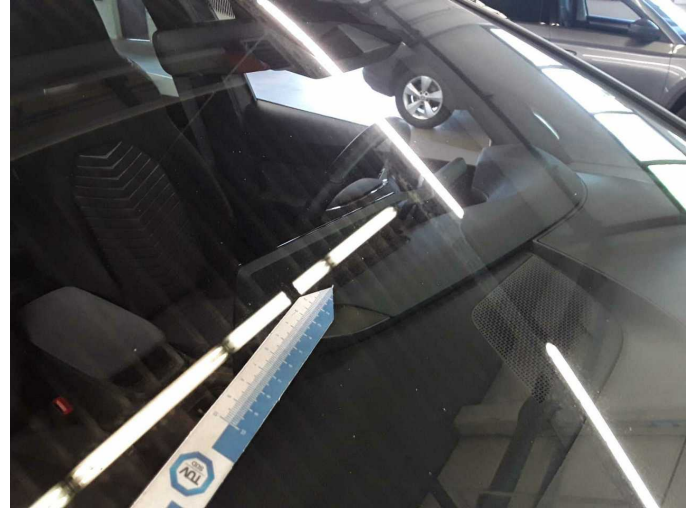
| No. | Component group | Description |
|---|---|---|
| 3 | Vehicle glazing | Windscreen - Stone chips - No deduction |

**Wear and tear 3:** Vehicle glazing: Windscreen - Stone chips - No deduction
