| Typ/Modell | Kona, Kauai | HU (Bericht lag vor) | 05/2028 |
| Fahrgestellnummer | TMAK381GFNJ038837 | Leistung / Hubraum | 28 kW |

Zustandsbericht

Besichtigungsdatum: 16.06.2026
Protokollnummer: 46029047
Erstellt durch: Paula Kube
Besichtigt durch: Baumgartner

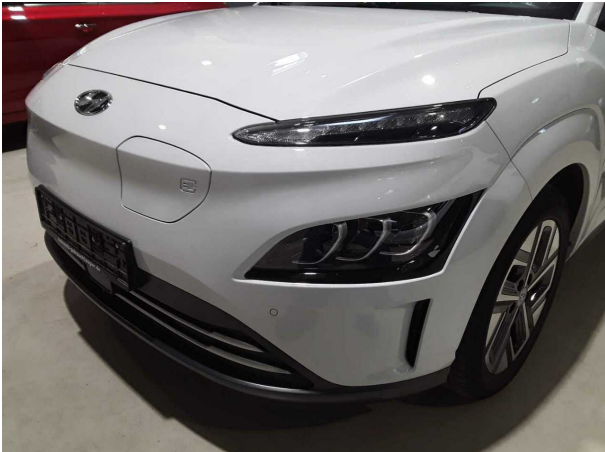
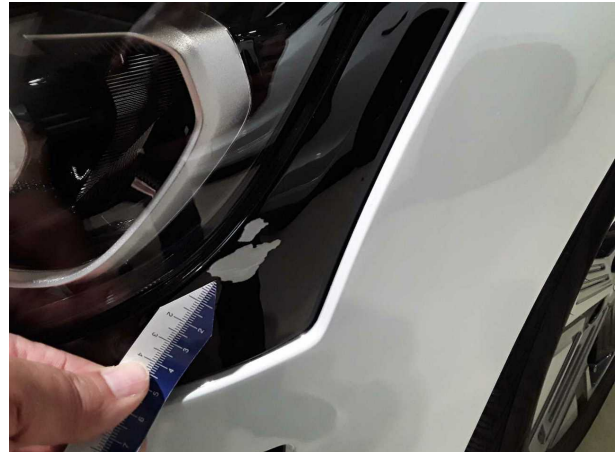
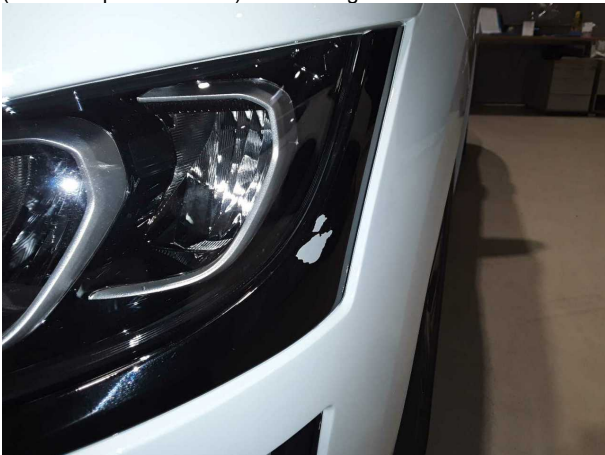
| Nr. | Bauteilgruppe | Beschreibung |
|---|---|--|
| 1 | Stoßfänger vorn | Blende unter Scheinwerfer (Blende li. platzt Lack ab) - Lackmangel - lackieren |

Beschädigung #1: Stossfänger vorn: Blende unter Scheinwerfer (Blende li. platzt Lack ab) - Lackmangel - lackieren

Beschädigung #1: Stossfänger vorn: Blende unter Scheinwerfer (Blende li. platzt Lack ab) - Lackmangel -

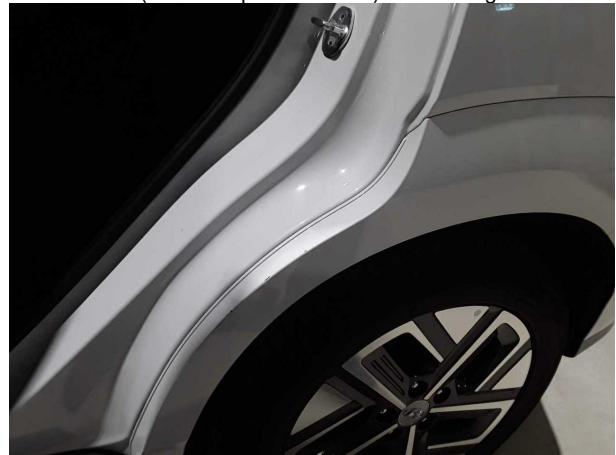
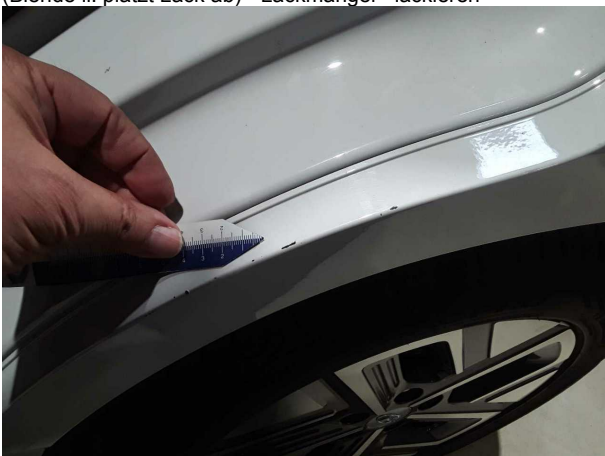
| Nr. | Bauteilgruppe | Beschreibung |
|---|---|--|
| 2 | Seitenwand links | Radlauf (Radlaufblende) - Kratzer - Smart Repair |

Beschädigung #2: Seitenwand links: Radlauf (Radlaufblende) - Kratzer - Smart Repair

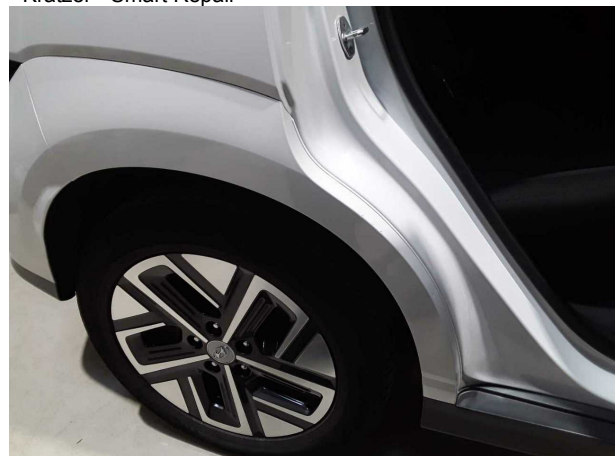
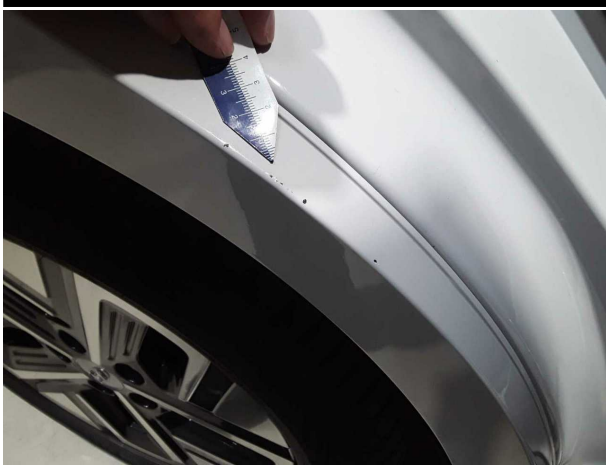
| Nr. | Bauteilgruppe | Beschreibung |
|---|---|--|
| 3 | Seitenwand rechts | Radlauf (Radlaufblende) - Kratzer - Smart Repair |

Beschädigung #3: Seitenwand rechts: Radlauf (Radlaufblende) - Kratzer - Smart Repair

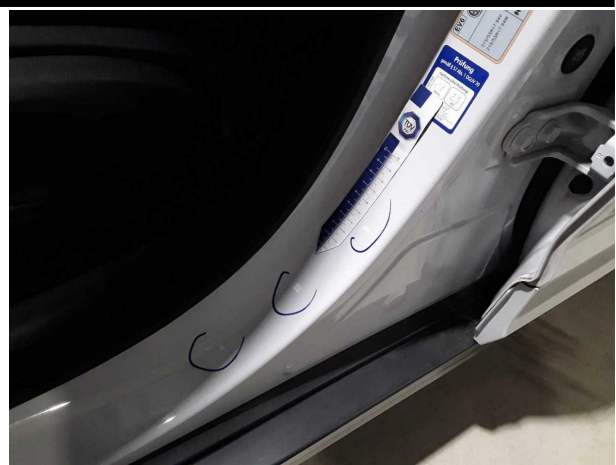
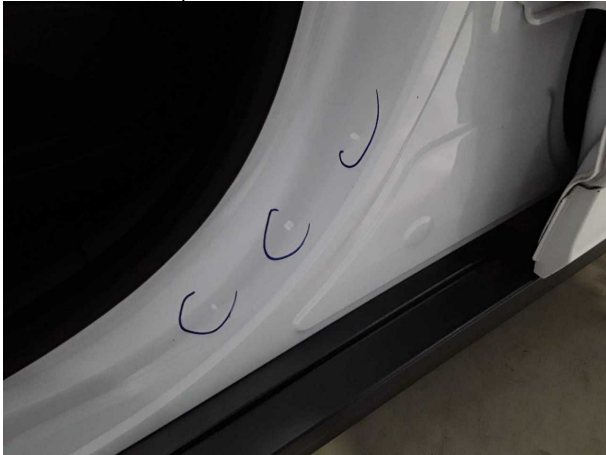
| Nr. | Bauteilgruppe | Beschreibung |
|---|---|--|
| 4 | Schweller links | Einstieg - Delle / Lackschaden - sanft instandsetzen |

Beschädigung #4: Schweller links: Einstieg - Delle / Lackschaden - sanft instandsetzen

Beschädigung #4: Schweller links: Einstieg - Delle / Lackschade... sanft instandsetzen

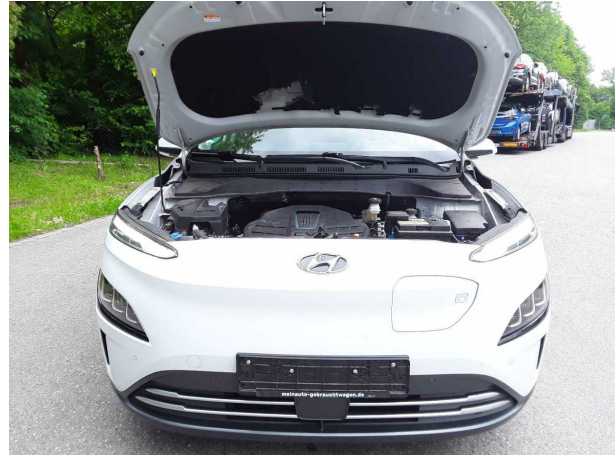
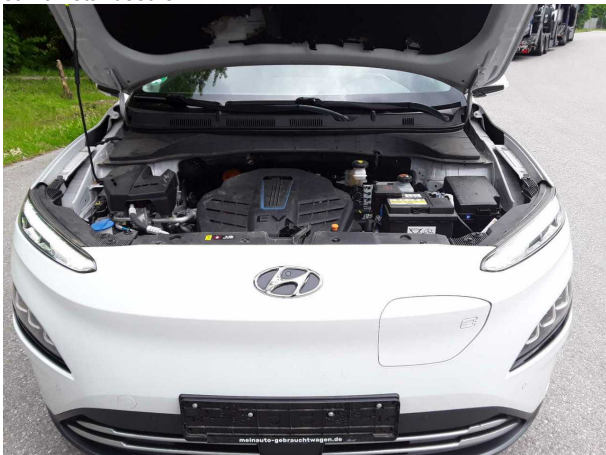
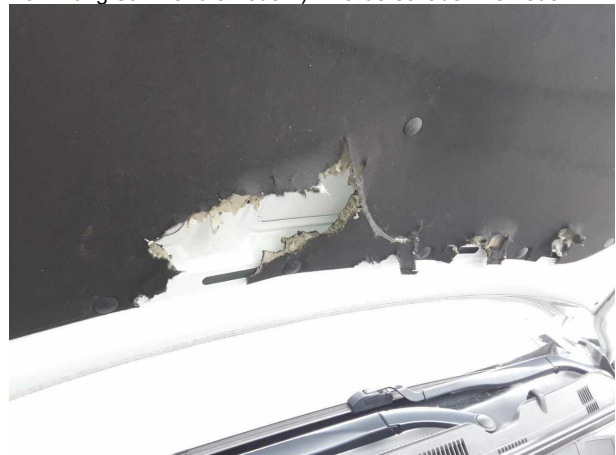
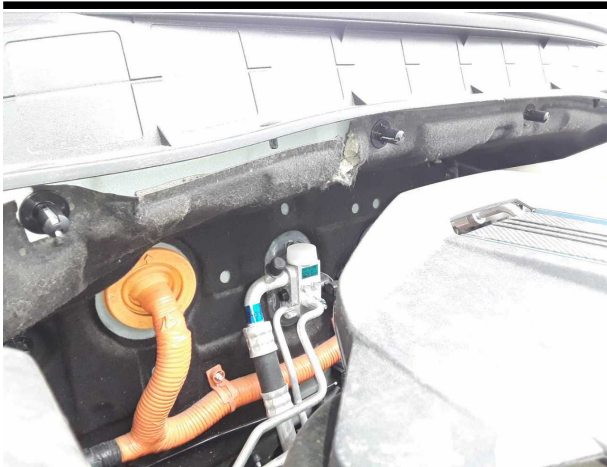
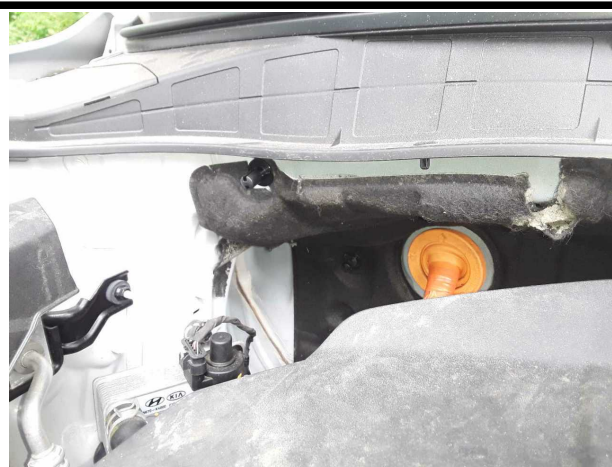
| Nr. | Bauteilgruppe | Beschreibung |
|---|---|--|
| 6 | Motorhaube | Dämmmatte (inklusive Dämmung Stirnwand erneuern) - Marderschaden - erneuern |

Beschädigung #6: Motorhaube: Dämmmatte (inklusive Dämmung Stirnwand erneuern) - Marderschaden - erneuern
