Expertise

Protocol number: 46662077  
Order No. / Reference: 26598411  
Inspection date: 22 Jul 2026

Manufacturer: Citroën

Model: Berlingo 1.5 BlueHDi 100 M S&S Club

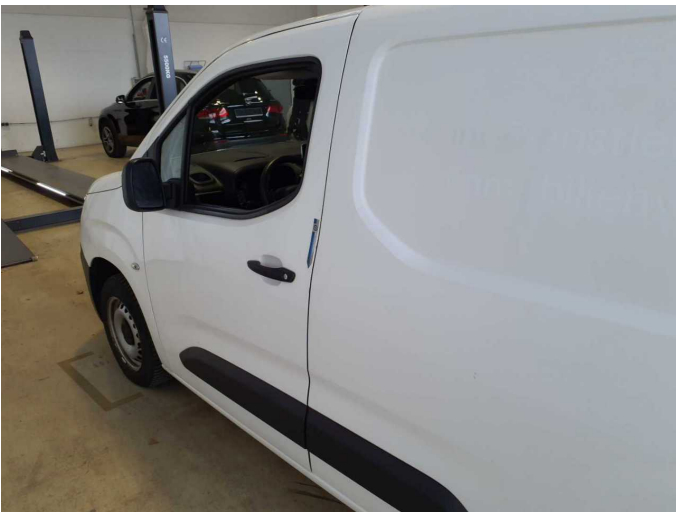
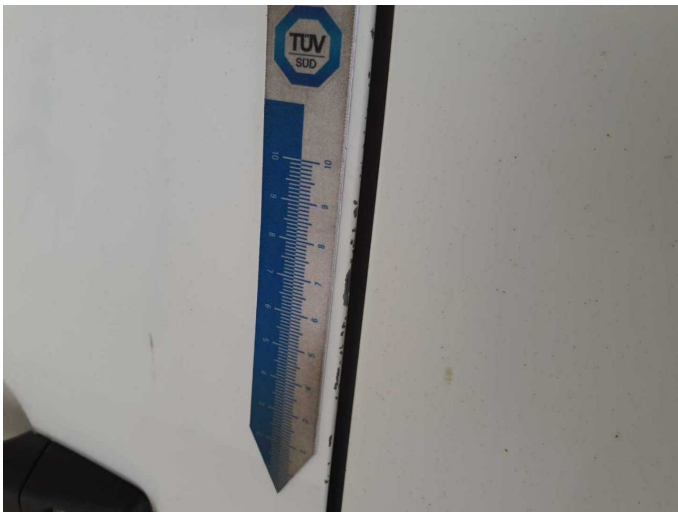
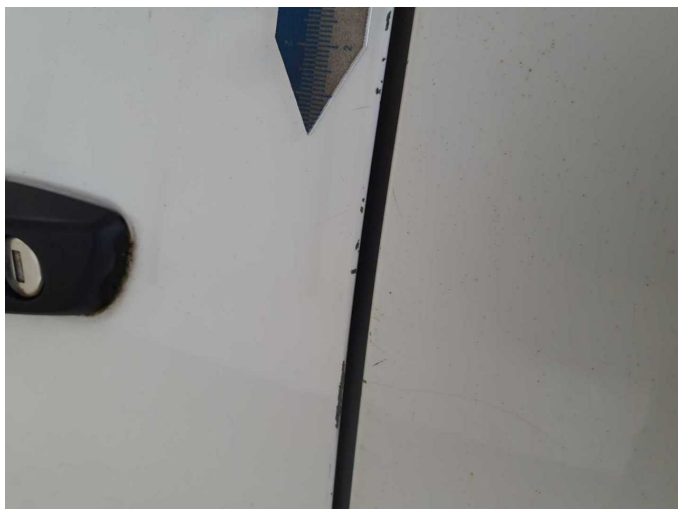
| No. | Component group | Description |
|---|---|---|
| 1 | Door - front left side | Door edge - Scratch(es) - Smart repair |

Damage 1: Door - front left side: Door edge - Scratch(es) - Smart repair

**Damage 1:** Door - front left side: Door edge - Scratch(es) - Smart repair

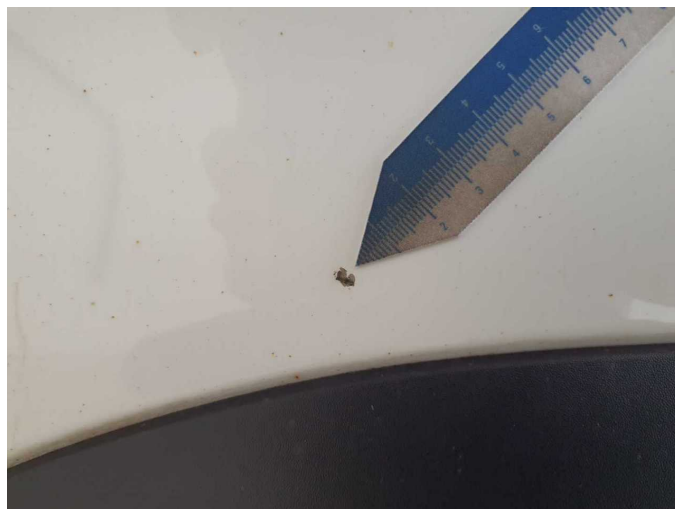
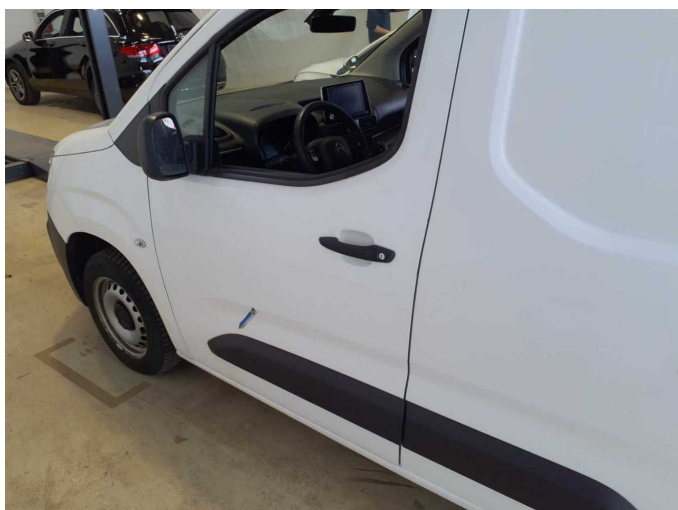
| No. | Component group | Description |
|---|---|---|
| 2 | Door - front left side | Door - Scratch(es) - Smart repair |

**Damage 2:** Door - front left side: Door - Scratch(es) - Smart repair

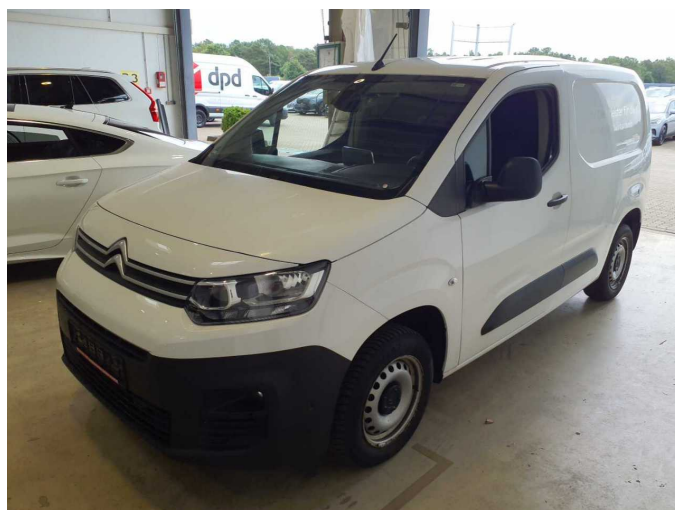
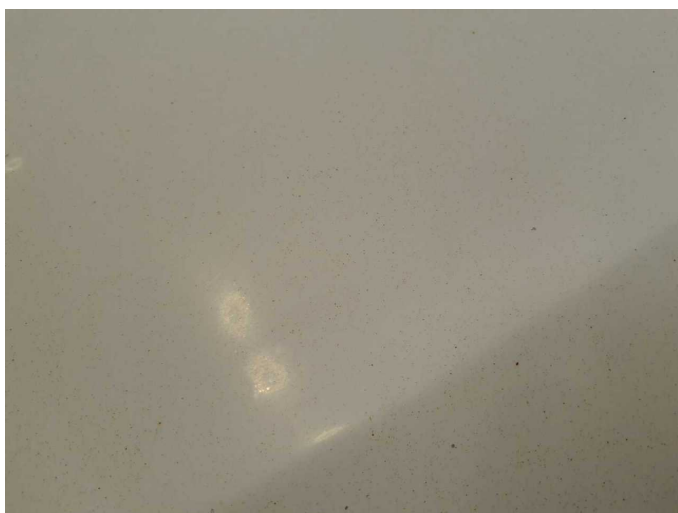
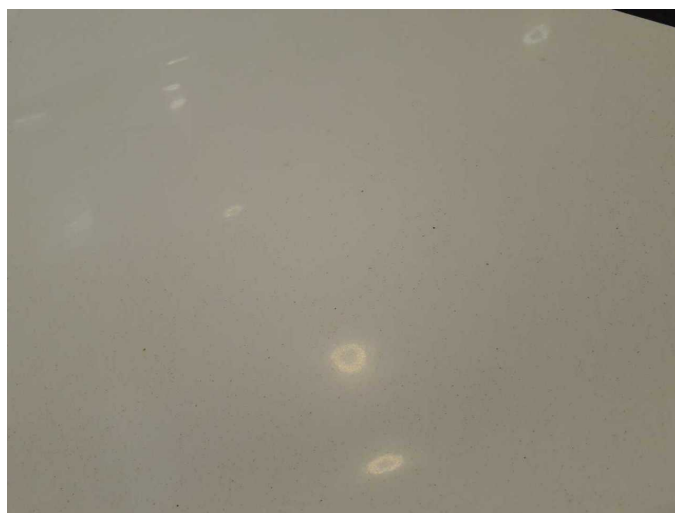
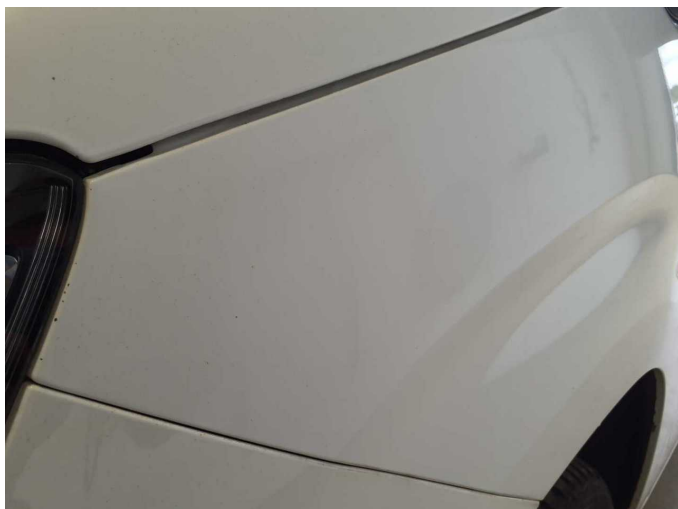
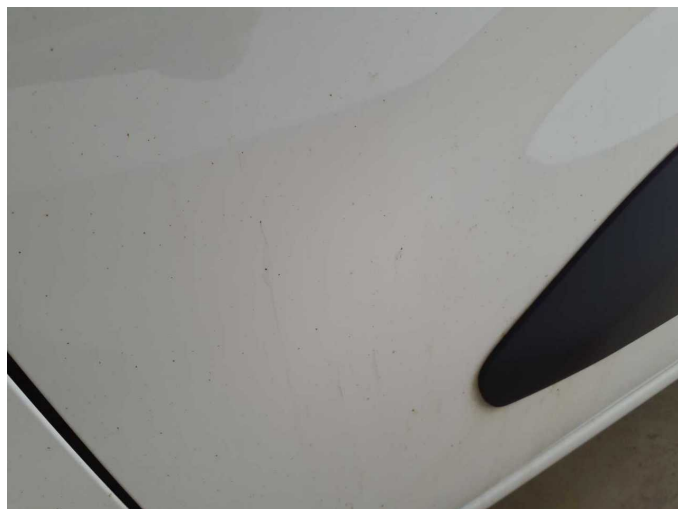
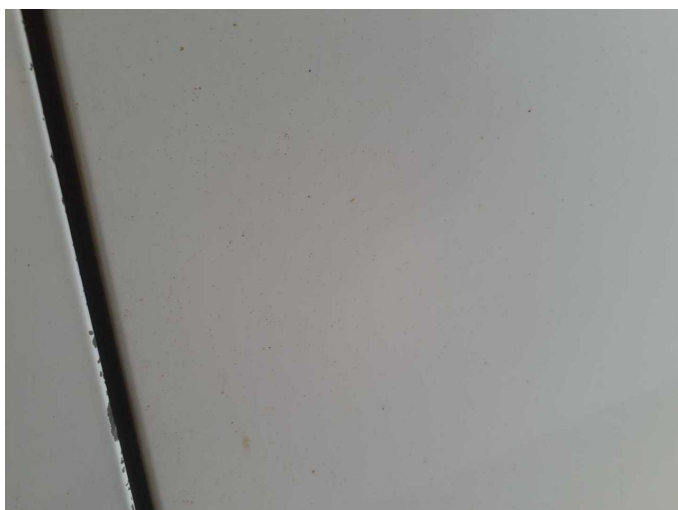
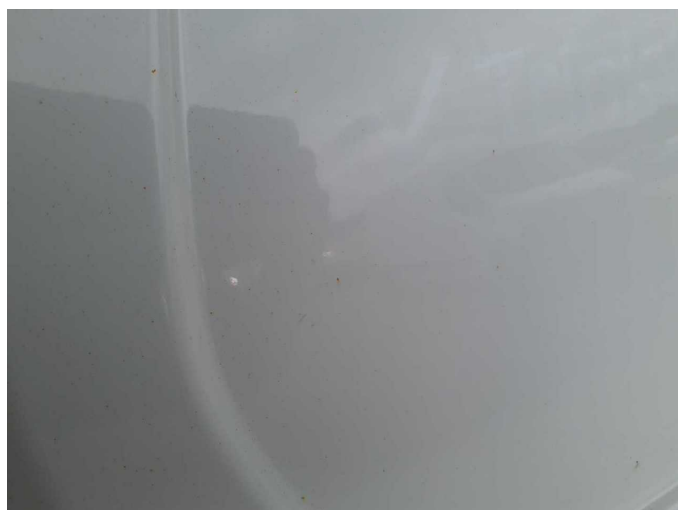
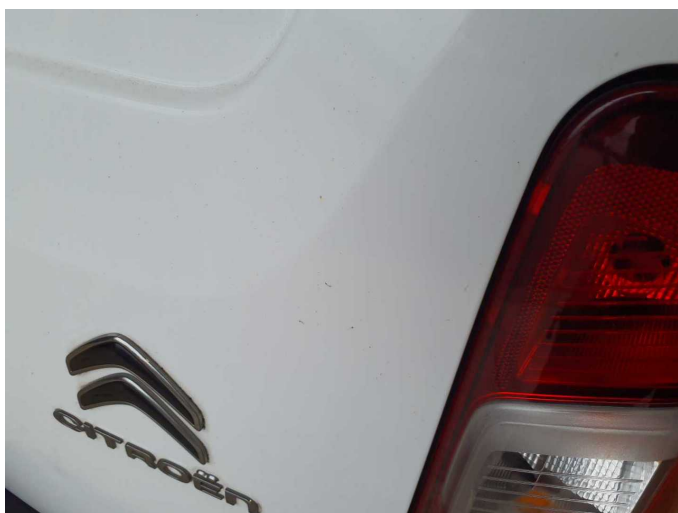
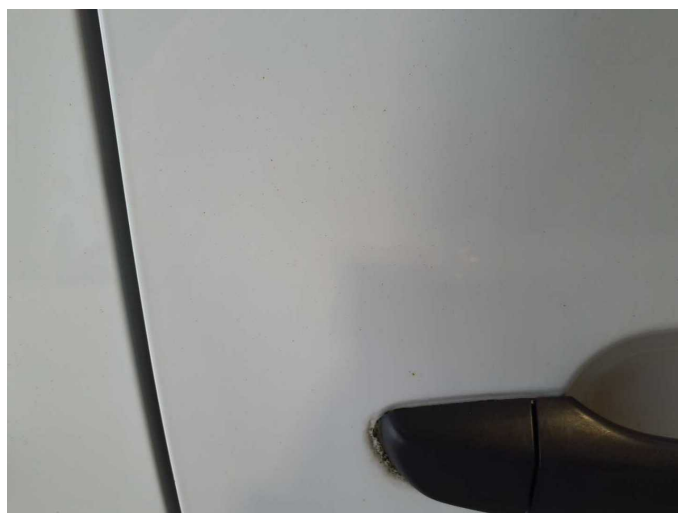
| No. | Component group | Description |
|---|---|---|
| 4 | Body | Body (Flugrost) - Soiled - Conditioning |

**Damage 4:** Body: Body (Flugrost) - Soiled - Conditioning

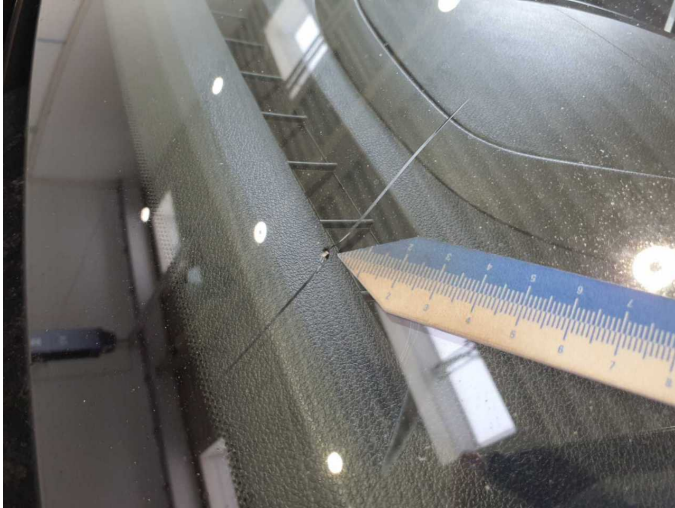
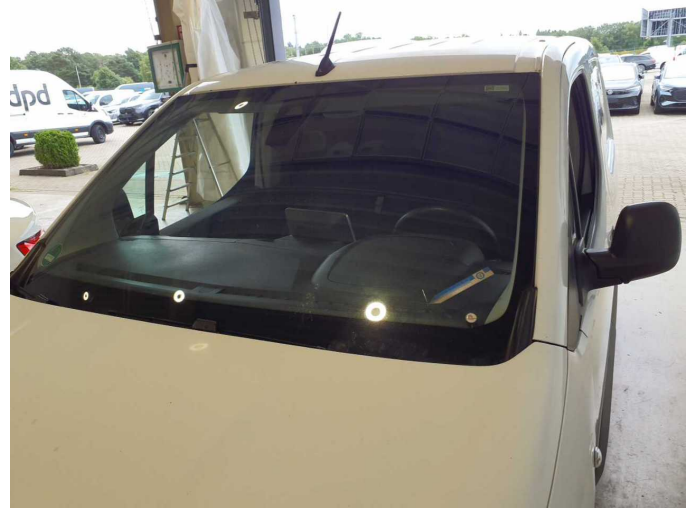
| No. | Component group | Description |
|---|---|---|
| 5 | Vehicle glazing | Windscreen - Broken / torn - Replace |

**Damage 5:** Vehicle glazing: Windscreen - Broken / torn - Replace

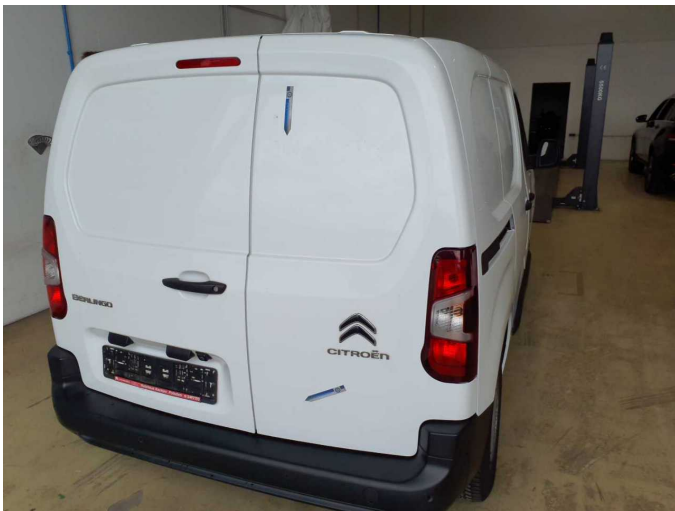
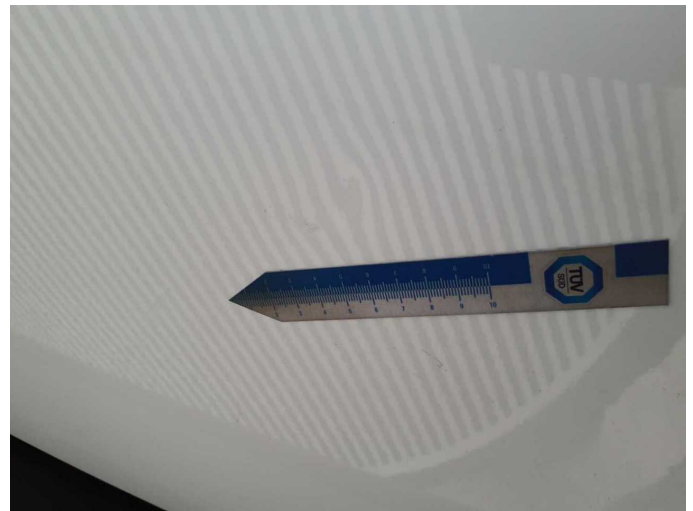
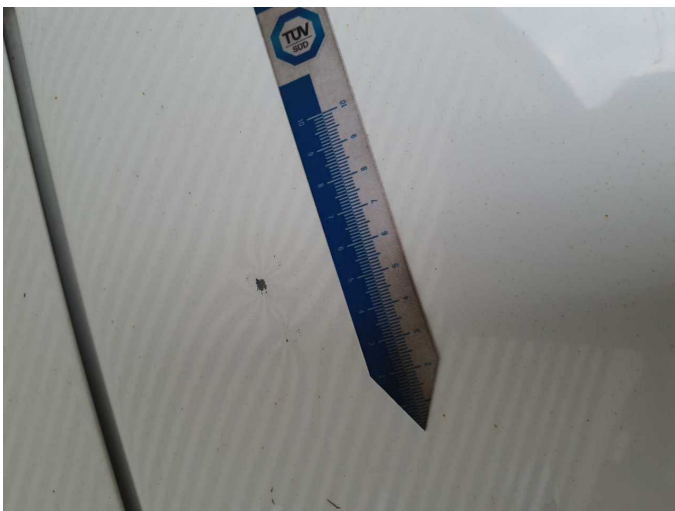
| No. | Component group | Description |
|---|---|---|
| 6 | Boot lid / rear door | Rear door - right side - Dent / paintcoat damage - Repair and paint |

**Damage 6:** Boot lid / rear door: Rear door - right side - Dent / paintcoat damage - Repair and paint

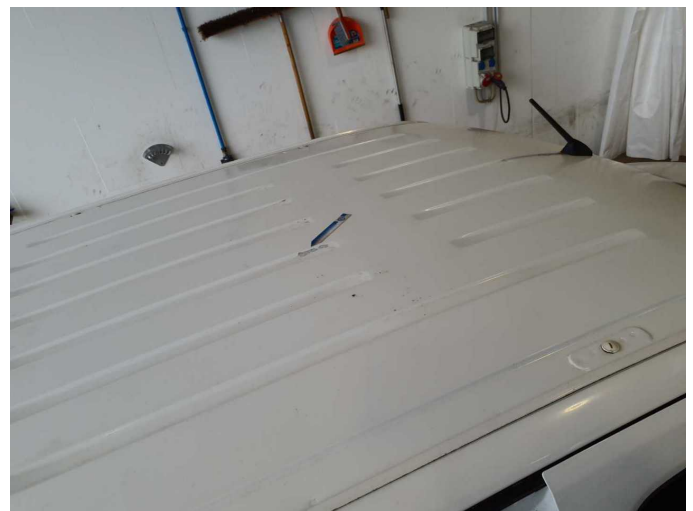
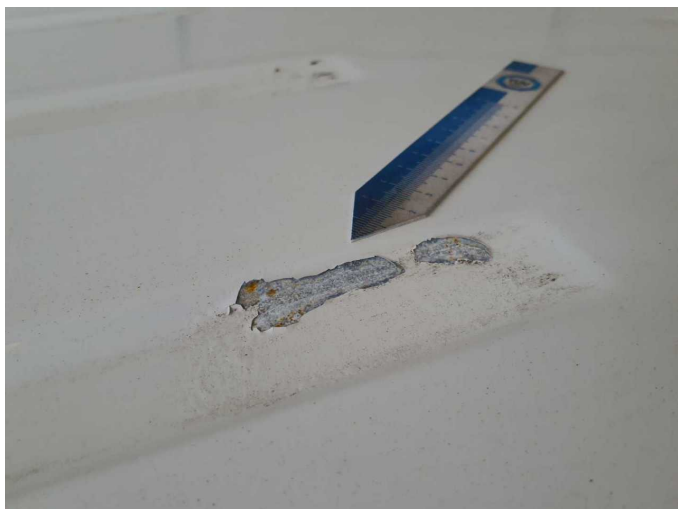
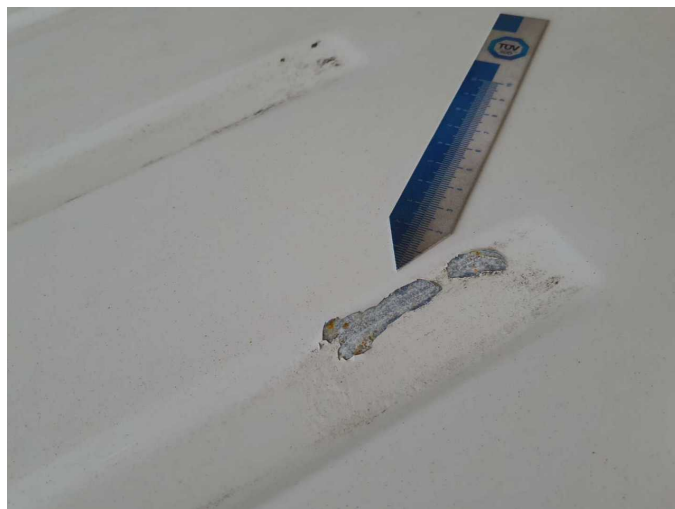
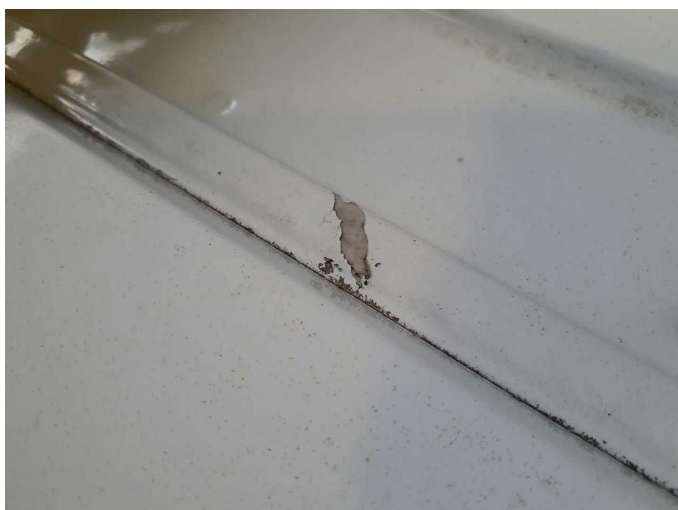
| No. | Component group | Description |
|---|---|---|
| 7 | Roof | Roof (Lack löst sich ab, zusätzlich Korrosion) - Paint defect - Repair and paint |

**Damage 7:** Roof: Roof (Lack löst sich ab, zusätzlich Korrosion) - Paint defect - Repair and paint

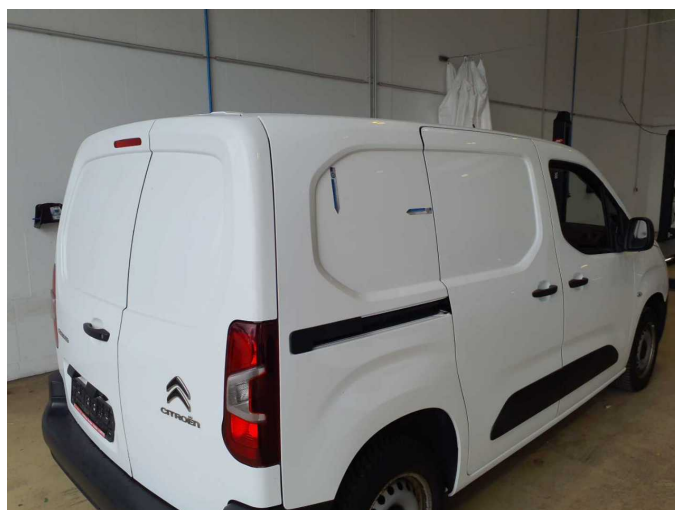
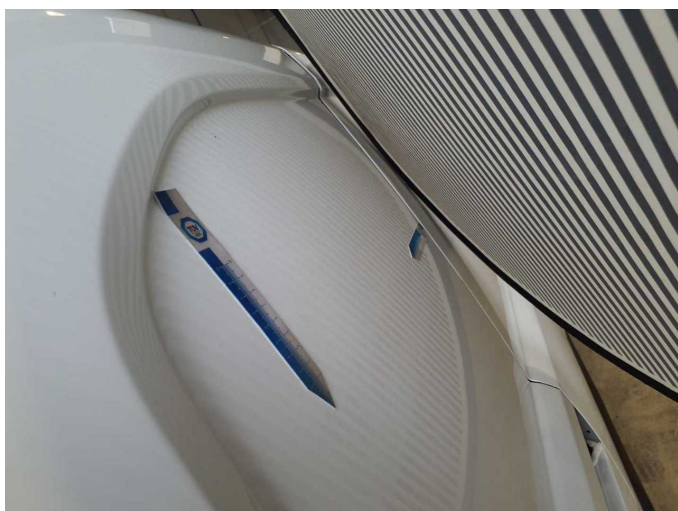
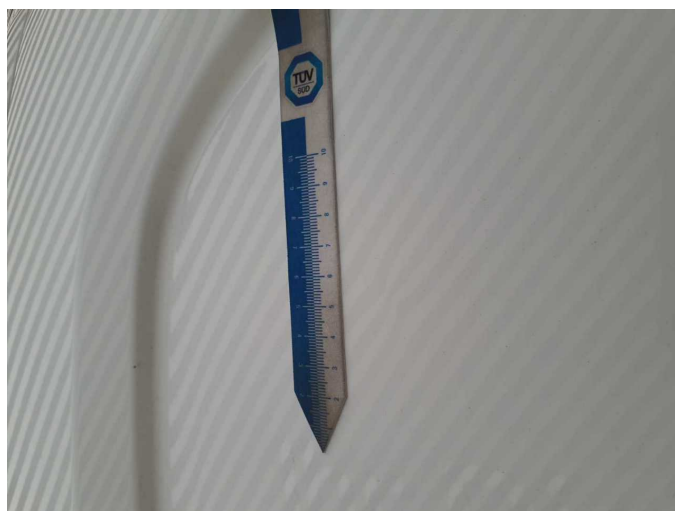
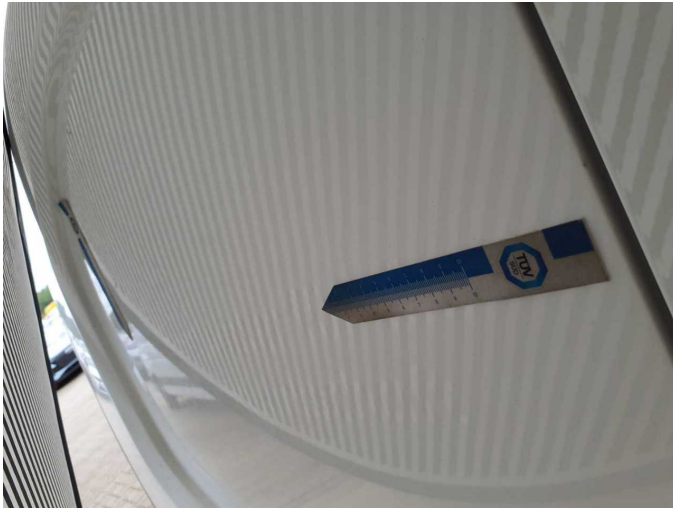
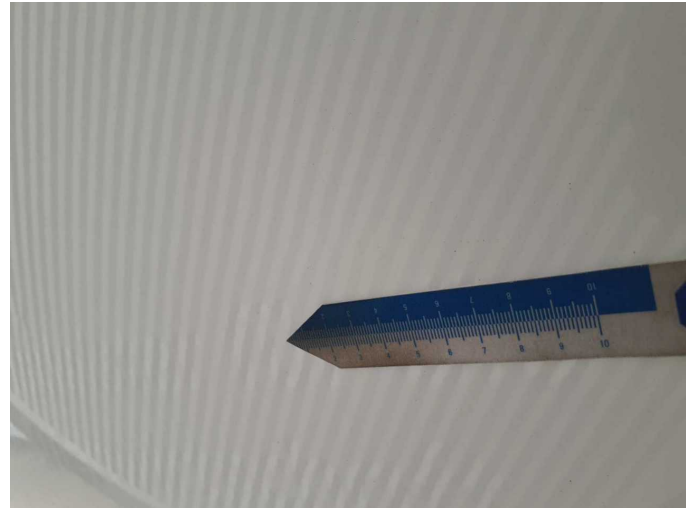
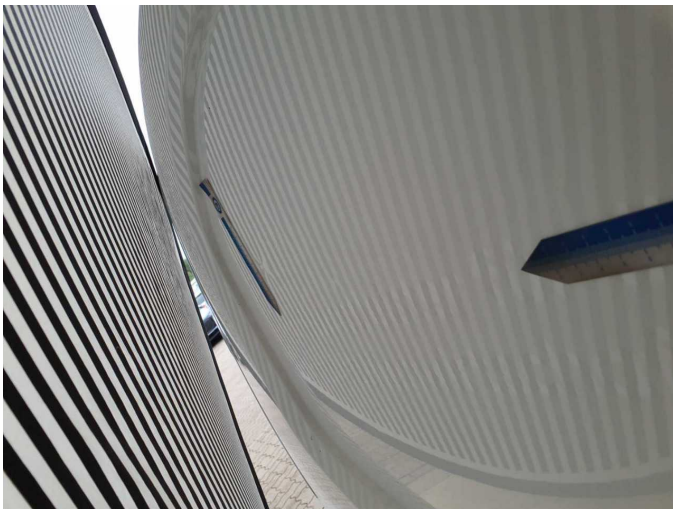
| No. | Component group | Description |
|---|---|---|
| 7 | Side panel - rear right side | Side panel - dent(s) - No deduction |

**Wear and tear 7:** Side panel - rear right side: Side panel - dent(s) - No deduction

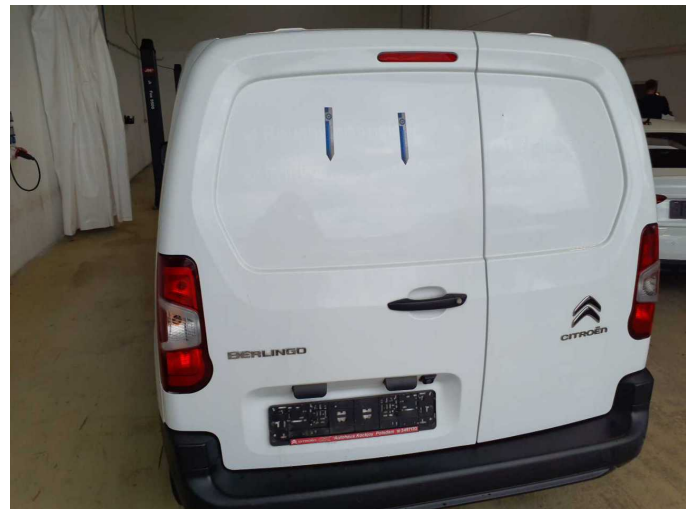
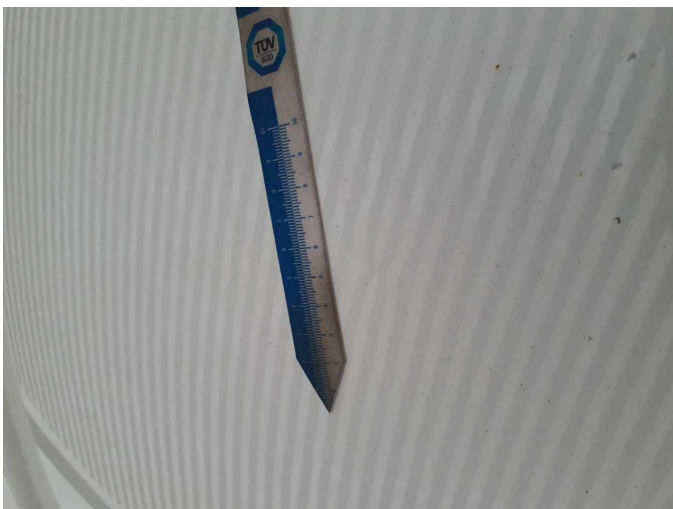
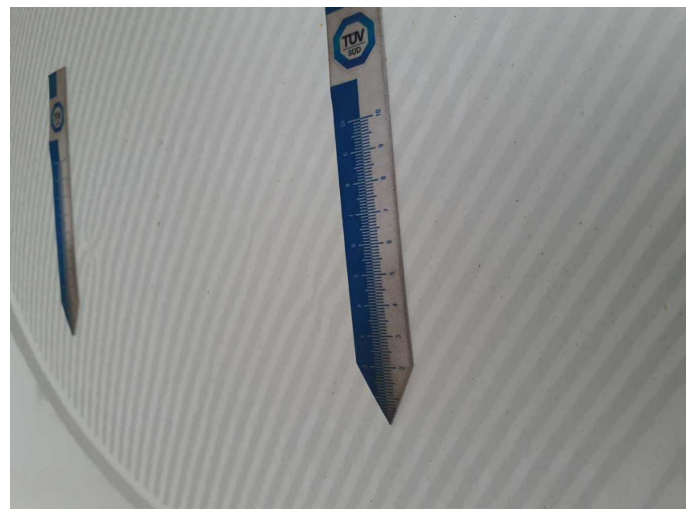
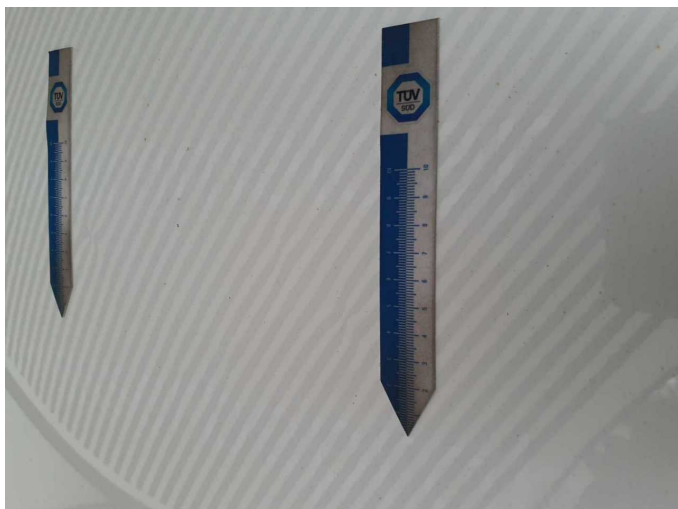
| No. | Component group | Description |
|---|---|---|
| 8 | Boot lid / rear door | Rear door - left side - dent(s) - No deduction |

**Wear and tear 8:** Boot lid / rear door: Rear door - left side - dent(s) - No deduction

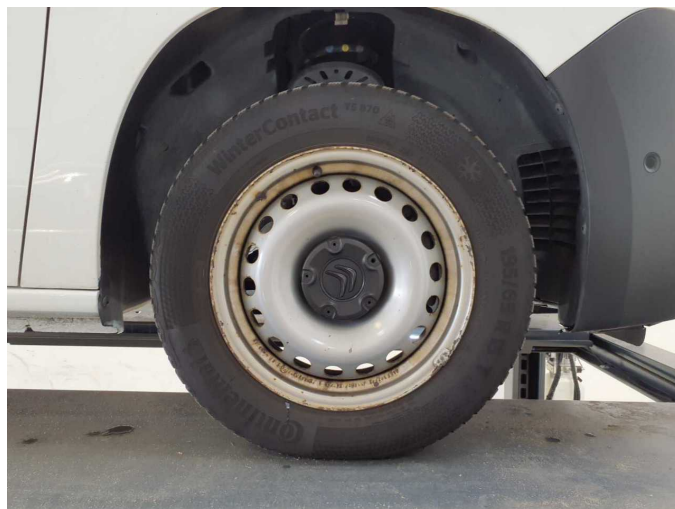
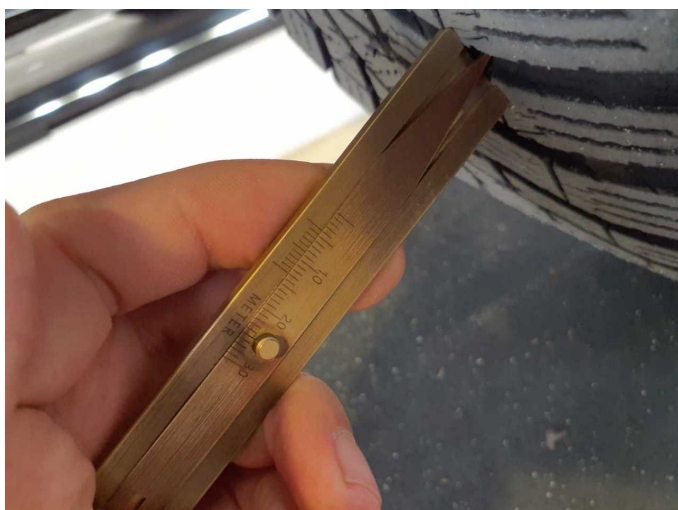
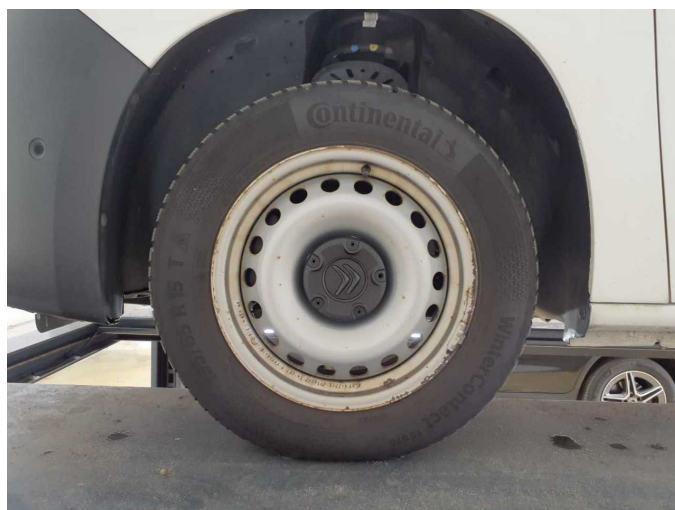
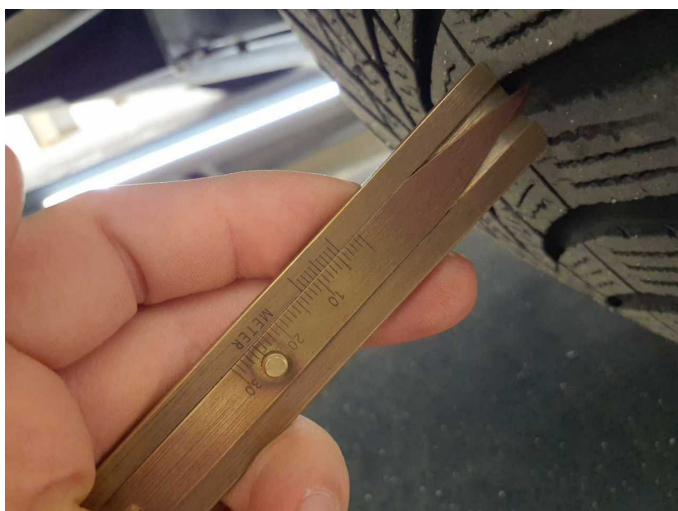
| No. | Component group | Description |
|---|---|---|
| 9 | Wheel / tyres | Tyre - front - Worn - No deduction |

**Wear and tear 9:** Wheel / tyres: Tyre - front - Worn - No deduction

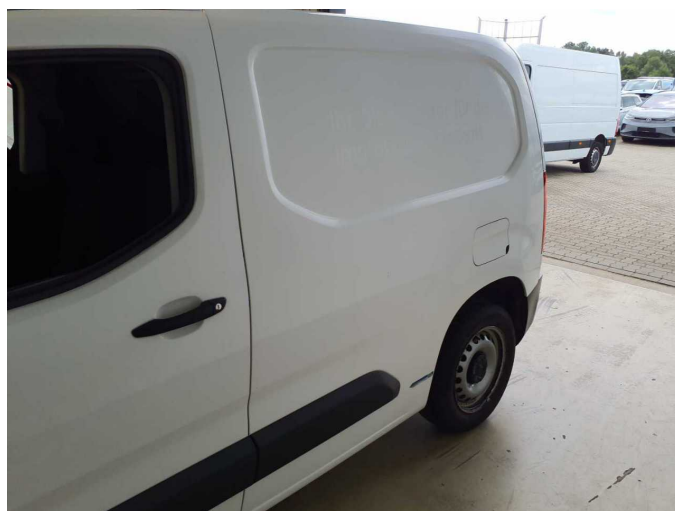
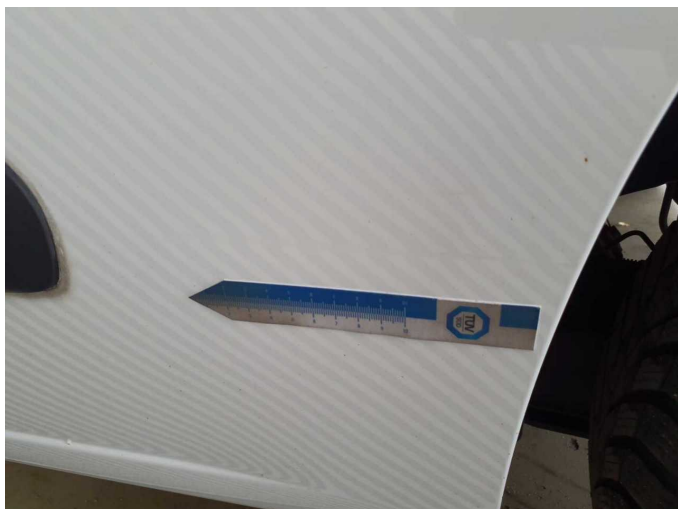
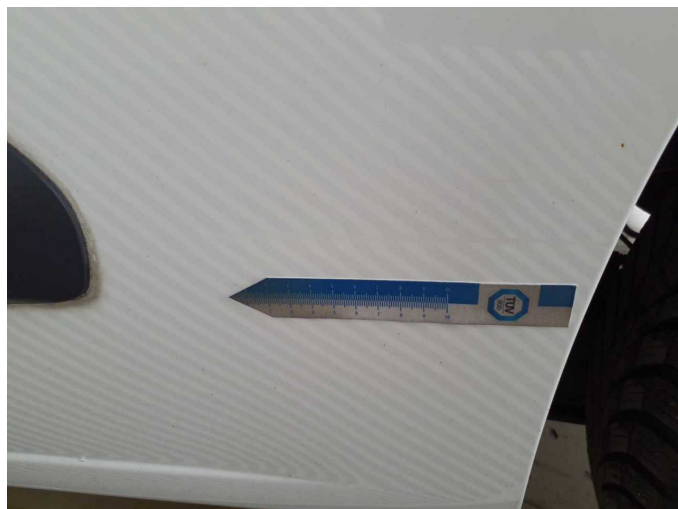
| No. | Component group | Description |
|---|---|---|
| 10 | Side panel - rear left side | Side panel (länglich, weich) - dent(s) - No deduction |

**Wear and tear 10:** Side panel - rear left side: Side panel (länglich, weich) - dent(s) - No deduction

**Wear and tear 10:** Side panel - rear left side: Side panel (länglich, weich)  
- dent(s) - No deduction

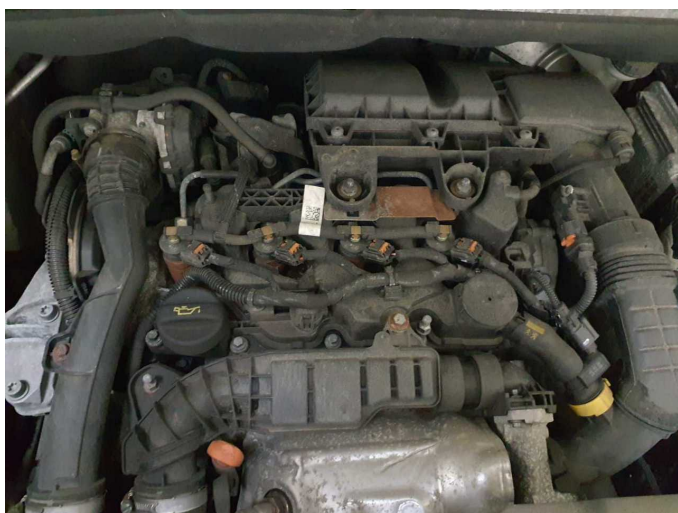
| Description |
|---|
| Engine - Engine cover |

**Missing part 1:** Engine: Engine cover - Missing - Replace
