## Expertise

Protocol number: 46109345  
Order No. / Reference: 26558558  
Inspection date: 23 Jun 2026

Manufacturer: Renault

Model: Twingo Electric ZEN

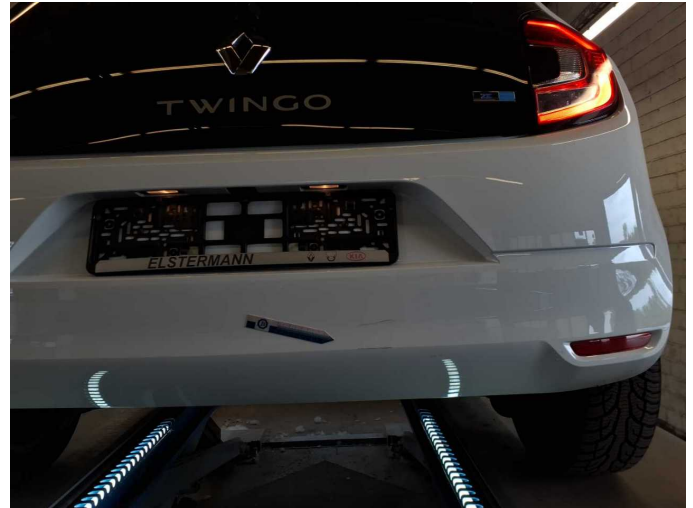
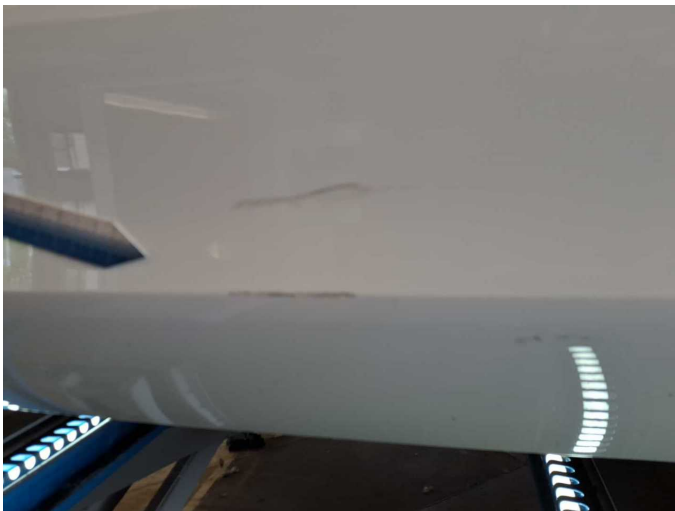
Damage 1: Rear bumper: Rear bumper - Scratch(es) - Smart repair

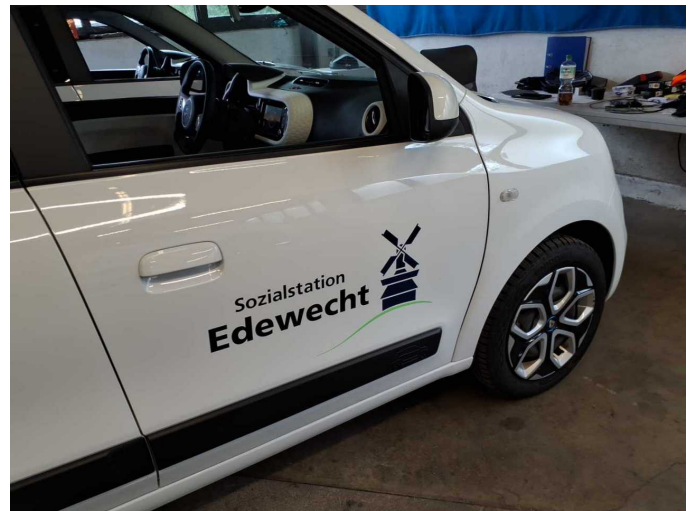
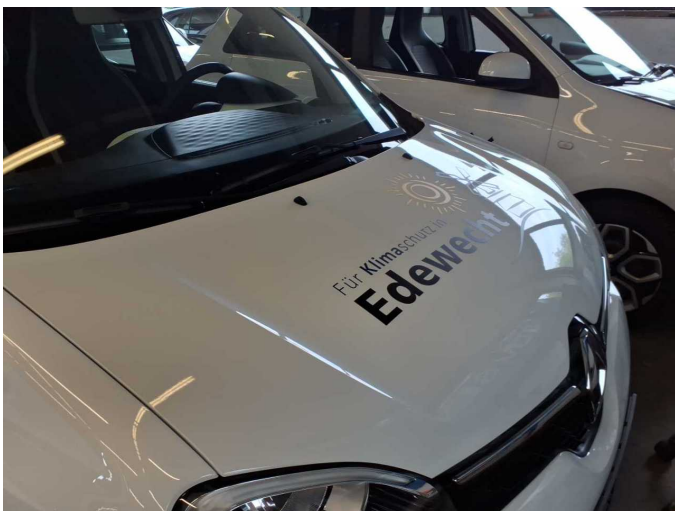
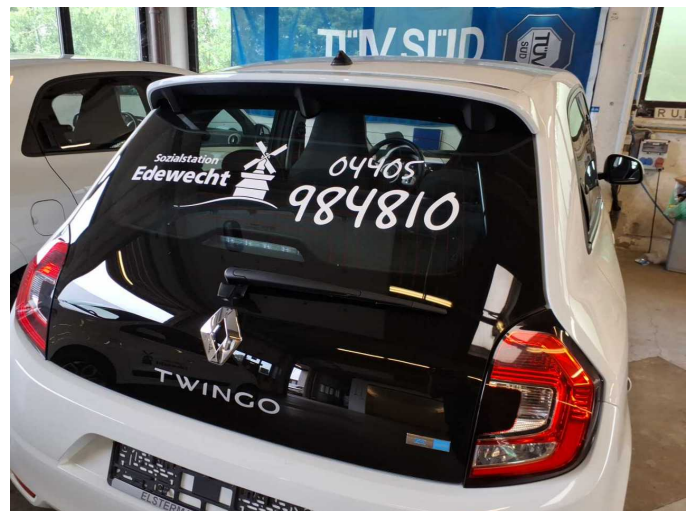
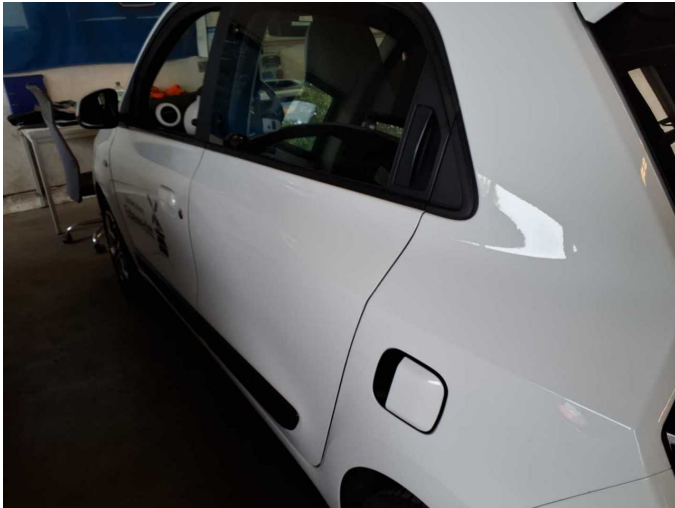
Damage 2: Body: Body - Glued / labelled - De-glue / neutralise

**Damage 2:** Body: Body - Glued / labelled - De-glue / neutralise

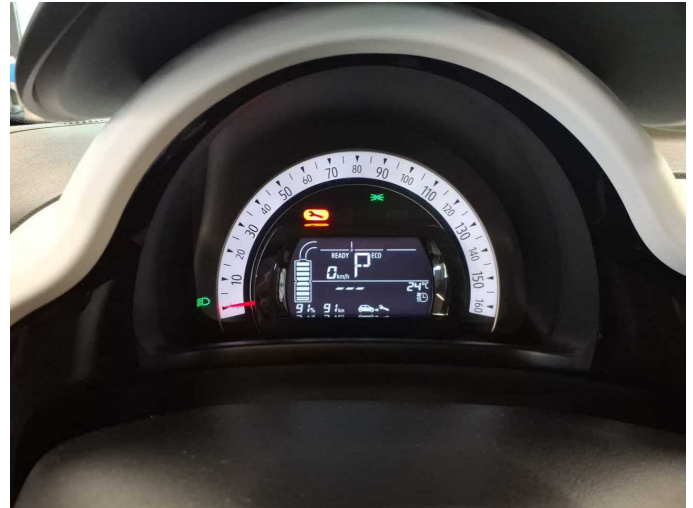
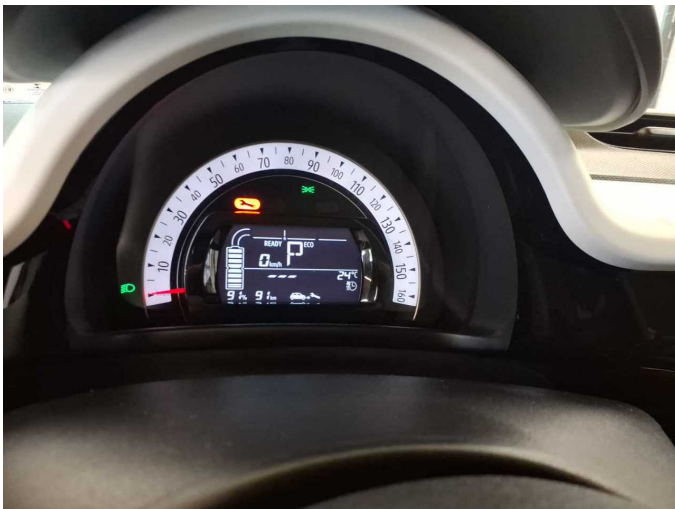
**Damage 3:** Misc.: Inspection / maintenance - Due - Perform

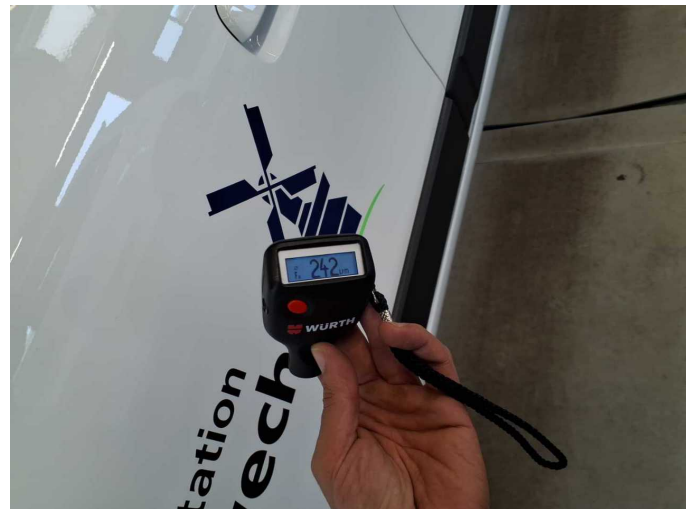
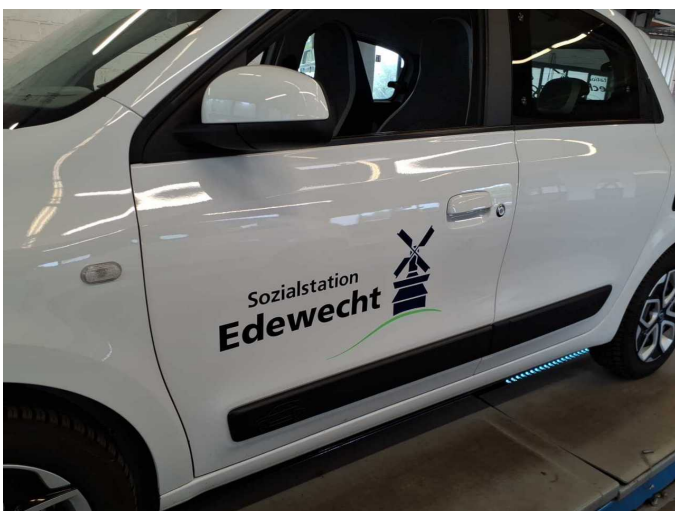
No.	Repainting
1	Door - front left side

Door - front left side	242 µm
------------------------	--------

**Repainting 1:** Door - front left side
