Expertise

Protocol number: 45975448
Order No. / Reference: 26445580
Inspection date: 16 Jun 2026

Manufacturer: Opel

Model: Insignia Sports Tourer 2.0 Diesel Aut. Business Elegance

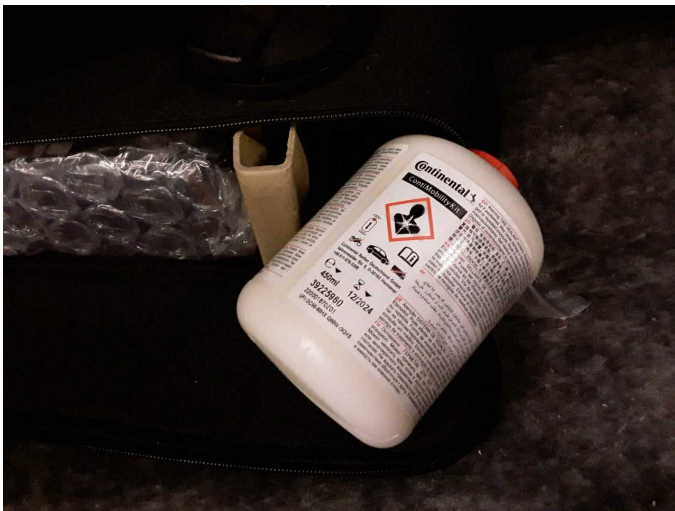
Damage 1: Equipment: Tirefit filler - Expired - Replace

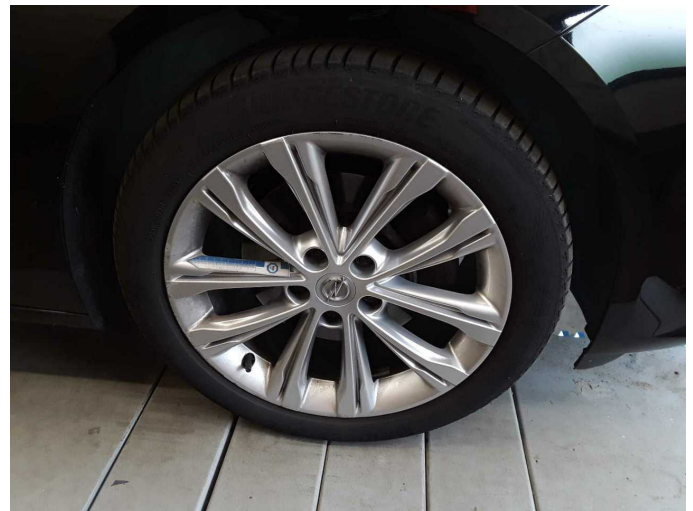
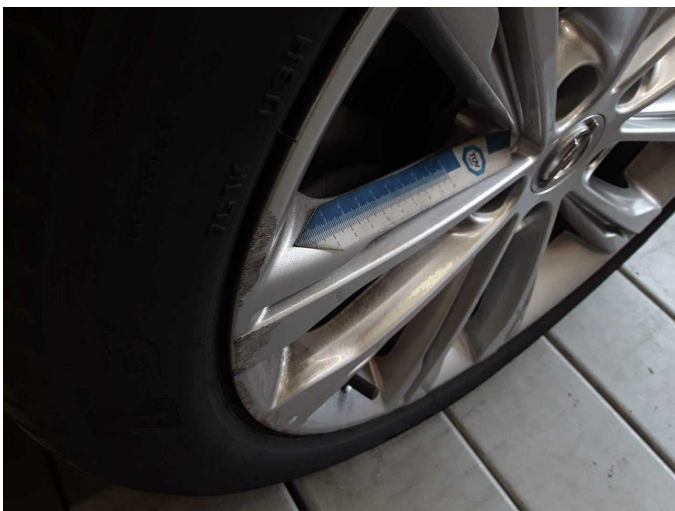
Damage 2: Wheel / tyres: Alloy rim - front right side - Scratched - Loss in value

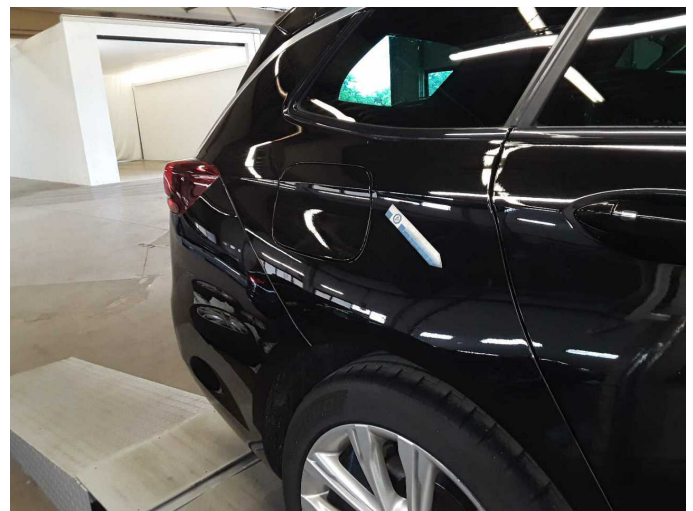
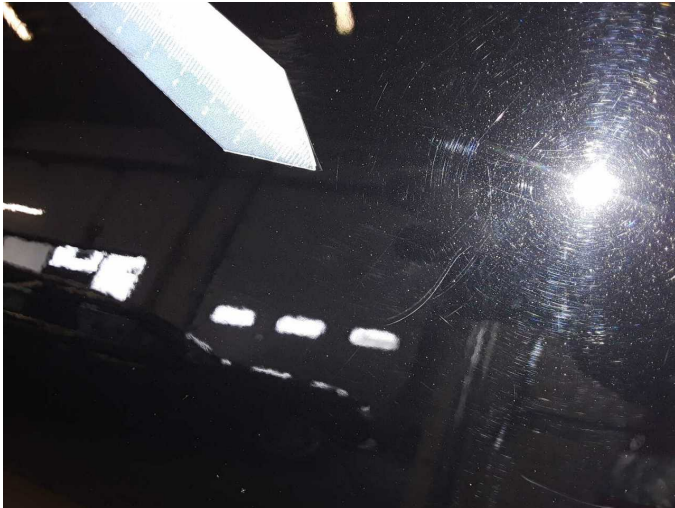
Damage 3: Side panel - rear right side: Side panel - Scratch(es) - Paint

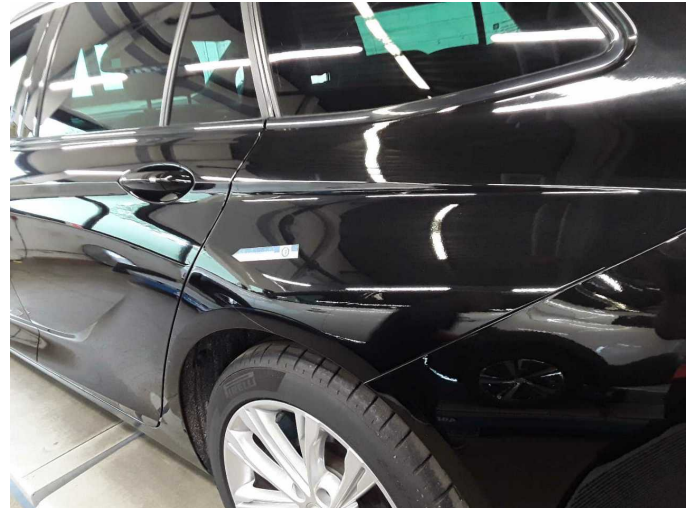
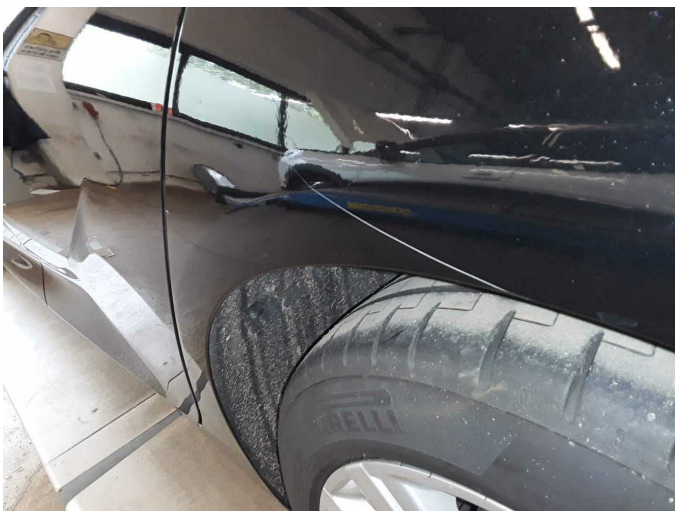
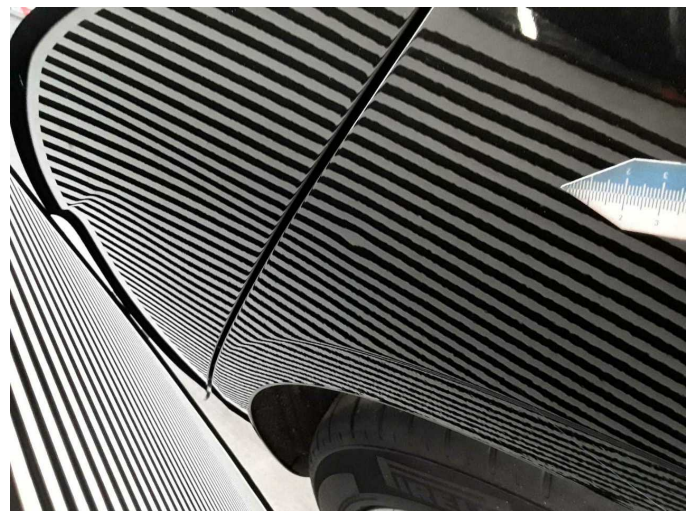
Damage 4: Side panel - rear left side: Side panel - Dent / paintcoat damage - Paint

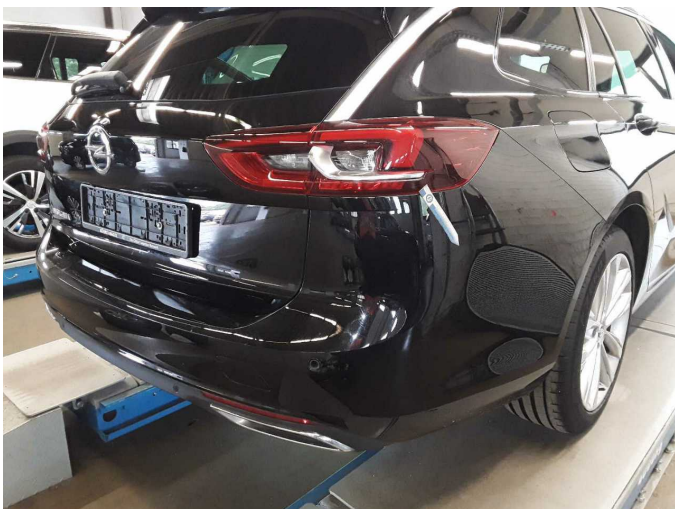
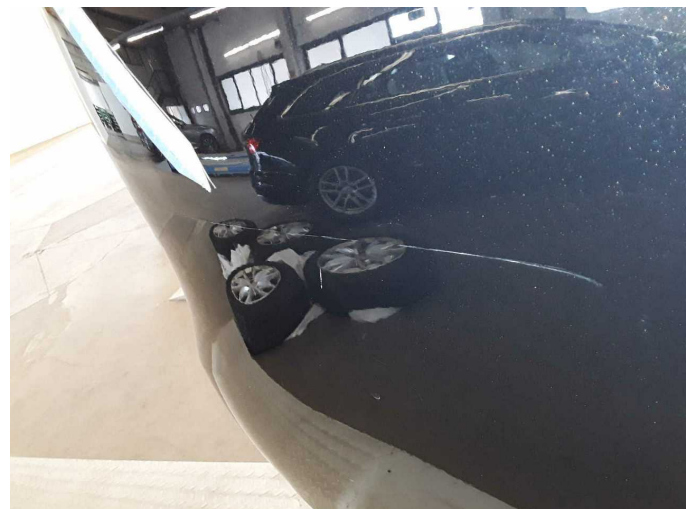
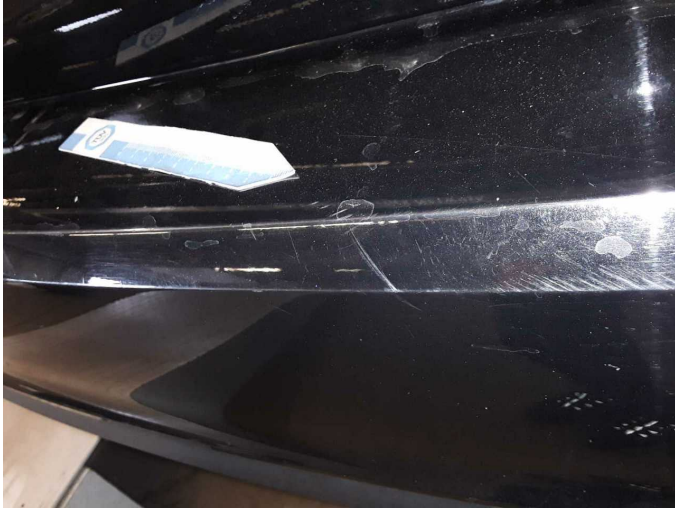
Damage 5: Rear bumper: Rear bumper - Scratch(es) - Paint

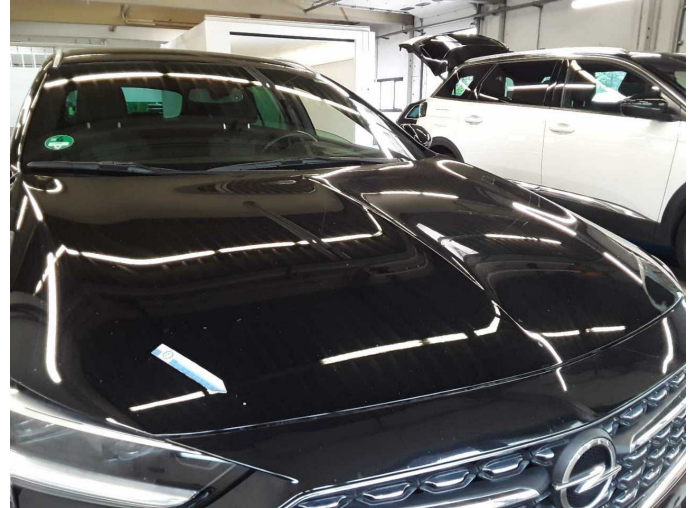
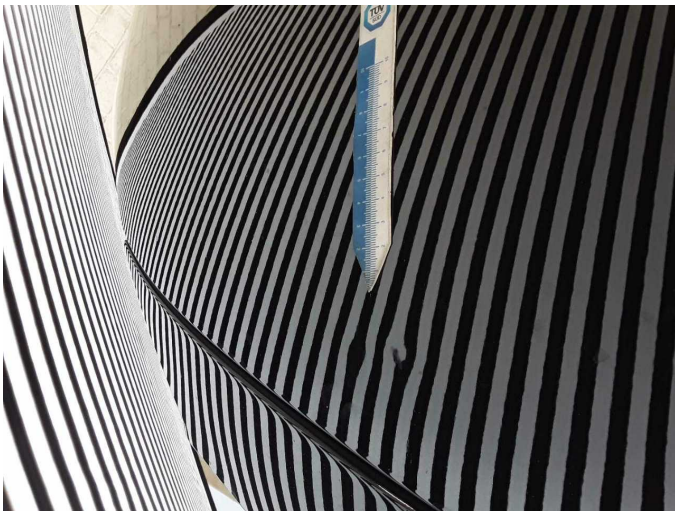
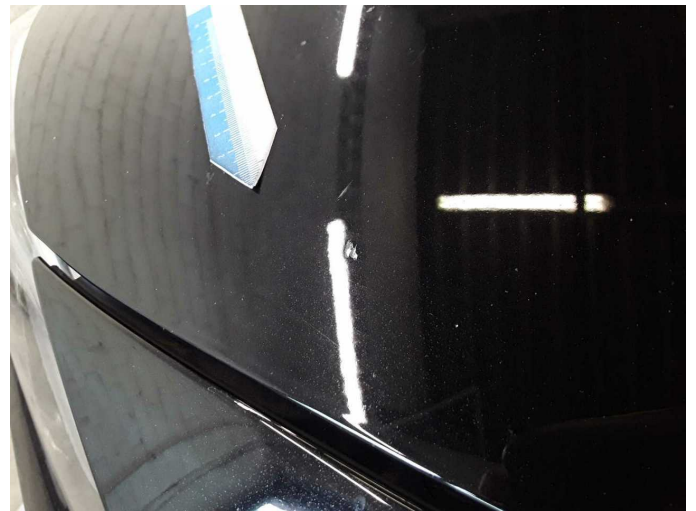
Damage 6: Bonnet: Bonnet - Dent / paintcoat damage - Repair and paint

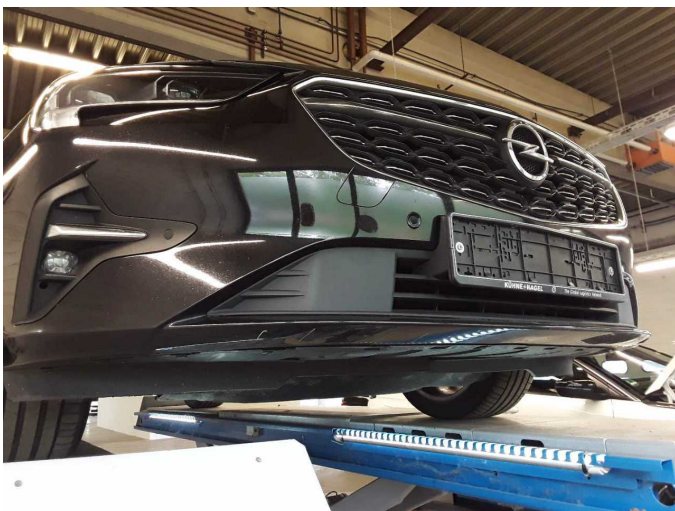
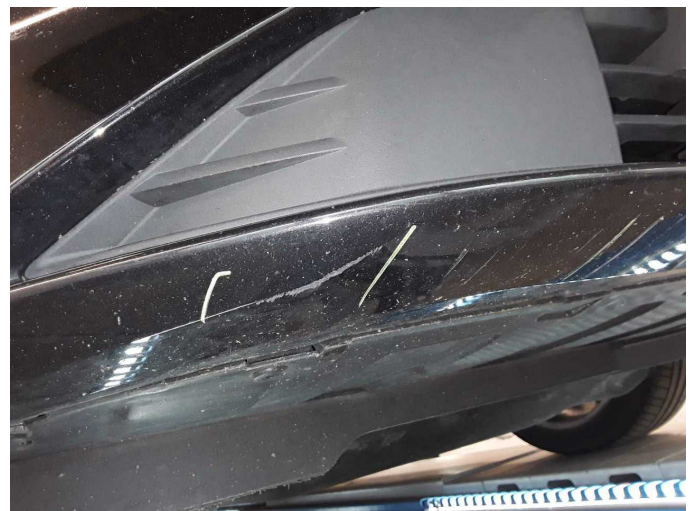
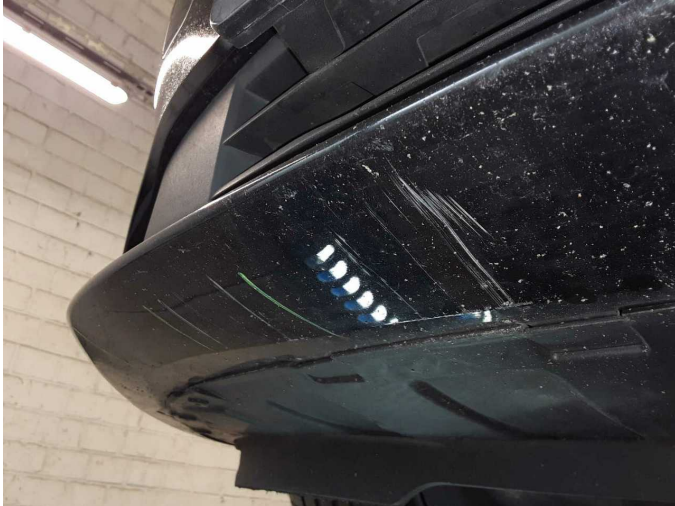
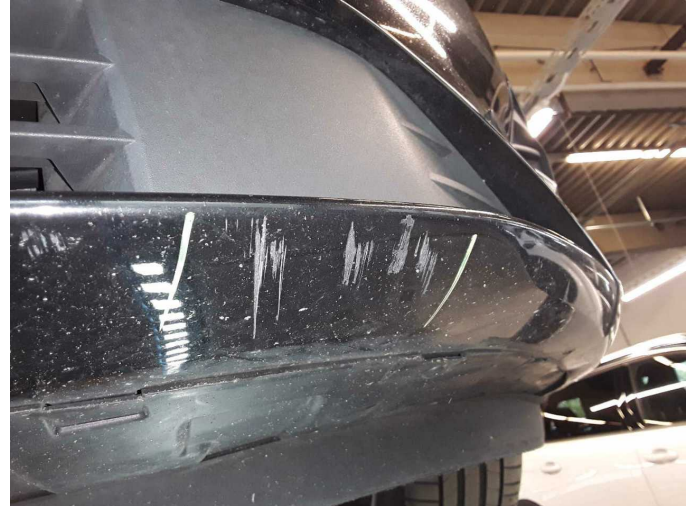
Damage 7: Front bumper: Front bumper - Scratch(es) - Paint

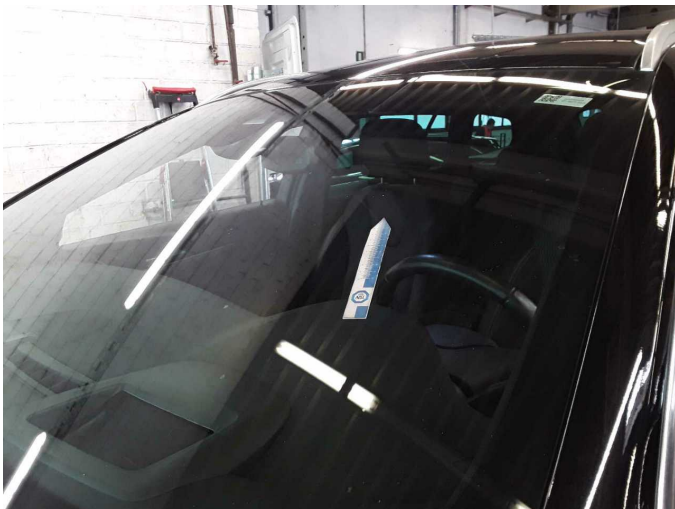
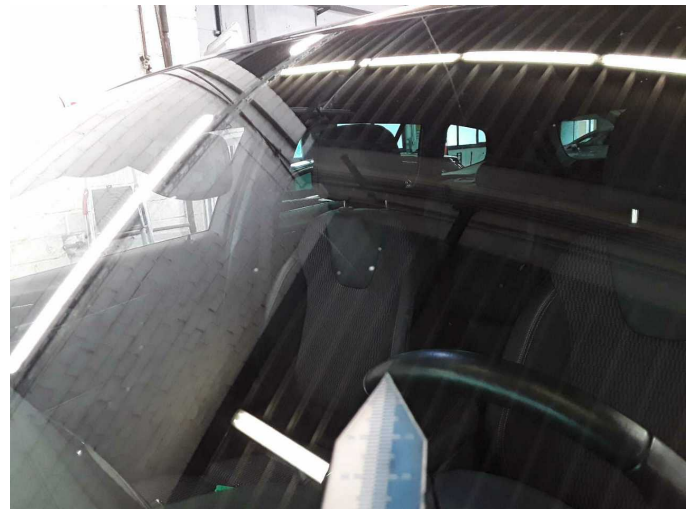
Wear and tear 2: Vehicle glazing: Windscreen - Stone chips - No deduction

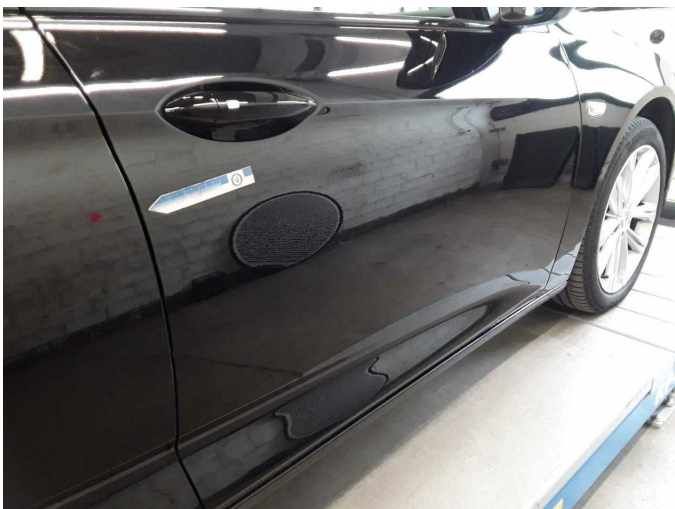
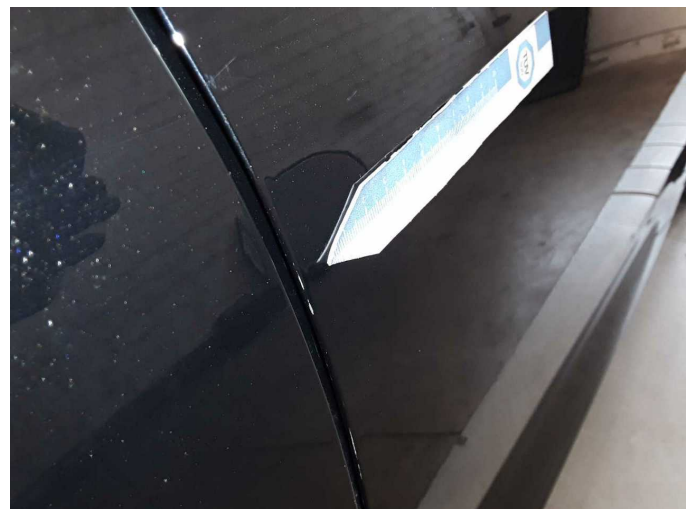
Wear and tear 3: Door - front right side: Door - Scratch(es) - No deduction
