Expertise

Protocol number: 46341519
Order No. / Reference: 26595562
Inspection date: 2 Jul 2026

Manufacturer: Peugeot

Model: 208 Elektromotor 136 Allure

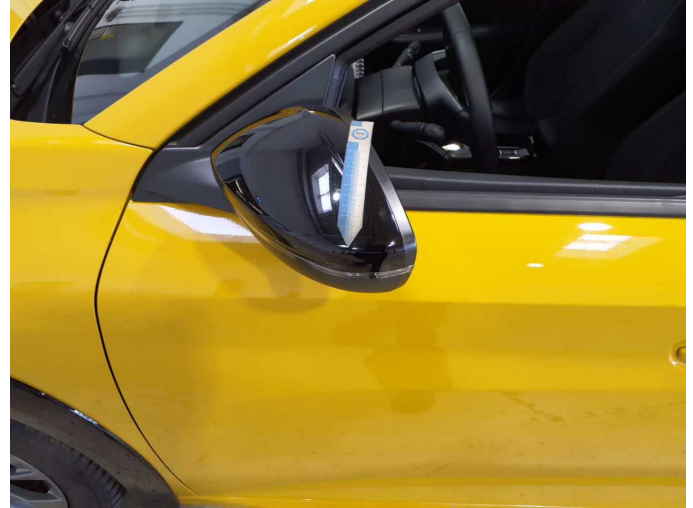
Damage 1: Wing mirror - left side: Cap - Scratch(es) - Smart repair

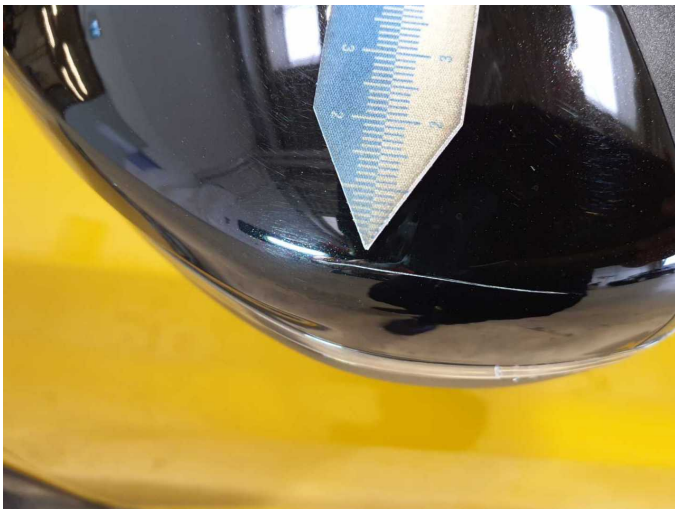
Damage 1: Wing mirror - left side: Cap - Scratch(es) - Smart repair

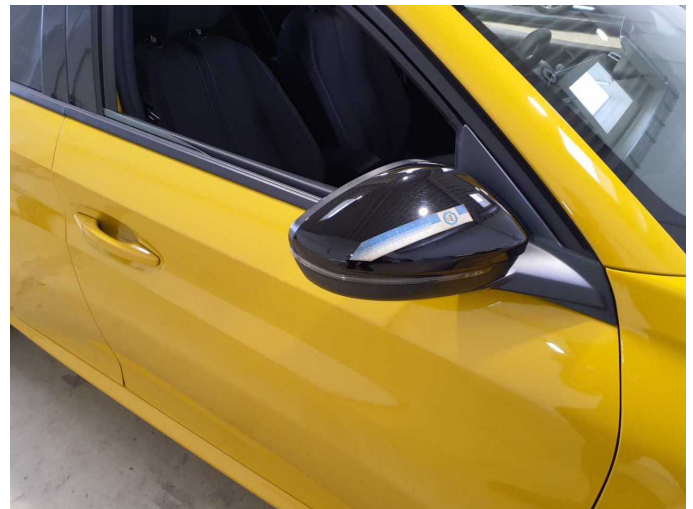
Damage 2: Wing mirror - right side: Cap - Scratch(es) - Smart repair

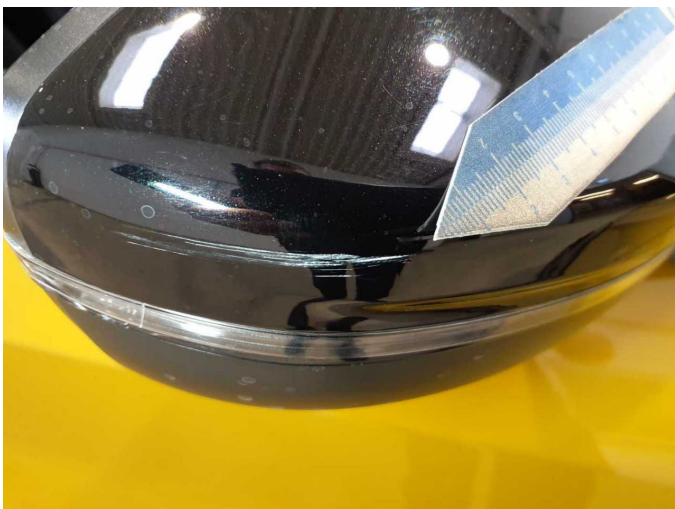
Damage 2: Wing mirror - right side: Cap - Scratch(es) - Smart repair

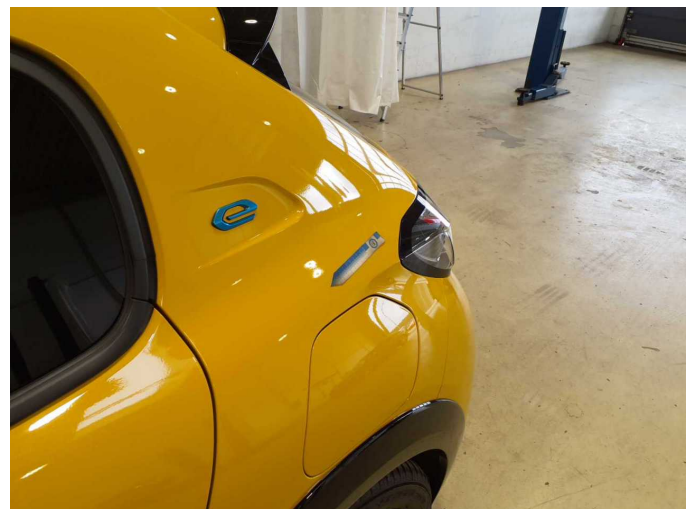
Damage 3: Side panel - rear left side: Side panel - dent(s) - Smooth repair work

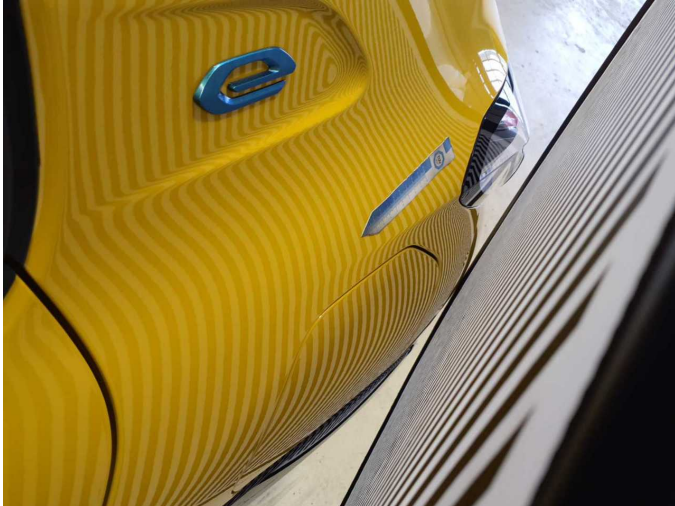
Damage 3: Side panel - rear left side: Side panel - dent(s) - Smooth repair work

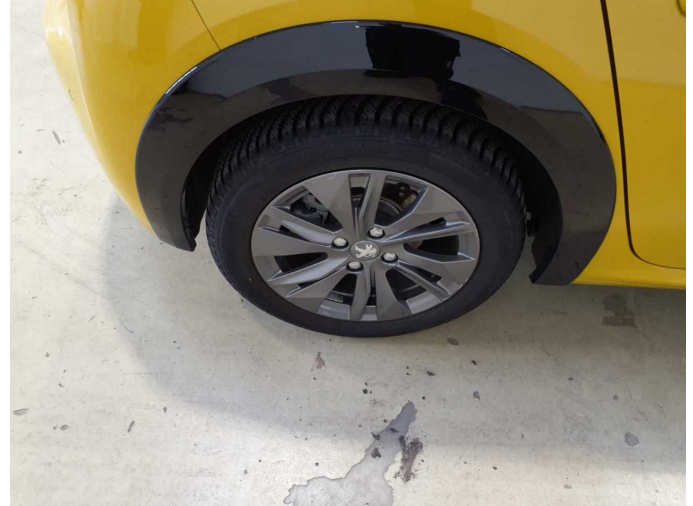
Damage 4: Wheel / tyres: Alloy rim - rear right side - Scratch(es) - Loss in value

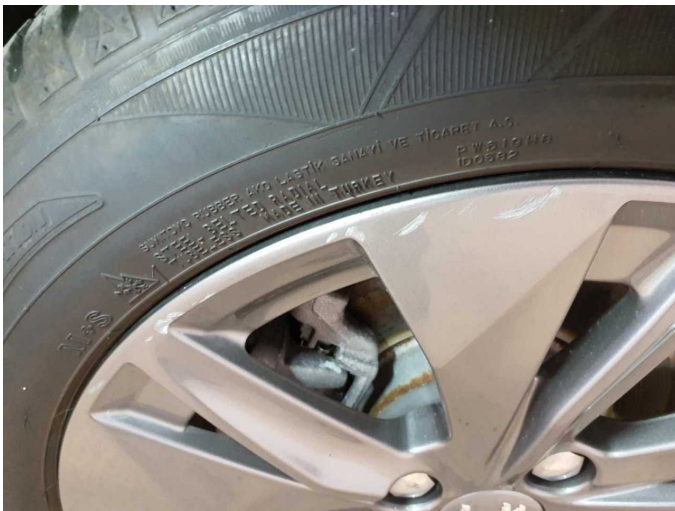
Damage 4: Wheel / tyres: Alloy rim - rear right side - Scratch(es) - Loss in value

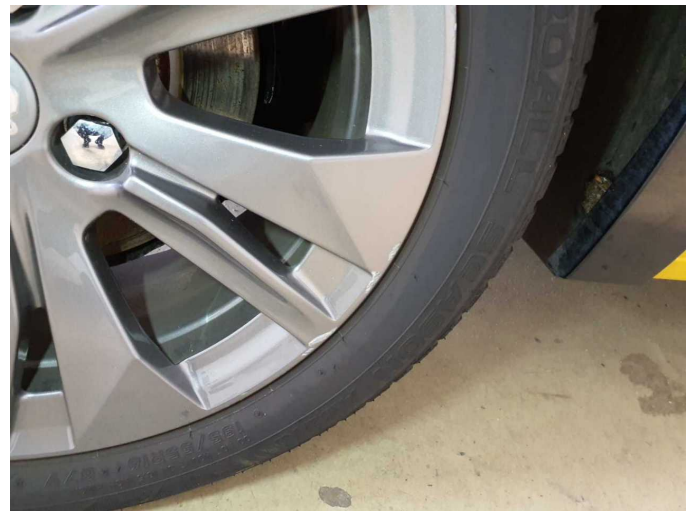
Damage 4: Wheel / tyres: Alloy rim - rear right side - Scratch(es) - Loss in value

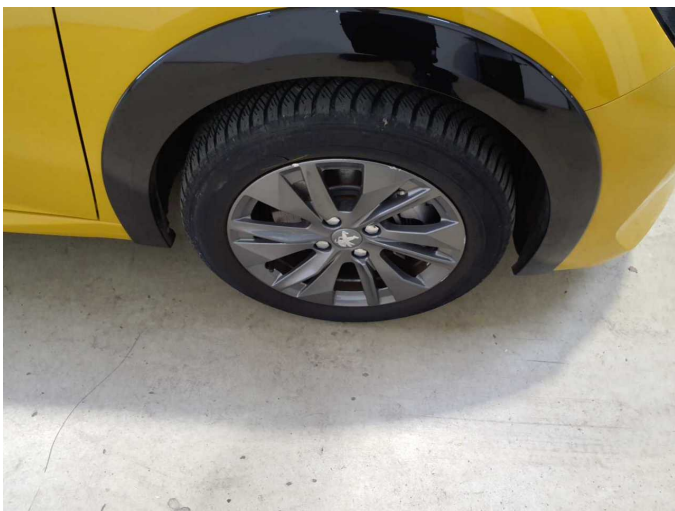
Damage 5: Wheel / tyres: Tyre - front right side - Broken / torn - Replace

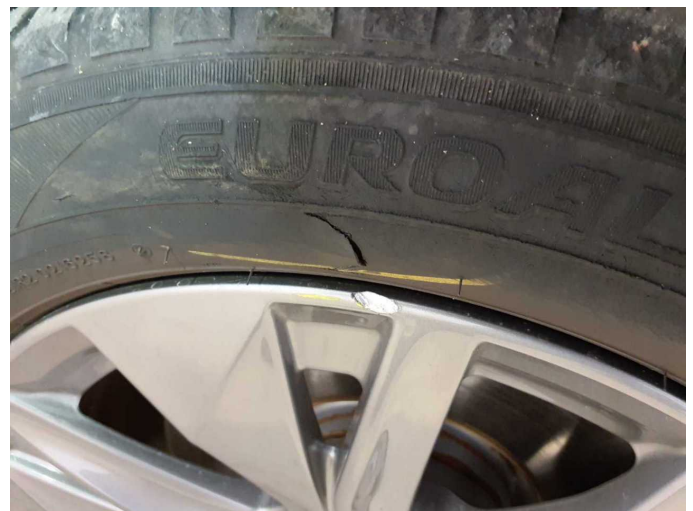
Damage 5: Wheel / tyres: Tyre - front right side - Broken / torn - Replace

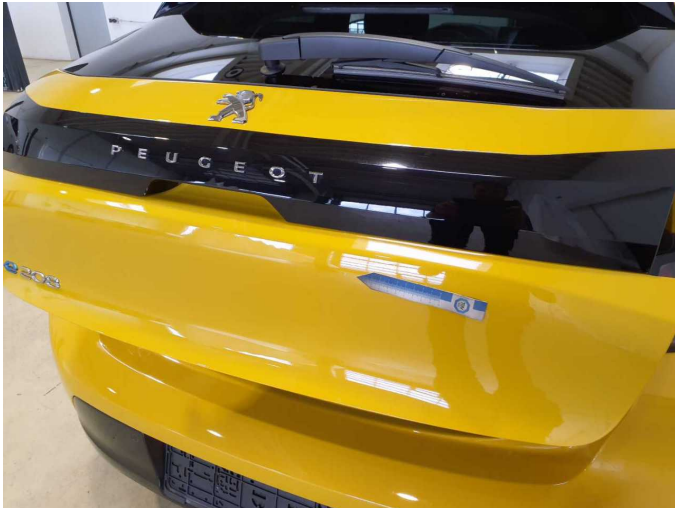
Damage 6: Boot lid / rear door: Boot lid - Scratch(es) - Smart repair

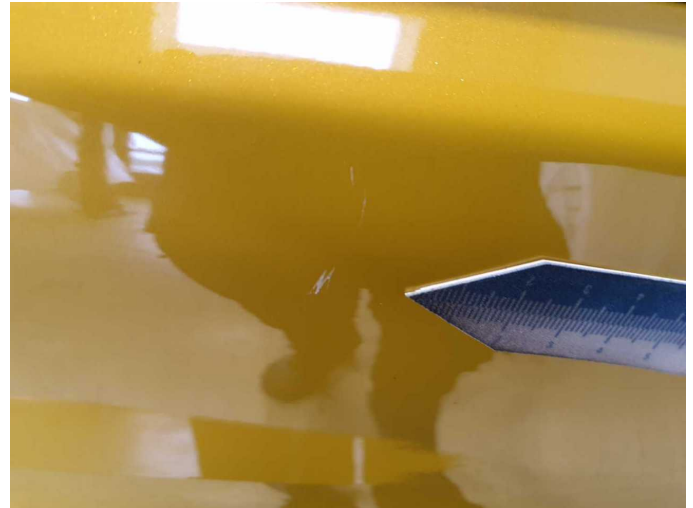
Damage 6: Boot lid / rear door: Boot lid - Scratch(es) - Smart repair

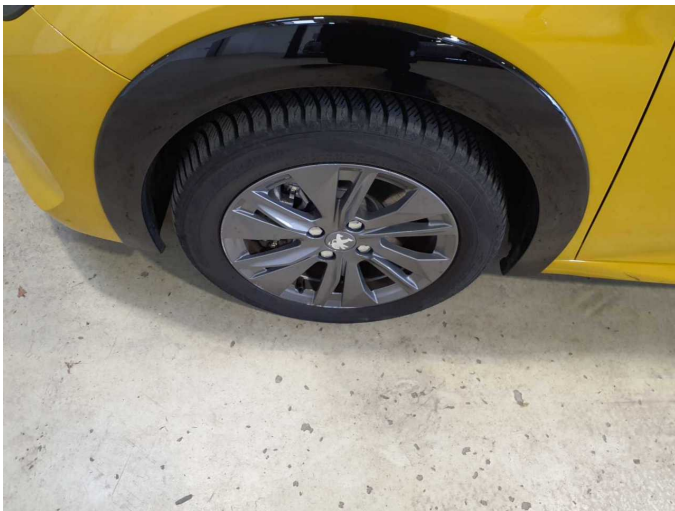
Damage 7: Wheel / tyres: Alloy rim - front left side - Scratch(es) - Replace

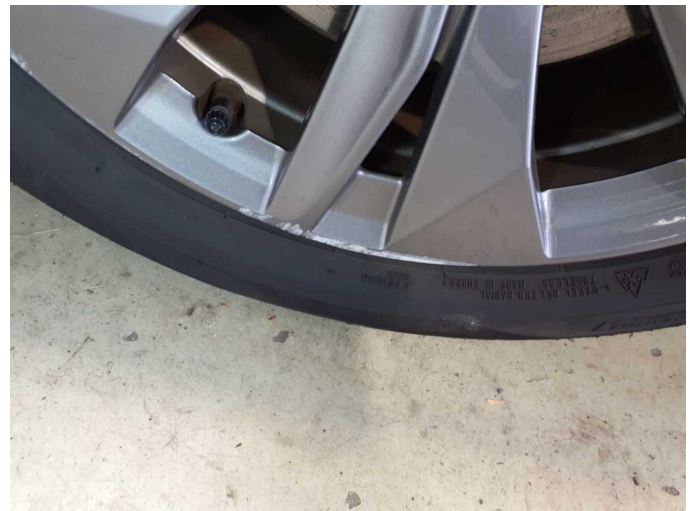
Damage 7: Wheel / tyres: Alloy rim - front left side - Scratch(es) - Replace

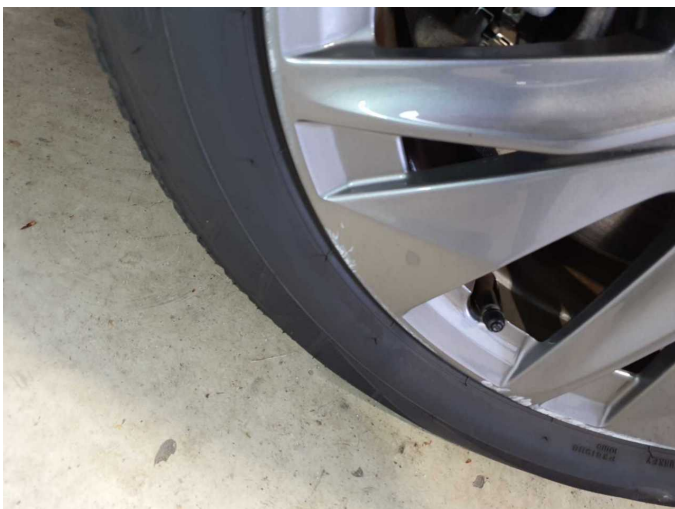
Damage 7: Wheel / tyres: Alloy rim - front left side - Scratch(es) - Replace

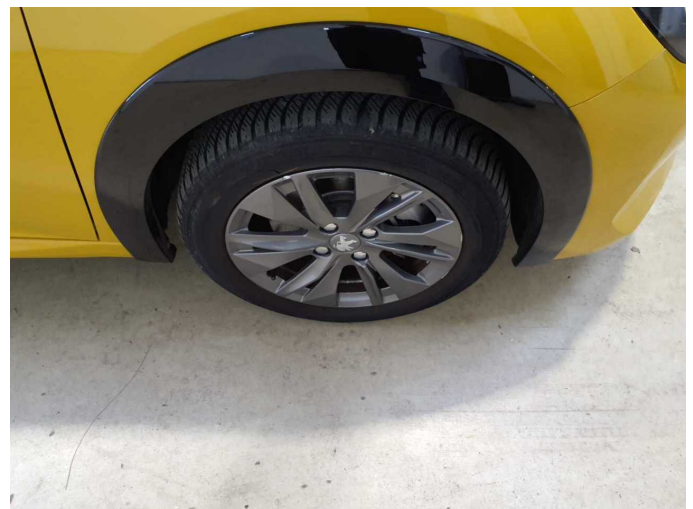
Damage 8: Wheel / tyres: Alloy rim - front right side - Scratch(es) - Replace

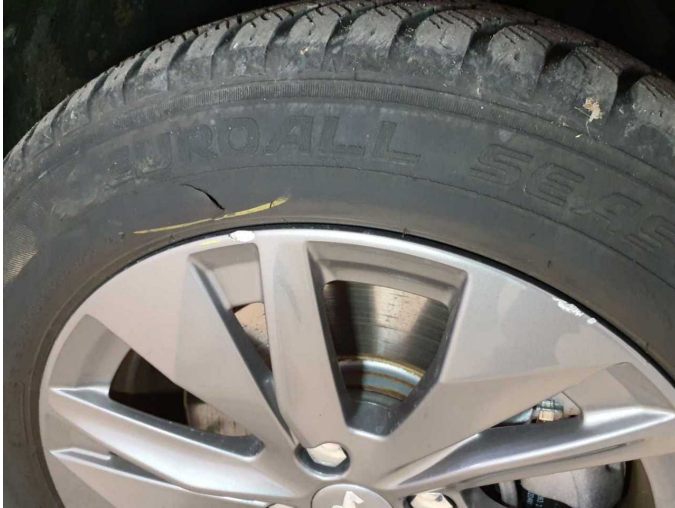
Damage 8: Wheel / tyres: Alloy rim - front right side - Scratch(es) - Replace

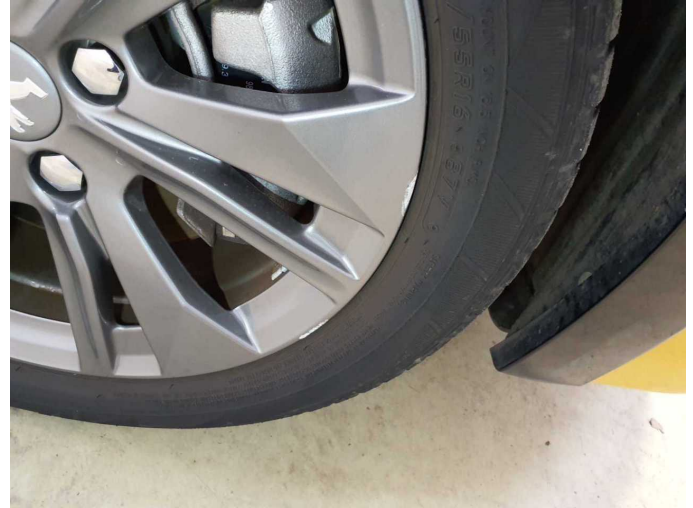
Damage 8: Wheel / tyres: Alloy rim - front right side - Scratch(es) - Replace

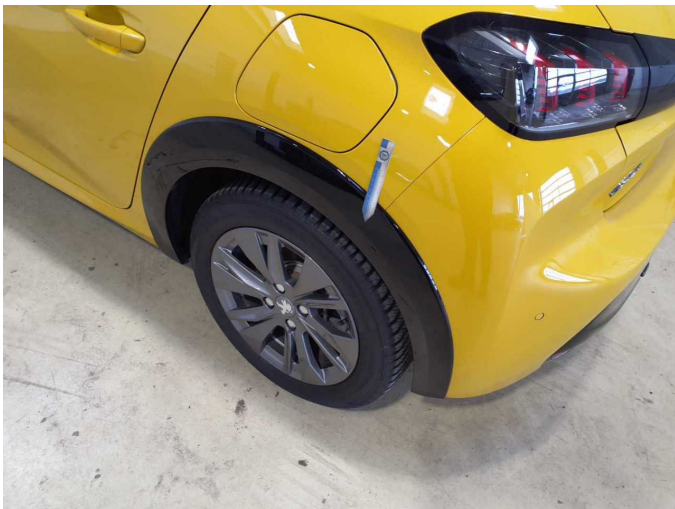
Damage 9: Side panel - rear left side: Wheel arch - Scratch(es) - Replace

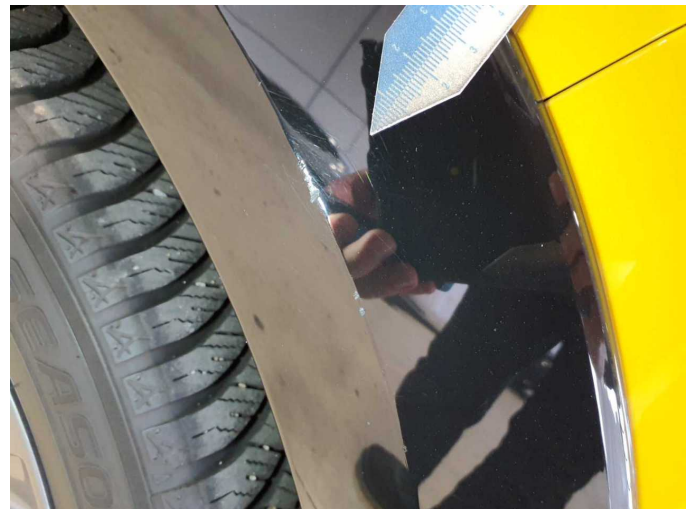
Damage 9: Side panel - rear left side: Wheel arch - Scratch(es) - Replace

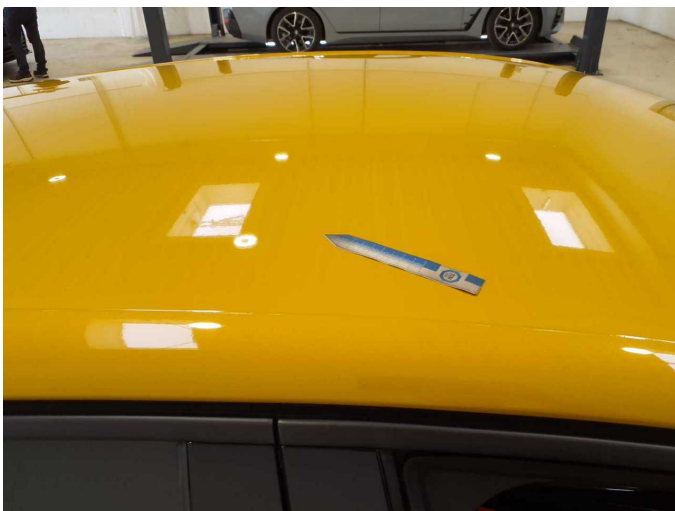
Damage 10: Roof: Roof - Dent / paintcoat damage - Repair and paint

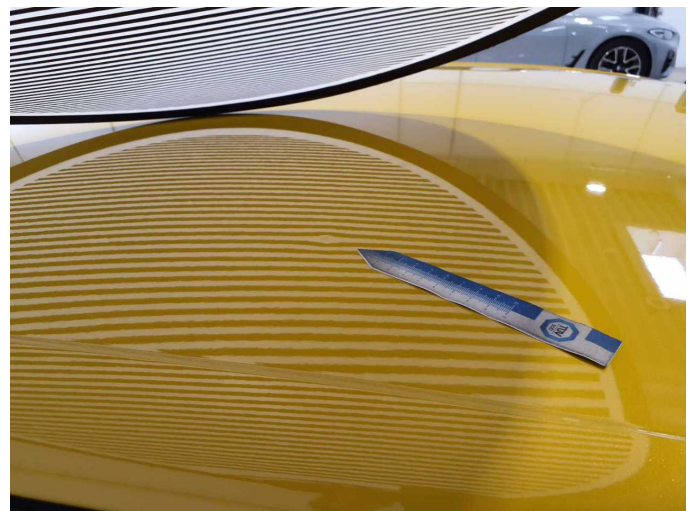
Damage 10: Roof: Roof - Dent / paintcoat damage - Repair and paint

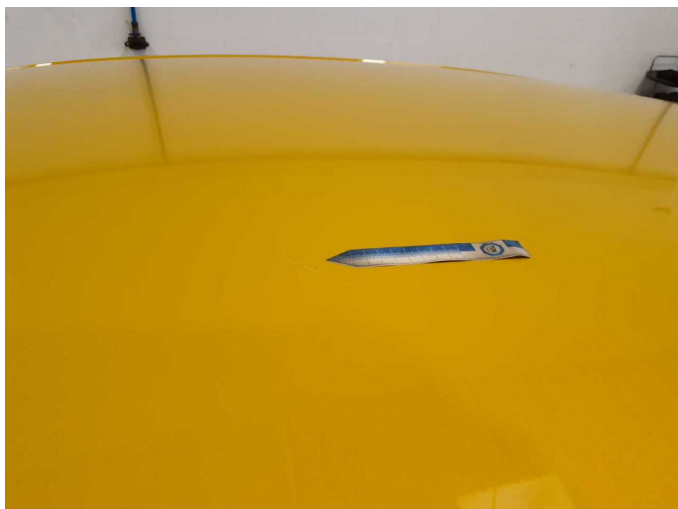
Damage 10: Roof: Roof - Dent / paintcoat damage - Repair and paint

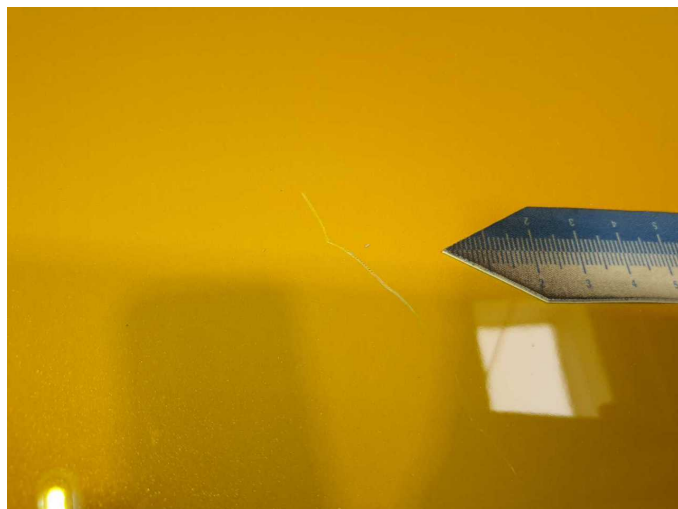
Damage 10: Roof: Roof - Dent / paintcoat damage - Repair and paint
