Expertise

Protocol number: 46904713  
Order No. / Reference: 26738389  
Inspection date: 5 Aug 2026

Manufacturer: Hyundai

Model: TUCSON 1.6 T-GDi Plug-in-Hybrid 4WD Prime

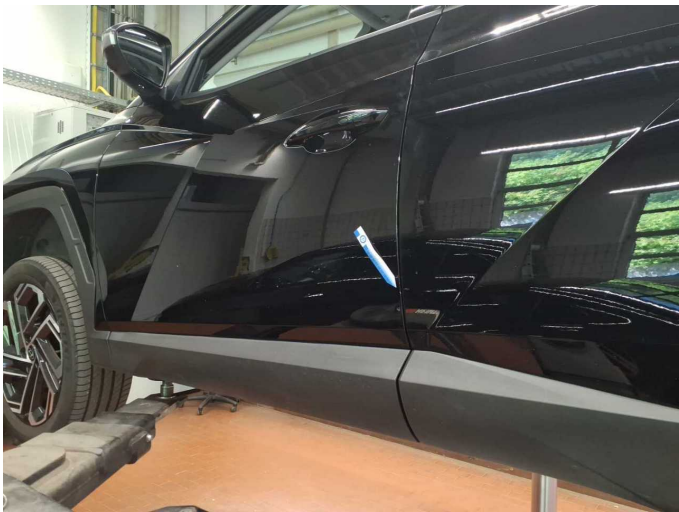
| No. | Component group | Description |
|---|---|---|
| 1 | Door - front left side | Door edge - Scratch(es) - Smart repair |

Damage 1: Door - front left side: Door edge - Scratch(es) - Smart repair

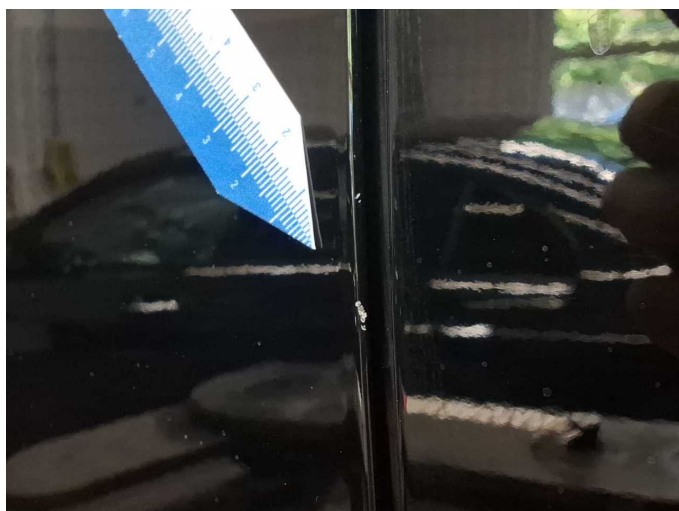
**Damage 1:** Door - front left side: Door edge - Scratch(es) - Smart repair

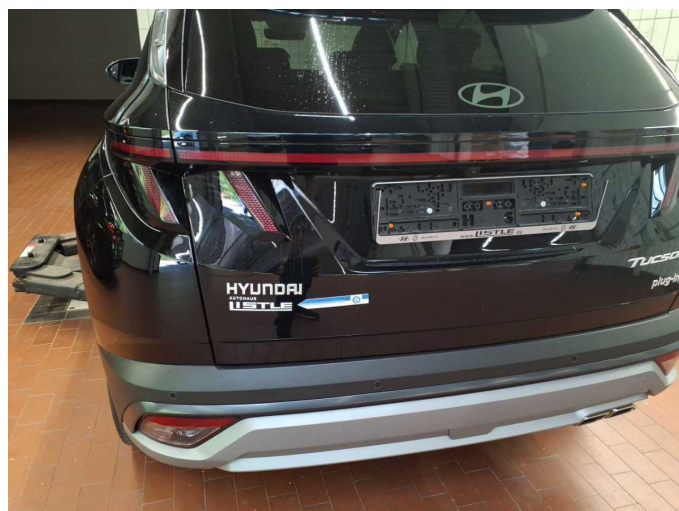
| No. | Component group | Description |
|---|---|---|
| 2 | Boot lid / rear door | Boot lid - Glued / labelled - De-glue / neutralise |

**Damage 2:** Boot lid / rear door: Boot lid - Glued / labelled - De-glue / neutralise

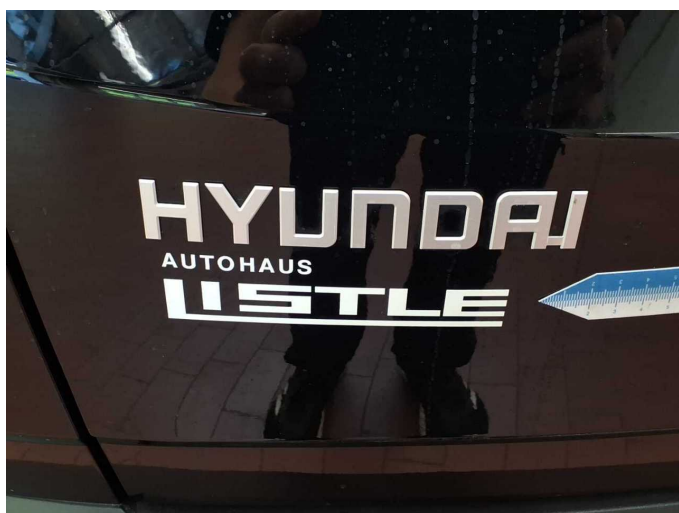
**Damage 2:** Boot lid / rear door: Boot lid - Glued / labelled - De-glue / neutralise

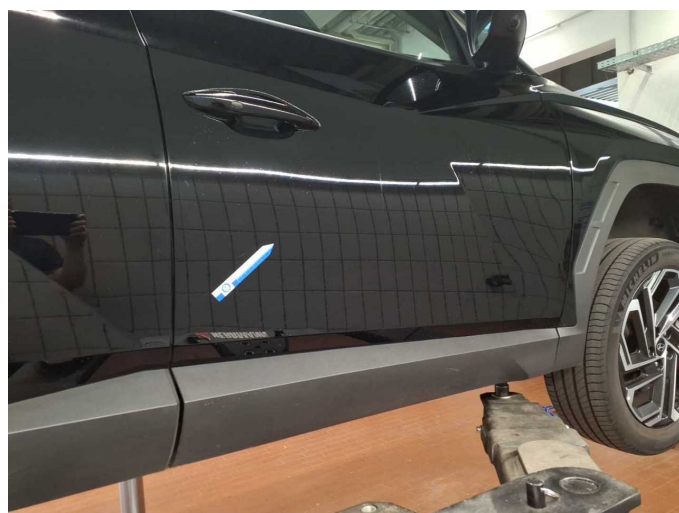
| No. | Component group | Description |
|---|---|---|
| 3 | Door - front right side | Door - Scratch(es) - Smart repair |

**Damage 3:** Door - front right side: Door - Scratch(es) - Smart repair

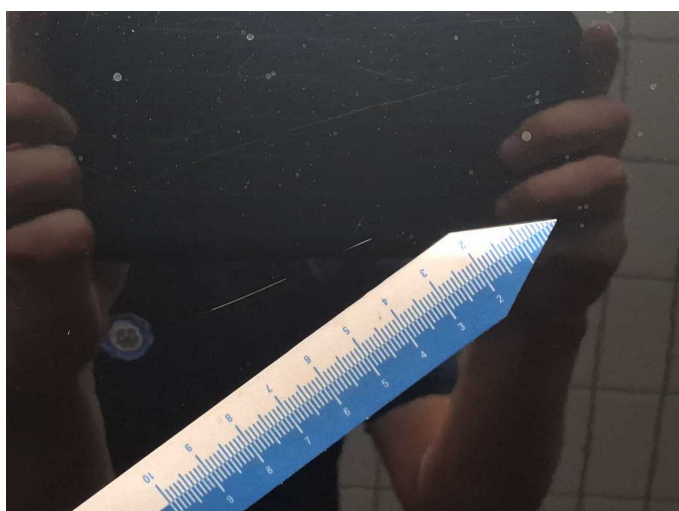
**Damage 3:** Door - front right side: Door - Scratch(es) - Smart repair

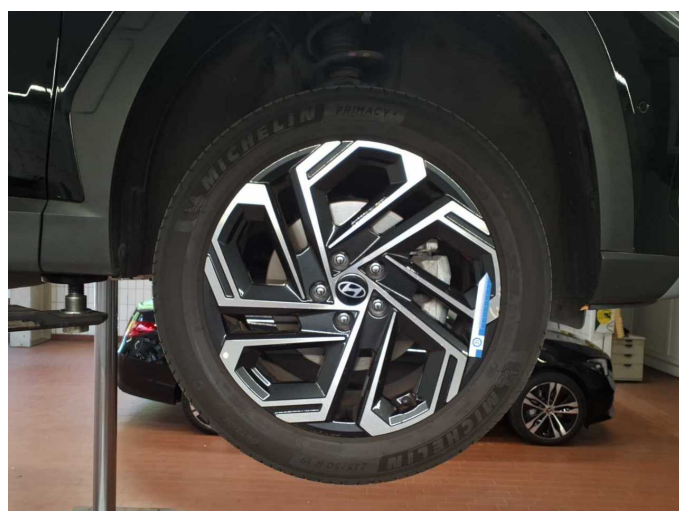
| No. | Component group | Description |
|---|---|---|
| 4 | Wheel / tyres | Alloy rim - front right side - Scratched - Loss in value |

**Damage 4:** Wheel / tyres: Alloy rim - front right side - Scratched - Loss in value

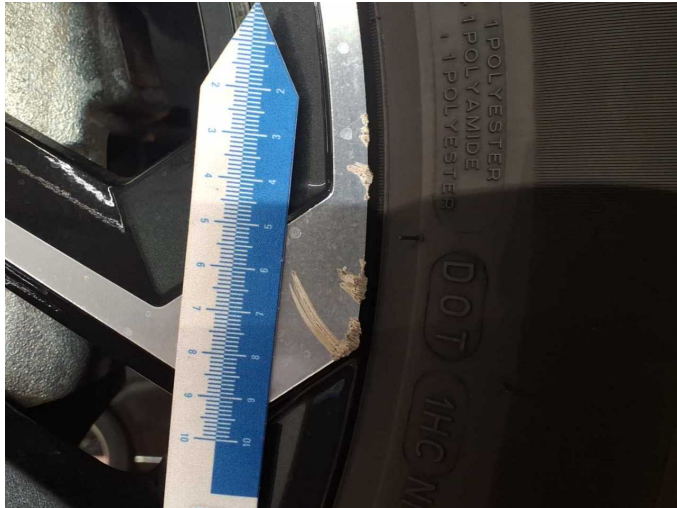
**Damage 4:** Wheel / tyres: Alloy rim - front right side - Scratched - Loss in value

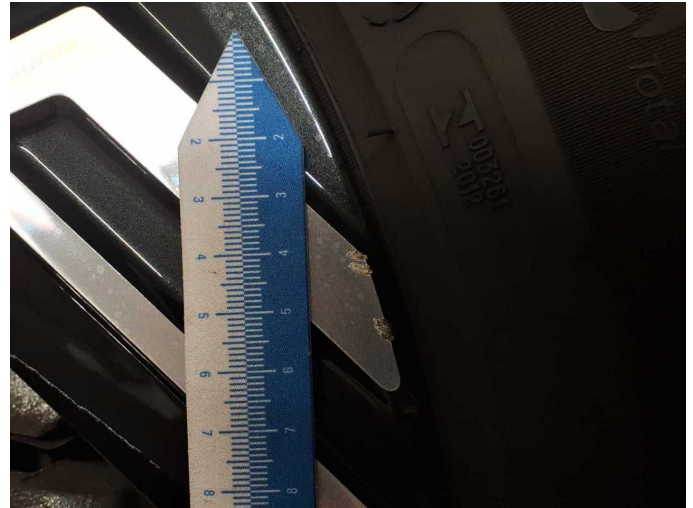
**Damage 4:** Wheel / tyres: Alloy rim - front right side - Scratched - Loss in value

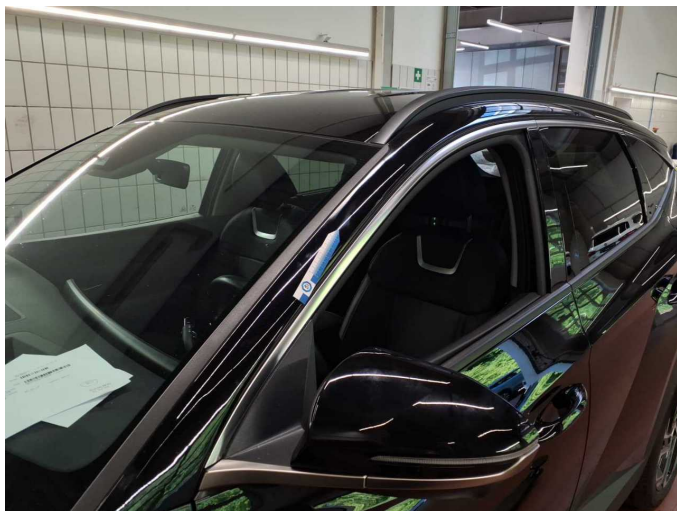
| No. | Component group | Description |
|---|---|---|
| 5 | Roof | Roof rail - left side (Wellig) - Unprofessionally repaired - Paint |

**Damage 5:** Roof: Roof rail - left side (Wellig) - Unprofessionally repaired - Paint

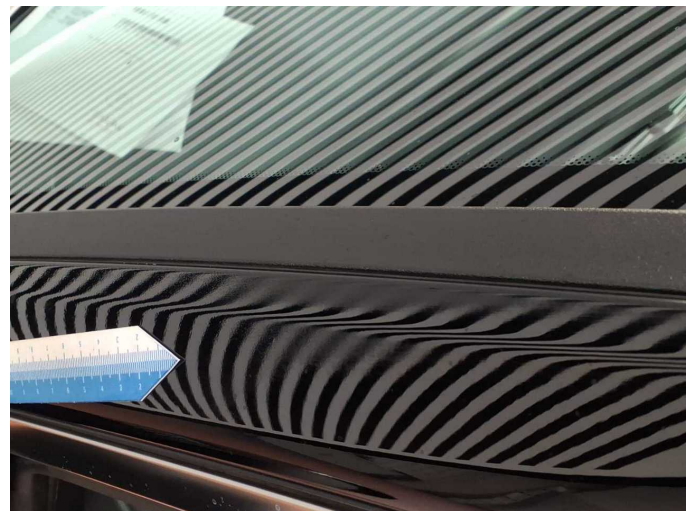
**Damage 5:** Roof: Roof rail - left side (Wellig) - Unprofessionally repaired - Paint

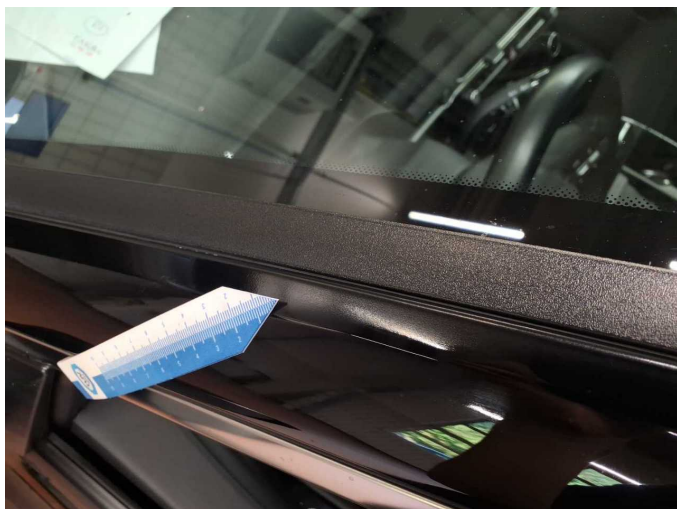
**Damage 5:** Roof: Roof rail - left side (Wellig) - Unprofessionally repaired - Paint

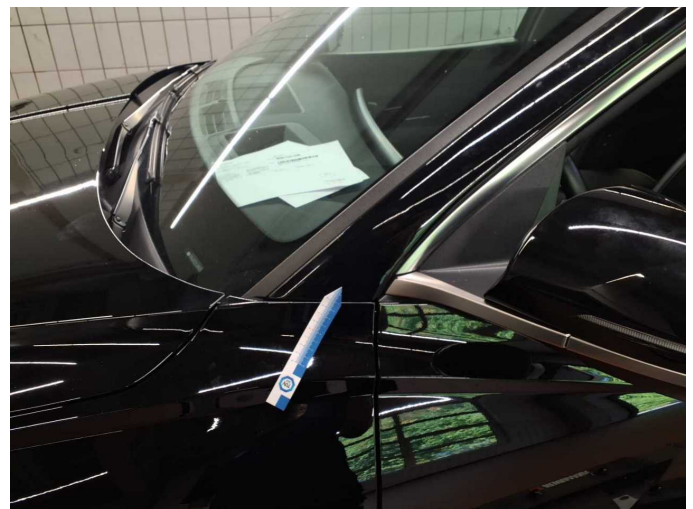
**Damage 5:** Roof: Roof rail - left side (Wellig) - Unprofessionally repaired - Paint

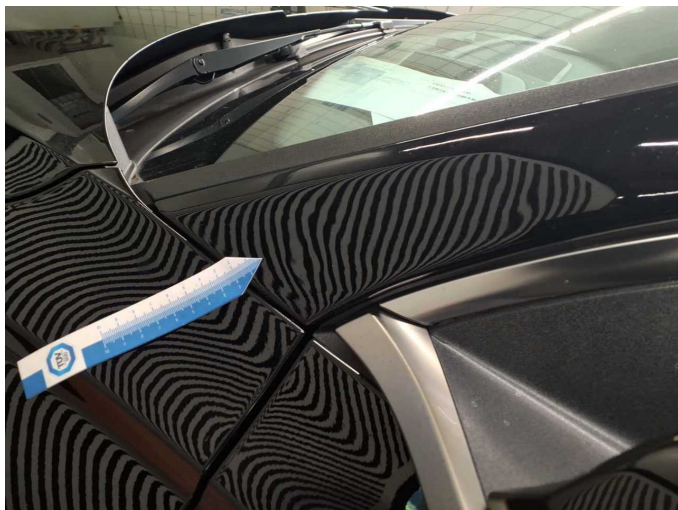
**Damage 5:** Roof: Roof rail - left side (Wellig) - Unprofessionally repaired - Paint

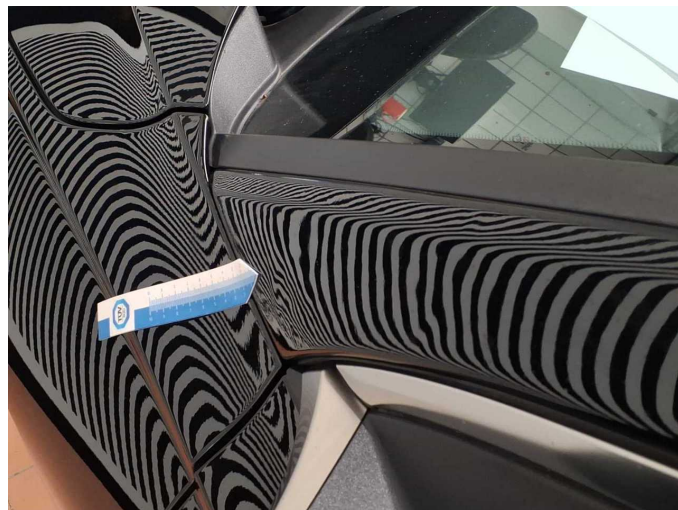
**Damage 5:** Roof: Roof rail - left side (Wellig) - Unprofessionally repaired - Paint

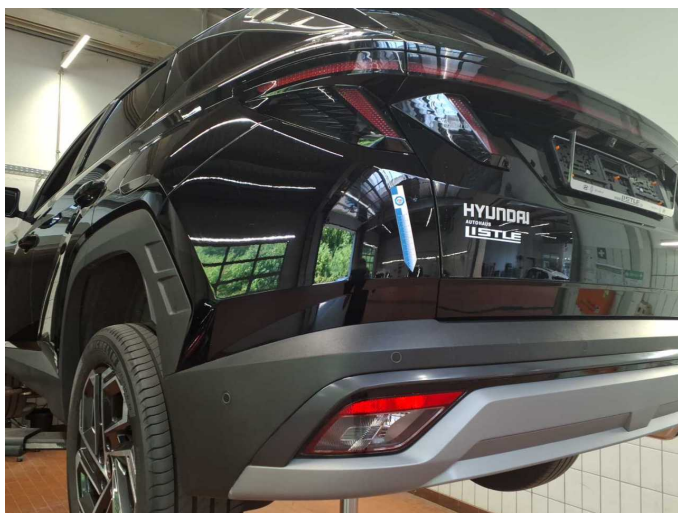
| No. | Component group | Description |
|---|---|---|
| 6 | Rear bumper | Rear bumper (Lackläufer/Einschlüsse; Orangenhaut) - Unprofessionally repaired - Repair and paint |

**Damage 6:** Rear bumper: Rear bumper (Lackläufer/Einschlüsse; Orangenhaut) - Unprofessionally repaired - Repair and paint

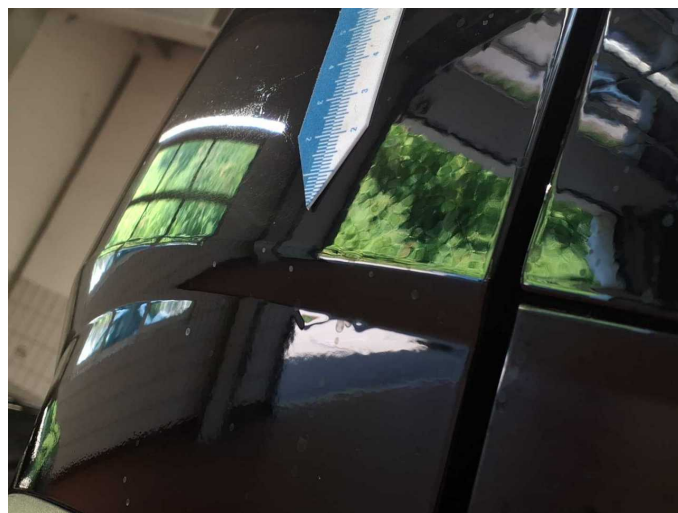
**Damage 6:** Rear bumper: Rear bumper (Lackläufer/Einschlüsse; Orangenhaut) - Unprofessionally repaired - Repair and paint

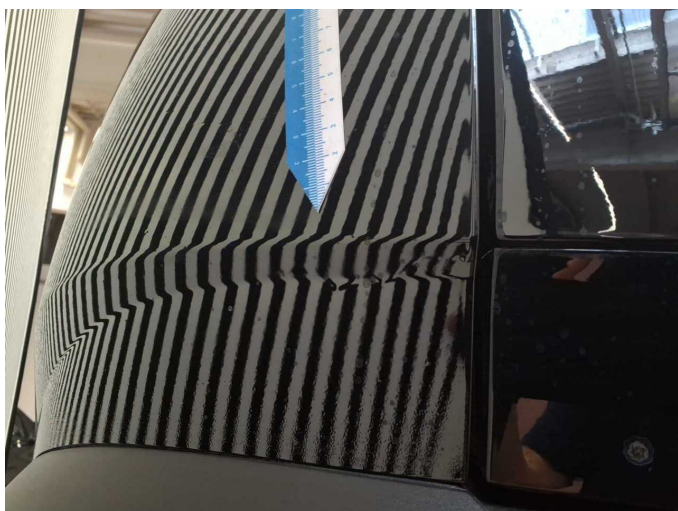
**Damage 6:** Rear bumper: Rear bumper (Lackläufer/Einschlüsse; Orangenhaut) - Unprofessionally repaired - Repair and paint

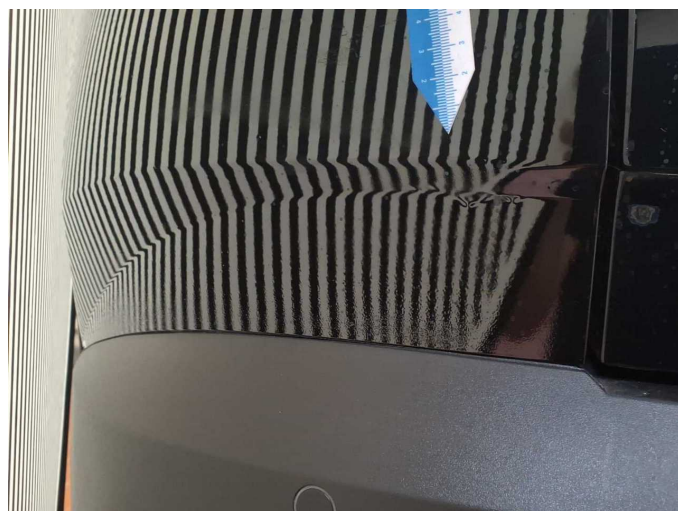
**Damage 6:** Rear bumper: Rear bumper (Lackläufer/Einschlüsse; Orangenhaut) - Unprofessionally repaired - Repair and paint

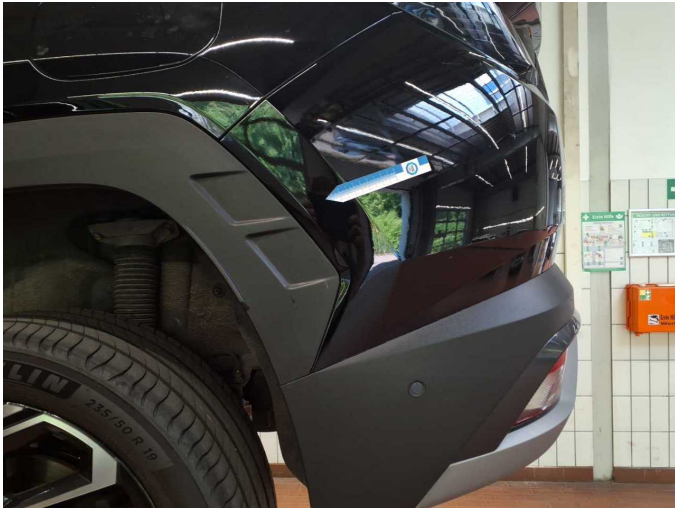
**Damage 6:** Rear bumper: Rear bumper (Lackläufer/Einschlüsse; Orangenhaut) - Unprofessionally repaired - Repair and paint

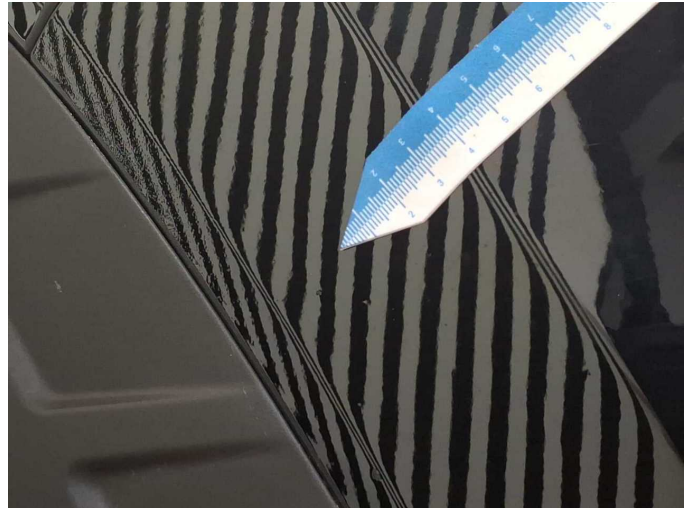
**Damage 6:** Rear bumper: Rear bumper (Lackläufer/Einschlüsse; Orangenhaut) - Unprofessionally repaired - Repair and paint

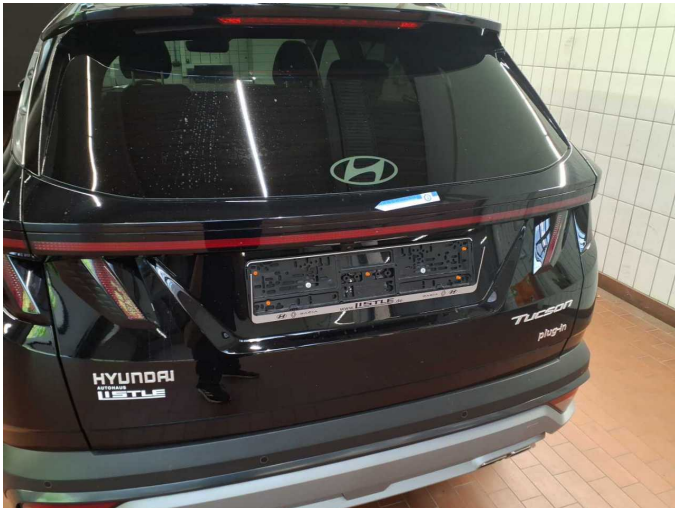
| No. | Component group | Description |
|---|---|---|
| 3 | Boot lid / rear door | Boot lid - Scratch(es) - No deduction |

**Wear and tear 3:** Boot lid / rear door: Boot lid - Scratch(es) - No deduction

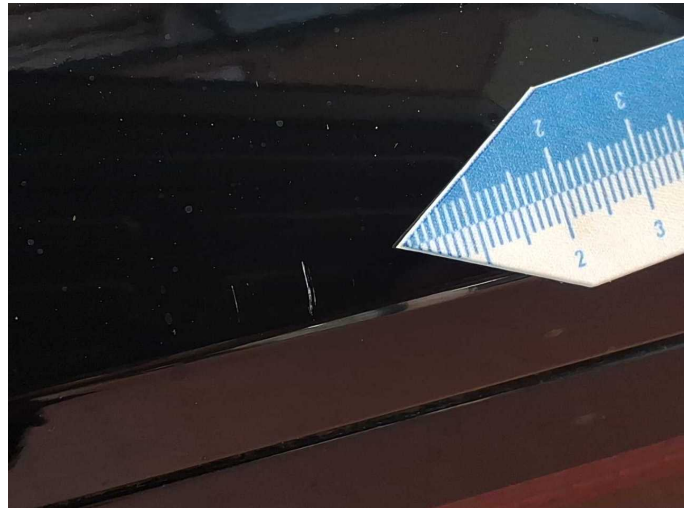
**Wear and tear 3:** Boot lid / rear door: Boot lid - Scratch(es) - No deduction

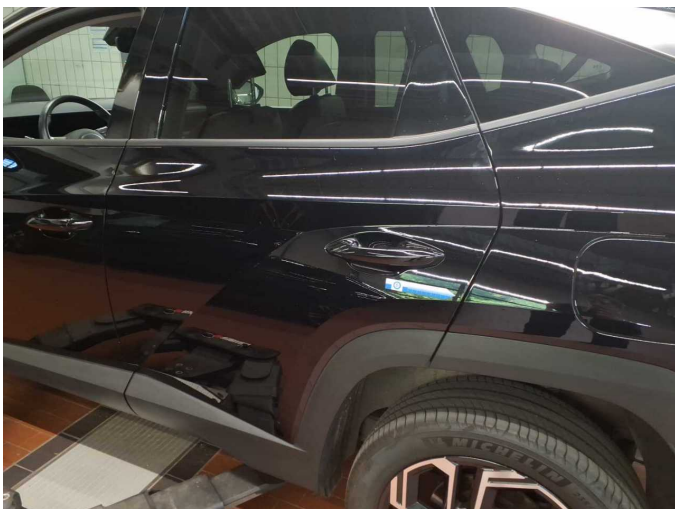
| No. | Component group | Description |
|---|---|---|
| 4 | Door - rear left side | Door - Scratch(es) - No deduction |

**Wear and tear 4:** Door - rear left side: Door - Scratch(es) - No deduction

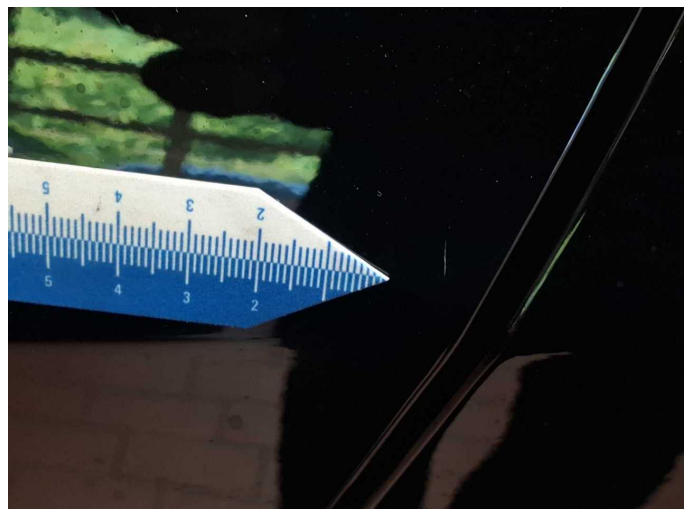
**Wear and tear 4:** Door - rear left side: Door - Scratch(es) - No deduction

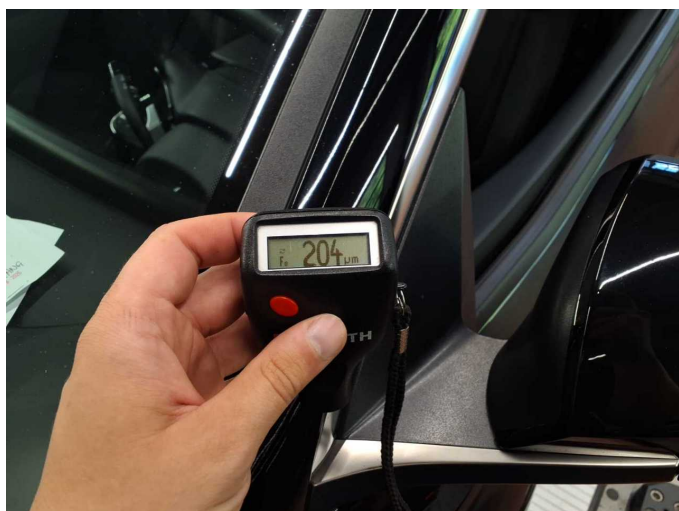
**Repainting 1:** Roof rail - left side

- 1 Roof rail - left side, Professionally carried out, Invoice of repair done Non-existent

Roof rail - left side

204 µm
