Expertise

Protocol number: 46879977  
Order No. / Reference: 26765631  
Inspection date: 4 Aug 2026

Manufacturer: Toyota

Model: Proace City Verso 1.2 Turbo L2 Aut Team Deutschland

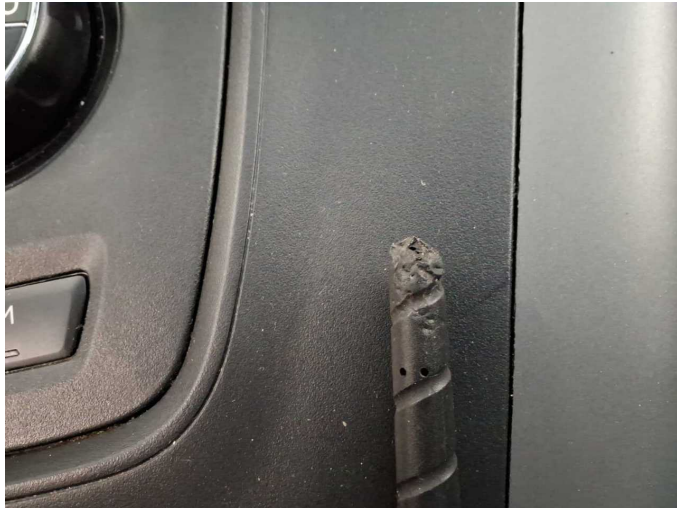
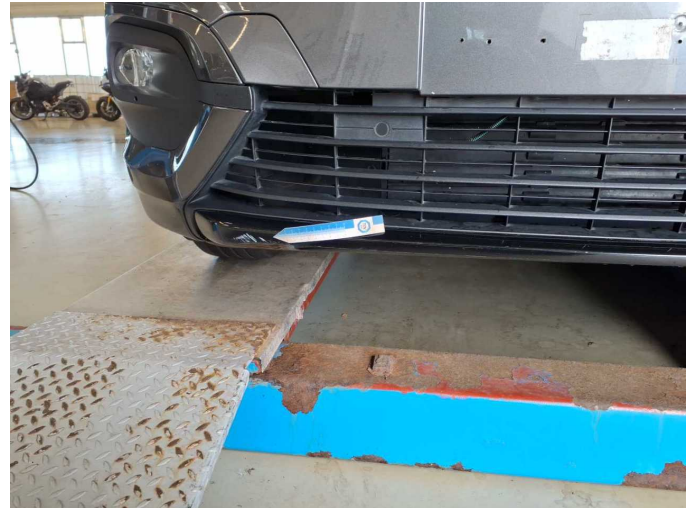
| No. | Component group | Description |
|---|---|---|
| 1 | Roof | Stub aerial - Damage caused by marten / rodent - Replace |

Damage 1: Roof: Stub aerial - Damage caused by marten / rodent - Replace

**Damage 1:** Roof: Stub aerial - Damage caused by marten / rodent - Replace

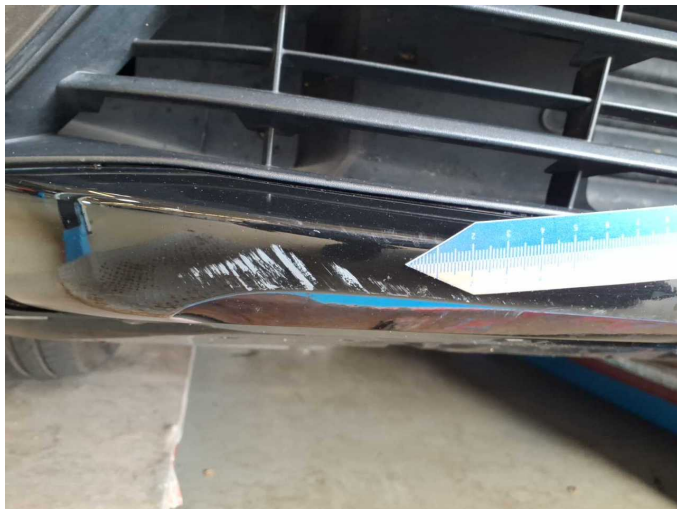
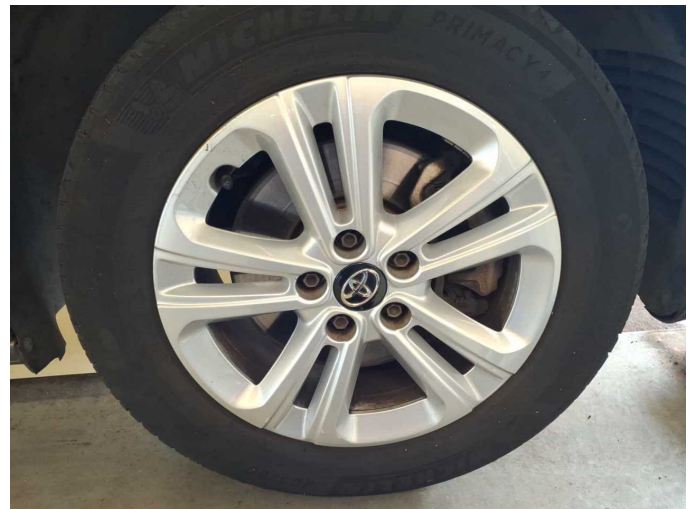
| No. | Component group | Description |
|---|---|---|
| 2 | Trim / covers | Trim / covers (Stossfänger vorn) - Scratch(es) - Smart repair |

**Damage 2:** Trim / covers: Trim / covers (Stoßfänger vorn) - Scratch(es) - Smart repair

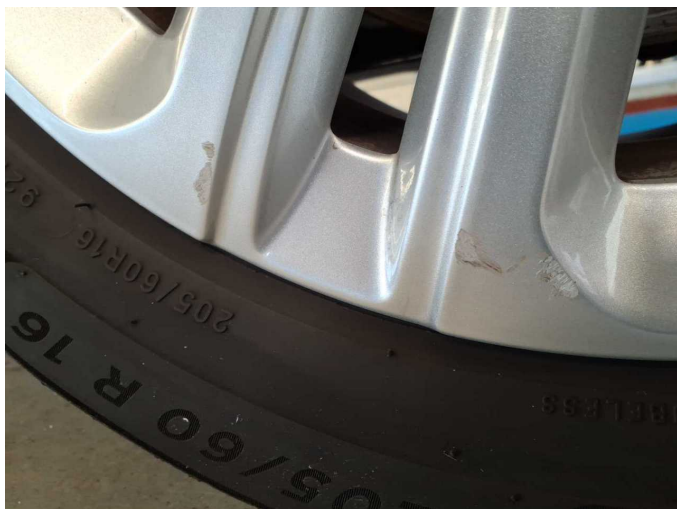
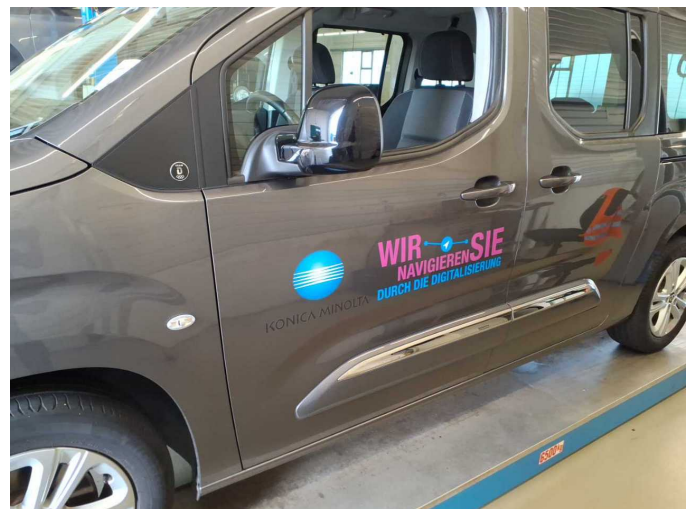
| No. | Component group | Description |
|---|---|---|
| 3 | Wheel / tyres | Alloy rim - front right side - Scratch(es) - Loss in value |

**Damage 3:** Wheel / tyres: Alloy rim - front right side - Scratch(es) - Loss in value

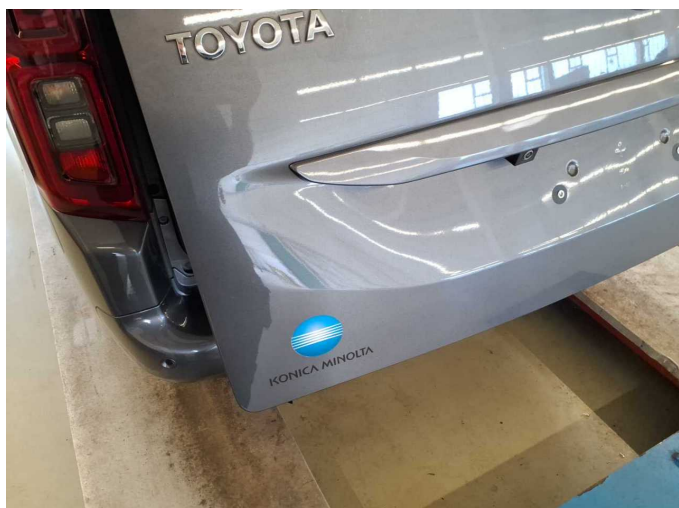
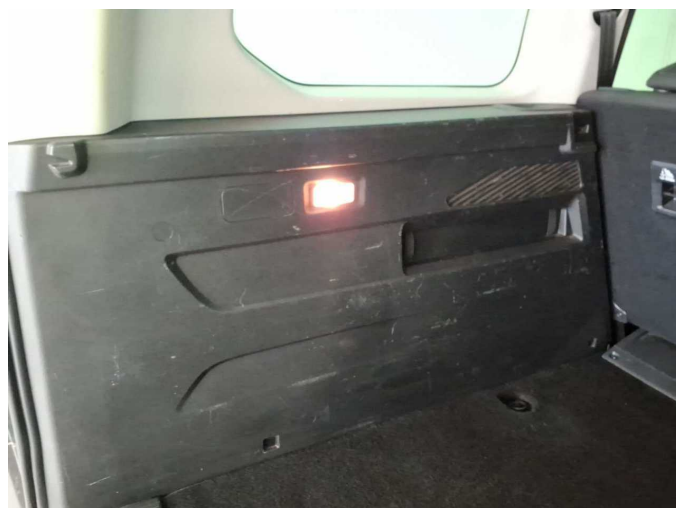
| No. | Component group | Description |
|---|---|---|
| 4 | Body | Body (Kostenausweitung möglich) - Glued / labelled - De-glue / neutralise |

**Damage 4:** Body: Body (Kostenausweitung möglich) - Glued / labelled - De-glue / neutralise

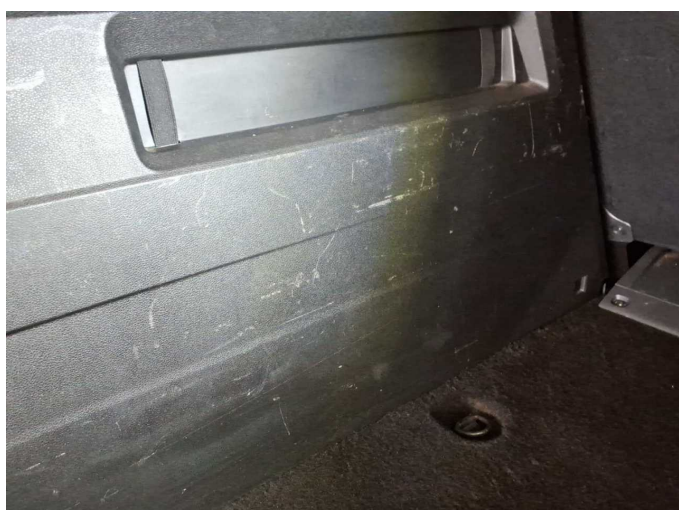
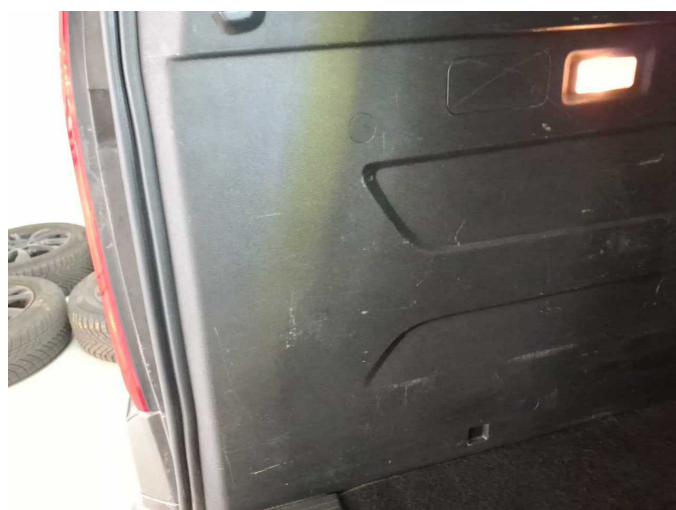
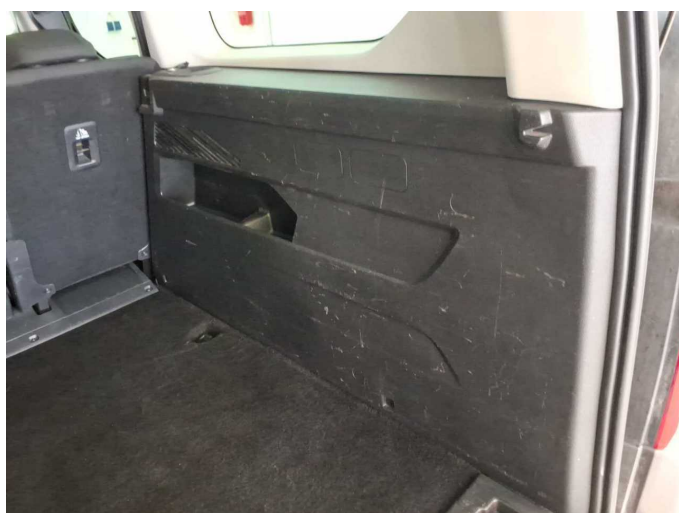
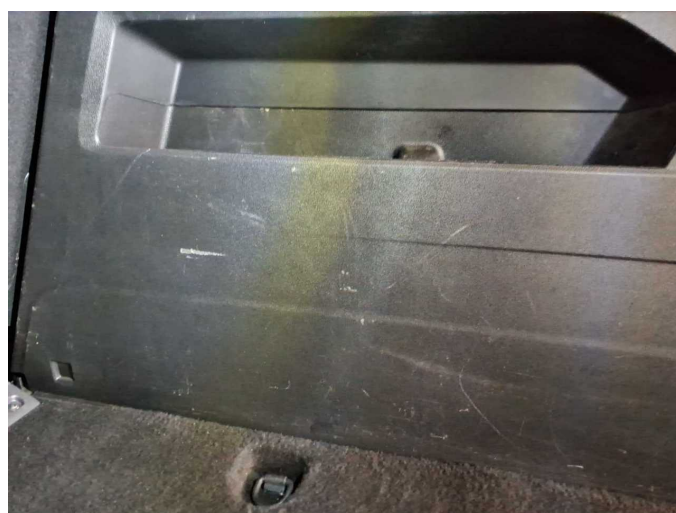
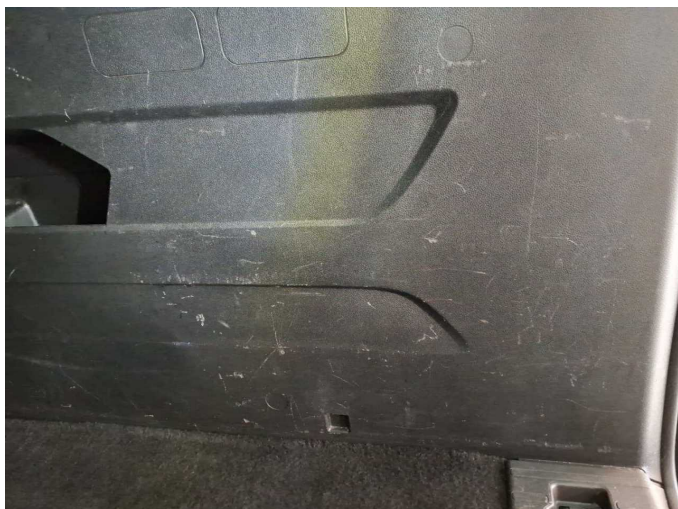
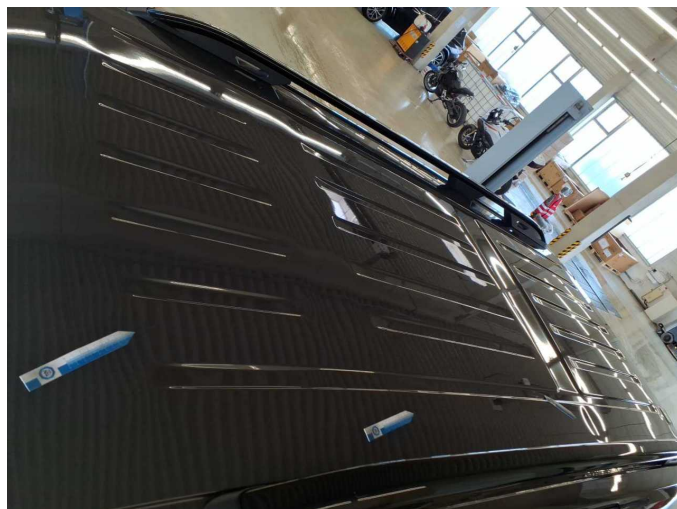
| No. | Component group | Description |
|---|---|---|
| 5 | Trim / covers | Trim / covers (Laderaum) - Scratched - Loss in value |

**Damage 5:** Trim / covers: Trim / covers (Laderaum) - Scratched - Loss in value

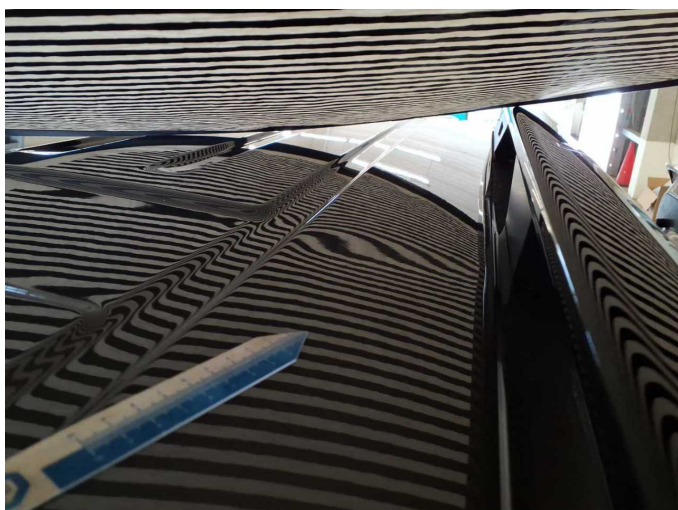
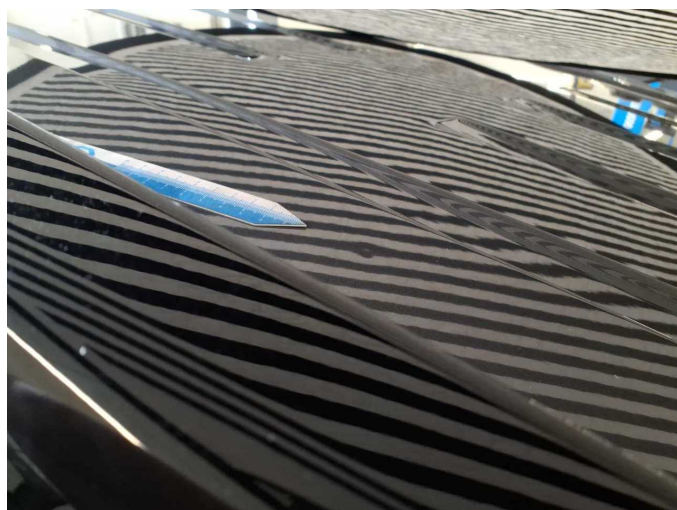
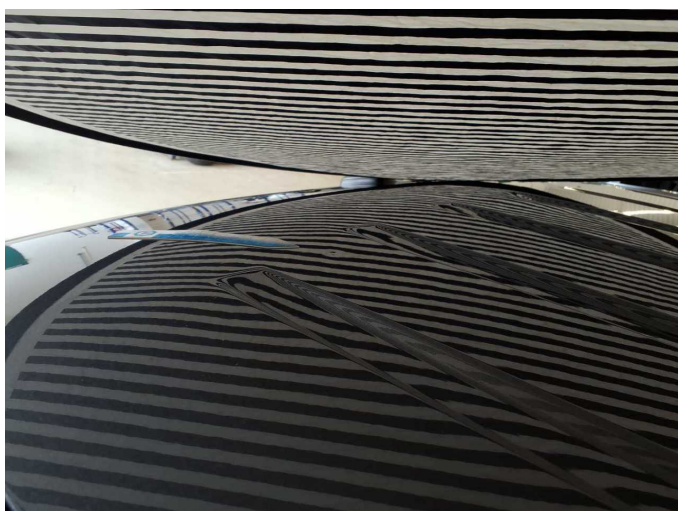
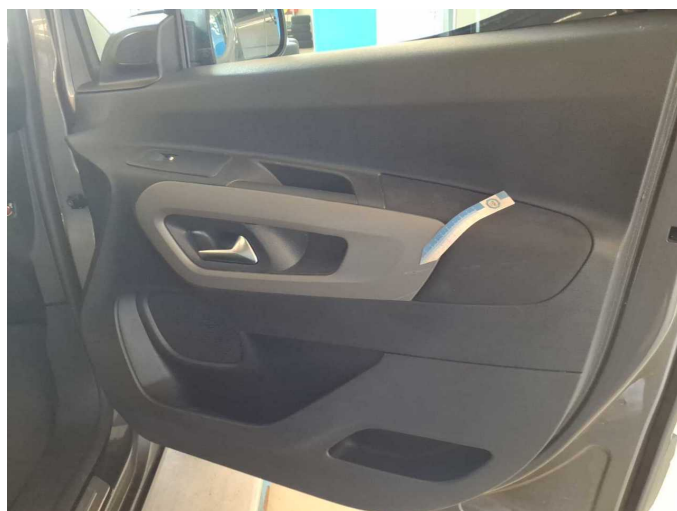
| No. | Component group | Description |
|---|---|---|
| 6 | Roof | Roof - dent(s) - Smooth repair work |

**Damage 6:** Roof: Roof - dent(s) - Smooth repair work

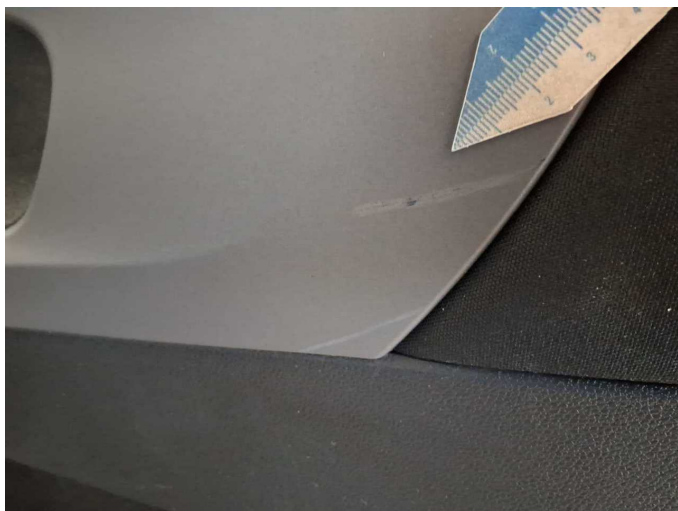
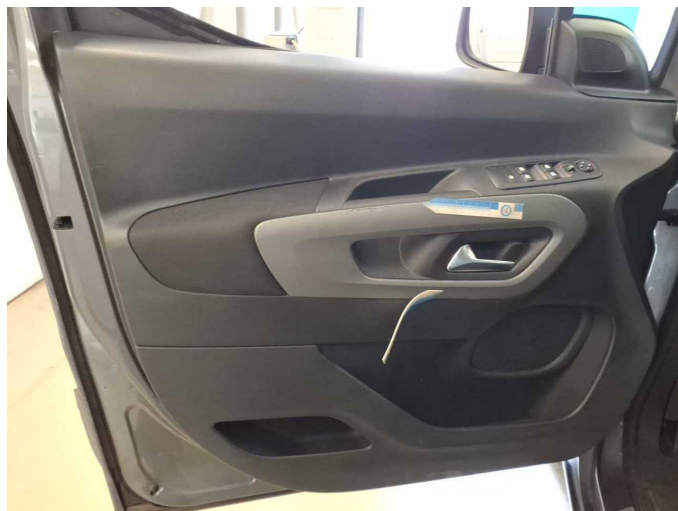
| No. | Component group | Description |
|---|---|---|
| 7 | Trim / covers | Door trim - front right side - Scratched - Replace |

**Damage 7:** Trim / covers: Door trim - front right side - Scratched - Replace

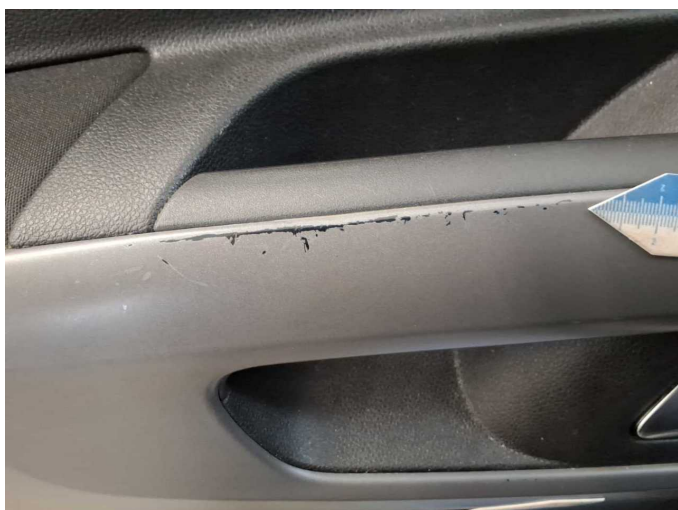
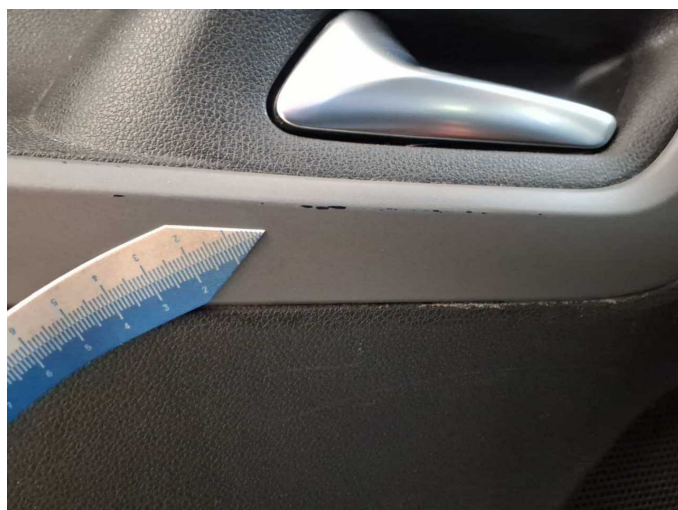
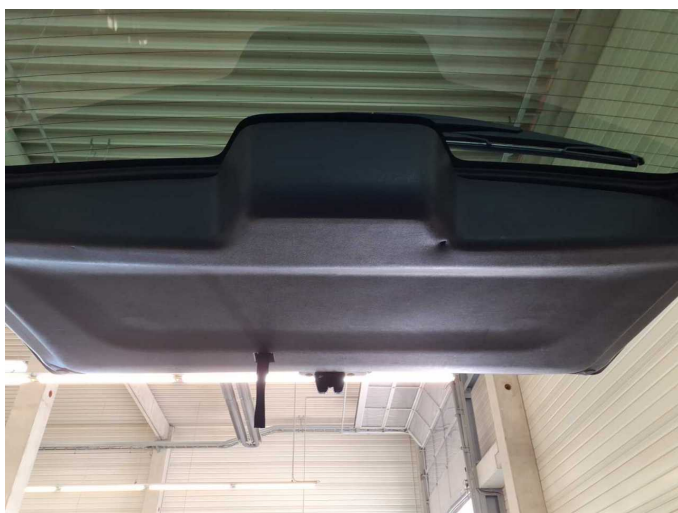
| No. | Component group | Description |
|---|---|---|
| 8 | Trim / covers | Door trim - front left side - Scratched - Replace |

**Damage 8:** Trim / covers: Door trim - front left side - Scratched - Replace

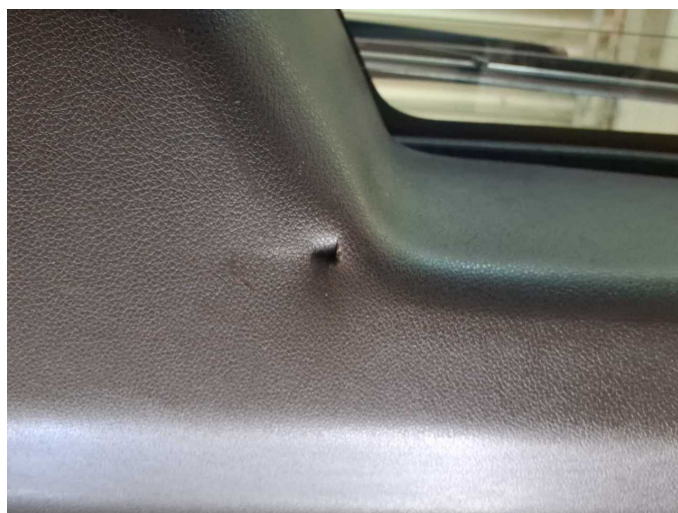
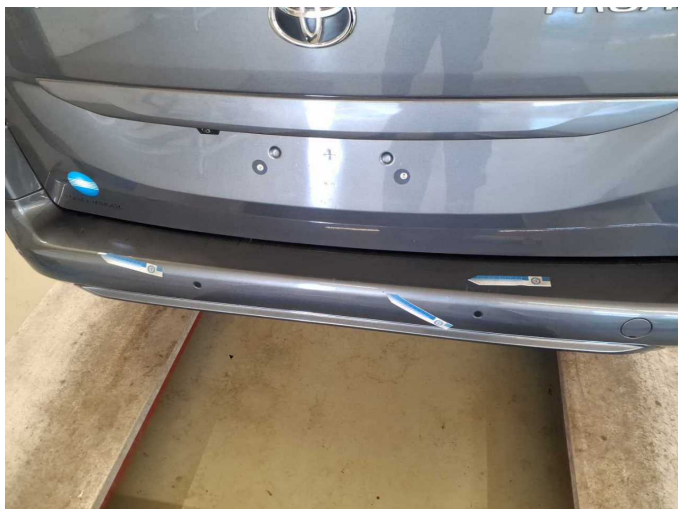
| No. | Component group | Description |
|---|---|---|
| 9 | Boot lid / rear door | Trim - standard - lower - Broken / torn - Replace |

**Damage 9:** Boot lid / rear door: Trim - standard - lower - Broken / torn - Replace

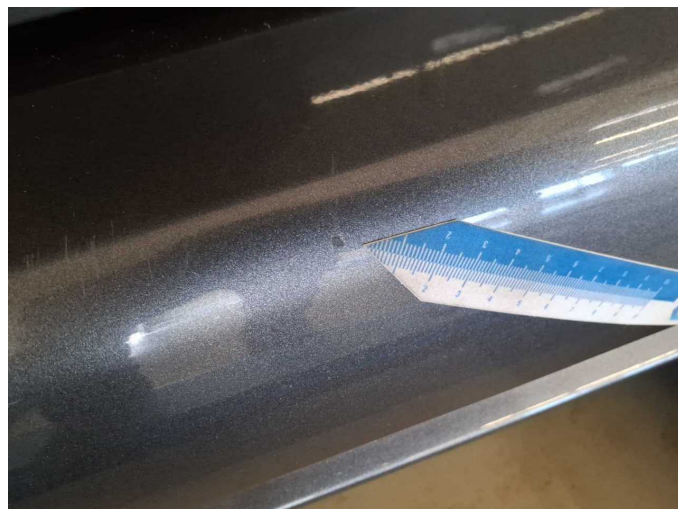
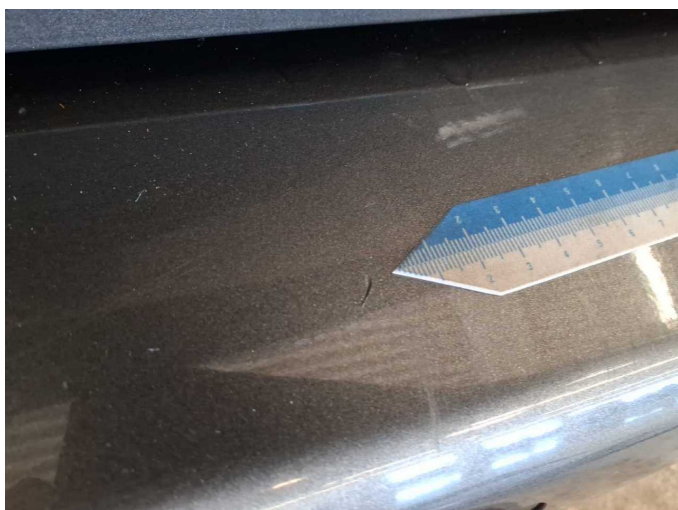
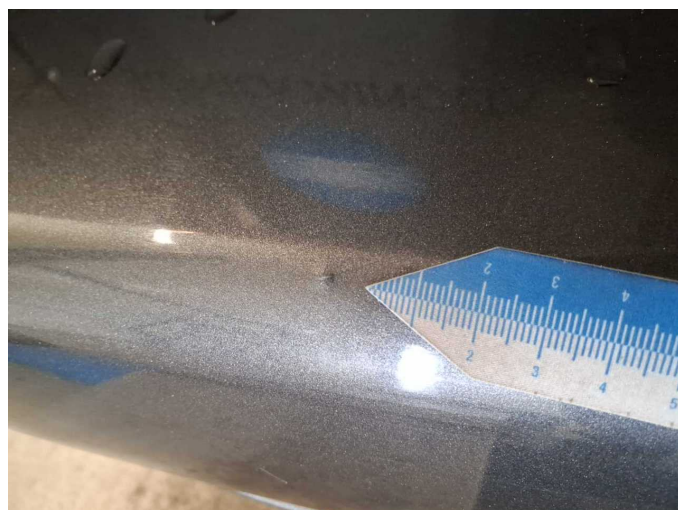
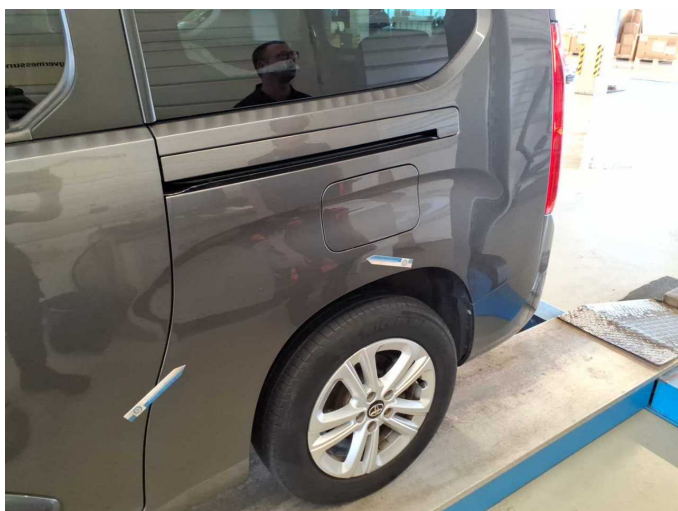
| No. | Component group | Description |
|---|---|---|
| 10 | Rear bumper | Bumper with Parktronic - Scratched - Paint |

**Damage 10:** Rear bumper: Bumper with Parktronic - Scratched - Paint

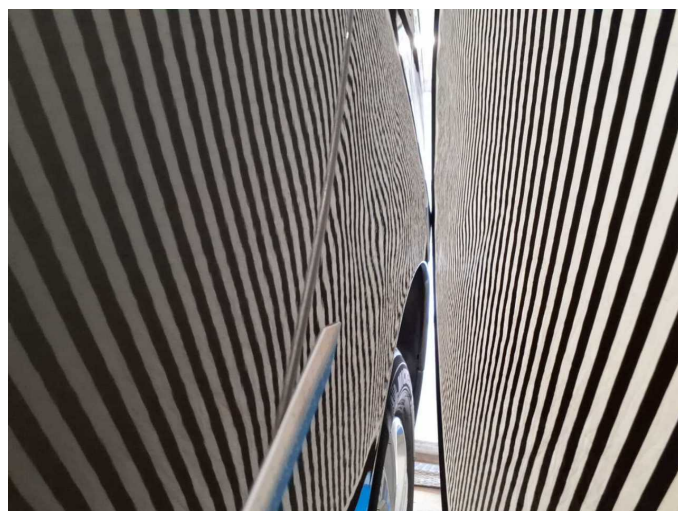
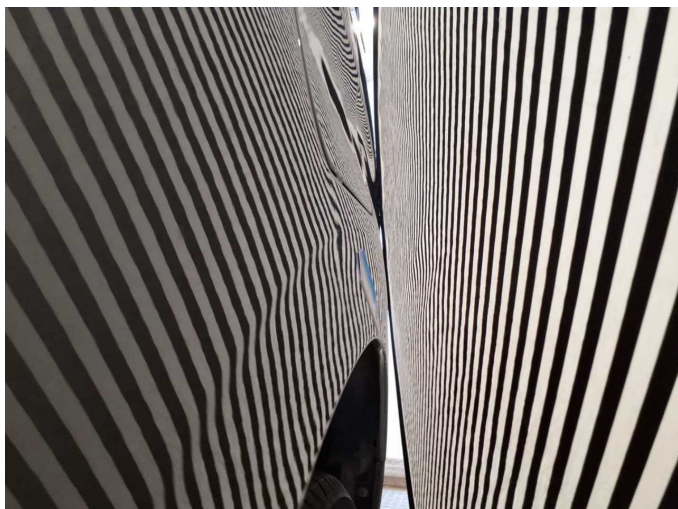
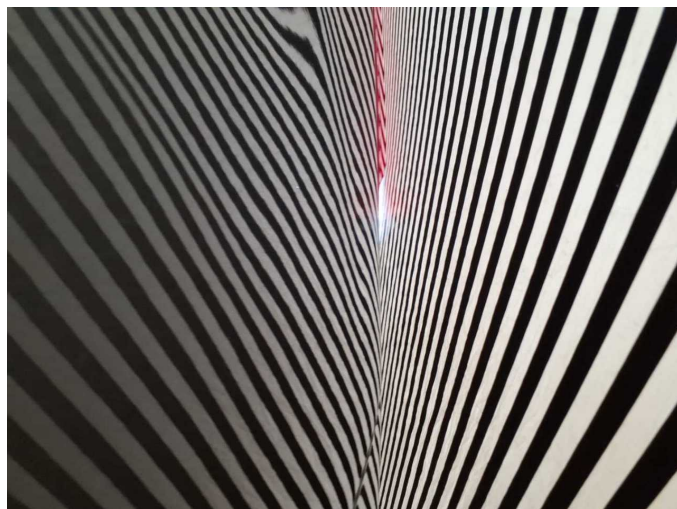
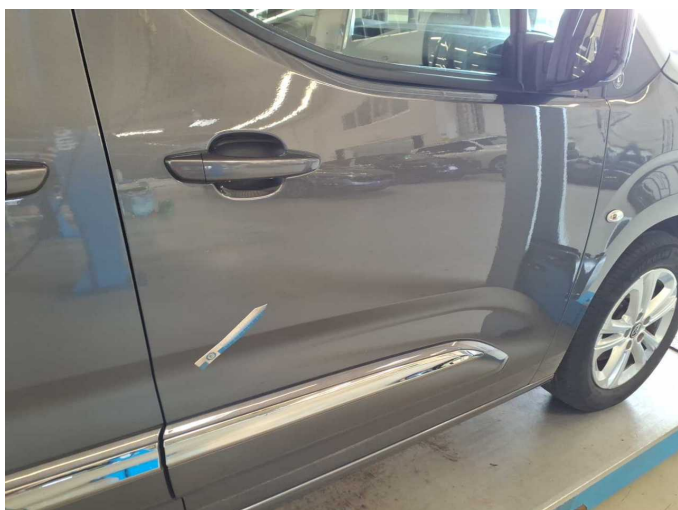
| No. | Component group | Description |
|---|---|---|
| 11 | Side panel - rear left side | Side panel (wellig-teilweise) - Unprofessionally repaired - Repair and paint |

| No. | Repainting |
|---|---|
| 1 | Side panel - rear left side, Door - front right side, Unprofessionally carried out |

**Damage 11:** Side panel - rear left side: Side panel (wellig-teilweise) - Unprofessionally repaired - Repair and paint

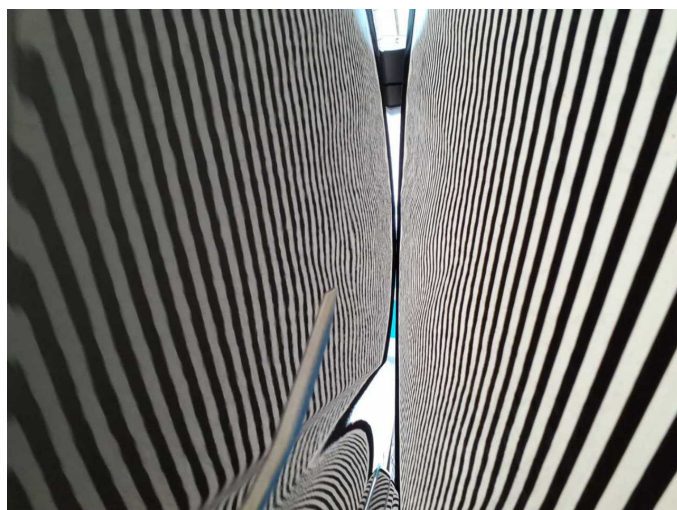
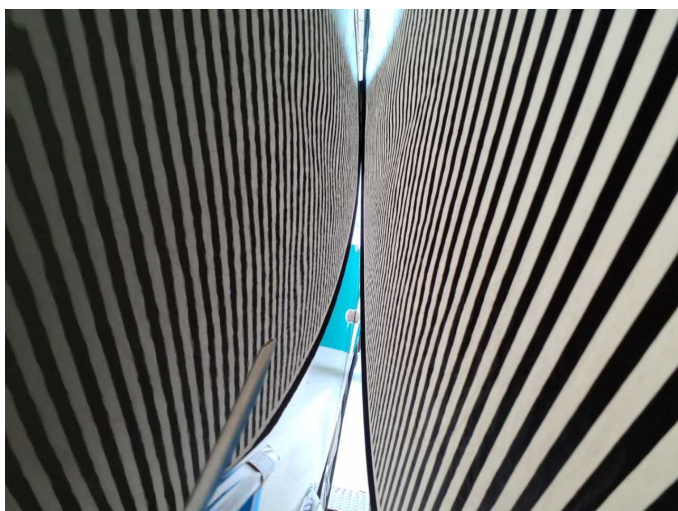
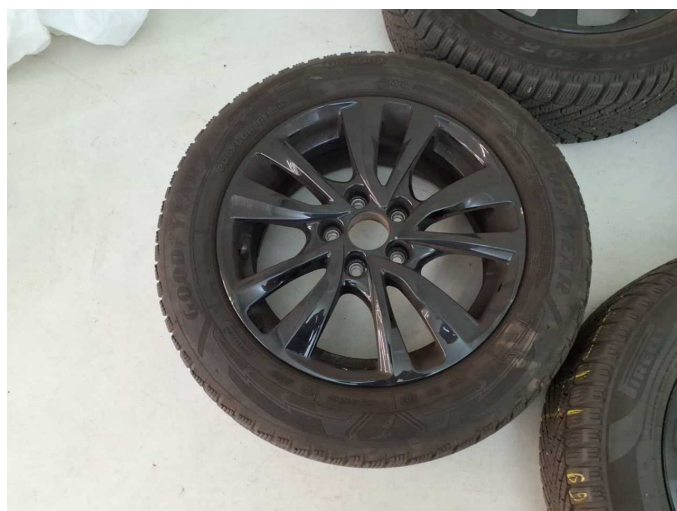
| No. | Component group | Description |
|---|---|---|
| 12 | Door - front right side | Door (wellig) - Unprofessionally repaired - Repair and paint |

**Damage 12:** Door - front right side: Door (wellig) - Unprofessionally repaired - Repair and paint

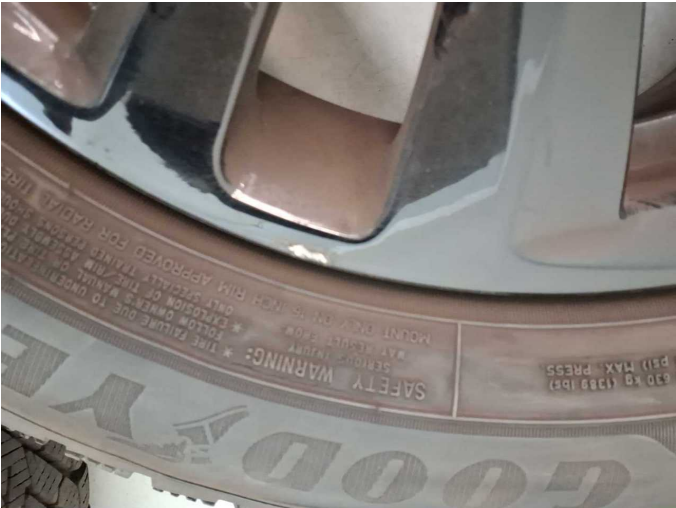
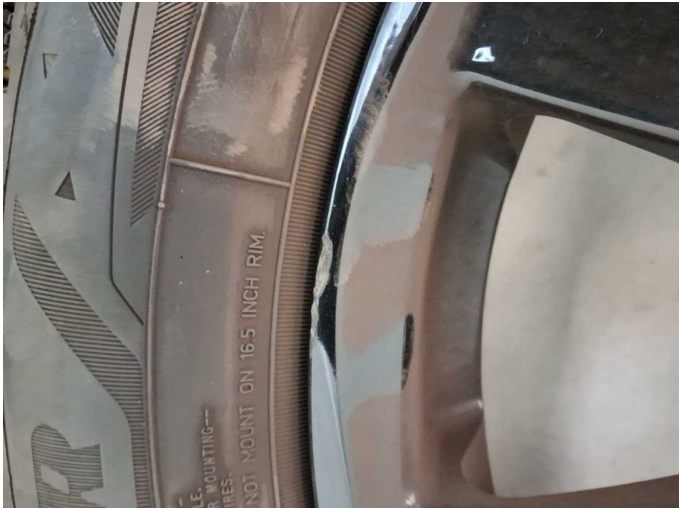
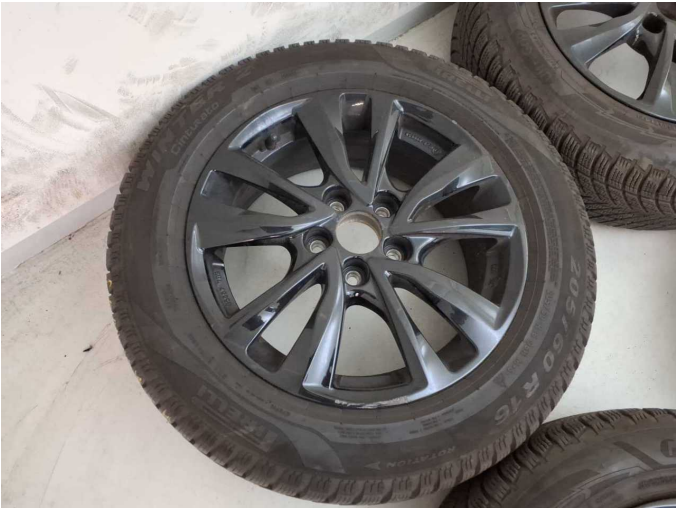
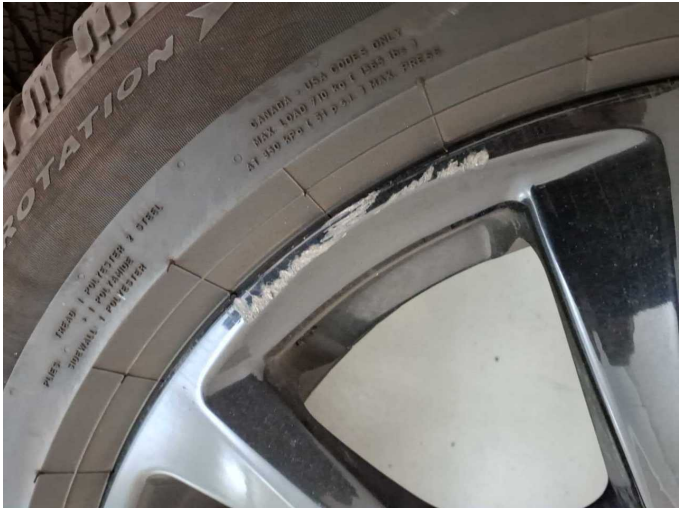
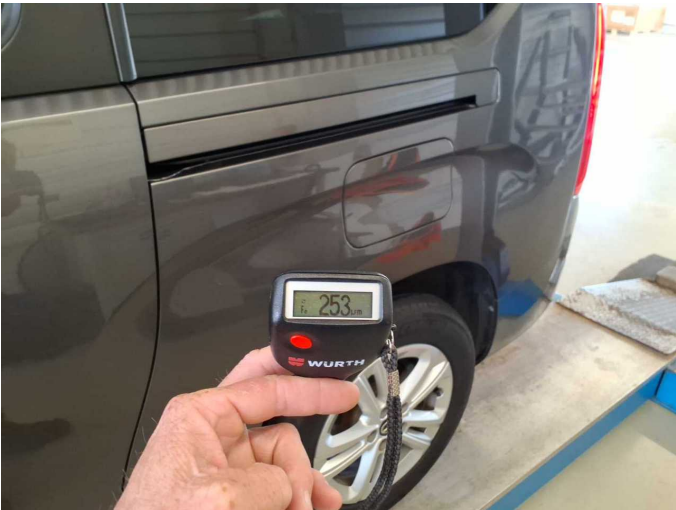
| No. | Component group | Description |
|---|---|---|
| 6 | 2nd wheel set | 2 alloy rims - Scratch(es) - No deduction |

**Wear and tear 6:** 2nd wheel set: 2 alloy rims - Scratch(es) - No deduction

Wear and tear 6: 2nd wheel set: 2 alloy rims - Scratch(es) - No deduction

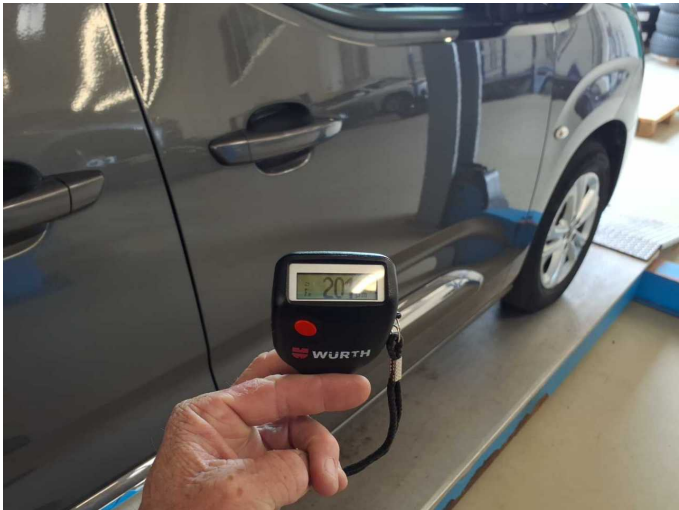
| Side panel - rear left side | 253 µm | Door - front right side | 201 µm |

Side panel - rear left side: 253 µm
