Protocol number: 46248515
Order No. / Reference: 26584592
Inspection date: 29 Jun 2026

Manufacturer: Ford

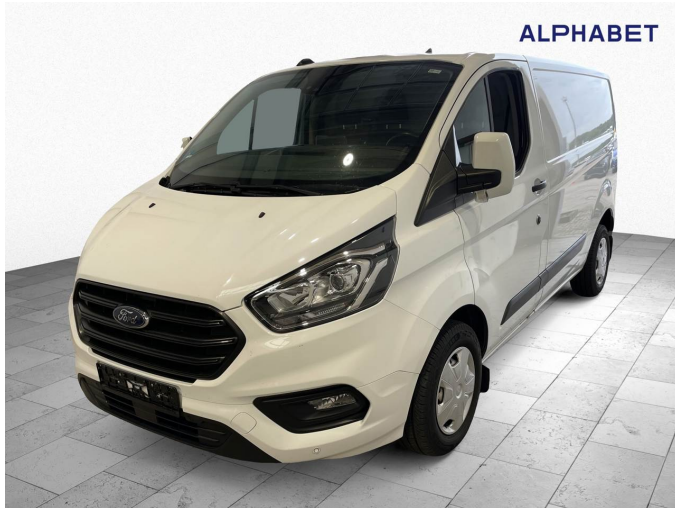
Figure 1: Diagonal front (left)

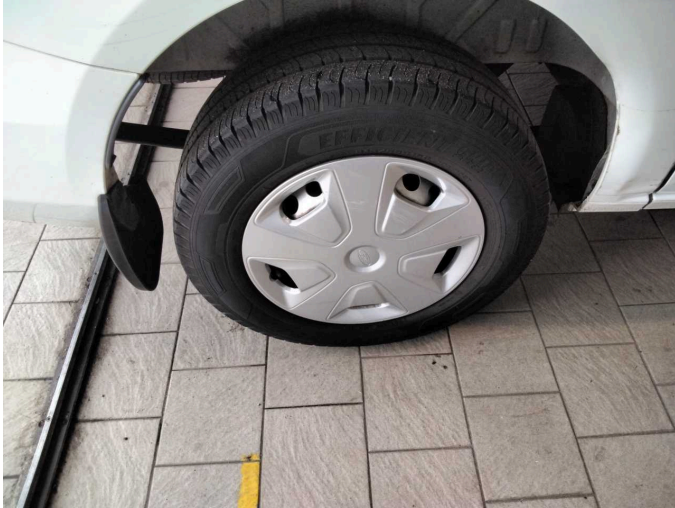
Damage 1: Wheel / tyres: Wheel cover - rear right side - Scratch(es) - Replace

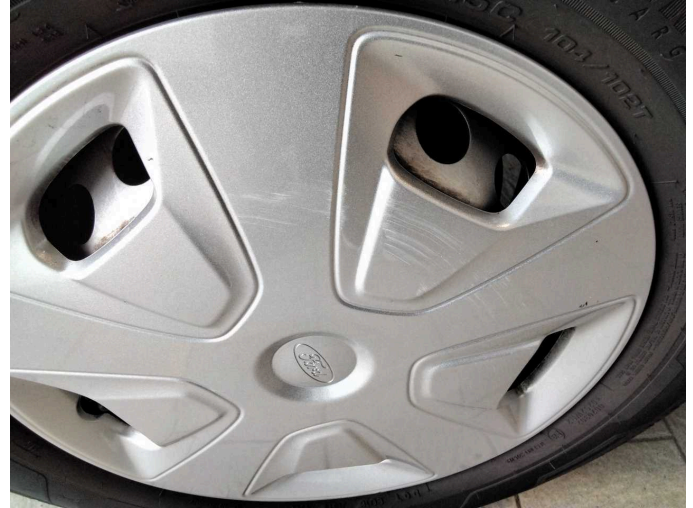
Damage 1: Wheel / tyres: Wheel cover - rear right side - Scratch(es) - Replace

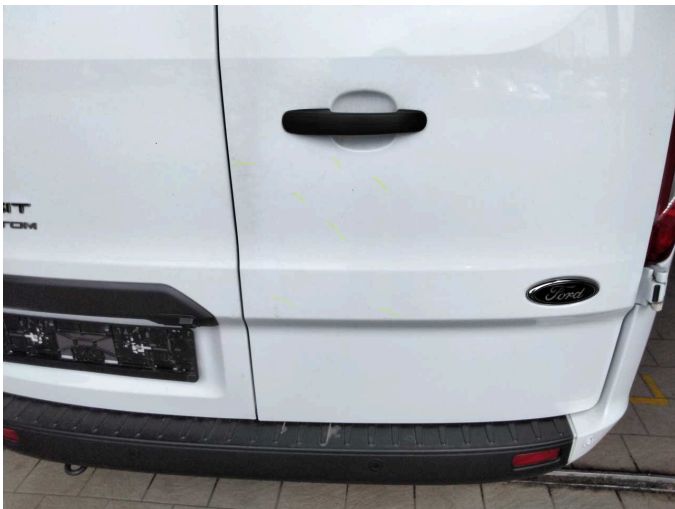
Damage 2: Boot lid / rear door: Rear door - right side - Scratch(es) - Smart repair

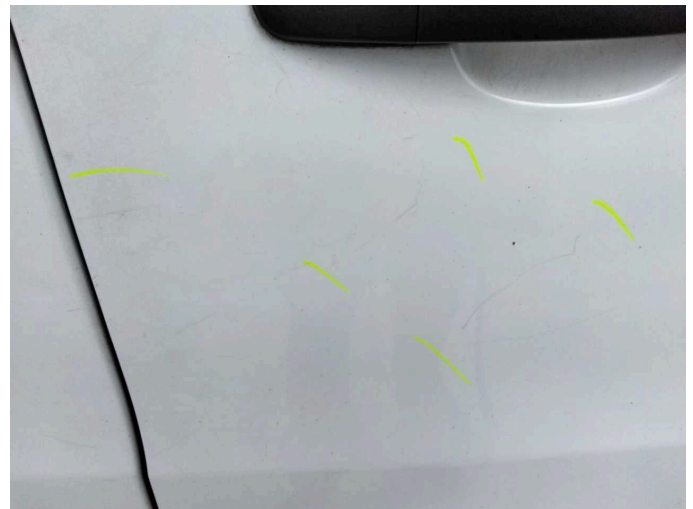
Damage 2: Boot lid / rear door: Rear door - right side - Scratch(es) - Smart repair

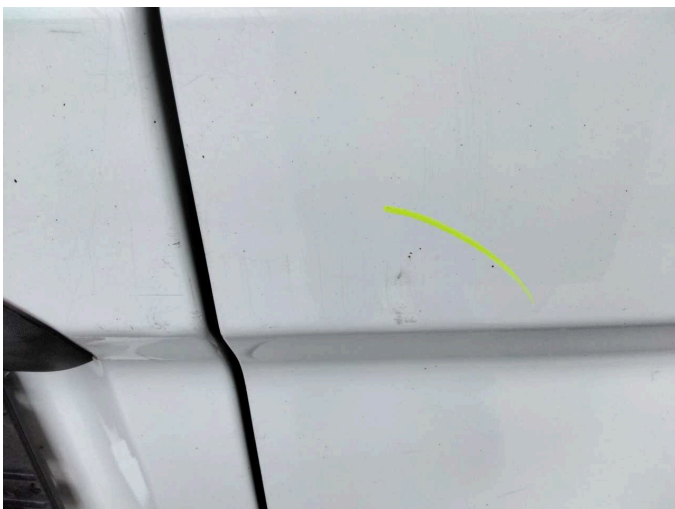
Damage 2: Boot lid / rear door: Rear door - right side - Scratch(es) - Smart repair

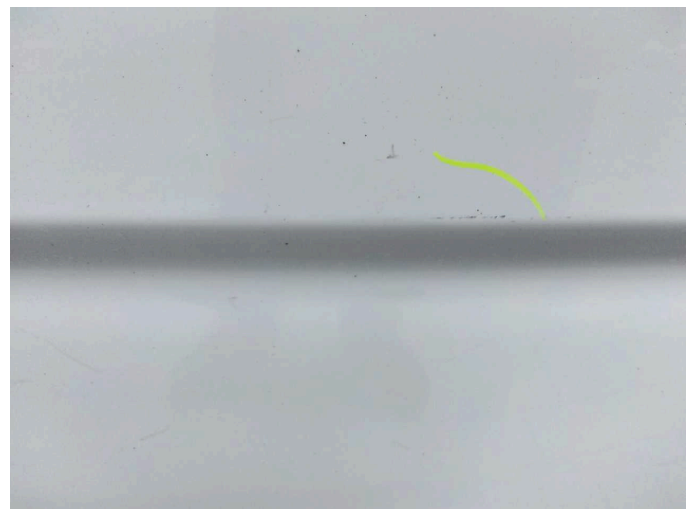
Damage 2: Boot lid / rear door: Rear door - right side - Scratch(es) - Smart repair

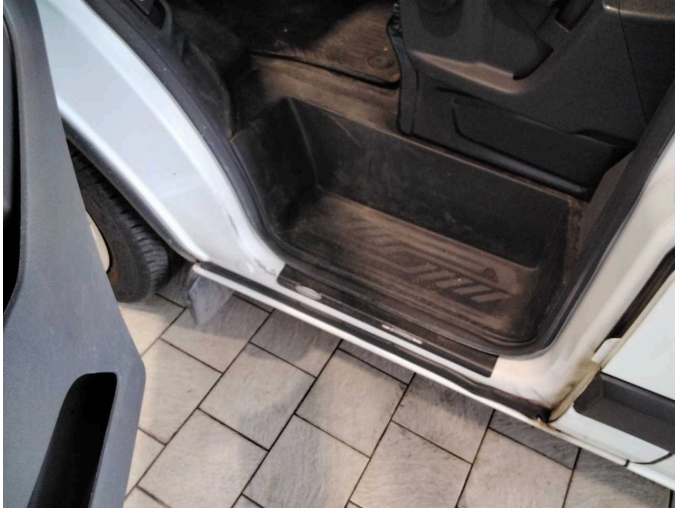
Damage 3: Sill - left side: Sill - Scratch(es) - Smart repair

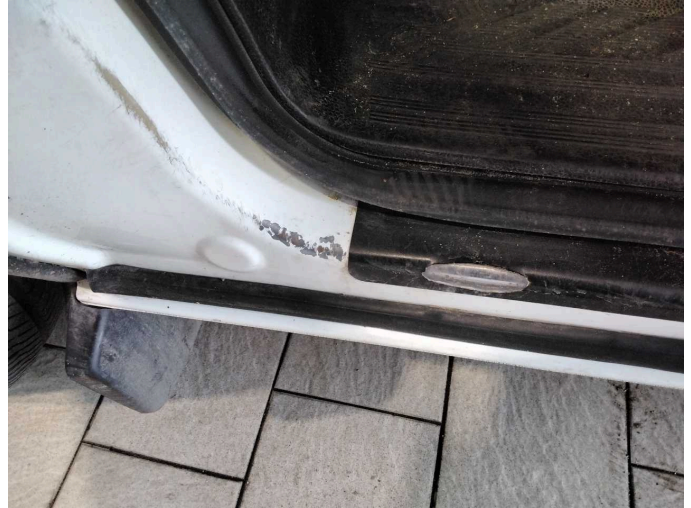
Damage 3: Sill - left side: Sill - Scratch(es) - Smart repair

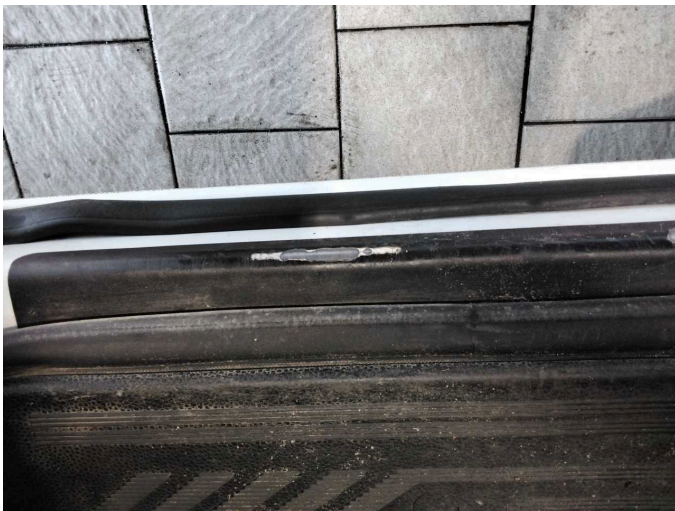
Damage 3: Sill - left side: Sill - Scratch(es) - Smart repair

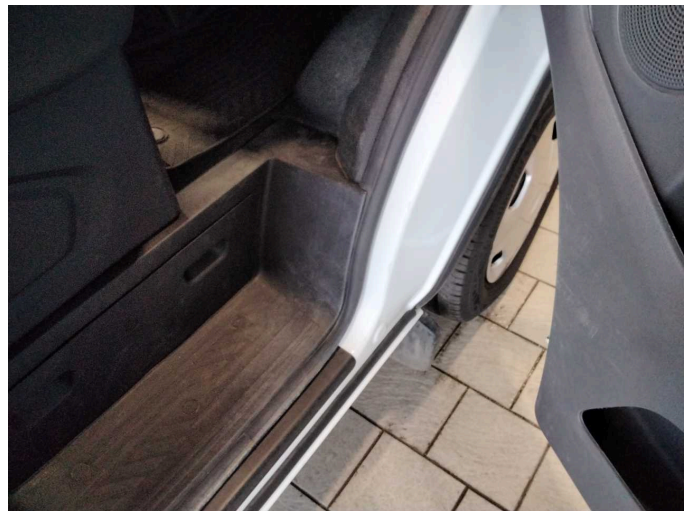
Damage 4: Sill - right side: Sill - Scratch(es) - Smart repair

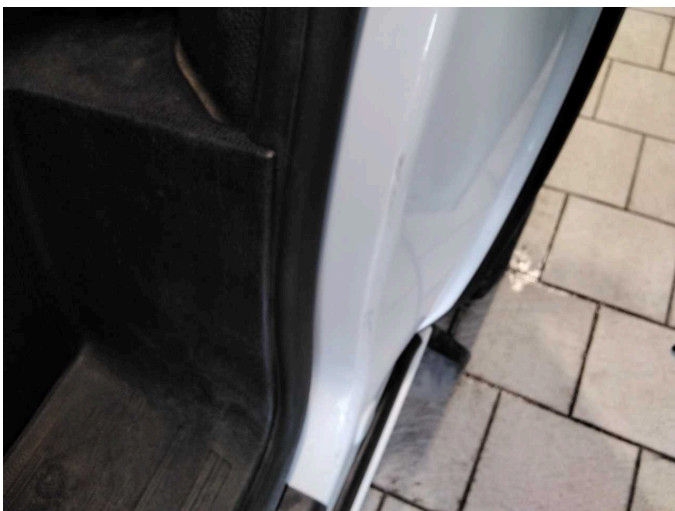
Damage 4: Sill - right side: Sill - Scratch(es) - Smart repair

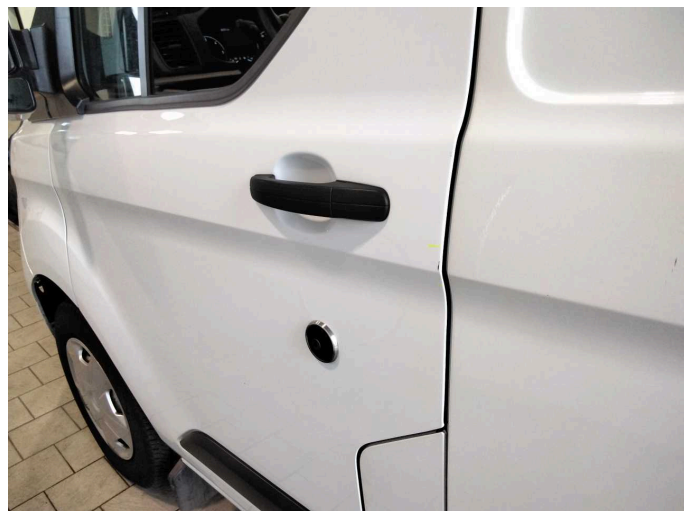
Damage 5: Door - front left side: Door edge - Scratch(es) - Smart repair

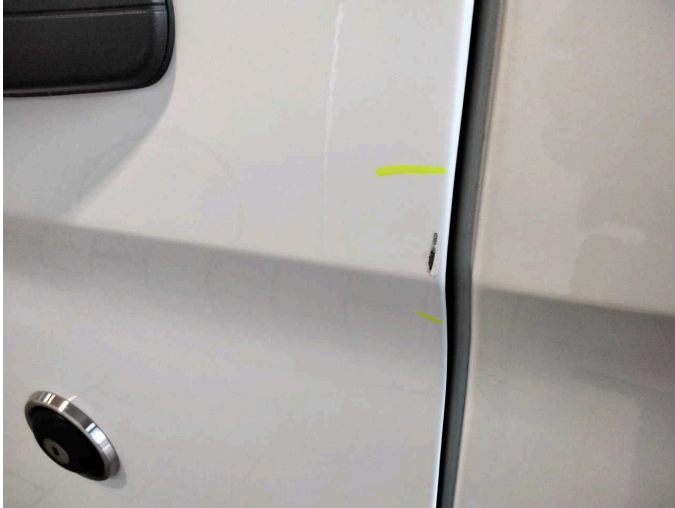
Damage 5: Door - front left side: Door edge - Scratch(es) - Smart repair

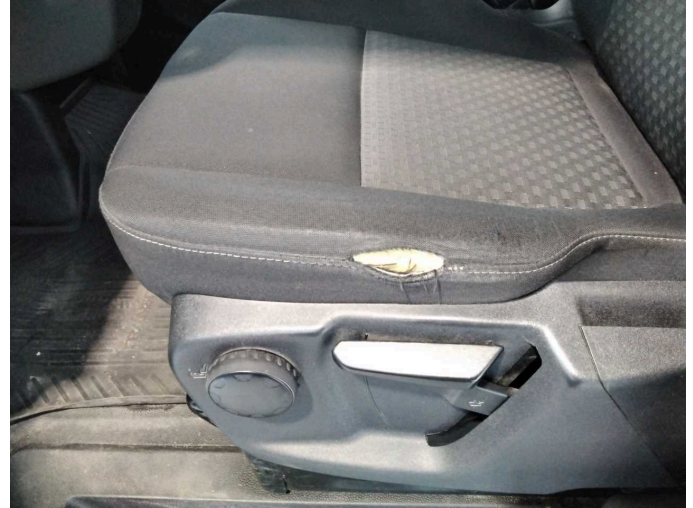
Damage 6: Seat - front: Seat cover - left side - Broken / torn - Replace

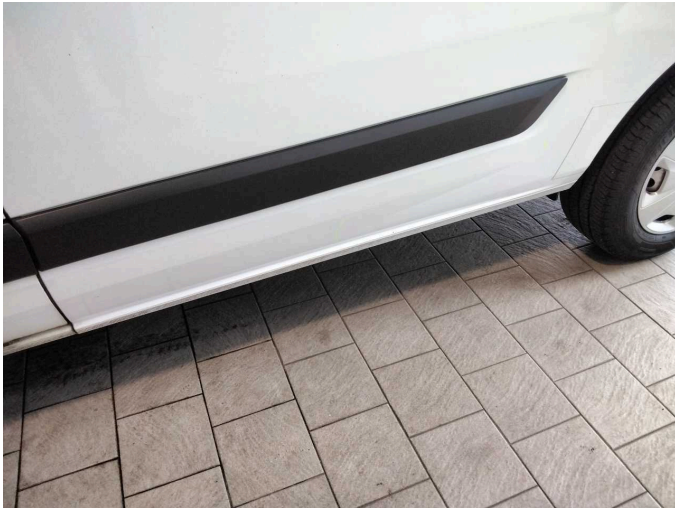
Damage 7: Side panel - rear left side: Side panel (Unterhalb) - dent(s) - Repair and paint

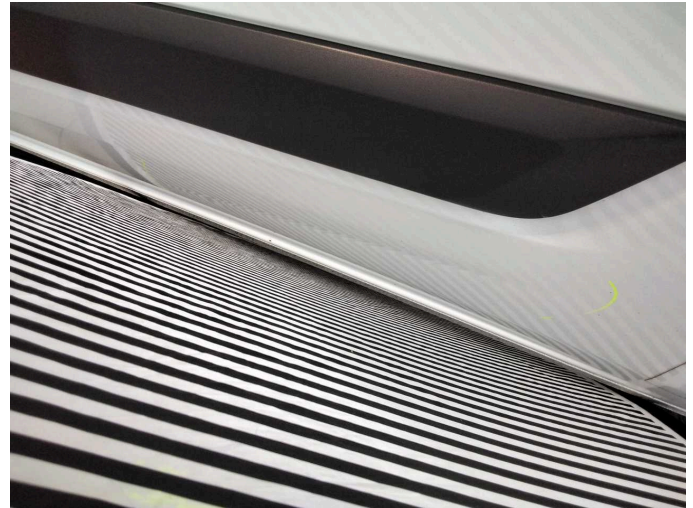
Damage 7: Side panel - rear left side: Side panel (Unterhalb) - dent(s) - Repair and paint

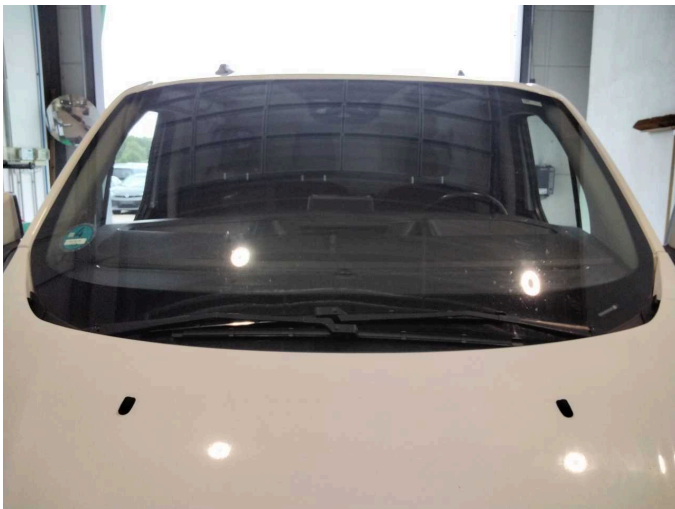
Wear and tear 1: Vehicle glazing: Windscreen - Stone chips - No deduction

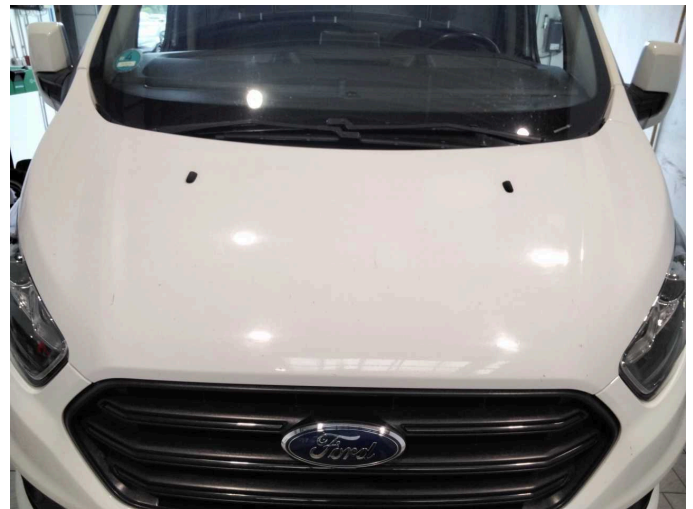
Wear and tear 2: Bonnet: Bonnet - Stone chips - No deduction

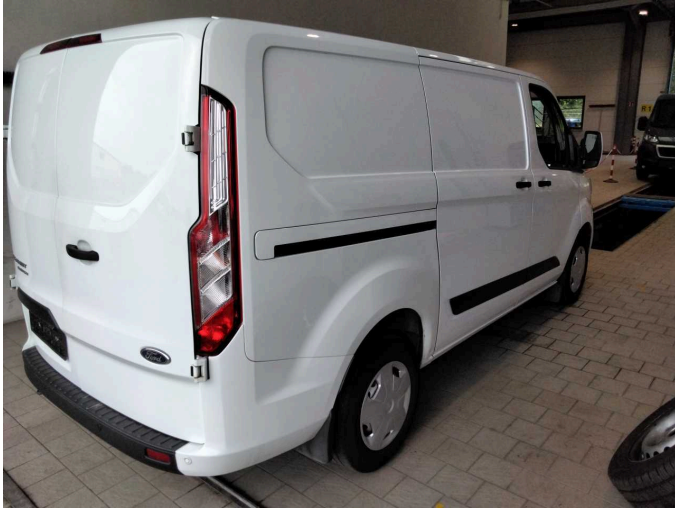
Accident 1: Side right
