MACDAM

Polestar Polestar 2 '19 BEV

Vehicle information

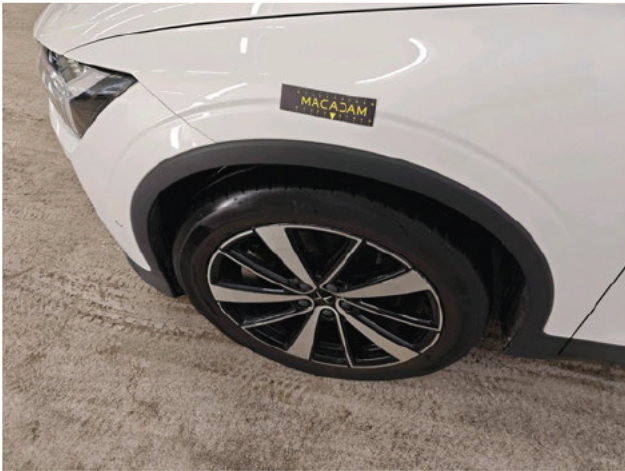
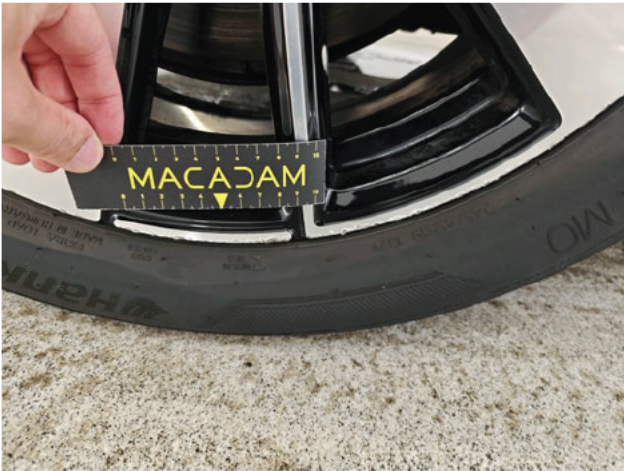
Alloy rim FL

Scratch(es)

Left

Repair and paint (complete)

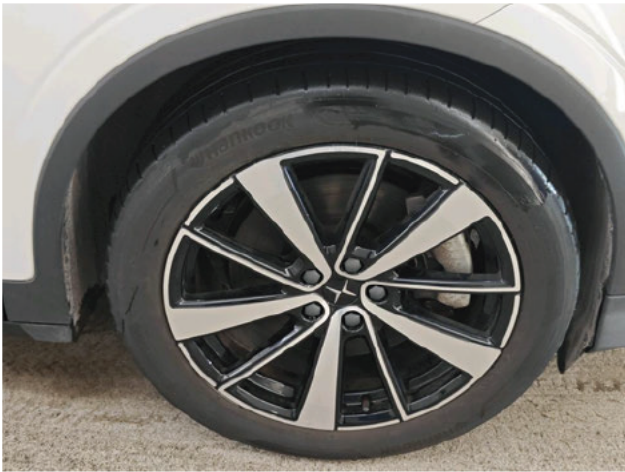
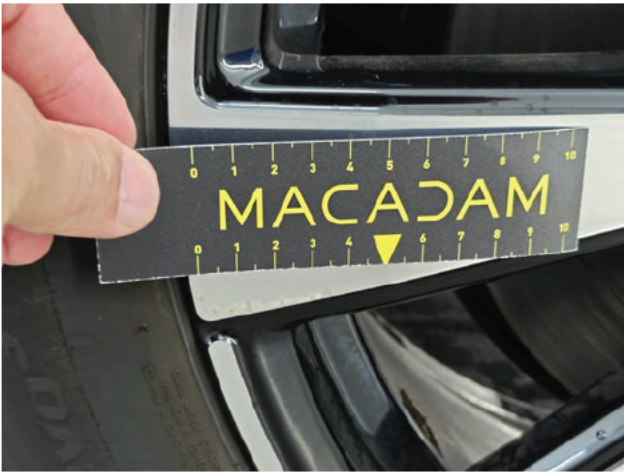
Alloy rim FR

Scratch(es)

Right

Repair and paint (complete)

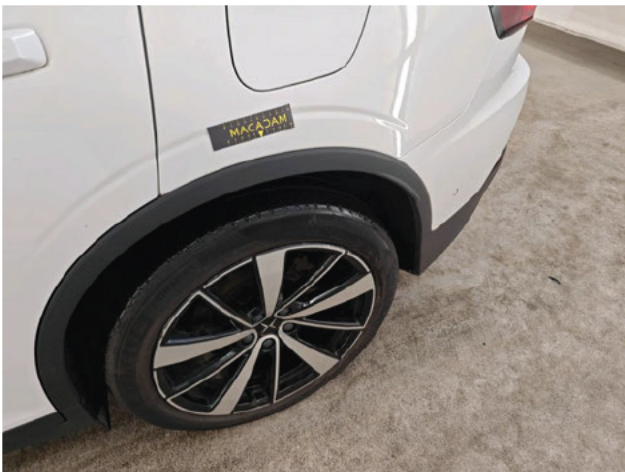
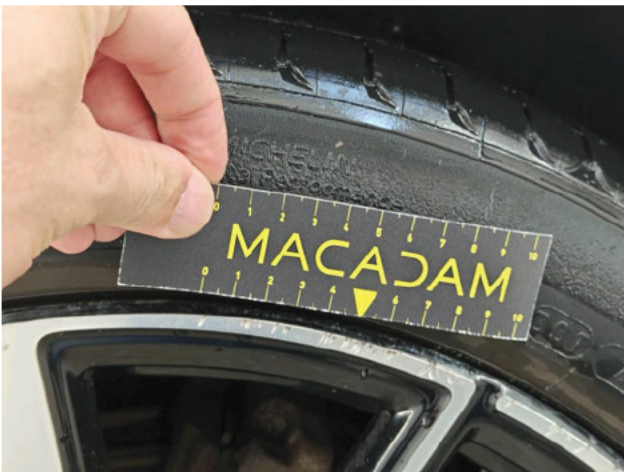
Alloy rim RL

Scratch(es)

Left

Repair and paint (complete)

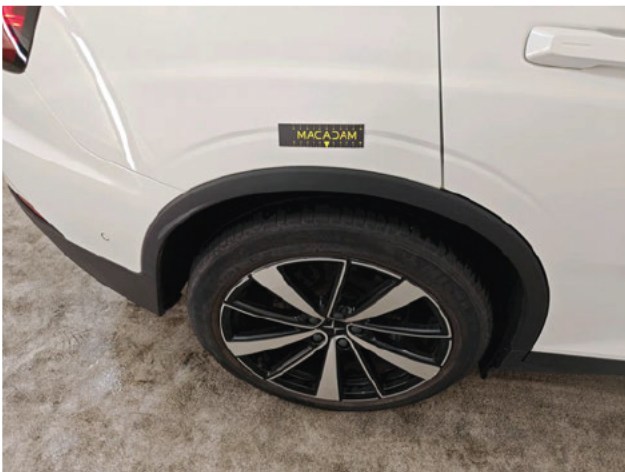
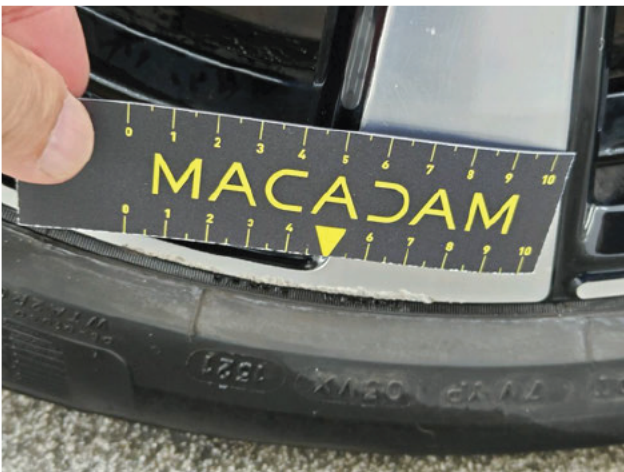
Alloy rim RR

Scratch(es)

Right

Repair and paint (complete)

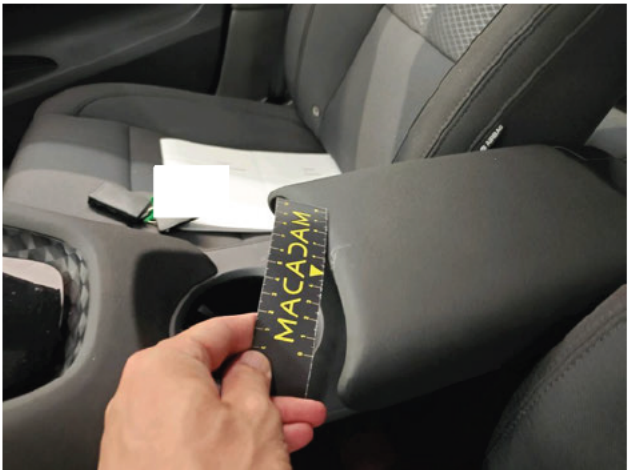
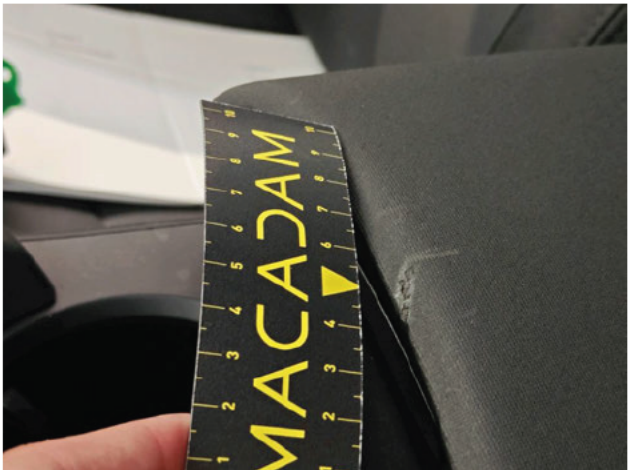
Armrest F M

Burned

Interior

Replace

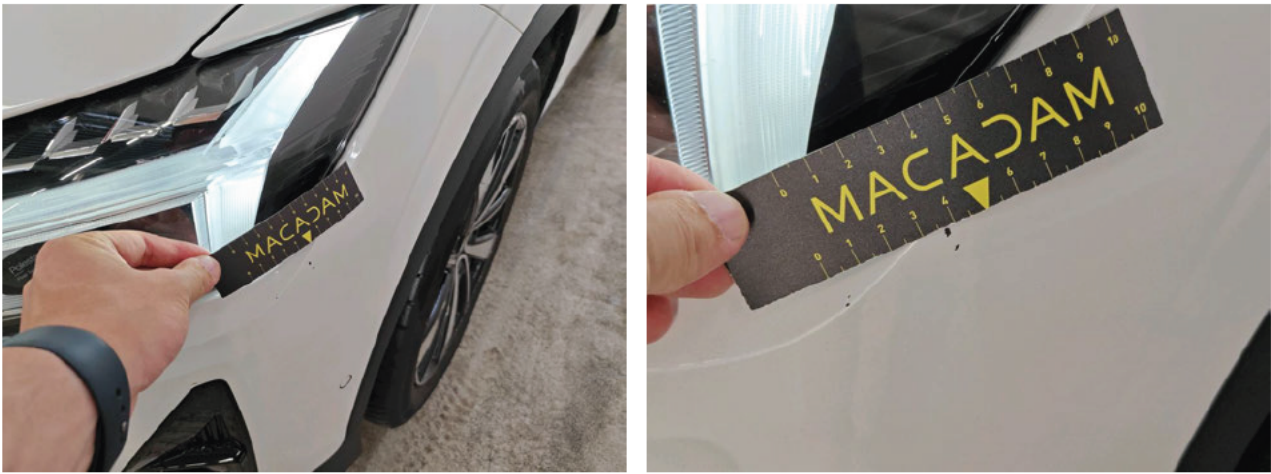
**Bumper F**  
Stone chip(s)  
Repair and paint (complete)  
Front

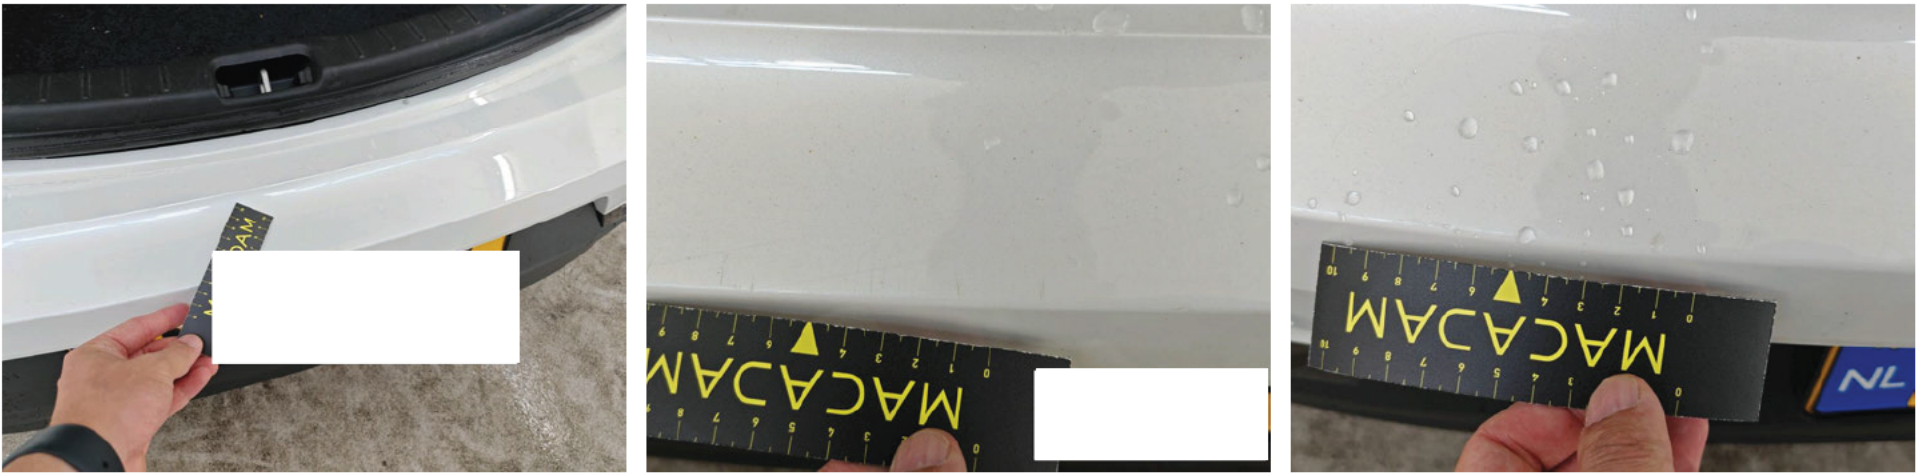
**Bumper R**  
Scratch(es)  
Repair and paint (complete)  
Rear

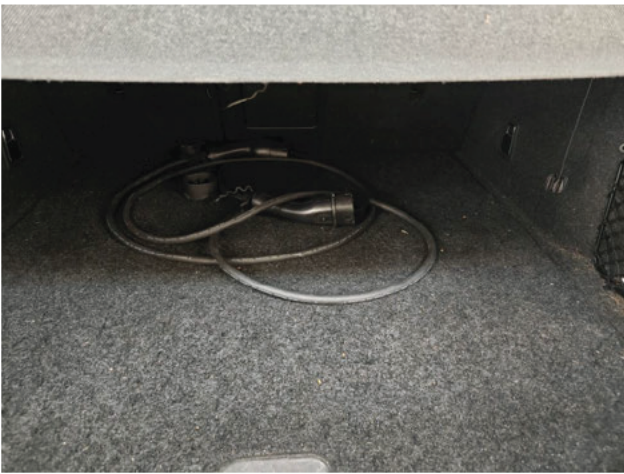
**Charging cable (normal)**  
Missing  
Replace  
Rear

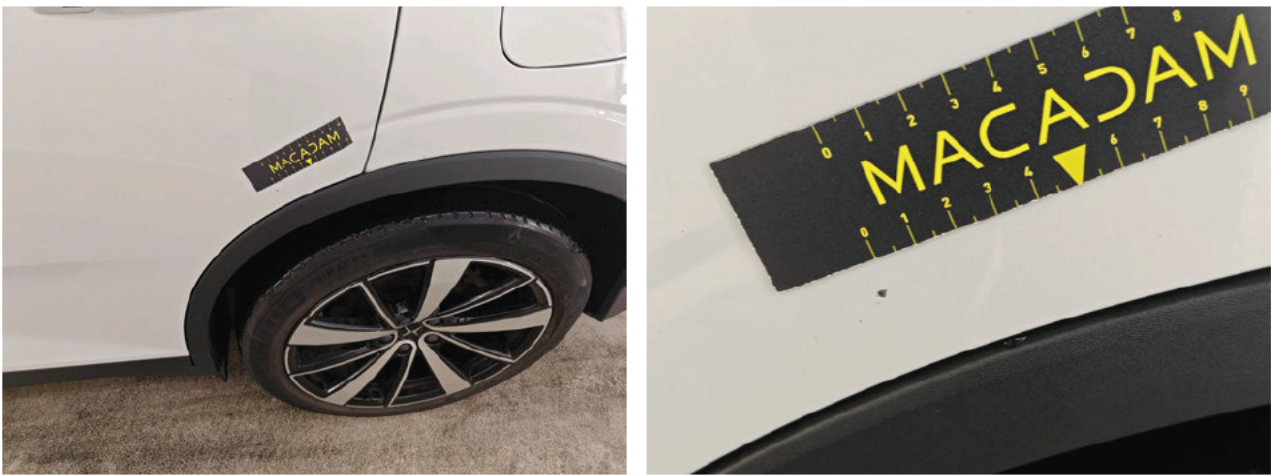
**Door RL**  
Scratch(es)  
Repair and paint (complete)  
Left

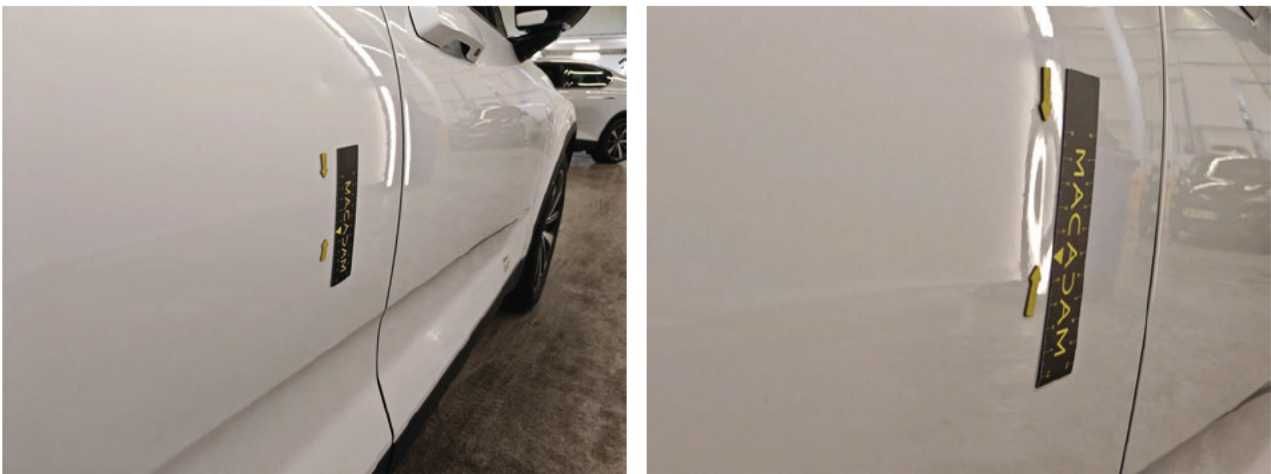
**Door RR**  
Dent(s) and scratch(es)  
Repair and paint (complete)  
Right

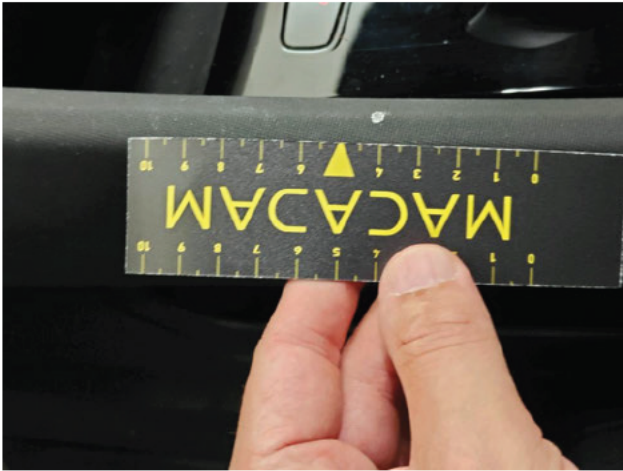
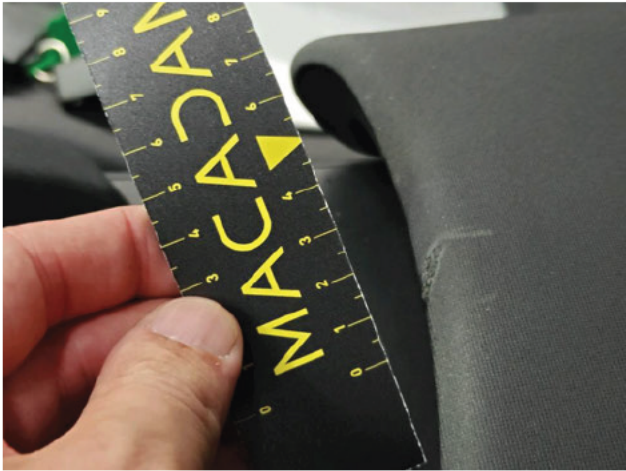
Smell

Interior

Ozone treatment (Smoke)
