Expertise

Protocol number: 46446393  
Order No. / Reference: 26294494  
Inspection date: 8 Jul 2026

Manufacturer: Mercedes-Benz

Model: Vito 116 CDI Lang HA Aut. PRO

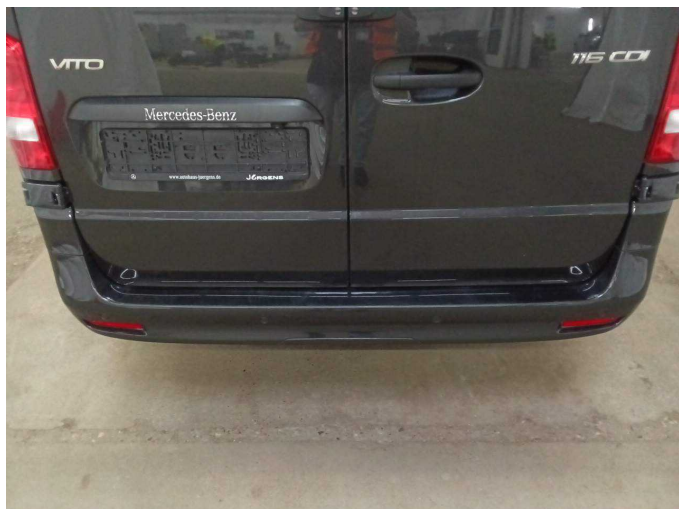
| No. | Component group | Description |
|---|---|---|
| 1 | Rear bumper | Rear bumper - Scratch(es) - Paint |

**Damage 1:** Rear bumper: Rear bumper - Scratch(es) - Paint

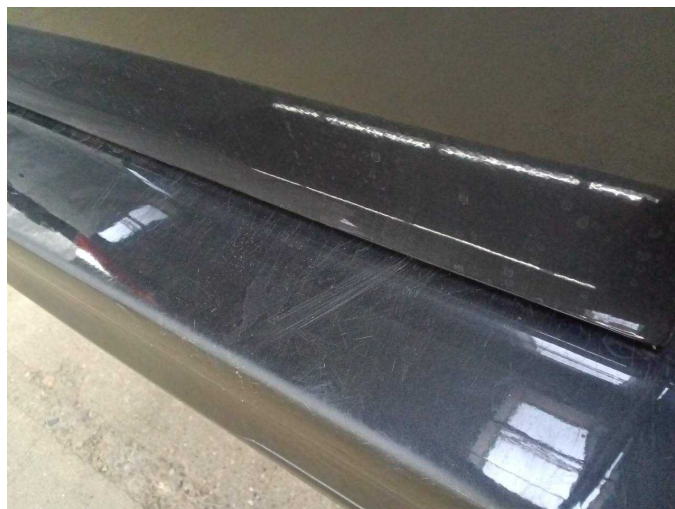
**Damage 1:** Rear bumper: Rear bumper - Scratch(es) - Paint

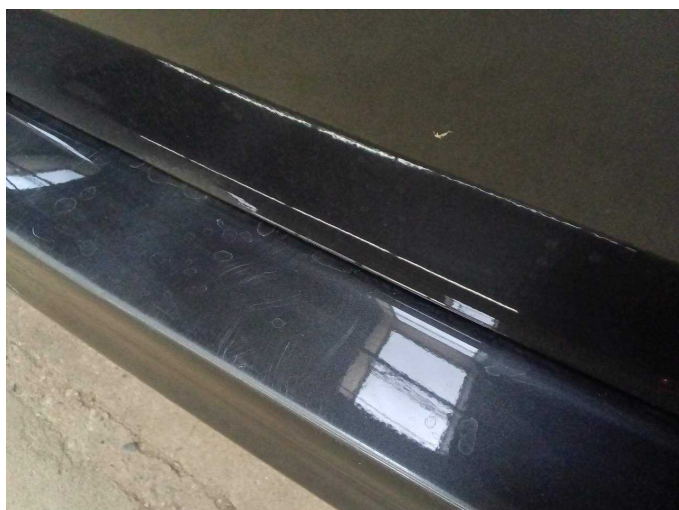
**Damage 1:** Rear bumper: Rear bumper - Scratch(es) - Paint

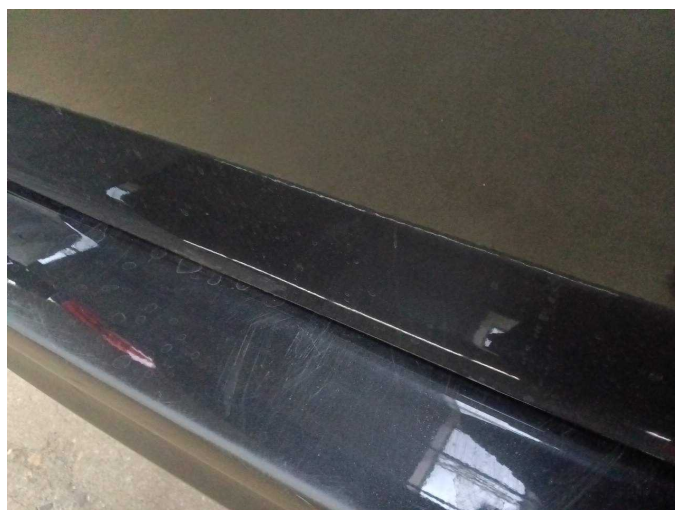
**Damage 1:** Rear bumper: Rear bumper - Scratch(es) - Paint

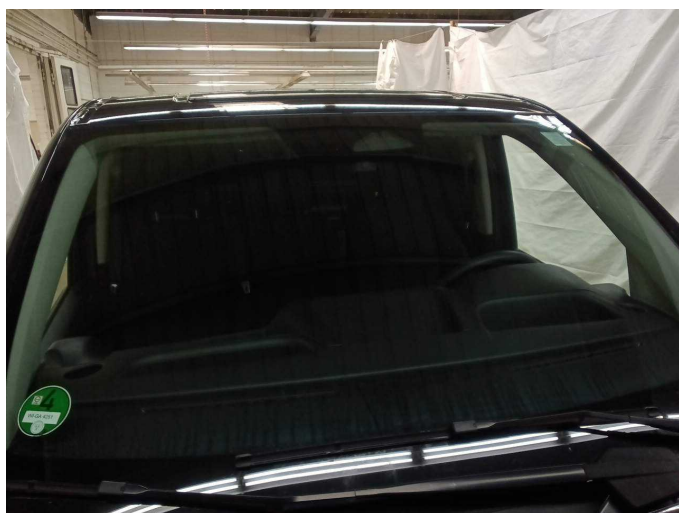
| No. | Component group | Description |
|---|---|---|
| 2 | Vehicle glazing | Windscreen (kein Staubschutz) - Stone chips - repair according to calculation |

**Damage 2:** Vehicle glazing: Windscreen (kein Staubschutz) - Stone chips - repair according to calculation

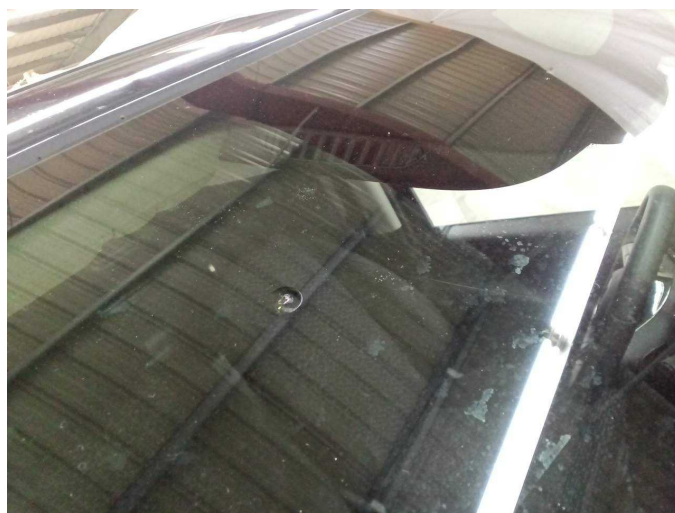
**Damage 2:** Vehicle glazing: Windscreen (kein Staubschutz) - Stone chips - repair according to calculation
