## Expertise

Protocol number: 46018496  
Order No. / Reference: 26466776  
Inspection date: 16 Jun 2026

Manufacturer: Opel

Model: Insignia Sports Tourer 2.0 Diesel Aut. Business Edition

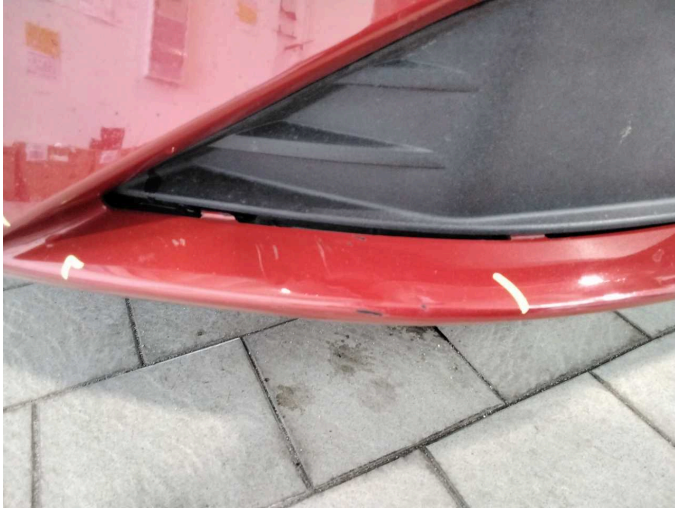
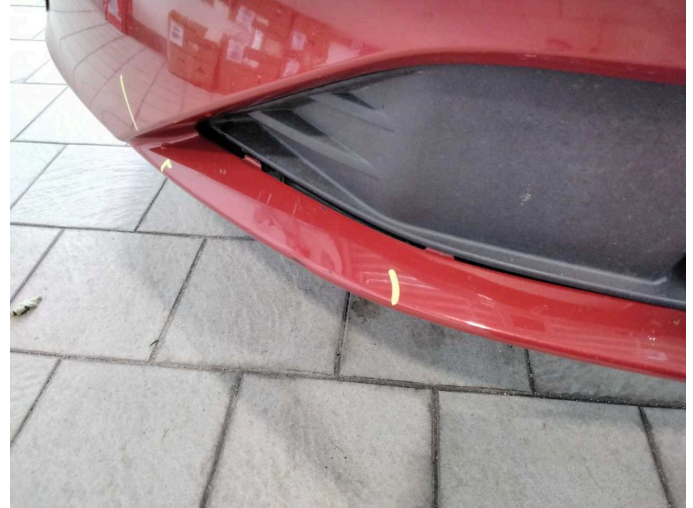
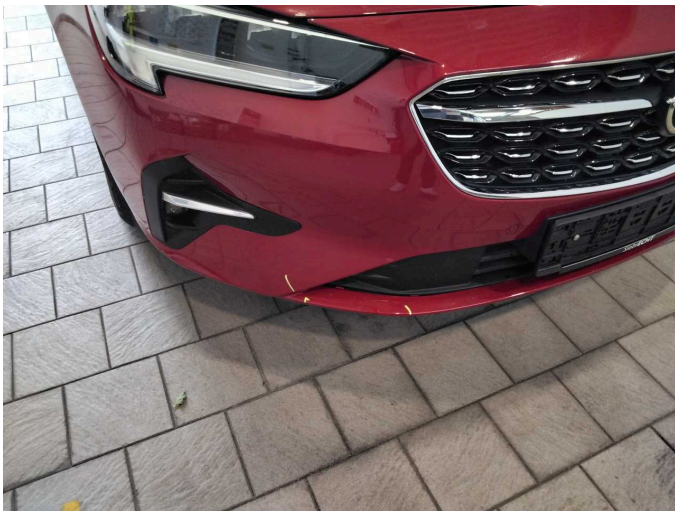
**Damage 1:** Front bumper: Front bumper - Malposition - Set / adjust

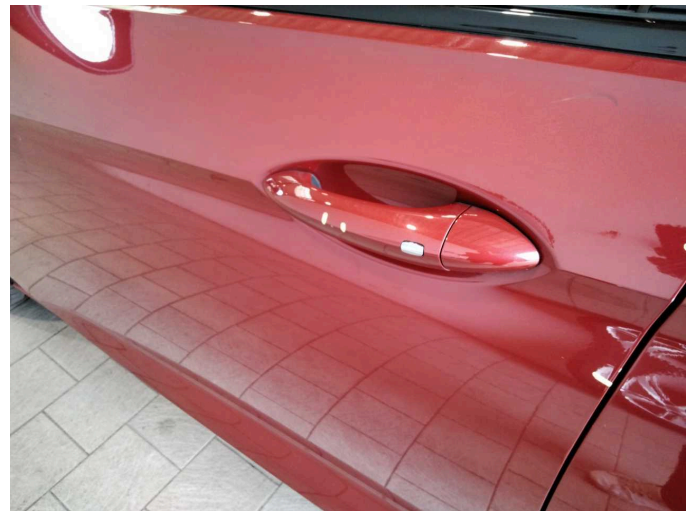
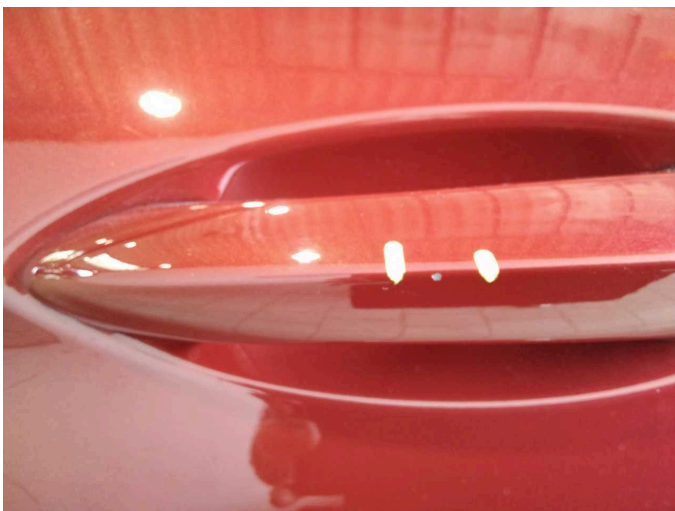
**Damage 2:** Door - front left side: Door handle - outside - Scratch(es) - Smart repair

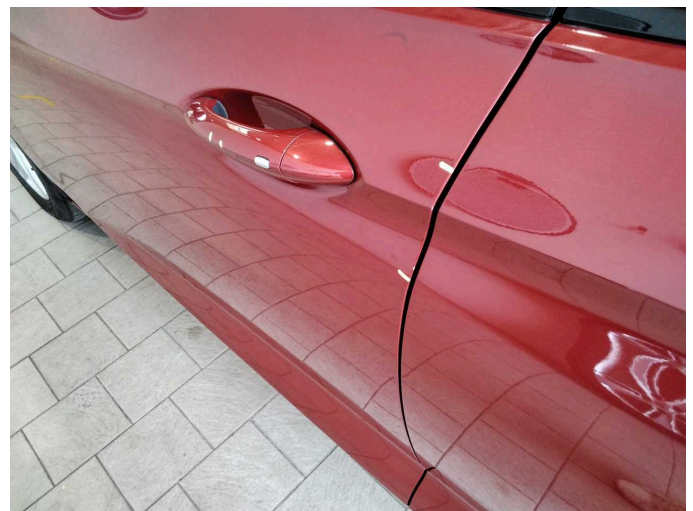
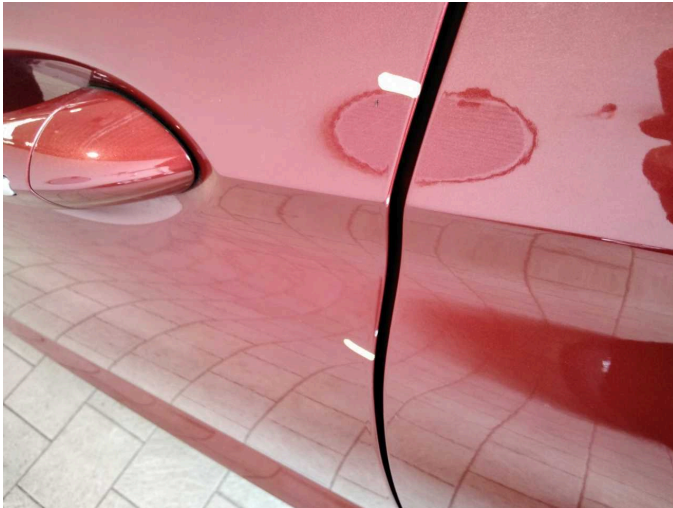
**Damage 3:** Door - front left side: Door edge - Scratch(es) - Smart repair

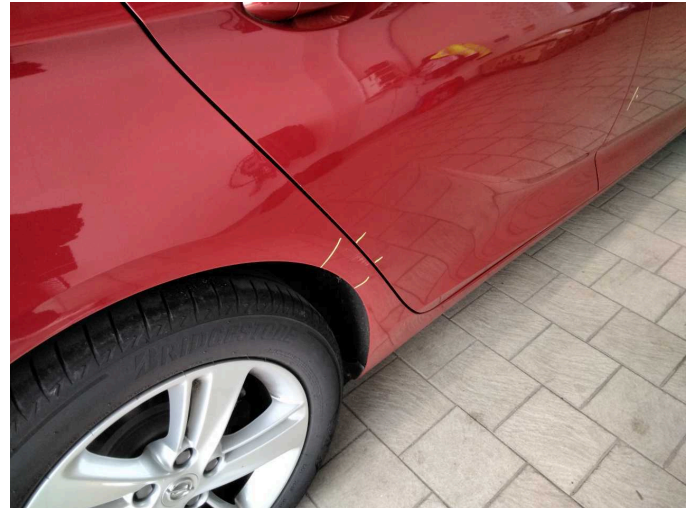
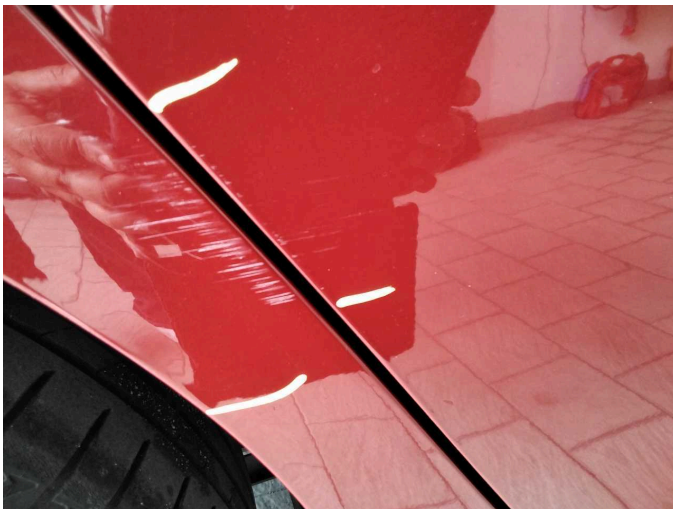
**Damage 4:** Door - rear right side: Door edge - Scratch(es) - Smart repair

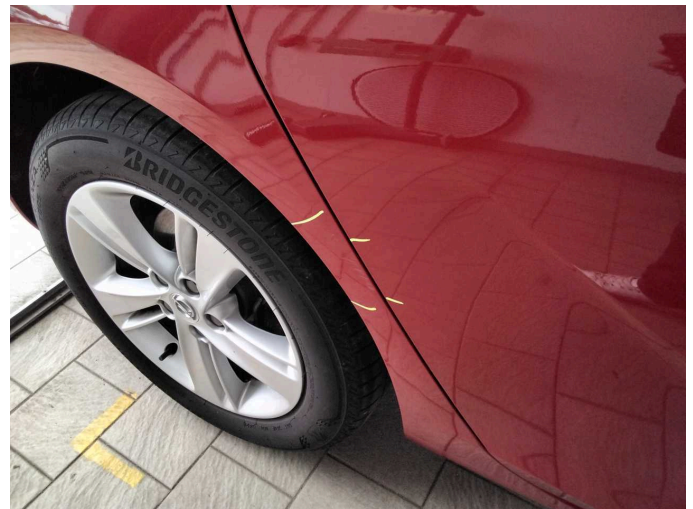
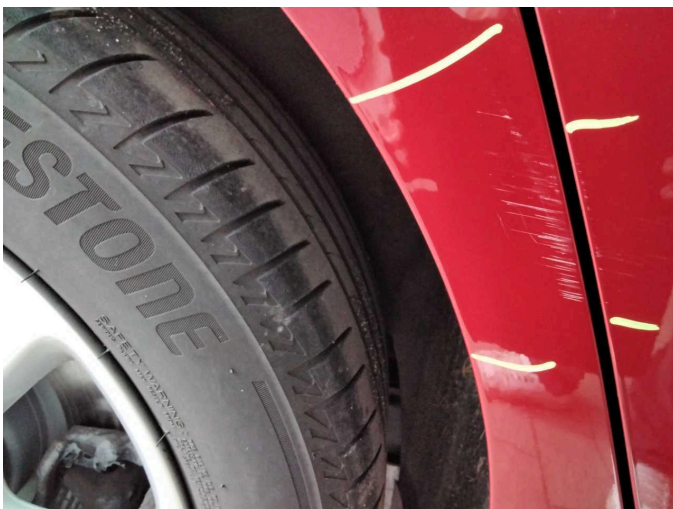
**Damage 5:** Side panel - rear right side: Side panel - Scratch(es) - Paint

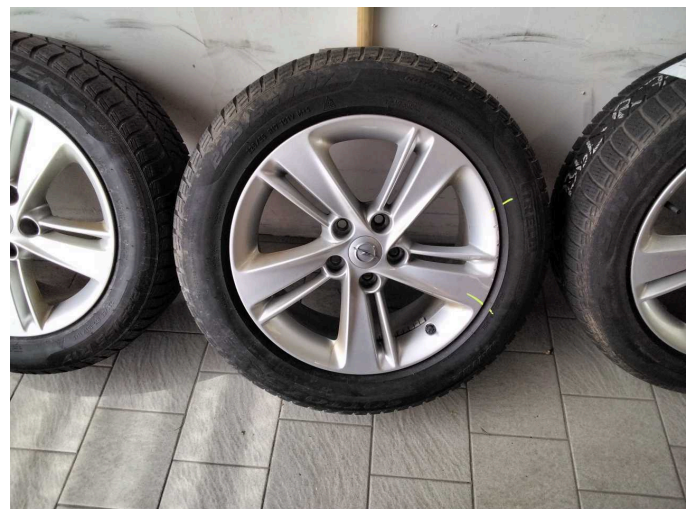
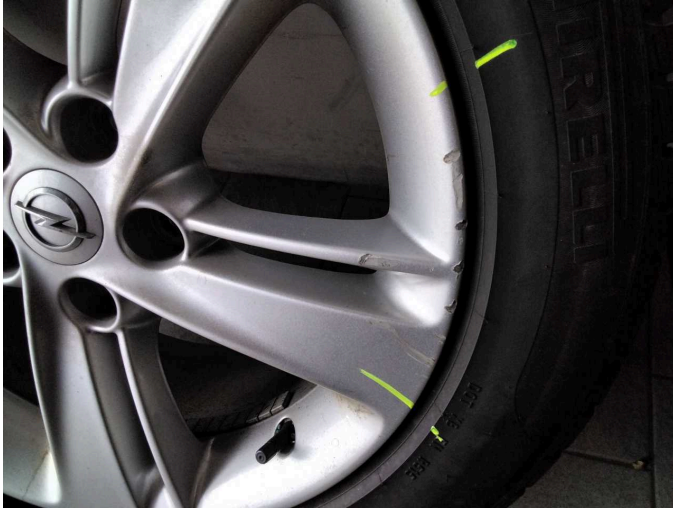
**Damage 6:** 2nd wheel set: 1 alloy rim - Scratch(es) - Replace

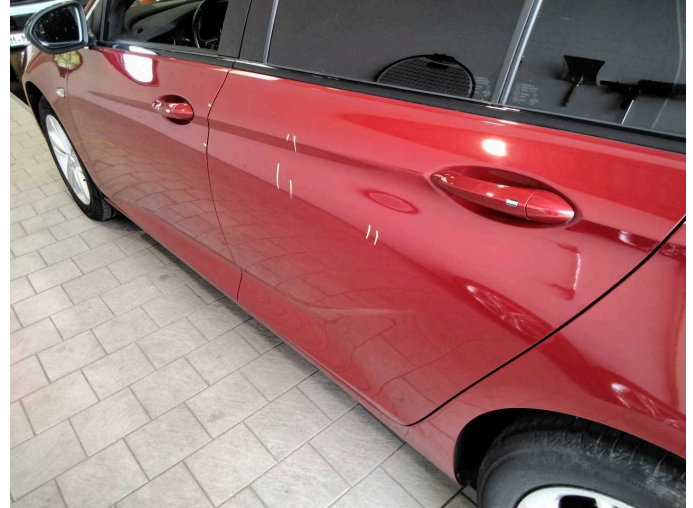
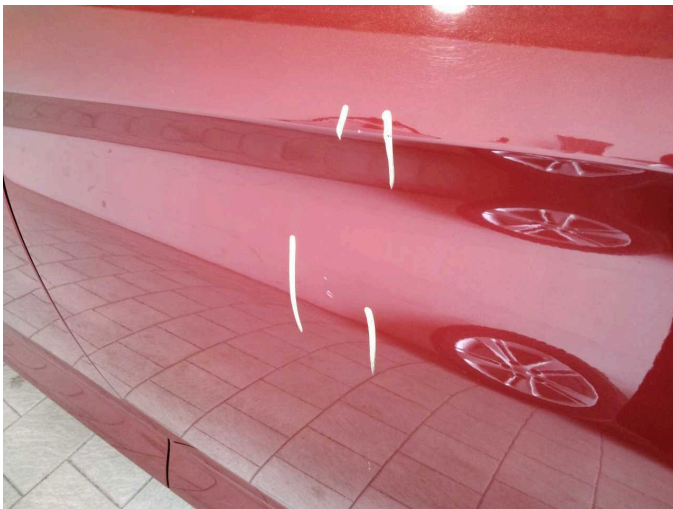
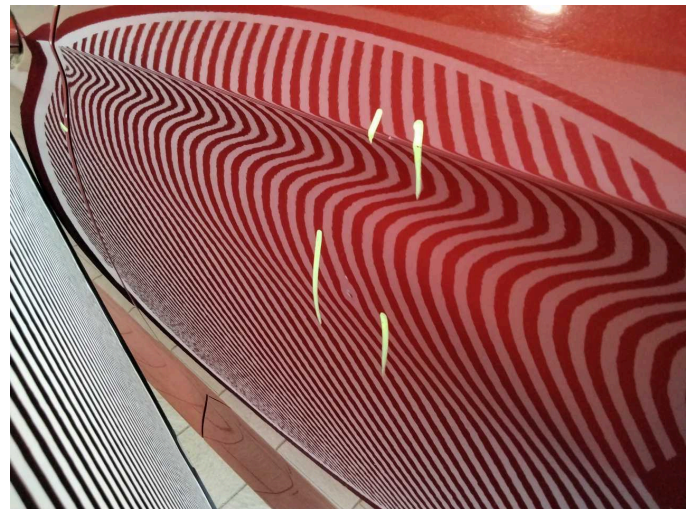
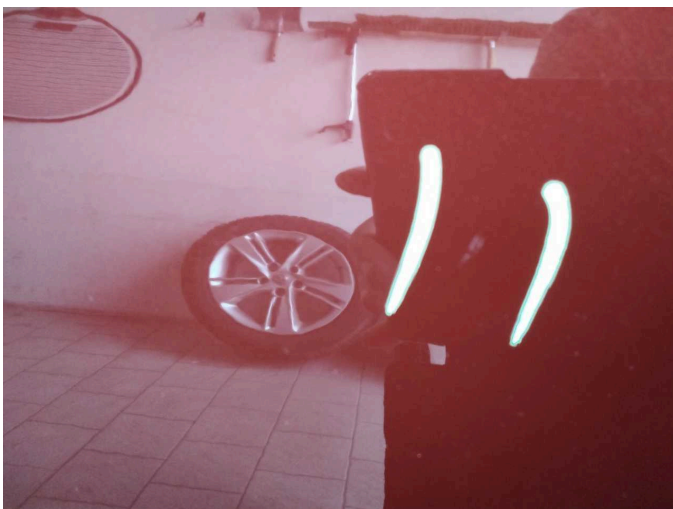
**Damage 7:** Door - rear left side: Door - Dent / paintcoat damage - Repair and paint

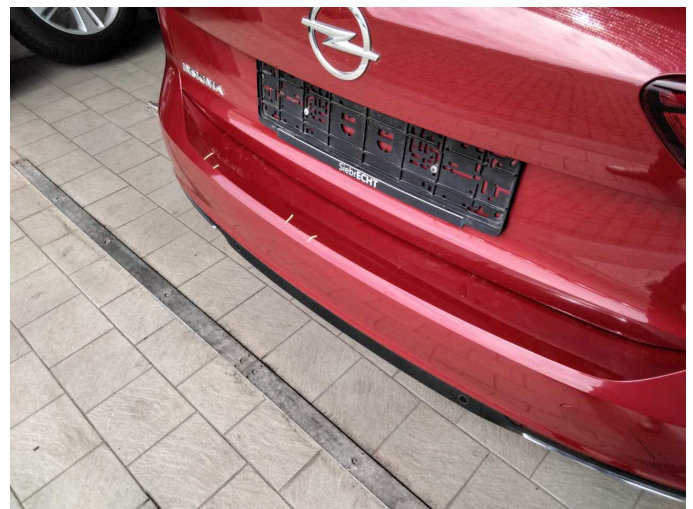
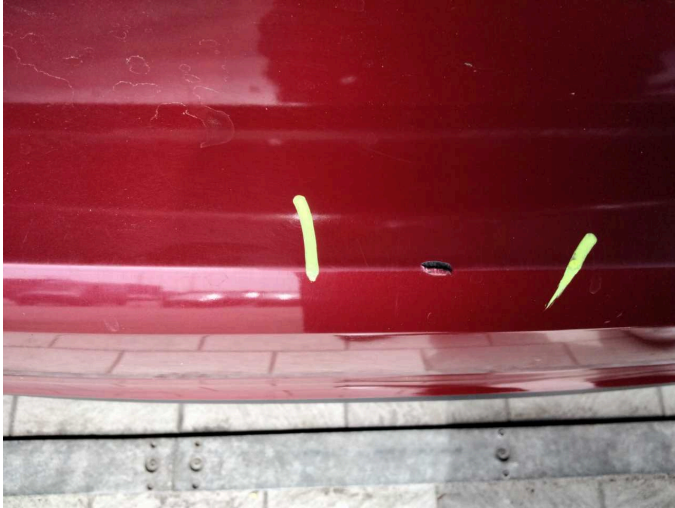
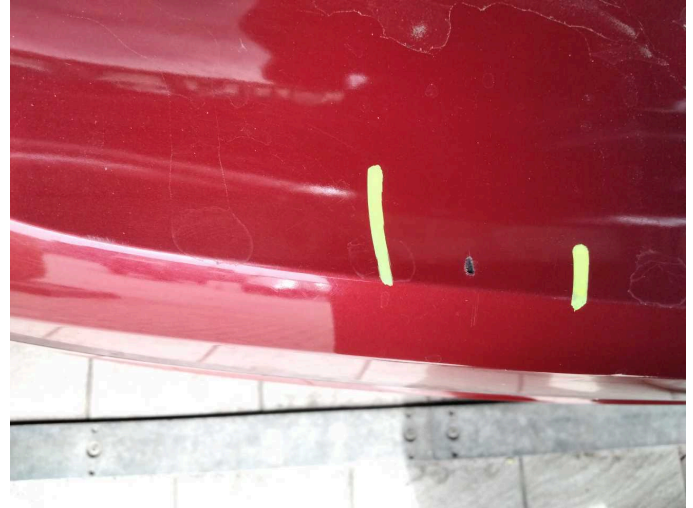
**Damage 8:** Rear bumper: Rear bumper - Scratch(es) - Paint

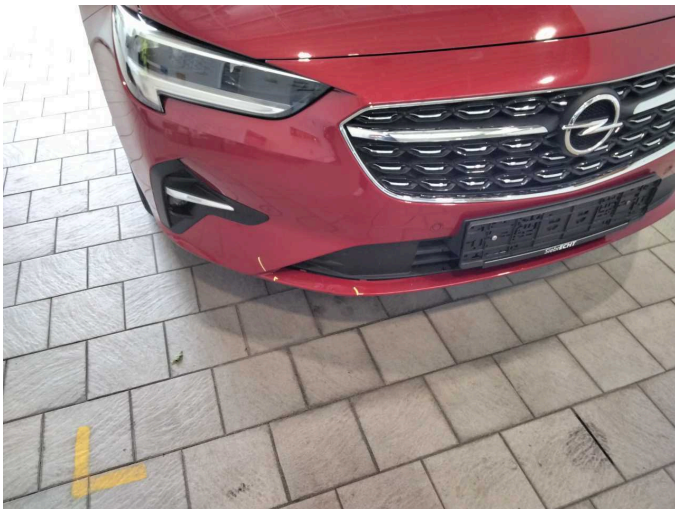
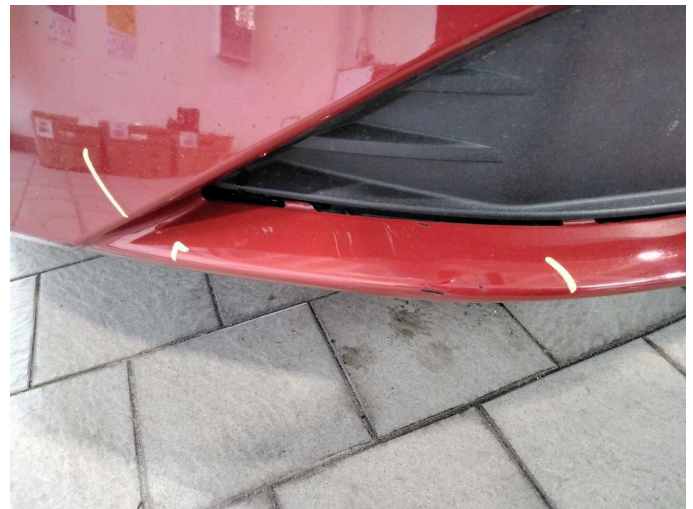
**Damage 9:** Front bumper: Front bumper - Scratch(es) - Repair and paint

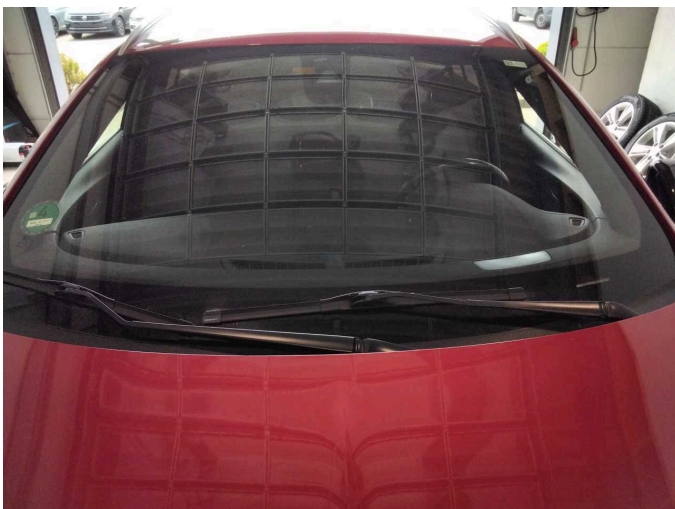
**Wear and tear 1:** Vehicle glazing: Windscreen - Stone chips - No deduction

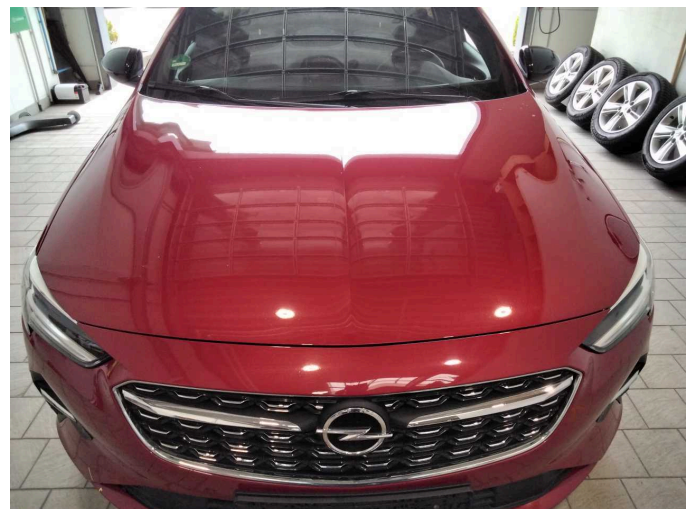
**Wear and tear 2:** Bonnet: Bonnet - Stone chips - No deduction

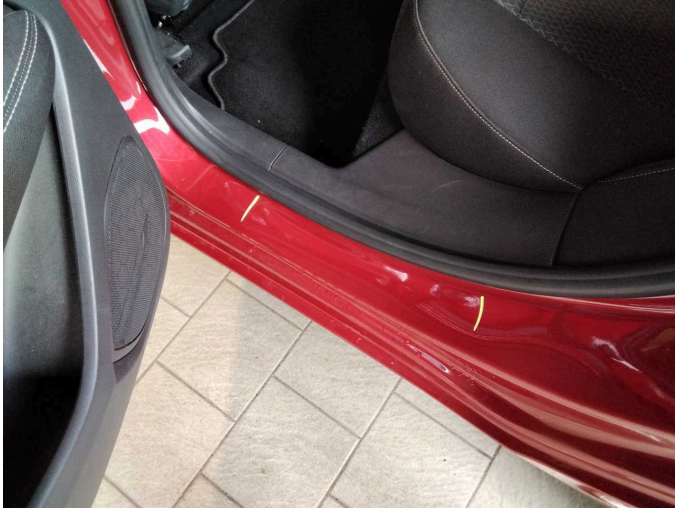
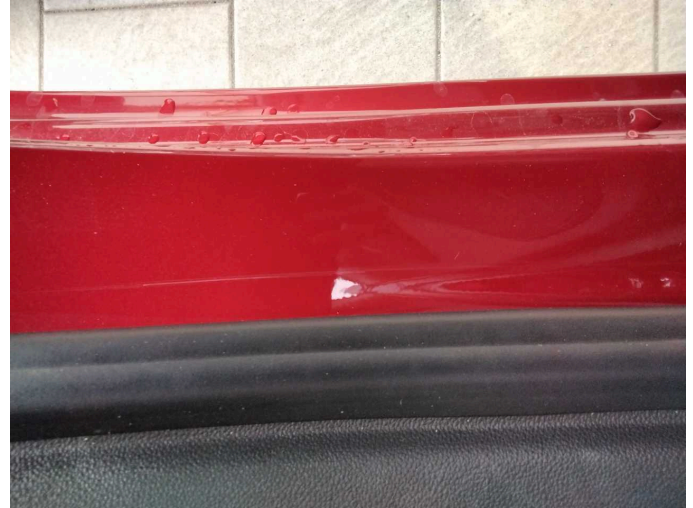
**Wear and tear 3:** Side panel - rear left side: Sill - Scratch(es) - No deduction

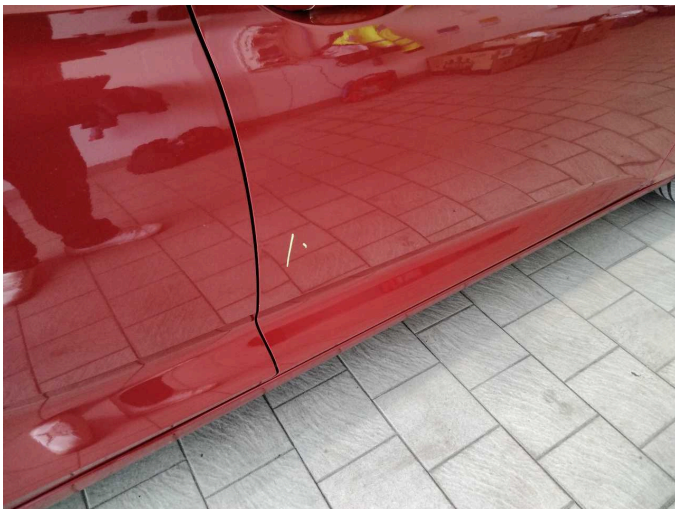
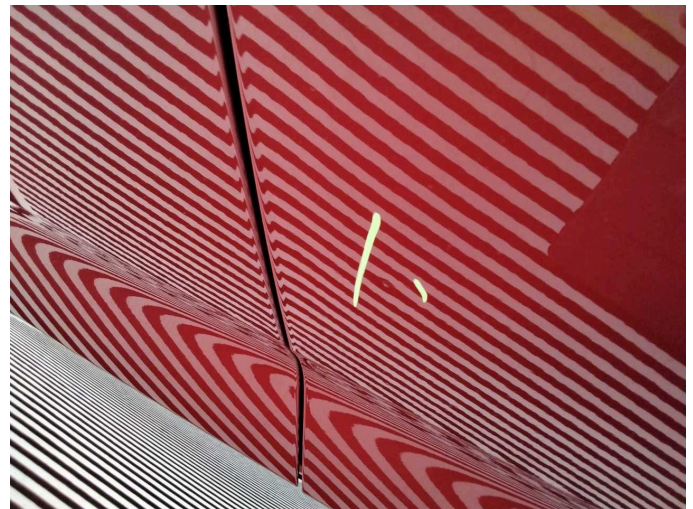
**Wear and tear 4:** Door - front right side: Door - Dent / paintcoat damage - No deduction
