Expertise

Protocol number: 46711579  
Order No. / Reference: 26795010  
Inspection date: 24 Jul 2026

Manufacturer: Opel

Model: Astra Sports Tourer 1.5 D Business Edition

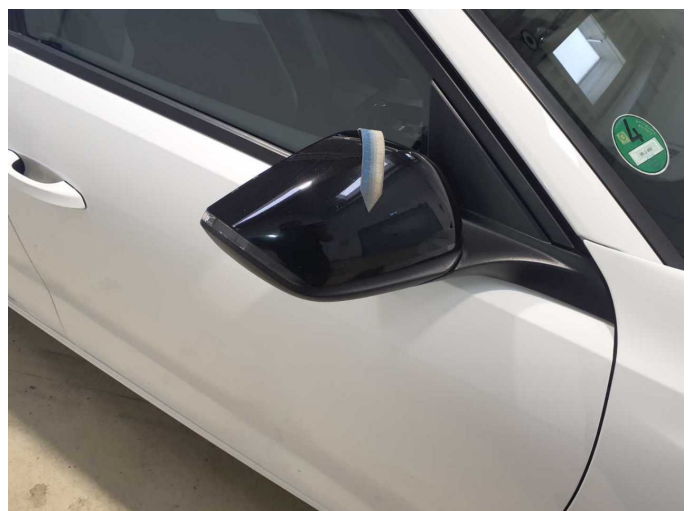
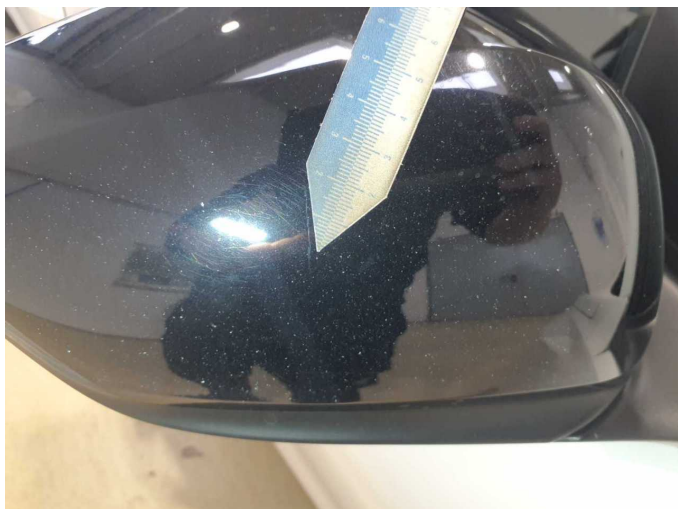
| No. | Component group | Description |
|---|---|---|
| 1 | Wing mirror - right side | Cap (Lack nebel) - Paint defect - Smart repair |

**Damage 1:** Wing mirror - right side: Cap (Lack nebel) - Paint defect - Smart repair

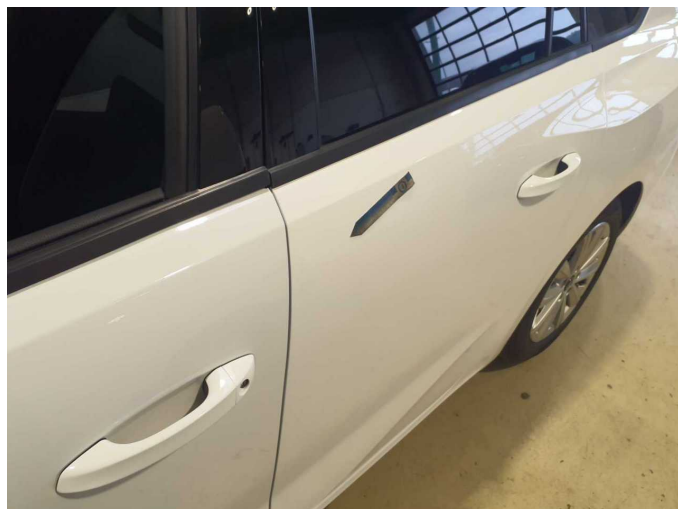
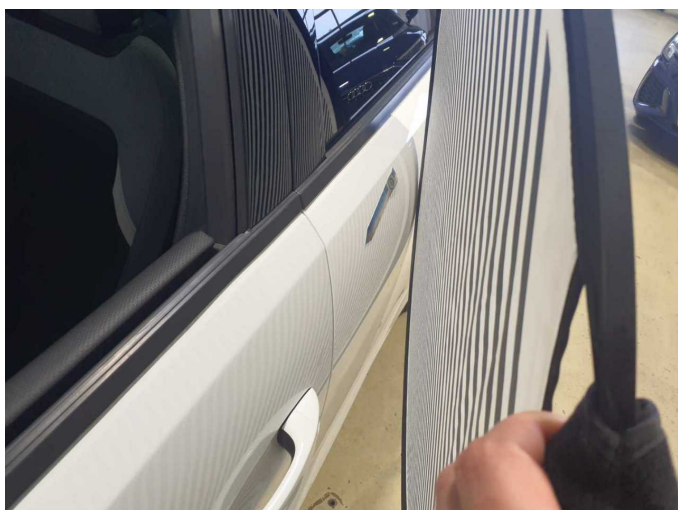
| No. | Component group | Description |
|---|---|---|
| 2 | Door - rear left side | Door - dent(s) - Smooth repair work |

**Damage 2:** Door - rear left side: Door - dent(s) - Smooth repair work

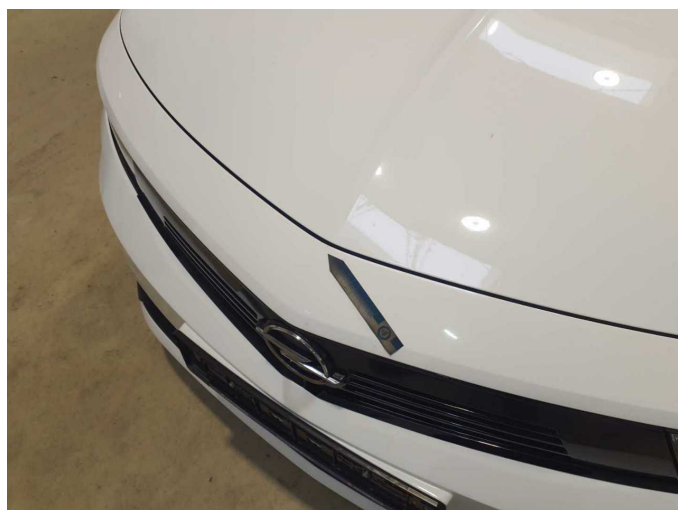
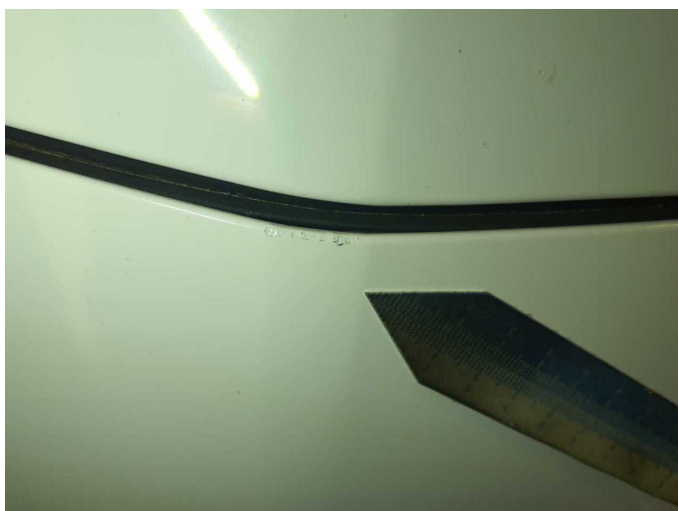
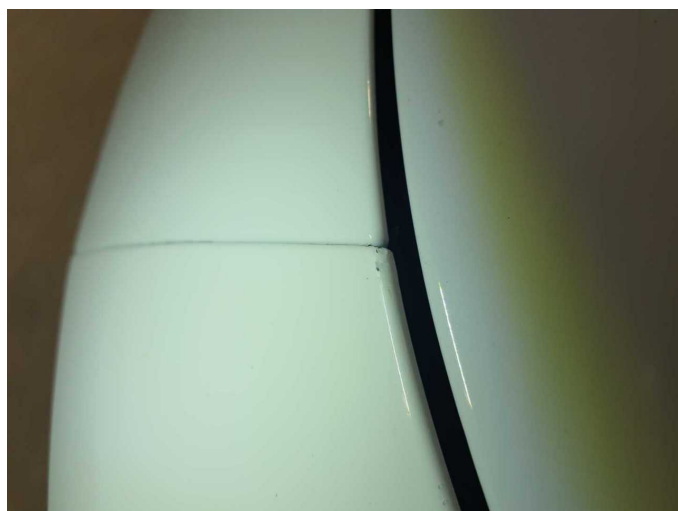
| No. | Component group | Description |
|---|---|---|
| 3 | Front bumper | Front bumper - Scratch(es) - Smart repair |

**Damage 3:** Front bumper: Front bumper - Scratch(es) - Smart repair

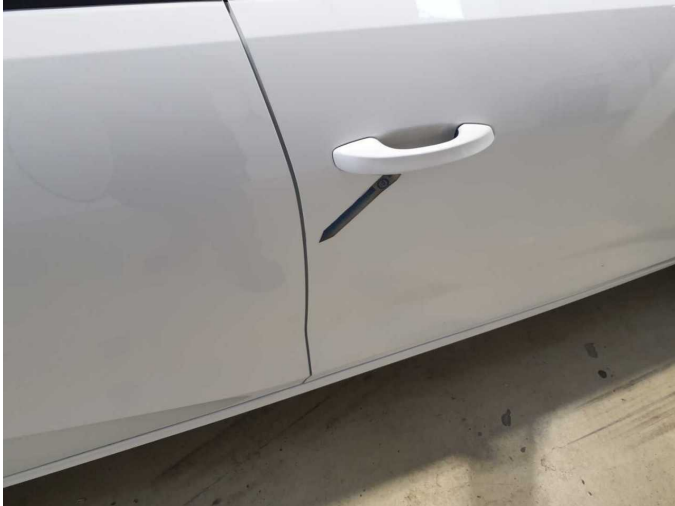
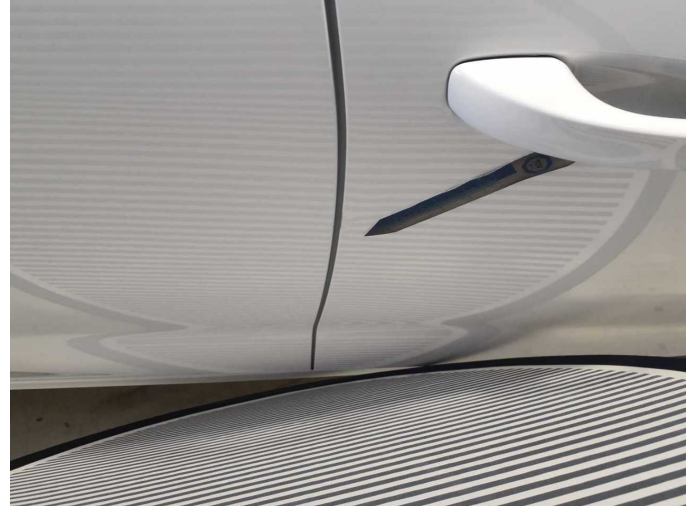
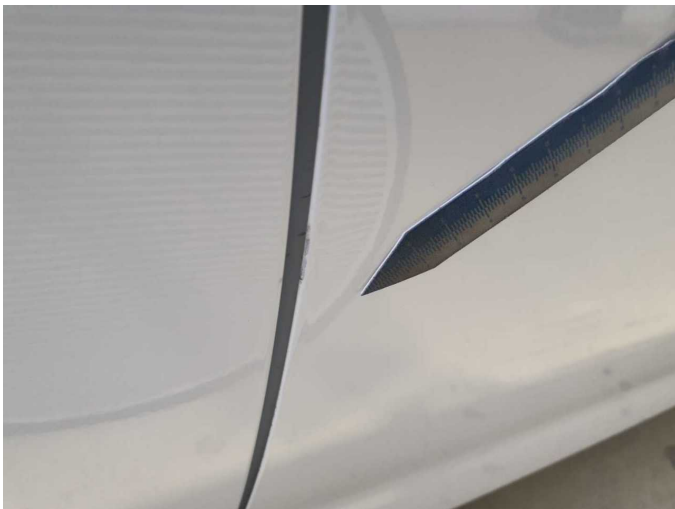
| No. | Component group | Description |
|---|---|---|
| 4 | Door - front right side | Door edge - Dent / paintcoat damage - Smart repair |

**Damage 4:** Door - front right side: Door edge - Dent / paintcoat damage - Smart repair

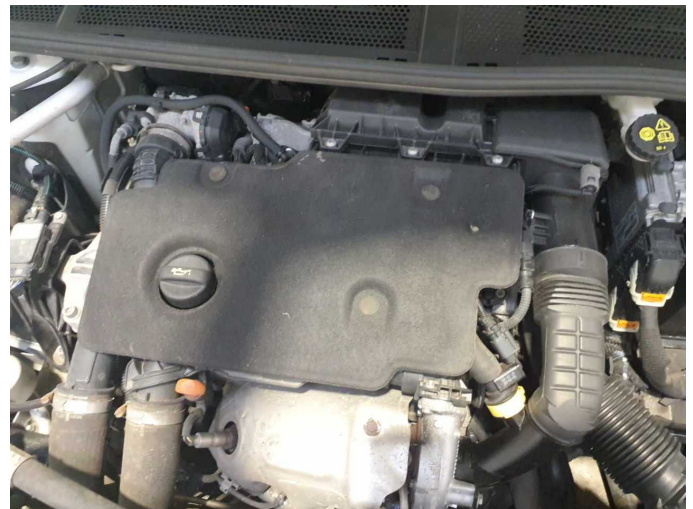
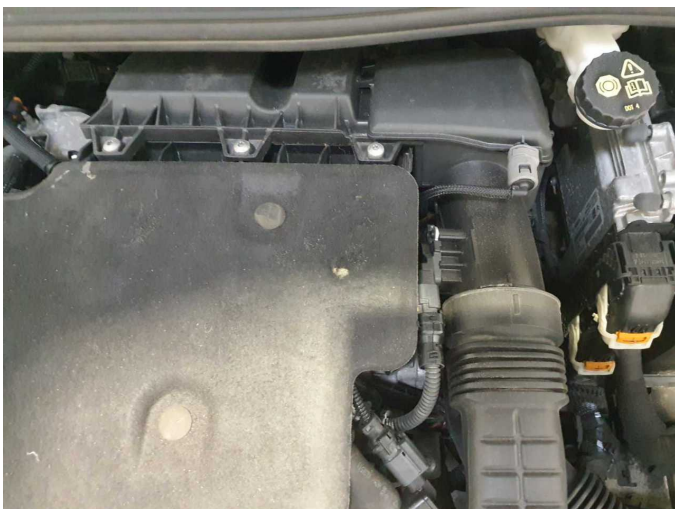
| No. | Component group | Description |
|---|---|---|
| 5 | Bonnet | Insulation lining - Broken / torn - Replace |

**Damage 5:** Bonnet: Insulation lining - Broken / torn - Replace

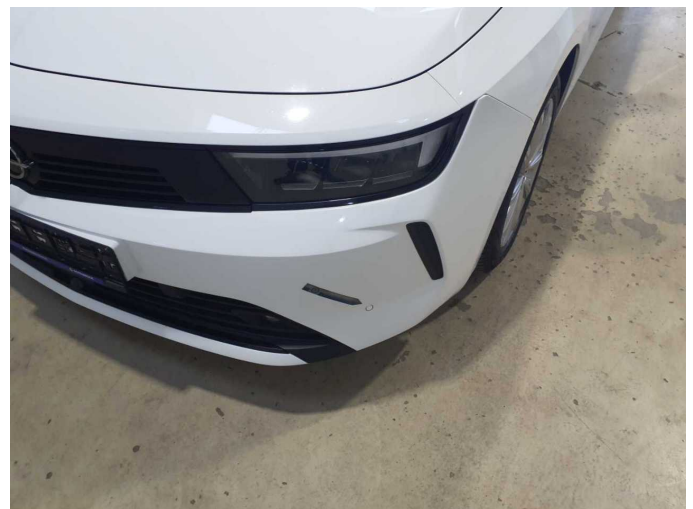
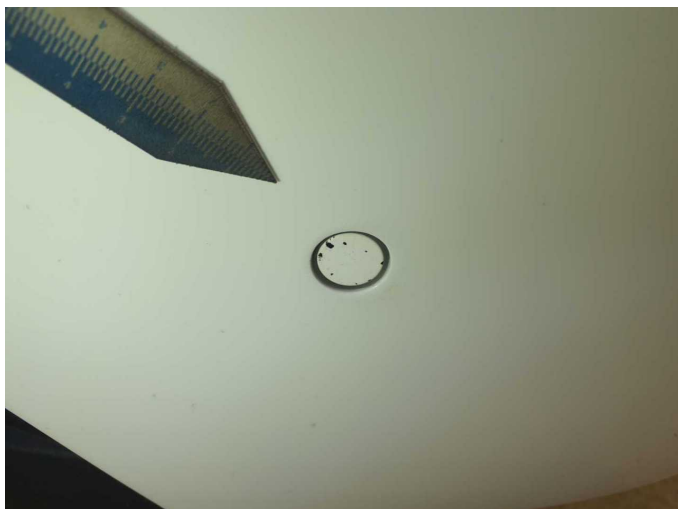
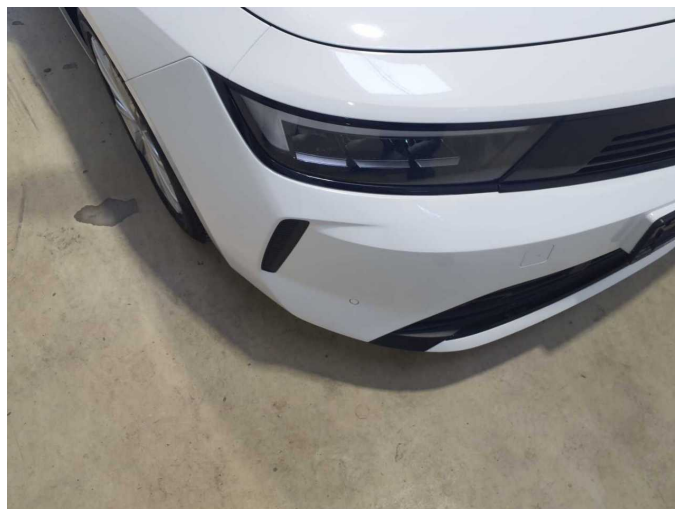
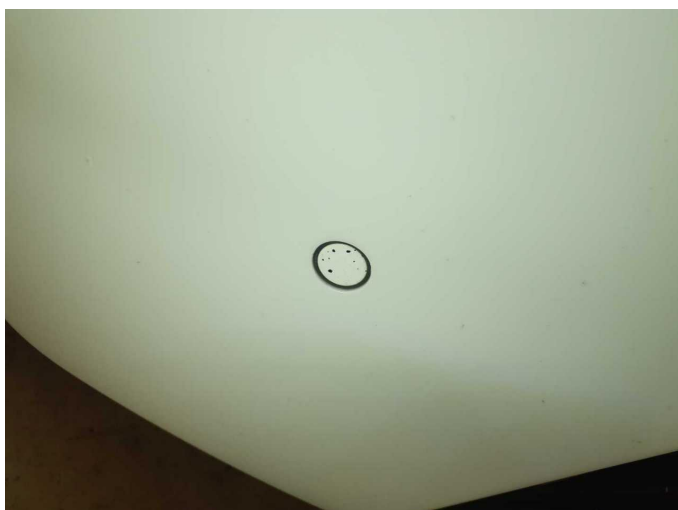
| No. | Component group | Description |
|---|---|---|
| 6 | Front bumper | Parking sensors - left side (Und rechts) - Stone chips - Paint |

**Damage 6:** Front bumper: Parking sensors - left side (Und rechts) - Stone chips - Paint

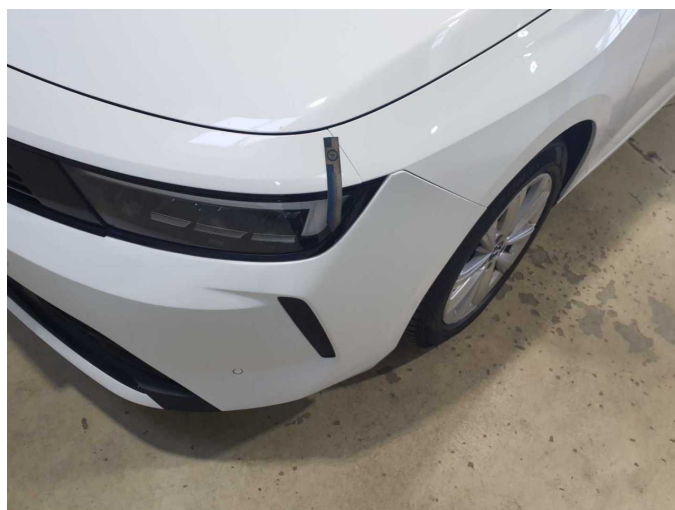
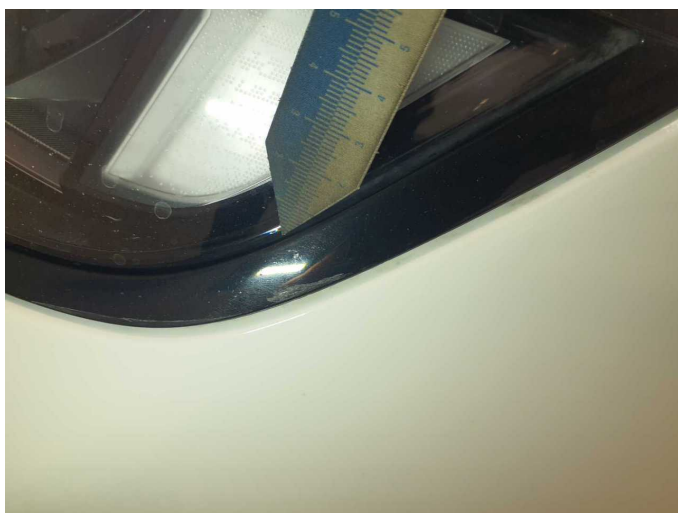
| No. | Component group | Description |
|---|---|---|
| 7 | Trim / covers | Trim / covers (Scheinwerfer zierleiste) - Scratch(es) - Replace |

**Damage 7:** Trim / covers: Trim / covers (Scheinwerfer zierleiste) - Scratch(es) - Replace

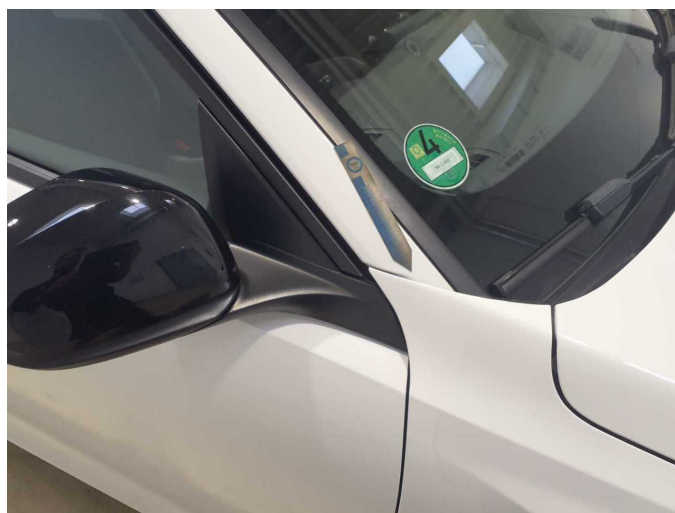
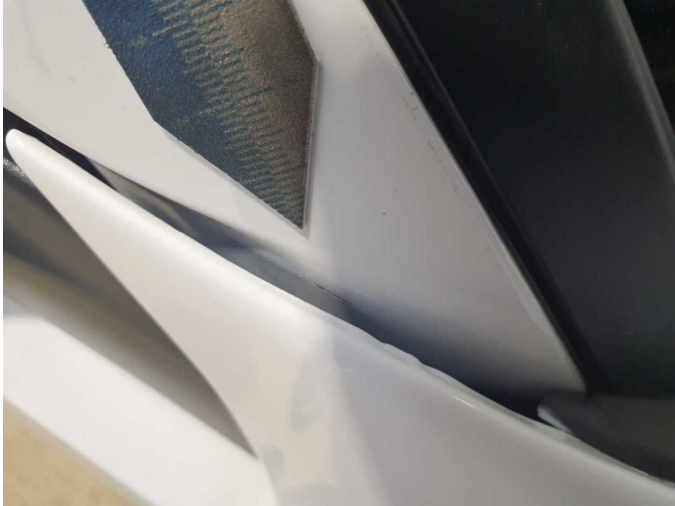
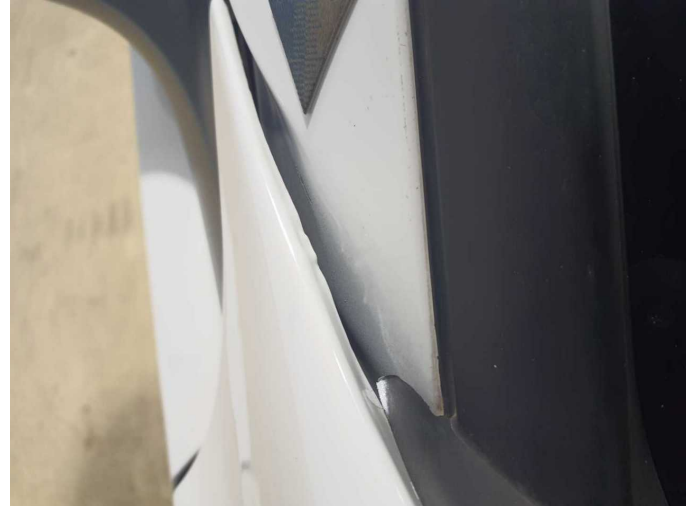
| No. | Component group | Description |
|---|---|---|
| 8 | Body | A-pillar - right side (Lack nebel) - Paint defect - Paint |

**Damage 8:** Body: A-pillar - right side (Lack nebel) - Paint defect - Paint

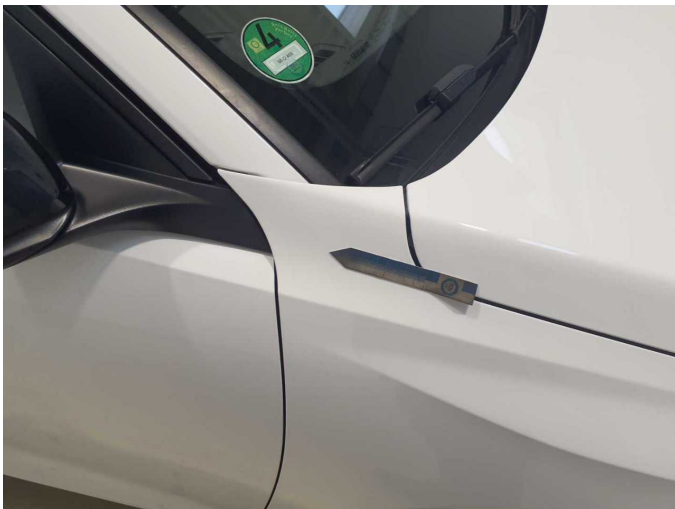
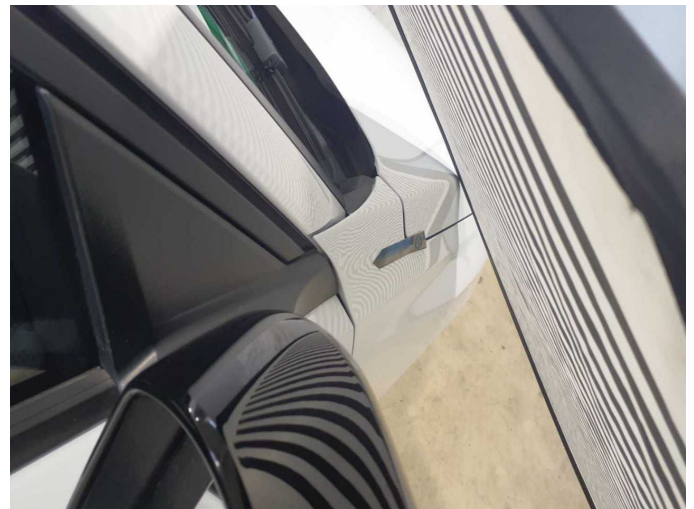
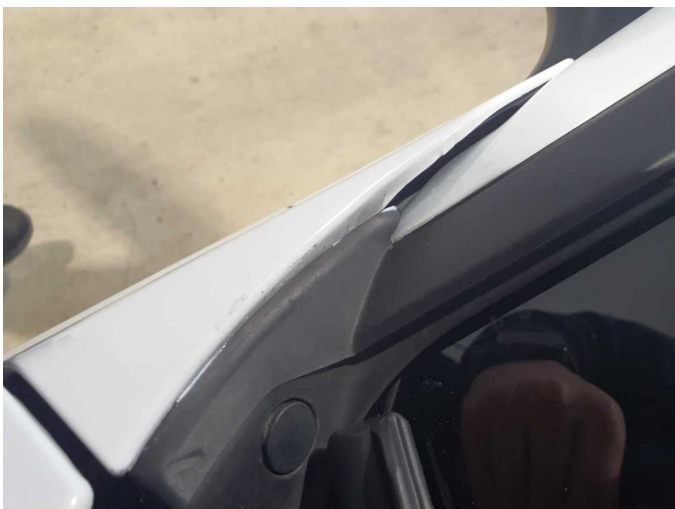
| No. | Component group | Description |
|---|---|---|
| 9 | Mudguard - right side | Mudguard - right side (Wellig und lack löst sich) - Unprofessionally repaired - Paint |

**Damage 9:** Mudguard - right side: Mudguard - right side (Wellig und lack löst sich) - Unprofessionally repaired - Paint

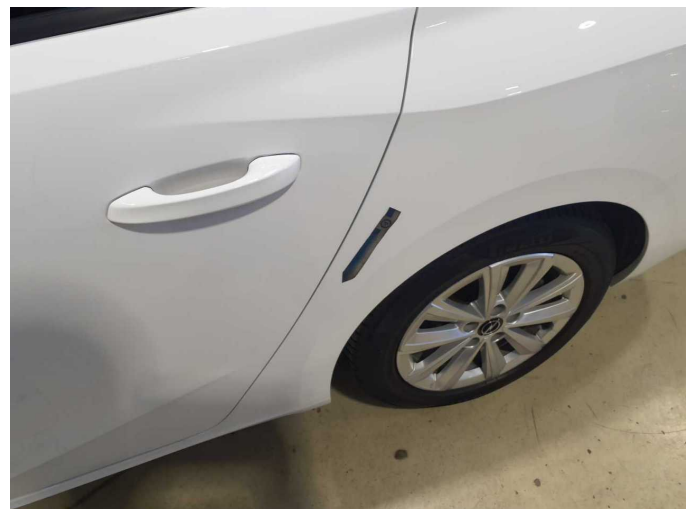
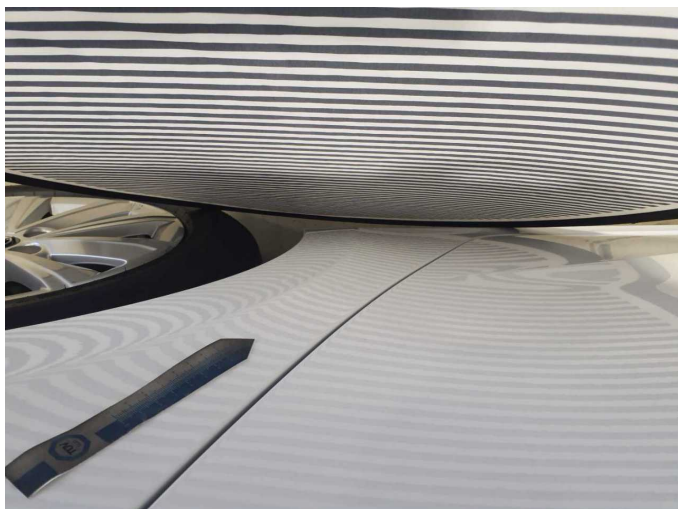
| No. | Component group | Description |
|---|---|---|
| 10 | Side panel - rear left side | Side panel (Wellig) - Unprofessionally repaired - Paint |

**Damage 10:** Side panel - rear left side: Side panel (Wellig) - Unprofessionally repaired - Paint

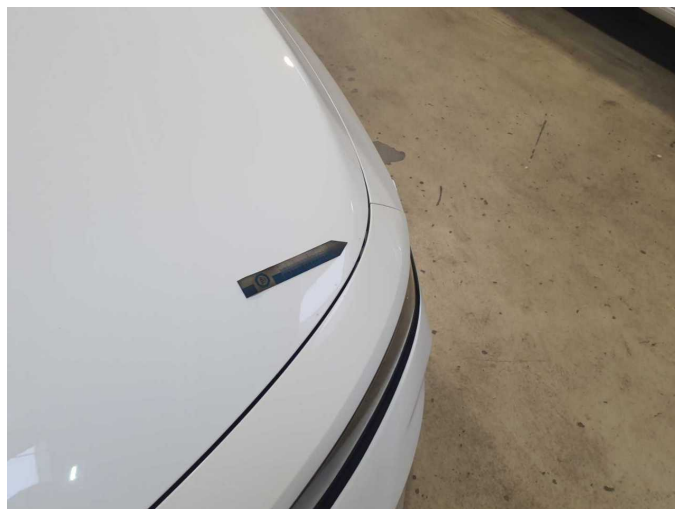
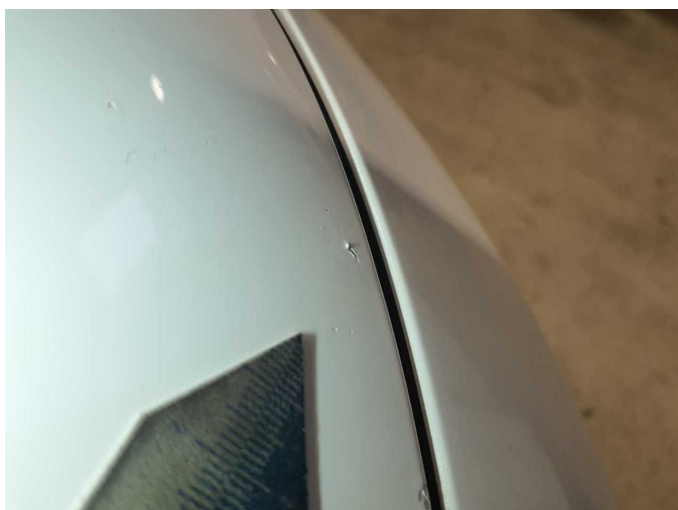
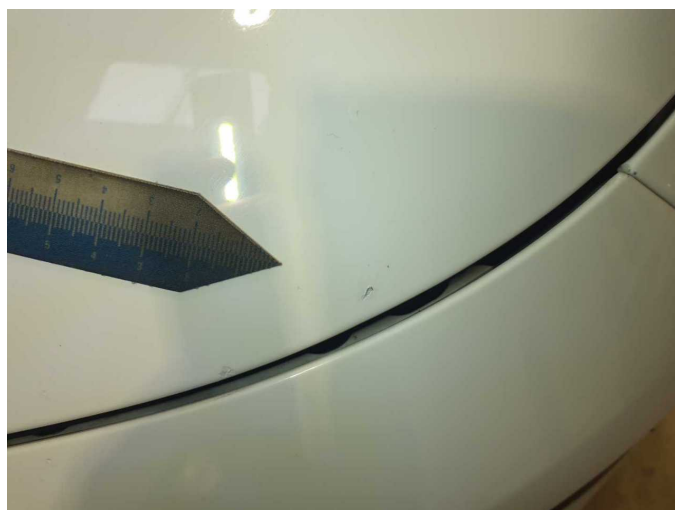
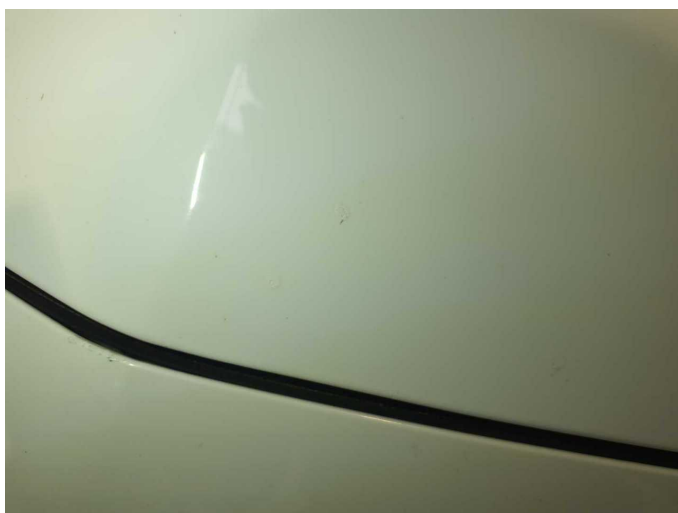
| No. | Component group | Description |
|---|---|---|
| 11 | Bonnet | Bonnet - Scratch(es) - Paint |

**Damage 11:** Bonnet: Bonnet - Scratch(es) - Paint

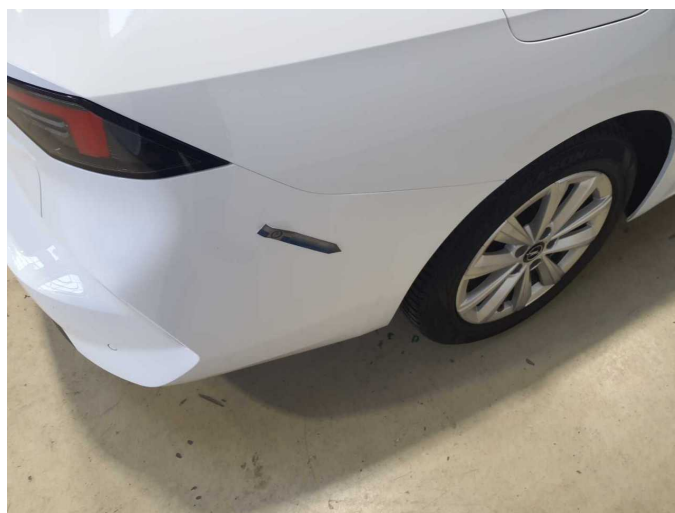
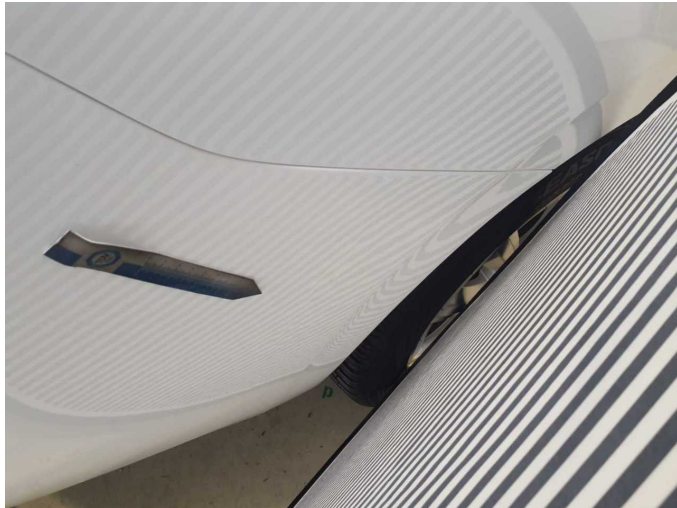
| No. | Component group | Description |
|---|---|---|
| 12 | Rear bumper | Rear bumper - dent(s) - Paint |

**Damage 12:** Rear bumper: Rear bumper - dent(s) - Paint

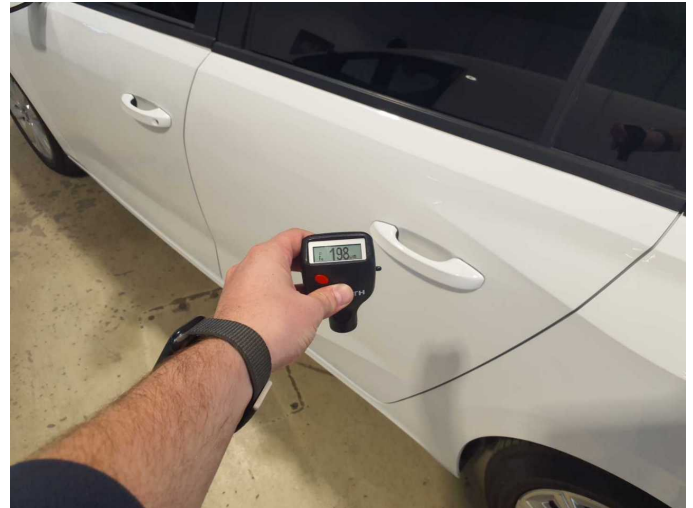
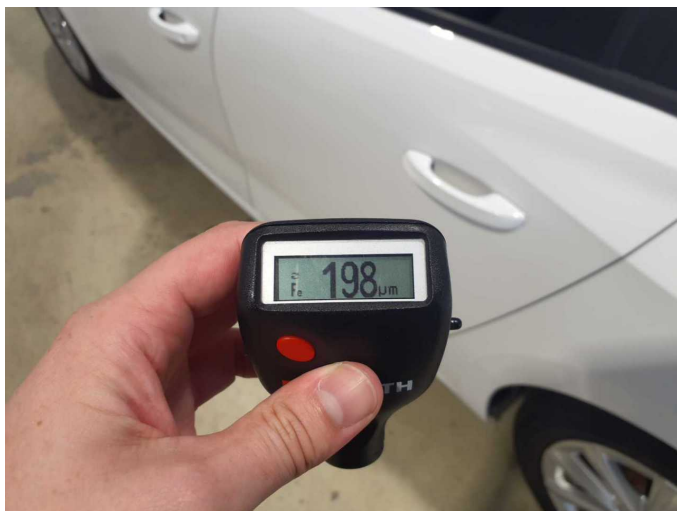
| No. | Repainting |
|---|---|
| 1 | Door - rear left side, Professionally carried out, Invoice of repair done Non-existent |

| Door - rear left side | 198 µm | Door - front left side | 420 µm |

**Repainting 1:** Door - rear left side

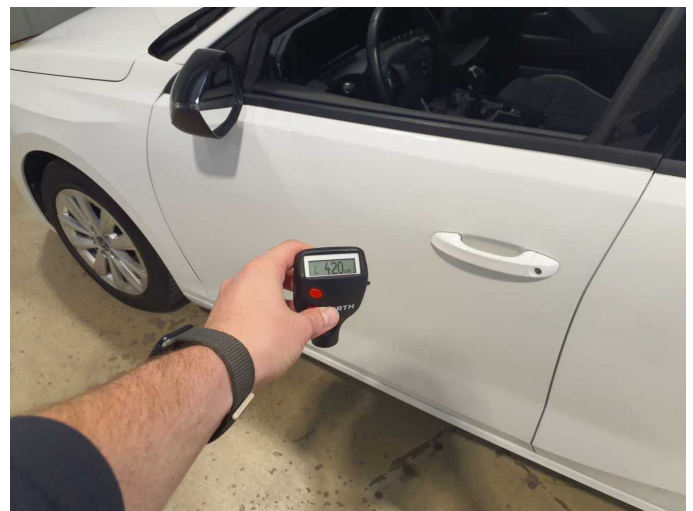
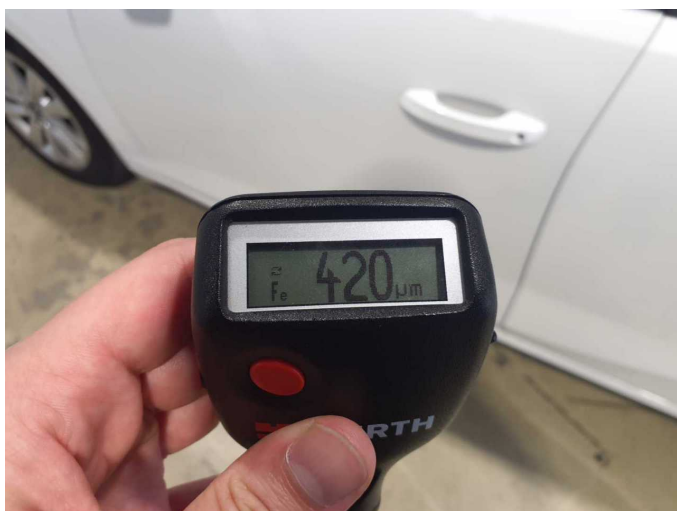
| No. | Repainting |
|---|---|
| 2 | Door - front left side, Professionally carried out, Invoice of repair done Non-existent |

**Repainting 2:** Door - front left side

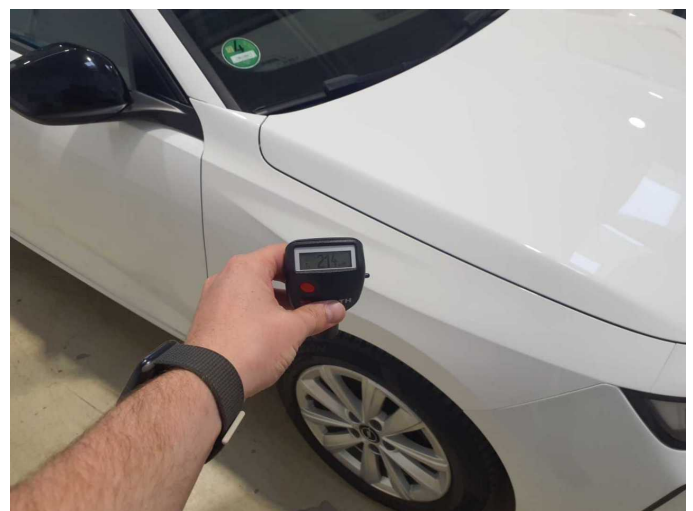
| No. | Repainting |
|---|---|
| 3 | Mudguard - right side, Unprofessionally carried out, Invoice of repair done Non-existent |

| Mudguard - right side | 214 µm | Side panel - rear left side | 229 µm |

**Repainting 3:** Mudguard - right side

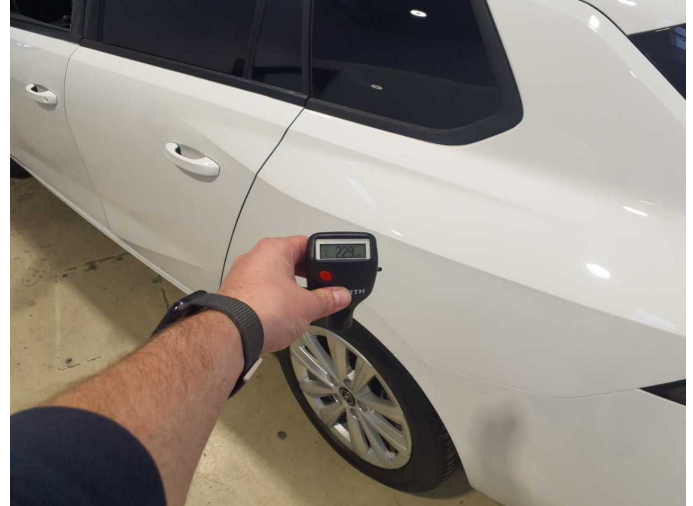
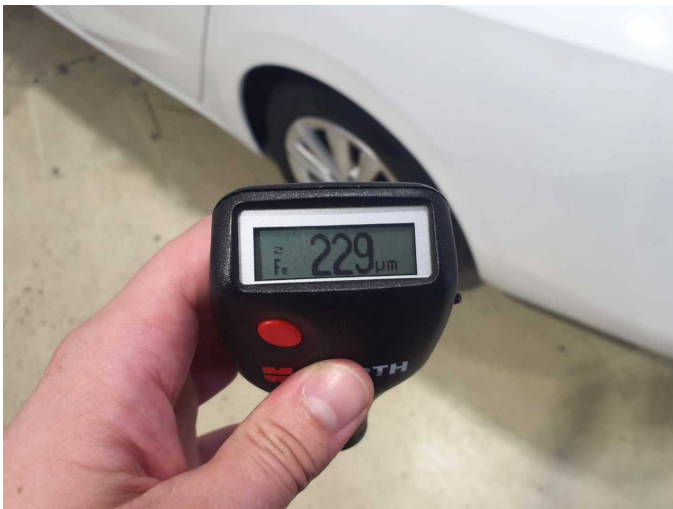
| No. | Repainting |
|---|---|
| 4 | Side panel - rear left side, Unprofessionally carried out, Invoice of repair done Non-existent |

**Repainting 4:** Side panel - rear left side
