Expertise

Protocol number: 45786982
Order No. / Reference: 26529446
Inspection date: 5 Jun 2026

Model: Focus Turnier 1.5 EcoBlue Start-Stopp-System Aut. TITANIUM

VIN: WF0PXXGCHPPL83827

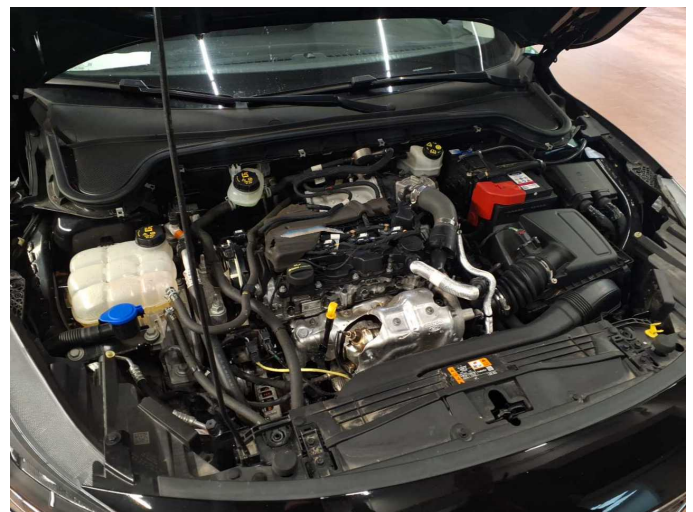
No.	Component group	Description
1	Misc.	Misc. (Isolierung Motor) - Damage caused by marten / rodent - Replace
2	Door - front left side	Door edge - Scratch(es) - Smart repair
3	Boot lid / rear door	Boot lid - Scratch(es) - Smart repair
4	Trim / covers	Door trim - front left side - Holes - Smart repair
5	Rear bumper	Rear bumper - Scratched - Repair and paint
6	Front bumper	Front bumper - Scratch(es) - Paint

Damage 1: Misc.: Misc. (Isolierung Motor) - Damage caused by marten / rodent - Replace

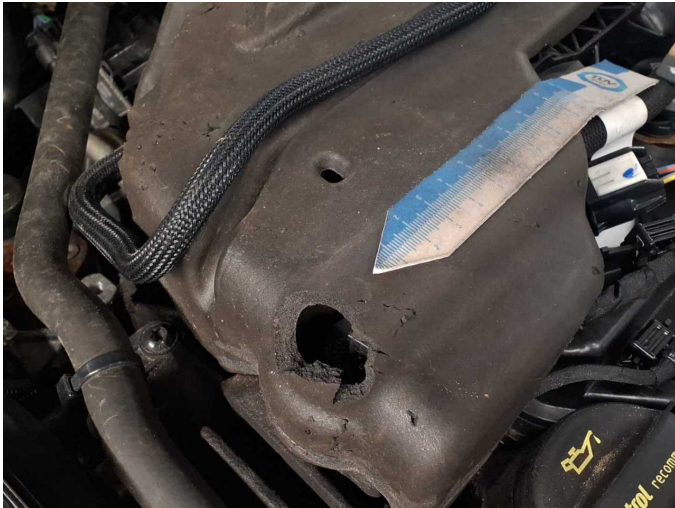
Damage 1: Misc.: Misc. (Isolierung Motor) - Damage caused by marten / rodent - Replace

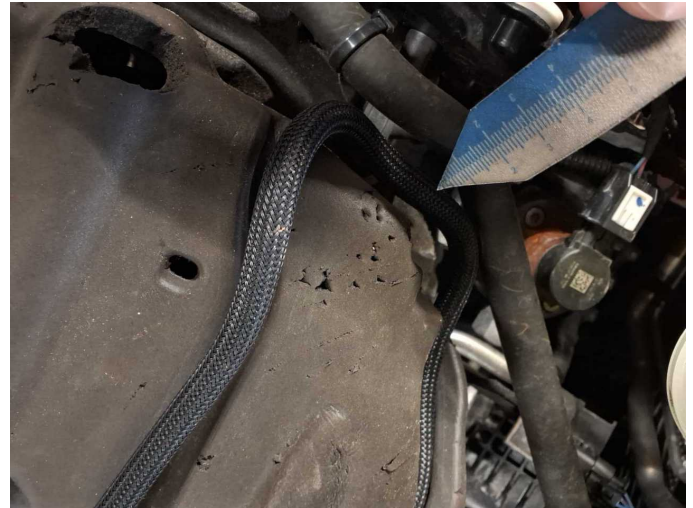
Damage 1: Misc.: Misc. (Isolierung Motor) - Damage caused by marten / rodent - Replace

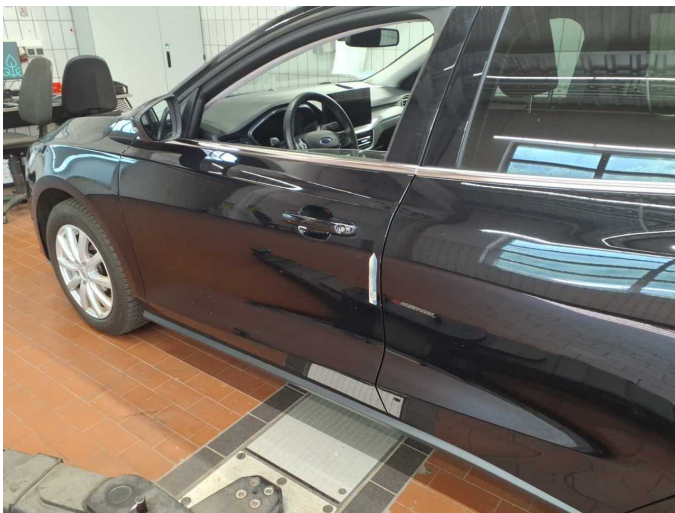
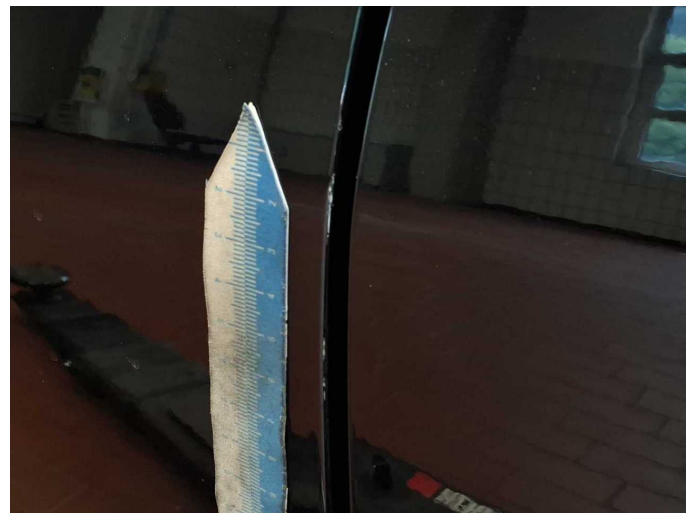
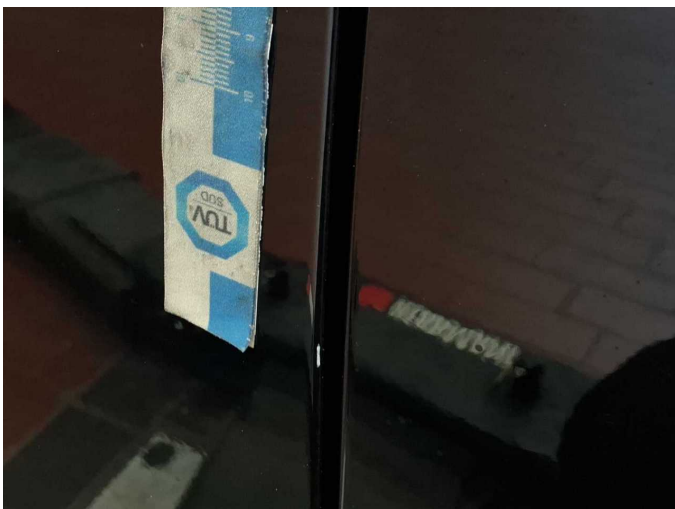
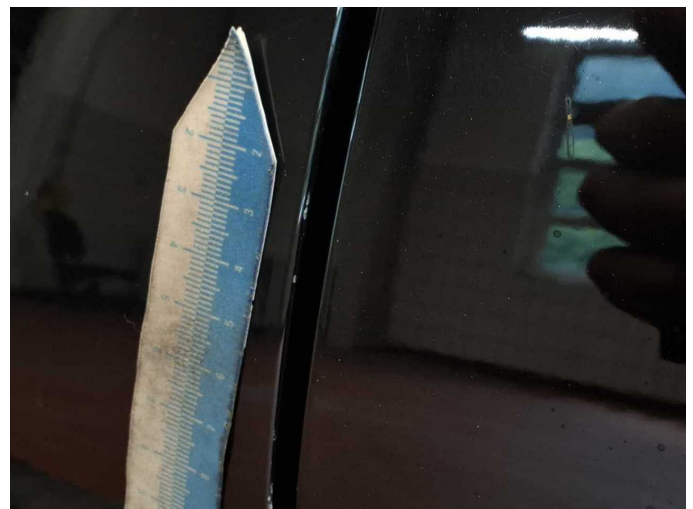
Damage 2: Door - front left side: Door edge - Scratch(es) - Smart repair

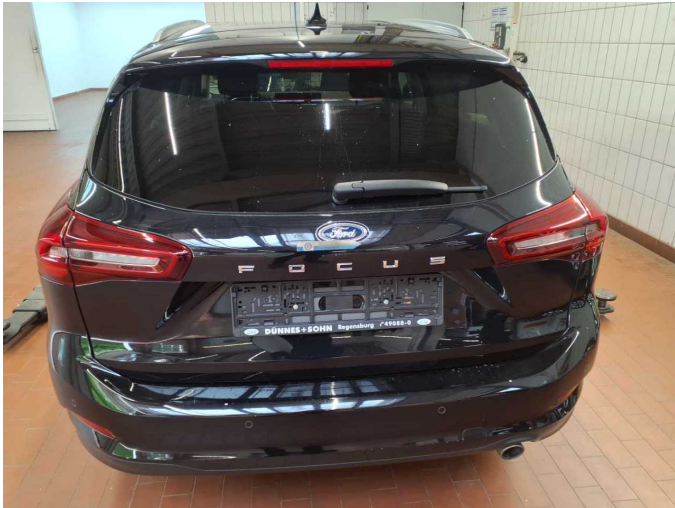
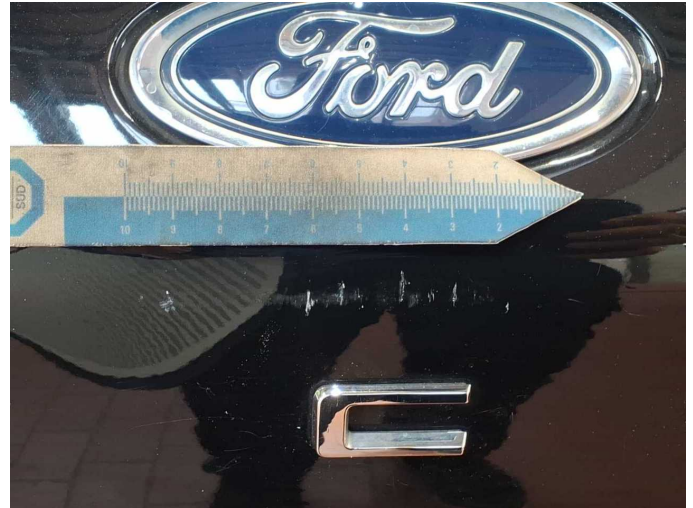
Damage 3: Boot lid / rear door: Boot lid - Scratch(es) - Smart repair

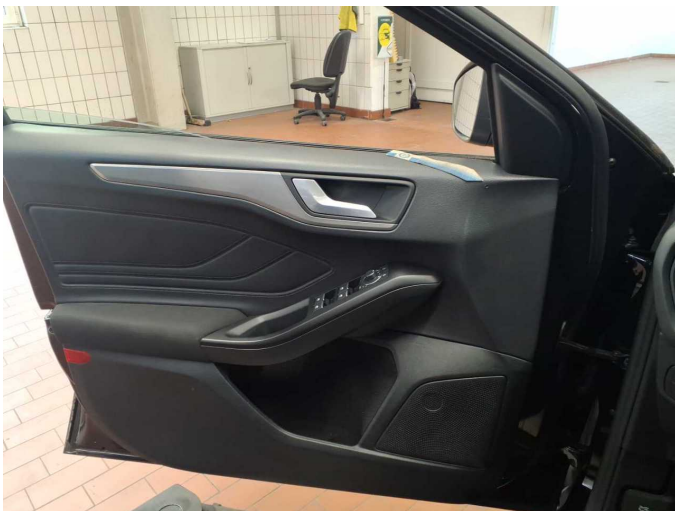
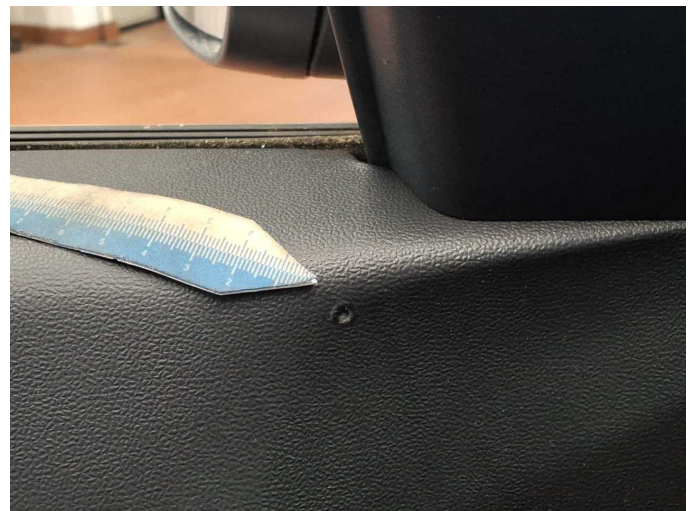
Damage 4: Trim / covers: Door trim - front left side - Holes - Smart repair

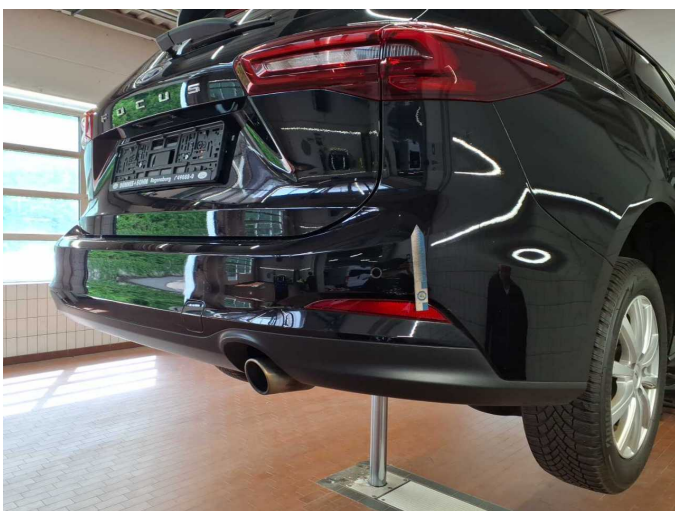
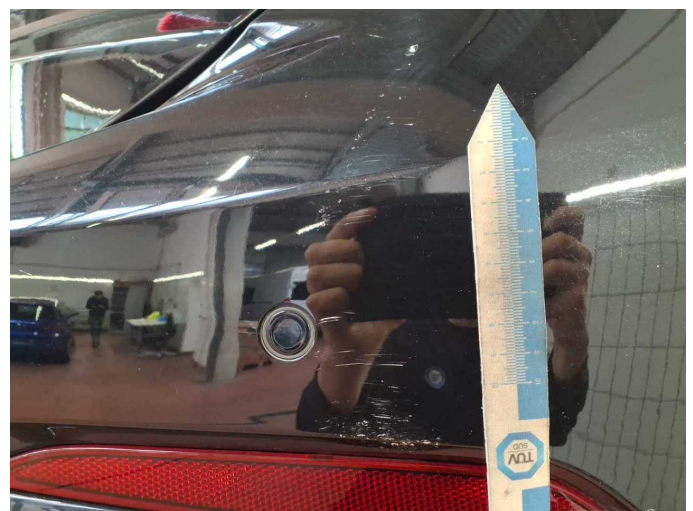
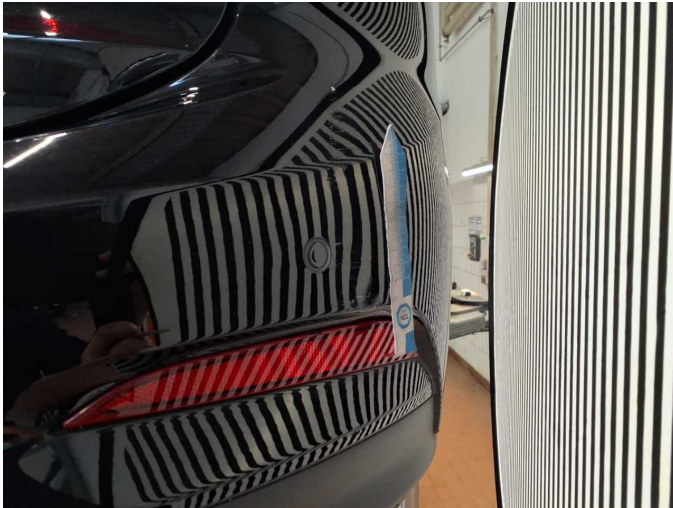
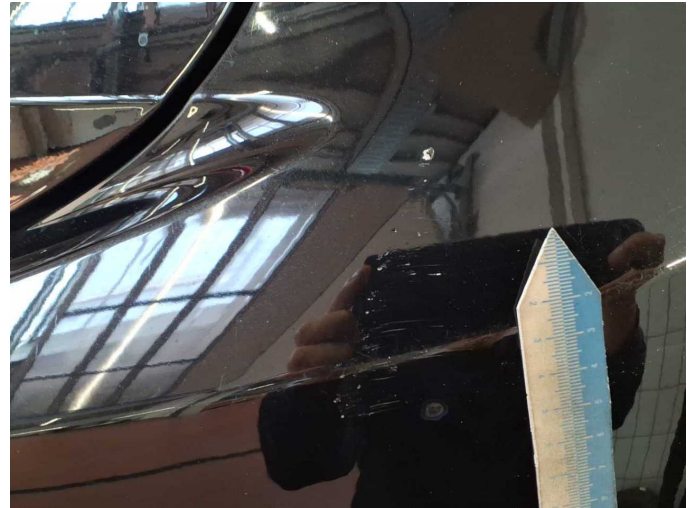
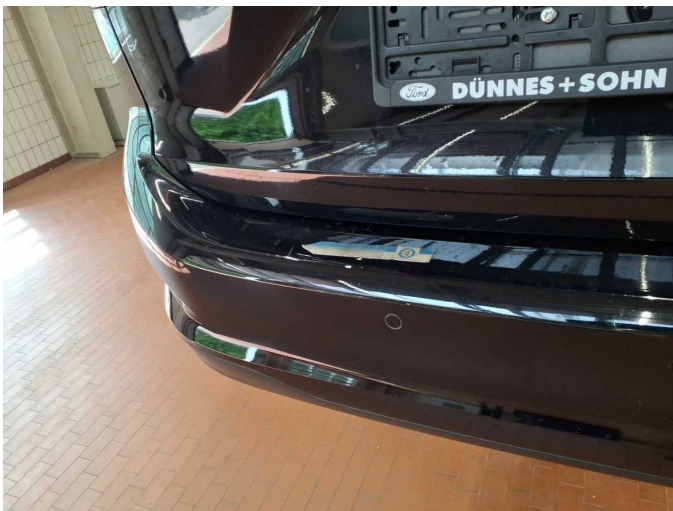
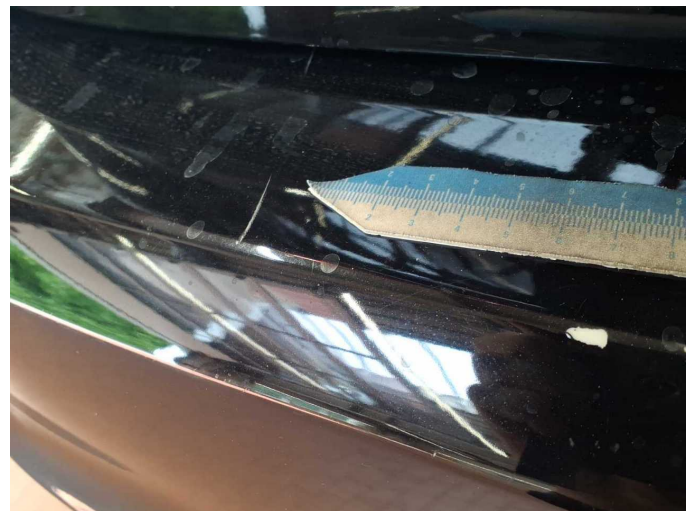
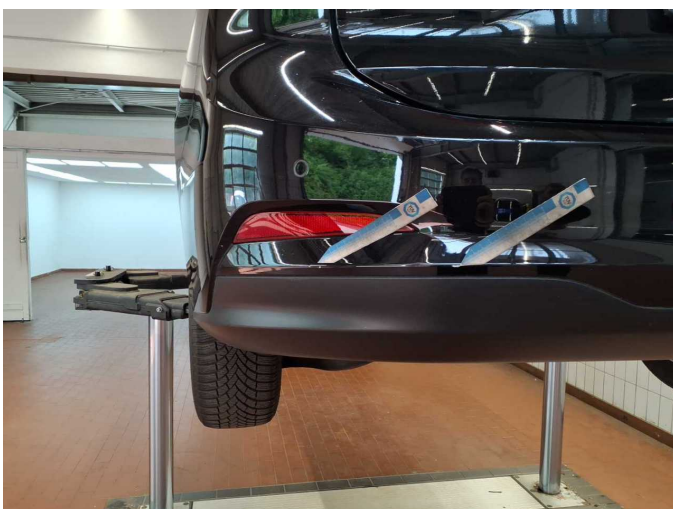
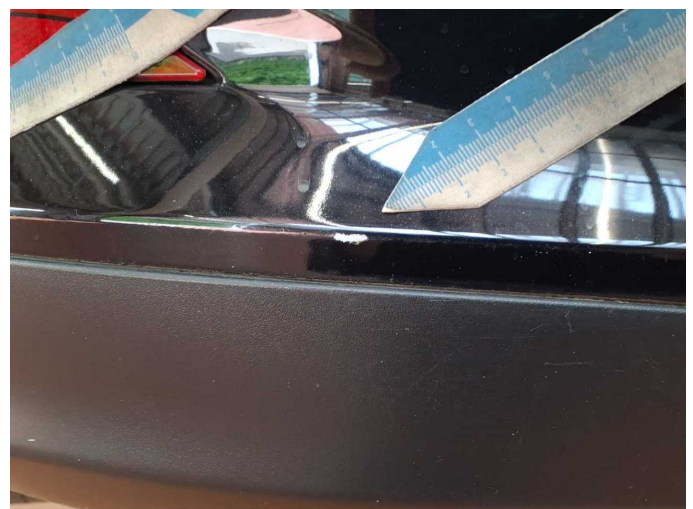
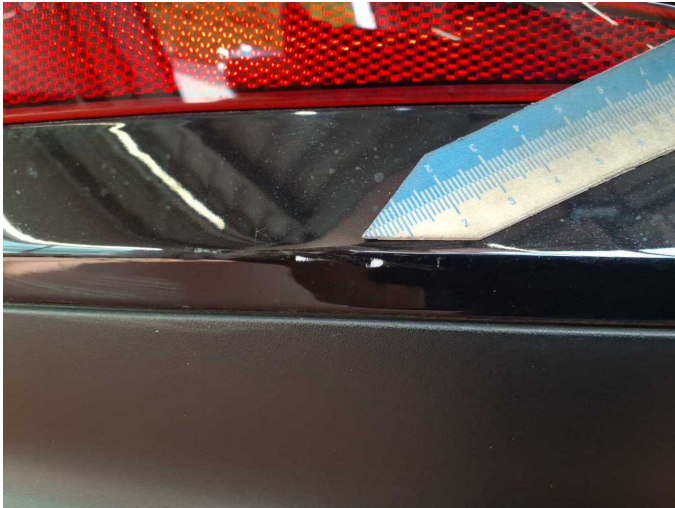
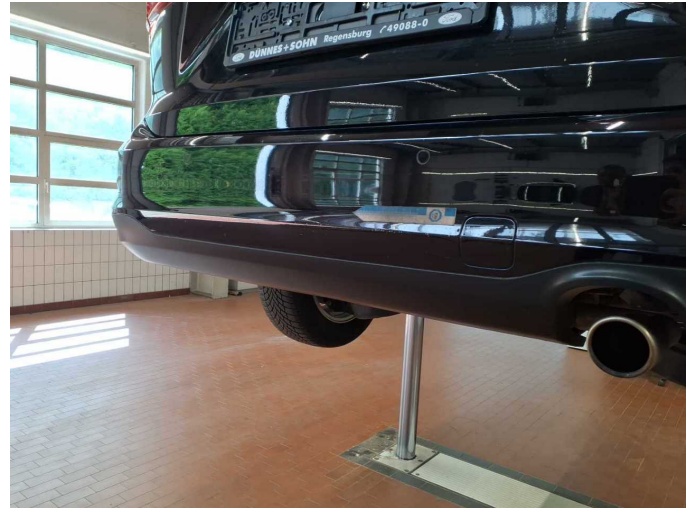
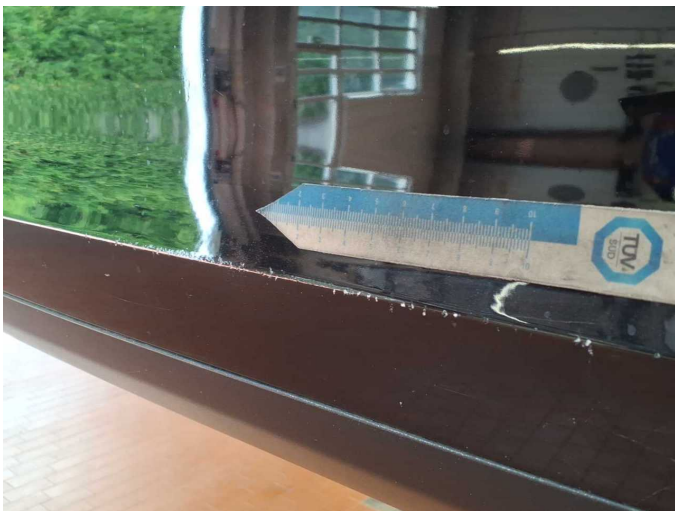
Damage 5: Rear bumper: Rear bumper - Scratched - Repair and paint

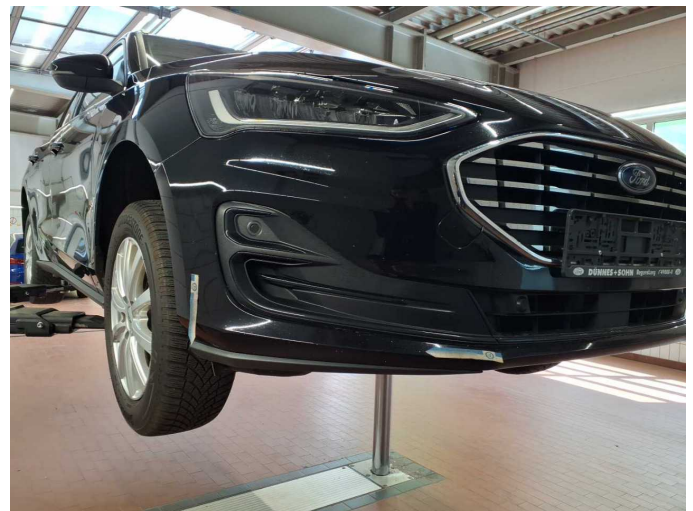
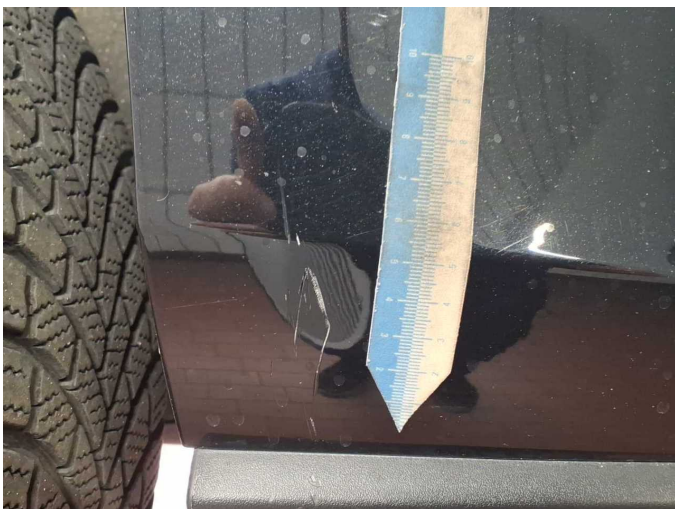
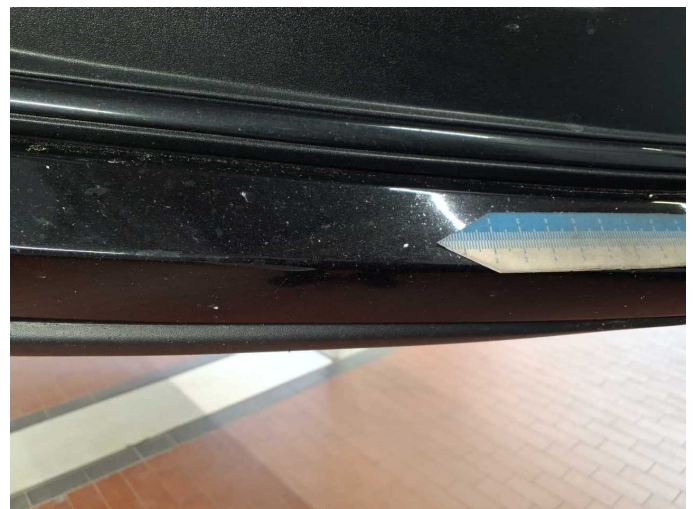
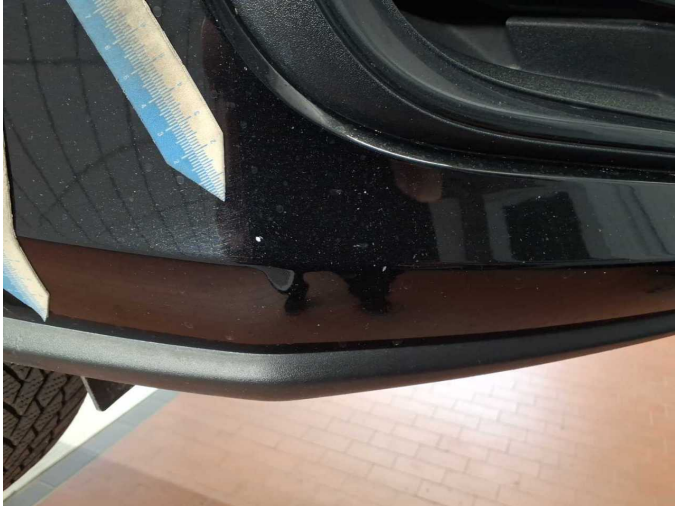
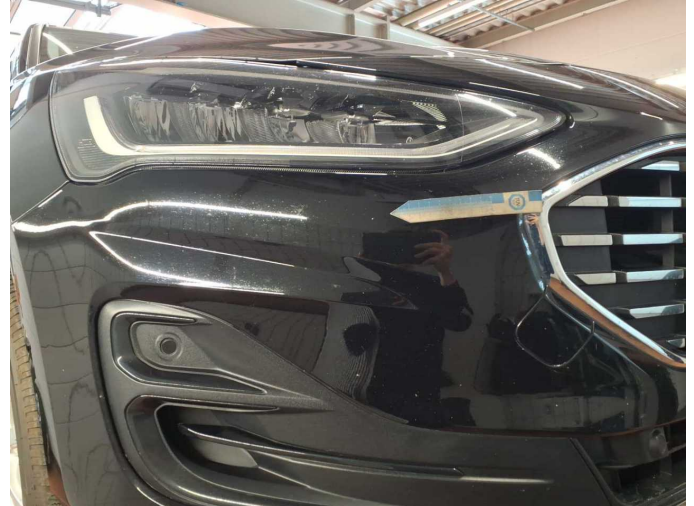
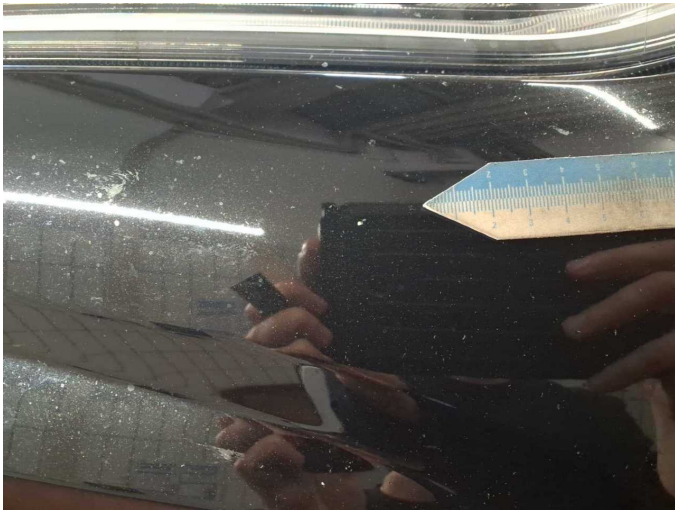
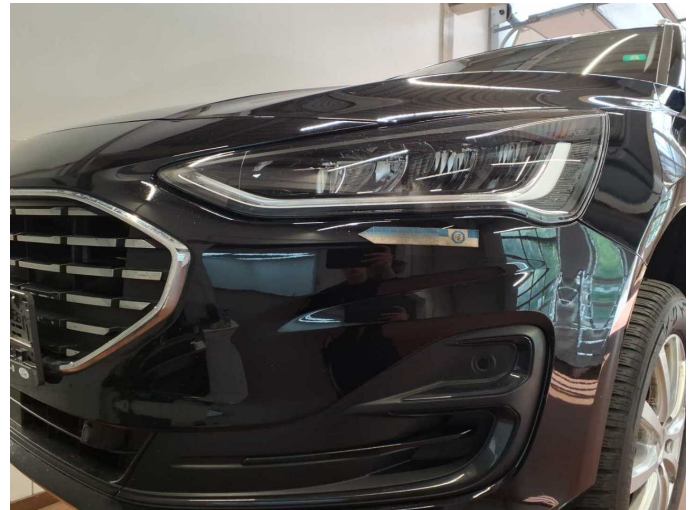
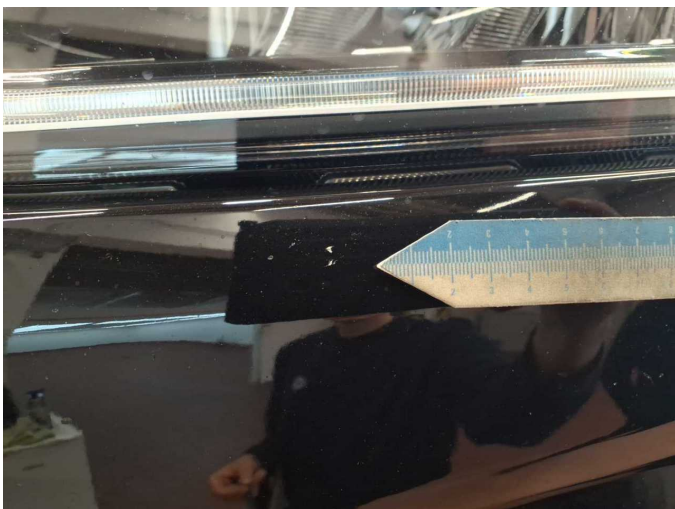
Damage 6: Front bumper: Front bumper - Scratch(es) - Paint

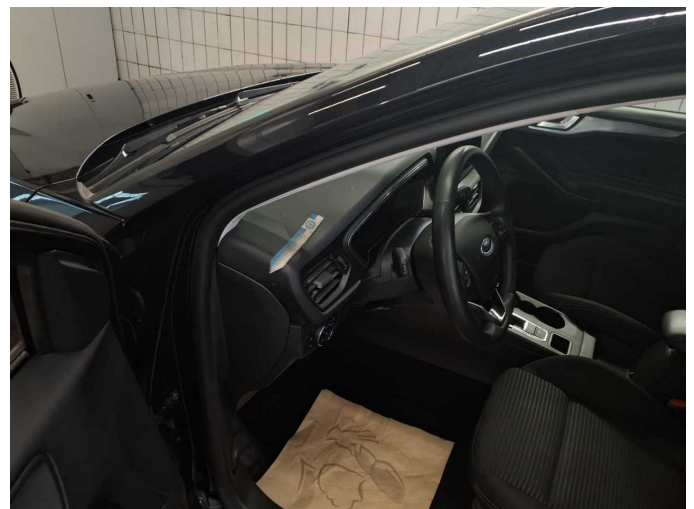
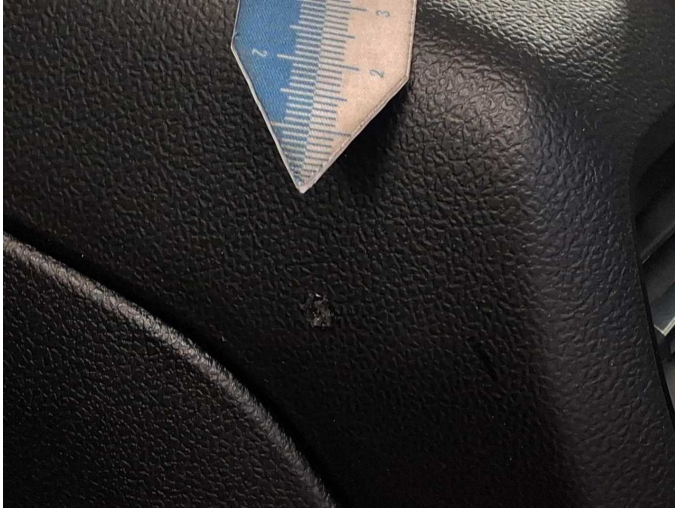
Wear and tear 2: Instrument panel: Centre console - front - Scratch(es) - No deduction

Wear and tear 2: Instrument panel: Centre console - front - Scratch(es) -
No deduction
