Expertise

Protocol number: 46444043  
Order No. / Reference: 26606471  
Inspection date: 10 Jul 2026

Manufacturer: Skoda  
VIN: TMBJC9NY2PF046094

Model: Enyaq iV 80

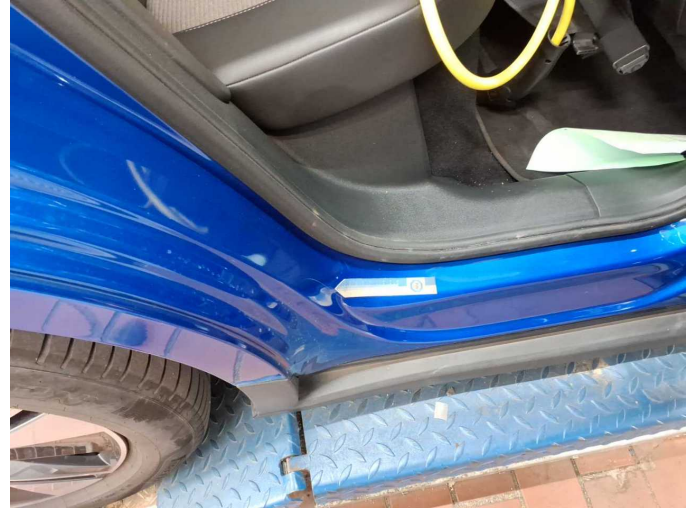
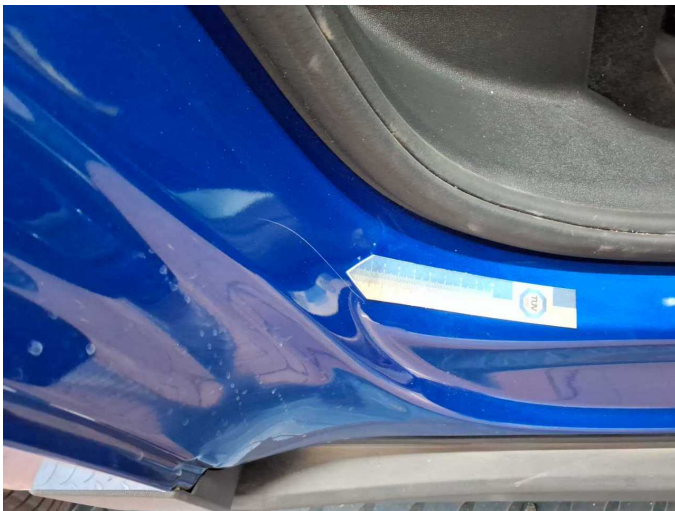
| No. | Component group | Description |
|---|---|---|
| 2 | Side panel - rear right side | Sill - Scratch(es) - Smart repair |

**Damage 2:** Side panel - rear right side: Sill - Scratch(es) - Smart repair

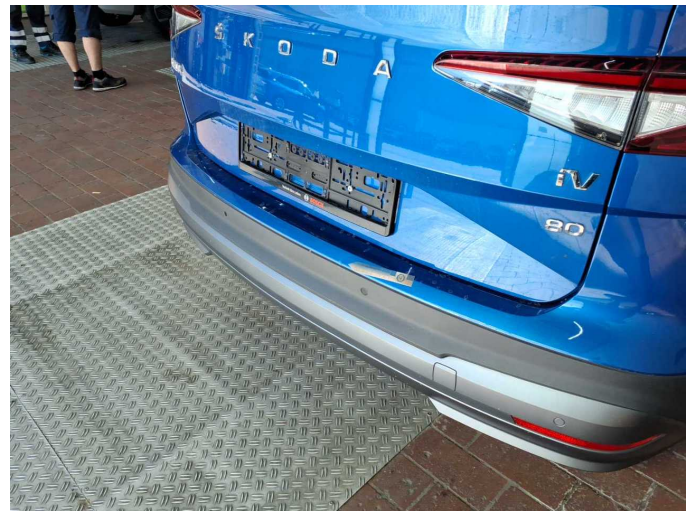
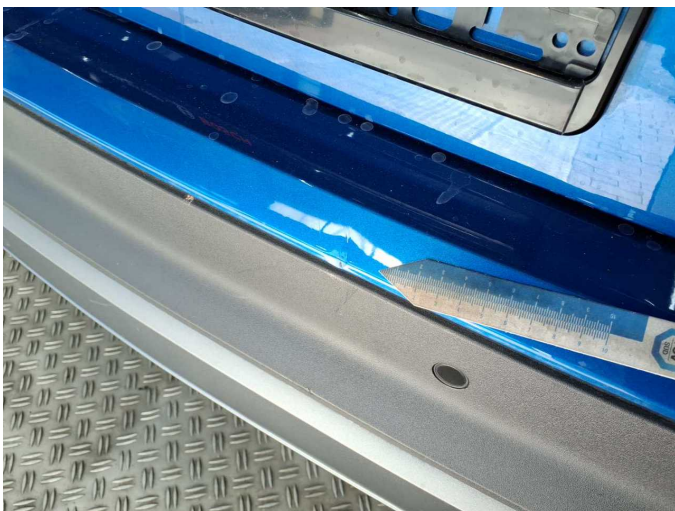
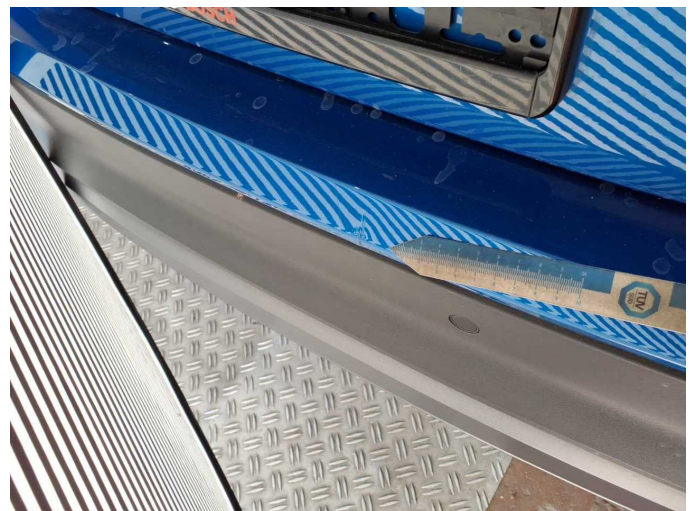
| No. | Component group | Description |
|---|---|---|
| 3 | Rear bumper | Rear bumper - Scratched - Repair and paint |

**Damage 3:** Rear bumper: Rear bumper - Scratched - Repair and paint

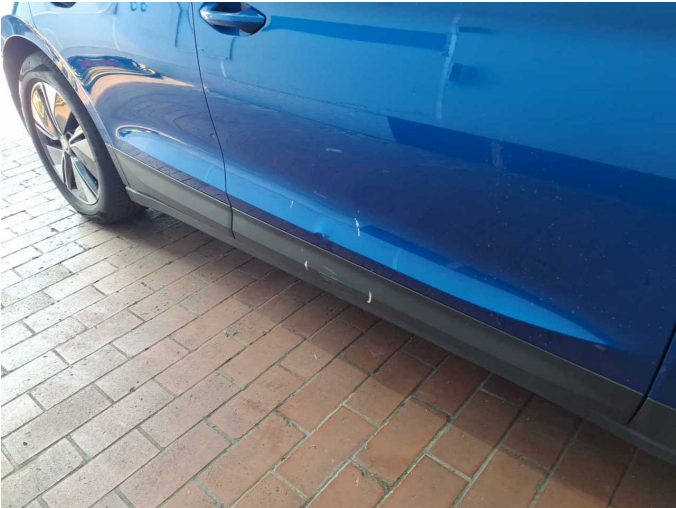
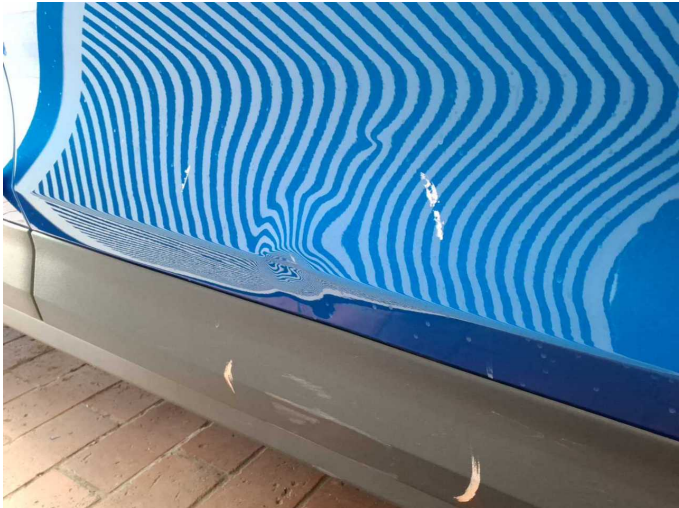
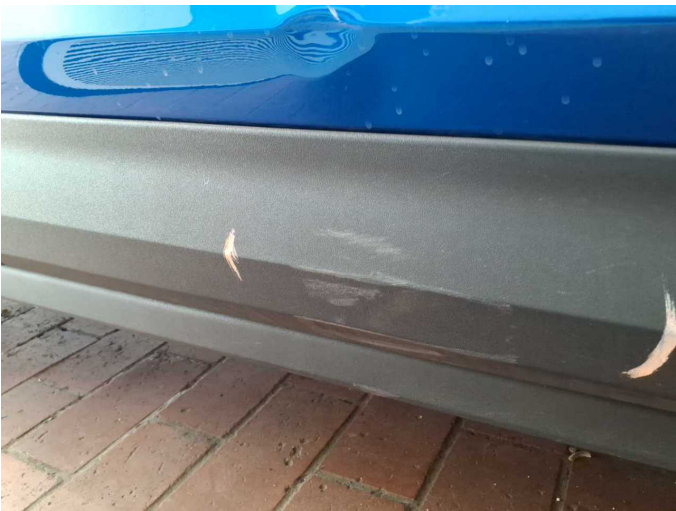
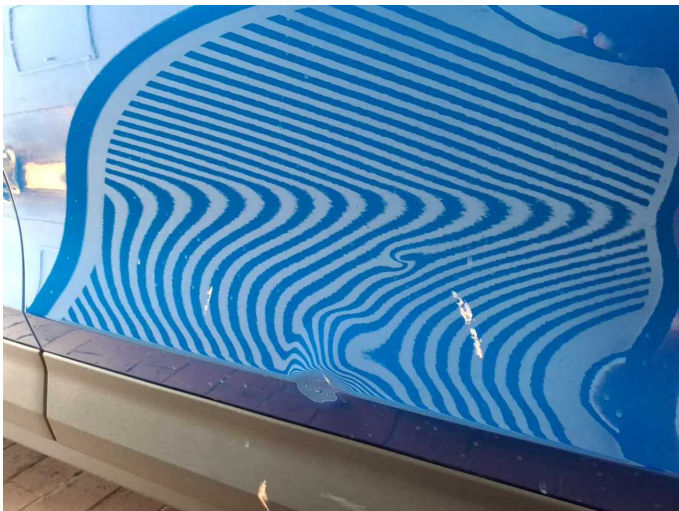
1 Side right

Accident 1: Side right

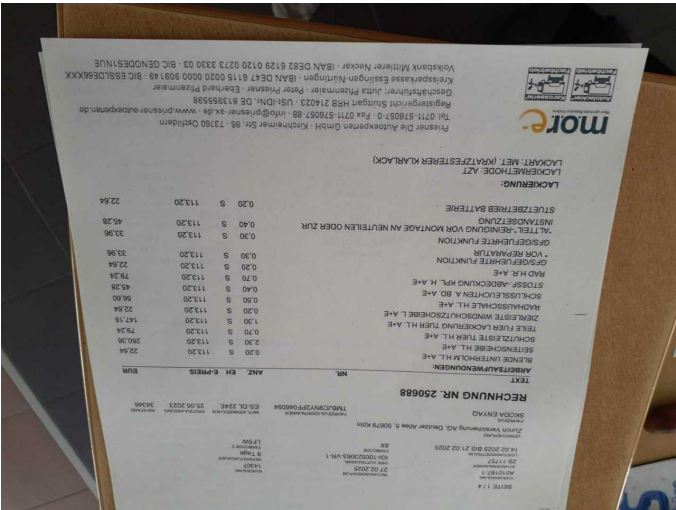
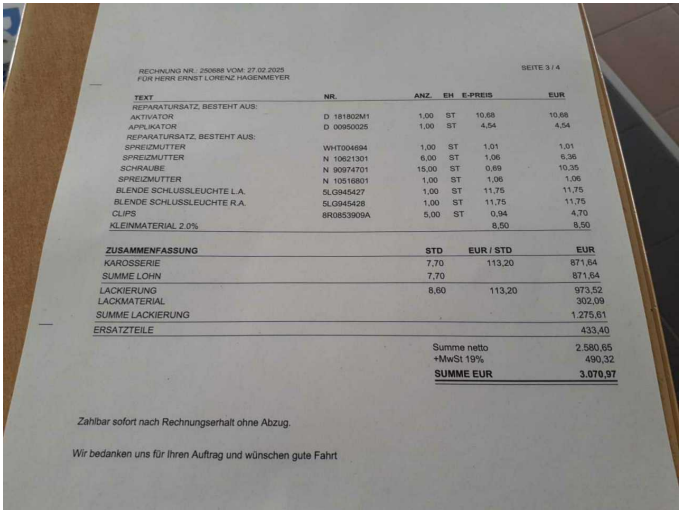
| No. | Previous damage | Extent of damage (Net) |
|---|---|---|
| 1 | Side - left, Provided by user / customer | 2.580,65 € |

Previous damage 1: Side - left

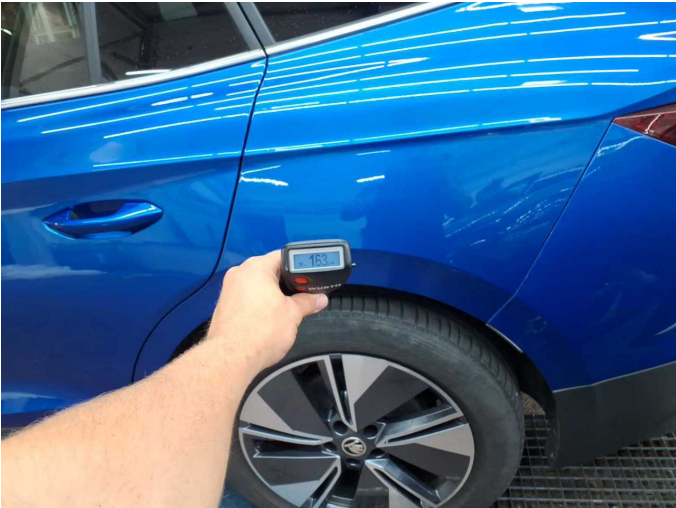
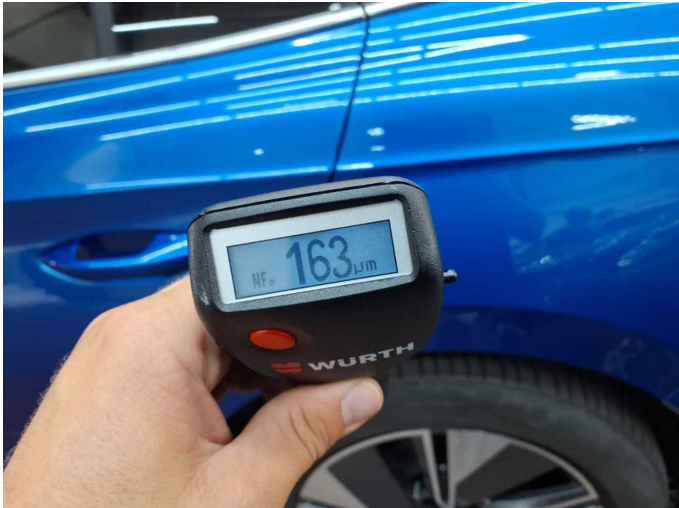
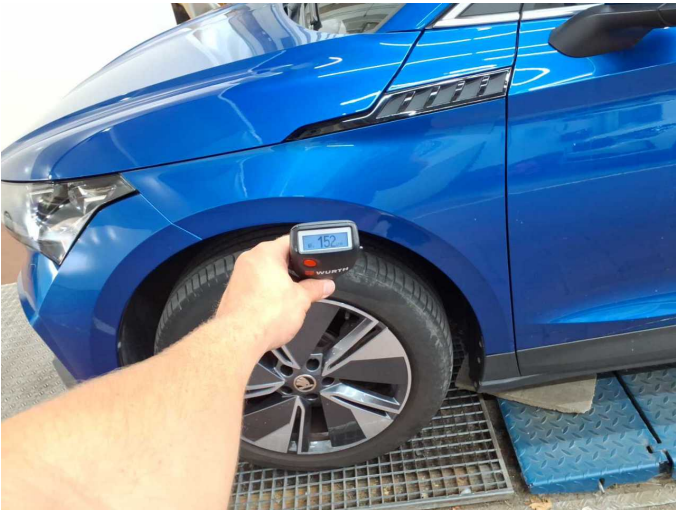
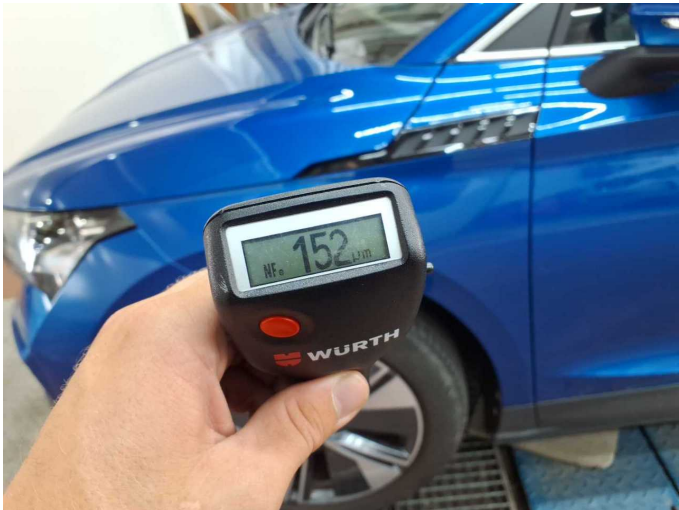
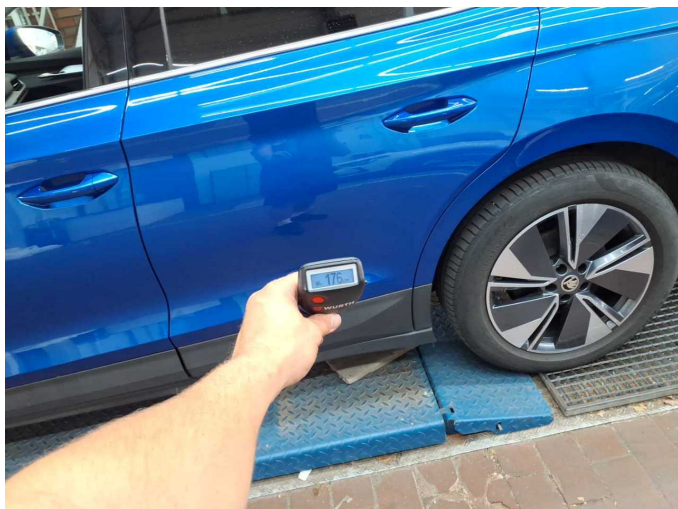
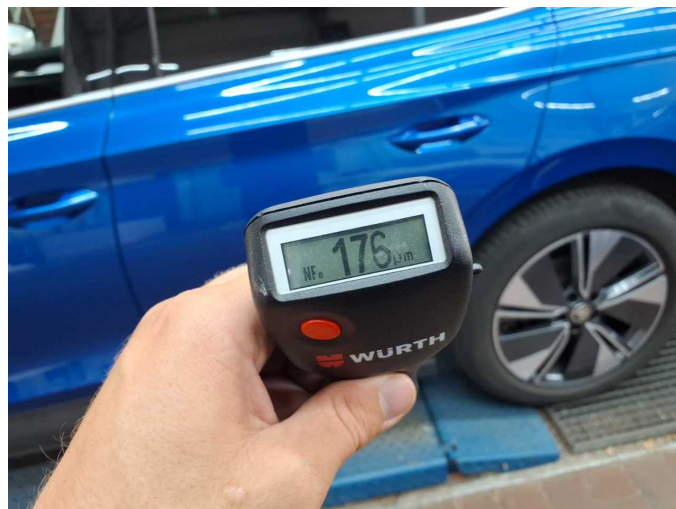
1 Mudguard - left side, Side panel - rear left side, Door - rear left side, Professionally carried out, Invoice of repair done Available

| Mudguard - left side | 152 µm | Side panel - rear left side | 163 µm |
| Door - rear left side | 176 µm | | |

Repainting 1: Mudguard - left side, Side panel - rear left side, Door - rear left side

**Repainting 1:** Mudguard - left side, Side panel - rear left side, Door - rear left side
