Expertise

Protocol number: 46505876  
Order No. / Reference: 26660744  
Inspection date: 14 Jul 2026

Manufacturer: Peugeot

Model: 508 SW Hybrid 225 e-EAT8 GT Pack

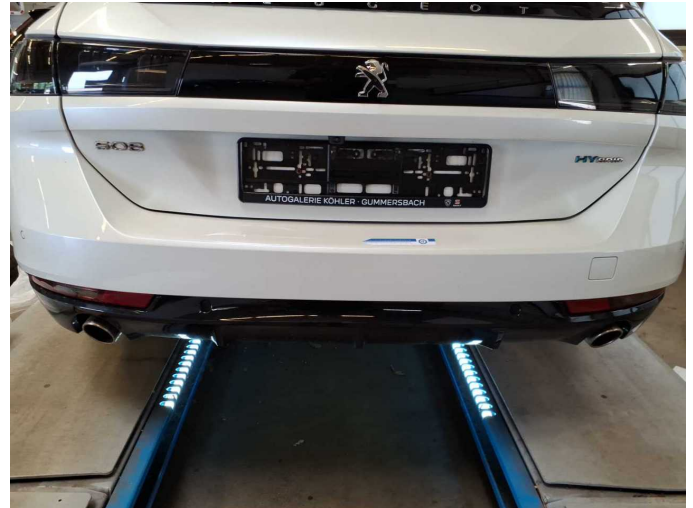
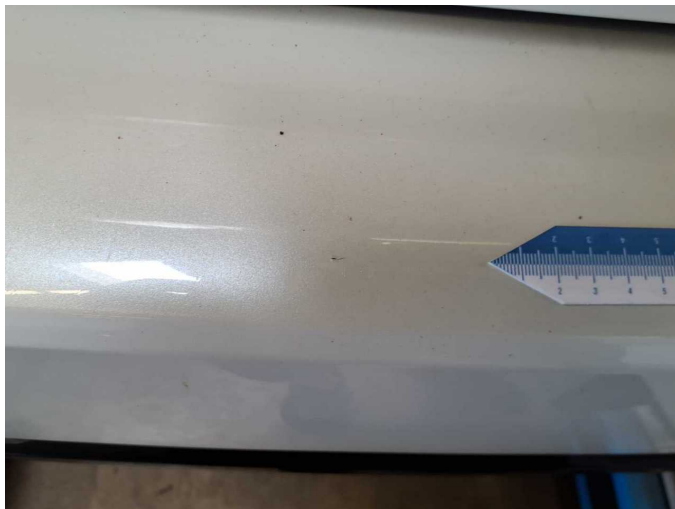
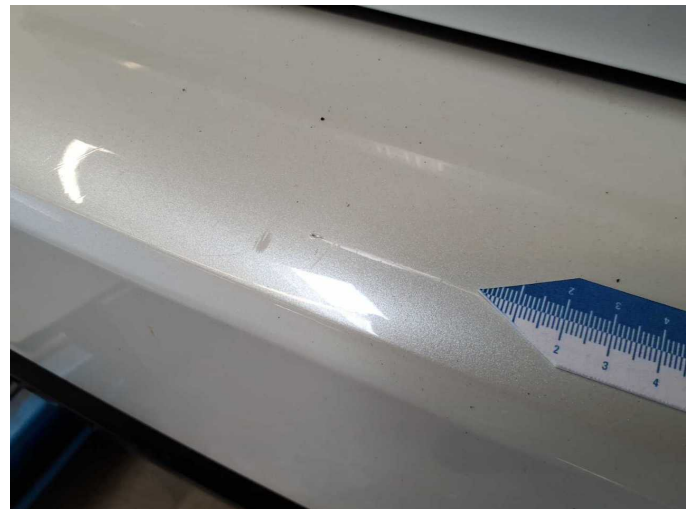
| No. | Component group | Description |
|---|---|---|
| 1 | Rear bumper | Rear bumper - Scratched - Smart repair |

**Damage 1:** Rear bumper: Rear bumper - Scratched - Smart repair

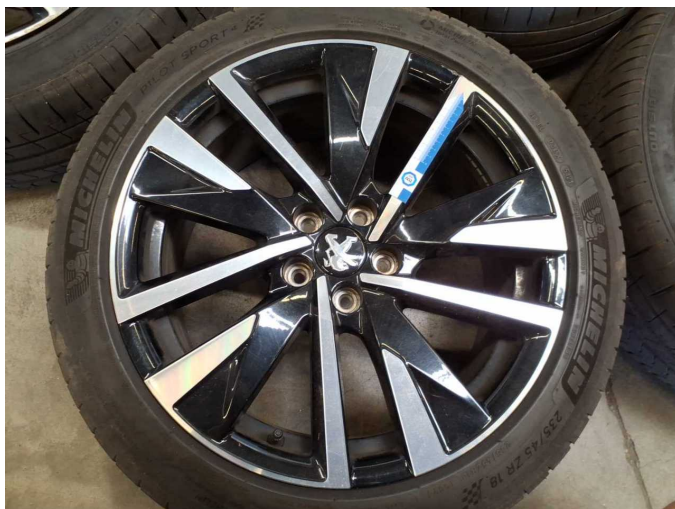
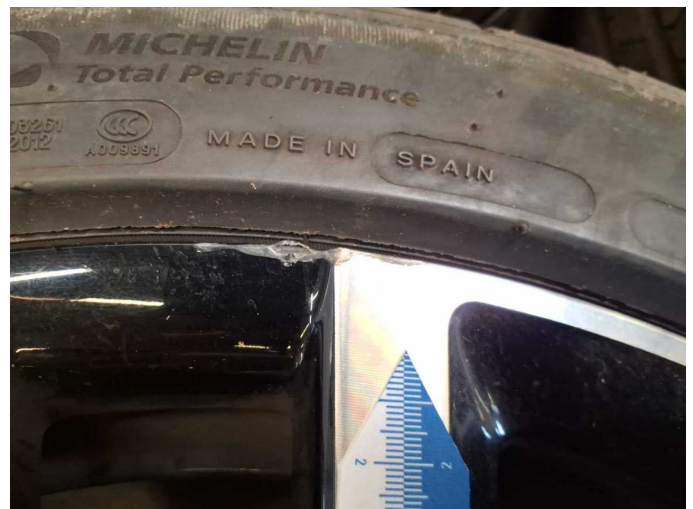
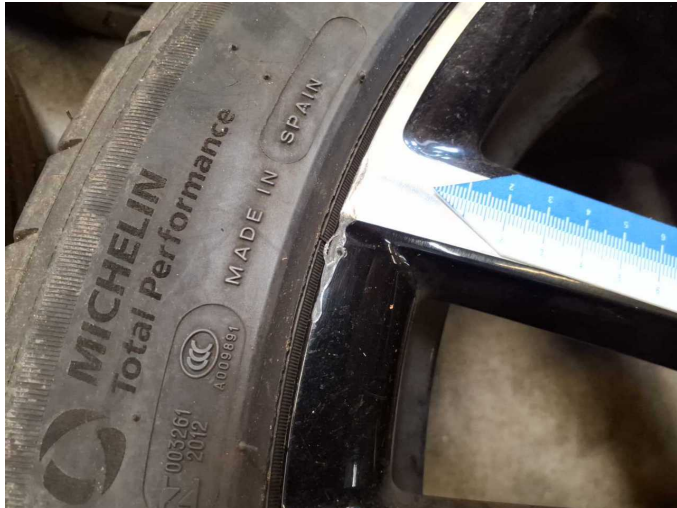
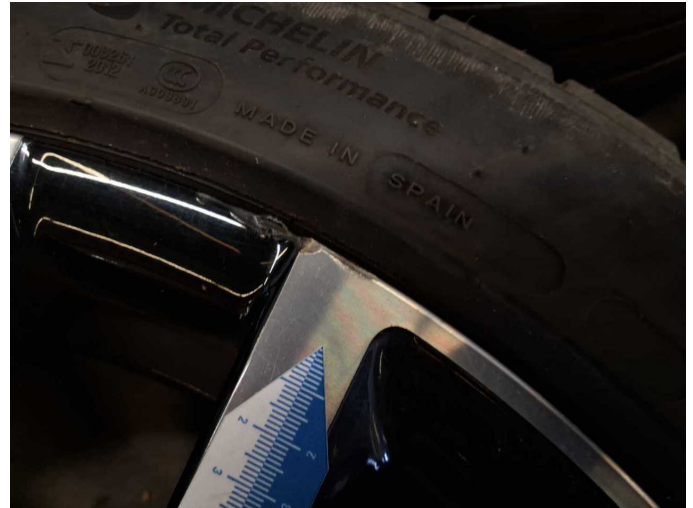
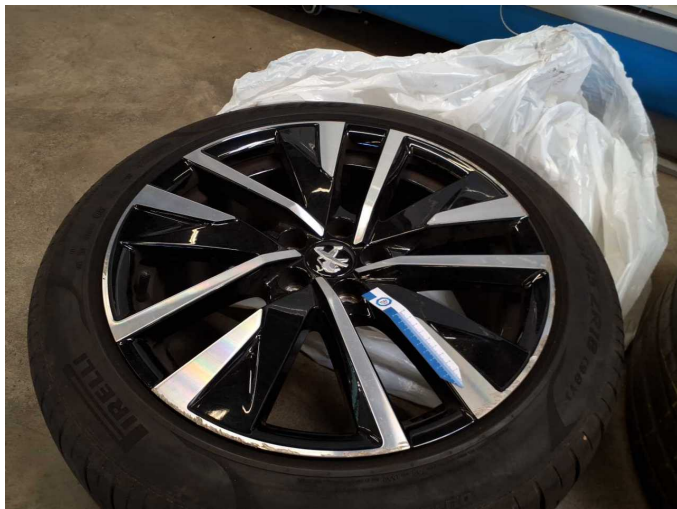
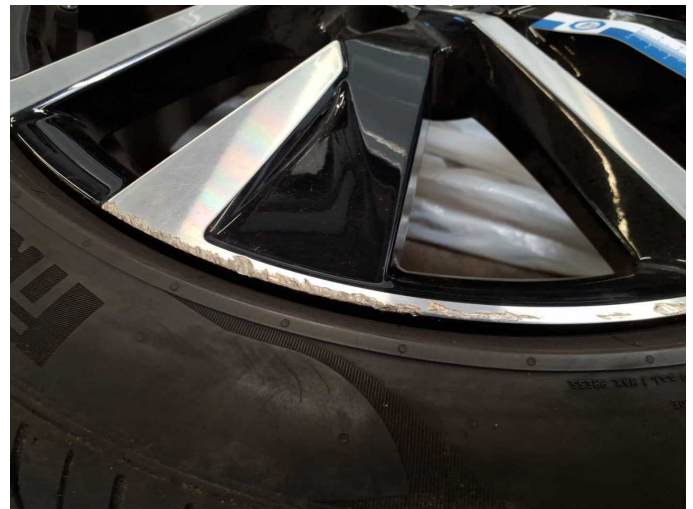
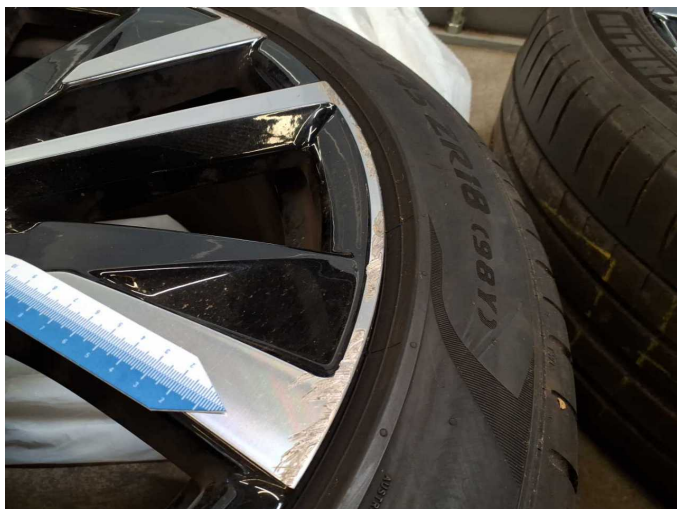
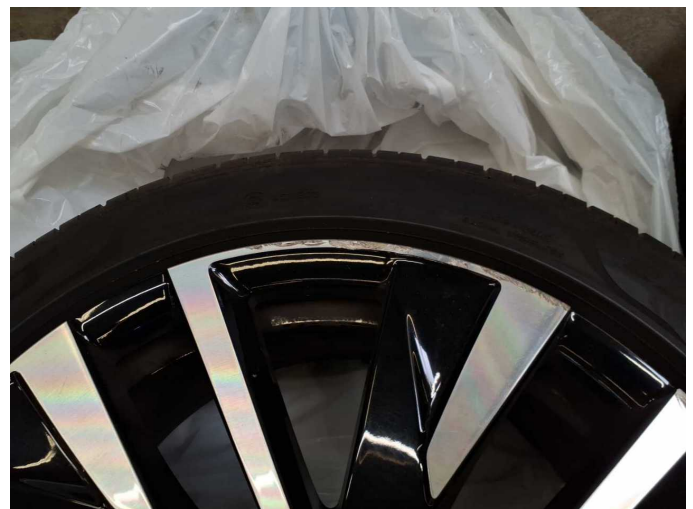
| No. | Component group | Description |
|---|---|---|
| 2 | 2nd wheel set | 2 alloy rims (Materialabtrag 18 Zoll) - Scratched - Loss in value |

**Damage 2:** 2nd wheel set: 2 alloy rims (Materialabtrag 18 Zoll) - Scratched - Loss in value

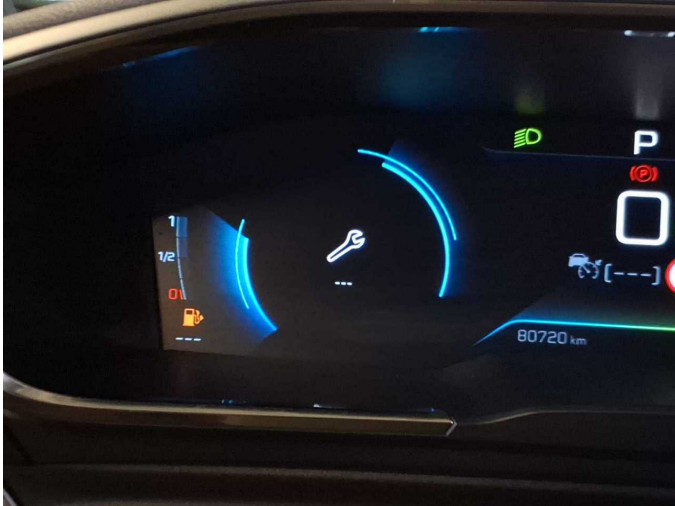
| No. | Component group | Description |
|---|---|---|
| 3 | Misc. | Inspection / maintenance - Due - Perform |

**Damage 3:** Misc.: Inspection / maintenance - Due - Perform

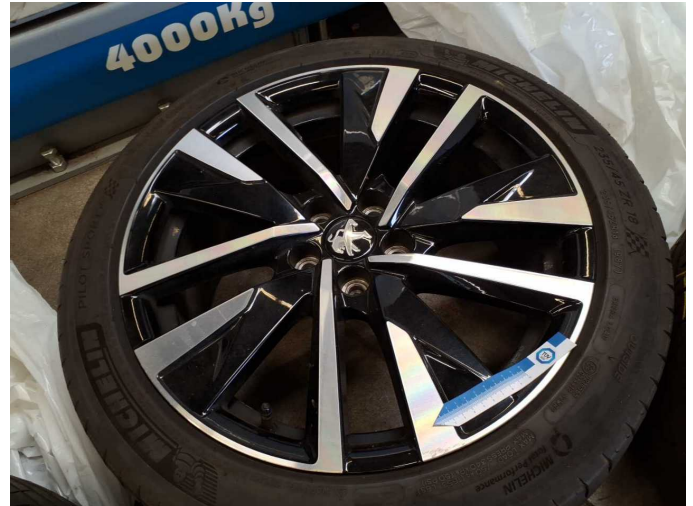
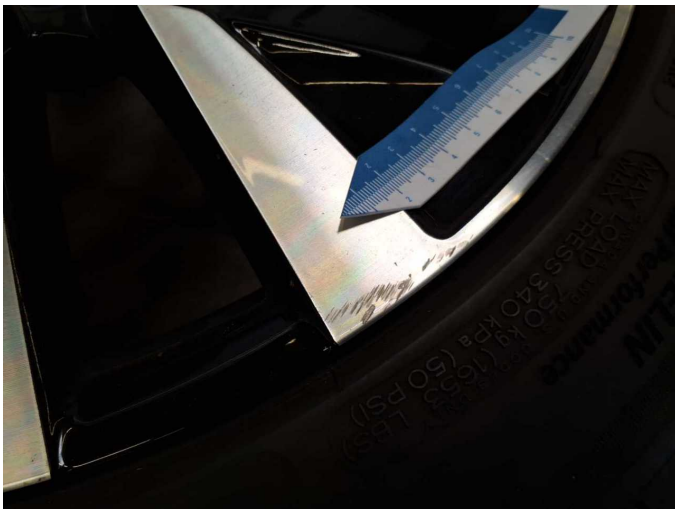
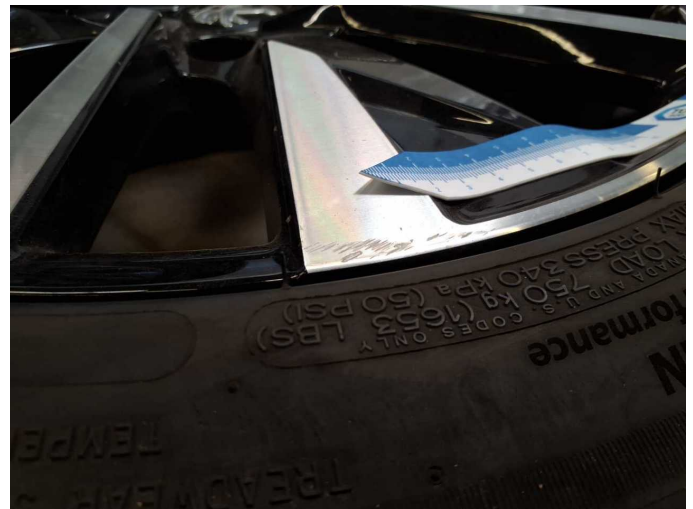
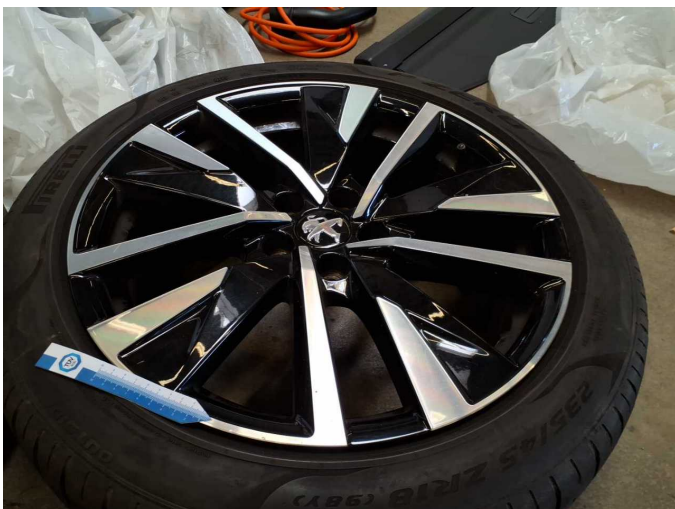
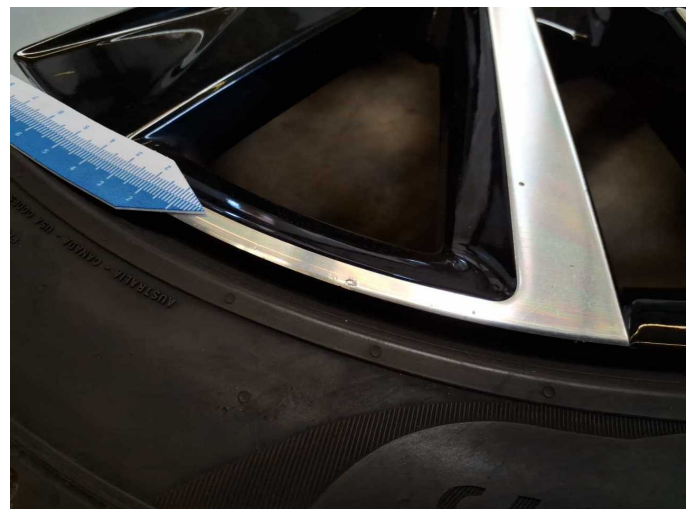
| No. | Component group | Description |
|---|---|---|
| 4 | 2nd wheel set | 2 alloy rims - Scratched - Loss in value |

**Damage 4:** 2nd wheel set: 2 alloy rims - Scratched - Loss in value

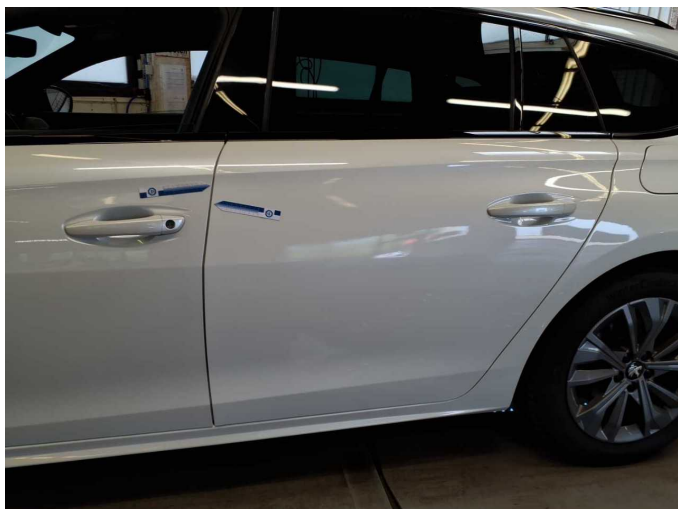
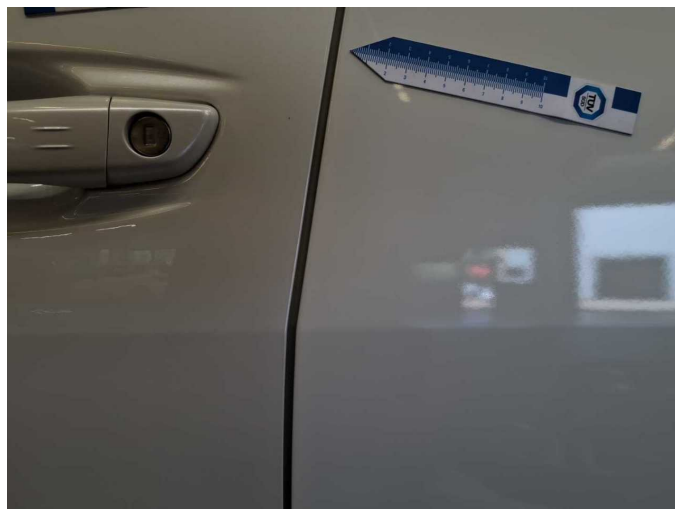
| No. | Component group | Description |
|---|---|---|
| 5 | Door - rear left side | Door (Farbabweichung) - Unprofessionally repaired - Lacquer |

| Side panel - rear left side | 766 µm | Door - rear left side | 202 µm |

**Damage 5:** Door - rear left side: Door (Farbabweichung) - Unprofessionally repaired - Lacquer

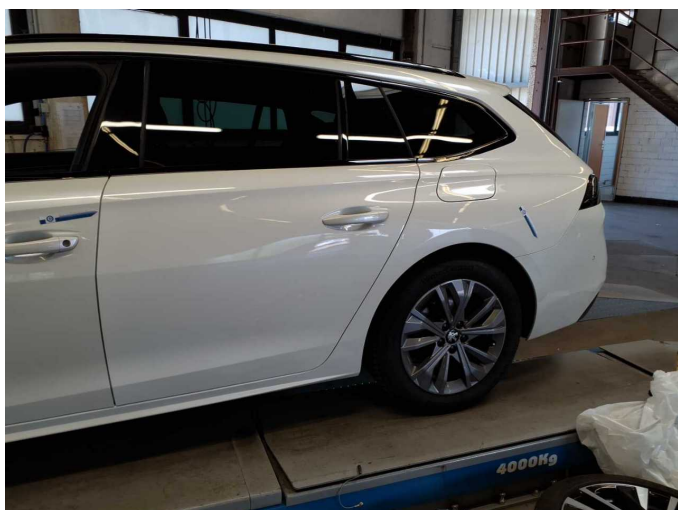
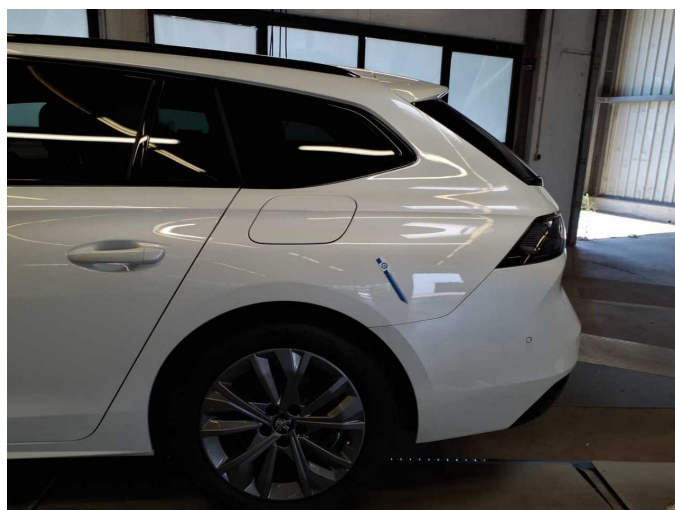
| No. | Component group | Description |
|---|---|---|
| 6 | Side panel - rear left side | Side panel (Farbabweichung) - Unprofessionally repaired - Lacquer |

**Damage 6:** Side panel - rear left side: Side panel (Farbabweichung) - Unprofessionally repaired - Lacquer

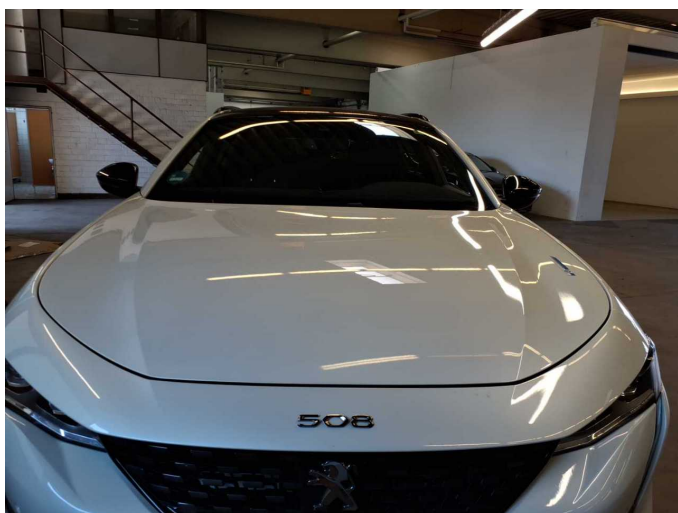
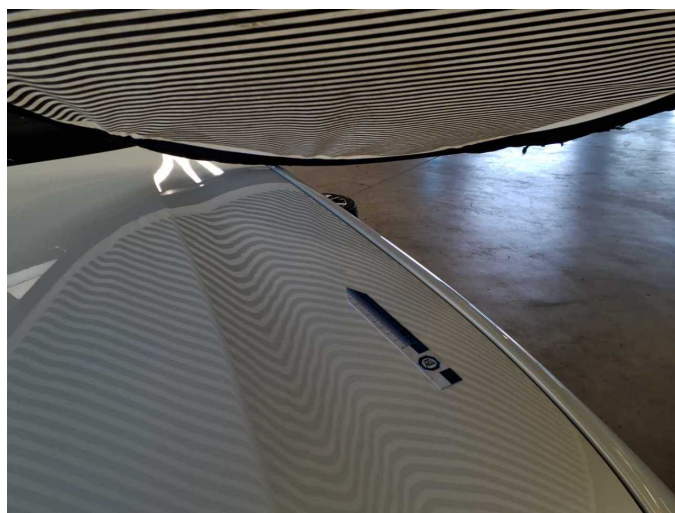
| No. | Component group | Description |
|---|---|---|
| 1 | Bonnet | Bonnet - dent(s) - Smooth repair work |

**Wear and tear 1:** Bonnet: Bonnet - dent(s) - Smooth repair work

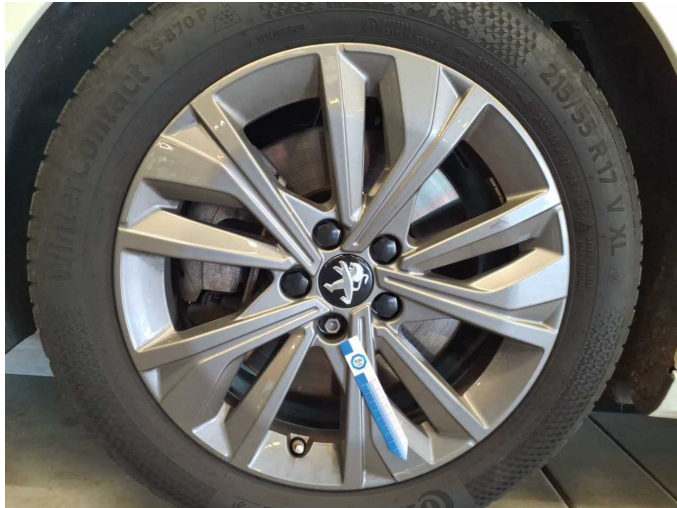
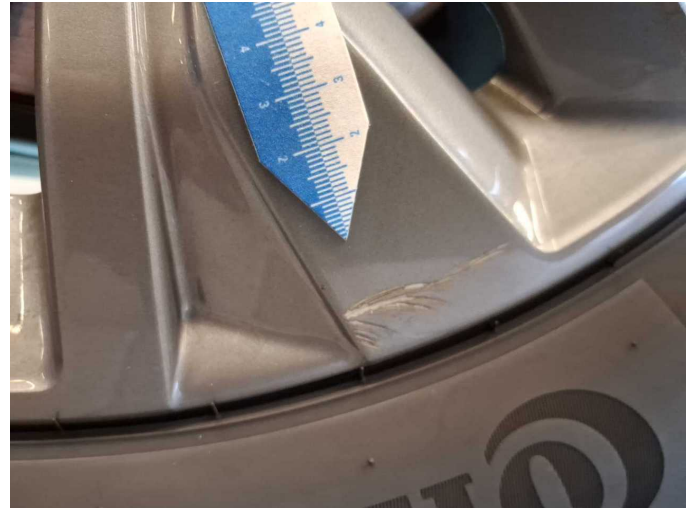
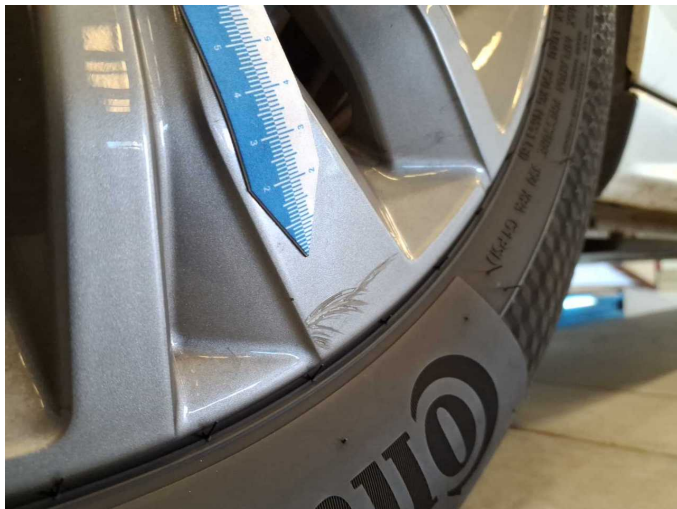
| No. | Component group | Description |
|---|---|---|
| 2 | Wheel / tyres | Wheel rim - front left side - Scratched - No deduction |

**Wear and tear 2:** Wheel / tyres: Wheel rim - front left side - Scratched - No deduction

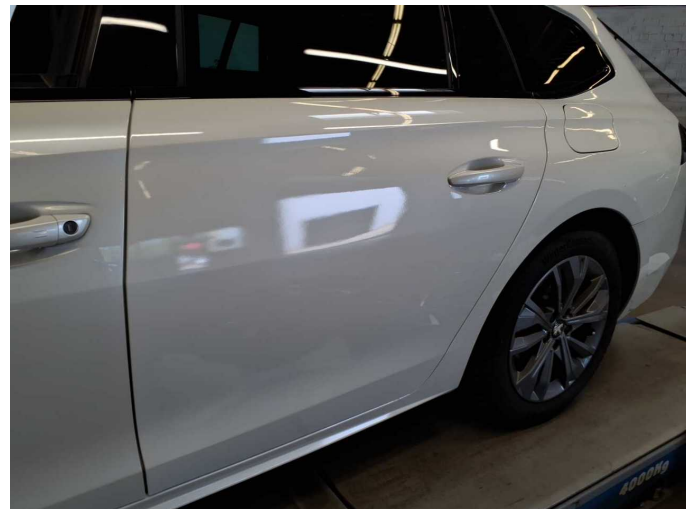
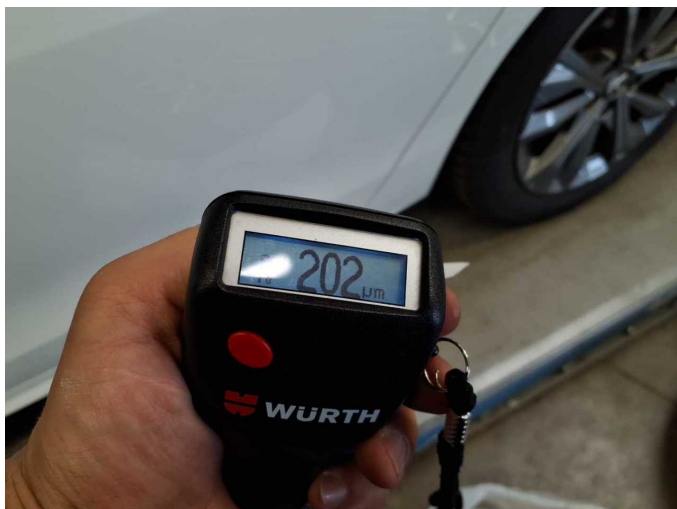
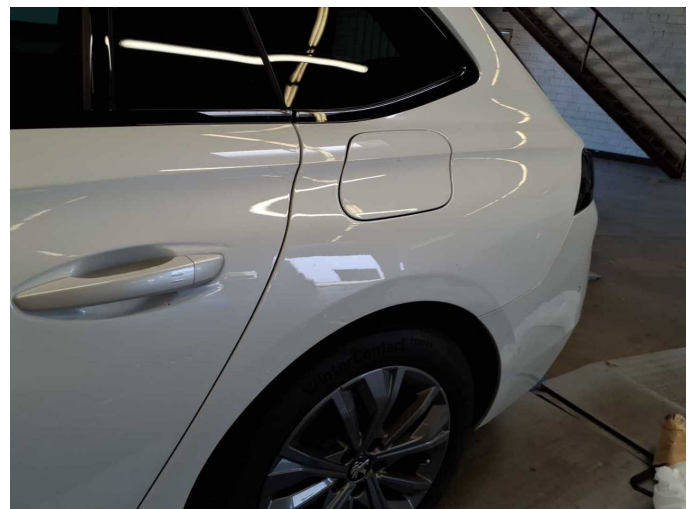
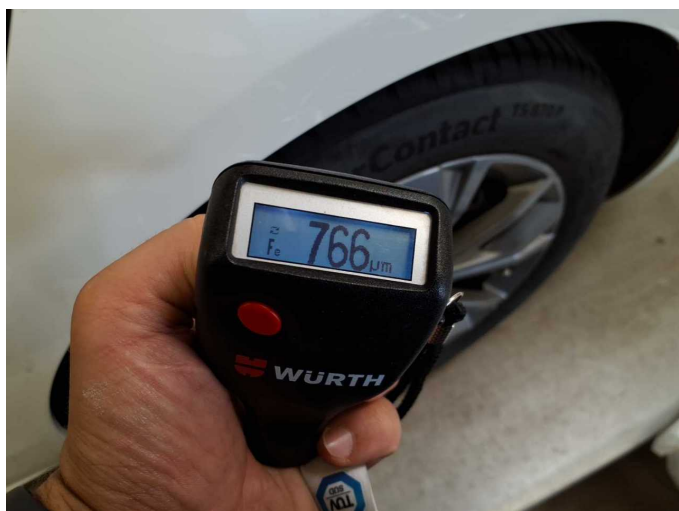
| No. | Repainting |
|---|---|
| 1 | Side panel - rear left side, Door - rear left side |

**Repainting 1:** Side panel - rear left side, Door - rear left side
