Expertise

Protocol number: 45803168
Order No. / Reference: 26410868
Inspection date: 1 Jun 2026

Manufacturer: Volkswagen

Model: Passat Variant 1.4 TSI Plug-In-Hybrid DSG GTE

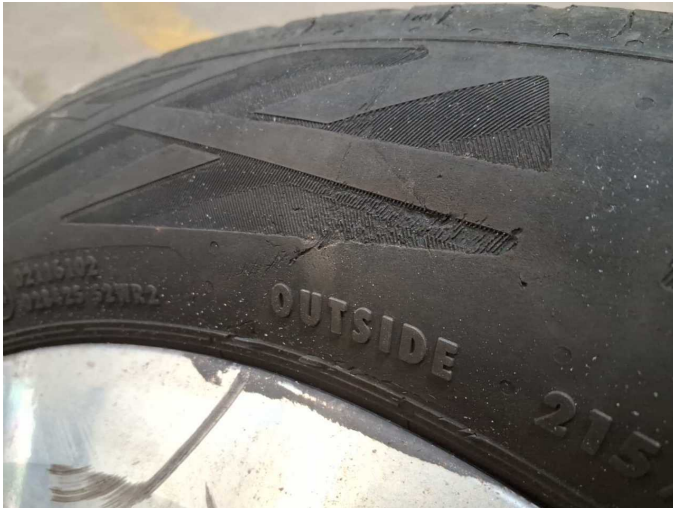
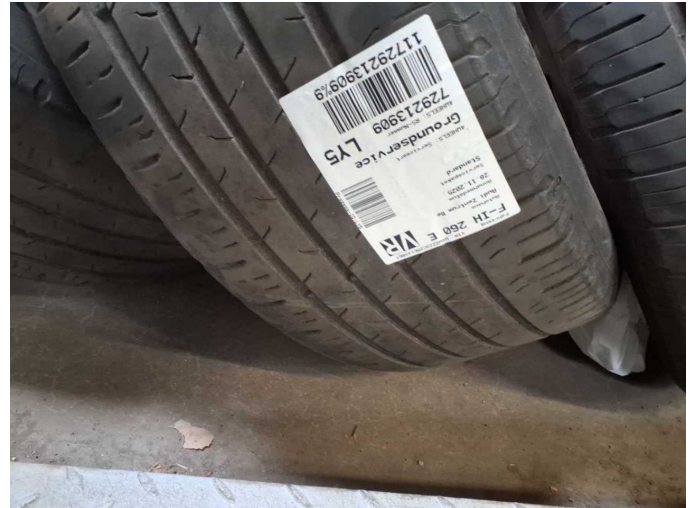
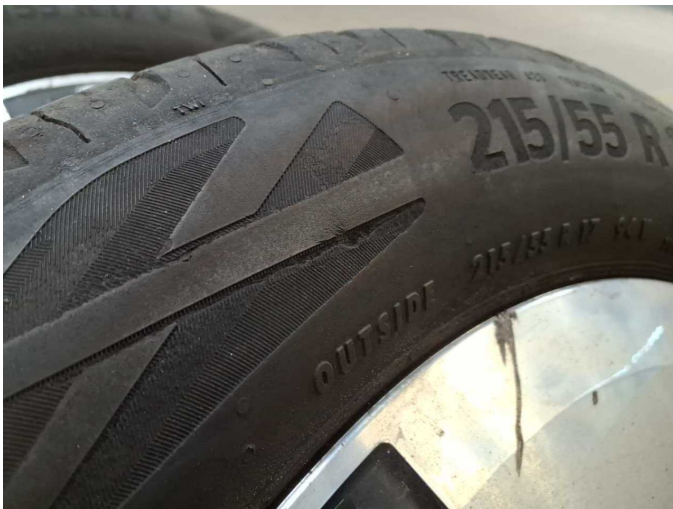
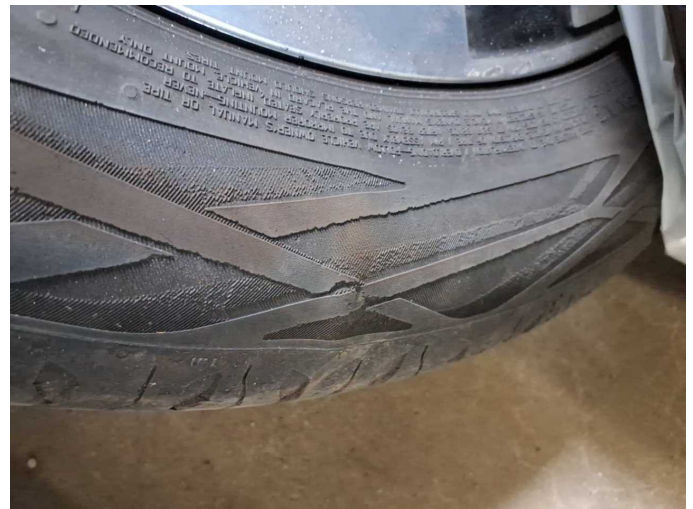
Damage 1: 2nd wheel set: 2 tyres (Flanke Sommerreifen) - Damaged - Replace

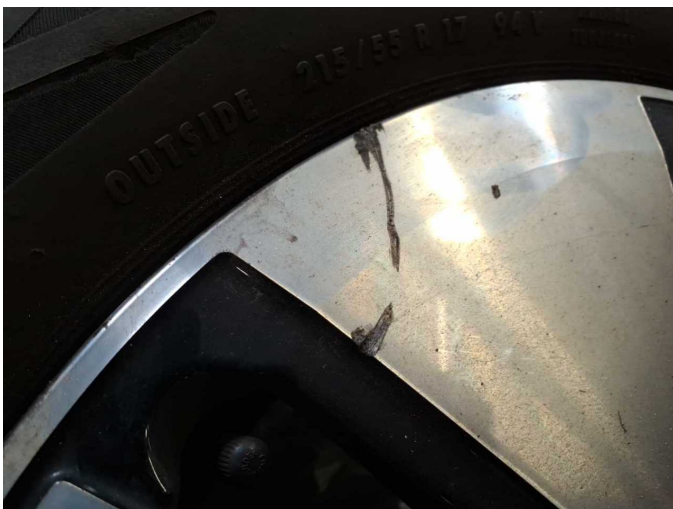
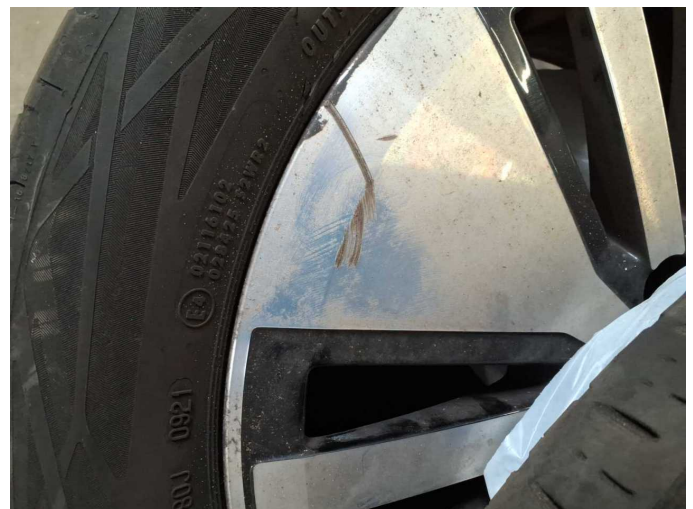
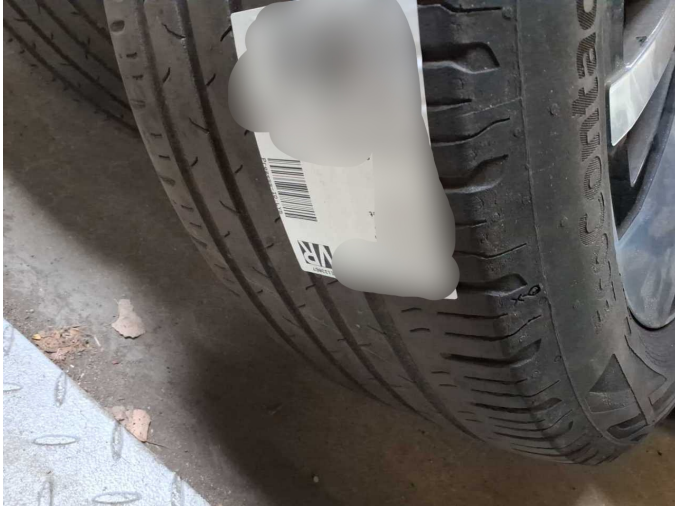
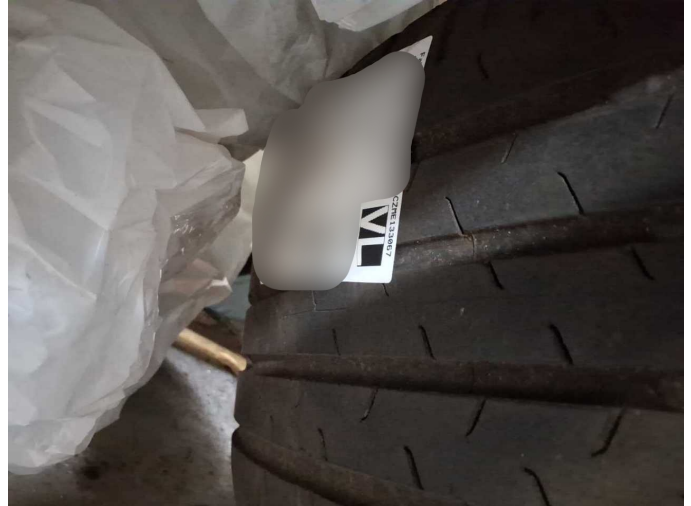
Damage 2: 2nd wheel set: 2 alloy rims - Scratch(es) - Loss in value

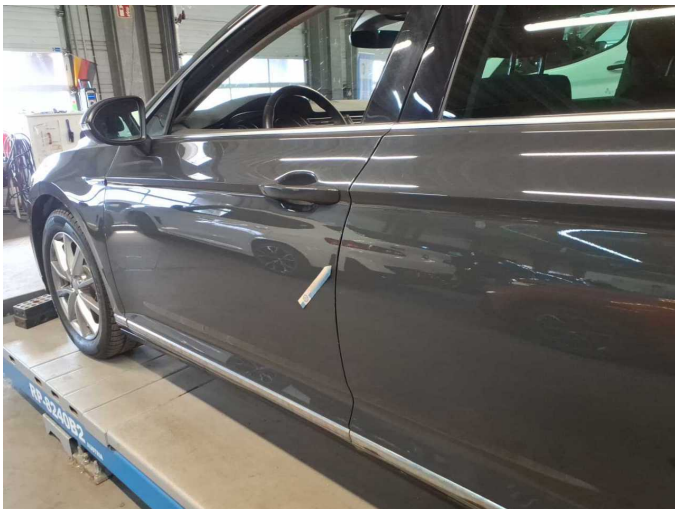
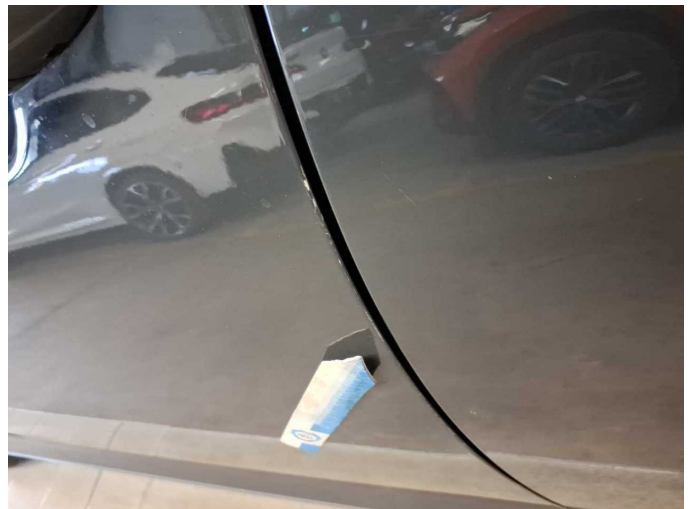
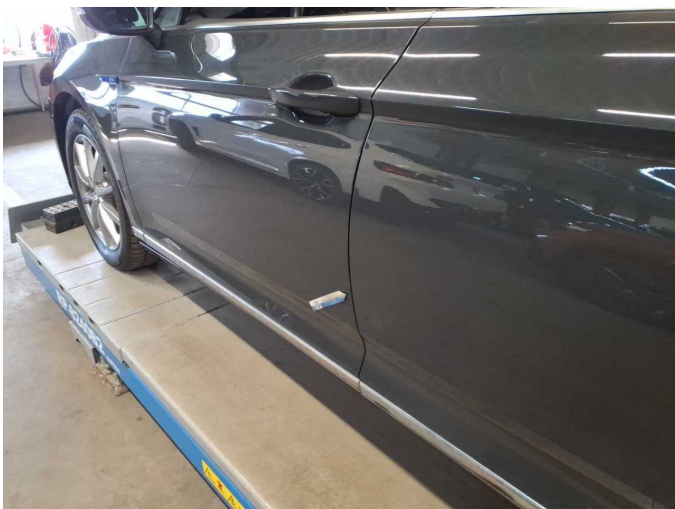
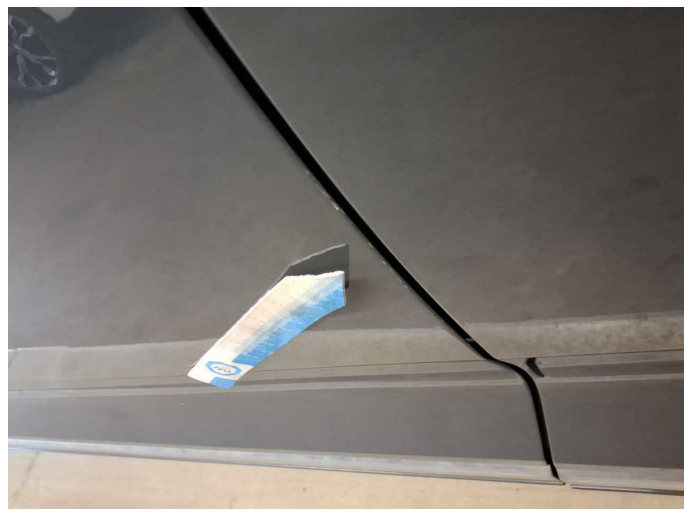
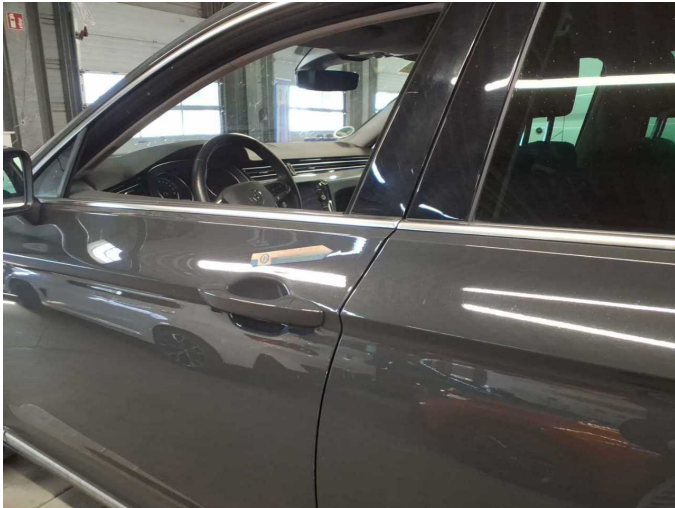
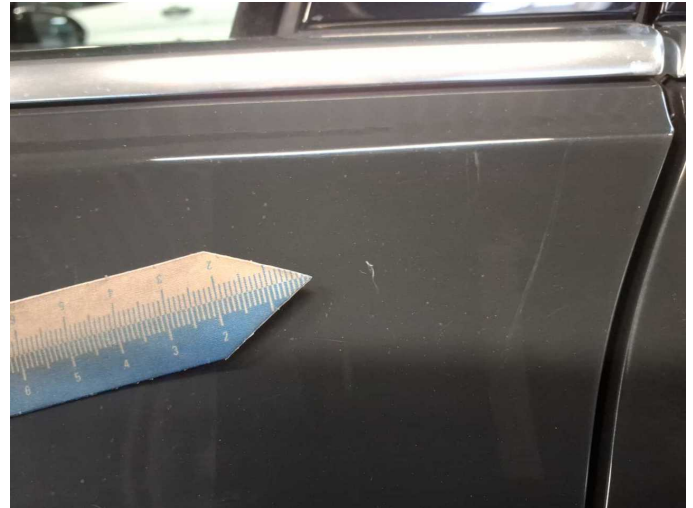
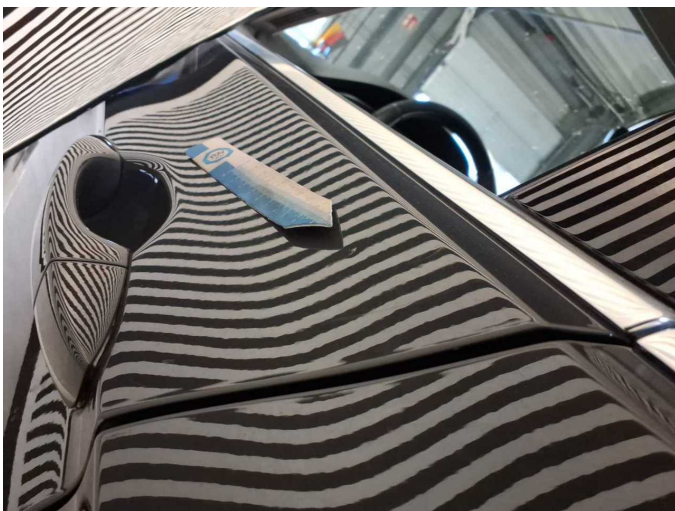
Damage 3: Door - front left side: Door - Dent / paintcoat damage - Paint

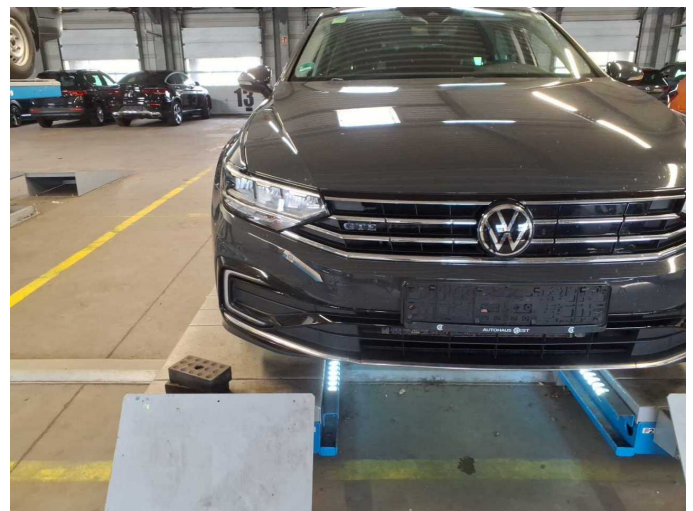
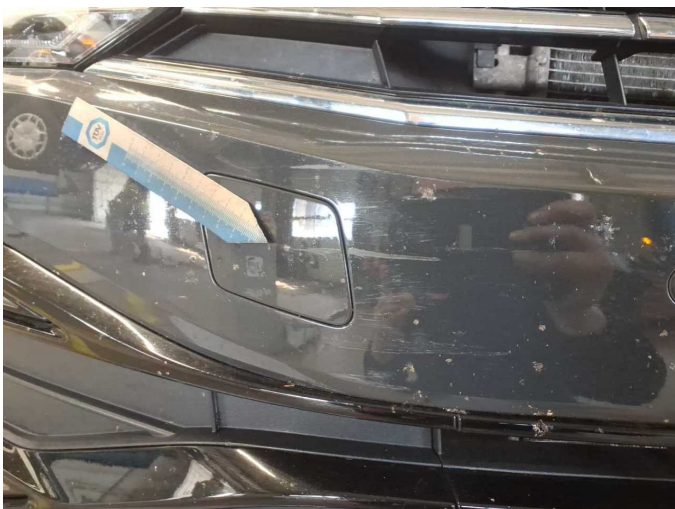
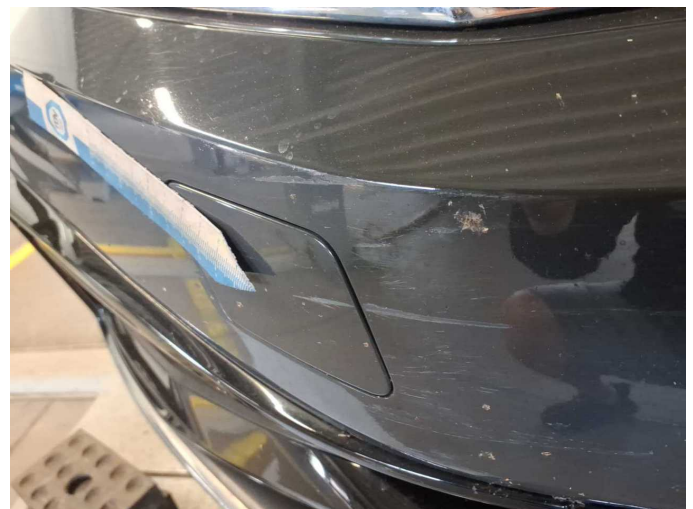
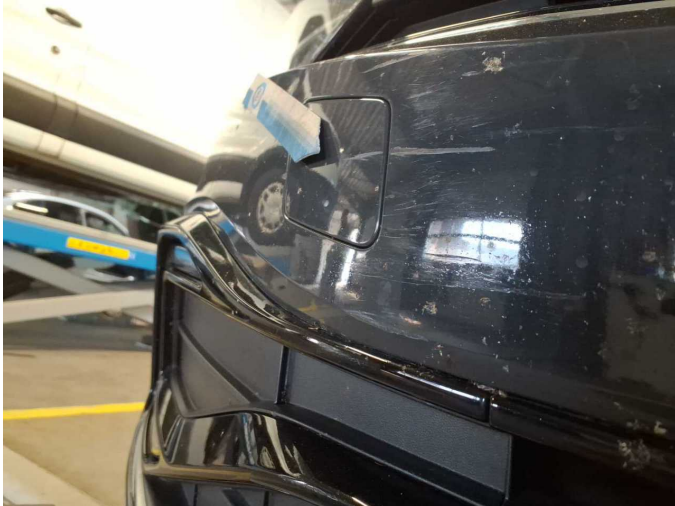
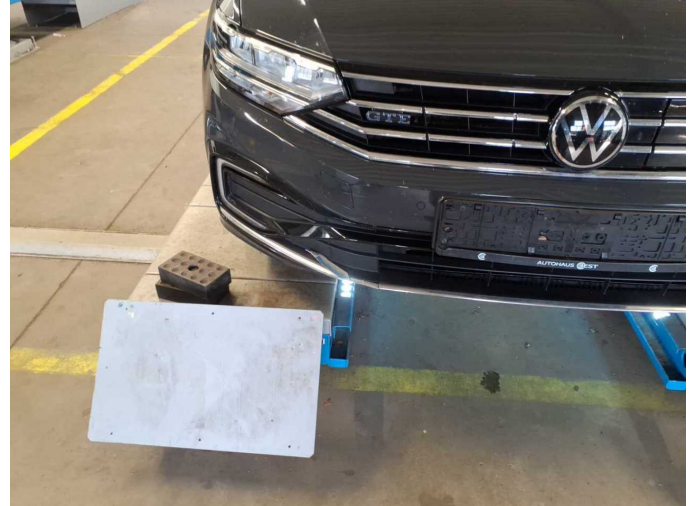
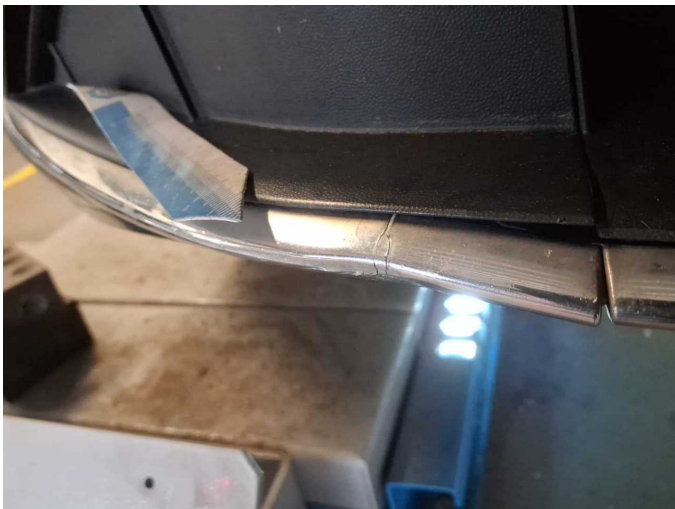
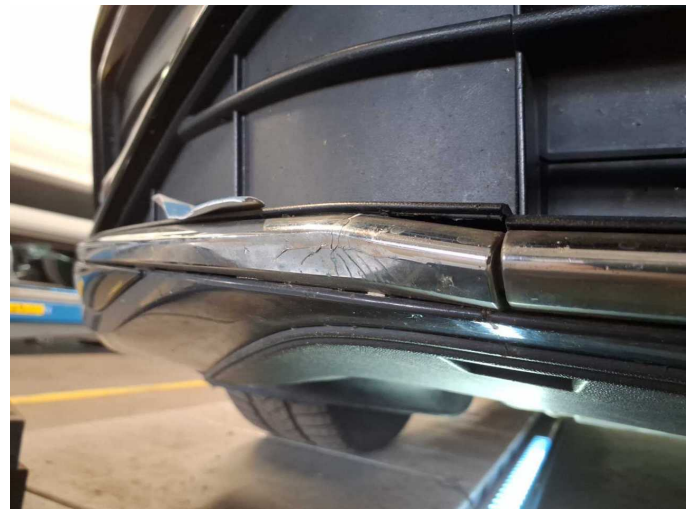
Damage 4: Front bumper: Front bumper (+ Zierleiste rechts erneuern) - Scratch(es) - Paint

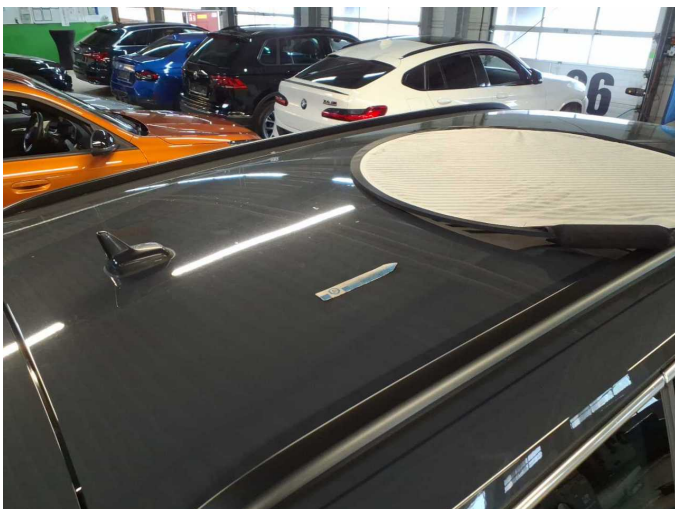
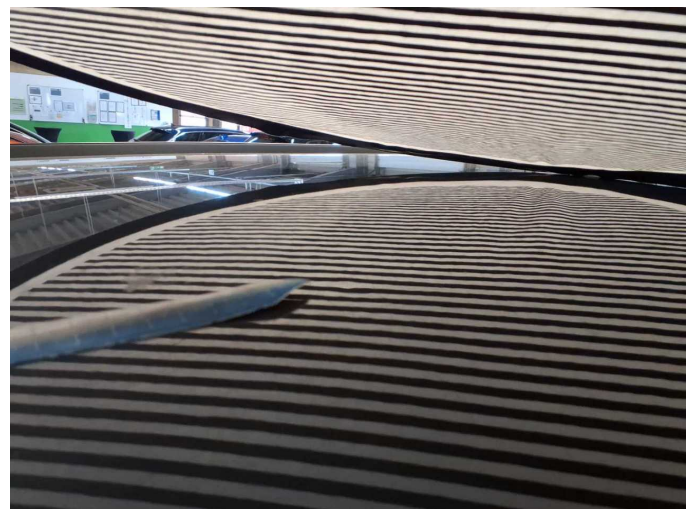
Wear and tear 2: Roof: Roof - dent(s) - No deduction

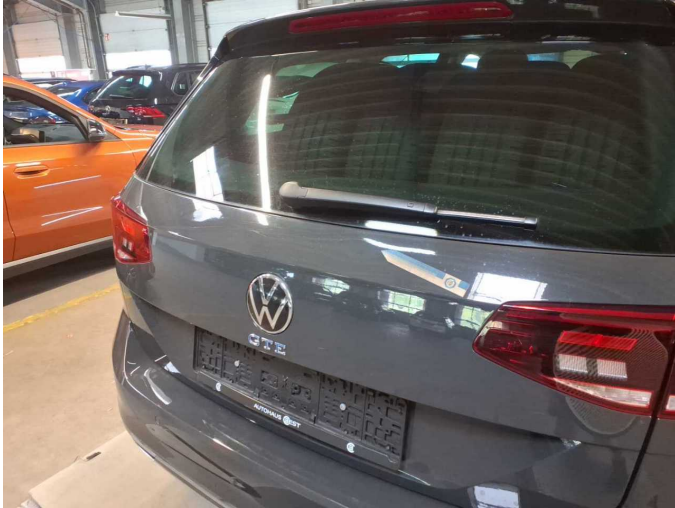
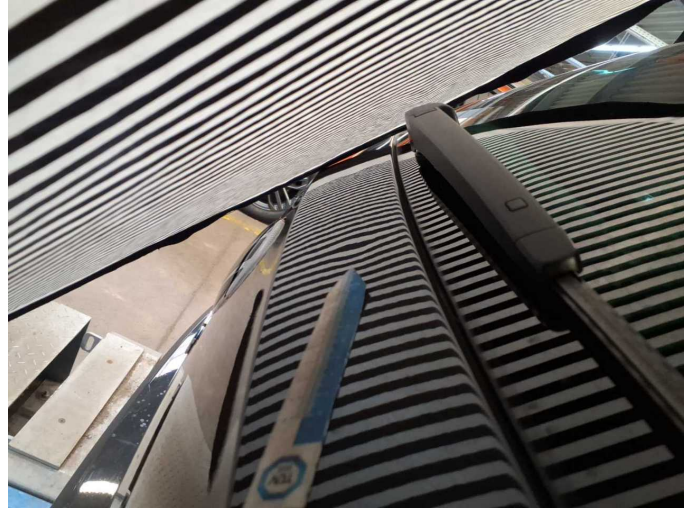
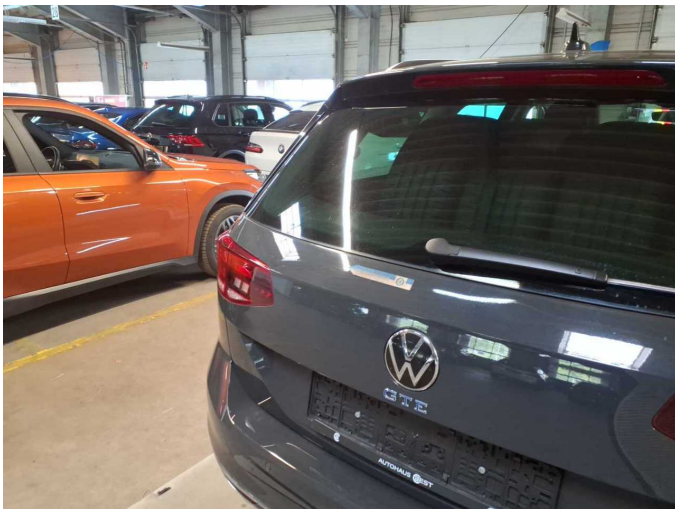
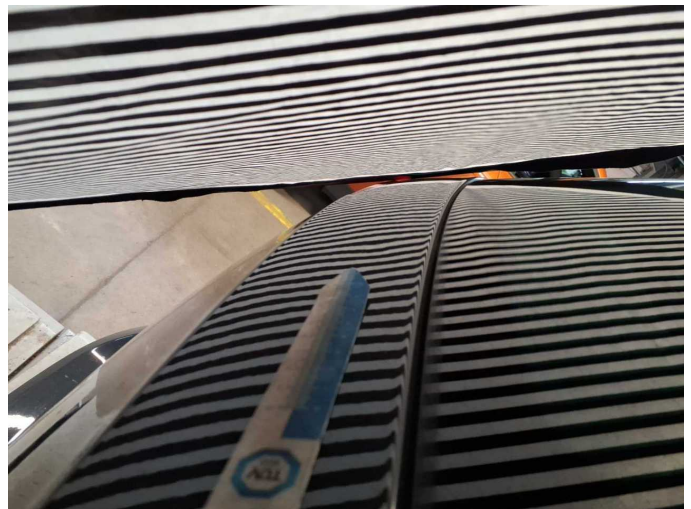
Wear and tear 3: Boot lid / rear door: Boot lid - dent(s) - No deduction

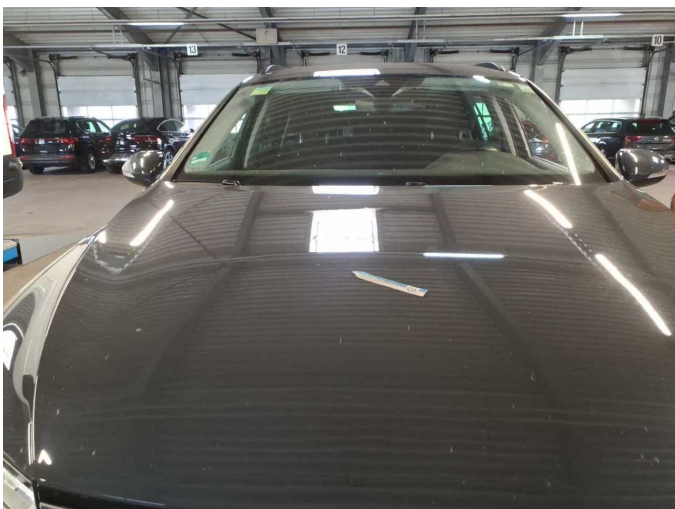
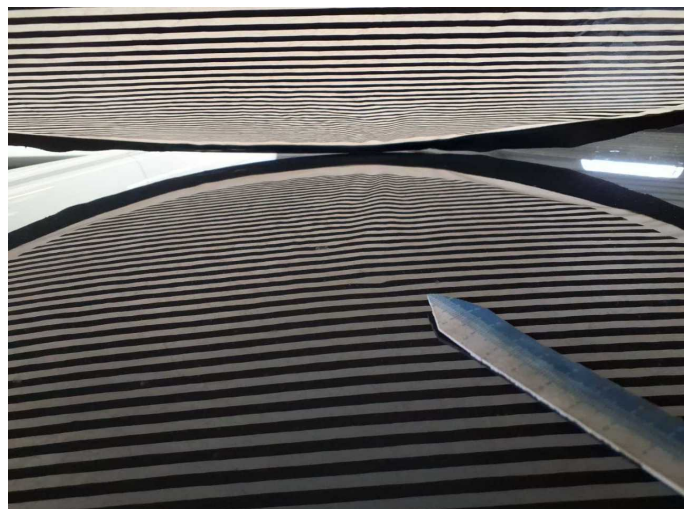
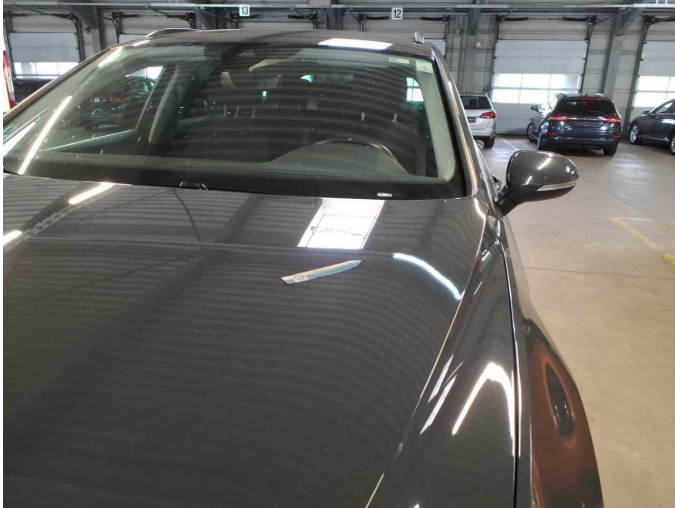
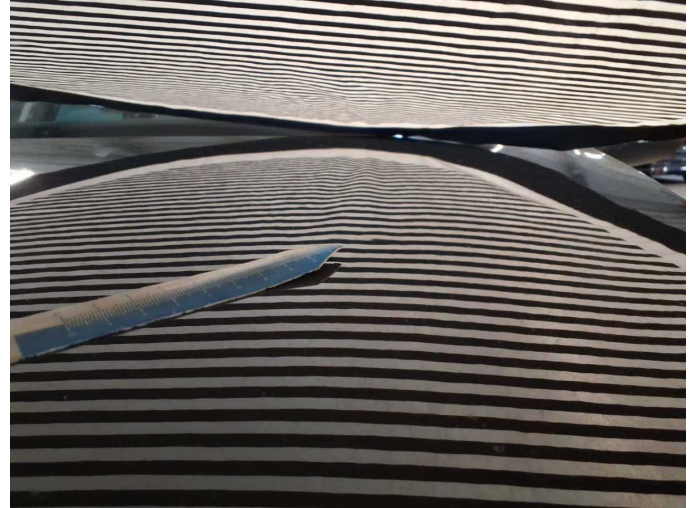
Wear and tear 4: Bonnet: Bonnet - dent(s) - No deduction

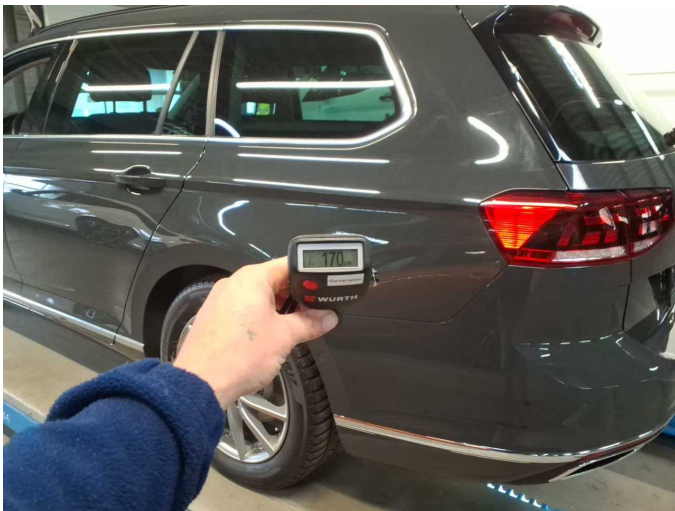
Repainting 1: Side panel - rear left side

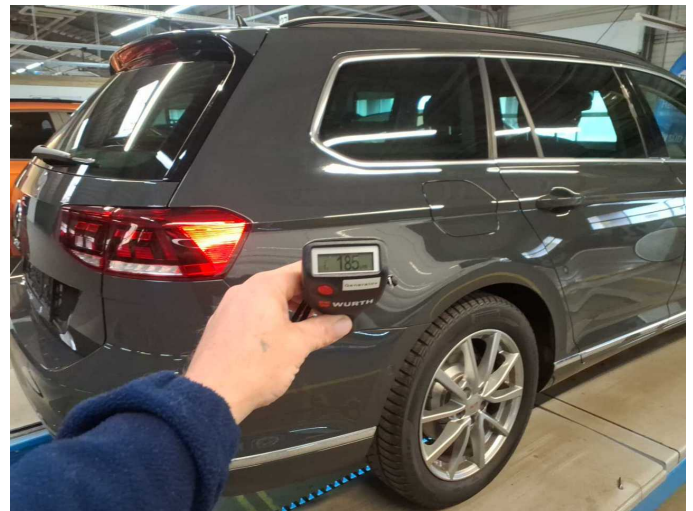
Repainting 2: Side panel - rear right side
