Expertise

Protocol number: 45751095
Order No. / Reference: 26510333
Inspection date: 2 Jun 2026

Manufacturer: Volkswagen

Model: Crafter 35 TDI MR HA

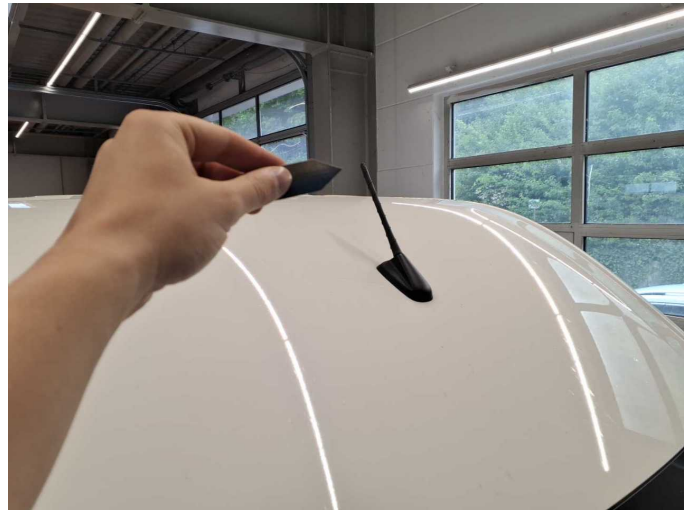
No.	Component group	Description
1	Roof	Stub aerial - Damage caused by marten / rodent - Replace
2	Electronic systems	Electronic systems (Reifendruckkontrollsystem) - Electrical fault - Perform diagnosis
3	Side panel - rear left side	Side panel - dent(s) - Smart repair
4	Bonnet	Bonnet - Stone chips - Repair and paint
5	Side panel - rear right side	Side panel - dent(s) - Repair and paint

Damage 1: Roof: Stub aerial - Damage caused by marten / rodent - Replace

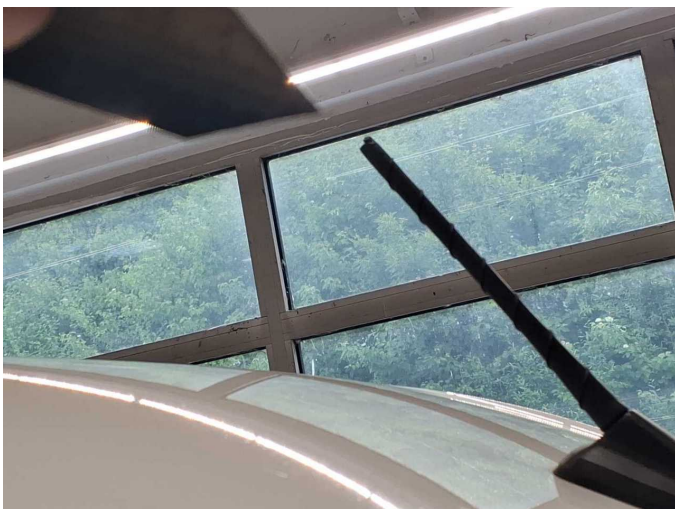
Damage 1: Roof: Stub aerial - Damage caused by marten / rodent - Replace

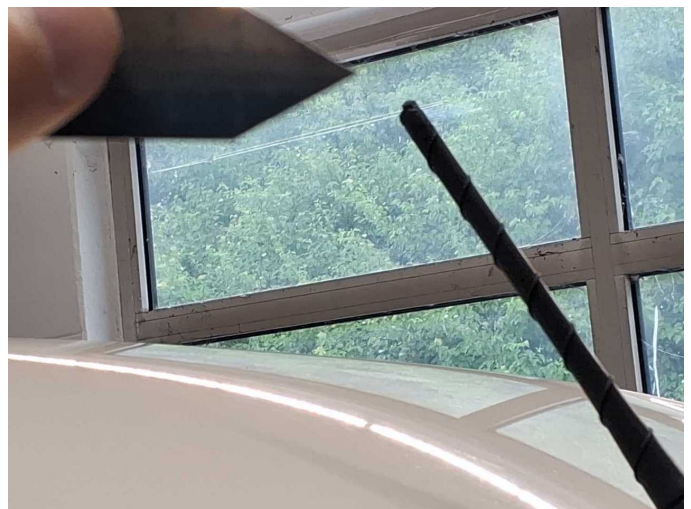
Damage 1: Roof: Stub aerial - Damage caused by marten / rodent - Replace

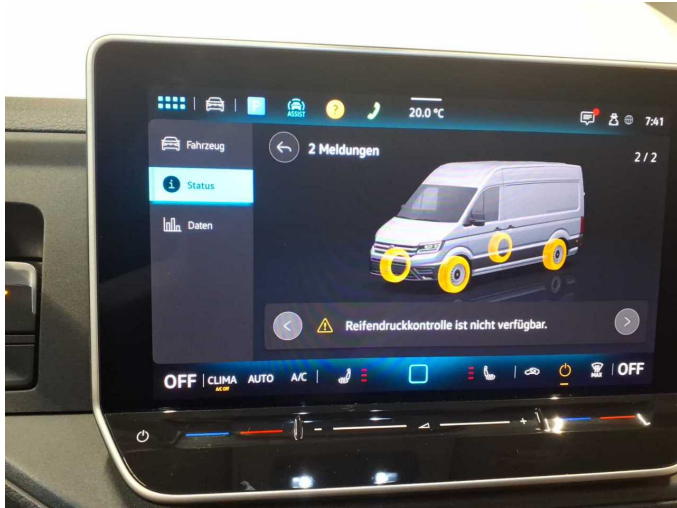
Damage 2: Electronic systems: Electronic systems (Reifendruckkontrollsystem) - Electrical fault - Perform diagnosis

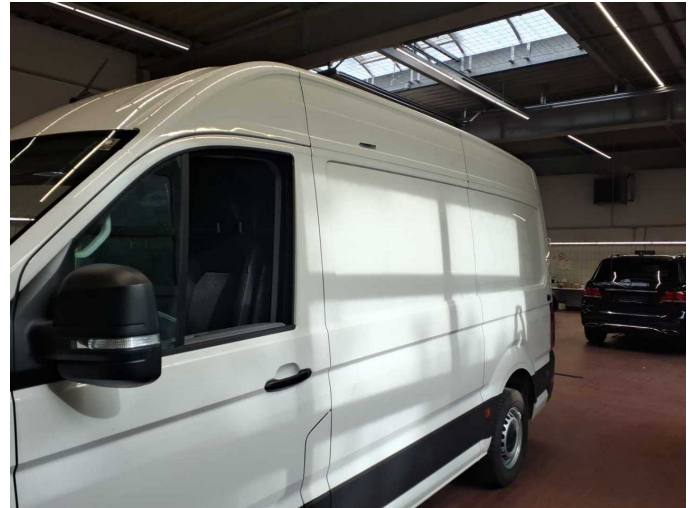
Damage 3: Side panel - rear left side: Side panel - dent(s) - Smart repair

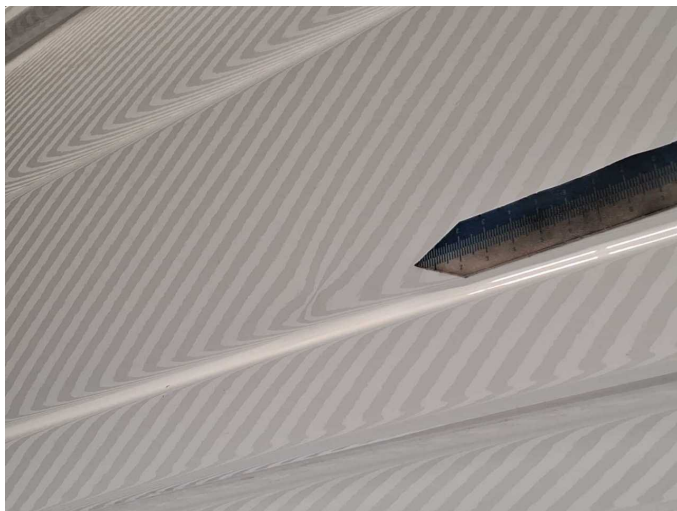
Damage 3: Side panel - rear left side: Side panel - dent(s) - Smart repair

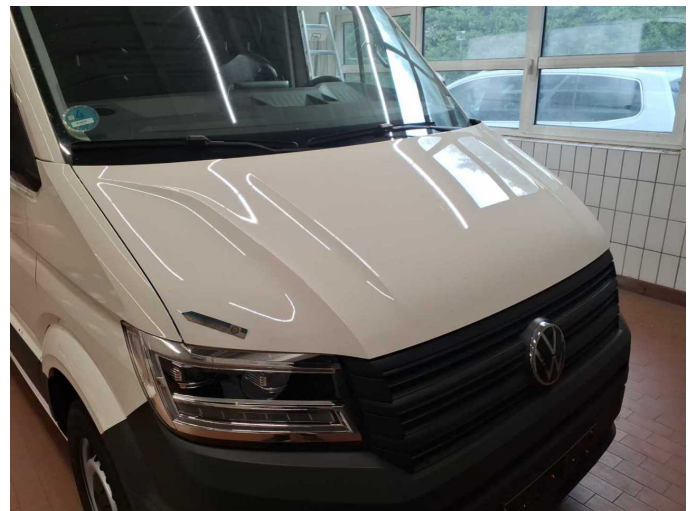
Damage 4: Bonnet: Bonnet - Stone chips - Repair and paint

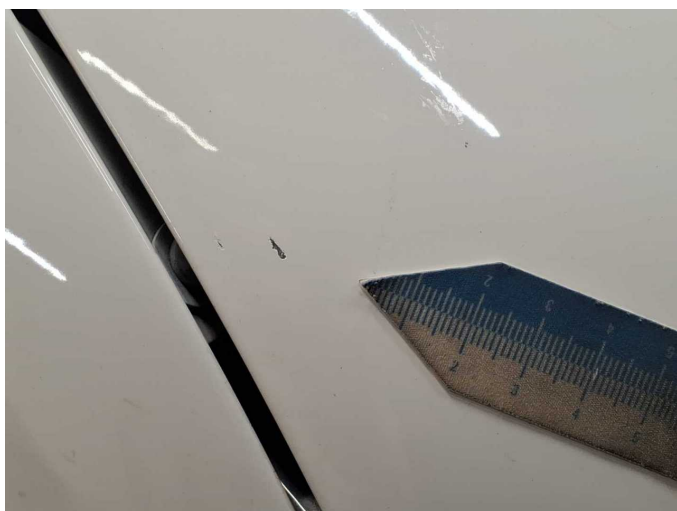
Damage 4: Bonnet: Bonnet - Stone chips - Repair and paint

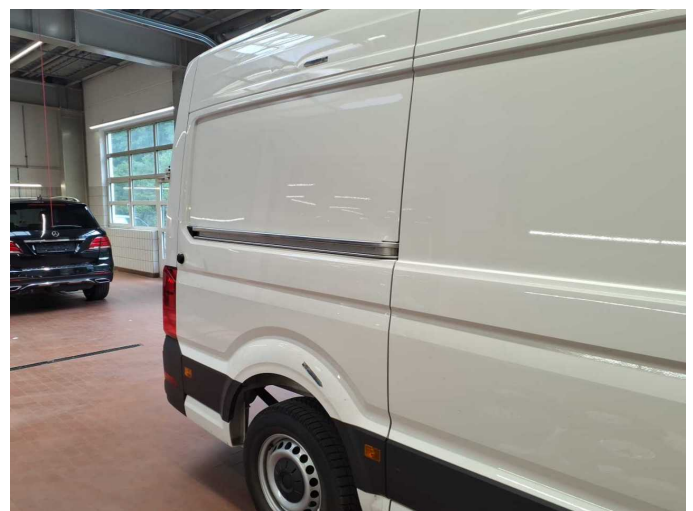
Damage 5: Side panel - rear right side: Side panel - dent(s) - Repair and paint

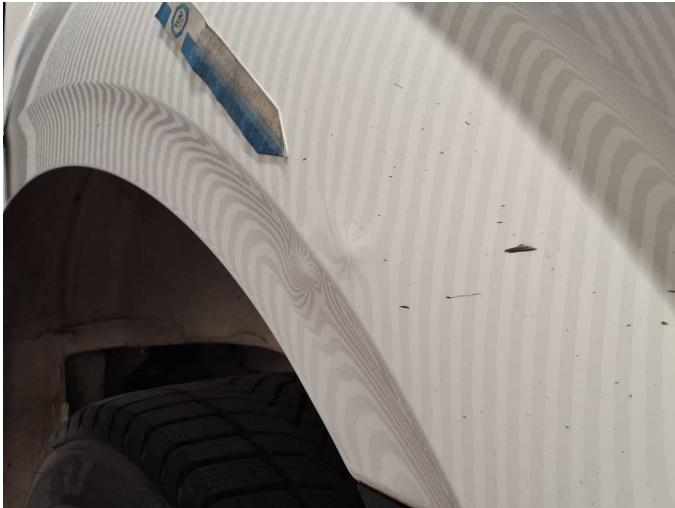
Damage 5: Side panel - rear right side: Side panel - dent(s) - Repair and paint

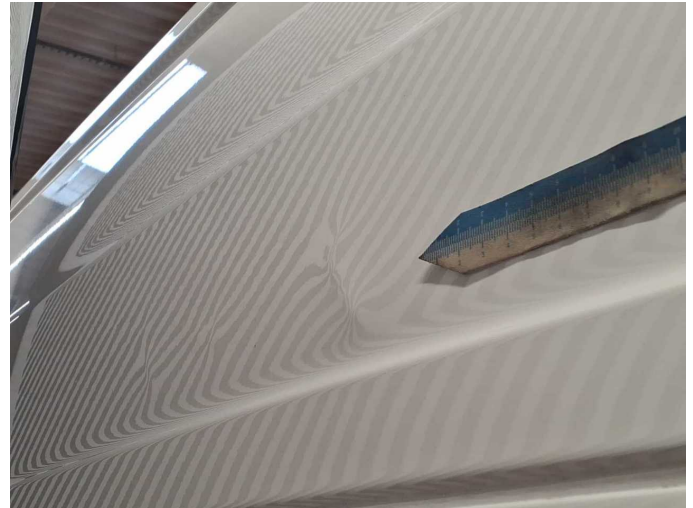
Damage 5: Side panel - rear right side: Side panel - dent(s) - Repair and paint

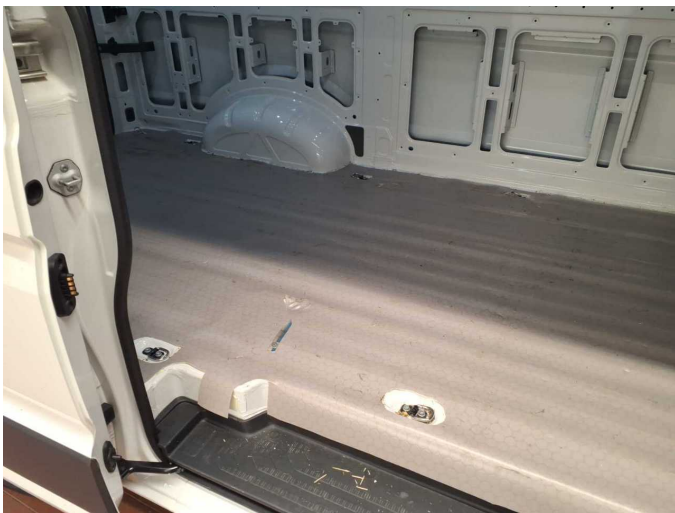
No.	Component group	Description
1	Interior	Cargo area floor - Broken / torn - No deduction
2	Interior	Interior - Scratch(es) - No deduction

Wear and tear 1: Interior: Cargo area floor - Broken / torn - No deduction

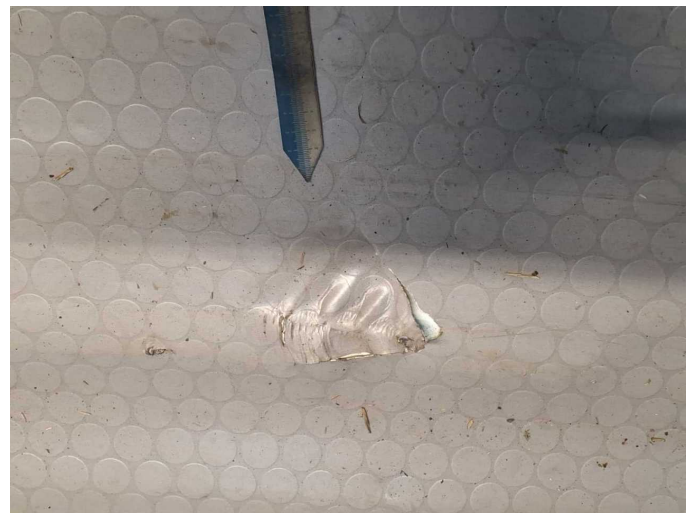
Wear and tear 1: Interior: Cargo area floor - Broken / torn - No deduction

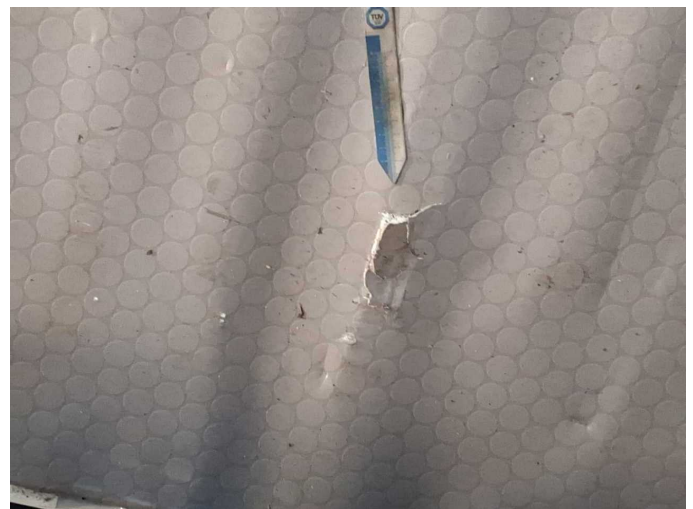
Wear and tear 1: Interior: Cargo area floor - Broken / torn - No deduction
