Expertise

Protocol number: 46242292
Order No. / Reference: 26588205
Inspection date: 29 Jun 2026

Manufacturer: Ford

Model: Transit 350 L3H3 Lkw VA Trend

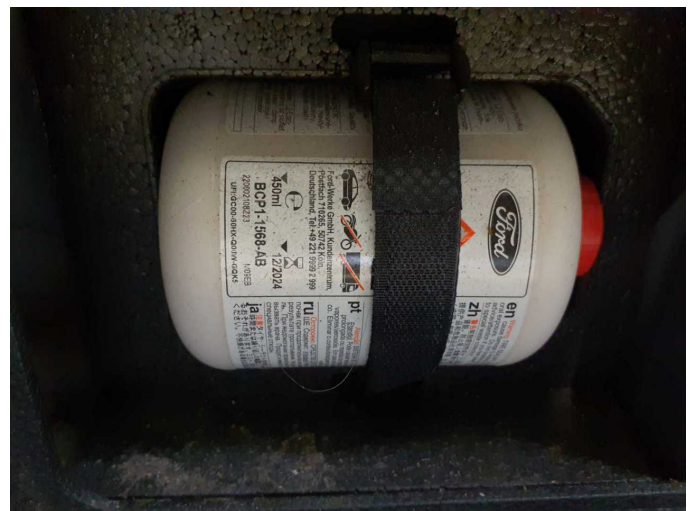
Damage 1: Equipment: Tirefit filler - Expired - Replace

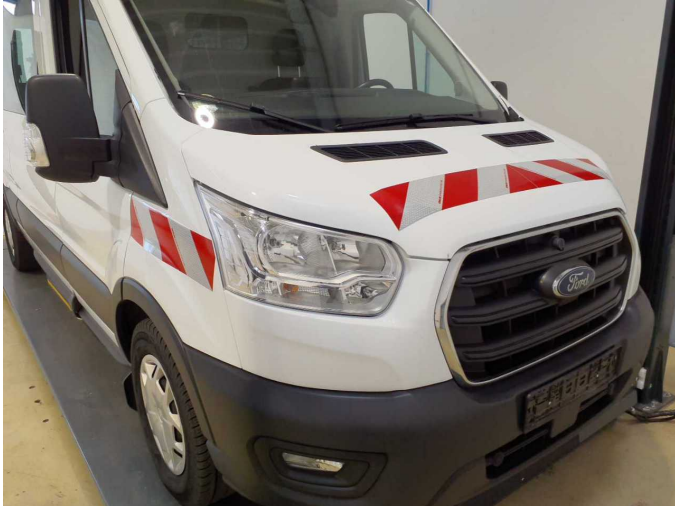
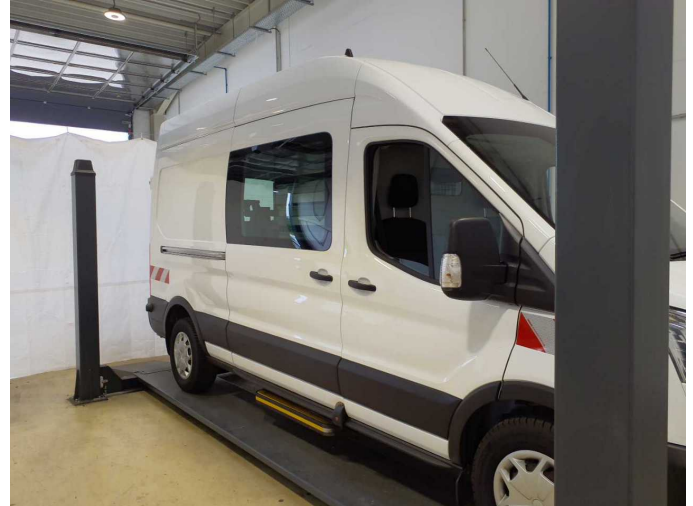
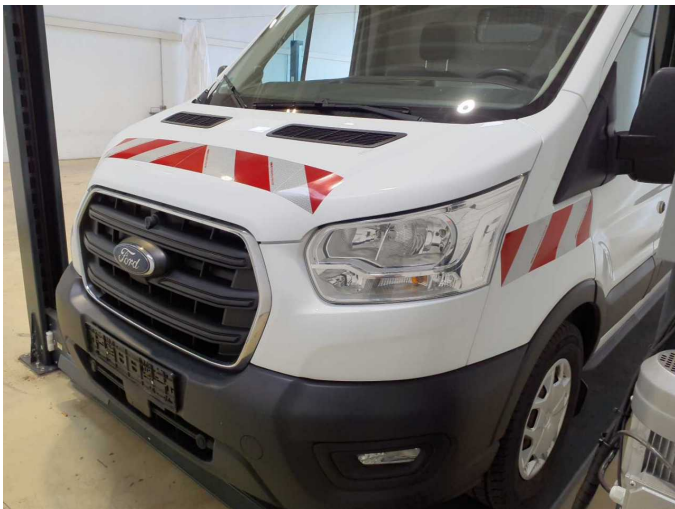
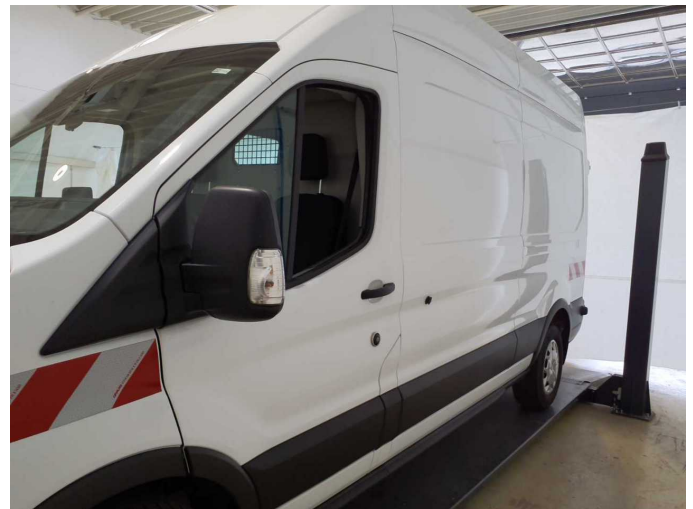
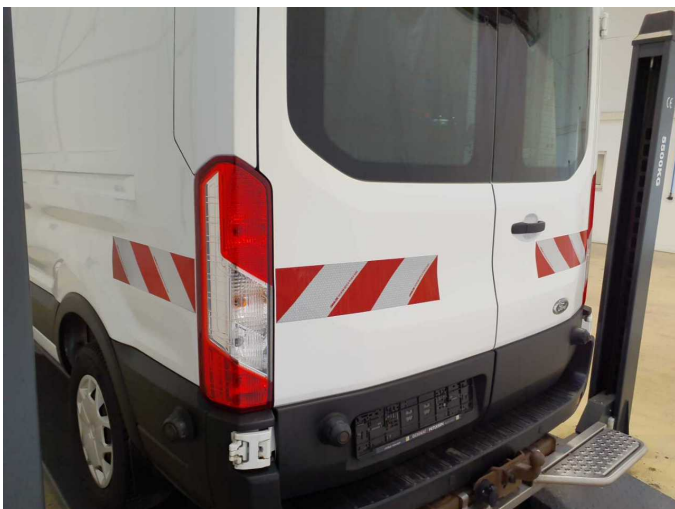
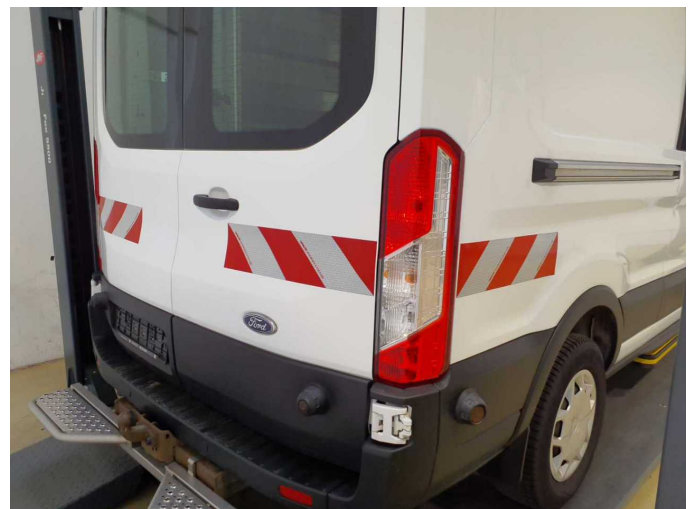
Damage 2: Body: Body - Glued / labelled - De-glue / neutralise

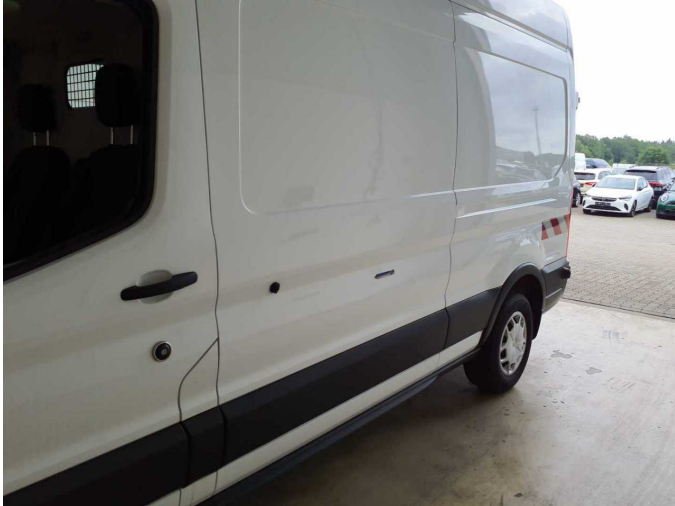
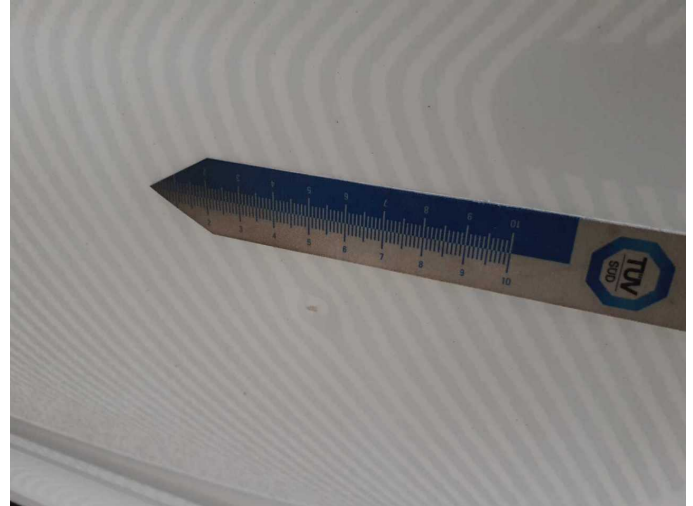
Damage 3: Side panel - rear left side: Side panel - Dent / paintcoat damage - Smart repair

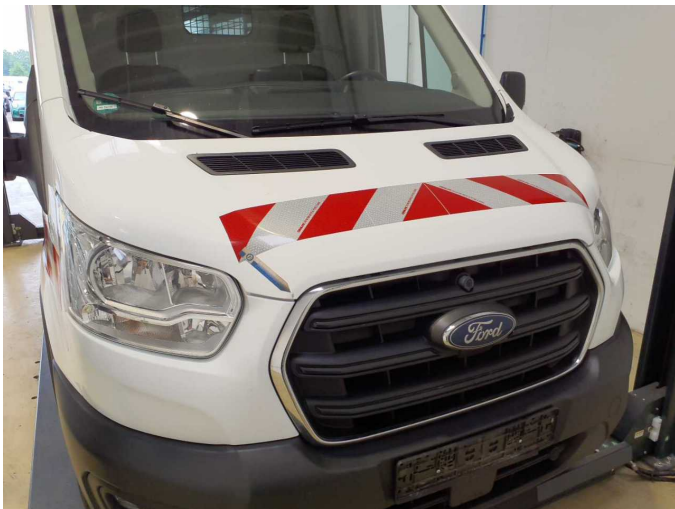
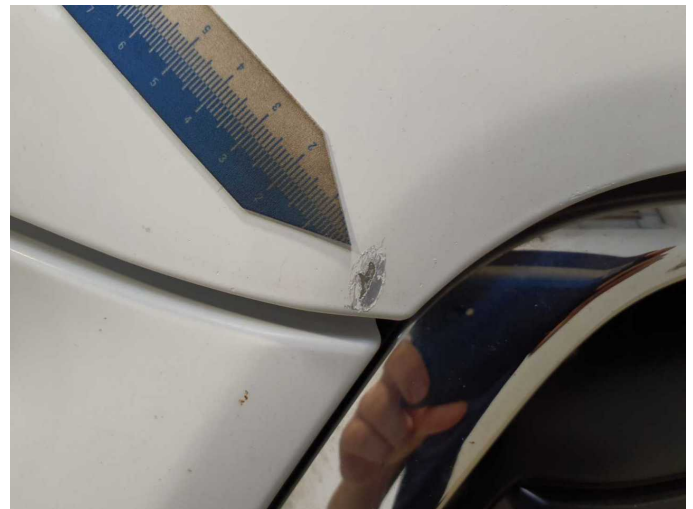
Damage 4: Bonnet: Bonnet - Scratch(es) - Smart repair

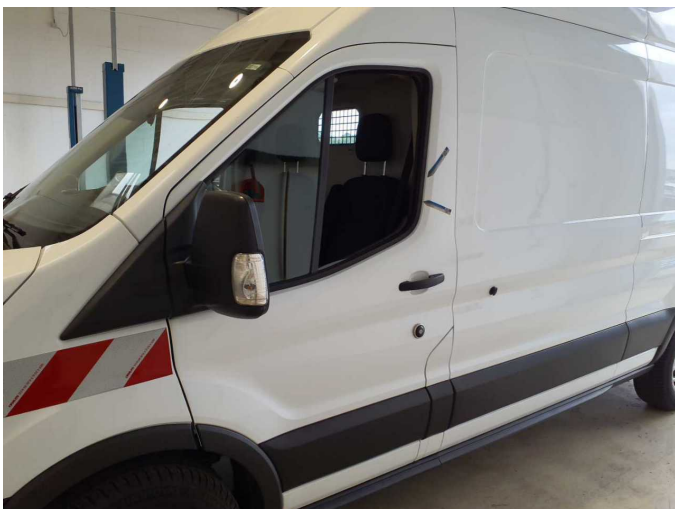
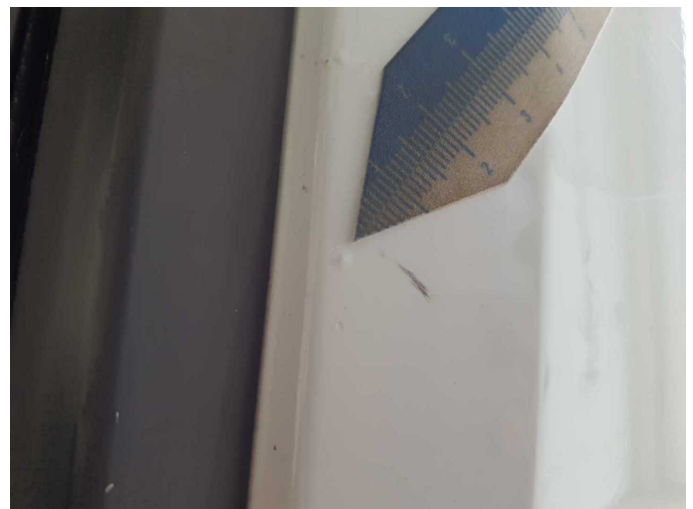
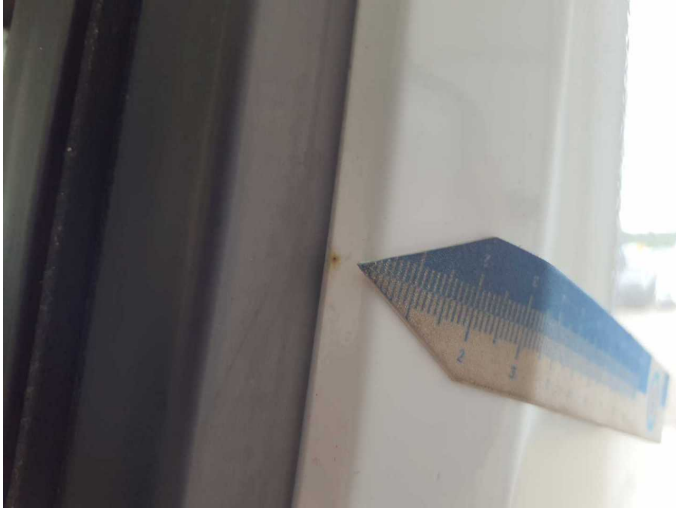
Damage 5: Door - front left side: Door - Corrosion - Smart repair

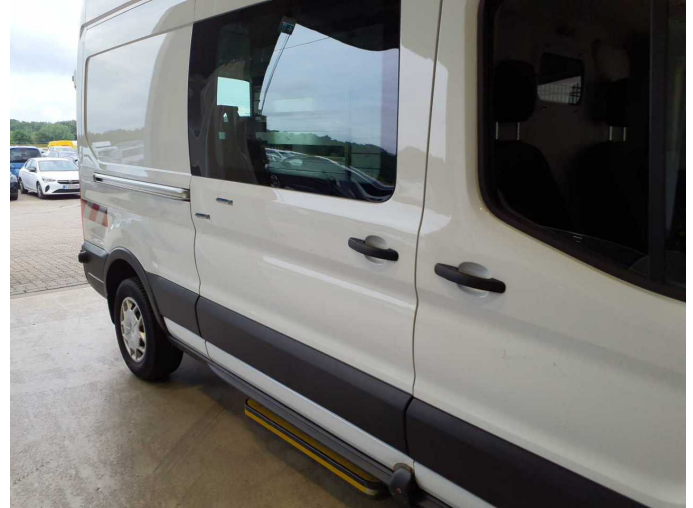
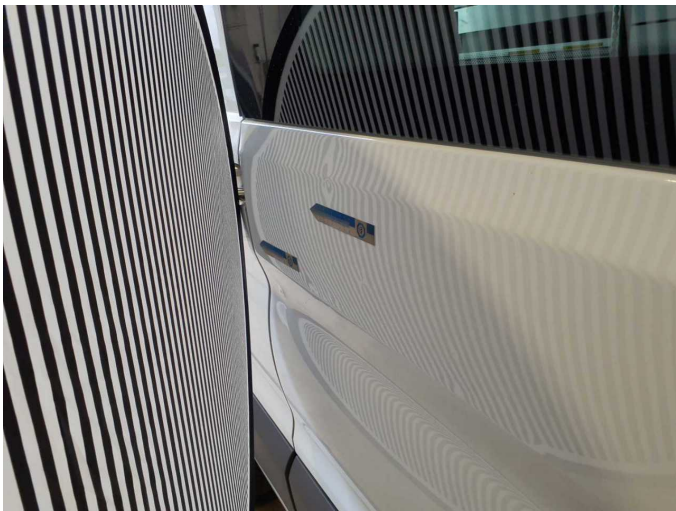
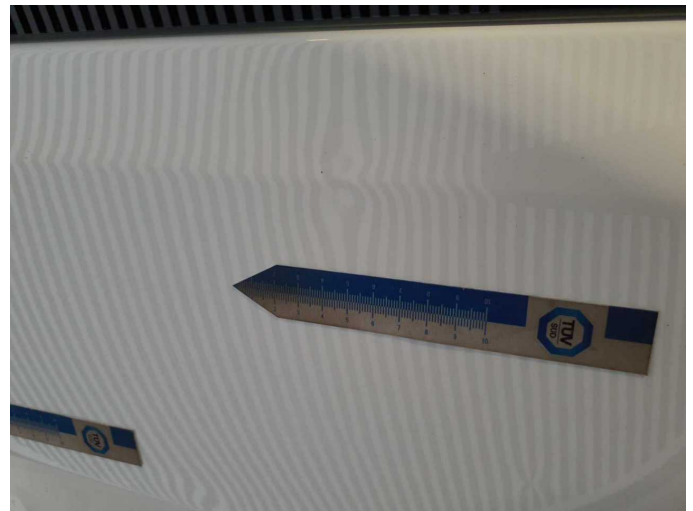
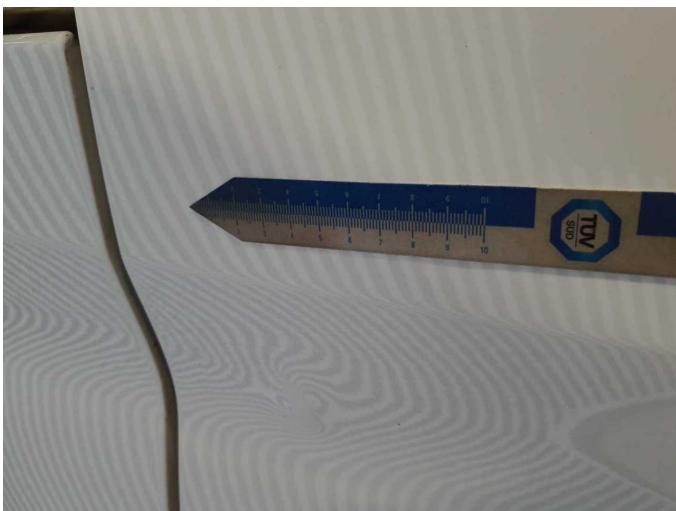
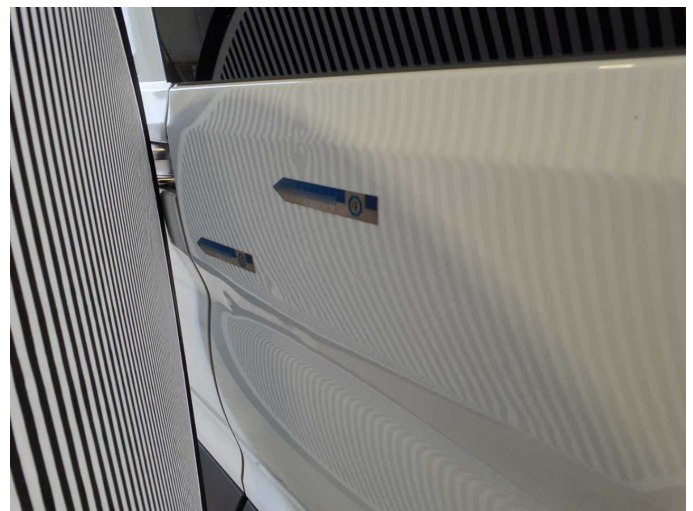
Damage 6: Sliding door, right: Sliding door - dent(s) - Smart repair

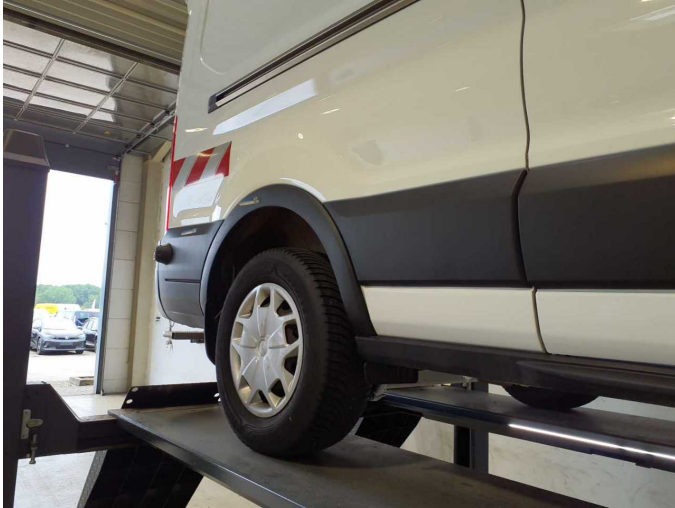
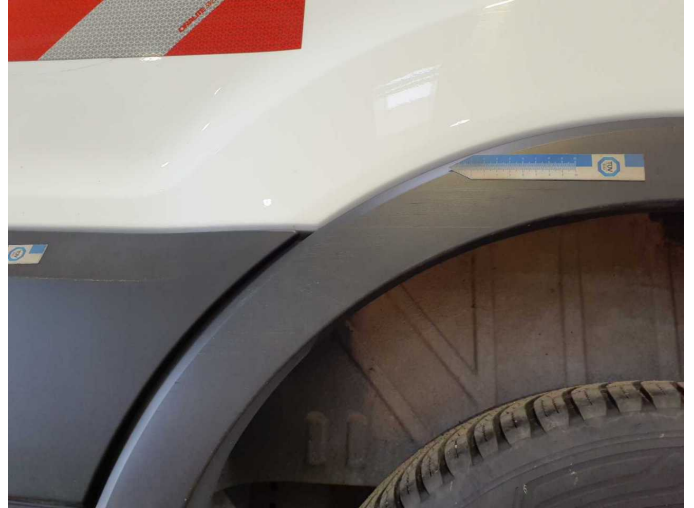
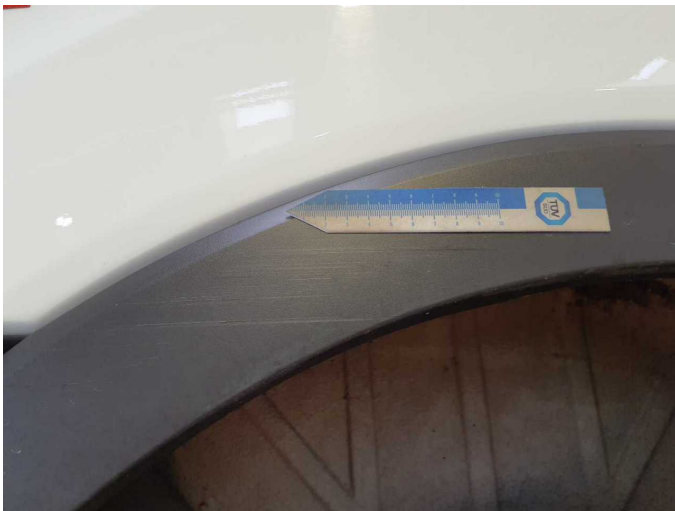
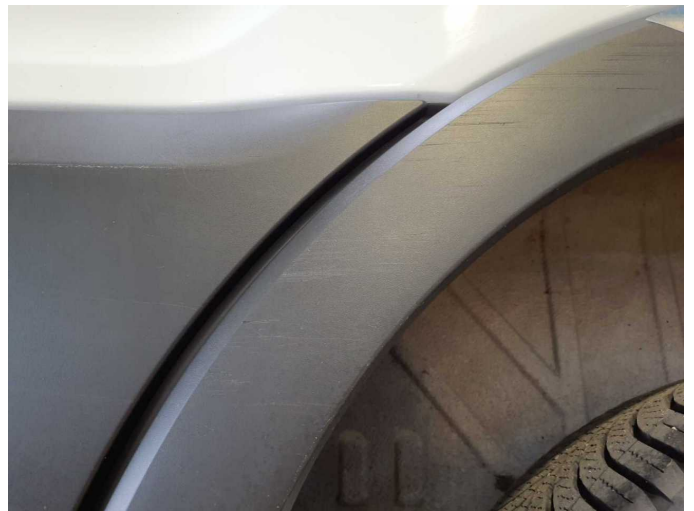
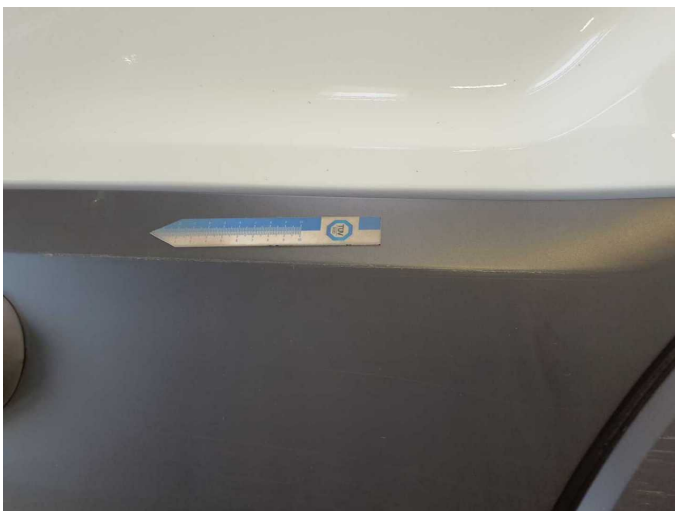
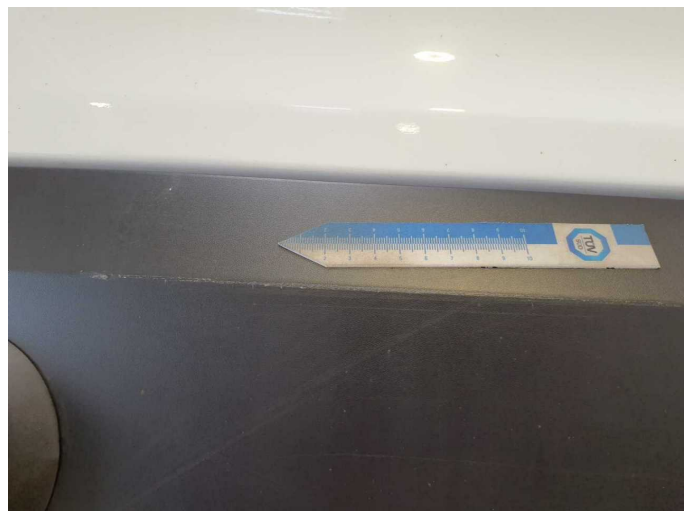
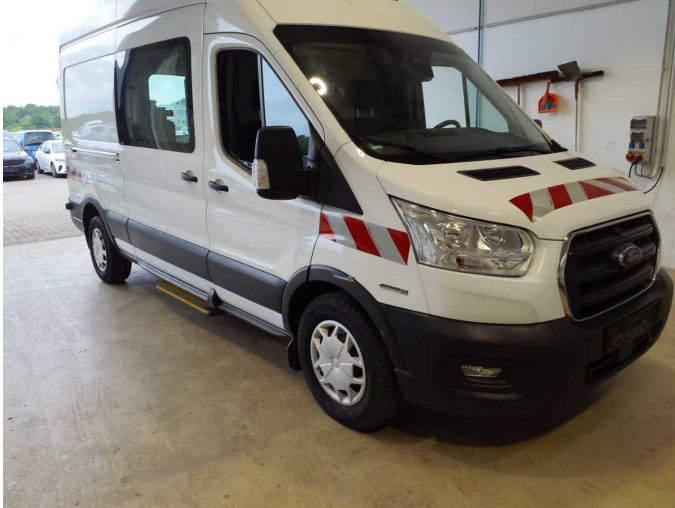
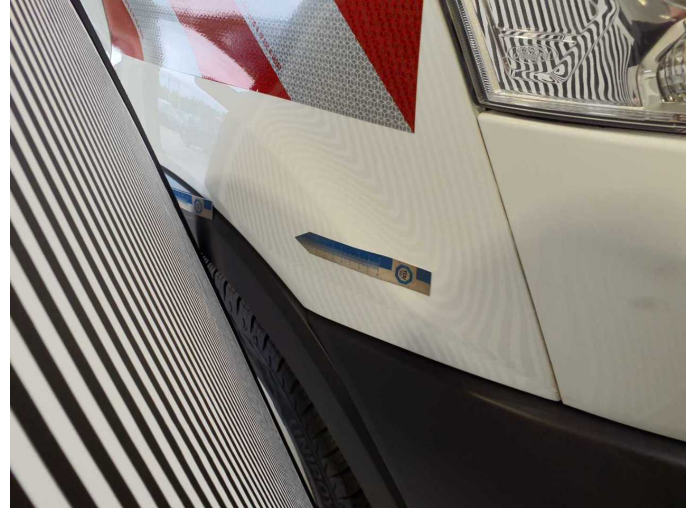
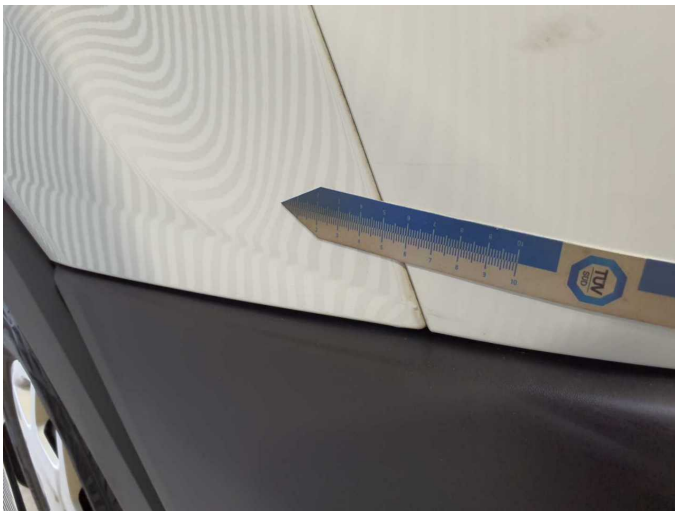
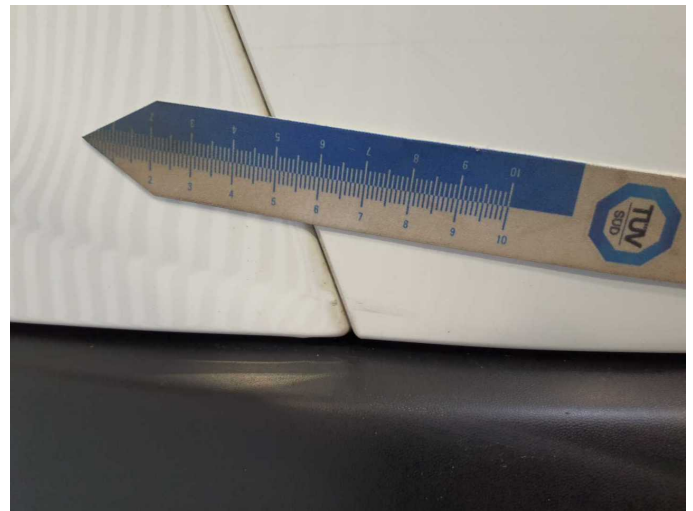
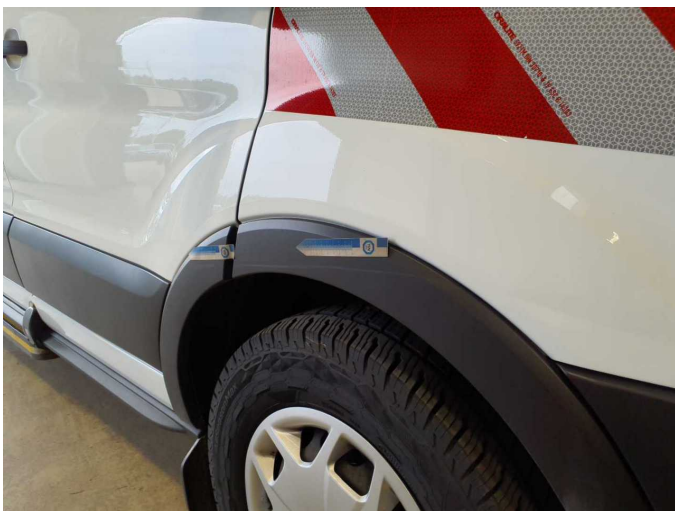
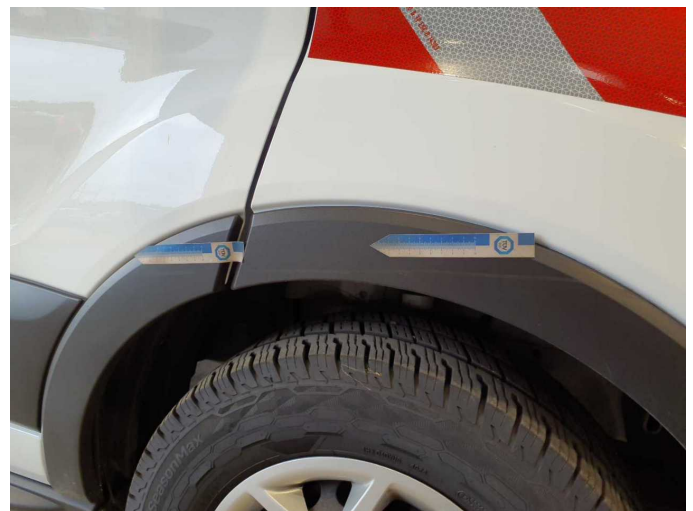
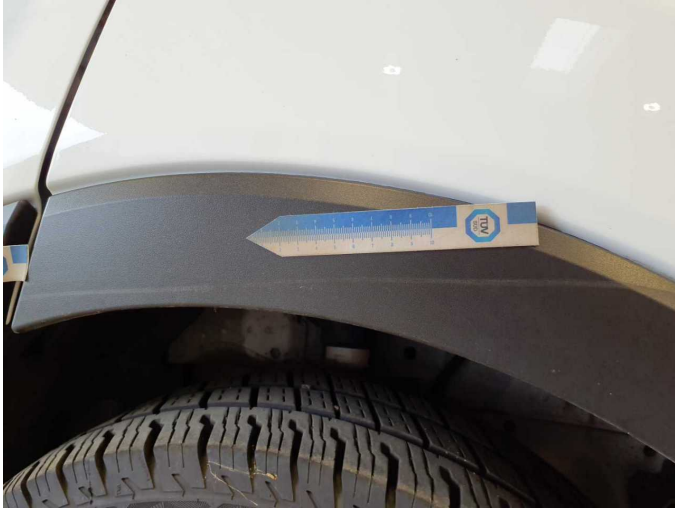
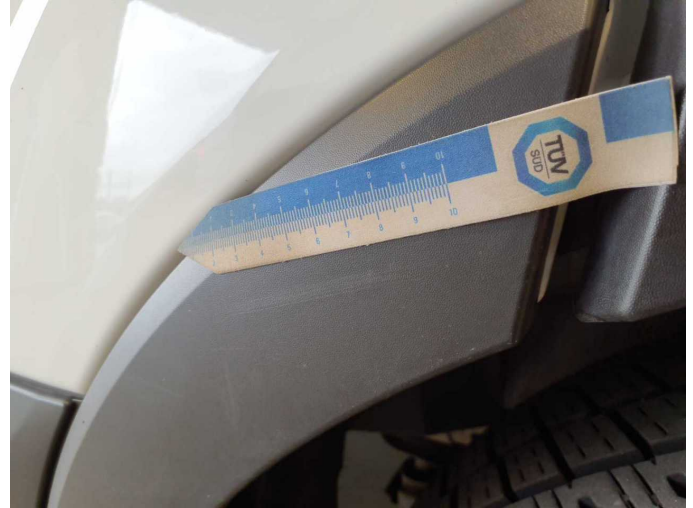
No.	Previous damage	Extent of damage (Net)
1	Rear, Provided by user / customer, from 4 Apr 2022	595,86 €
2	Front, Side right, Provided by user / customer, from 22 Jun 2022	11.279,38 €

1 Side right

Accident 1: Side right

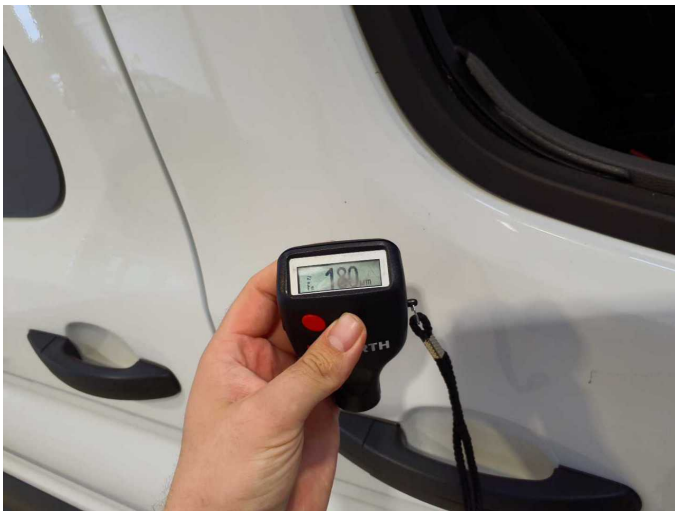
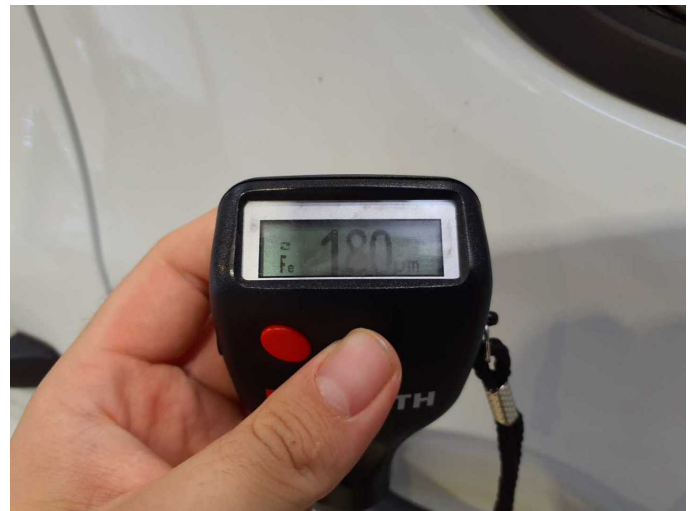
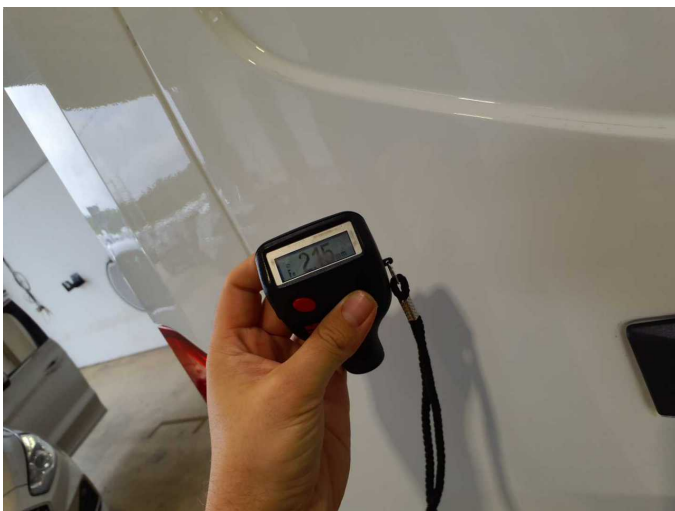
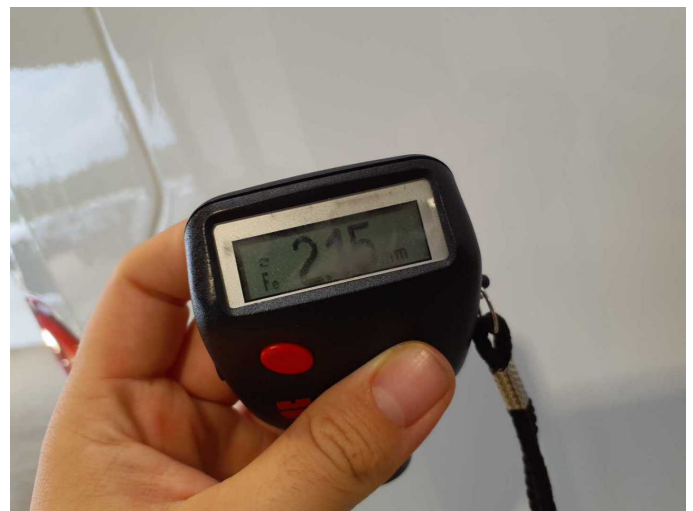
1 Side panel - rear right side, Door - front right side, Professionally carried out

Side panel - rear right side	2,150 µm	Door - front right side	180 µm
------------------------------	-------------	-------------------------	--------

Repainting 1: Side panel - rear right side, Door - front right side
