Expertise

Protocol number: 45582237
Order No. / Reference: 26381404
Inspection date: 22 May 2026

Model: Kodiaq 2.0 TDI 4x4 DSG Style

VIN: TMBLN9NS6P8523208

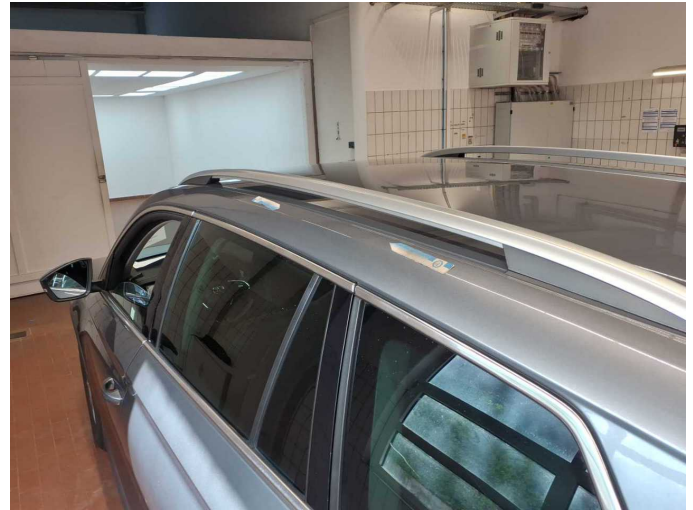
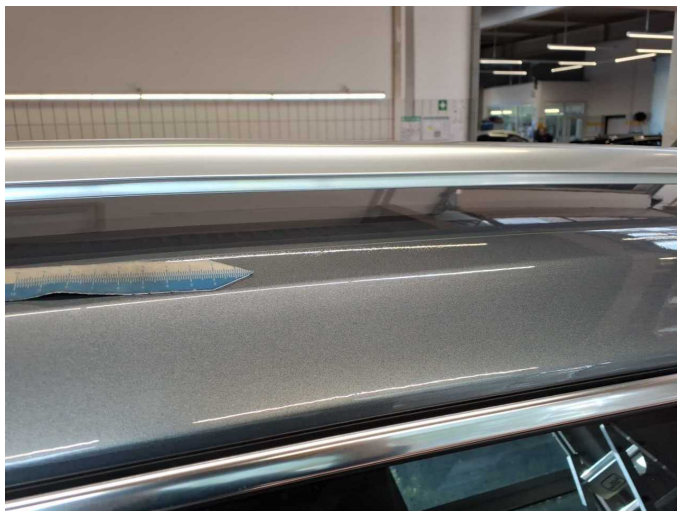
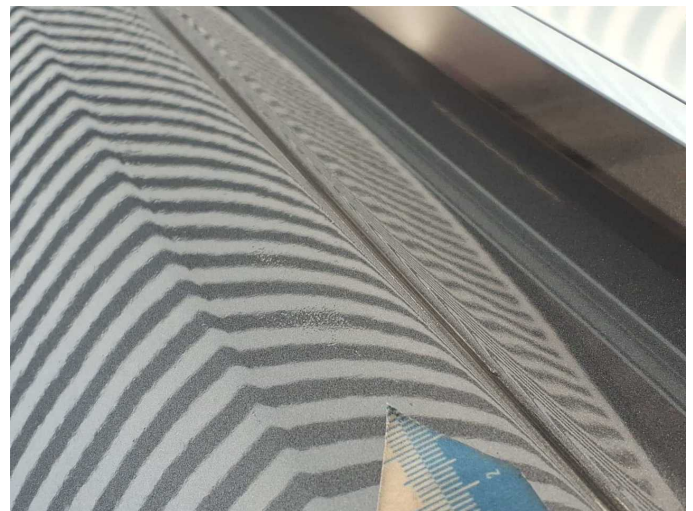
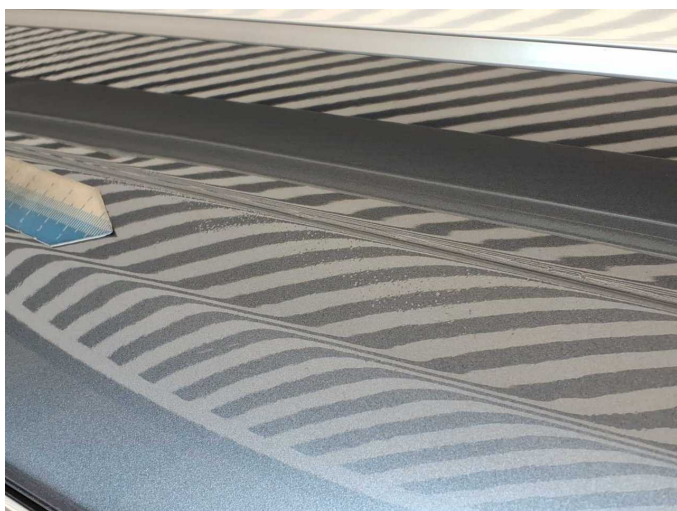
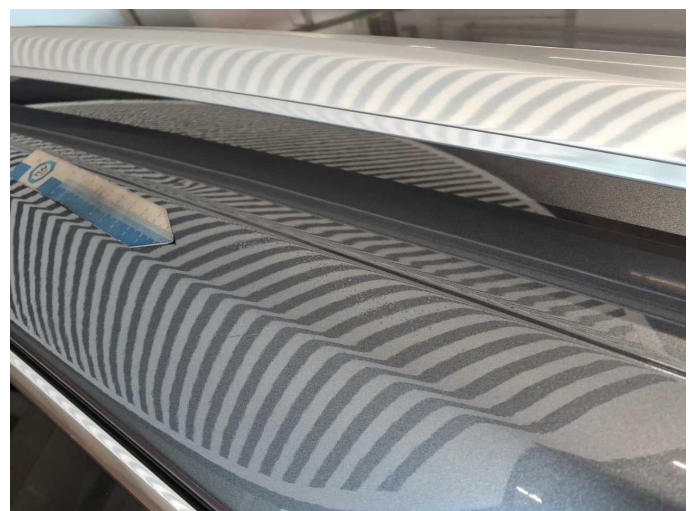
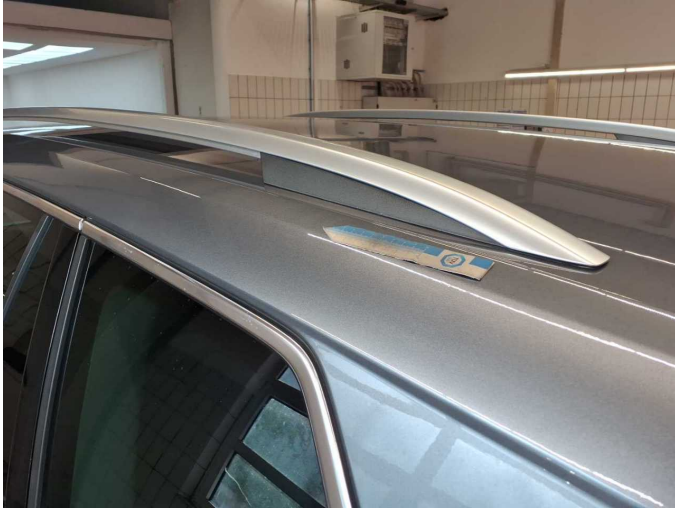
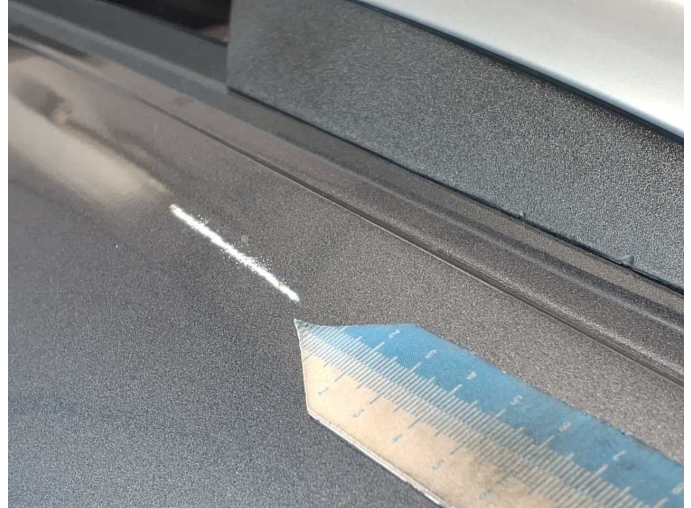
Roof	203 µm	Roof rail - left side	458 µm
Roof rail - right side	393 µm	Side panel - rear left side	174 µm
Side panel - rear right side	220 µm

Damage 1: Roof: Roof rail - left side (Lackeinschlüsse) - Unprofessionally repaired - Paint

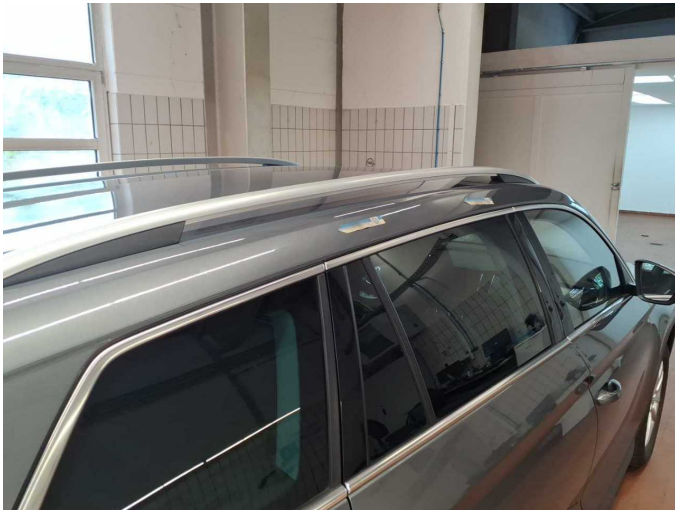
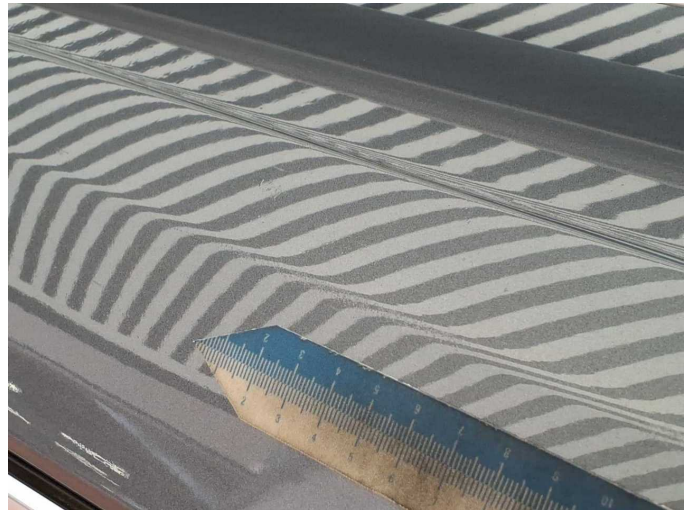
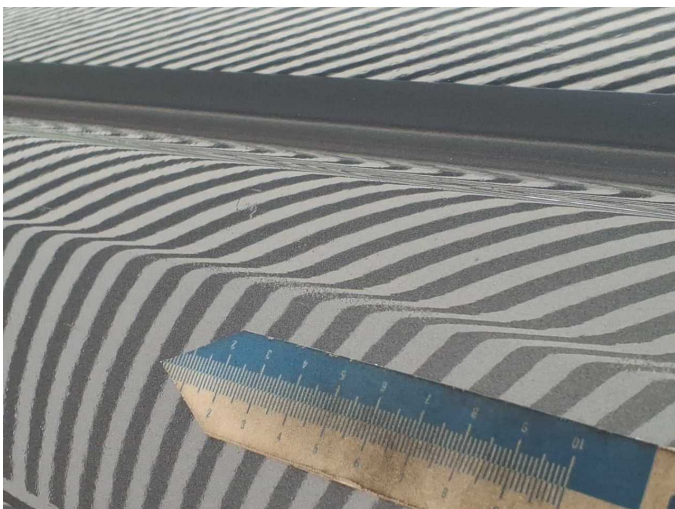
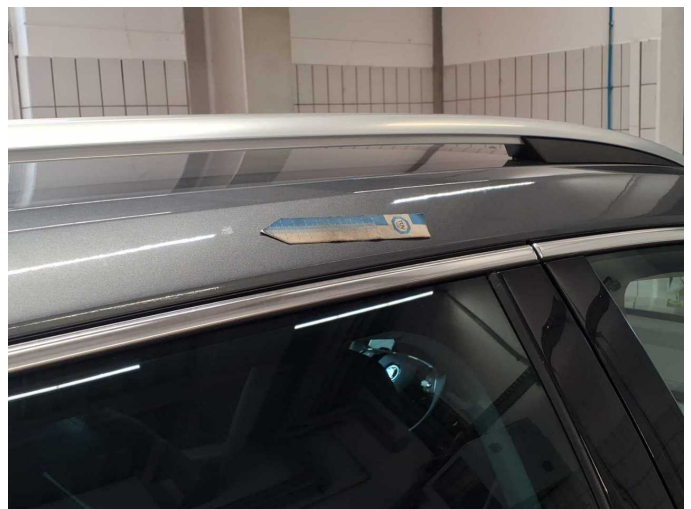
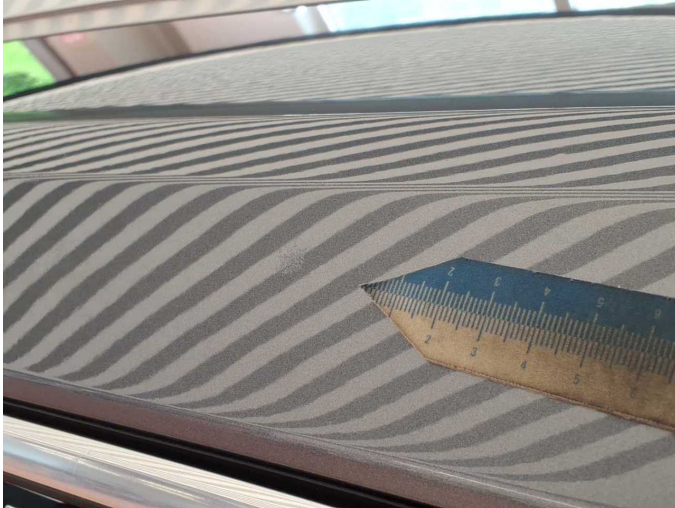
Damage 2: Roof: Roof rail - right side (Lackeinschlüsse) - Unprofessionally repaired - Paint

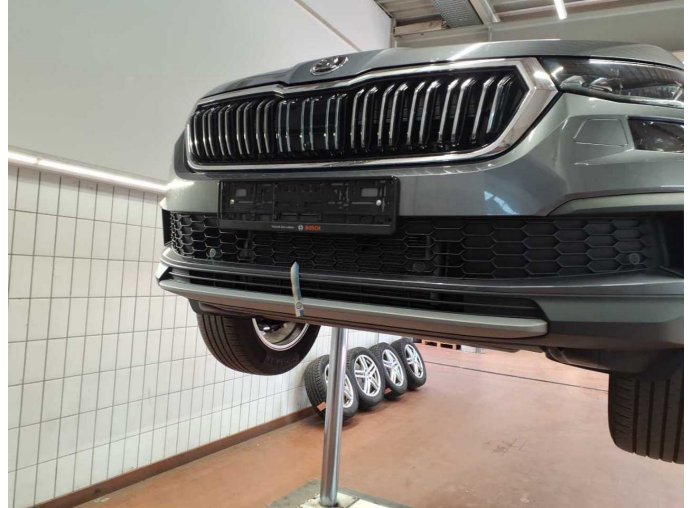
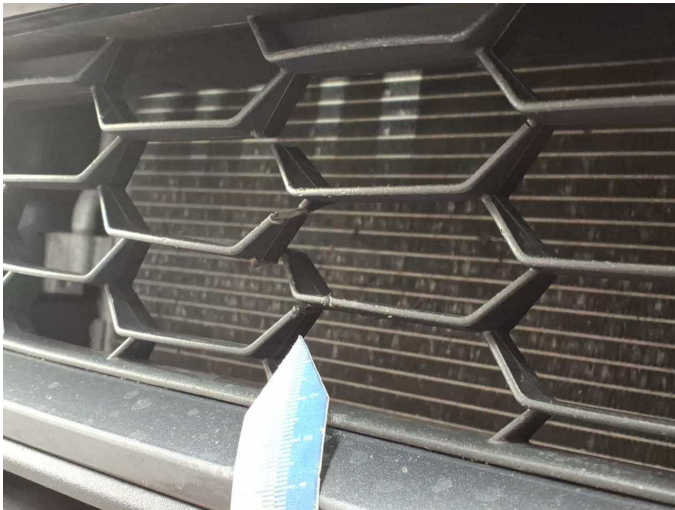
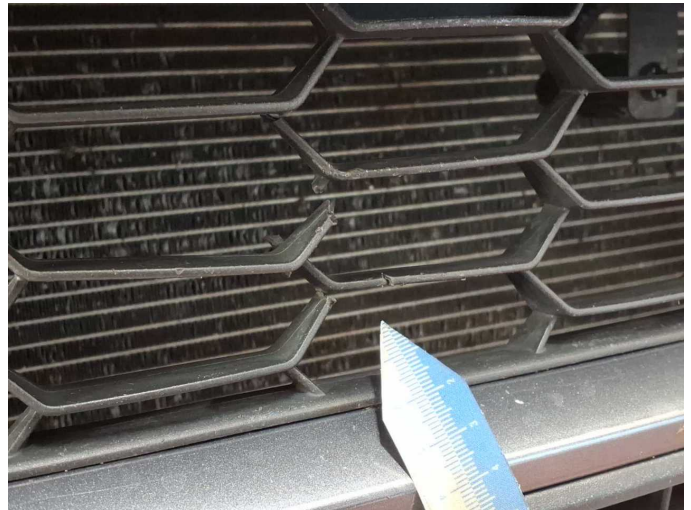
Damage 3: Front bumper: Grille - Broken / torn - Replace

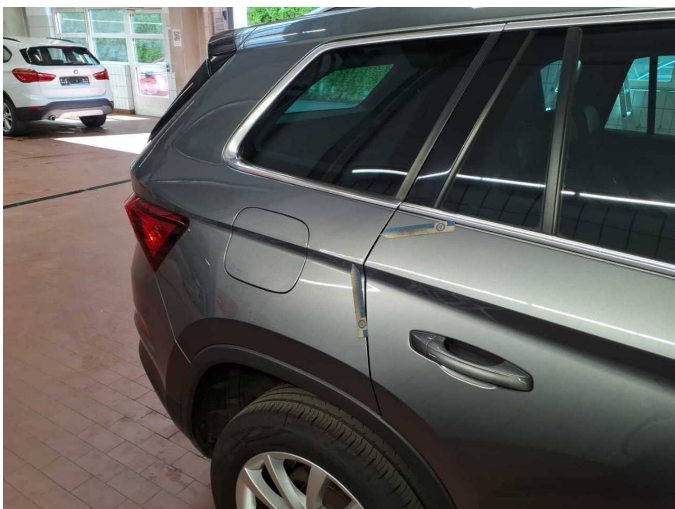
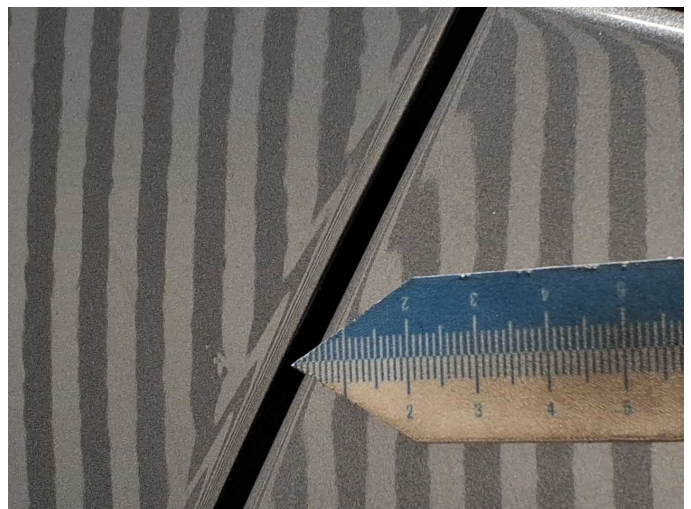
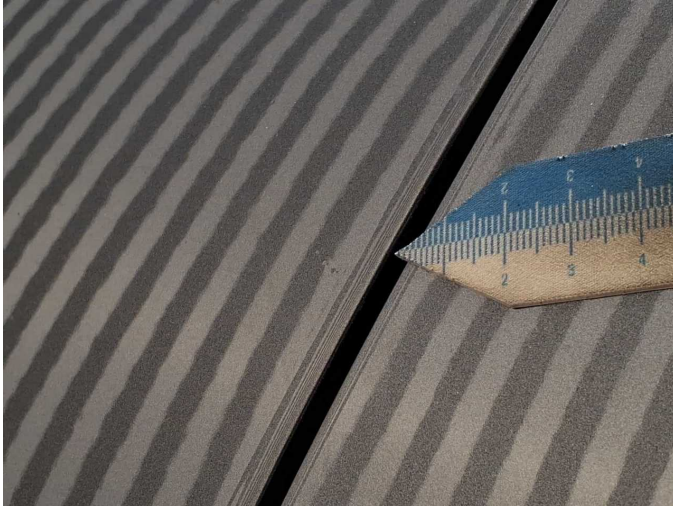
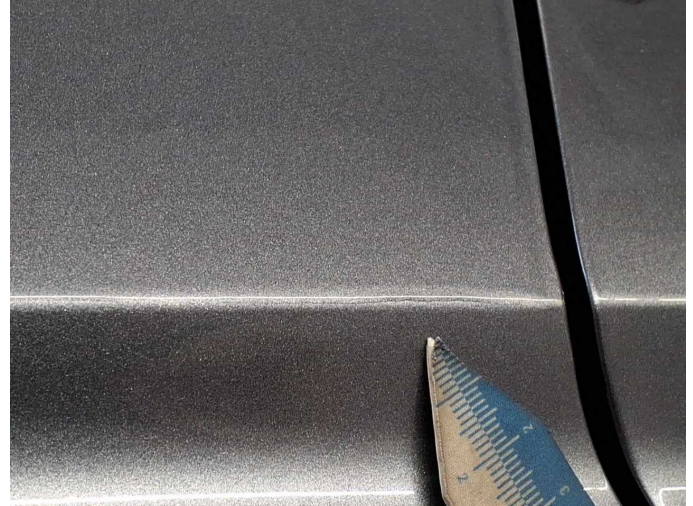
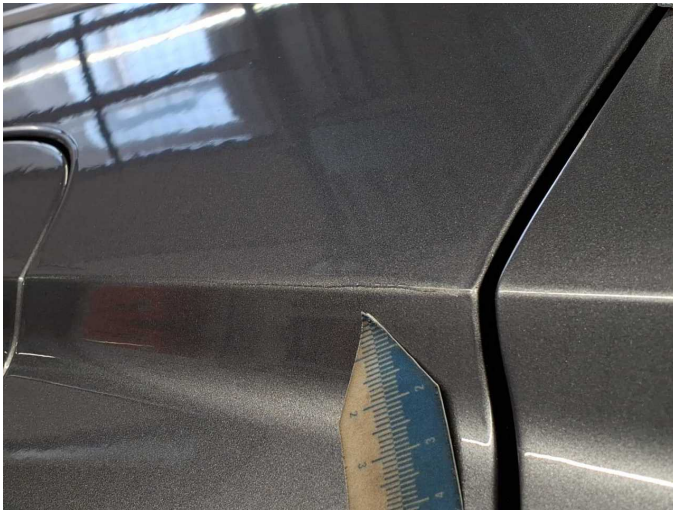
Damage 4: Side panel - rear right side: Side panel (Lackeinschlüsse, Lackierkante sichtbar) - Unprofessionally repaired - Paint

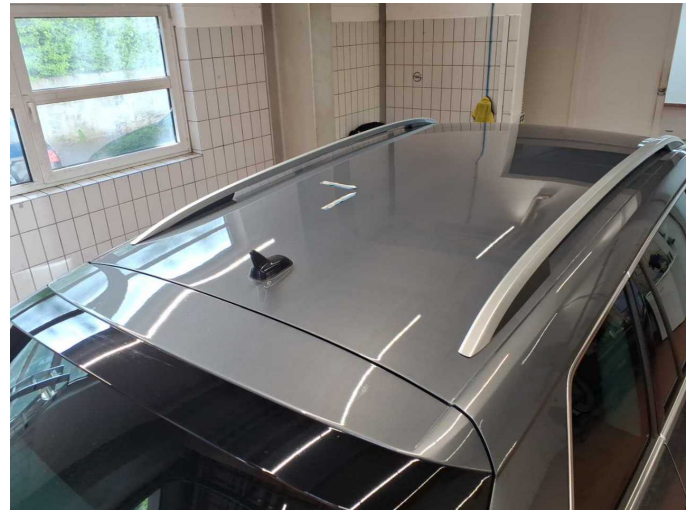
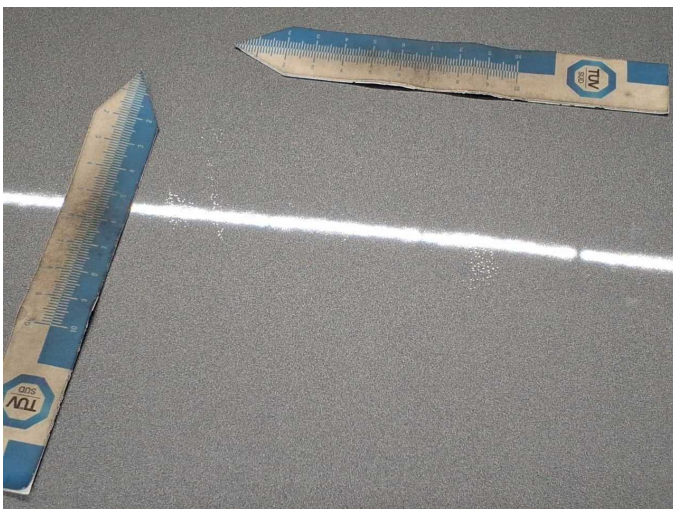
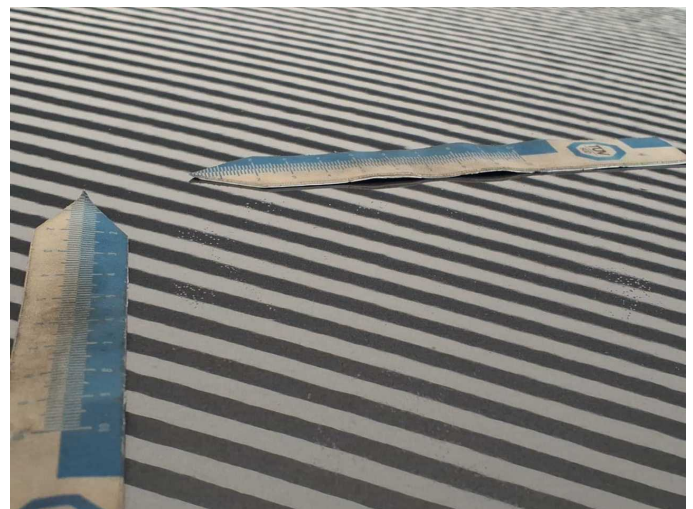
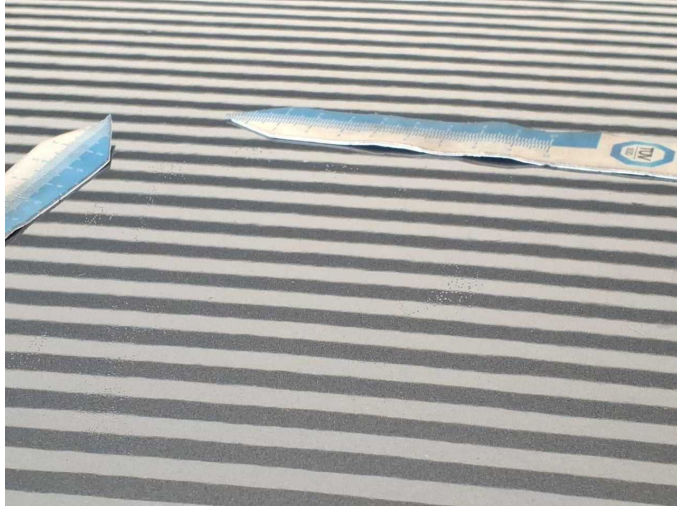
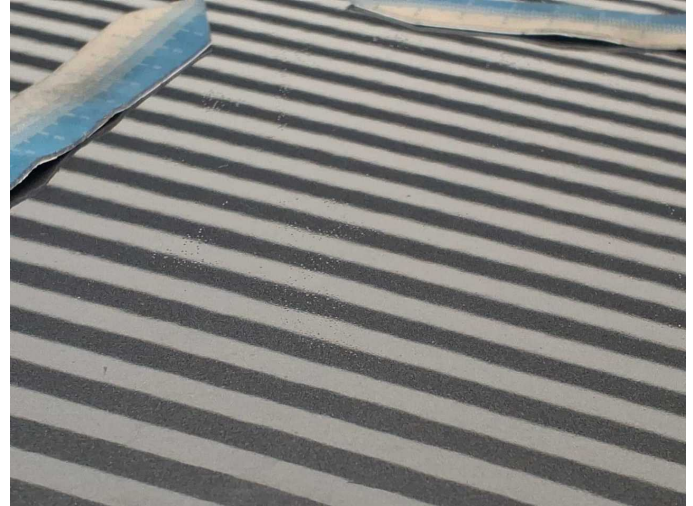
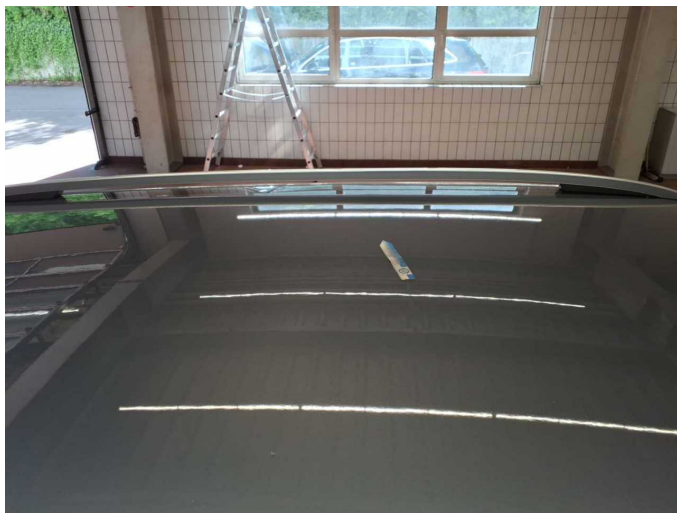
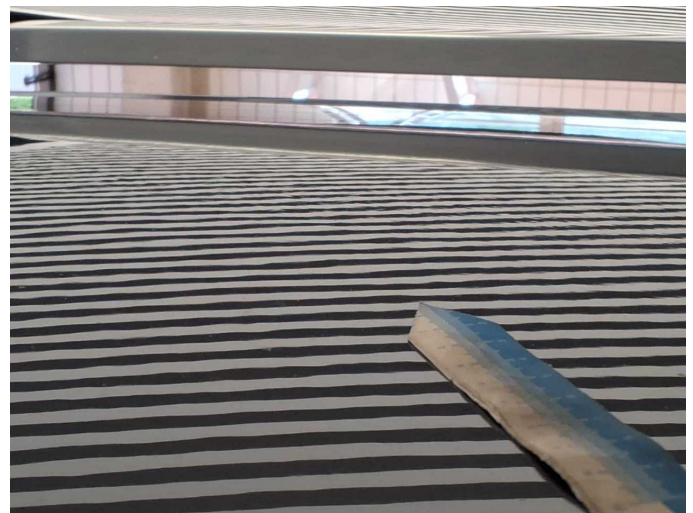
Damage 5: Roof: Roof (Lackeinschlüsse; wellig (+Dellen Gebrauchspur)) - Unprofessionally repaired - Paint

Damage 5: Roof: Roof (Lackeinschlüsse; wellig (+Dellen Gebrauchspur))
- Unprofessionally repaired - Paint

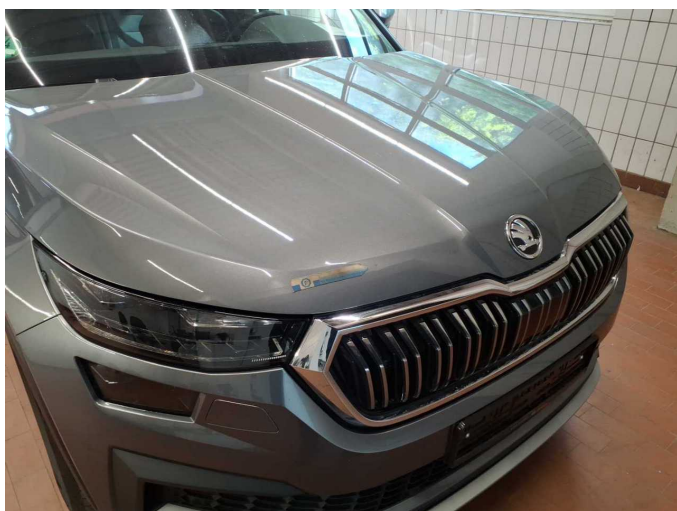
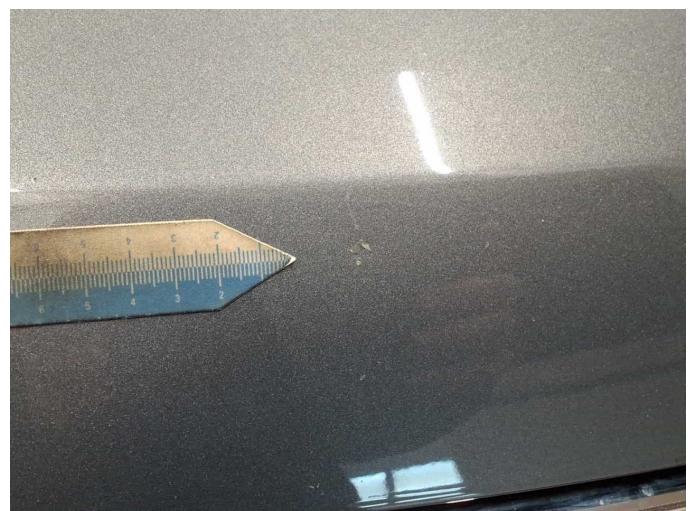
Wear and tear 1: Bonnet: Bonnet (Auslegen) - Stone chips - No deduction

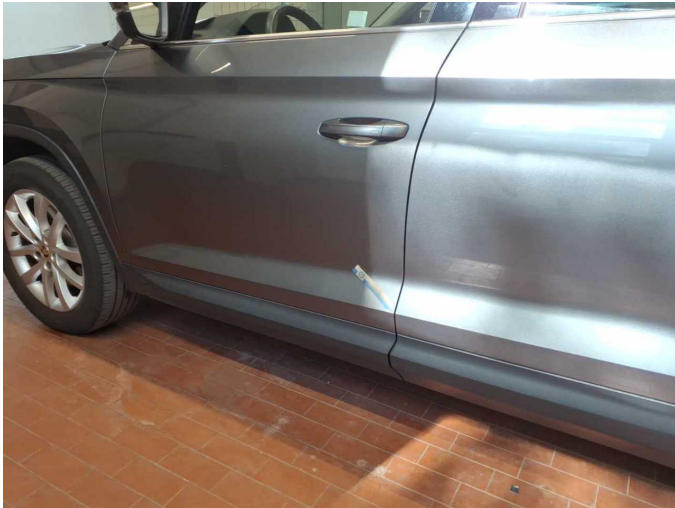
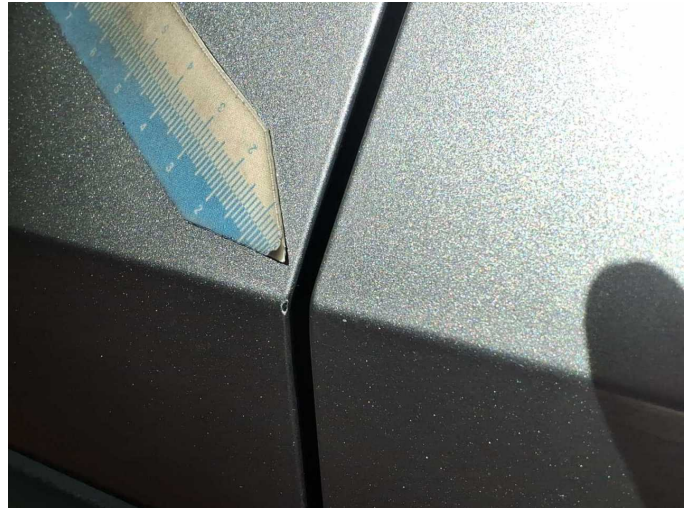
Wear and tear 2: Door - front left side: Door edge - Scratch(es) - No deduction

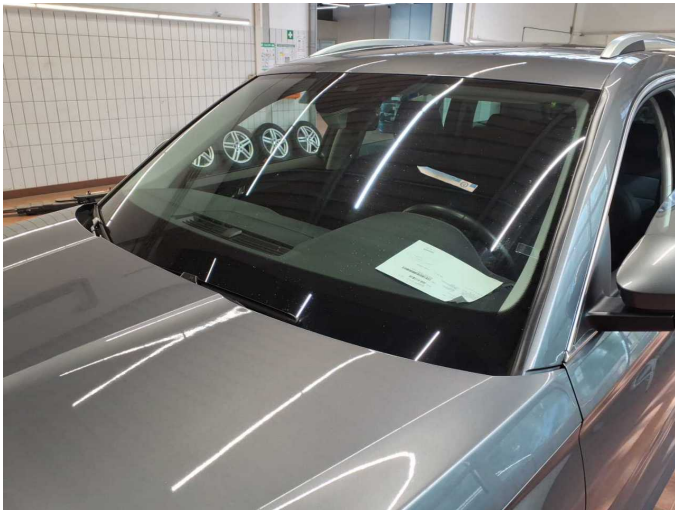
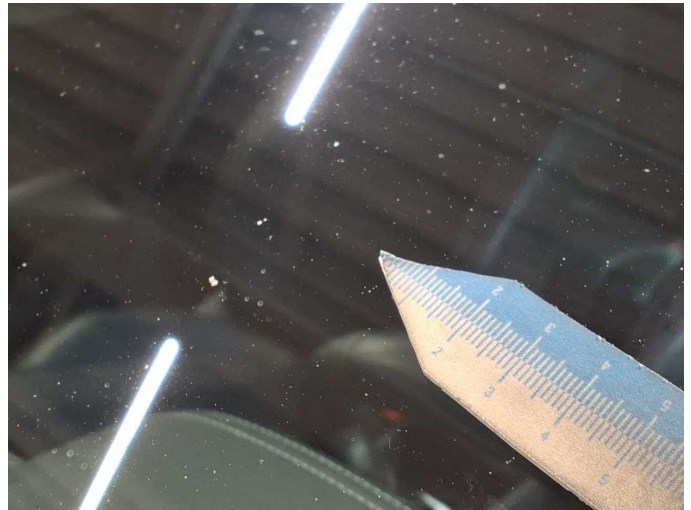
Wear and tear 3: Vehicle glazing: Windscreen (Ohne Rissbildung) - Stone chips - No deduction
