Expertise

Protocol number: 46609702  
Order No. / Reference: 26768057  
Inspection date: 21 Jul 2026

Manufacturer: Ford

Model: Transit Connect 220 L2 Trend

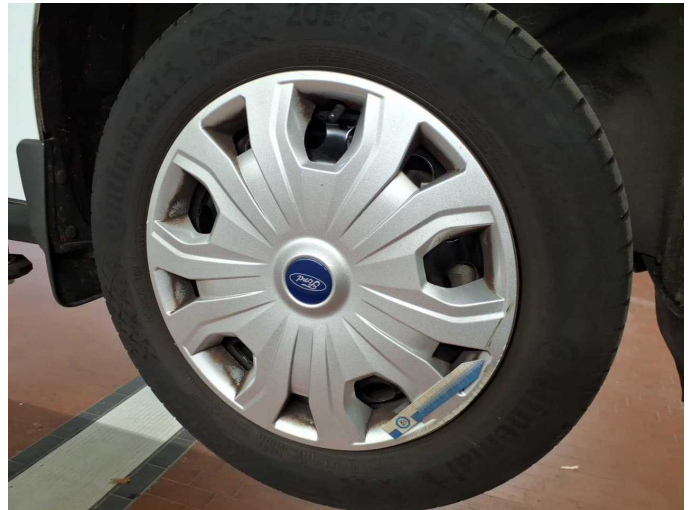
| No. | Component group | Description |
|---|---|---|
| 1 | Wheel / tyres | Wheel cover - front right side - Scratched - Replace |

**Damage 1:** Wheel / tyres: Wheel cover - front right side - Scratched - Replace

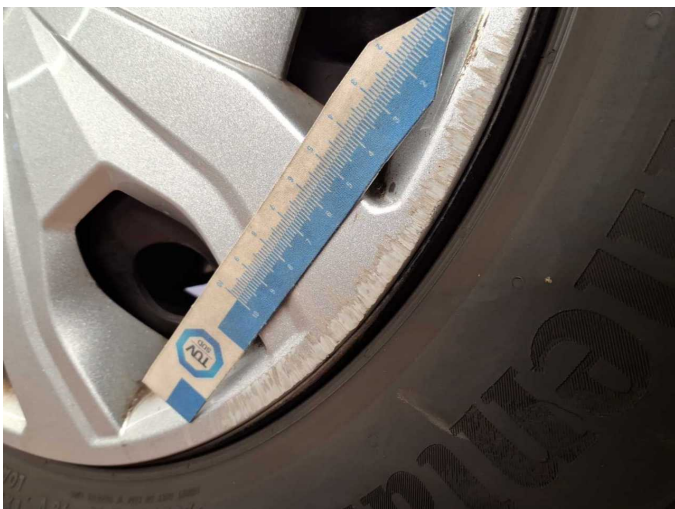
**Damage 1:** Wheel / tyres: Wheel cover - front right side - Scratched - Replace

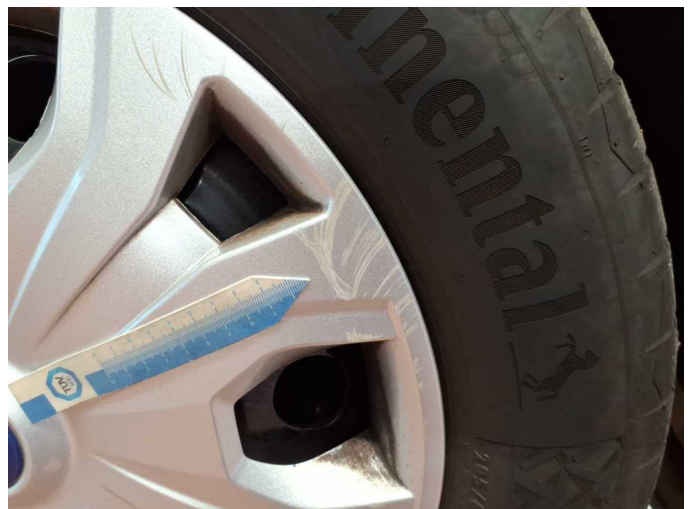
| No. | Component group | Description |
|---|---|---|
| 2 | Wheel / tyres | Wheel cover - front left side - Scratched - Replace |

**Damage 2:** Wheel / tyres: Wheel cover - front left side - Scratched - Replace

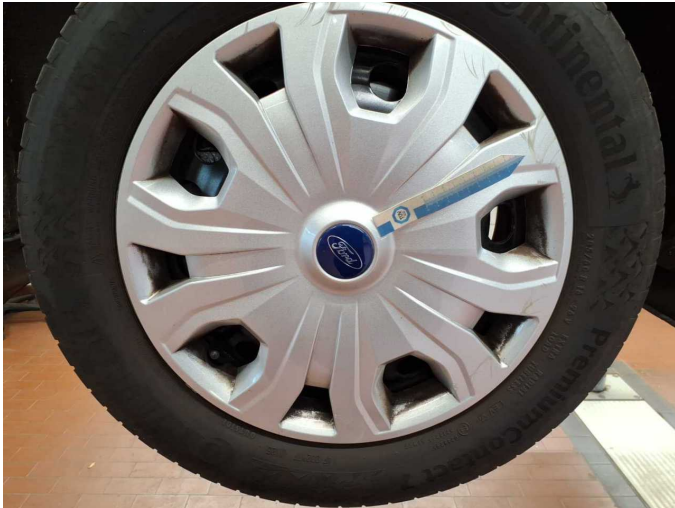
**Damage 2:** Wheel / tyres: Wheel cover - front left side - Scratched - Replace

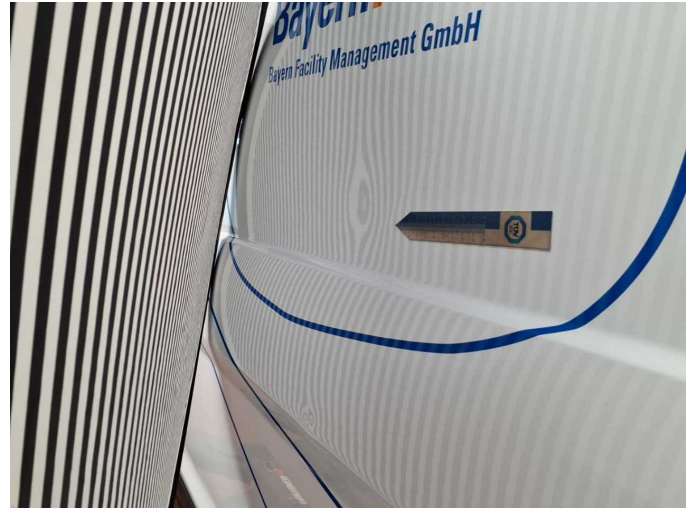
| No. | Component group | Description |
|---|---|---|
| 4 | Side panel - rear left side | Side panel - dent(s) - Smooth repair work |

**Damage 4:** Side panel - rear left side: Side panel - dent(s) - Smooth repair work

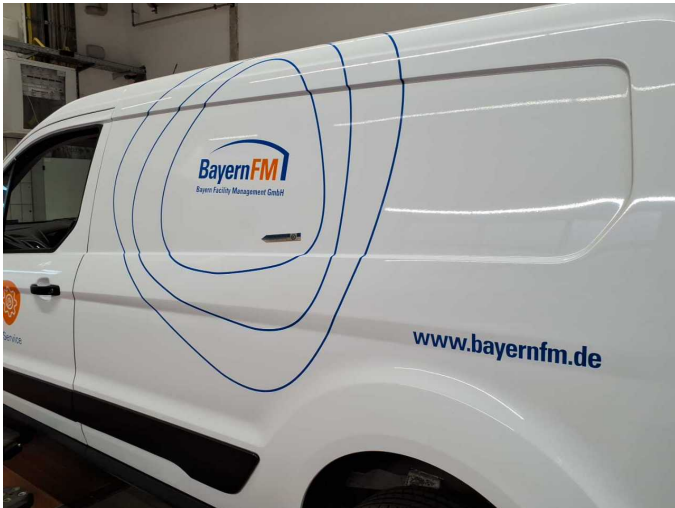
**Damage 4:** Side panel - rear left side: Side panel - dent(s) - Smooth repair work

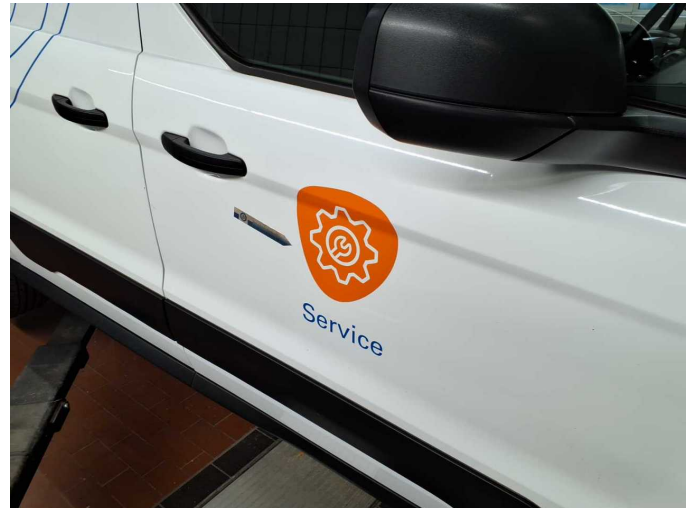
| No. | Component group | Description |
|---|---|---|
| 5 | Body | Body - Glued / labelled - De-glue / neutralise |

**Damage 5:** Body: Body - Glued / labelled - De-glue / neutralise

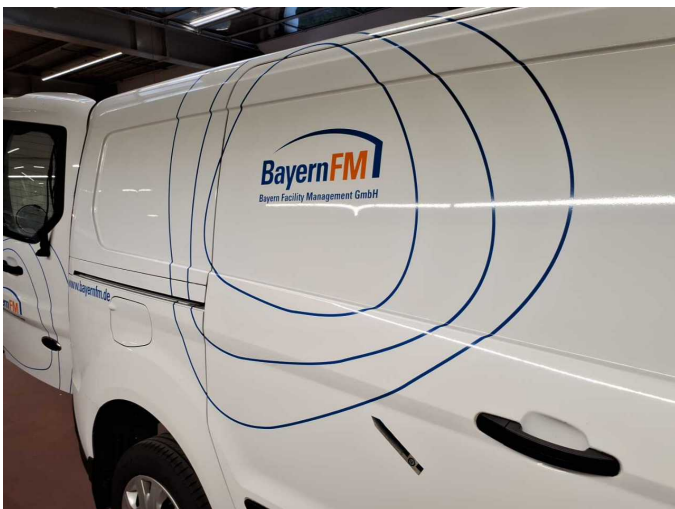
**Damage 5:** Body: Body - Glued / labelled - De-glue / neutralise

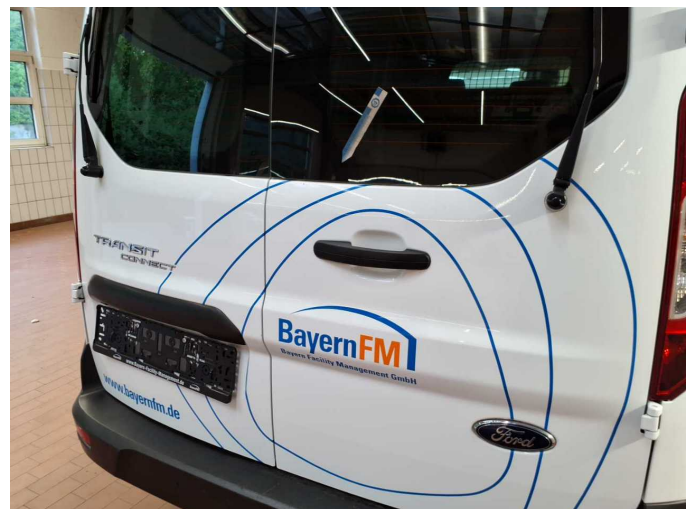
**Damage 5:** Body: Body - Glued / labelled - De-glue / neutralise

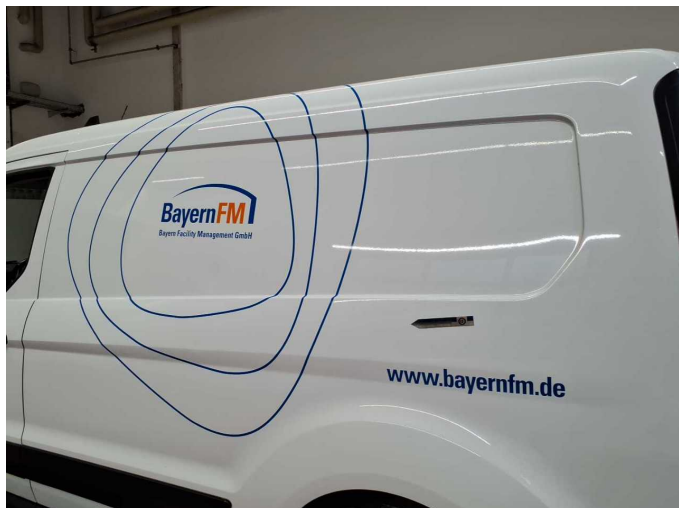
**Damage 5:** Body: Body - Glued / labelled - De-glue / neutralise

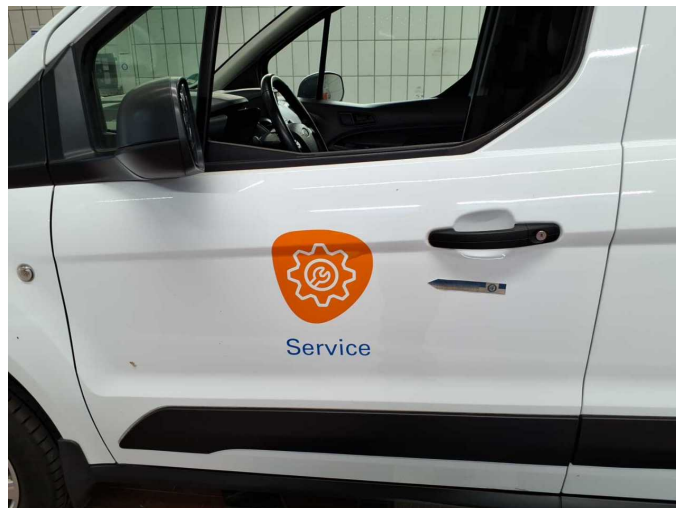
**Damage 5:** Body: Body - Glued / labelled - De-glue / neutralise

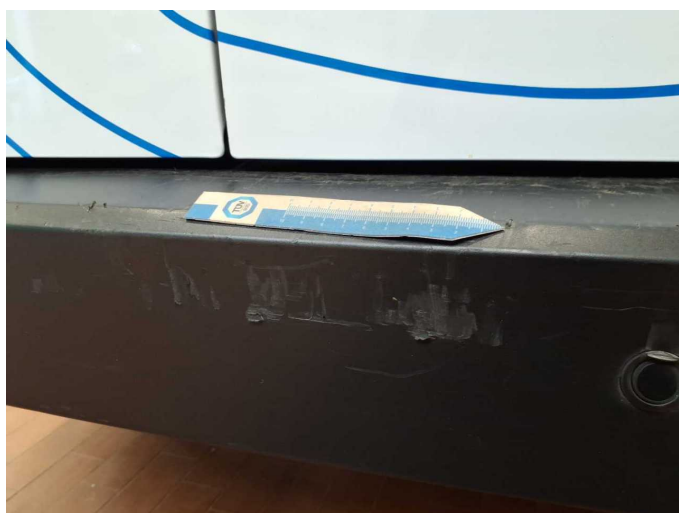
| No. | Component group | Description |
|---|---|---|
| 6 | Rear bumper | Rear bumper - Scratch(es) - Replace |

**Damage 6:** Rear bumper: Rear bumper - Scratch(es) - Replace

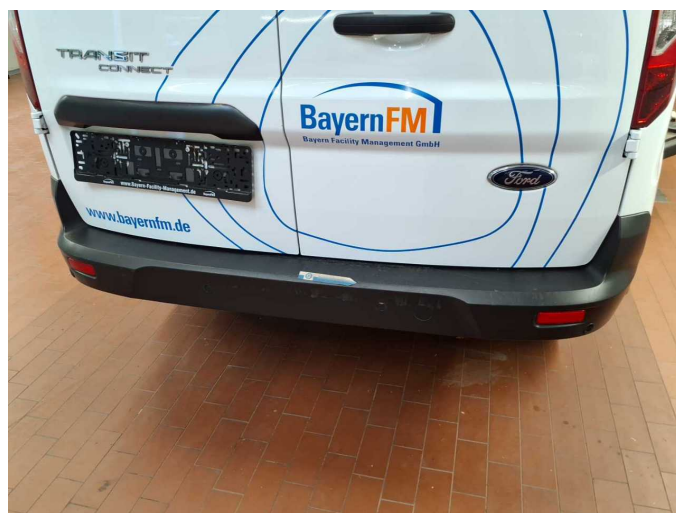
**Damage 6:** Rear bumper: Rear bumper - Scratch(es) - Replace

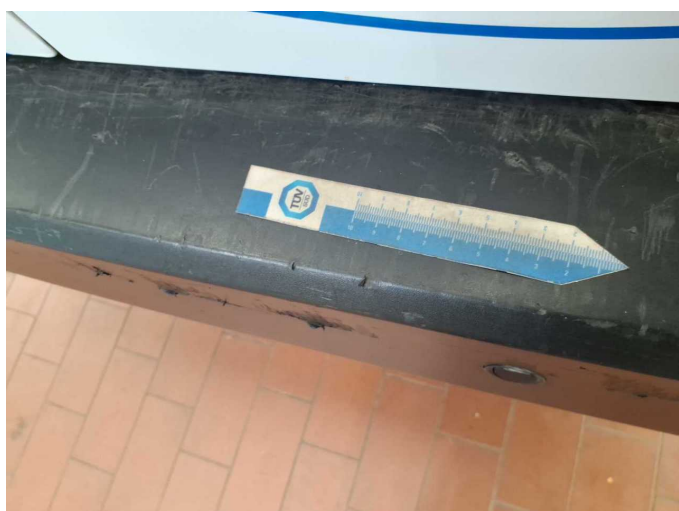
**Damage 6:** Rear bumper: Rear bumper - Scratch(es) - Replace

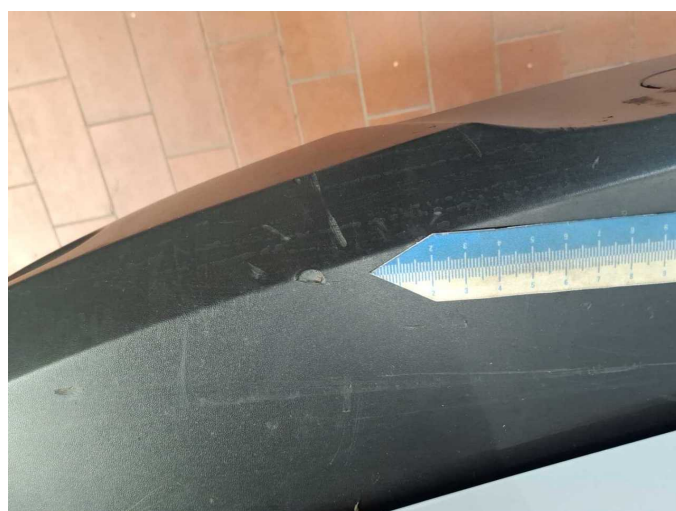
**Damage 6:** Rear bumper: Rear bumper - Scratch(es) - Replace

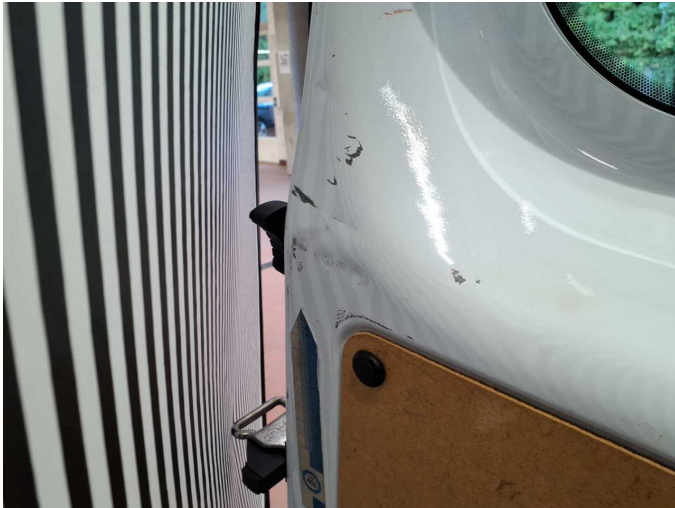
| No. | Component group | Description |
|---|---|---|
| 7 | Boot lid / rear door | Rear door - left side - Dent / paintcoat damage - Repair and paint |

**Damage 7:** Boot lid / rear door: Rear door - left side - Dent / paintcoat damage - Repair and paint

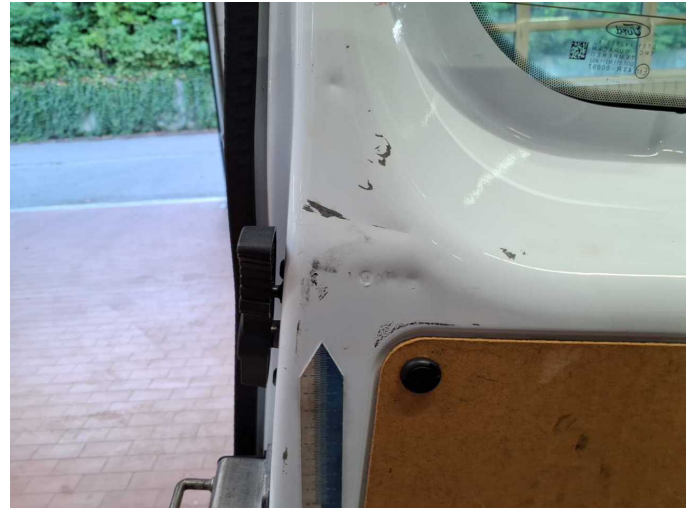
**Damage 7:** Boot lid / rear door: Rear door - left side - Dent / paintcoat damage - Repair and paint

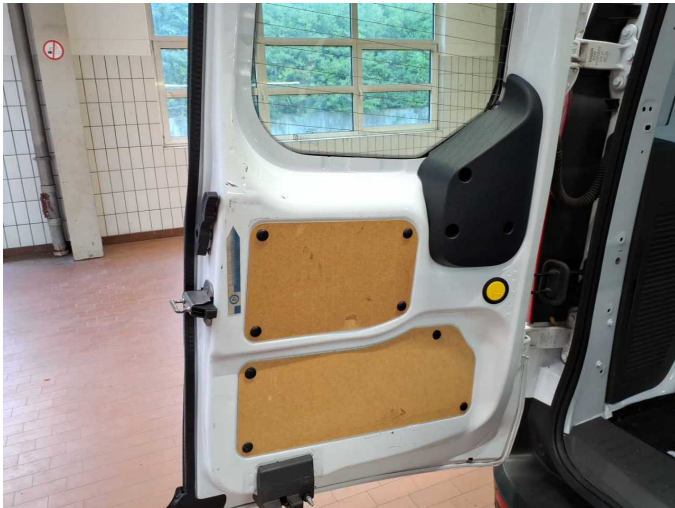
**Damage 7:** Boot lid / rear door: Rear door - left side - Dent / paintcoat damage - Repair and paint

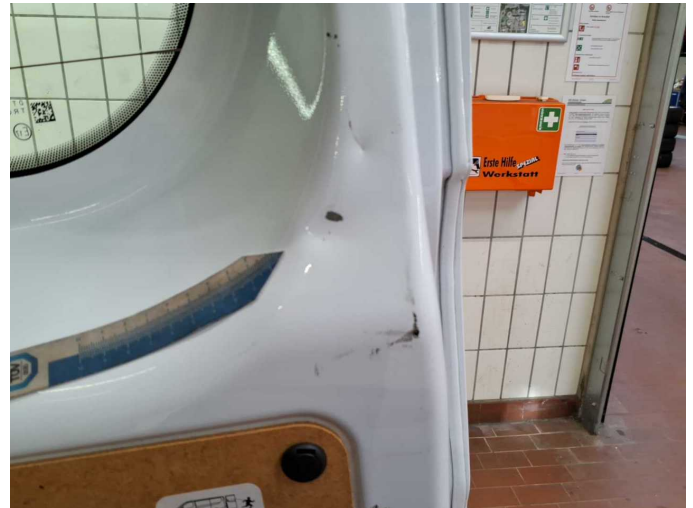
| No. | Component group | Description |
|---|---|---|
| 8 | Boot lid / rear door | Rear door - right side - Dent / paintcoat damage - Repair and paint |

**Damage 8:** Boot lid / rear door: Rear door - right side - Dent / paintcoat damage - Repair and paint

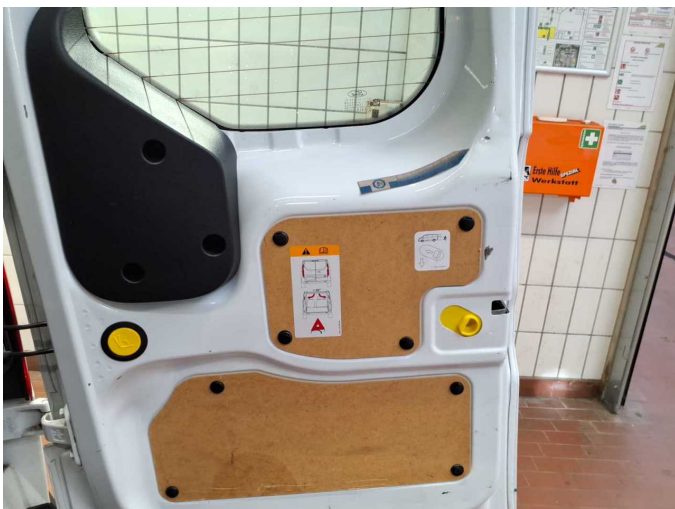
**Damage 8:** Boot lid / rear door: Rear door - right side - Dent / paintcoat damage - Repair and paint

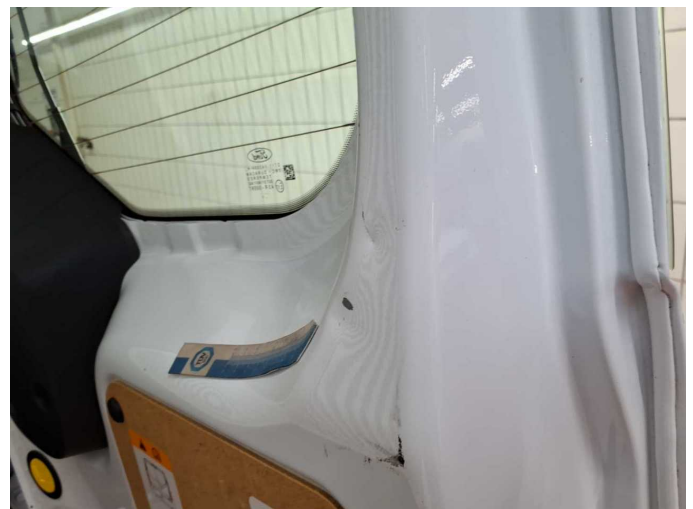
**Damage 8:** Boot lid / rear door: Rear door - right side - Dent / paintcoat damage - Repair and paint

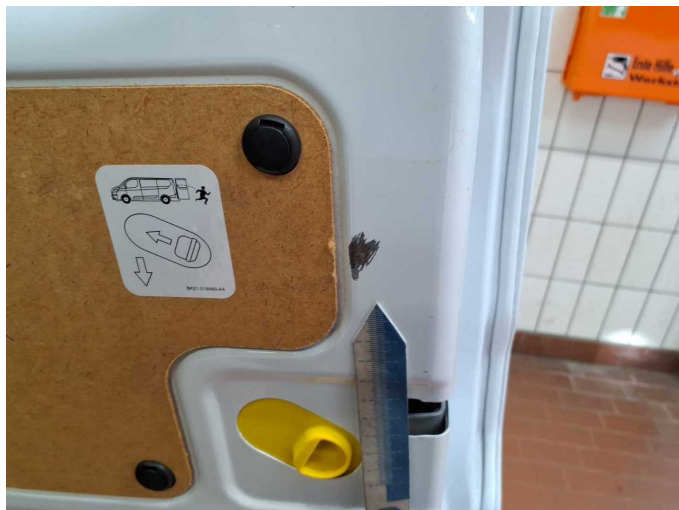
**Damage 8:** Boot lid / rear door: Rear door - right side - Dent / paintcoat damage - Repair and paint

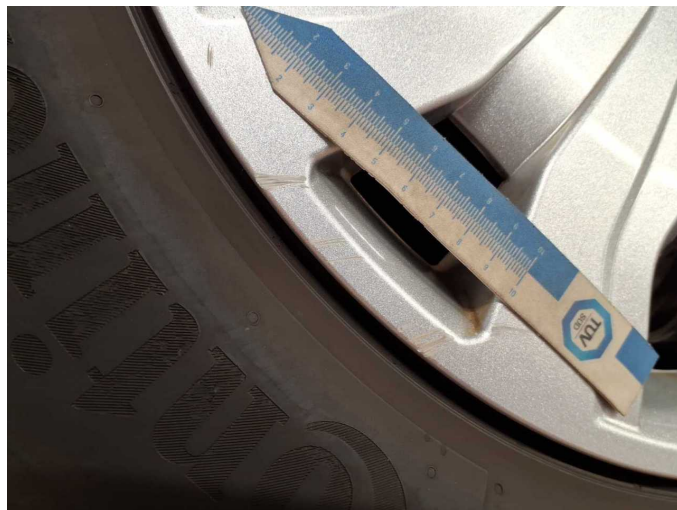
| No. | Component group | Description |
|---|---|---|
| 1 | Wheel / tyres | Wheel cover - rear right side - Scratched - No deduction |

**Wear and tear 1:** Wheel / tyres: Wheel cover - rear right side - Scratched - No deduction

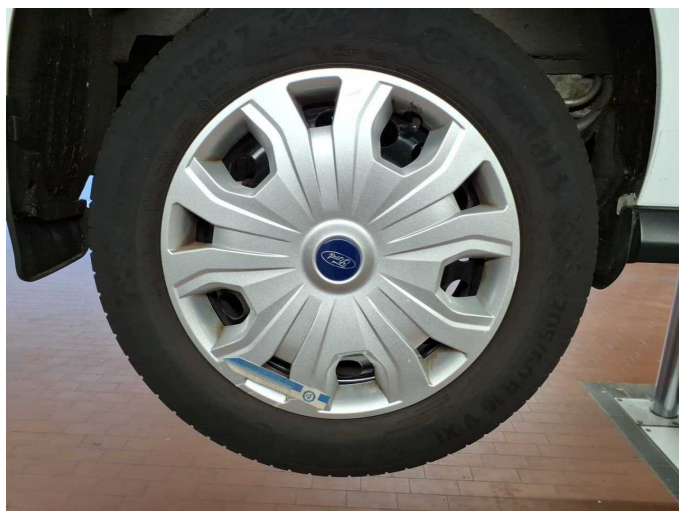
**Wear and tear 1:** Wheel / tyres: Wheel cover - rear right side - Scratched - No deduction

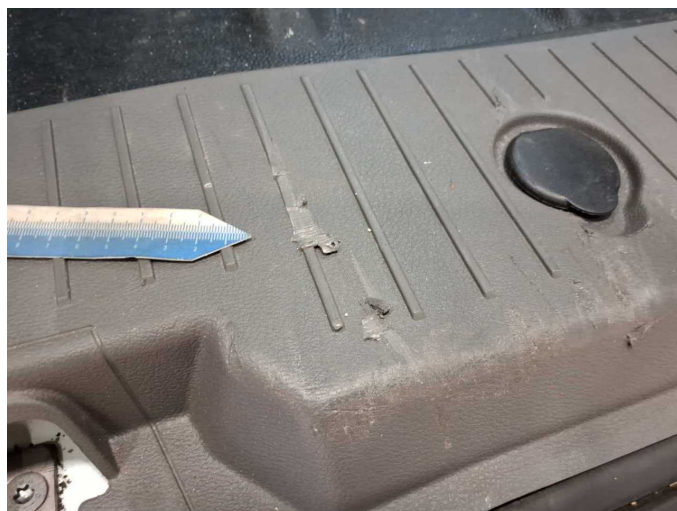
| No. | Component group | Description |
|---|---|---|
| 5 | Trim / covers | Boot sill cover - Scratch(es) - No deduction |

**Wear and tear 5:** Trim / covers: Boot sill cover - Scratch(es) - No deduction

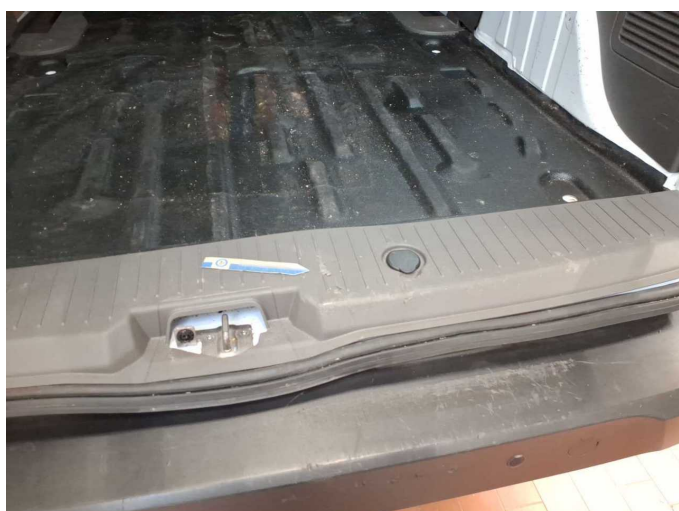
**Wear and tear 5:** Trim / covers: Boot sill cover - Scratch(es) - No deduction
