Expertise

Protocol number: 46432527  
Order No. / Reference: 26546800  
Inspection date: 10 Jun 2026

Manufacturer: MAN  
VIN: WMA03VUY6P9012523

Model: TGE 3.140 4X2F SB

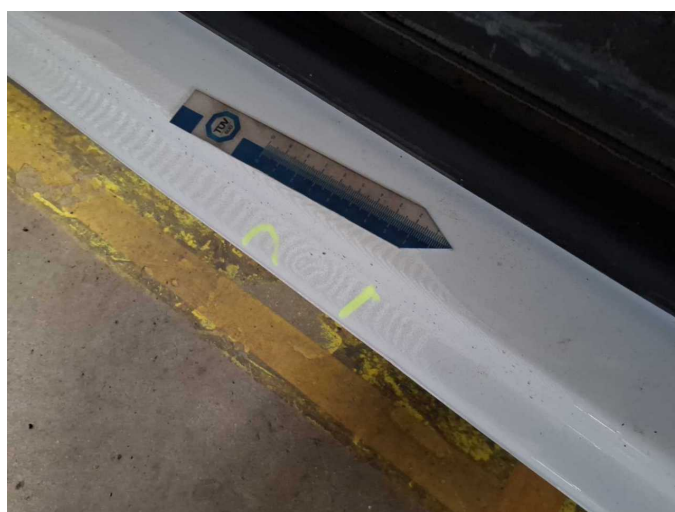
| No. | Component group | Description |
|---|---|---|
| 1 | Sill - right side | Sill - dent(s) - Smooth repair work |

Damage 1: Sill - right side: Sill - dent(s) - Smooth repair work

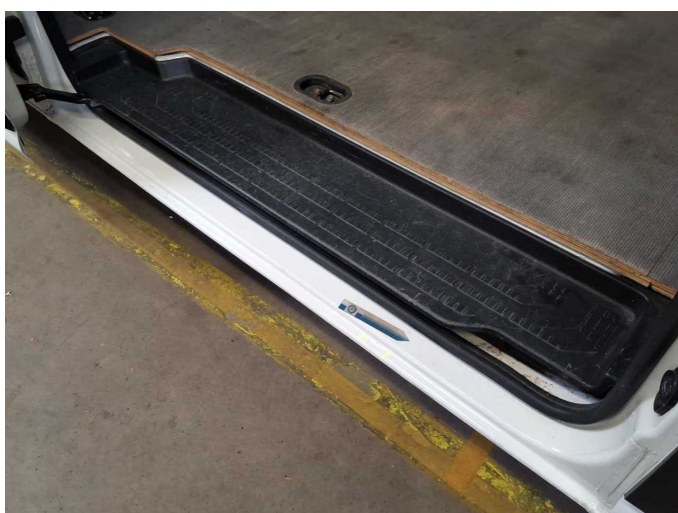
Damage 1: Sill - right side: Sill - dent(s) - Smooth repair work

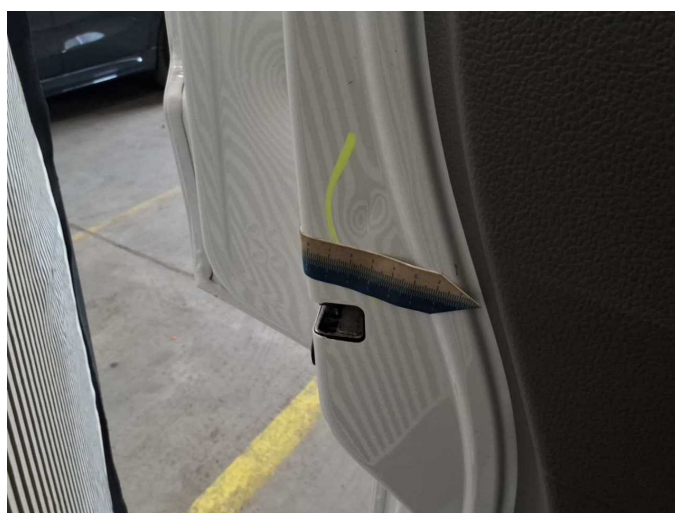
| No. | Component group | Description |
|---|---|---|
| 2 | Door - front left side | Door (Innen) - dent(s) - Smooth repair work |

Damage 2: Door - front left side: Door (Innen) - dent(s) - Smooth repair work

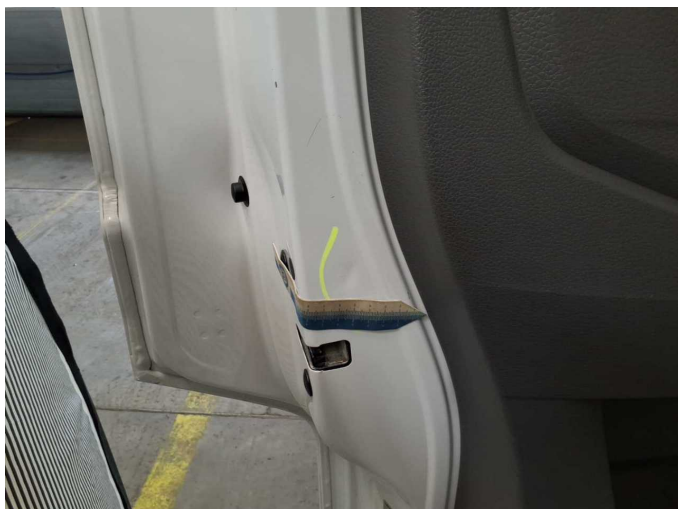
**Damage 2:** Door - front left side: Door (Innen) - dent(s) - Smooth repair work

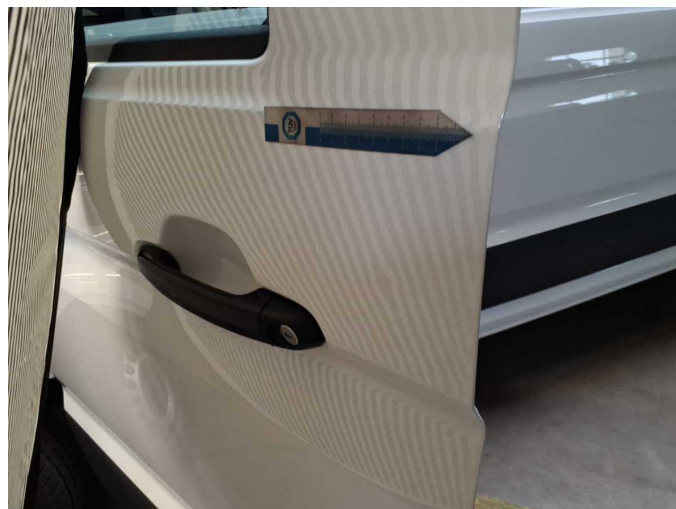
| No. | Component group | Description |
|---|---|---|
| 3 | Door - front left side | Door - dent(s) - Smooth repair work |

**Damage 3:** Door - front left side: Door - dent(s) - Smooth repair work

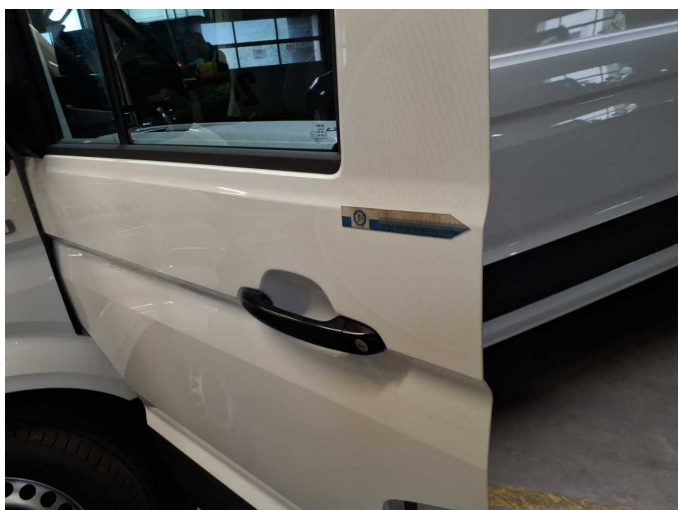
**Damage 3:** Door - front left side: Door - dent(s) - Smooth repair work

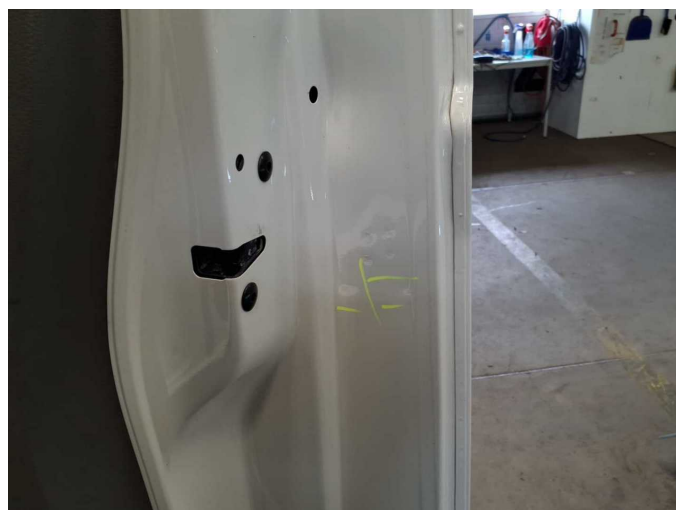
| No. | Component group | Description |
|---|---|---|
| 4 | Door - front right side | Door (Innen) - dent(s) - Smooth repair work |

**Damage 4:** Door - front right side: Door (Innen) - dent(s) - Smooth repair work

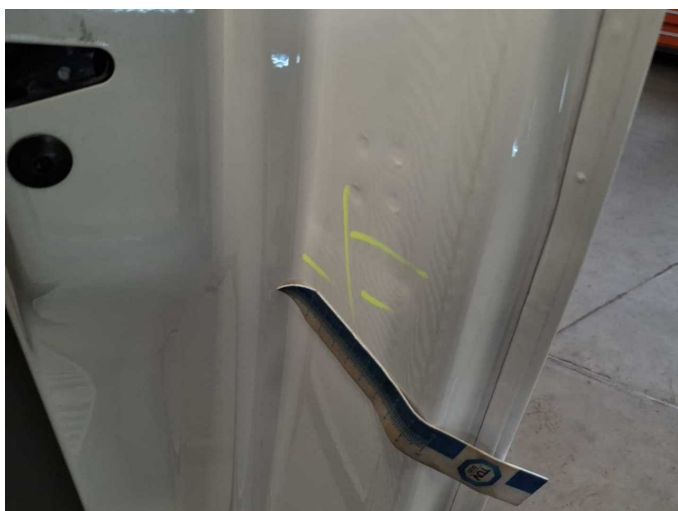
**Damage 4:** Door - front right side: Door (Innen) - dent(s) - Smooth repair work

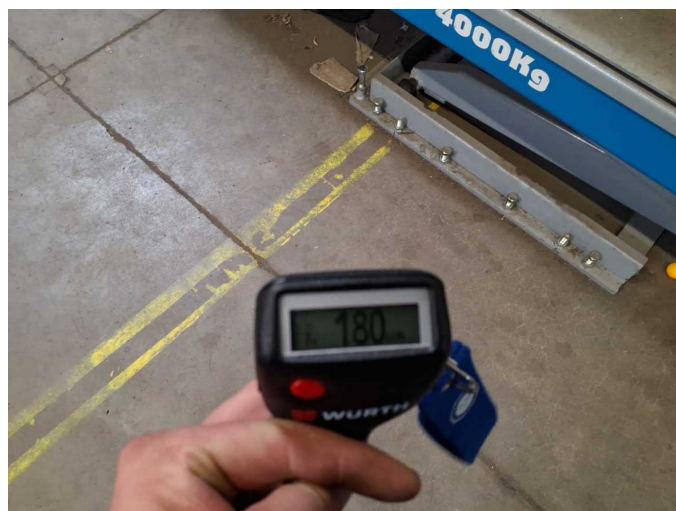
**Repainting 1:** Side panel - rear right side

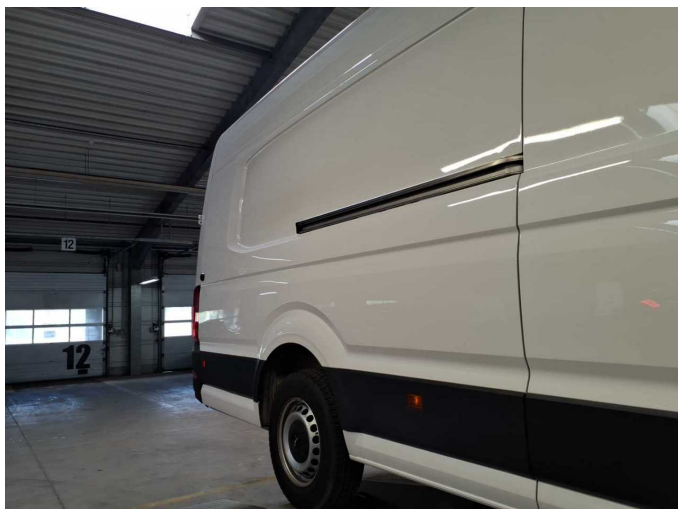
**Repainting 1:** Side panel - rear right side

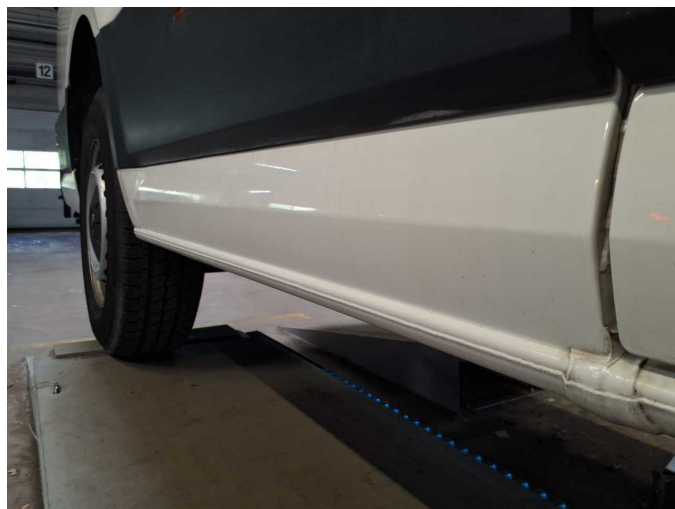
**Repainting 1:** Side panel - rear right side

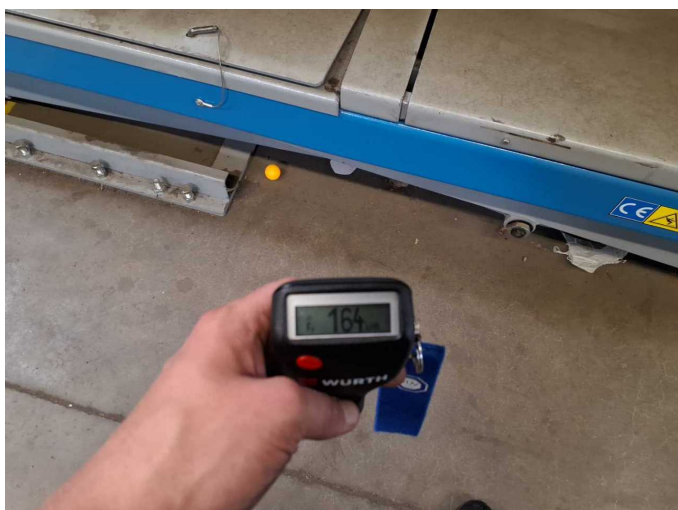
**Repainting 2:** Door - rear right side

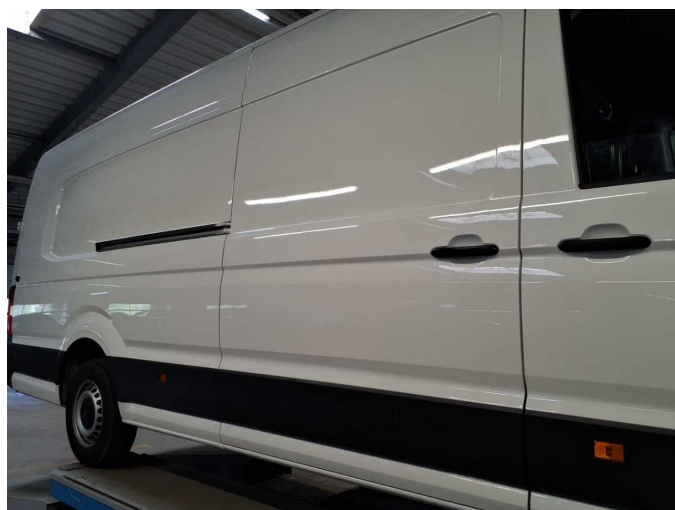
**Repainting 2:** Door - rear right side

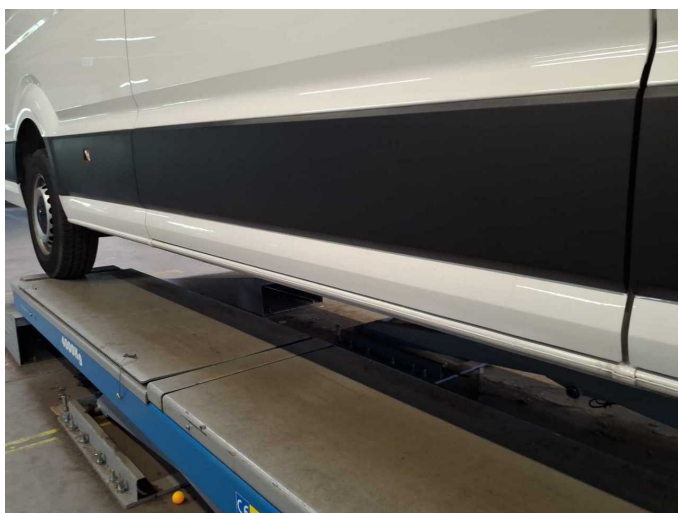
**Repainting 2:** Door - rear right side

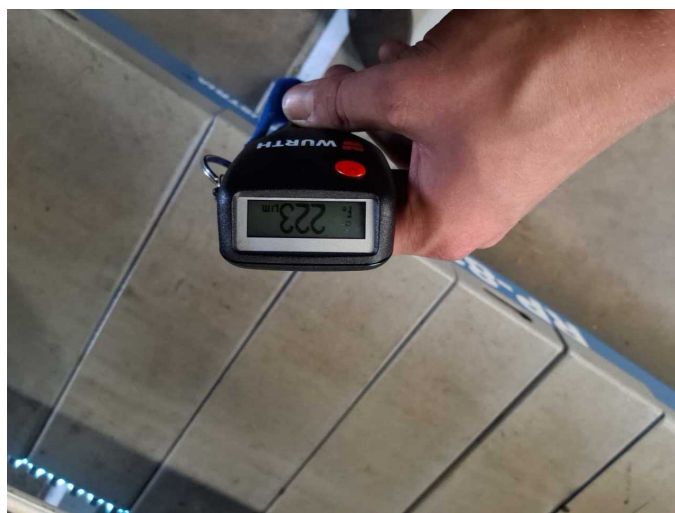
**Repainting 3:** Door - front right side

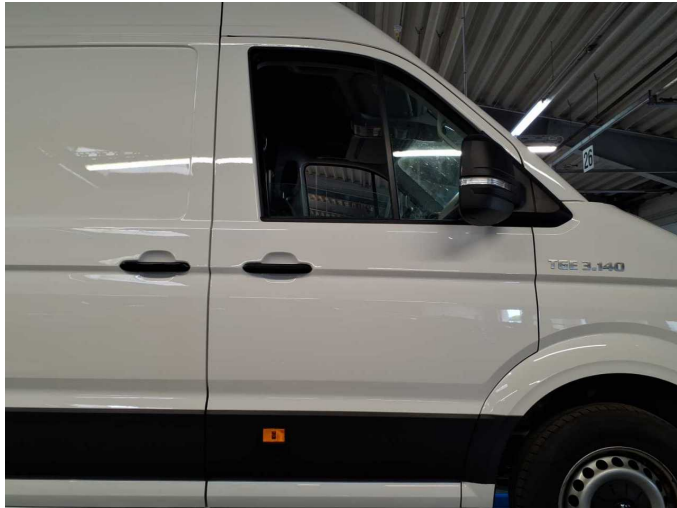
**Repainting 3: Door - front right side**

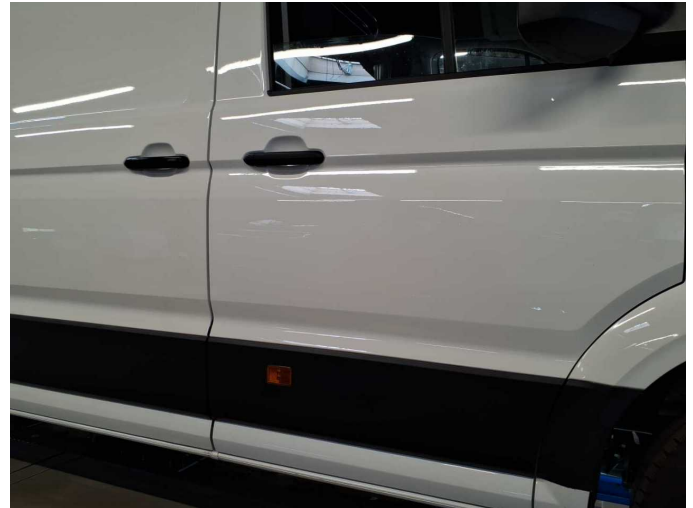
**Repainting 3: Door - front right side**

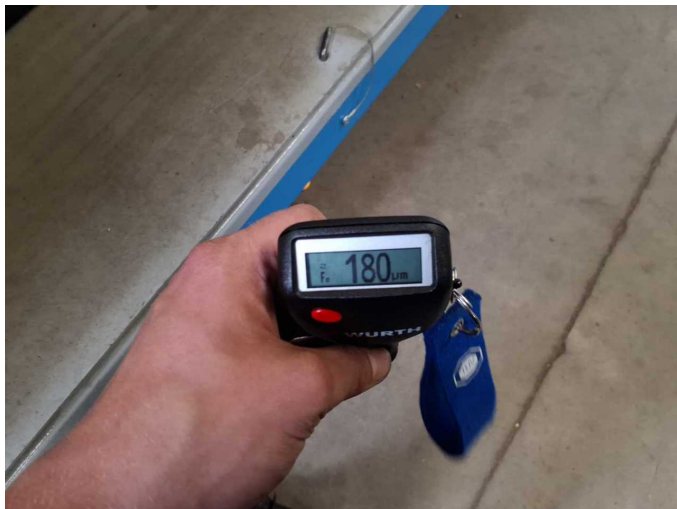
**Side panel - rear right side: 180 µm**

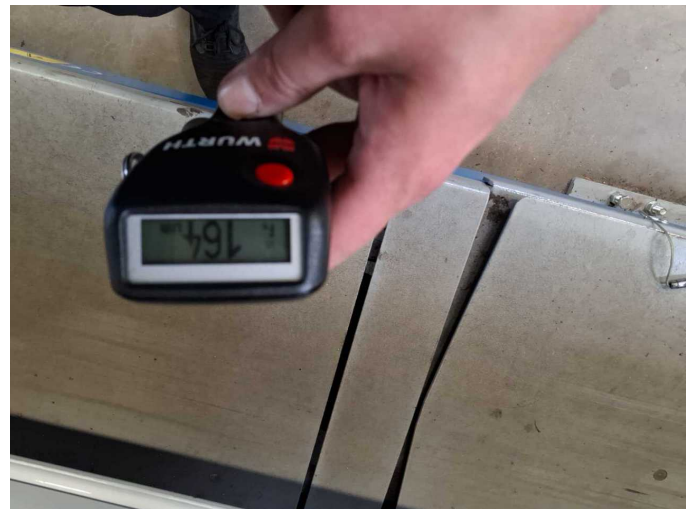
**Door - rear right side: 164 µm**

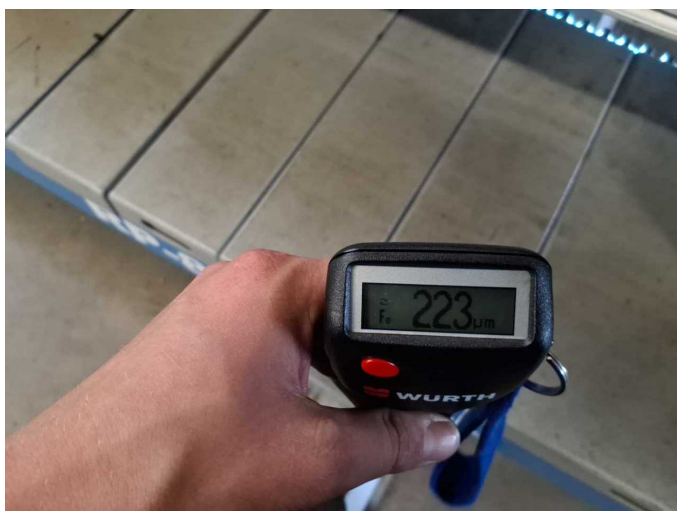
**Door - front right side: 223 µm**
