Expertise

Protocol number: 46487100  
Order No. / Reference: 26184119  
Inspection date: 30 Jun 2026

Manufacturer: Mercedes-Benz  
VIN: W1VVLBEZ6T4562734

Model: Vito 116 CDI Lang HA PRO Kasten

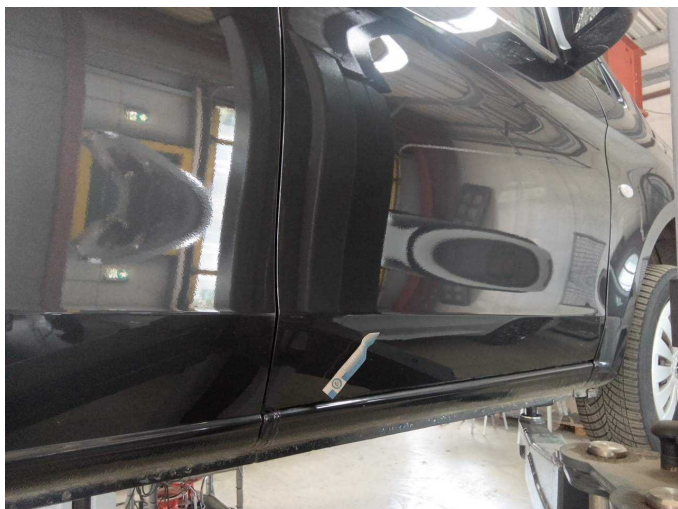
| No. | Component group | Description |
|---|---|---|
| 1 | Door - front right side | Door (2) - dent(s) - Lacquer |

**Damage 1:** Door - front right side: Door (2) - dent(s) - Lacquer

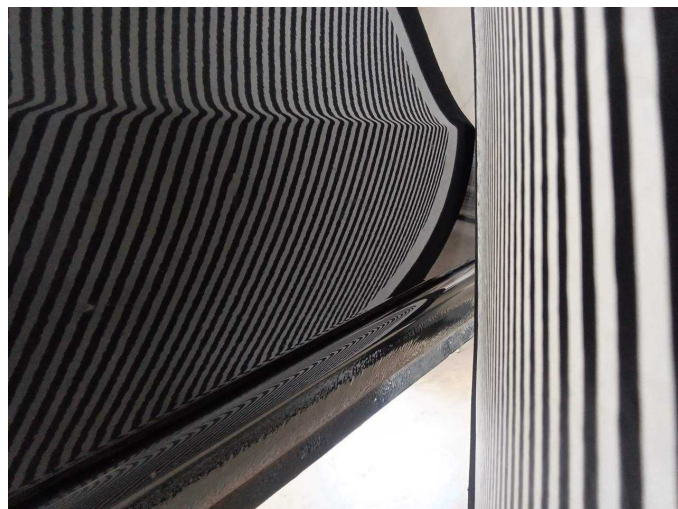
**Damage 1:** Door - front right side: Door (2) - dent(s) - Lacquer

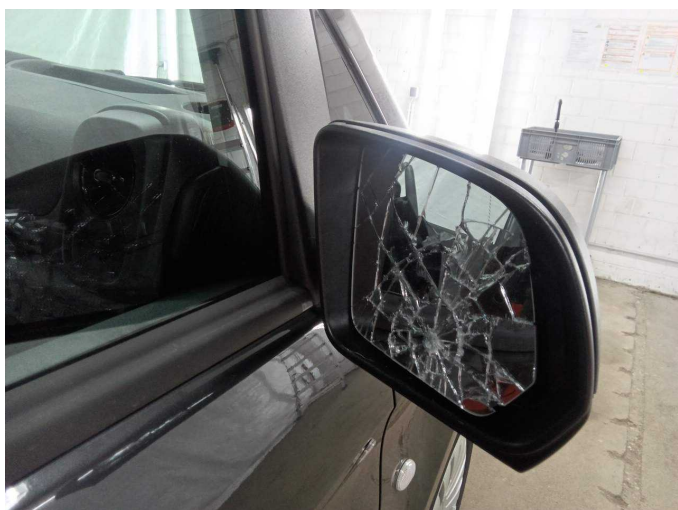
| No. | Component group | Description |
|---|---|---|
| 2 | Wing mirror - right side | Mirror glass - Broken / torn - Replace |

**Damage 2:** Wing mirror - right side: Mirror glass - Broken / torn - Replace

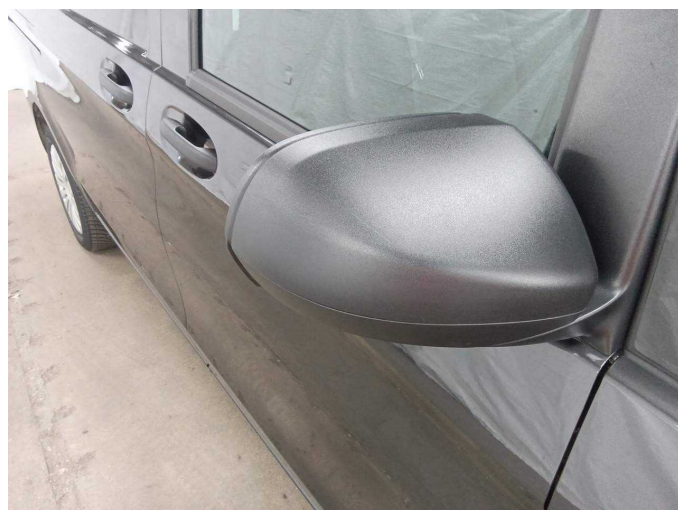
**Damage 2:** Wing mirror - right side: Mirror glass - Broken / torn - Replace

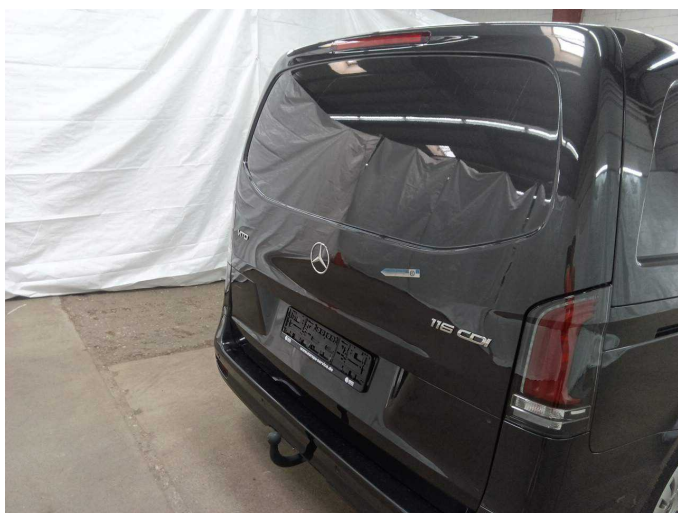
| No. | Component group | Description |
|---|---|---|
| 3 | Boot lid / rear door | Boot lid (5) - dent(s) - Smooth repair work |

**Damage 3:** Boot lid / rear door: Boot lid (5) - dent(s) - Smooth repair work

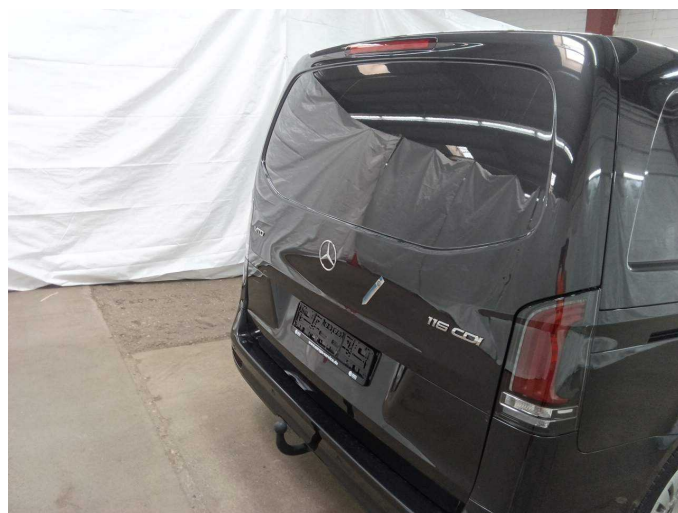
**Damage 3:** Boot lid / rear door: Boot lid (5) - dent(s) - Smooth repair work

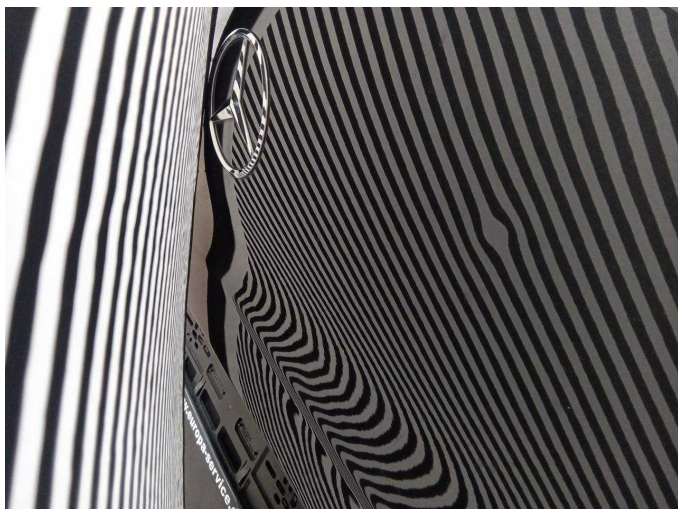
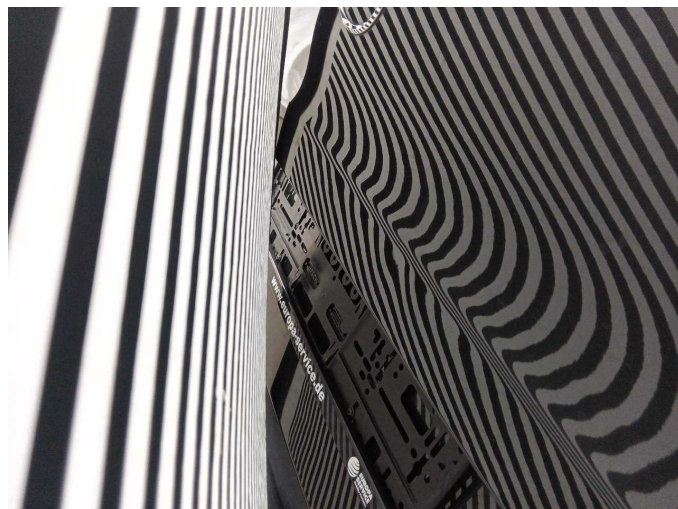
**Damage 3:** Boot lid / rear door: Boot lid (5) - dent(s) - Smooth repair work

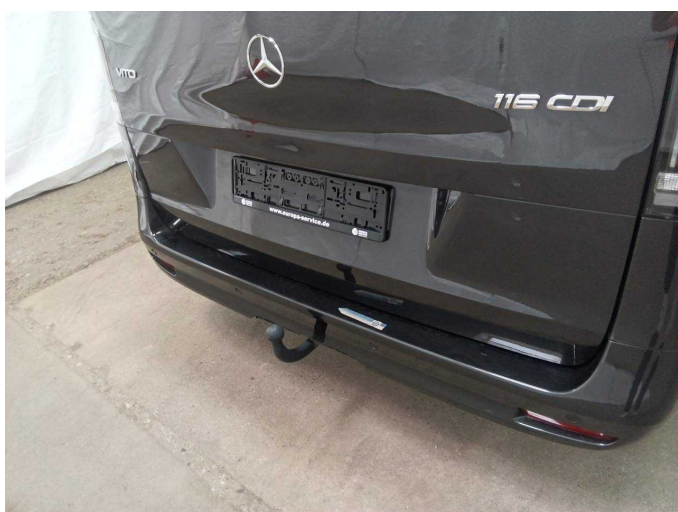
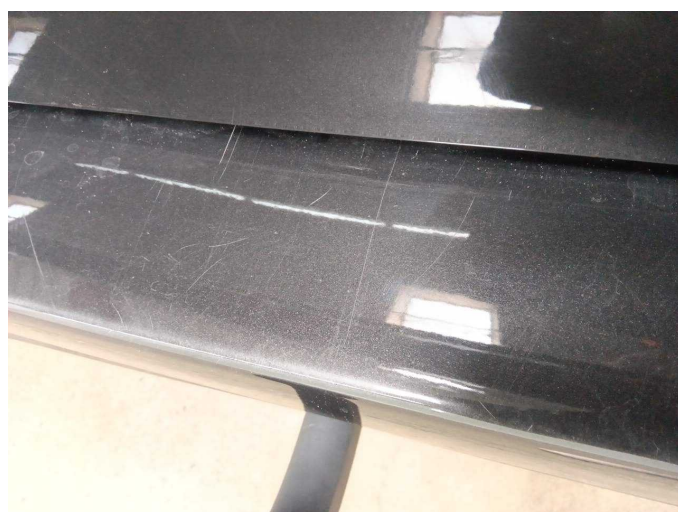
| No. | Component group | Description |
|---|---|---|
| 4 | Rear bumper | Rear bumper - Scratch(es) - Paint |

**Damage 4:** Rear bumper: Rear bumper - Scratch(es) - Paint

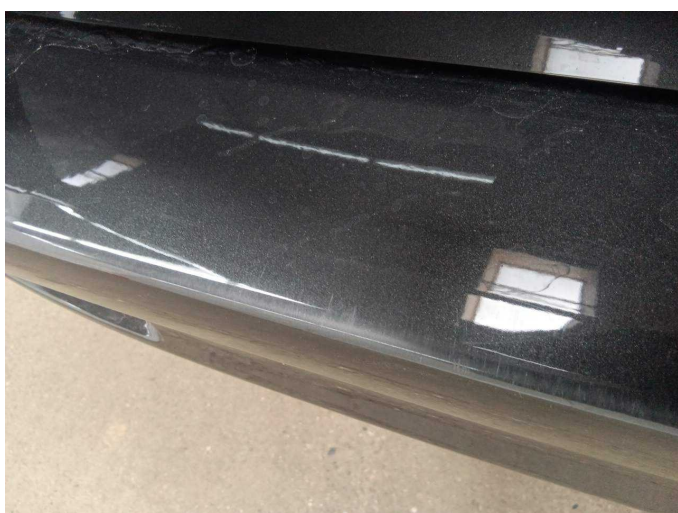
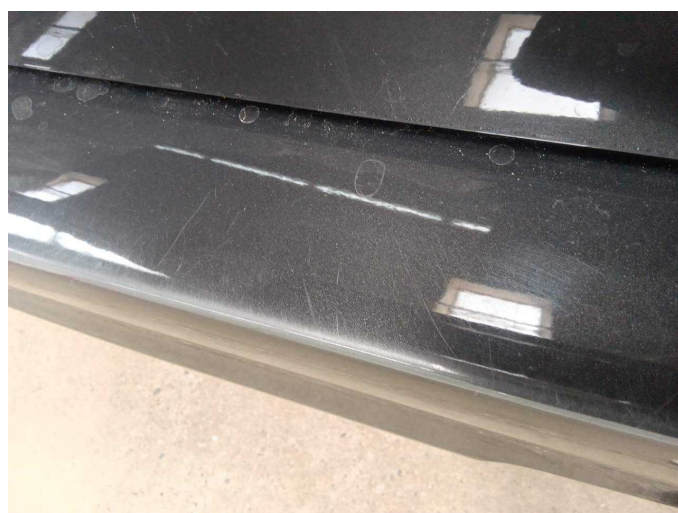
**Damage 4:** Rear bumper: Rear bumper - Scratch(es) - Paint

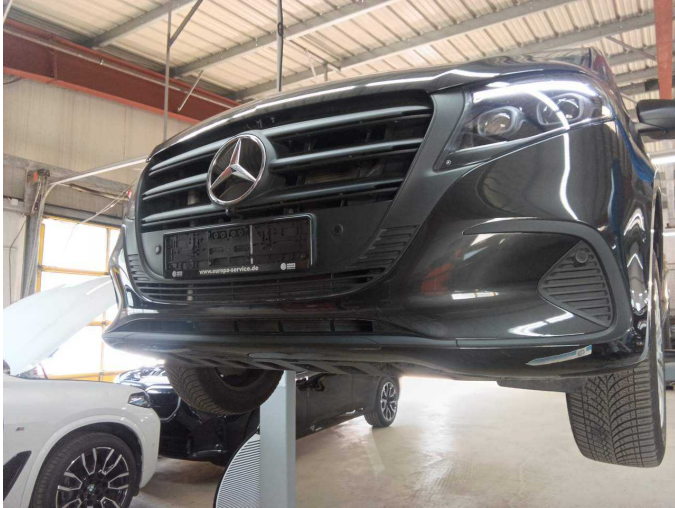
| No. | Component group | Description |
|---|---|---|
| 5 | Front bumper | Front bumper - Scratch(es) - Paint |

**Damage 5:** Front bumper: Front bumper - Scratch(es) - Paint

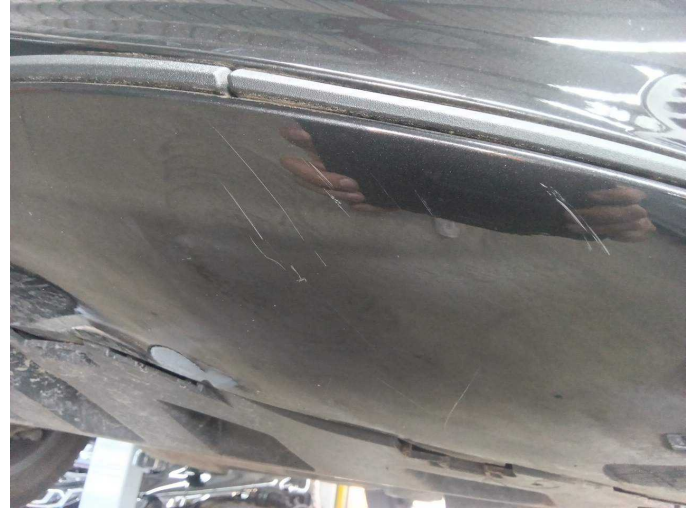
**Damage 5:** Front bumper: Front bumper - Scratch(es) - Paint
