Expertise

Protocol number: 44909409
Order No. / Reference: 25987366
Inspection date: 31 Mar 2026

Manufacturer: Opel

Model: Movano 2.2 D L3H2 2WD VA Edition

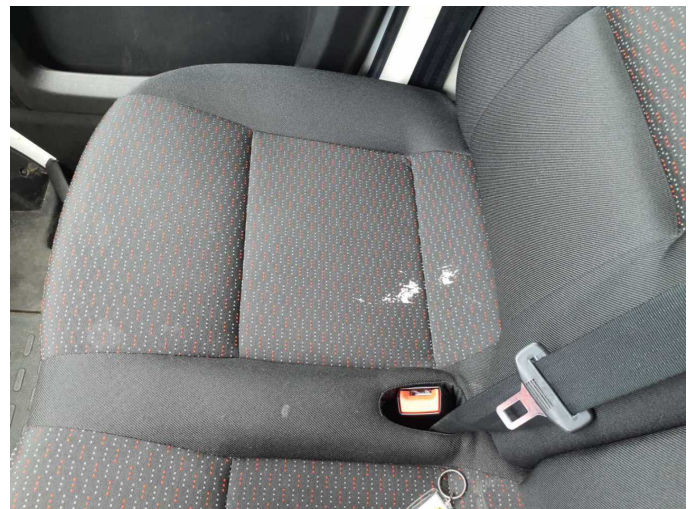
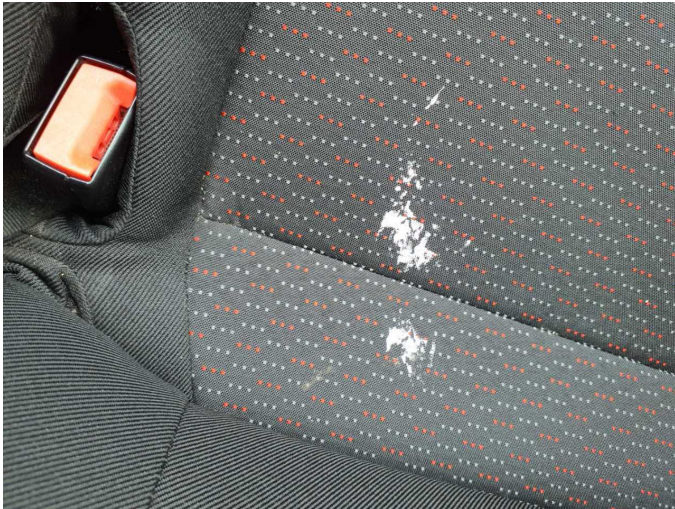
Damage 2: Seat - front: Seat cover - right side - Soiled - Clean

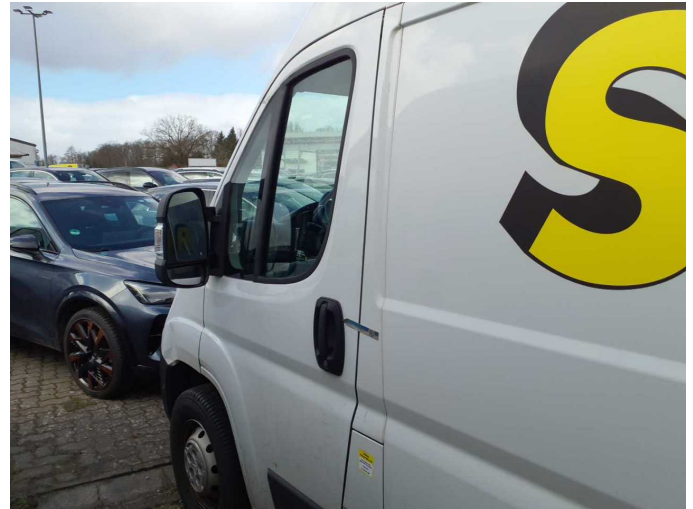
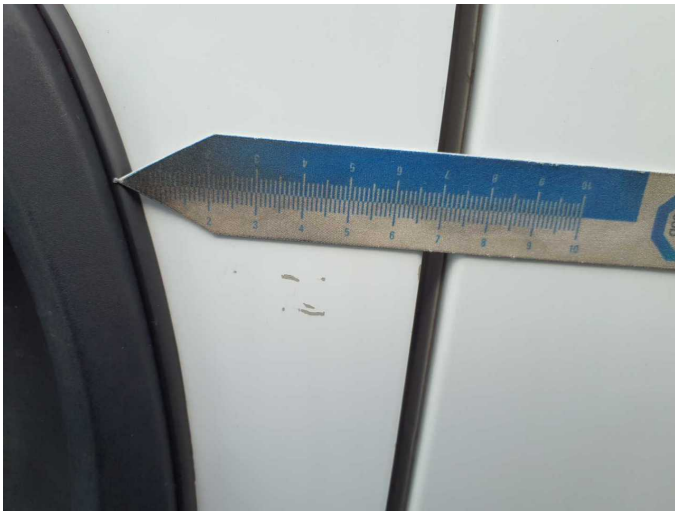
Damage 3: Door - front left side: Door - Scratch(es) - Smart repair

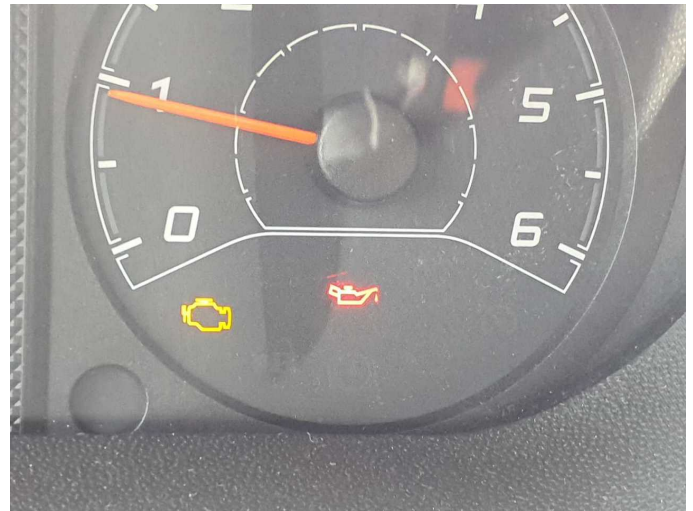
- Fahrzeug nicht fahrbereit, Verdacht auf Motorschaden.

Damage 5: Instrument panel: Indicator light (Öldruck, hohe Mehrkosten wahrscheinlich) - on - Perform diagnosis

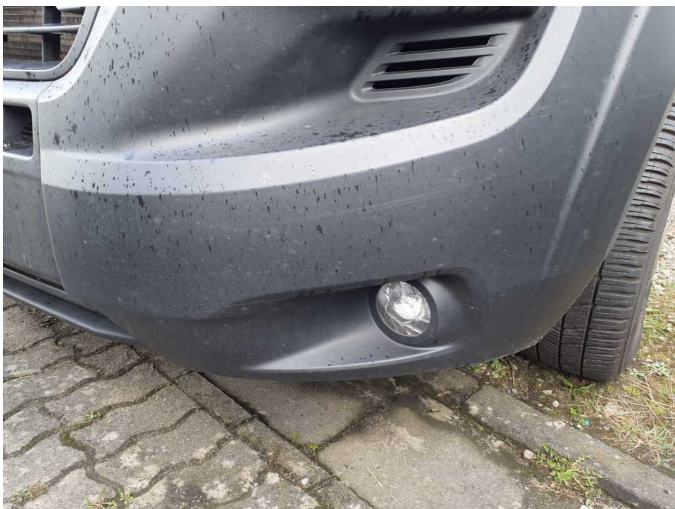
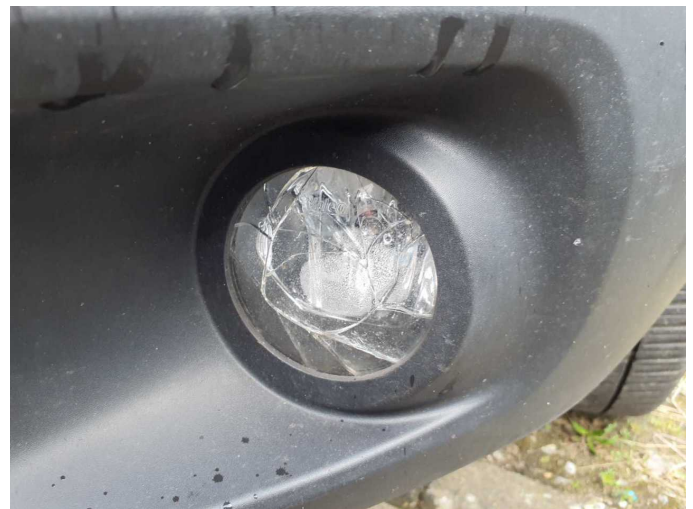
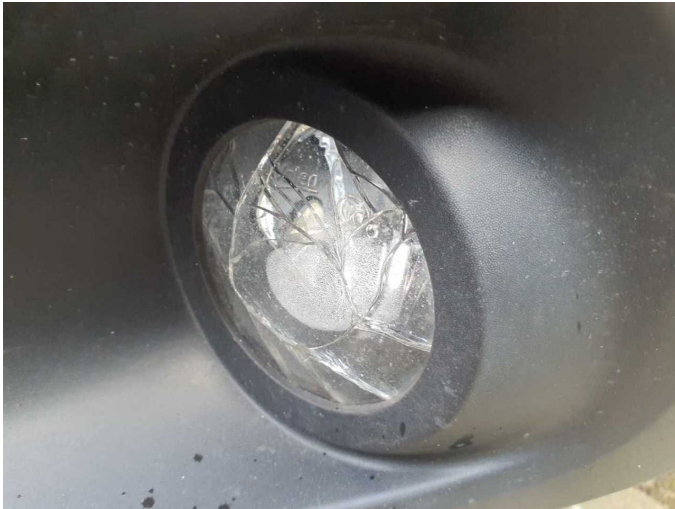
Damage 6: Fog lamp: Fog lamp - front left side - Broken / torn - Replace

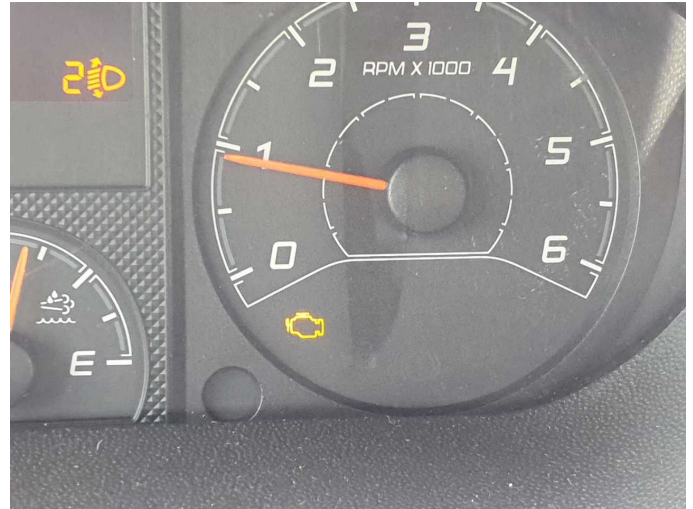
Damage 7: Instrument panel: Indicator light (Motorkontrolleuchte, Mehrkosten möglich) - on - Perform diagnosis

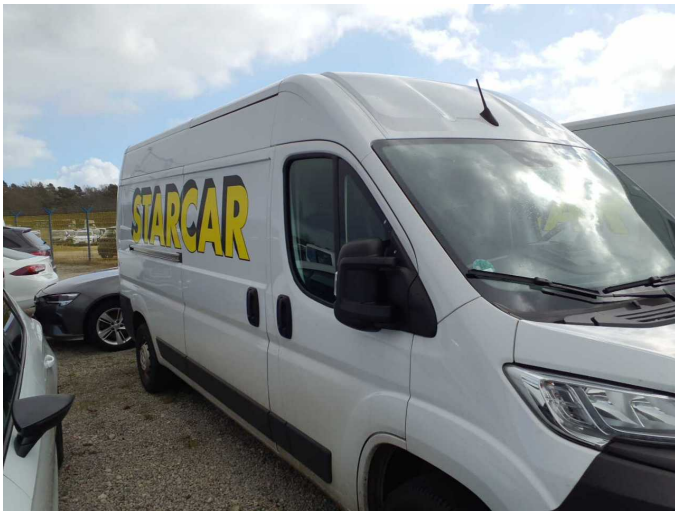
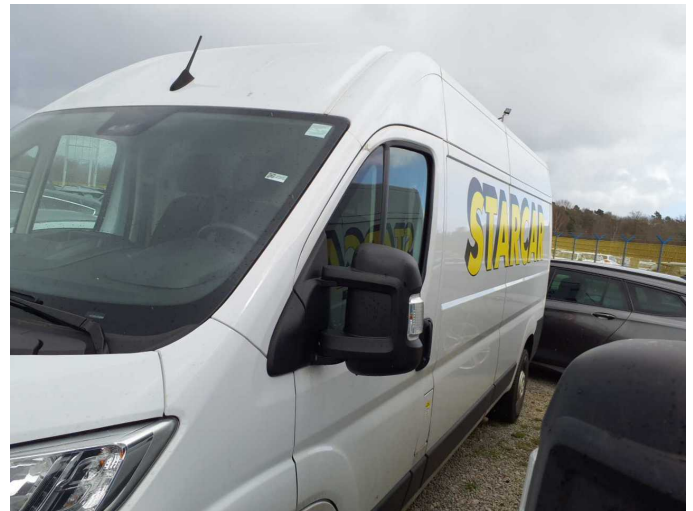
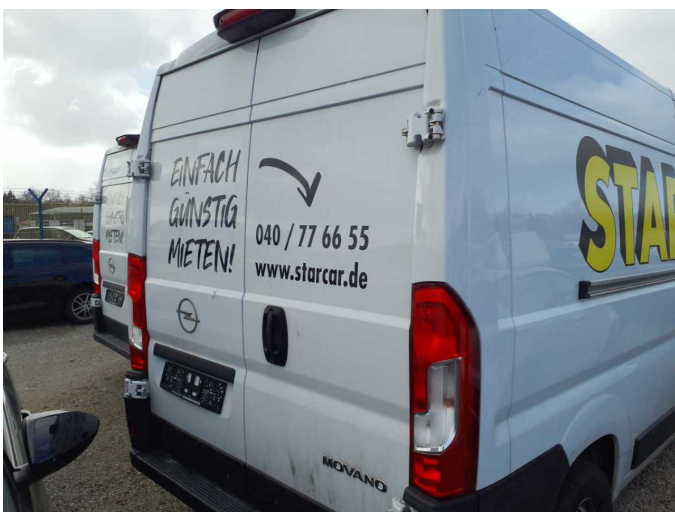
Damage 8: Body: Body - Glued / labelled - De-glue / neutralise

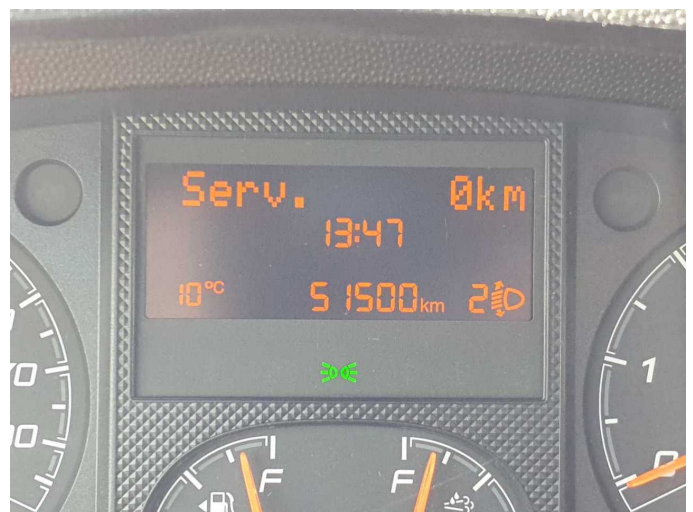
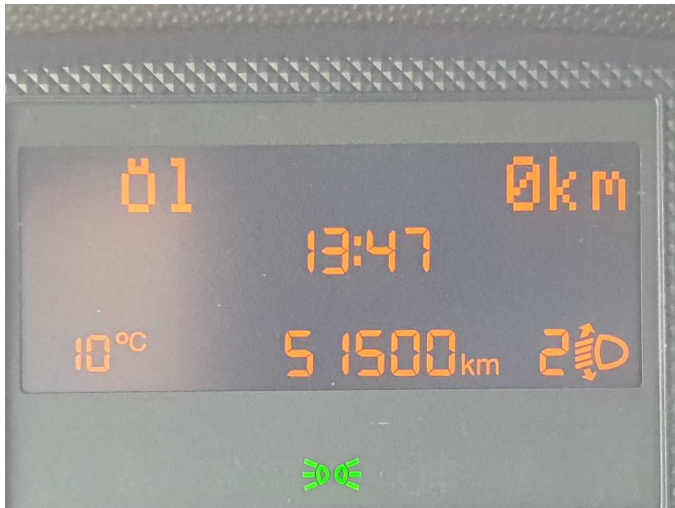
Damage 9: Misc.: Inspection / maintenance - Due - Perform

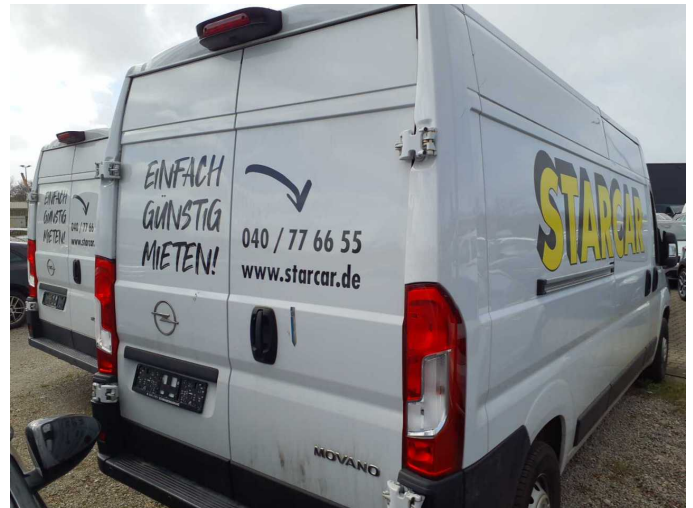
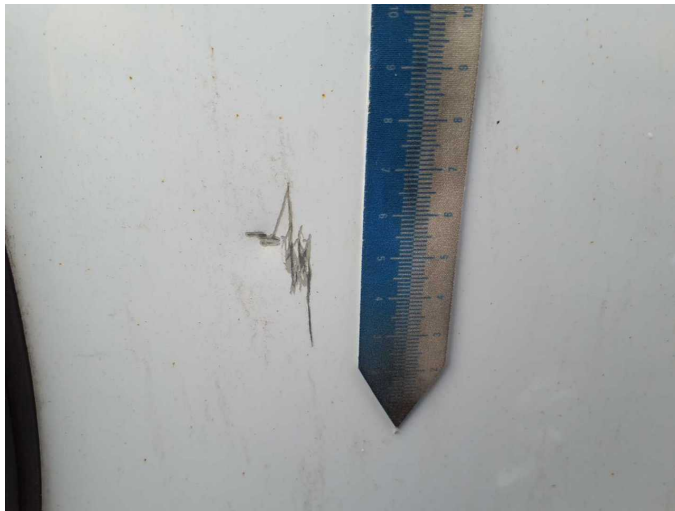
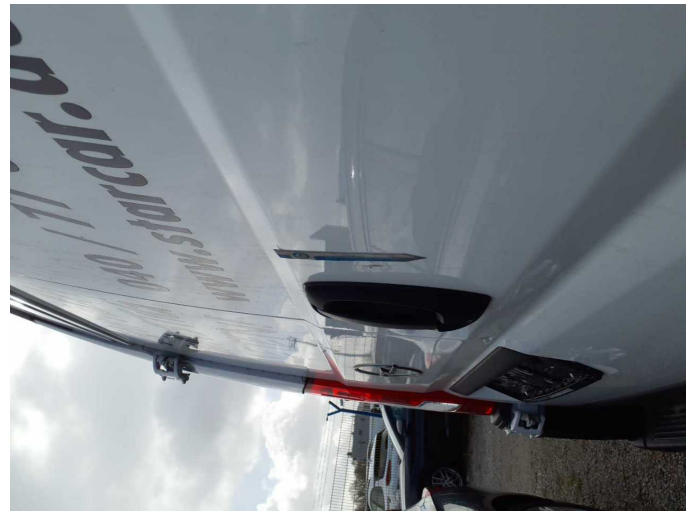
Damage 10: Boot lid / rear door: Rear door - right side - Dent / paintcoat damage - Repair and paint

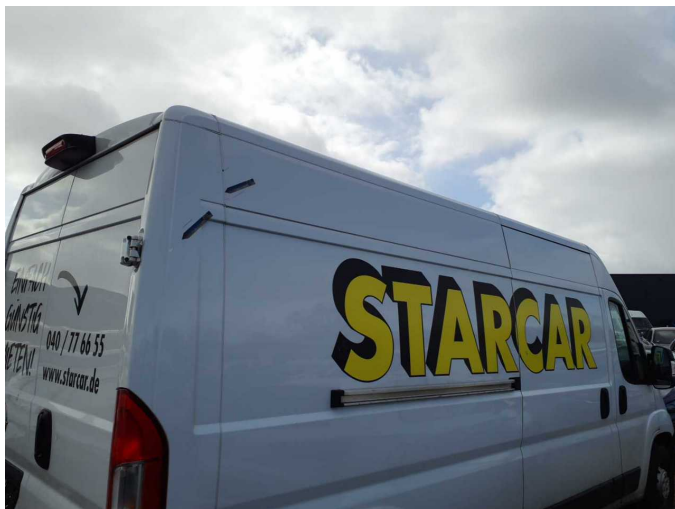
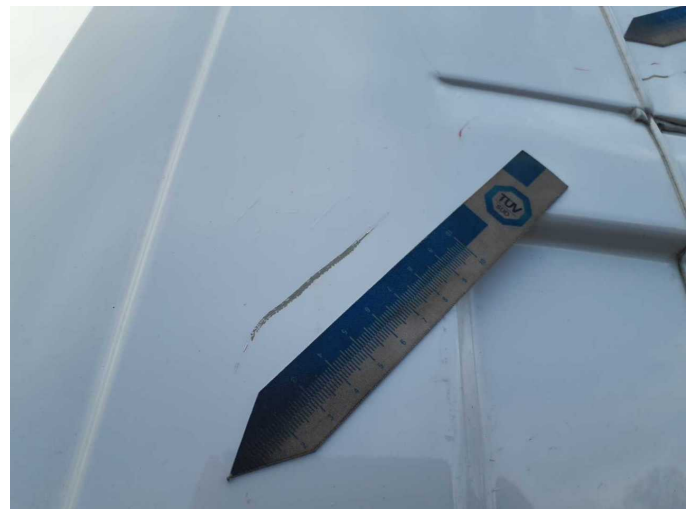
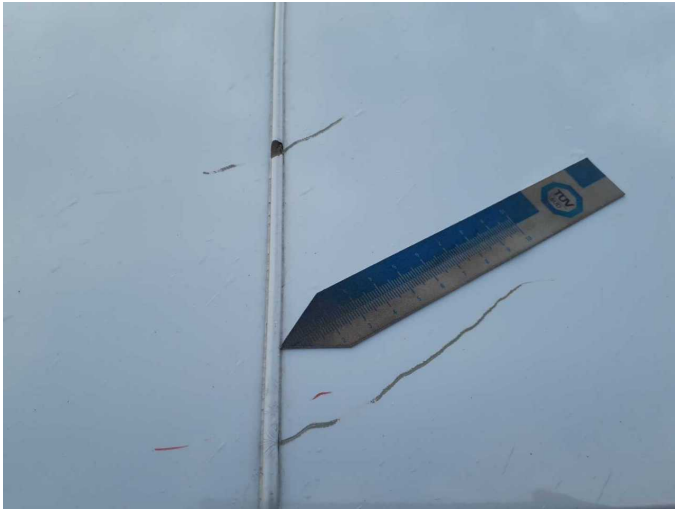
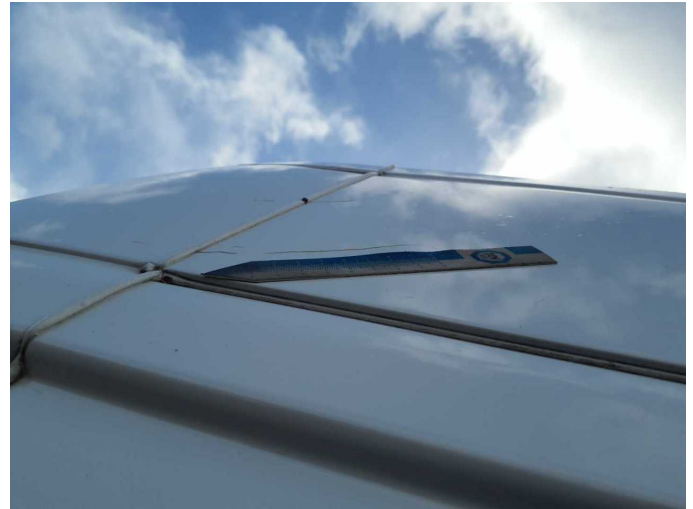
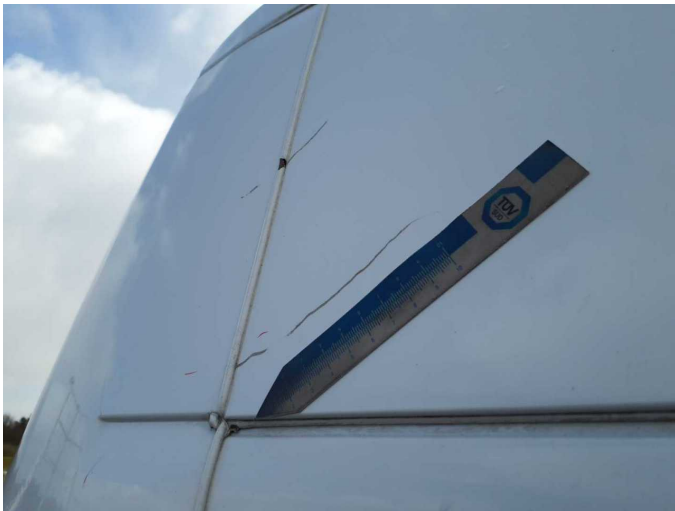
Damage 11: Side panel - rear right side: Side panel - Scratch(es) - Paint

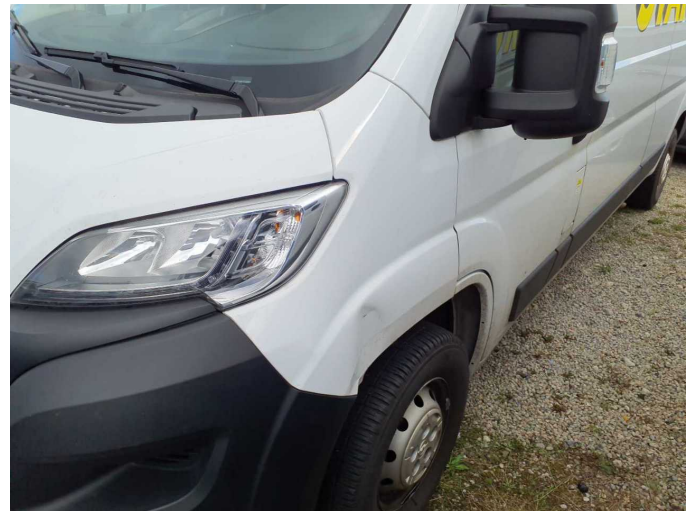
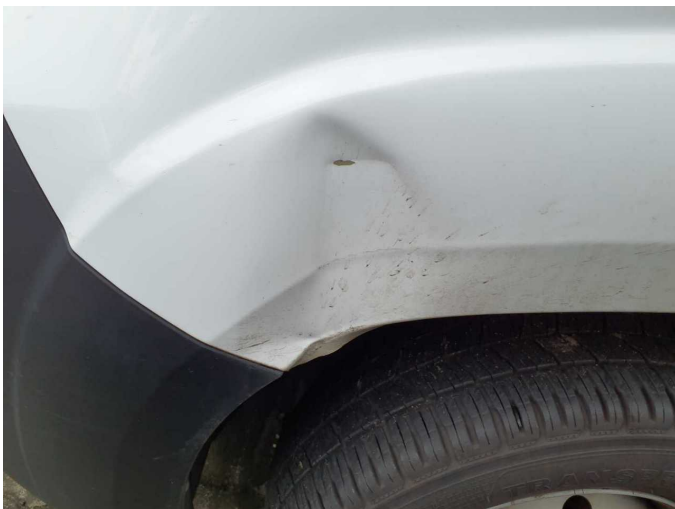
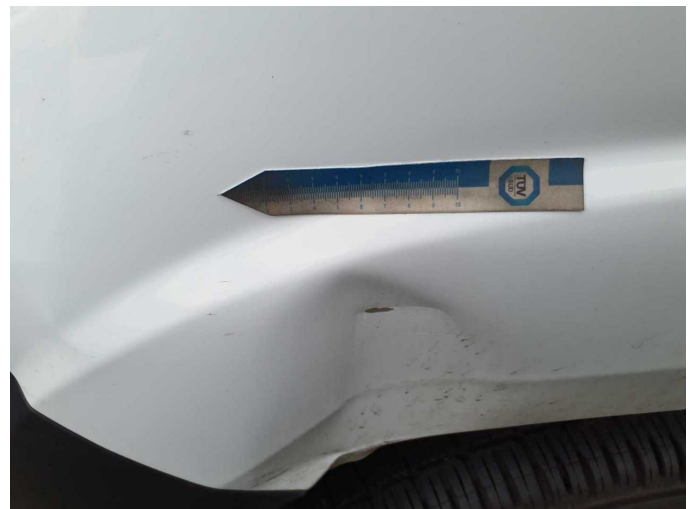
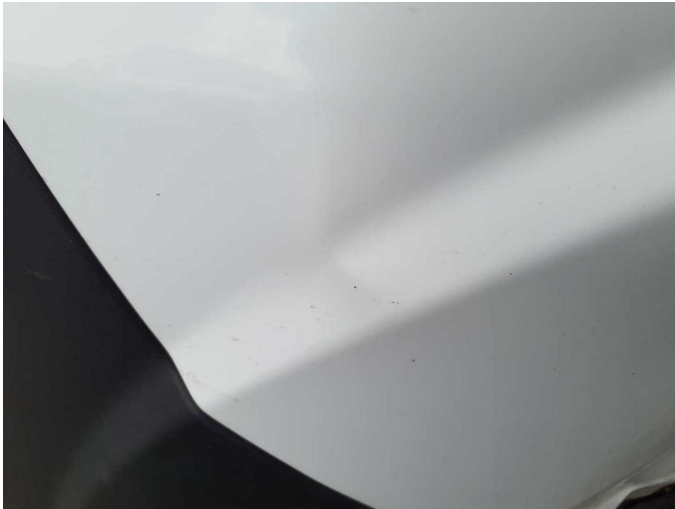
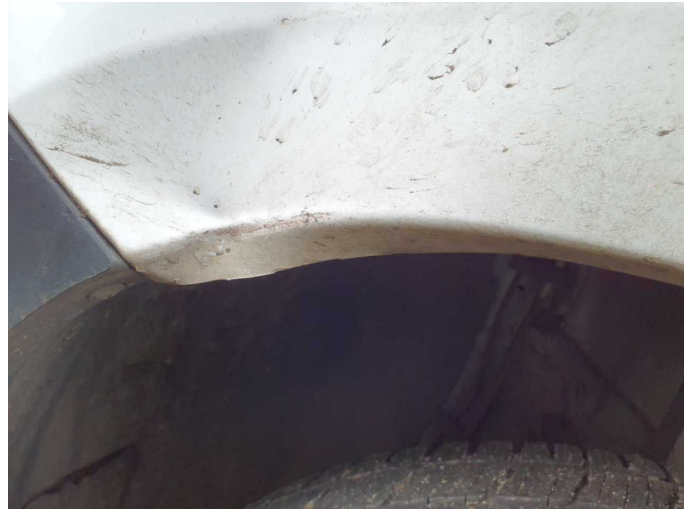
Damage 12: Mudguard - left side: Mudguard - left side - Deformed - Replace
