Expertise

Protocol number: 45856167
Order No. / Reference: 26453799
Inspection date: 9 Jun 2026

Manufacturer: Opel

Model: Astra Sports Tourer 1.5 D Automatik Business Elegance

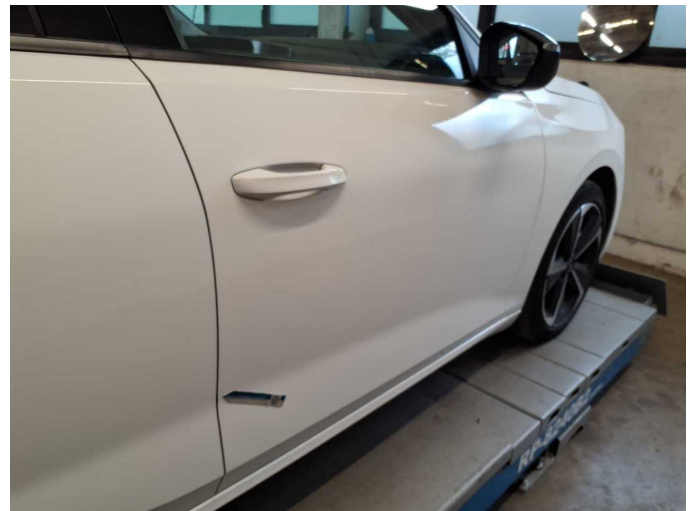
Damage 1: Door - front right side: Door edge - Scratched - Smart repair

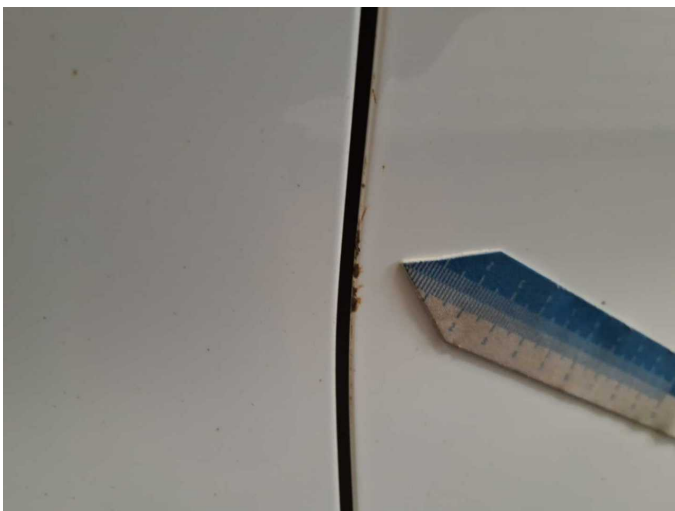
Damage 1: Door - front right side: Door edge - Scratched - Smart repair

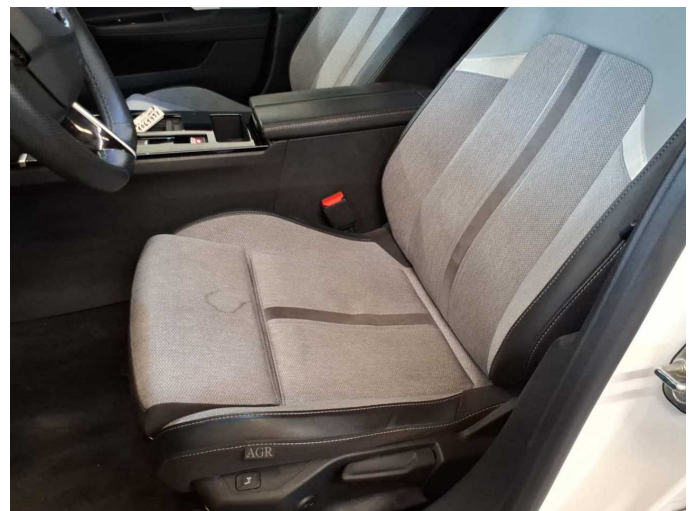
Damage 2: Seat - front: Seat cover - left side - Soiled - Clean

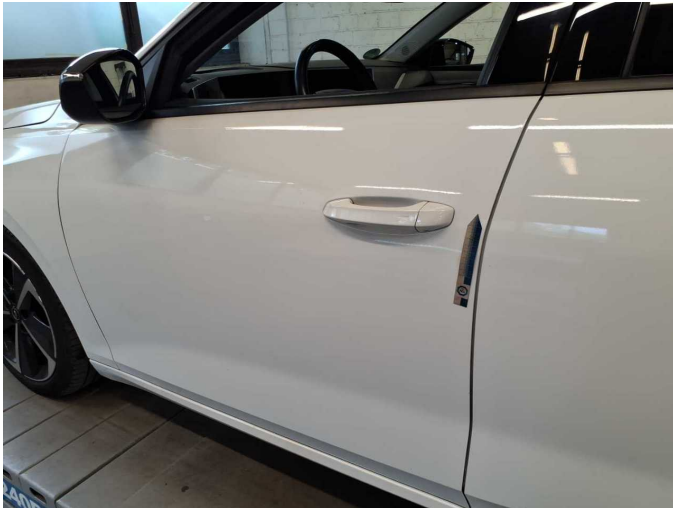
Damage 3: Door - front left side: Door edge - Scratched - Smart repair

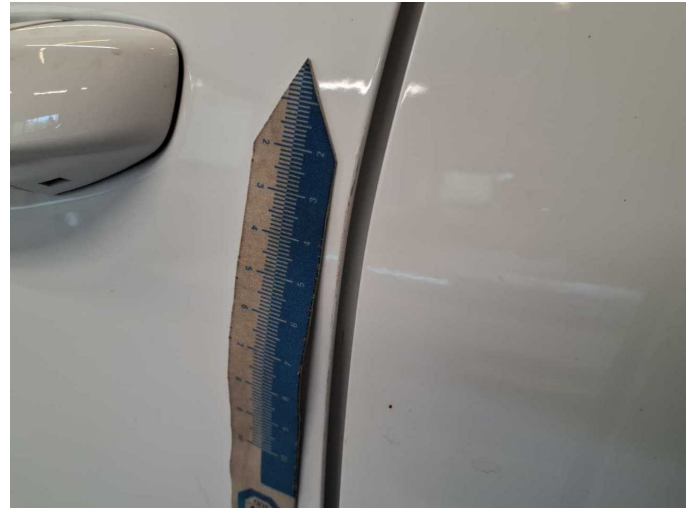
Damage 3: Door - front left side: Door edge - Scratched - Smart repair

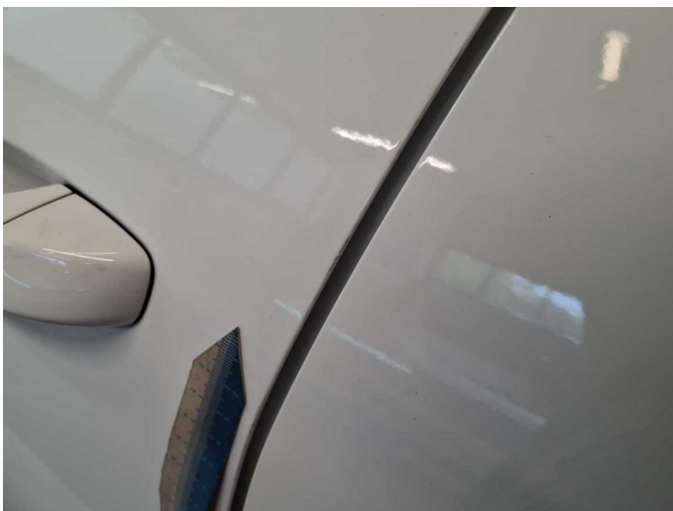
Damage 3: Door - front left side: Door edge - Scratched - Smart repair

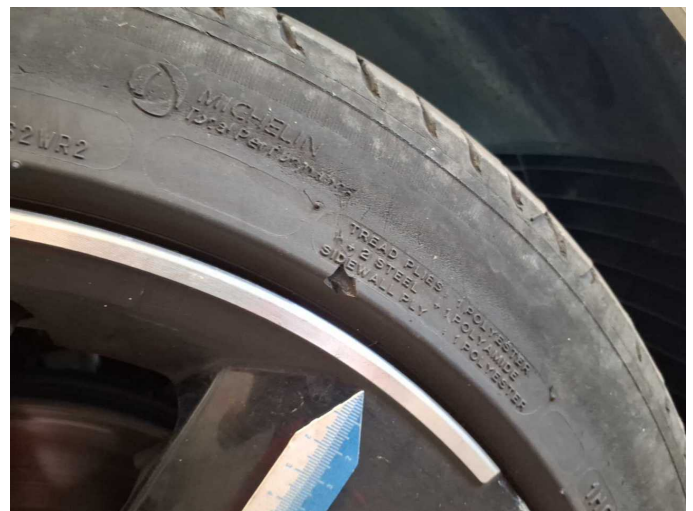
Damage 4: Wheel / tyres: Tyre - front right side - Broken / torn - Replace

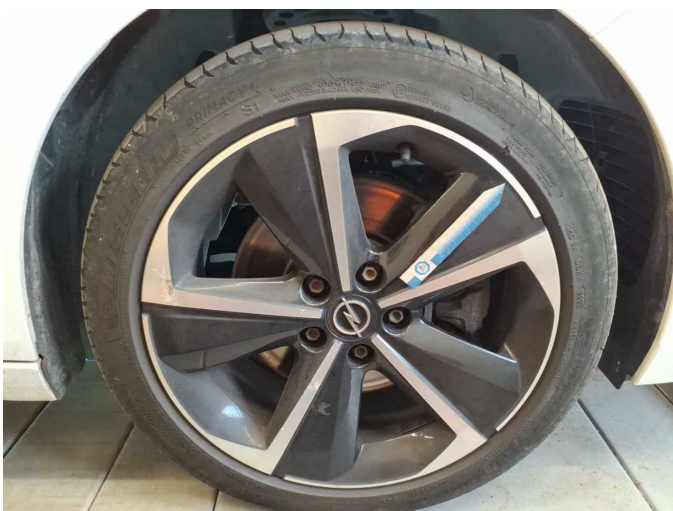
Damage 4: Wheel / tyres: Tyre - front right side - Broken / torn - Replace

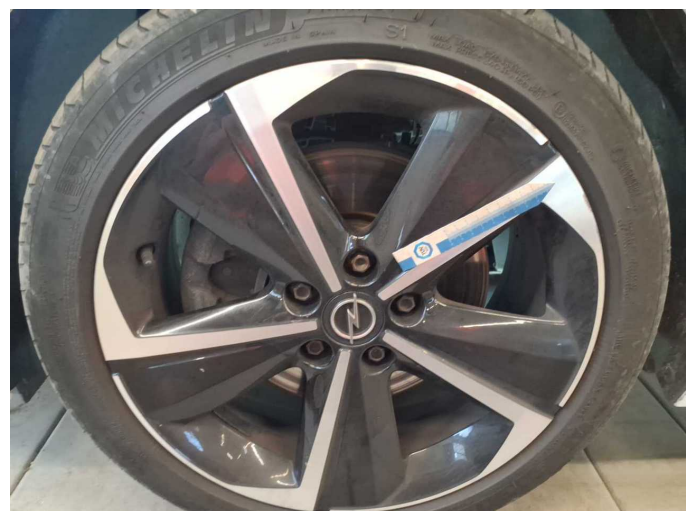
Damage 5: Wheel / tyres: Alloy rim - front left side - Scratched - Loss in value

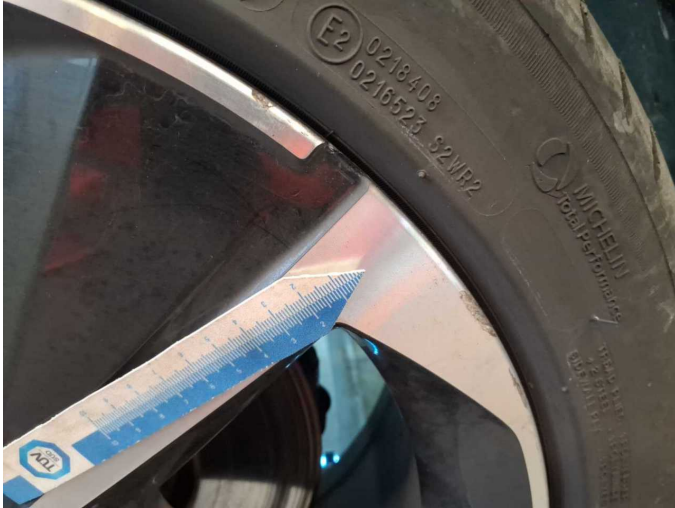
Damage 5: Wheel / tyres: Alloy rim - front left side - Scratched - Loss in value

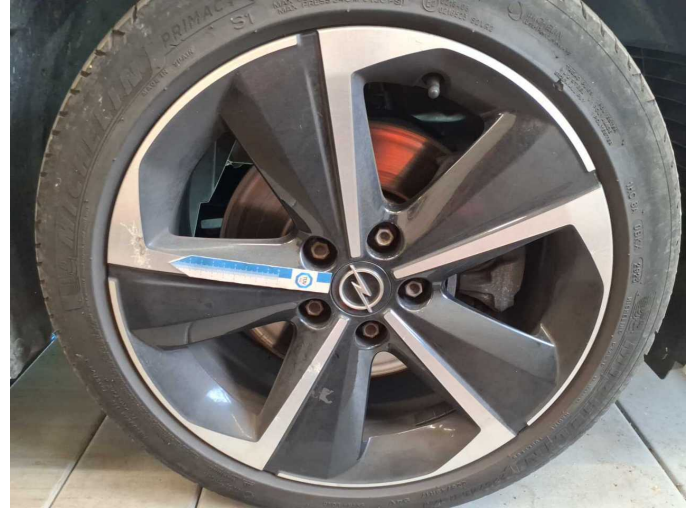
Damage 6: Wheel / tyres: Alloy rim - front right side - Corrosion - Loss in value

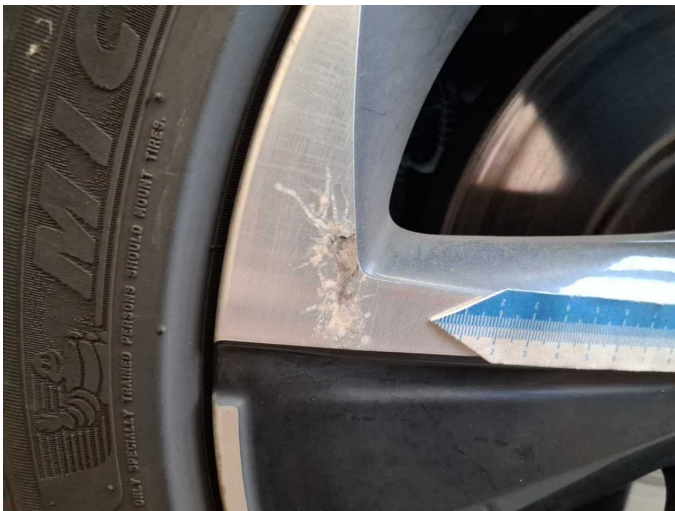
Damage 6: Wheel / tyres: Alloy rim - front right side - Corrosion - Loss in value

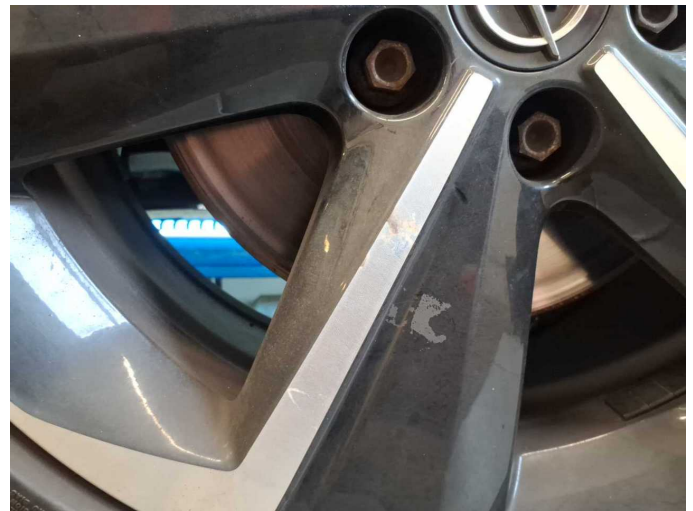
Damage 6: Wheel / tyres: Alloy rim - front right side - Corrosion - Loss in value

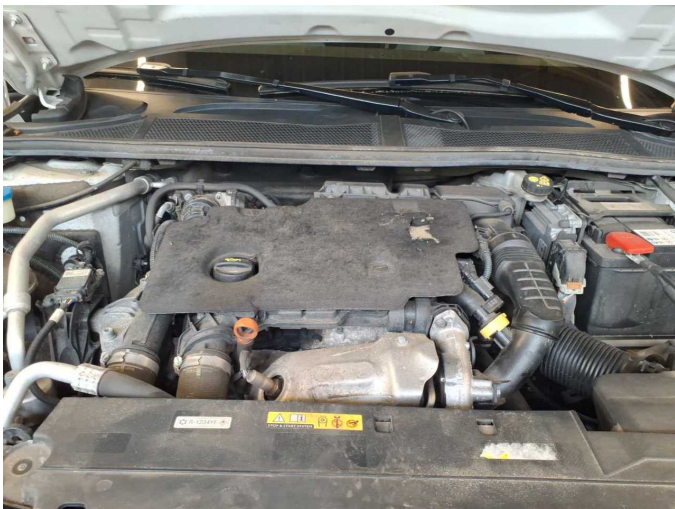
Damage 7: Engine: Engine cover - Damage caused by marten / rodent - Replace

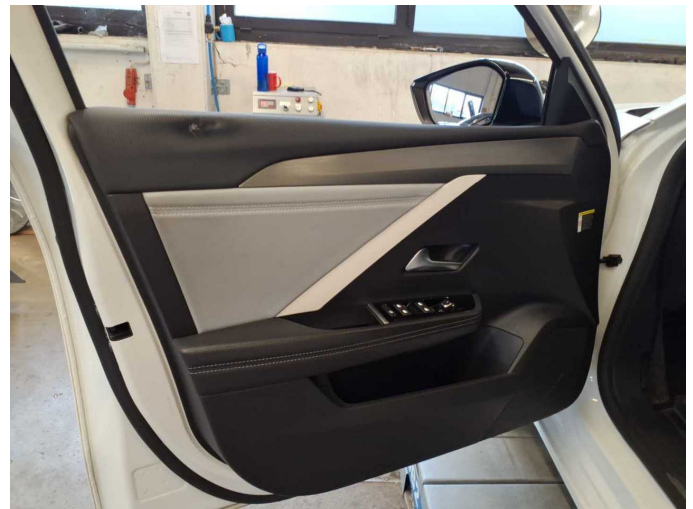
Damage 8: Trim / covers: Door trim - front left side - Broken / torn - Replace

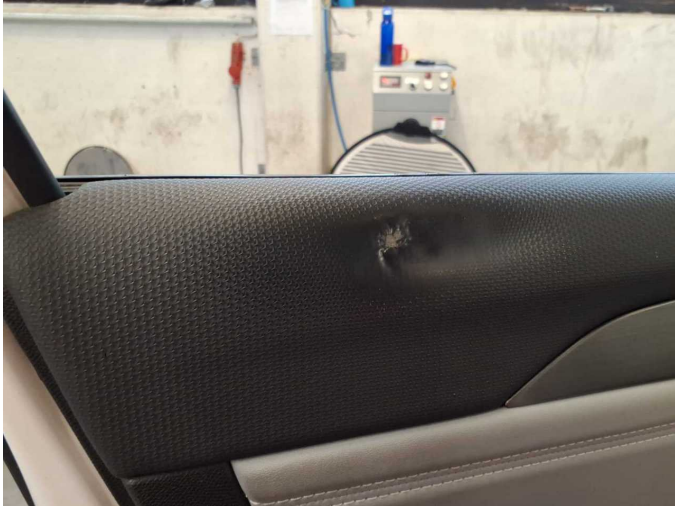
Damage 8: Trim / covers: Door trim - front left side - Broken / torn - Replace

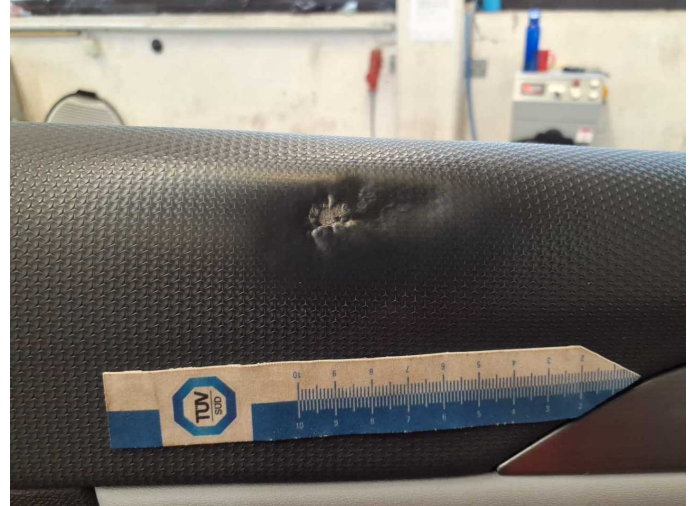
Damage 8: Trim / covers: Door trim - front left side - Broken / torn - Replace

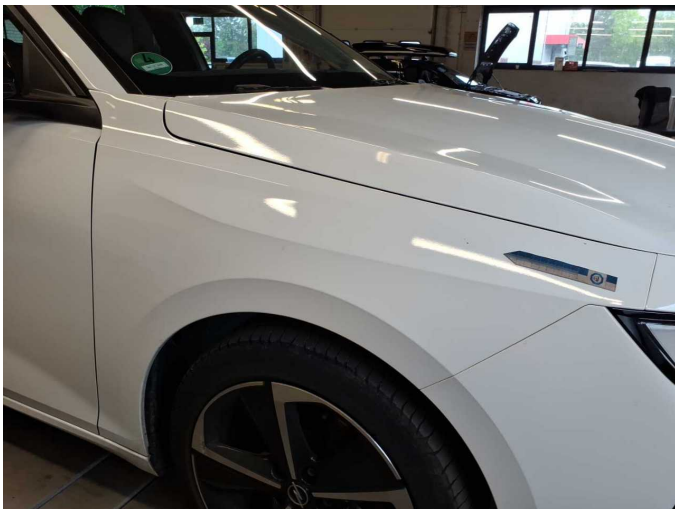
Damage 9: Mudguard - right side: Mudguard - right side - Stone chips - Paint

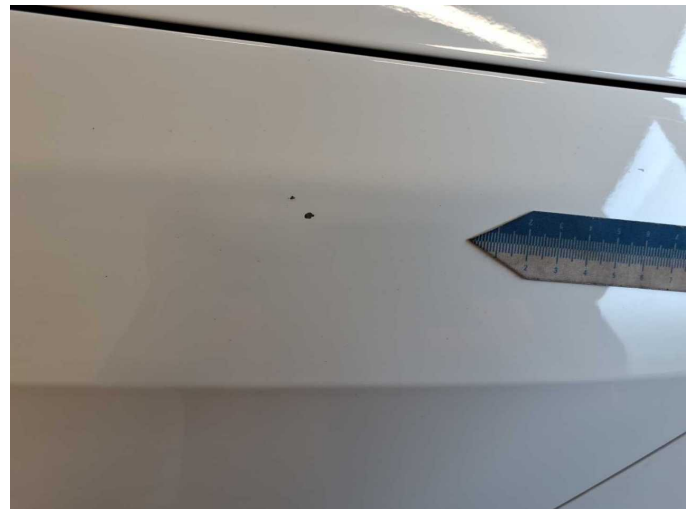
Damage 9: Mudguard - right side: Mudguard - right side - Stone chips - Paint

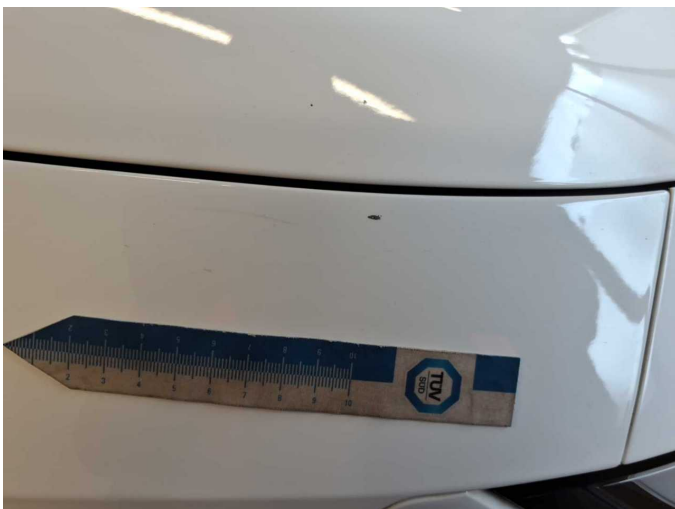
Damage 9: Mudguard - right side: Mudguard - right side - Stone chips - Paint

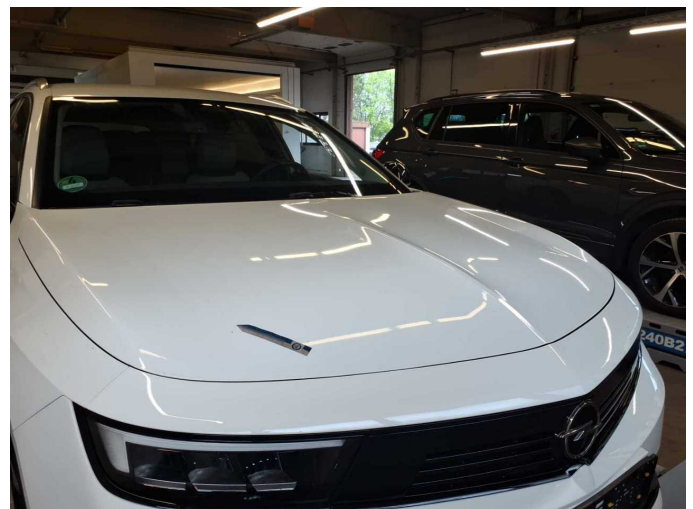
Damage 10: Bonnet: Bonnet - Stone chips - Paint

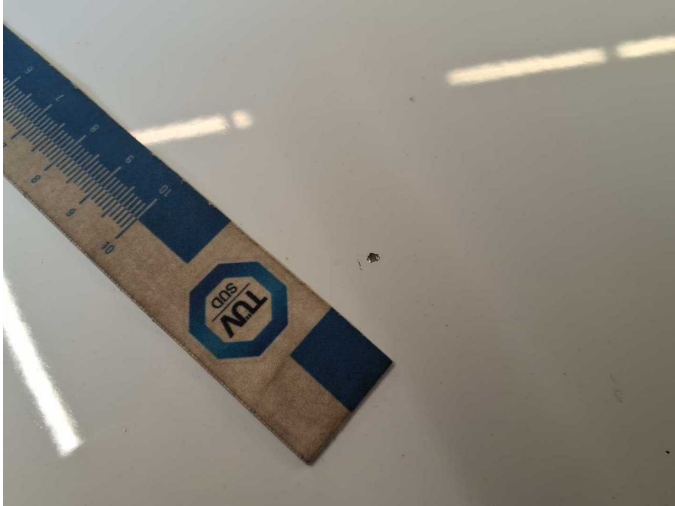
Damage 10: Bonnet: Bonnet - Stone chips - Paint

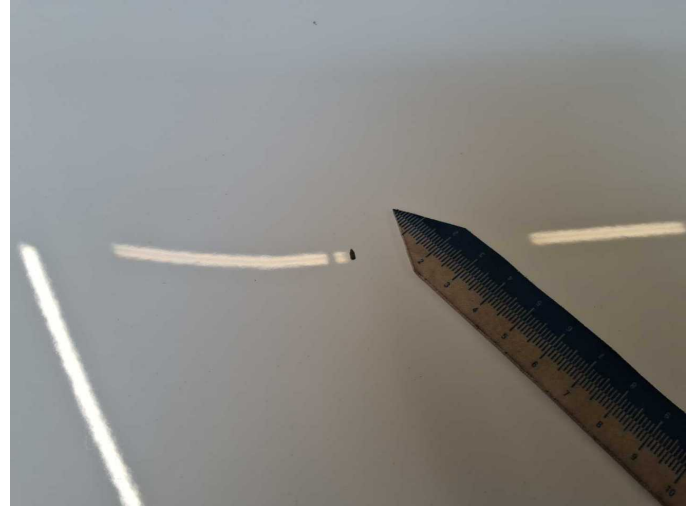
Damage 10: Bonnet: Bonnet - Stone chips - Paint

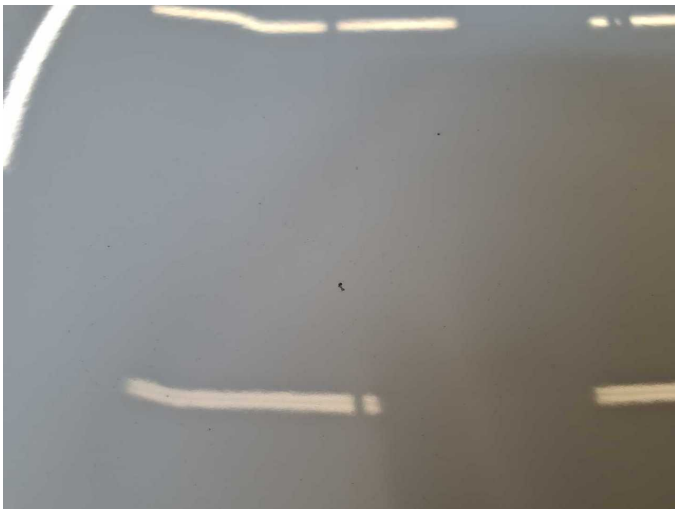
Damage 10: Bonnet: Bonnet - Stone chips - Paint

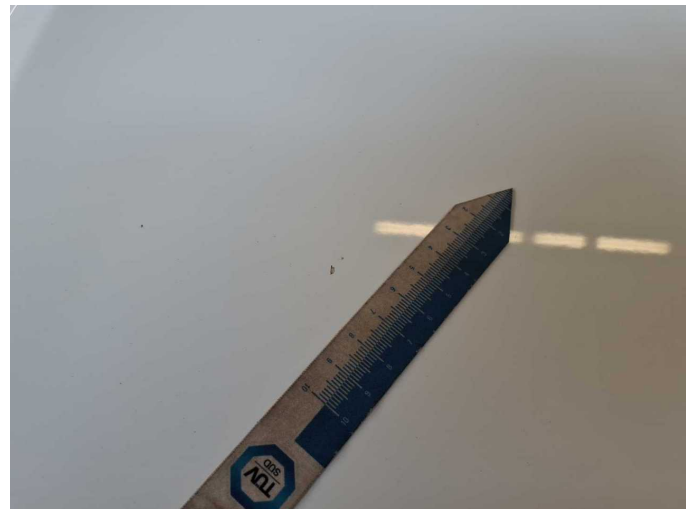
Damage 10: Bonnet: Bonnet - Stone chips - Paint

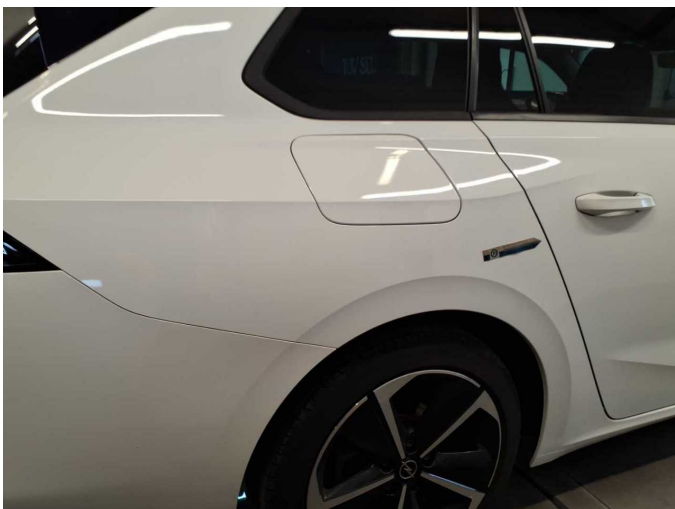
Damage 11: Side panel - rear right side: Side panel - Scratched - Paint

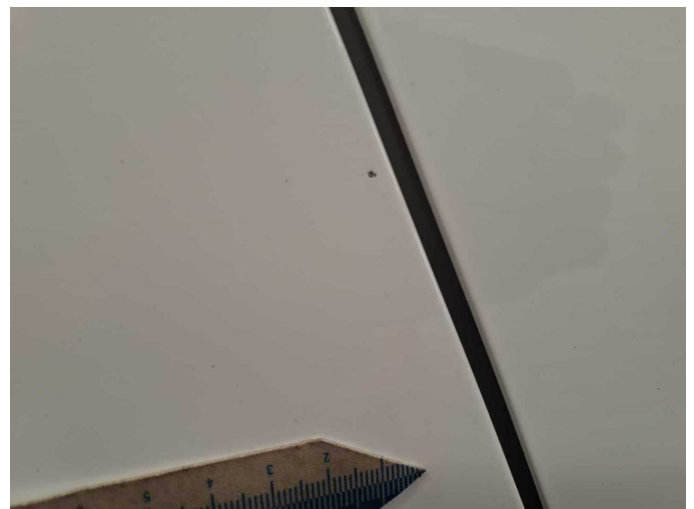
Damage 11: Side panel - rear right side: Side panel - Scratched - Paint

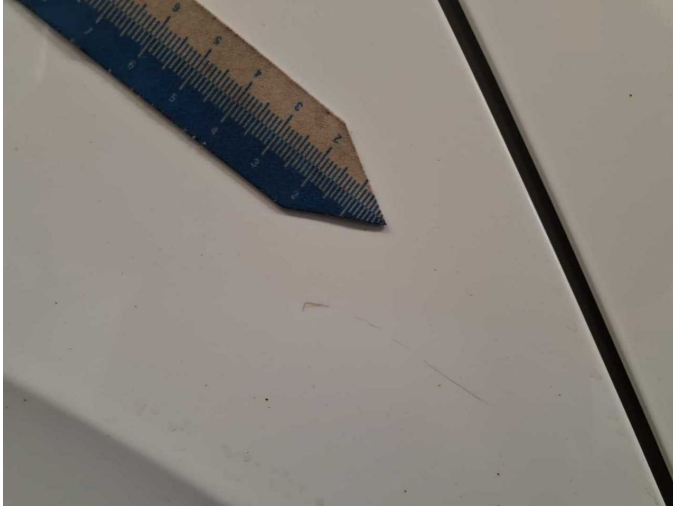
Damage 11: Side panel - rear right side: Side panel - Scratched - Paint

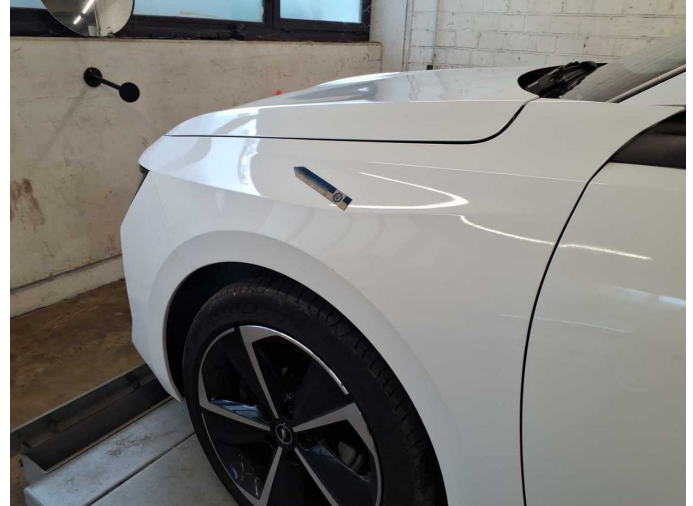
Wear and tear 1: Mudguard - left side: Mudguard - left side - dent(s) - No deduction

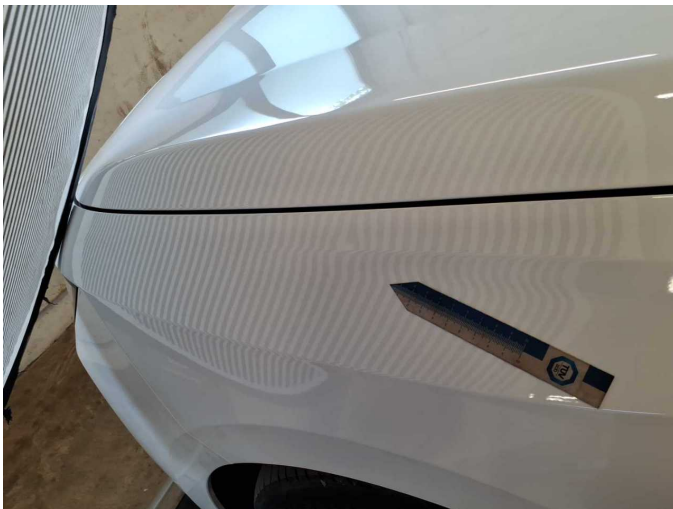
Wear and tear 1: Mudguard - left side: Mudguard - left side - dent(s) - No deduction

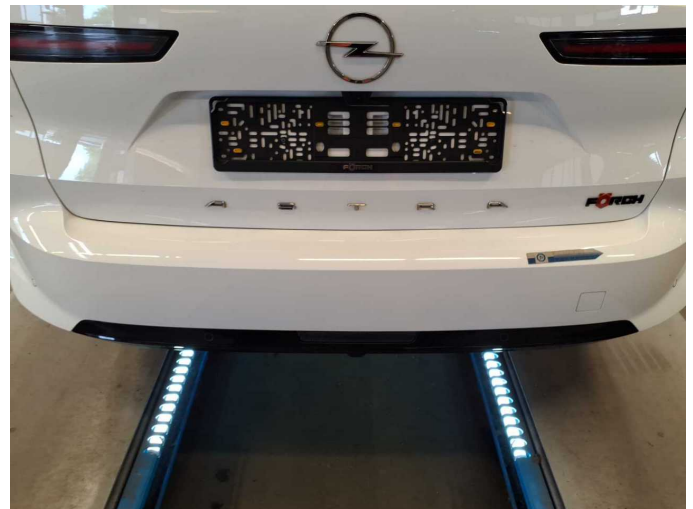
Wear and tear 2: Rear bumper: Rear bumper - Scratched - No deduction

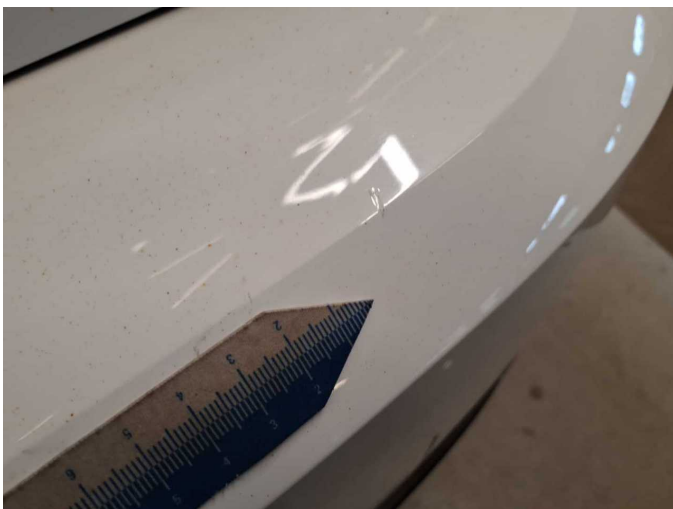
Wear and tear 2: Rear bumper: Rear bumper - Scratched - No deduction

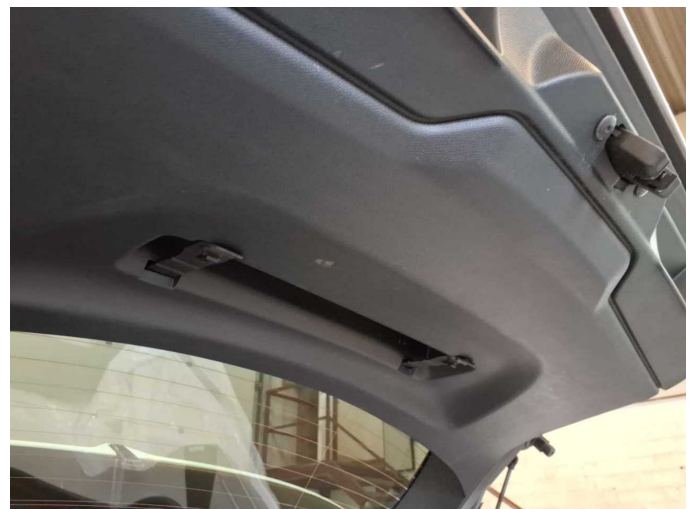
Missing part 1: Equipment: Warning triangle - Missing - Replace
