Expertise

Protocol number: 46257605
Order No. / Reference: 26606006
Inspection date: 29 Jun 2026

Manufacturer: Hyundai

Model: KONA EV ADVANTAGE

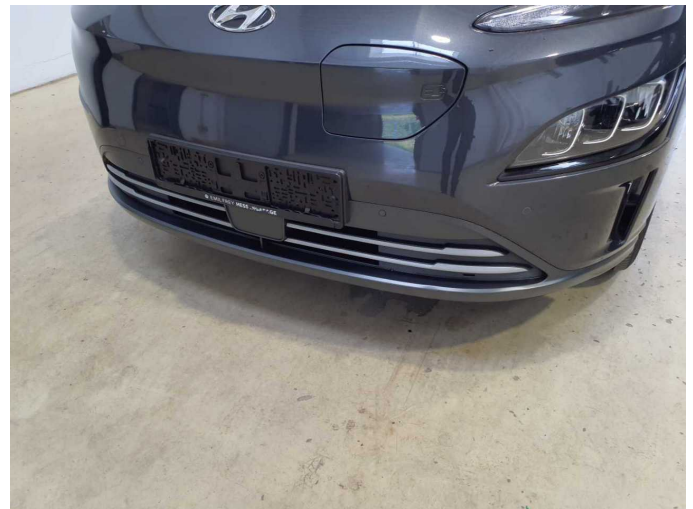
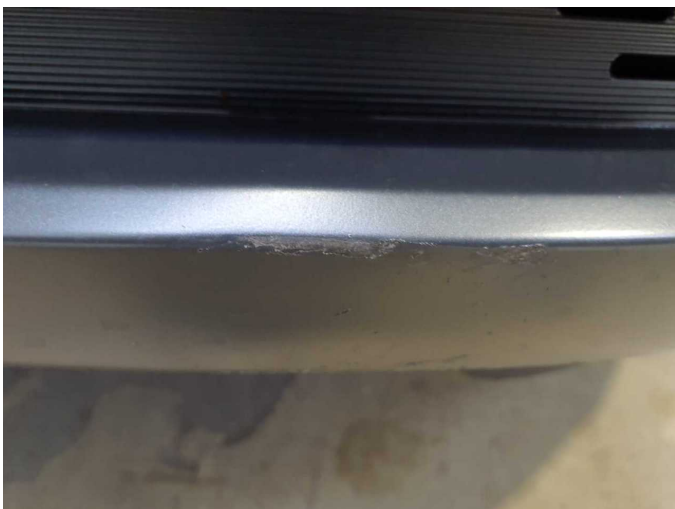
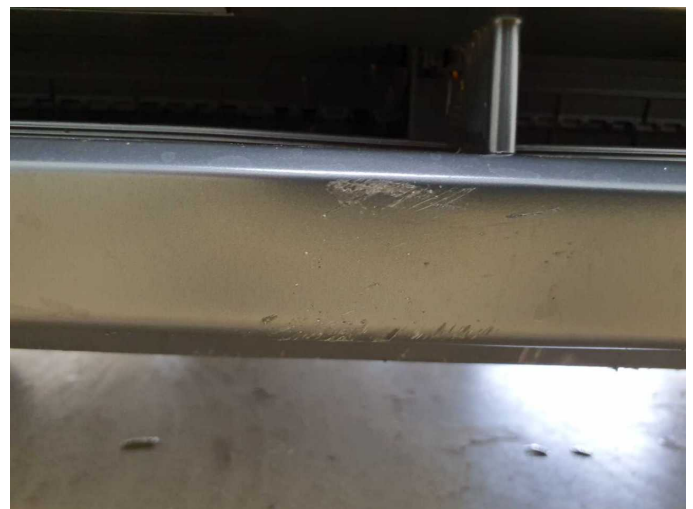
No.	Component group	Description
1	Front bumper	Spoiler - Scratch(es) - Replace
2	Mudguard - right side	Wheel well extension - Scratch(es) - Smart repair
3	Door - rear right side	Door - Scratch(es) - Smart repair
4	Side panel - rear right side	Wheel well extension (Anätzung) - Paint defect - Smart repair
5	Side panel - rear left side	Side panel - Dent / paintcoat damage - Paint
6	Front bumper	Front bumper (Zusätzlich Blende rechts Kratzer) - Scratch(es) - Paint
7	Rear bumper	Rear bumper - Scratch(es) - Paint
8	Bonnet	Bonnet (Anätzung) - Paint defect - Paint

Damage 1: Front bumper: Spoiler - Scratch(es) - Replace

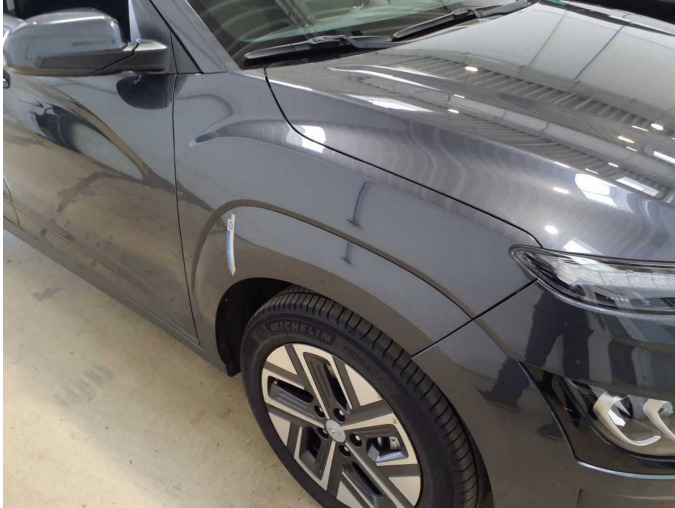
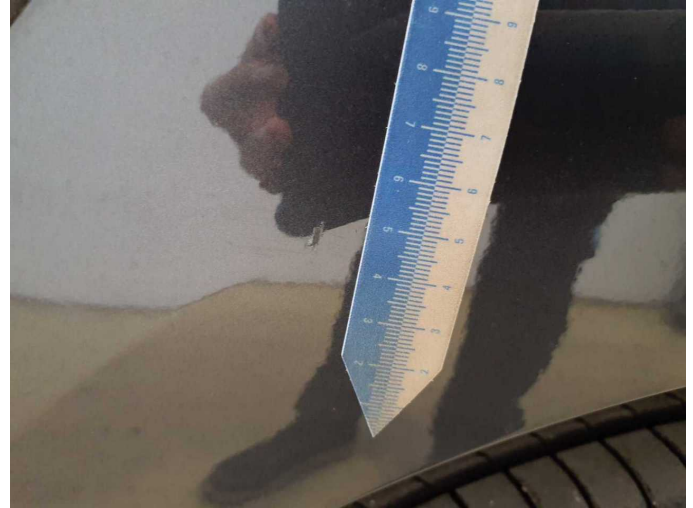
Damage 2: Mudguard - right side: Wheel well extension - Scratch(es) - Smart repair

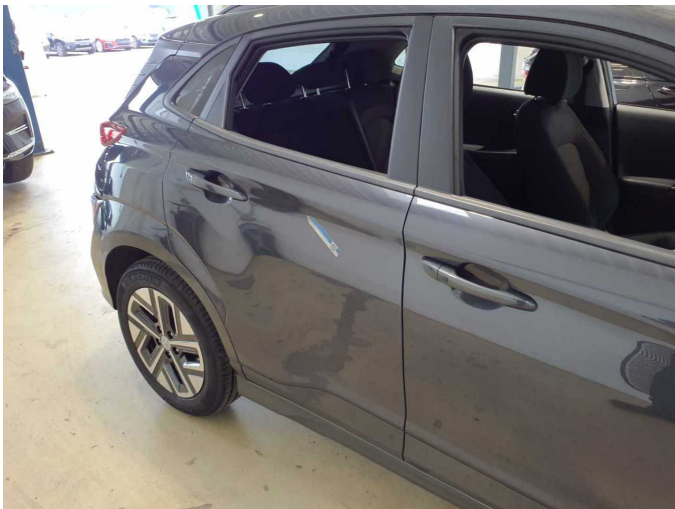
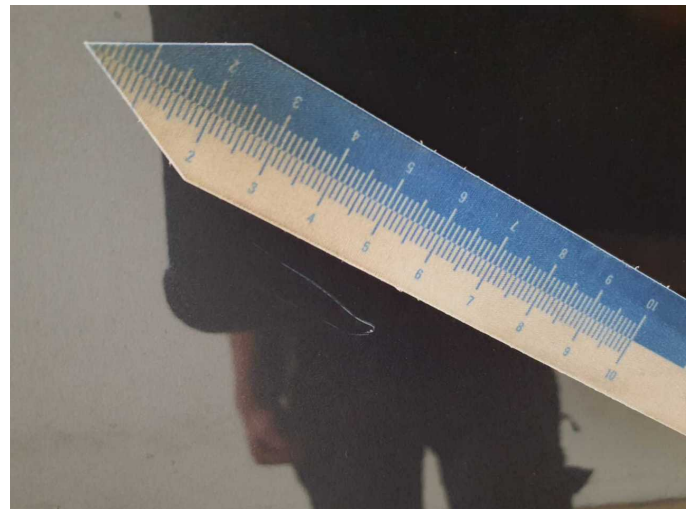
Damage 3: Door - rear right side: Door - Scratch(es) - Smart repair

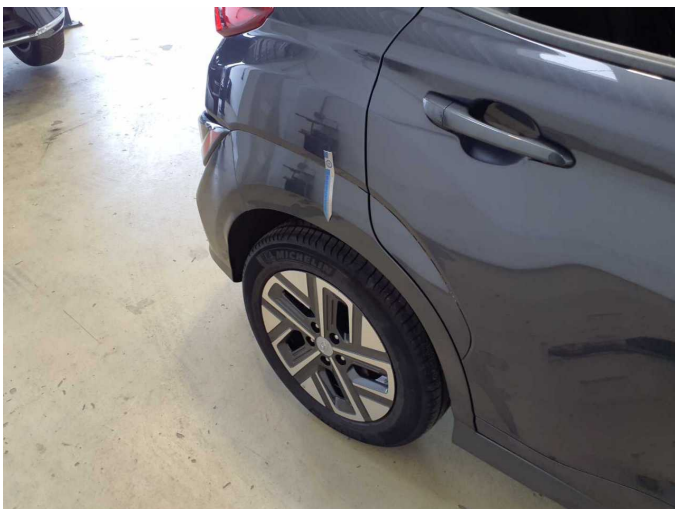
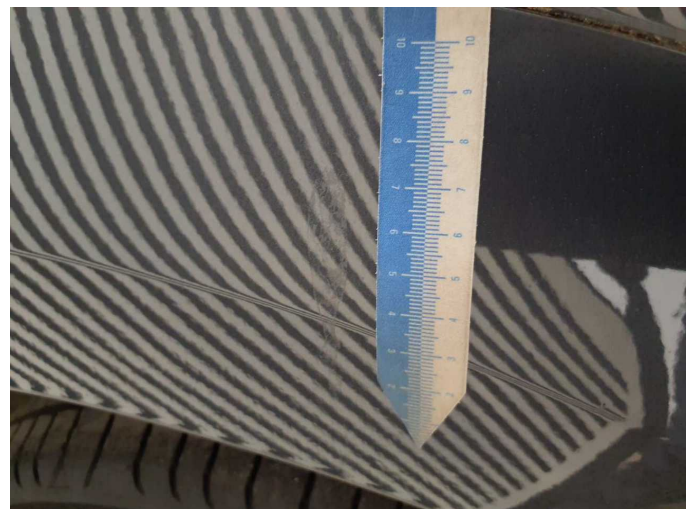
Damage 4: Side panel - rear right side: Wheel well extension (Anätzung) - Paint defect - Smart repair

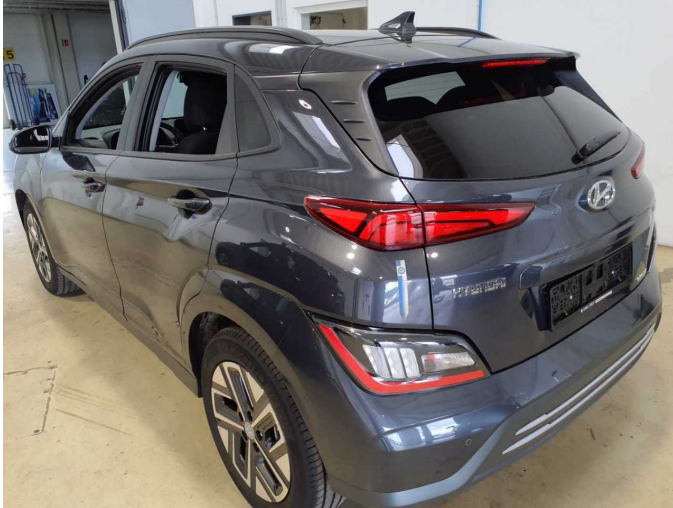
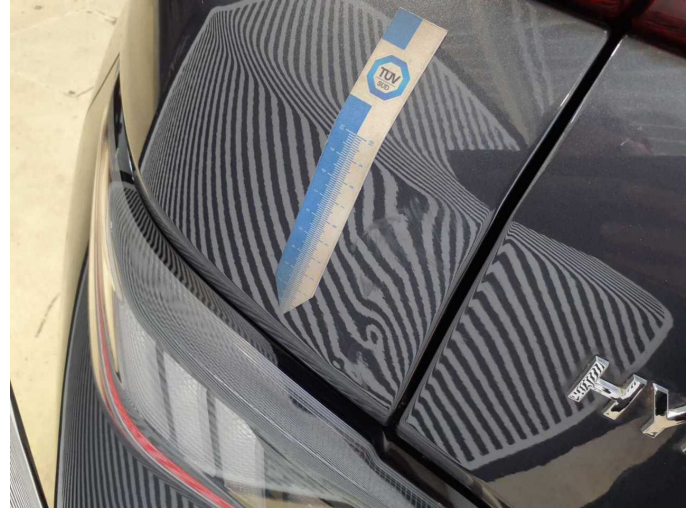
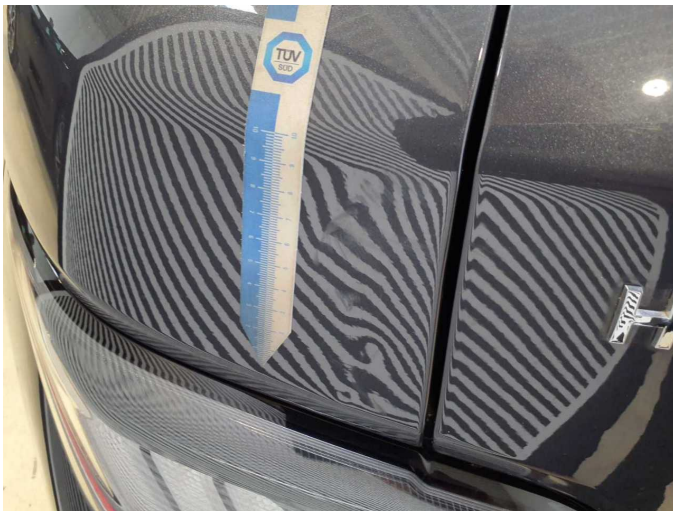
Damage 5: Side panel - rear left side: Side panel - Dent / paintcoat damage - Paint

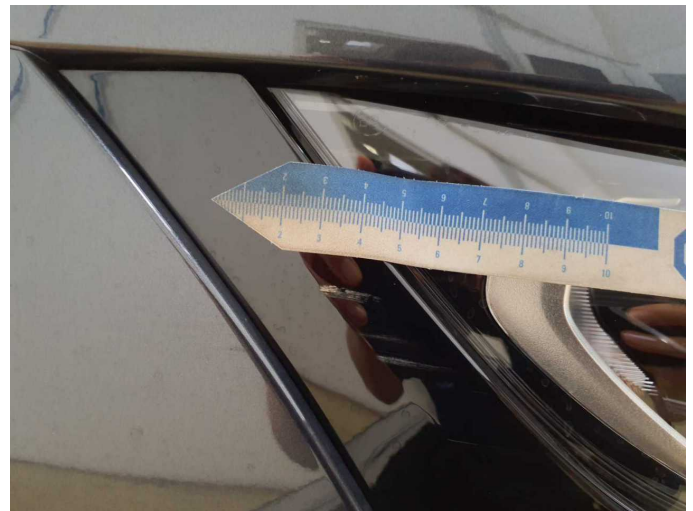
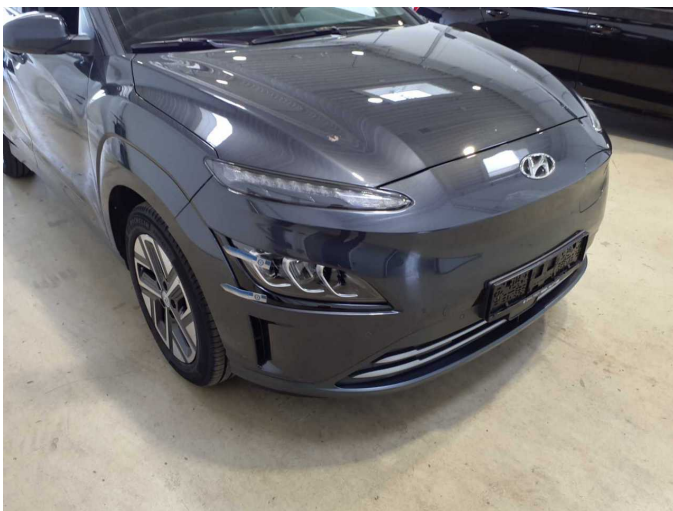
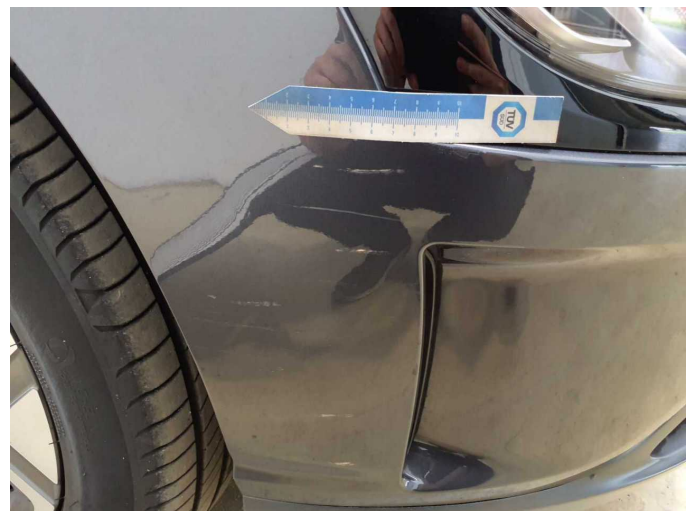
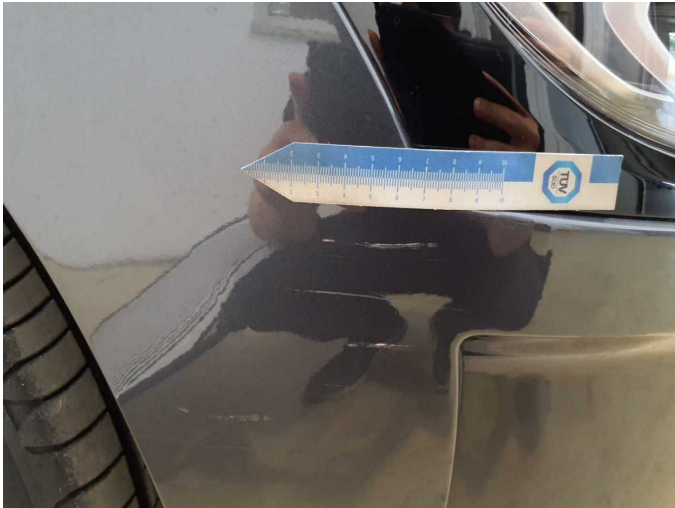
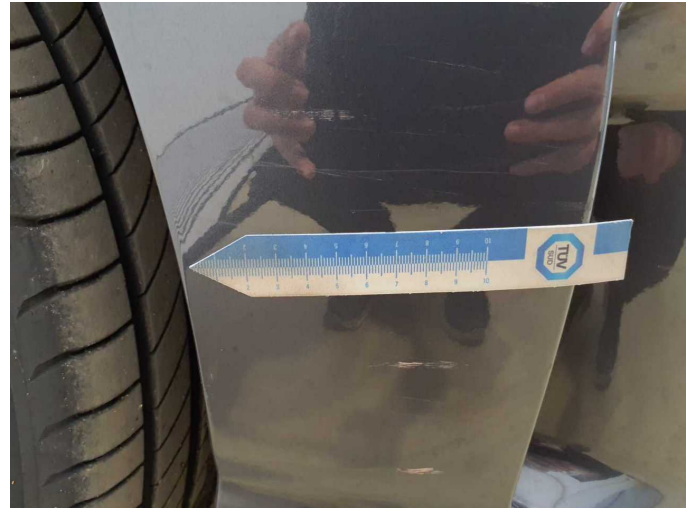
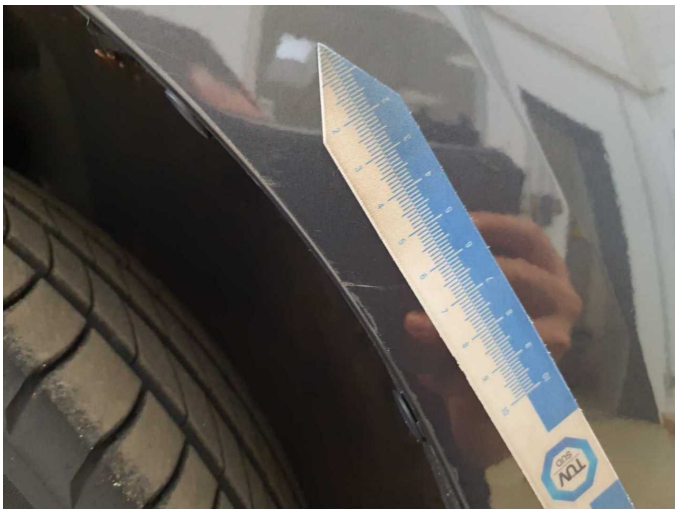
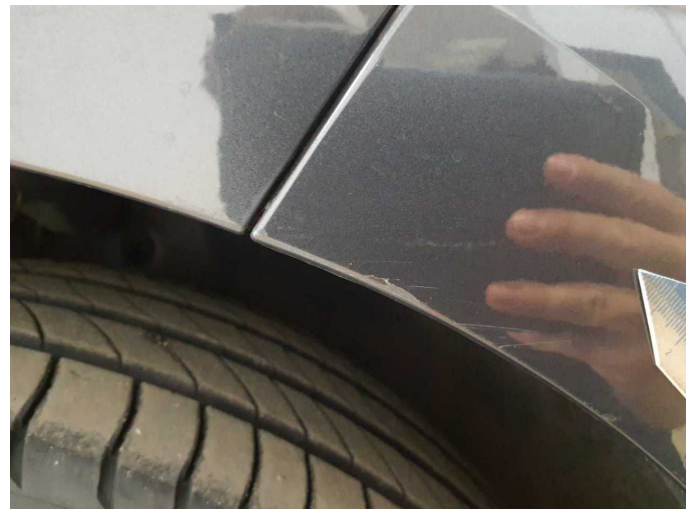
Damage 6: Front bumper: Front bumper (Zusätzlich Blende rechts Kratzer) - Scratch(es) - Paint

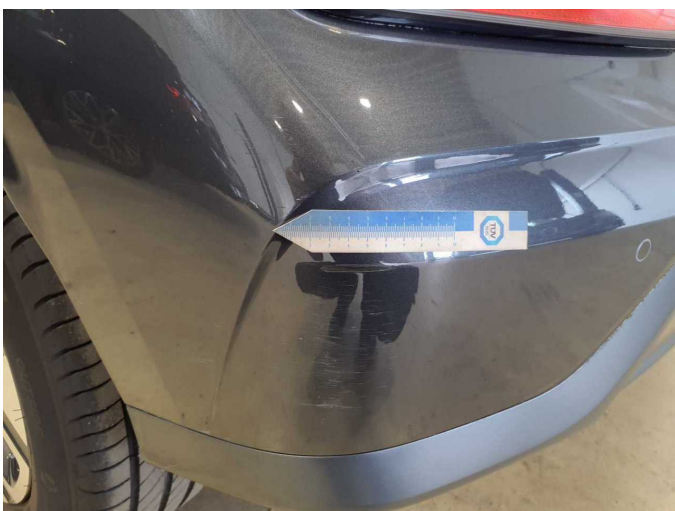
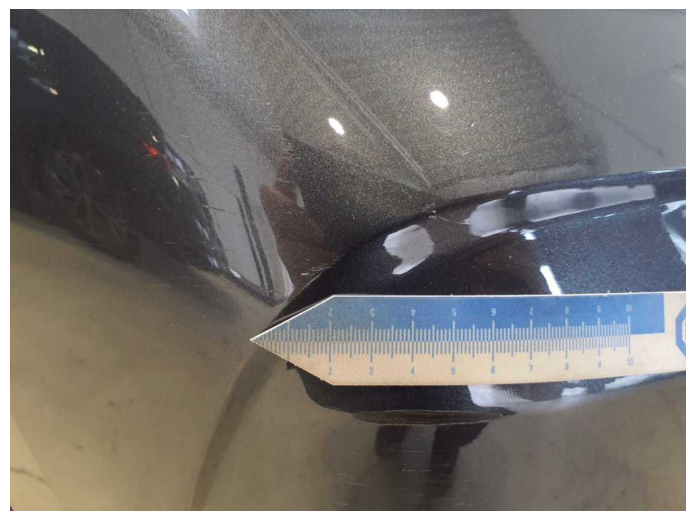
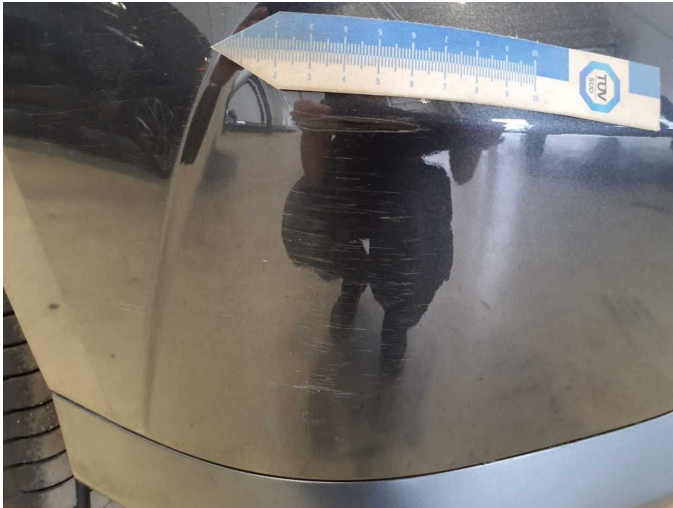
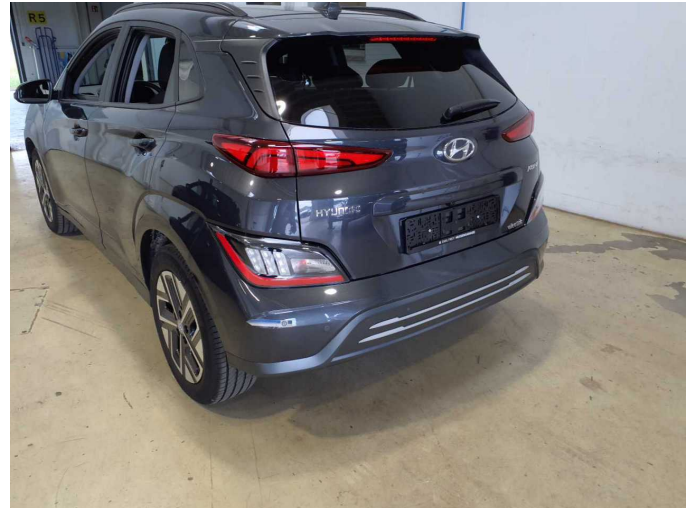
Damage 7: Rear bumper: Rear bumper - Scratch(es) - Paint

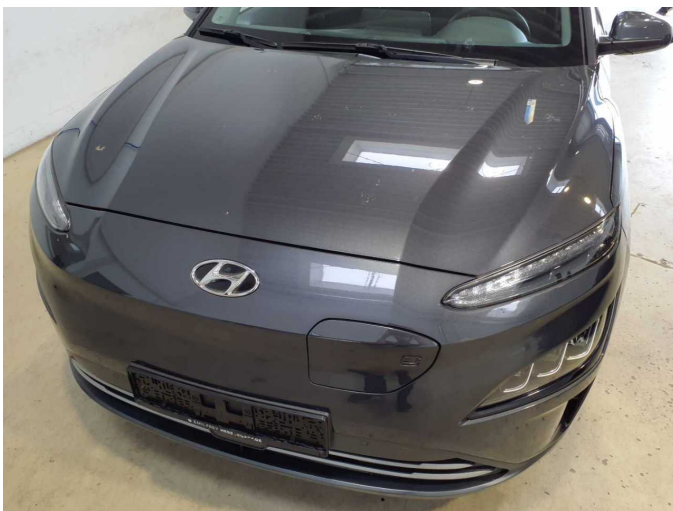
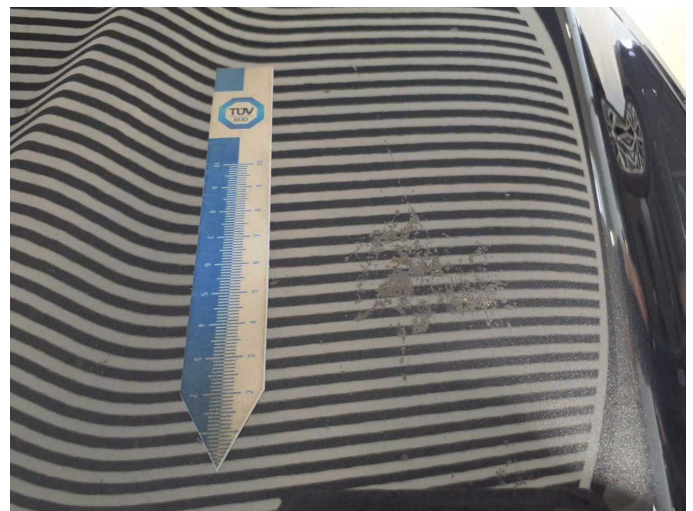
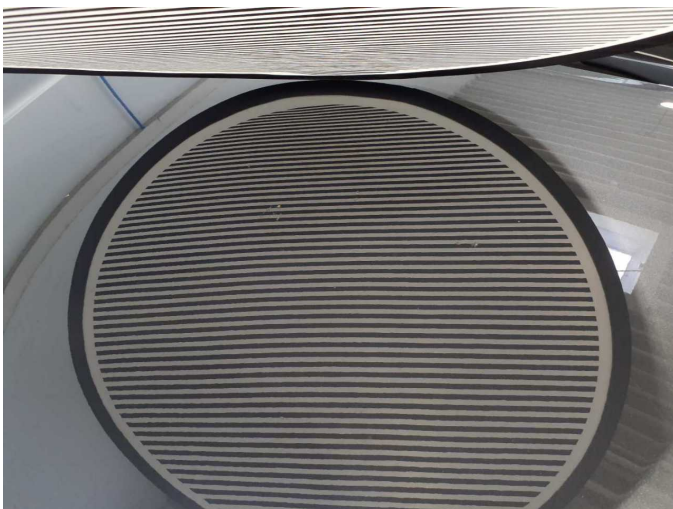
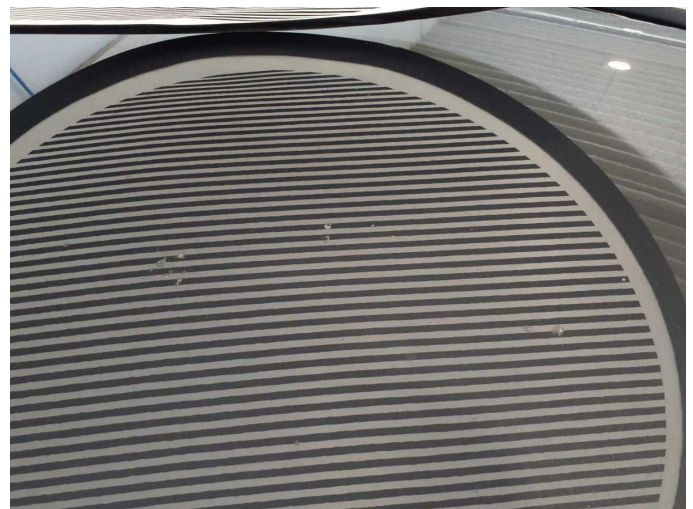
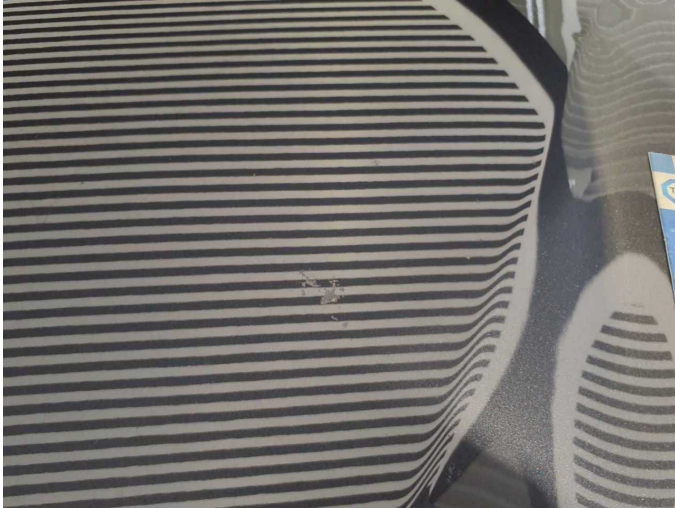
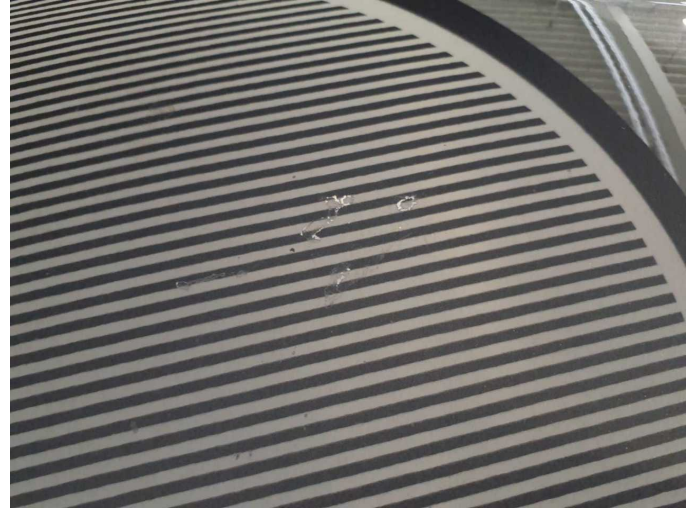
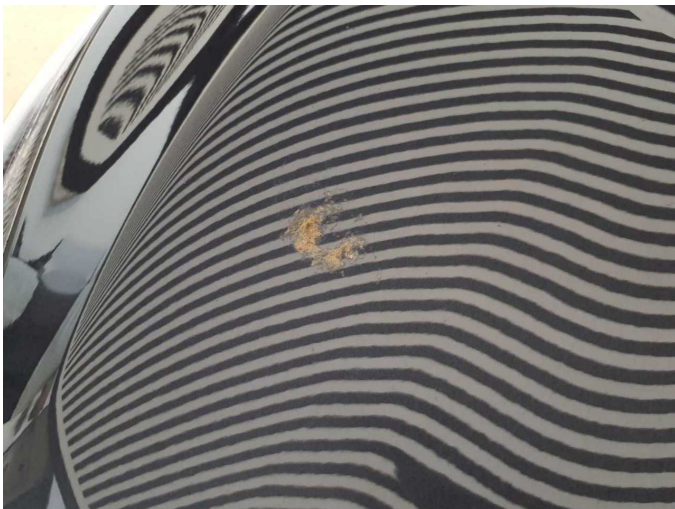
Damage 8: Bonnet: Bonnet (Anätzung) - Paint defect - Paint

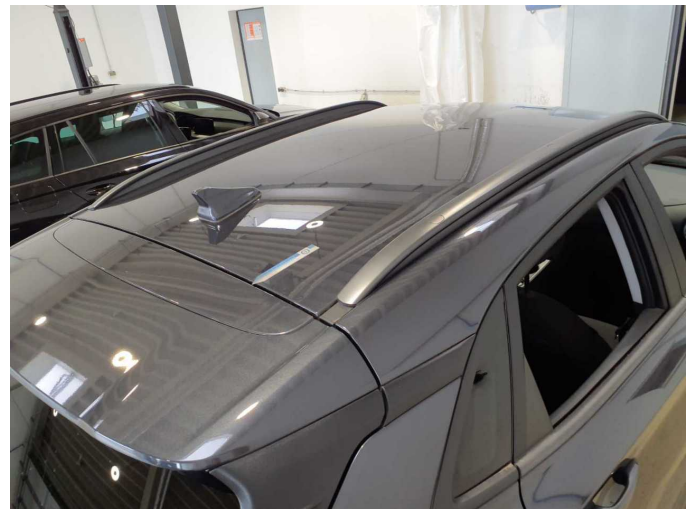
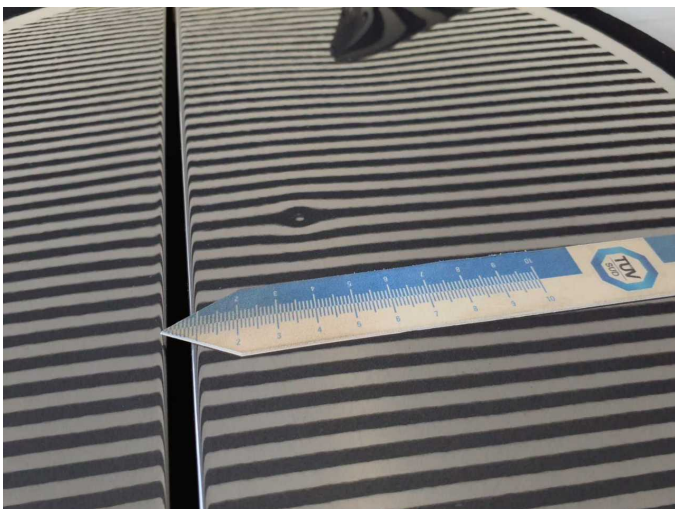
No.	Component group	Description
1	Vehicle glazing	Windscreen - Stone chips - No deduction
2	Roof	Roof - dent(s) - No deduction
3	Door - front left side	Door - dent(s) - No deduction
4	Documents	Service book - No evidence - No deduction

Wear and tear 2: Roof: Roof - dent(s) - No deduction

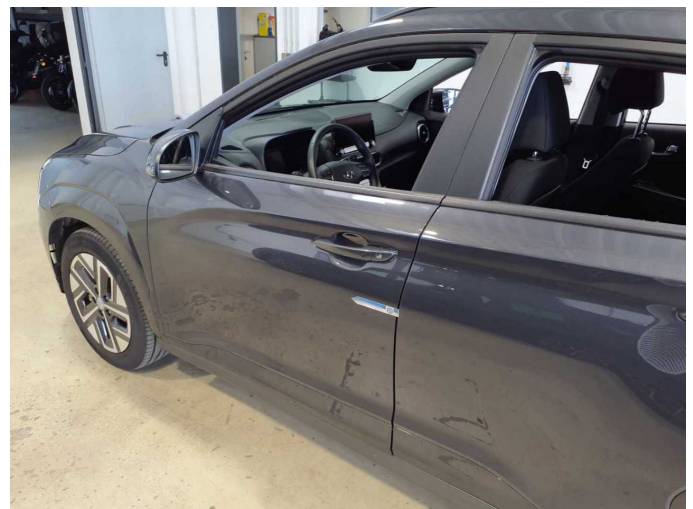
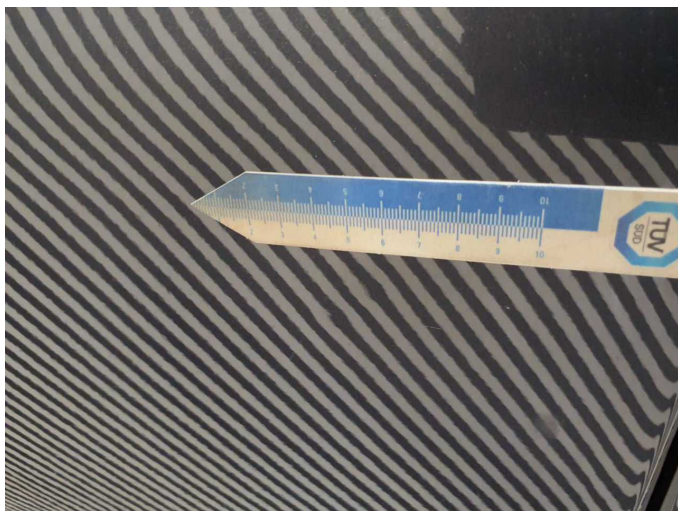
Wear and tear 3: Door - front left side: Door - dent(s) - No deduction
