Expertise

Protocol number: 46486898  
Order No. / Reference: 26018510  
Inspection date: 10 Jul 2026

Manufacturer: Mercedes-Benz

Model: Vito 116 CDI Extralang HA Aut. PRO

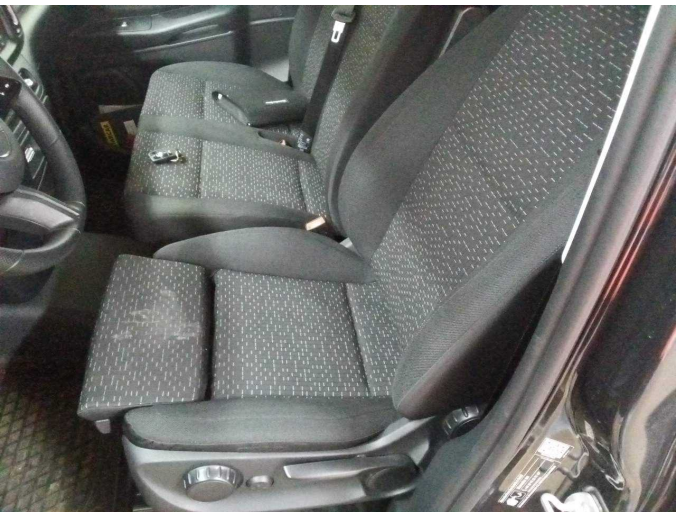
| No. | Component group | Description |
|---|---|---|
| 1 | Seat - front | Seat cover - left side (Verschmutzt) - Clean |

Damage 1: Seat - front: Seat cover - left side (Verschmutzt) - Clean

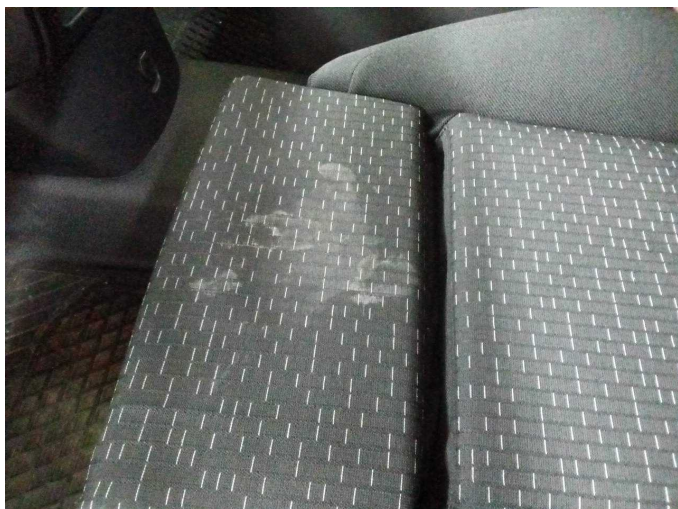
**Damage 1:** Seat - front: Seat cover - left side (Verschmutzt) - Clean

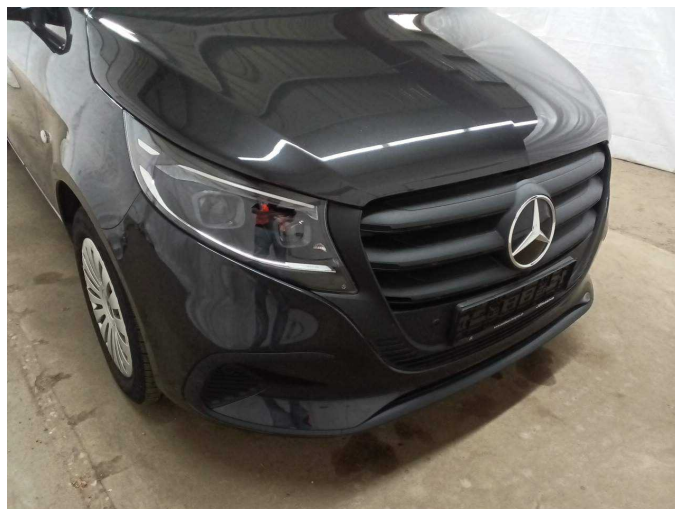
| No. | Component group | Description |
|---|---|---|
| 2 | Front bumper | Cover bumper - front - Scratch(es) - Smart repair |

**Damage 2:** Front bumper: Cover bumper - front - Scratch(es) - Smart repair

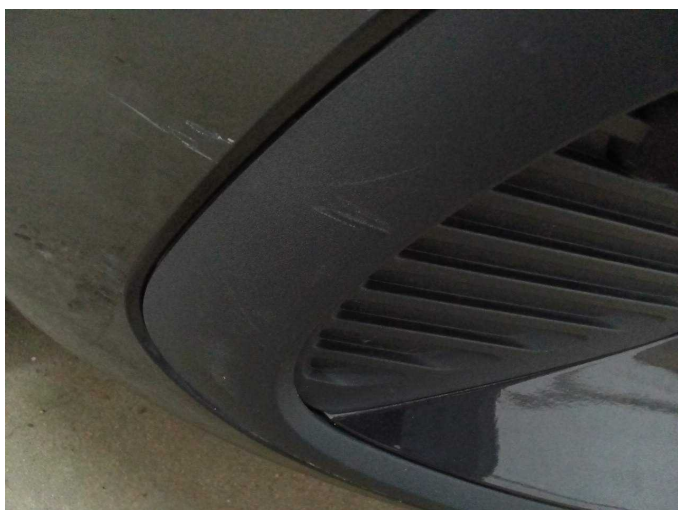
**Damage 2:** Front bumper: Cover bumper - front - Scratch(es) - Smart repair

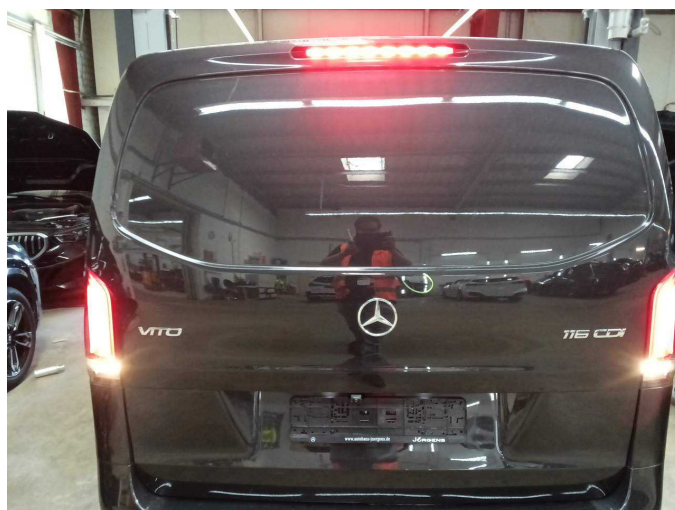
| No. | Component group | Description |
|---|---|---|
| 3 | Boot lid / rear door | Boot lid - Scratch(es) - Smart repair |

**Damage 3:** Boot lid / rear door: Boot lid - Scratch(es) - Smart repair

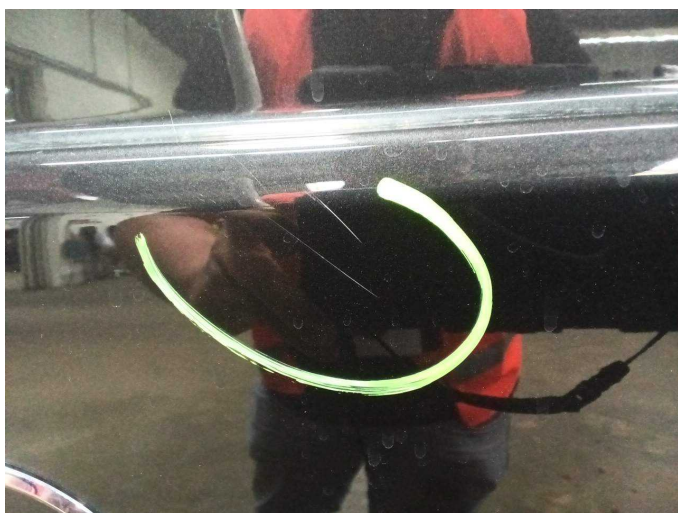
**Damage 3:** Boot lid / rear door: Boot lid - Scratch(es) - Smart repair

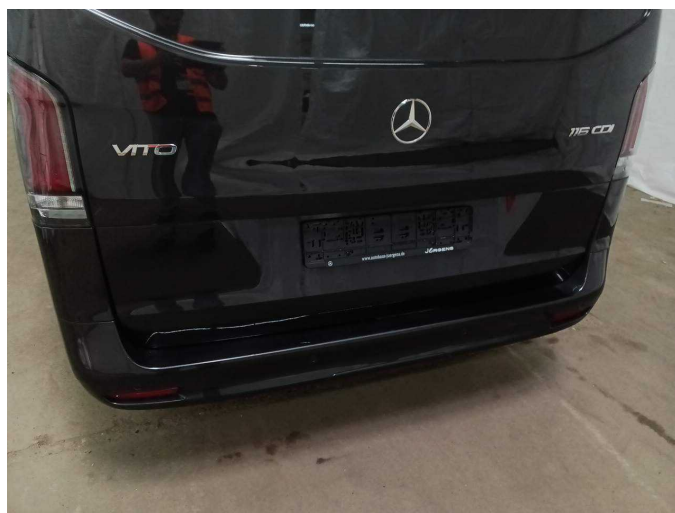
| No. | Component group | Description |
|---|---|---|
| 4 | Rear bumper | Rear bumper - Scratch(es) - Paint |

**Damage 4:** Rear bumper: Rear bumper - Scratch(es) - Paint

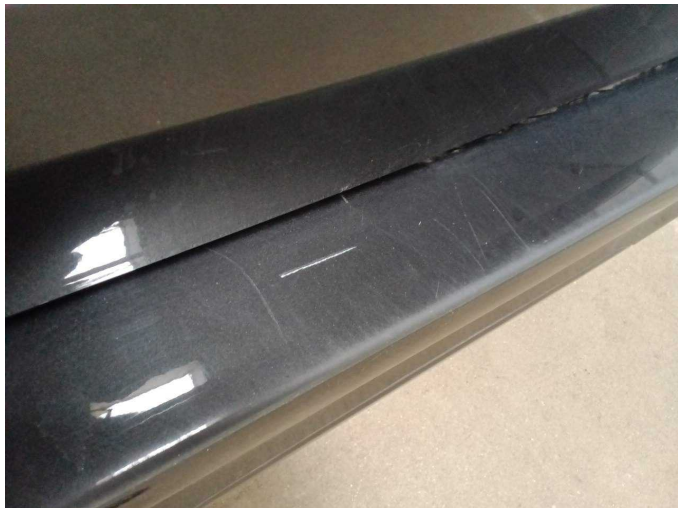
**Damage 4:** Rear bumper: Rear bumper - Scratch(es) - Paint

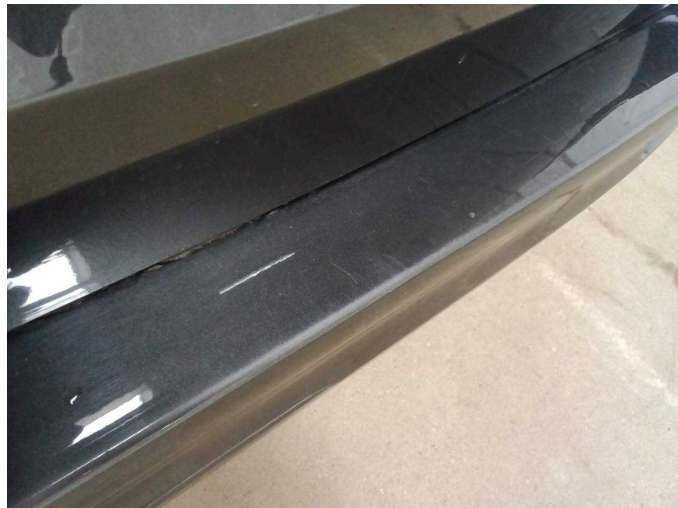
**Damage 4:** Rear bumper: Rear bumper - Scratch(es) - Paint

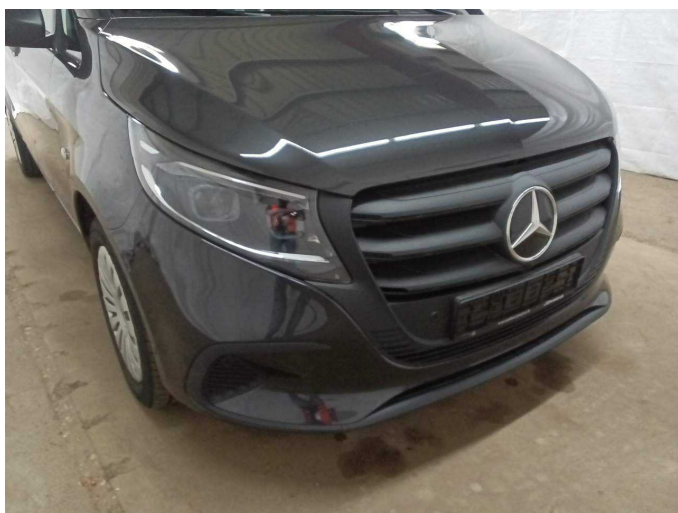
| No. | Component group | Description |
|---|---|---|
| 5 | Front bumper | Front bumper - Scratch(es) - Paint |

**Damage 5:** Front bumper: Front bumper - Scratch(es) - Paint

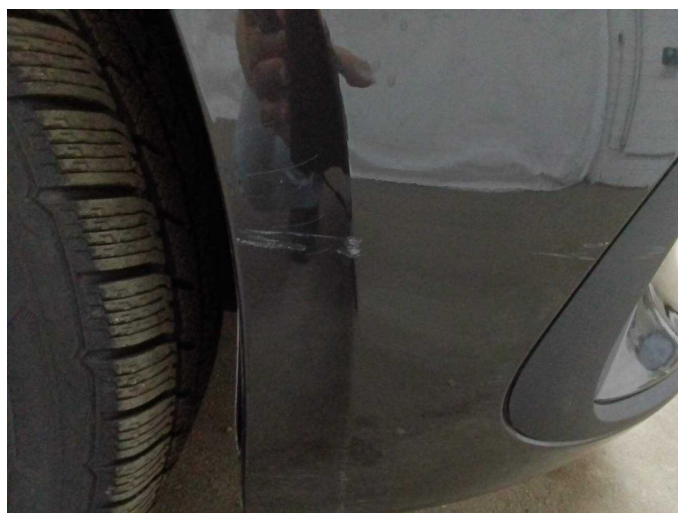
**Damage 5:** Front bumper: Front bumper - Scratch(es) - Paint

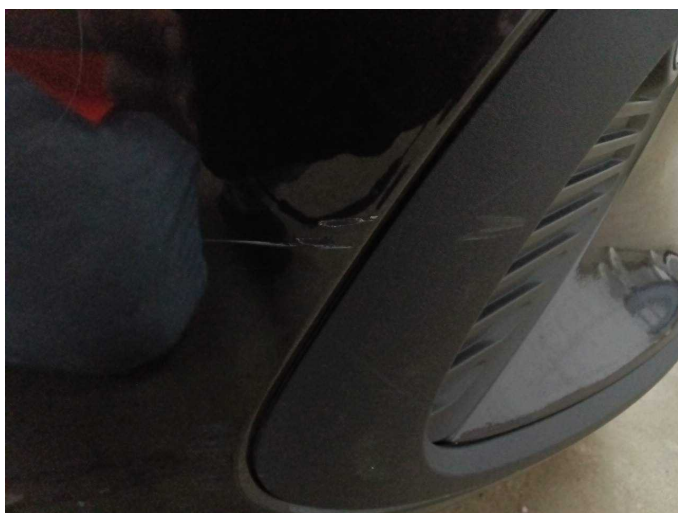
**Damage 5:** Front bumper: Front bumper - Scratch(es) - Paint

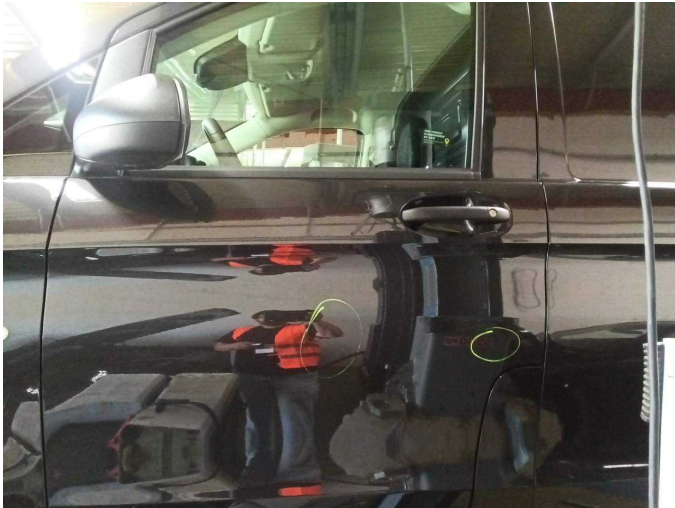
| No. | Component group | Description |
|---|---|---|
| 6 | Door - front left side | Door - Dent / paintcoat damage - Repair and paint |

**Damage 6:** Door - front left side: Door - Dent / paintcoat damage - Repair and paint

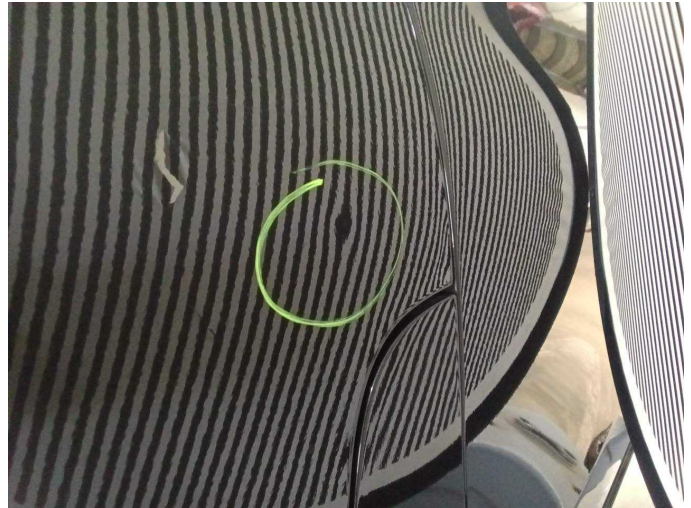
**Damage 6:** Door - front left side: Door - Dent / paintcoat damage - Repair and paint

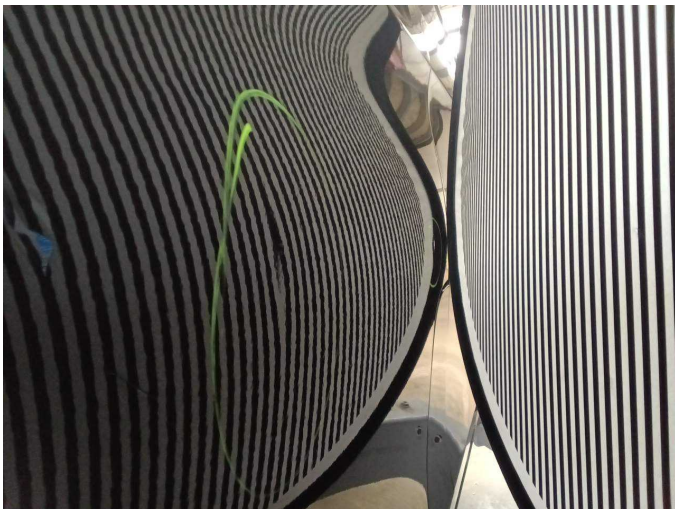
**Damage 6:** Door - front left side: Door - Dent / paintcoat damage - Repair and paint

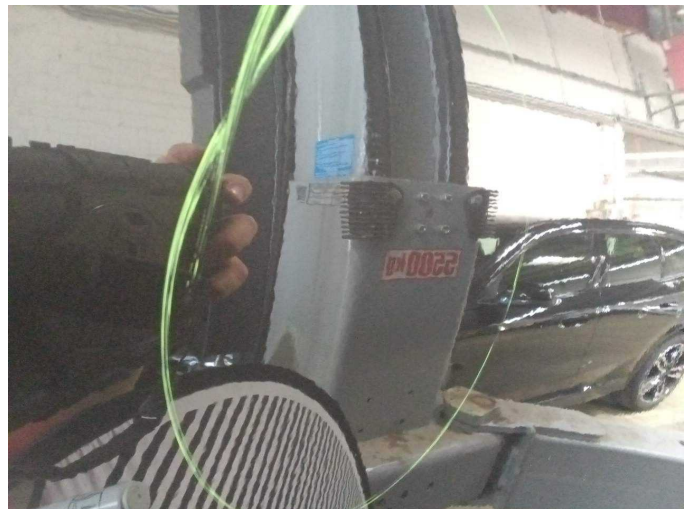
**Damage 6:** Door - front left side: Door - Dent / paintcoat damage - Repair and paint
