Expertise

Protocol number: 45947893  
Order No. / Reference: 26466913  
Inspection date: 15 Jun 2026

Manufacturer: Mercedes-Benz  
VIN: W1K5M1CBXPN353331

Model: CLA 200 d Shooting Brake 8G-DCT

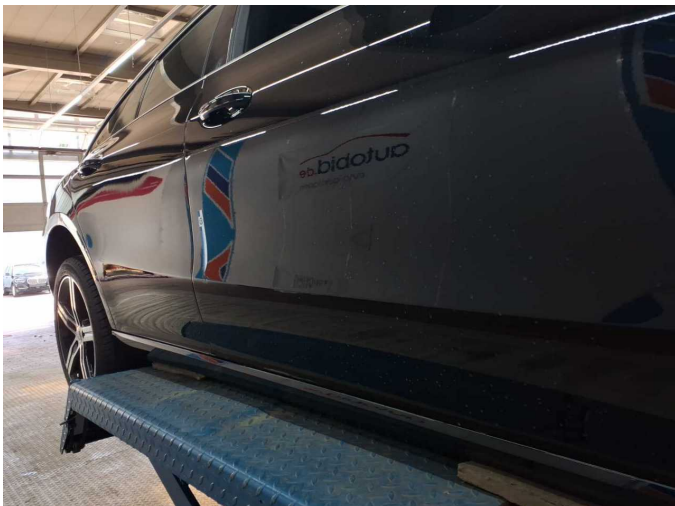
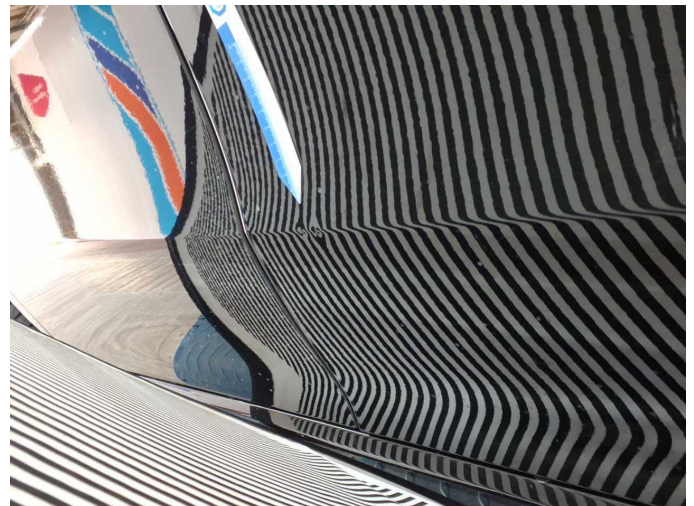
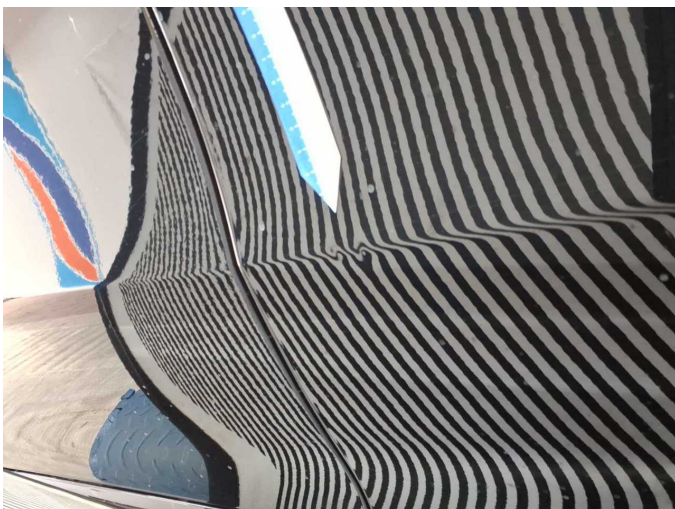
| No. | Component group | Description |
|---|---|---|
| 2 | Door - front right side | Door - dent(s) - Smooth repair work |

**Damage 2:** Door - front right side: Door - dent(s) - Smooth repair work

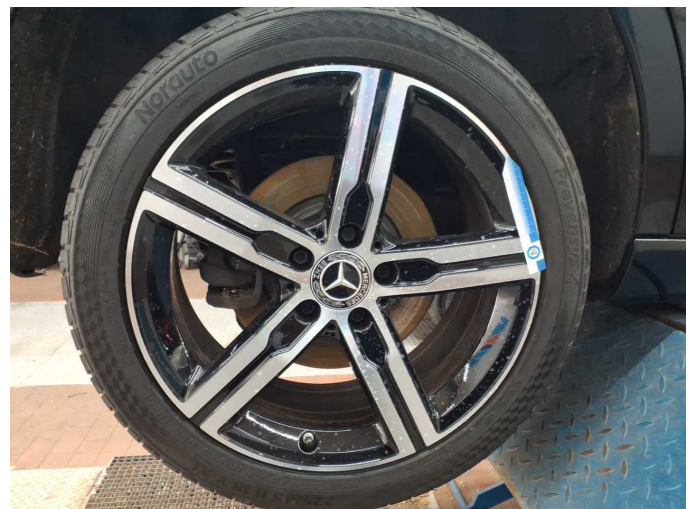
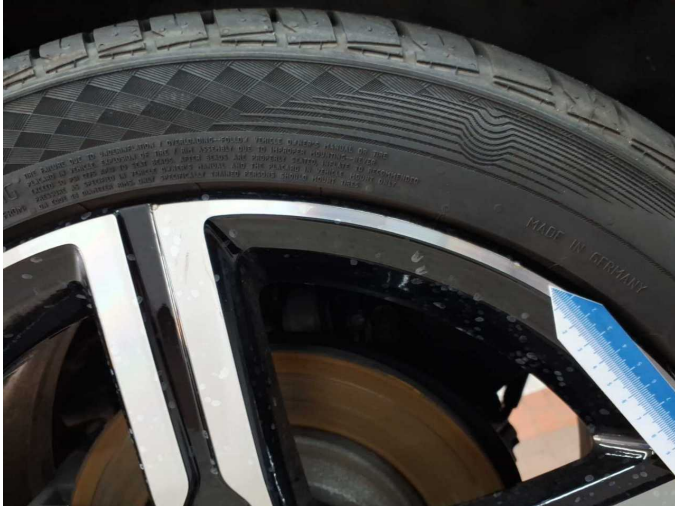
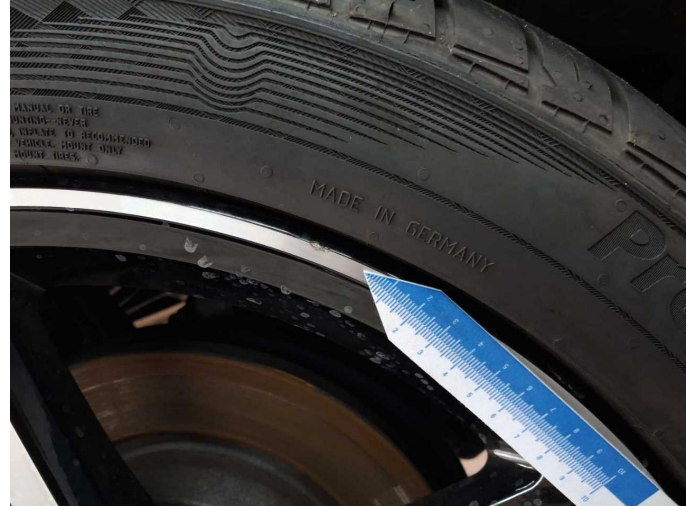
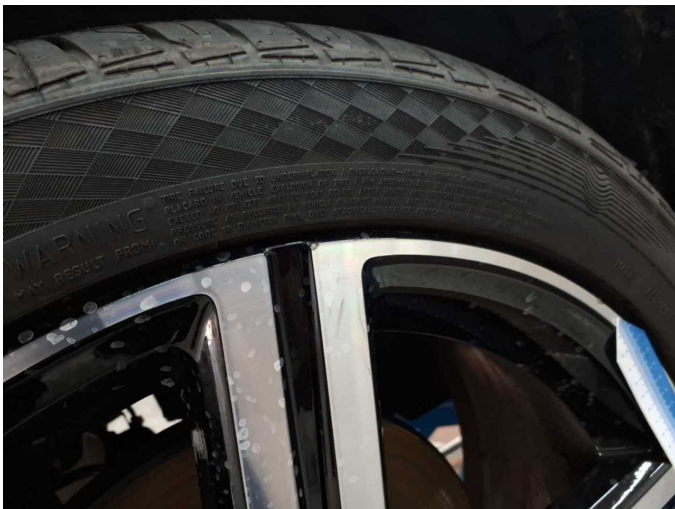
| No. | Component group | Description |
|---|---|---|
| 3 | Wheel / tyres | Alloy rim - rear right side - Scratch(es) - Loss in value |

**Damage 3:** Wheel / tyres: Alloy rim - rear right side - Scratch(es) - Loss in value

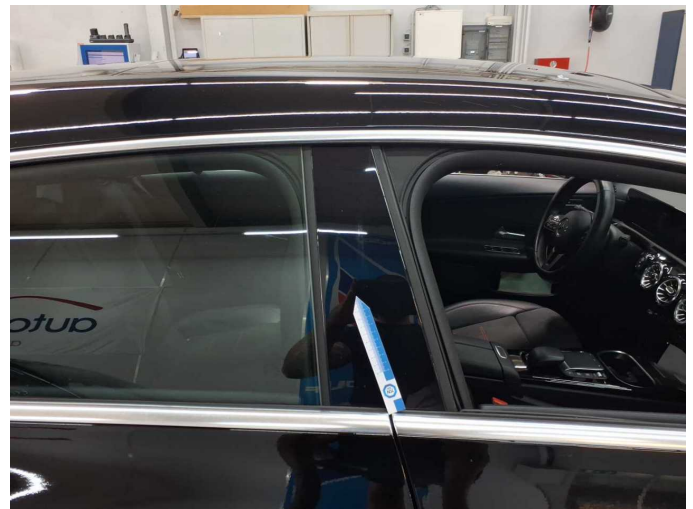
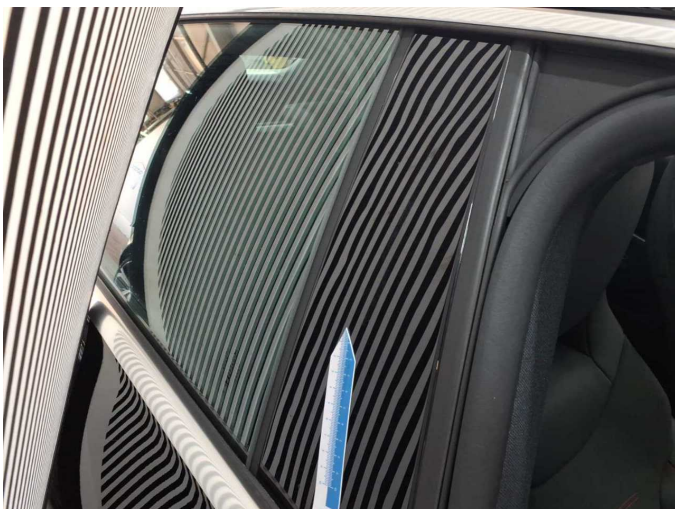
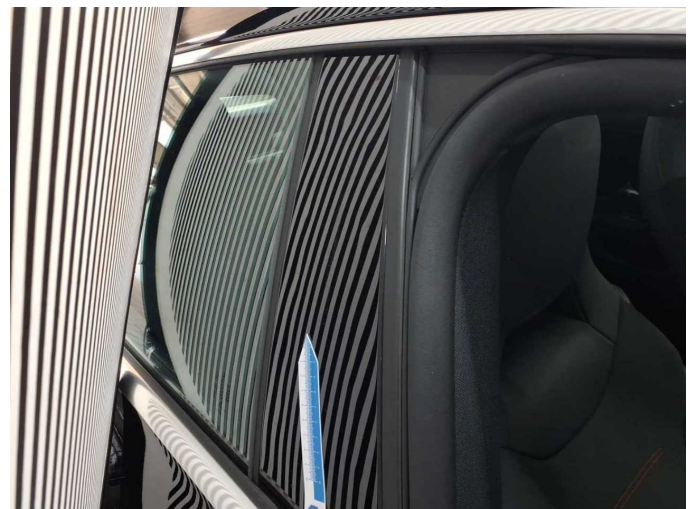
| No. | Component group | Description |
|---|---|---|
| 4 | Door - front right side | Window guide (3 dellen) - dent(s) - Replace |

**Damage 4:** Door - front right side: Window guide (3 dellen) - dent(s) - Replace

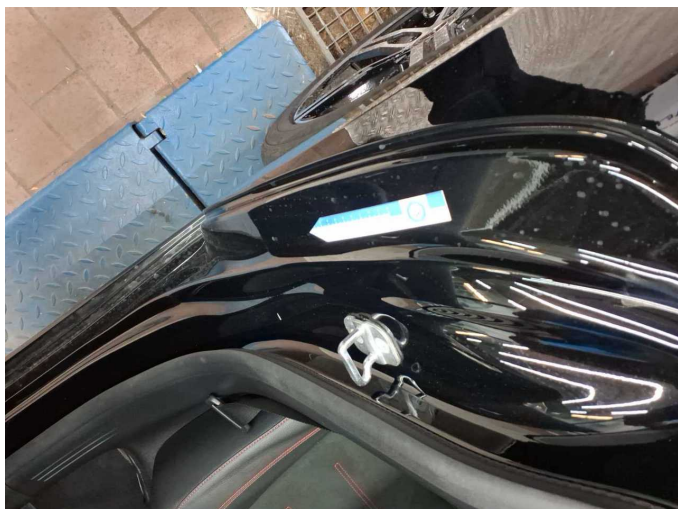
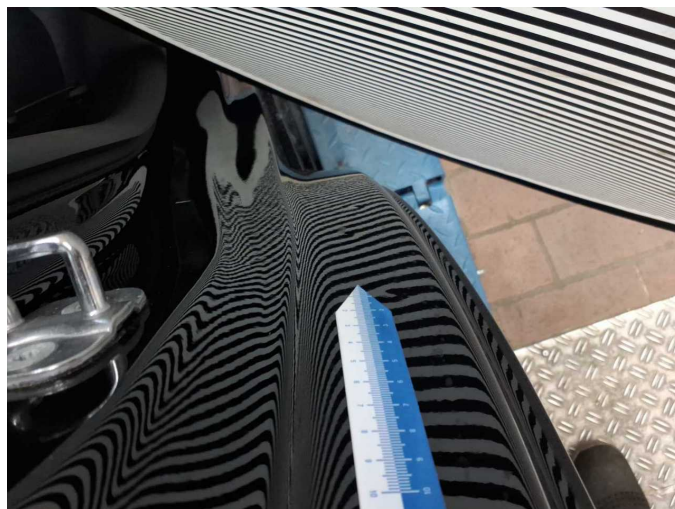
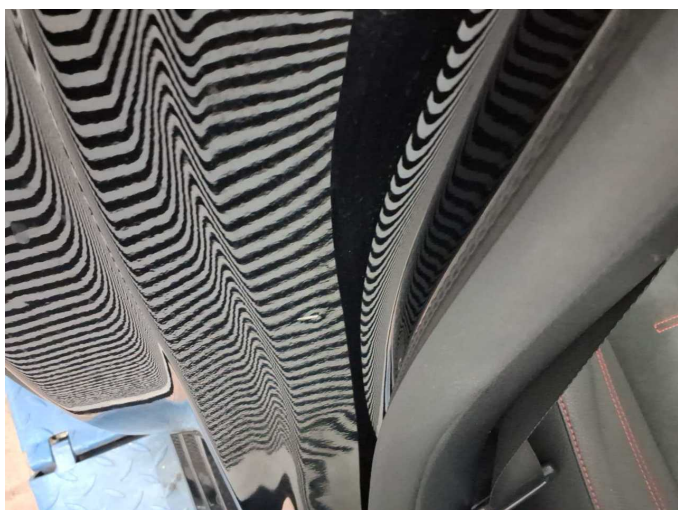
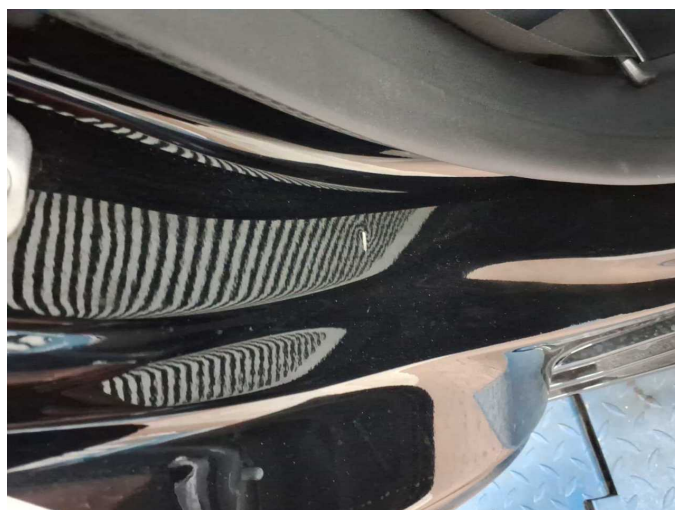
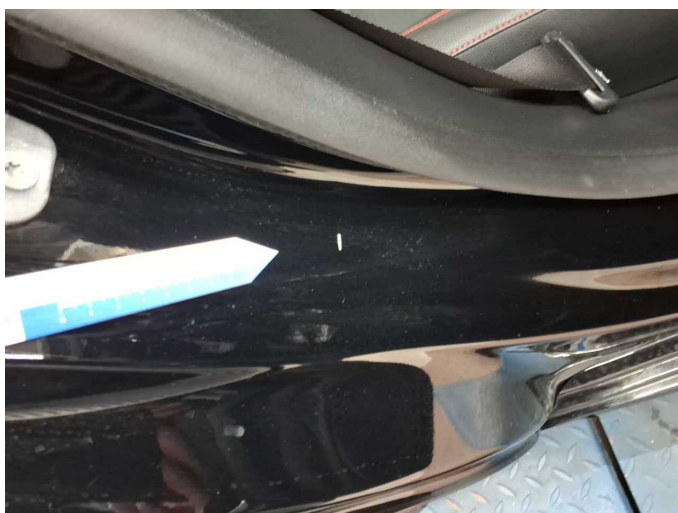
| No. | Component group | Description |
|---|---|---|
| 5 | Side panel - rear right side | Sill (Und kratzer) - dent(s) - Smart repair |

**Damage 5:** Side panel - rear right side: Sill (Und kratzer) - dent(s) - Smart repair

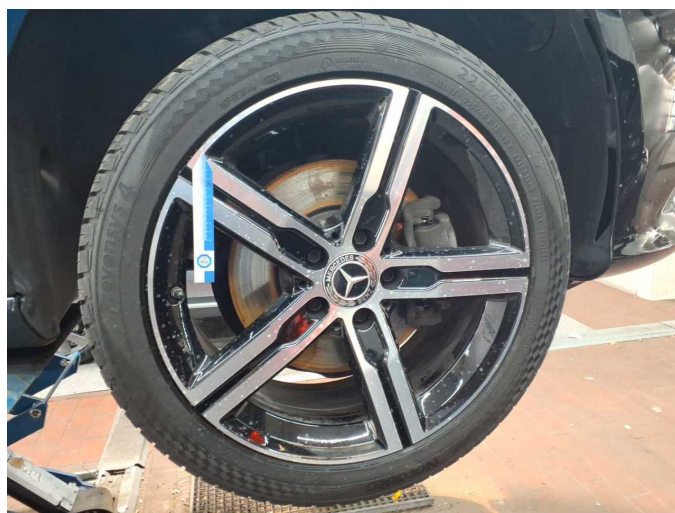
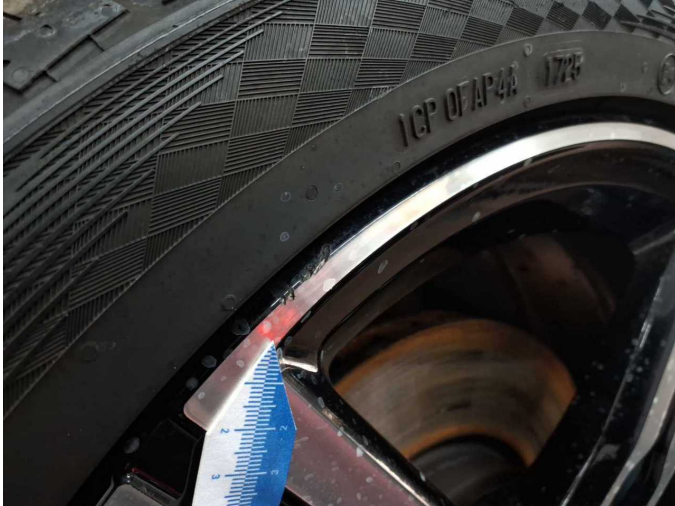
| No. | Component group | Description |
|---|---|---|
| 6 | Wheel / tyres | Alloy rim - front right side - Scratch(es) - Loss in value |

**Damage 6:** Wheel / tyres: Alloy rim - front right side - Scratch(es) - Loss in value

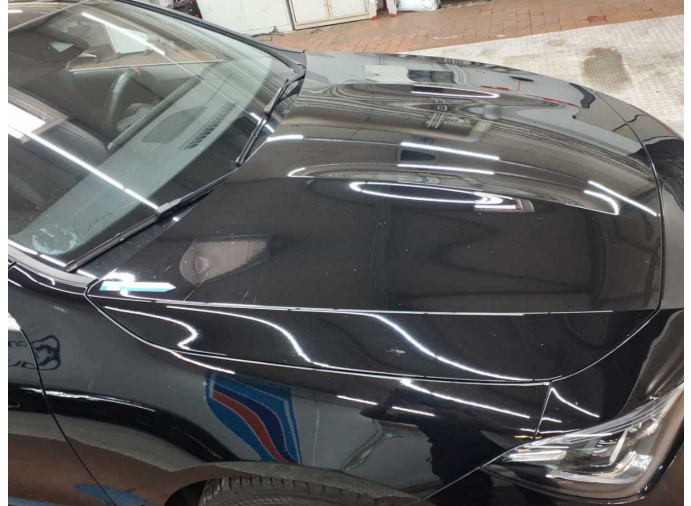
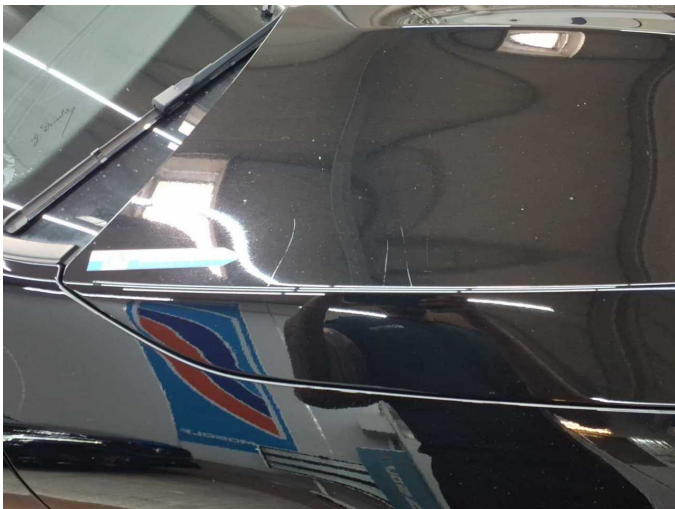
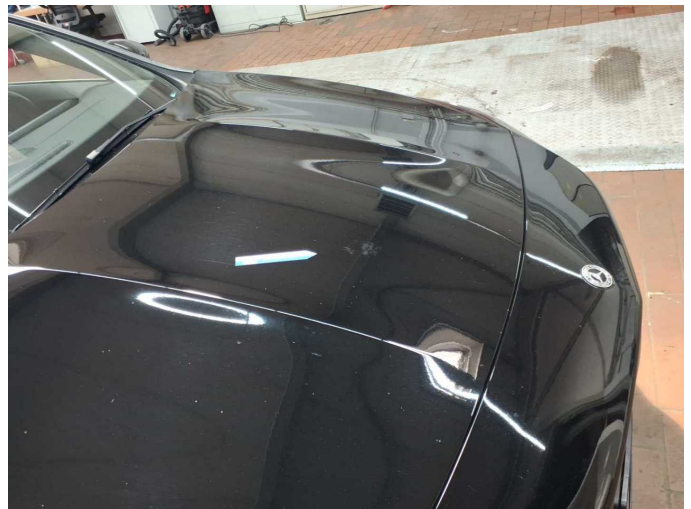
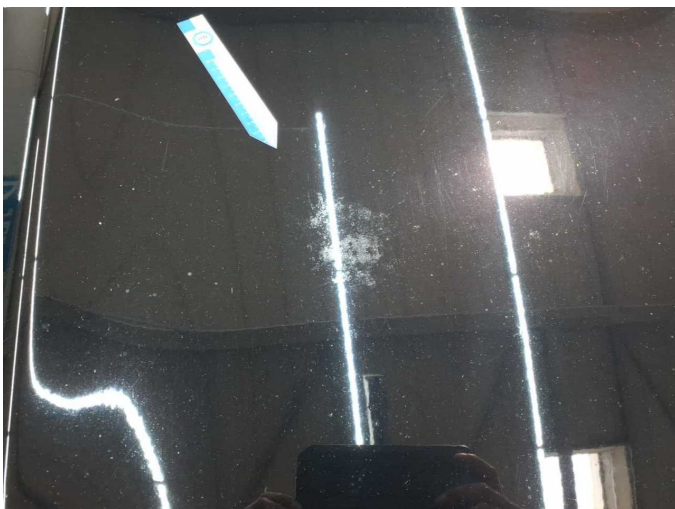
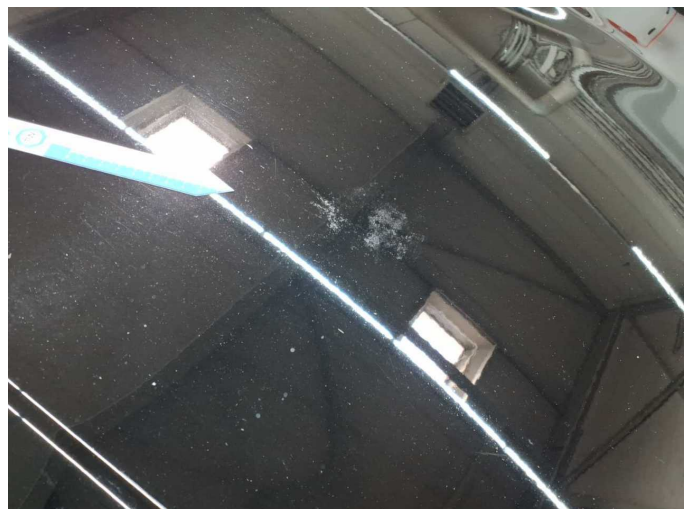
| No. | Component group | Description |
|---|---|---|
| 7 | Bonnet | Bonnet (Und verätzung [Harz]) - Scratch(es) - Paint |

**Damage 7:** Bonnet: Bonnet (Und verätzung [Harz]) - Scratch(es) - Paint

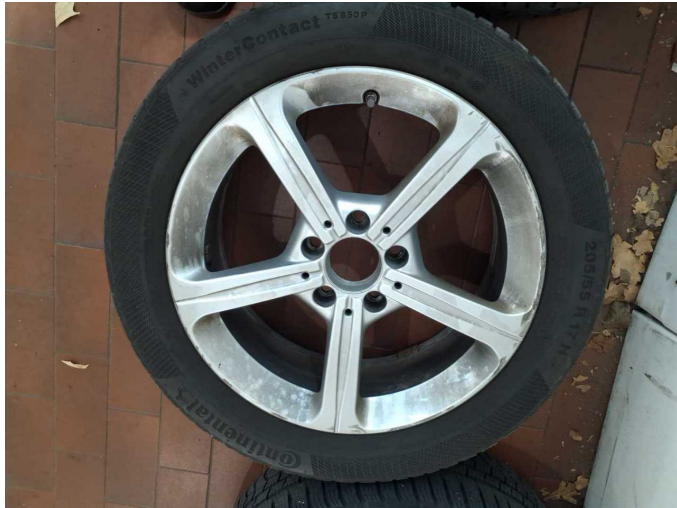
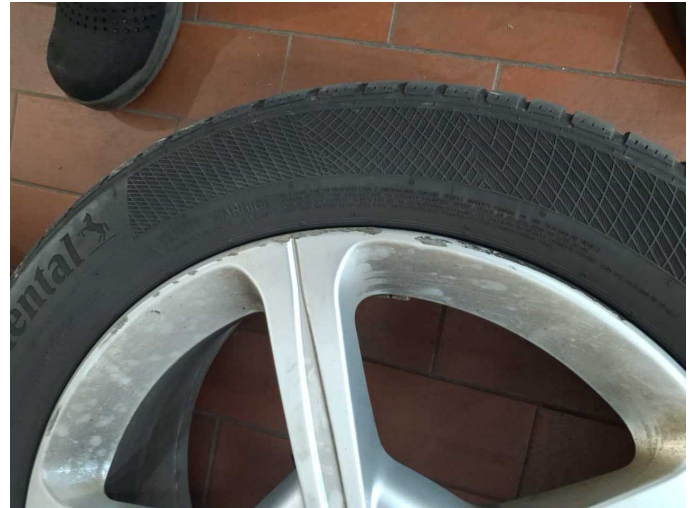
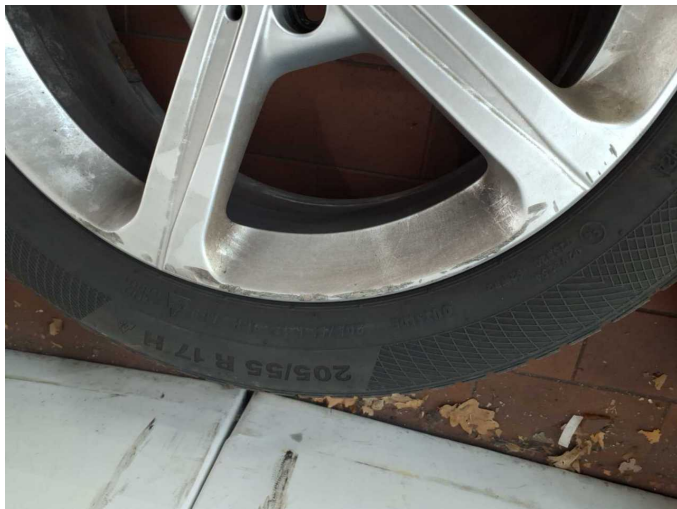
| No. | Component group | Description |
|---|---|---|
| 2 | 2nd wheel set | 1 alloy rim - Scratched - No deduction |

**Wear and tear 2:** 2nd wheel set: 1 alloy rim - Scratched - No deduction

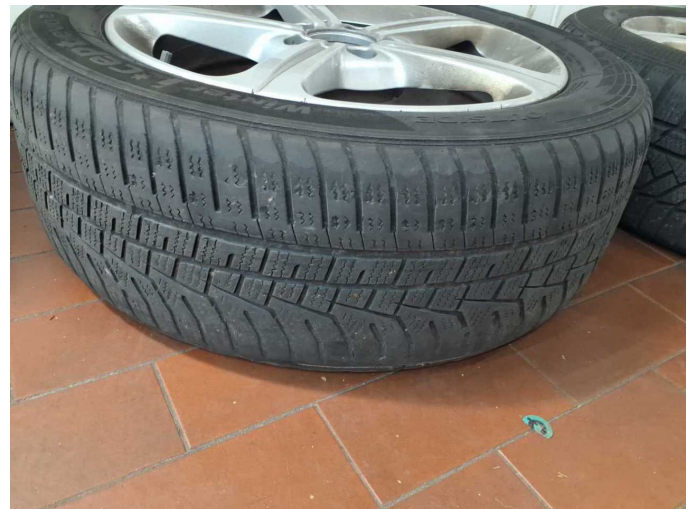
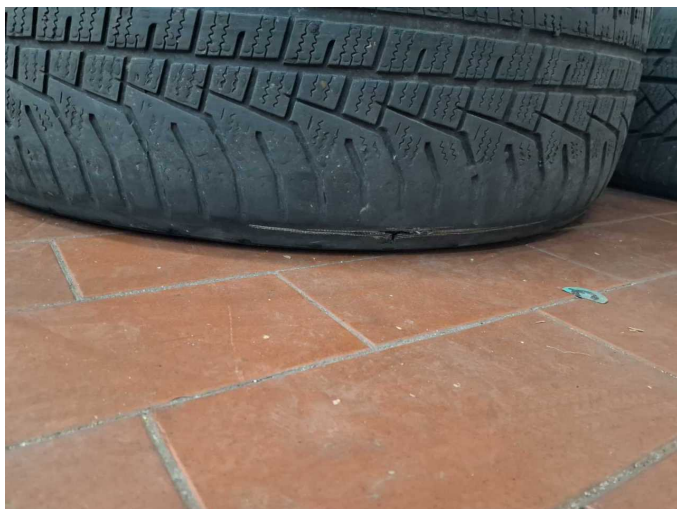
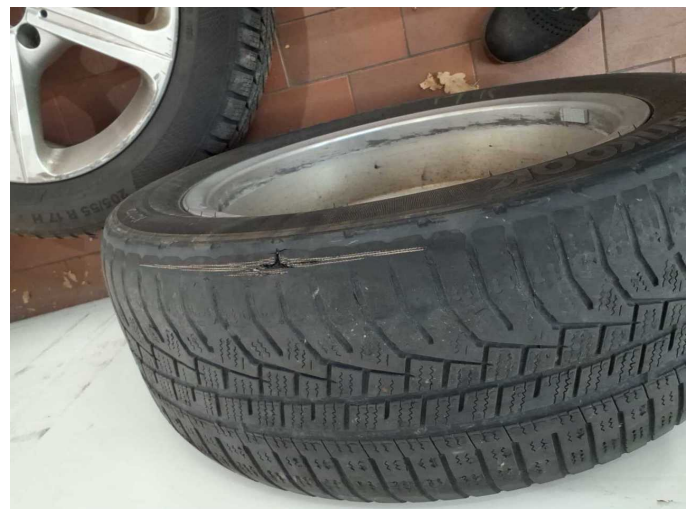
| No. | Component group | Description |
|---|---|---|
| 3 | 2nd wheel set | 1 tyre - Broken / torn - No deduction |

**Wear and tear 3:** 2nd wheel set: 1 tyre - Broken / torn - No deduction

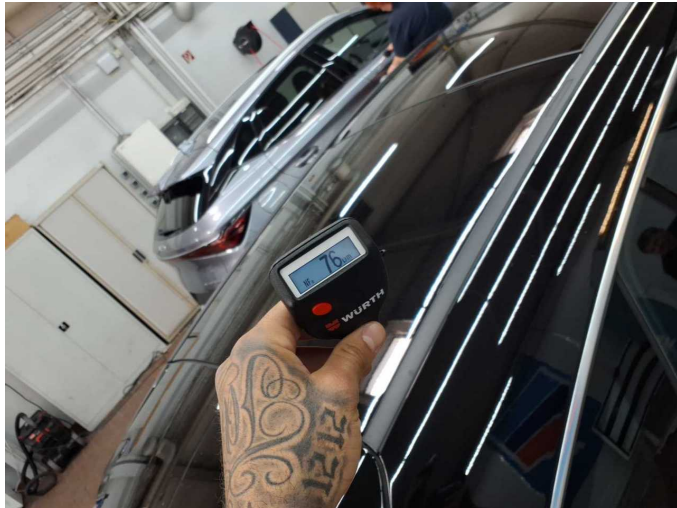
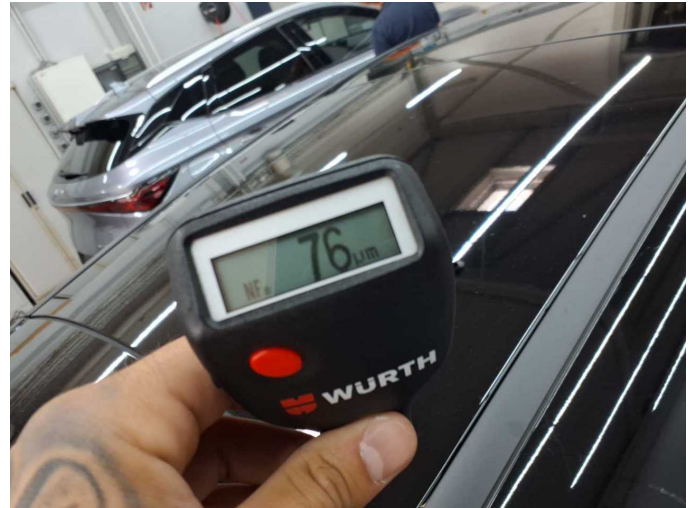
| No. | Previous damage | Extent of damage (Net) |
|---|---|---|
| 1 | Roof, Provided by user / customer, from 14 May 2025 | 606,66 € |

Previous damage 1: Roof

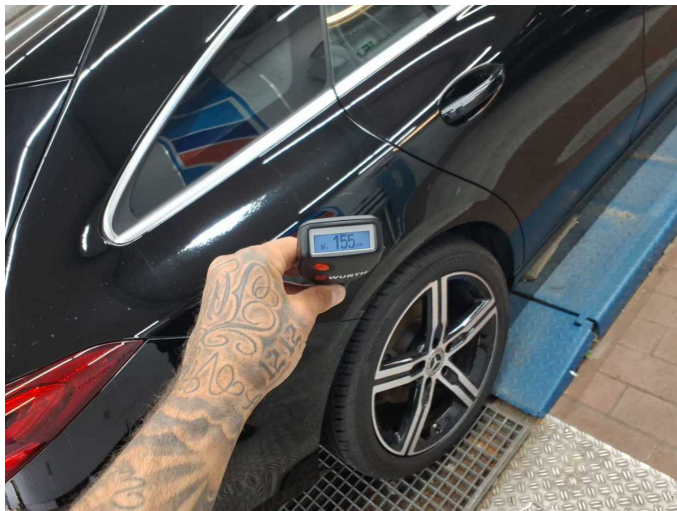
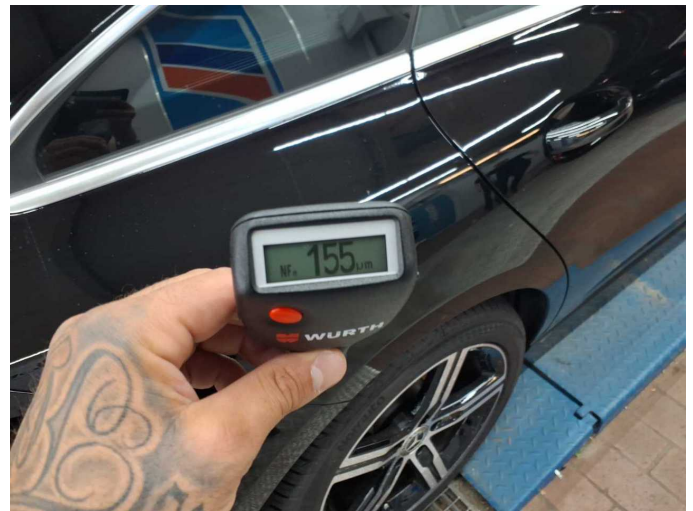
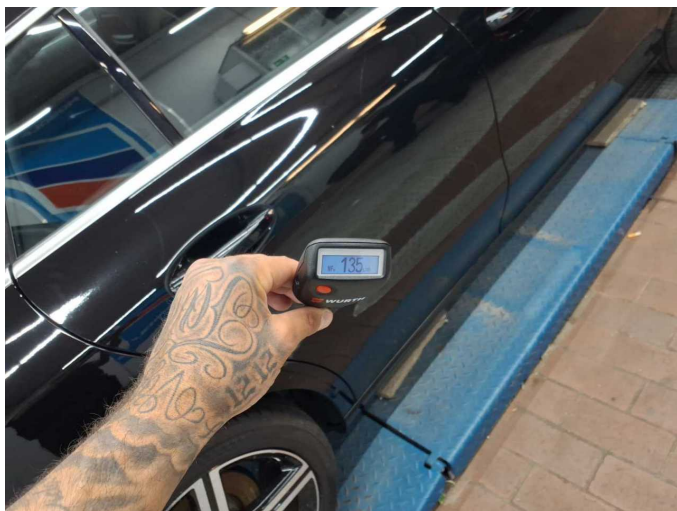
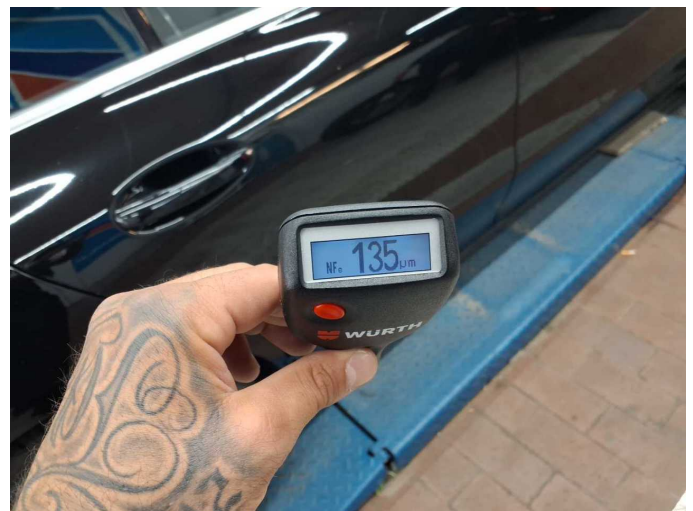
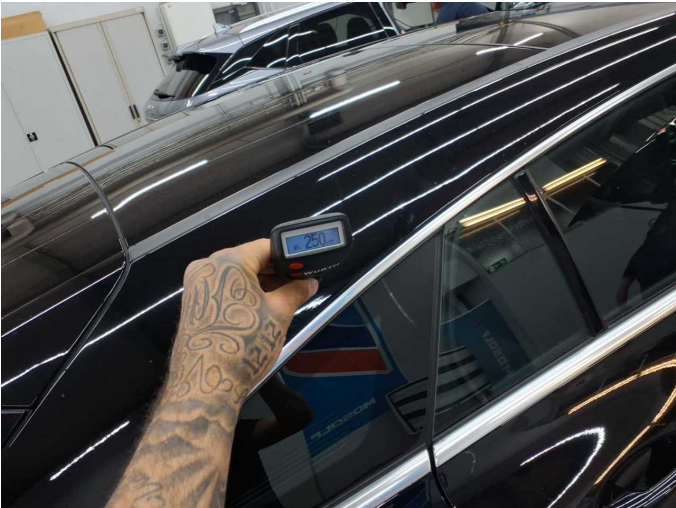
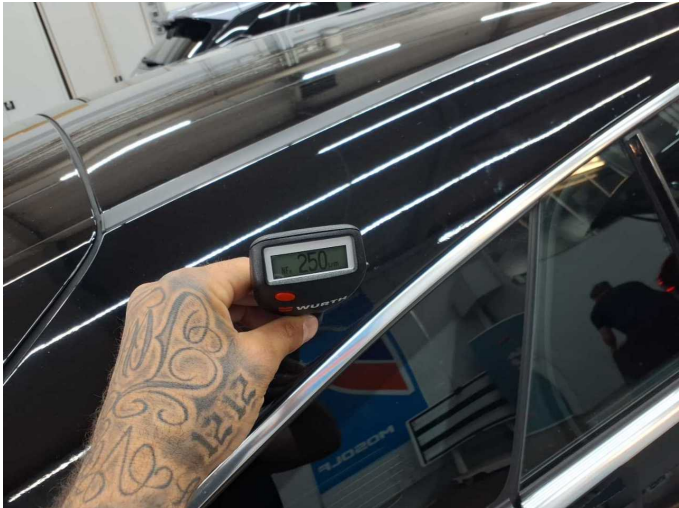
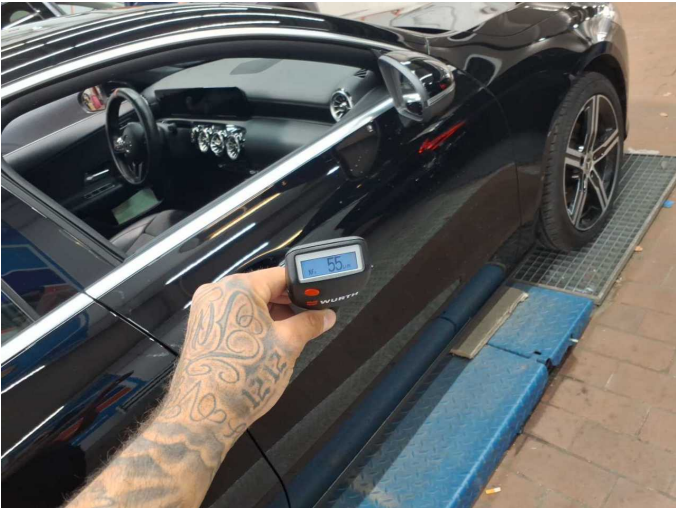
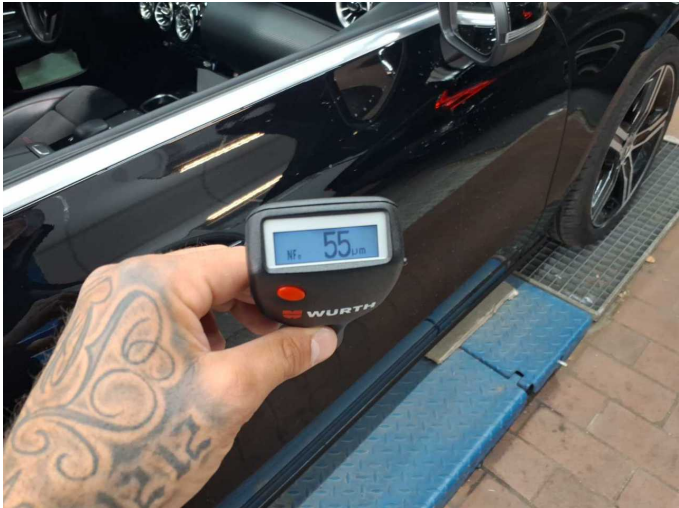
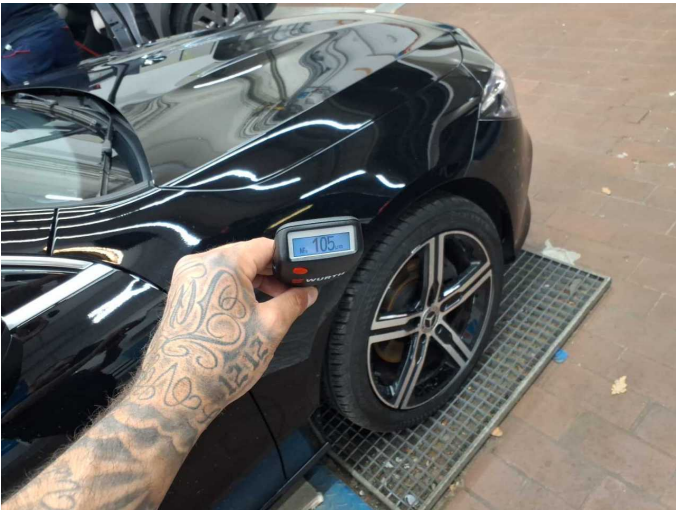
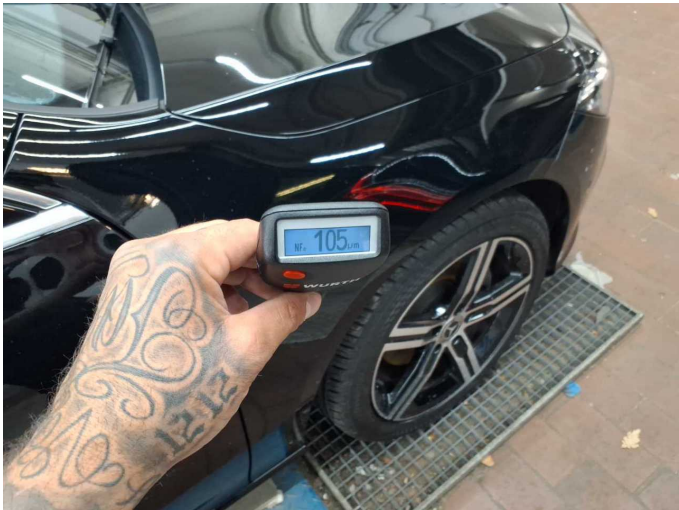
| No. | Previous damage | Extent of damage (Net) |
|---|---|---|
| 4 | Side right, Provided by user / customer, from 27 Feb 2025 | 1.648,46 € |

Previous damage 4: Side right

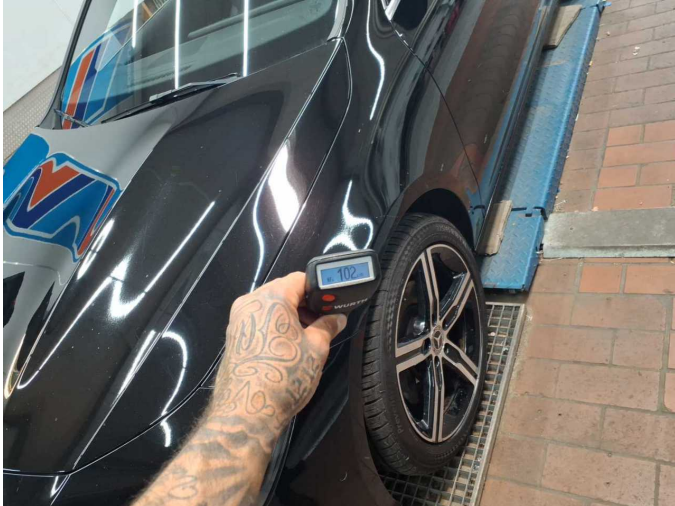
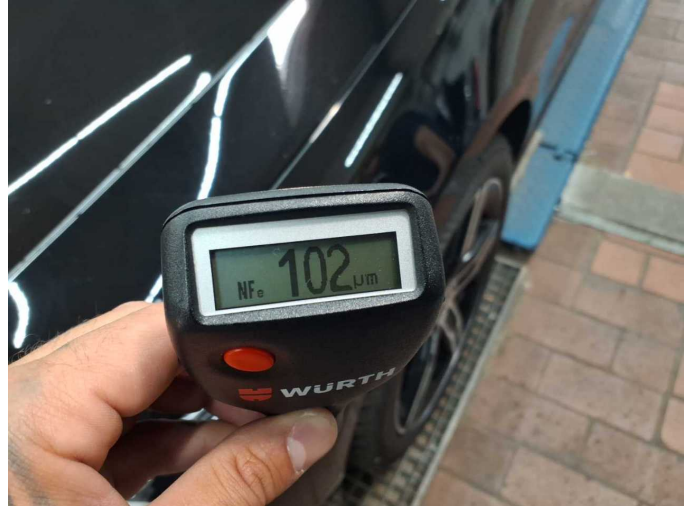
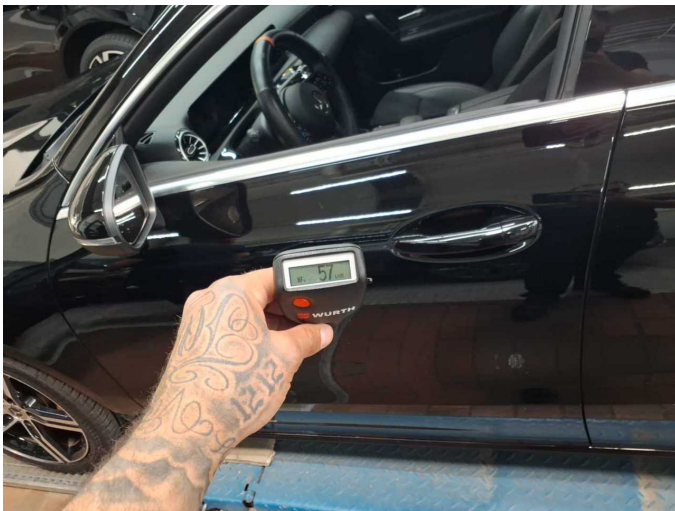
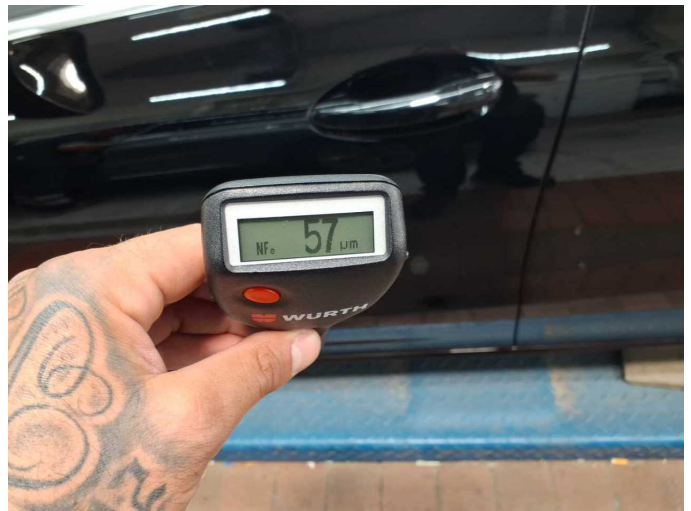
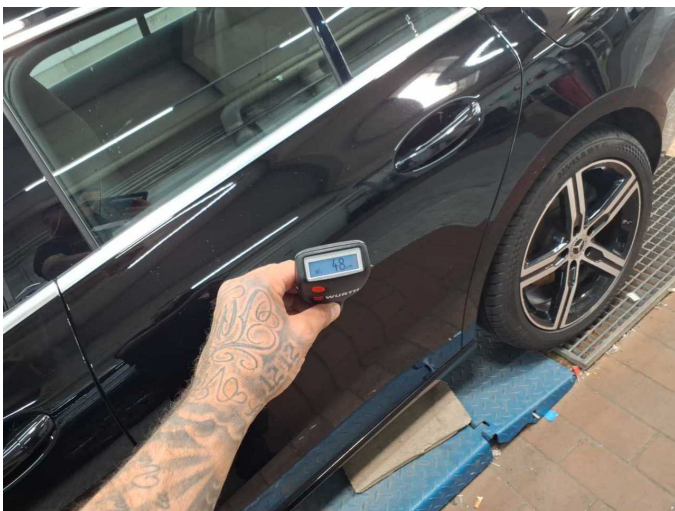
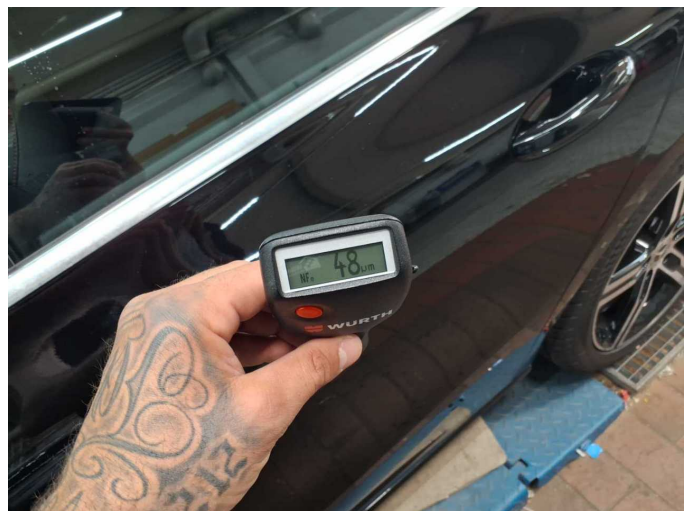
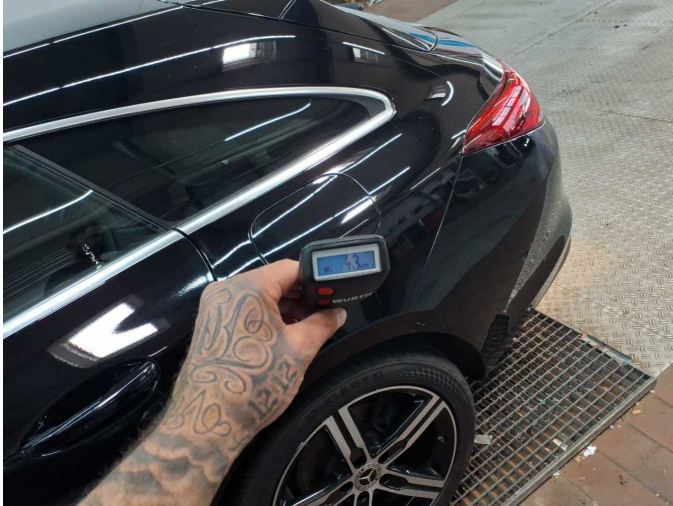
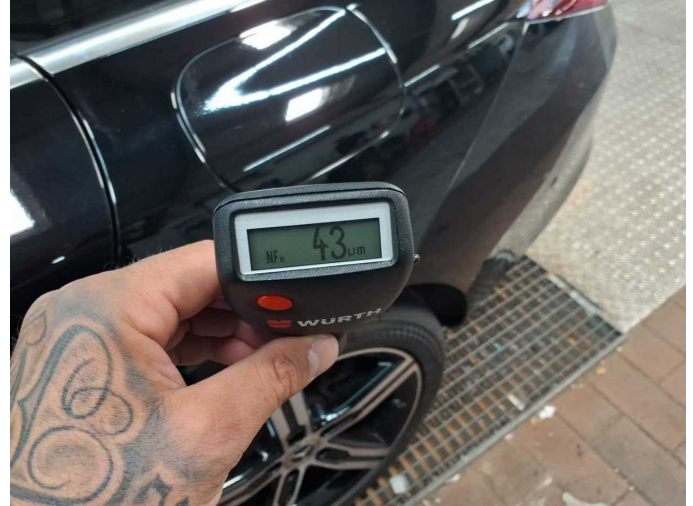
| No. | Previous damage | Extent of damage (Net) |
|---|---|---|
| 5 | Side - left, Provided by user / customer, from 11 Sept 2025 | 2.137,44 € |

Previous damage 5: Side - left

**Previous damage 5:** Side - left

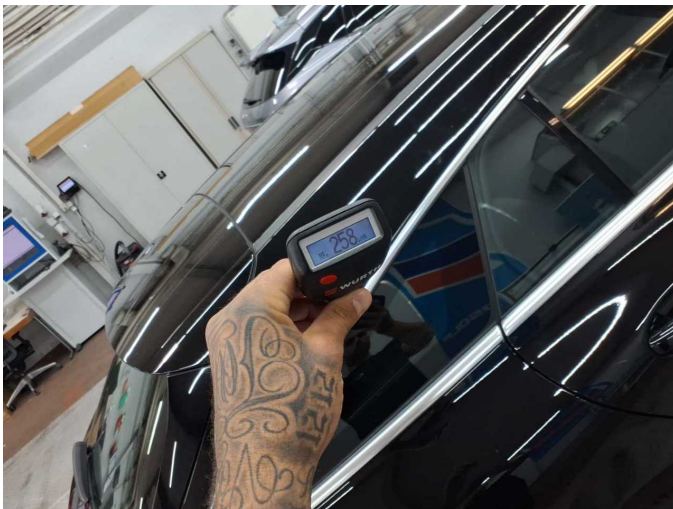
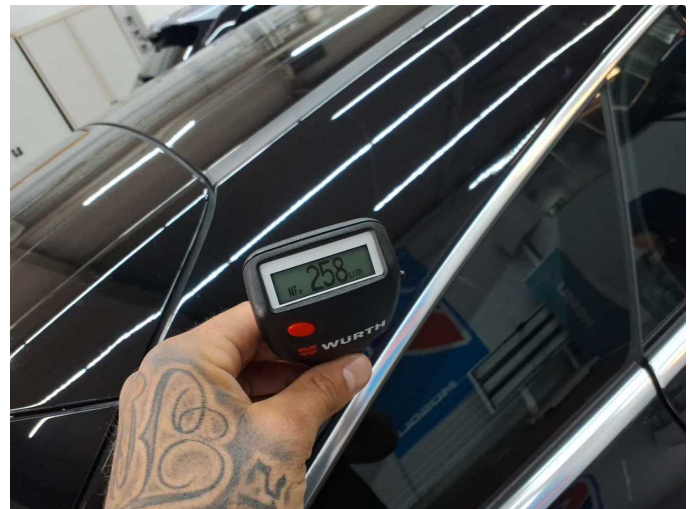
| No. | Repainting |
|---|---|
| 1 | Side panel - rear right side, Professionally carried out |

| Side panel - rear right side | 258 µm |

**Repainting 1:** Side panel - rear right side
