Expertise

Protocol number: 46516074  
Order No. / Reference: 26430524  
Inspection date: 7 Jul 2026

Model: 508 SW BlueHDi 130 EAT8 Allure Pack

VIN: VR3FCYHZTNY573744

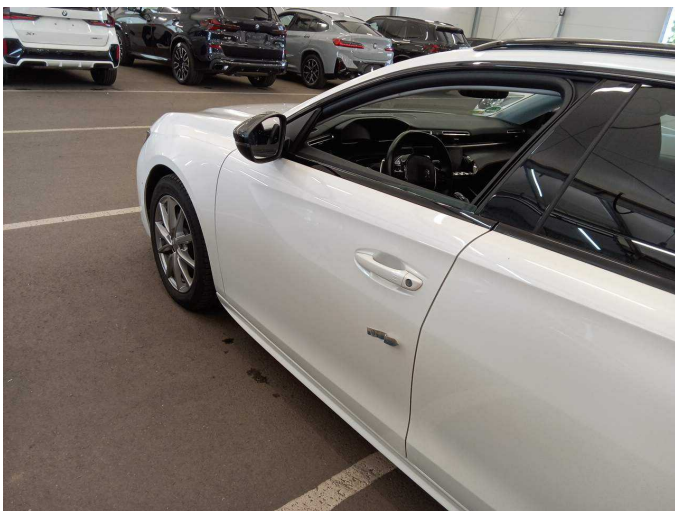
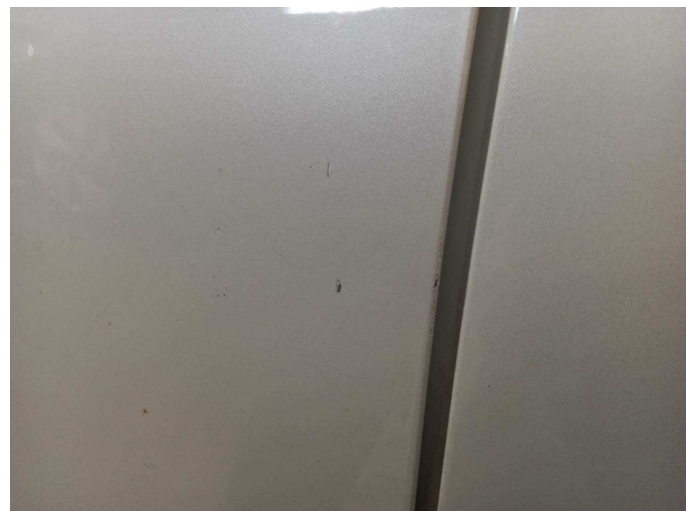
| No. | Component group | Description |
|---|---|---|
| 1 | Door - front left side | Door edge (Perlmutterlack erhöhter Aufwand) - Scratch(es) - Smart repair |

**Damage 1:** Door - front left side: Door edge (Perlmutterlack erhöhter Aufwand) - Scratch(es) - Smart repair

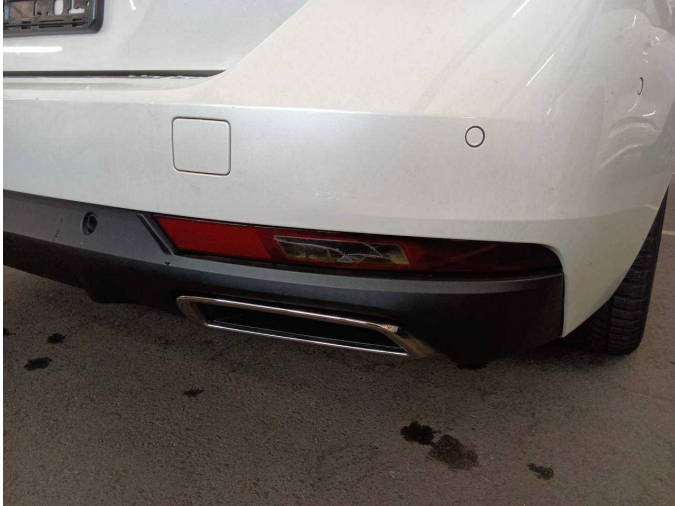
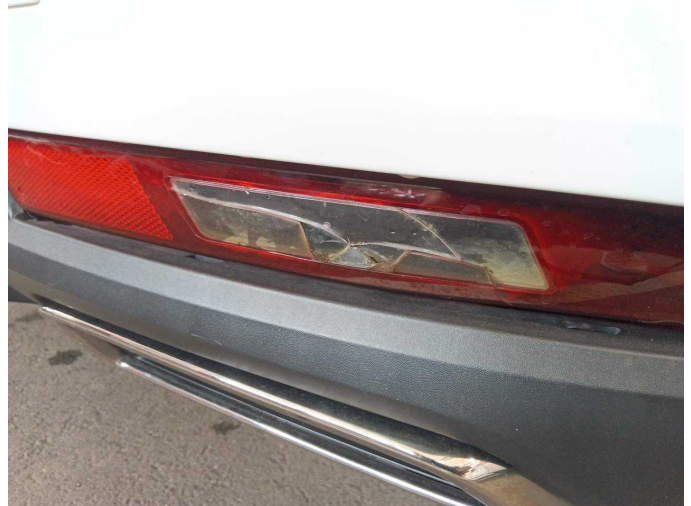
| No. | Component group | Description |
|---|---|---|
| 2 | Rear bumper | Reflector - right side (& Nebelschlussleuchte) - Broken / torn - Replace |

**Damage 2:** Rear bumper: Reflector - right side (& Nebelschlussleuchte) - Broken / torn - Replace

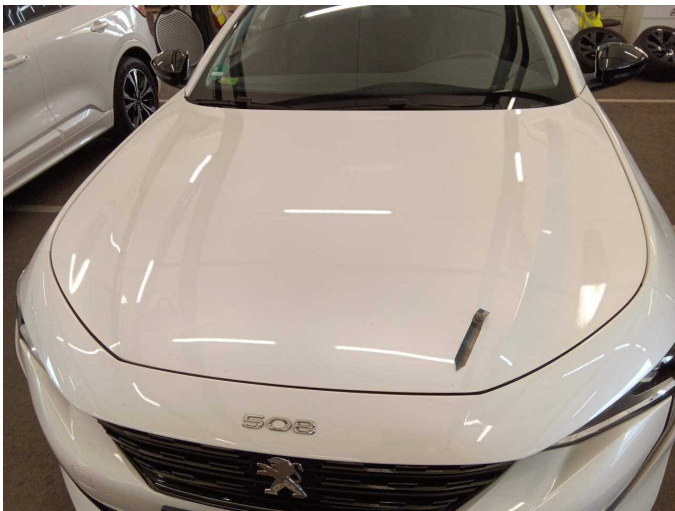
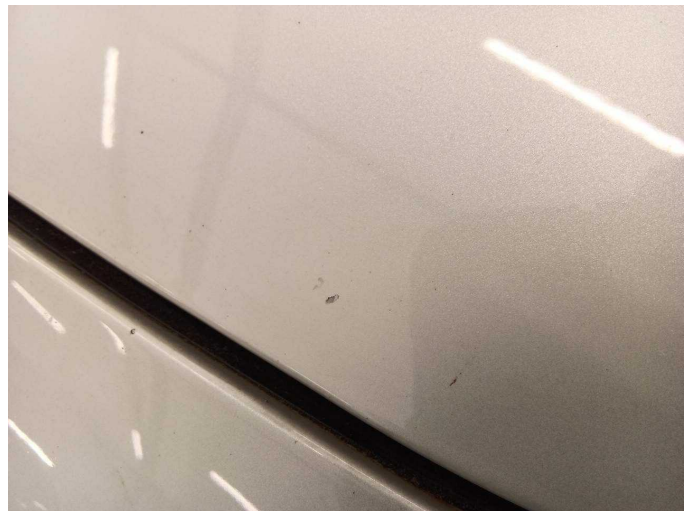
| No. | Component group | Description |
|---|---|---|
| 1 | Bonnet | Bonnet - Stone chips - No deduction |

**Wear and tear 1:** Bonnet: Bonnet - Stone chips - No deduction

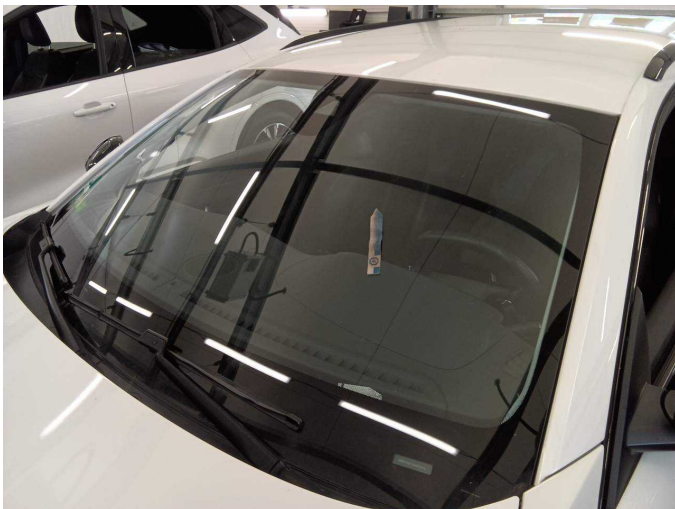
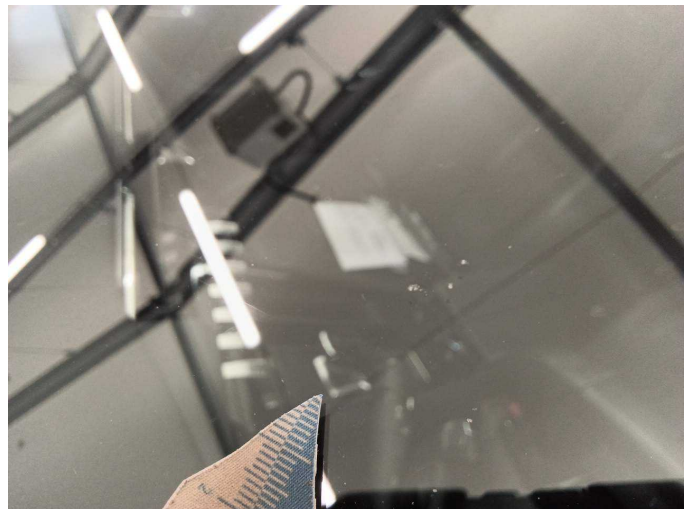
| No. | Component group | Description |
|---|---|---|
| 2 | Vehicle glazing | Windscreen - Stone chips - No deduction |

**Wear and tear 2:** Vehicle glazing: Windscreen - Stone chips - No deduction

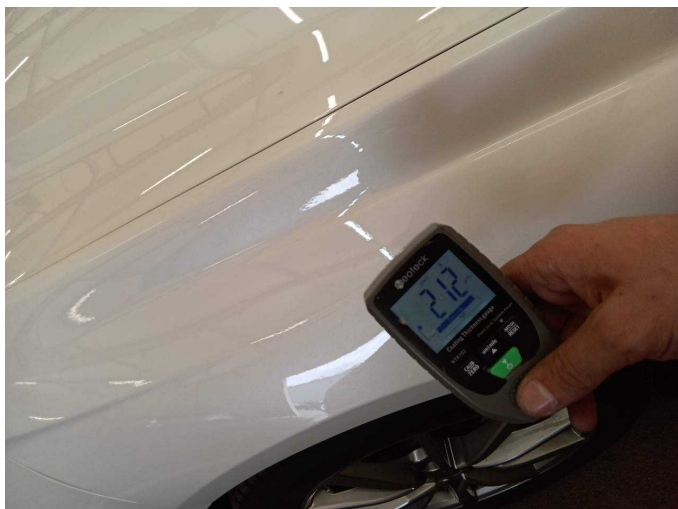
| No. | Repainting |
|---|---|
| 1 | Mudguard - left side |

| Mudguard - left side | 212 µm |

**Repainting 1:** Mudguard - left side
