Expertise

Protocol number: 47118355  
Order No. / Reference: 26832933  
Inspection date: 17 Aug 2026

Manufacturer: Mazda

Model: 2 SKYACTIV G 90 M HYBRID Homura

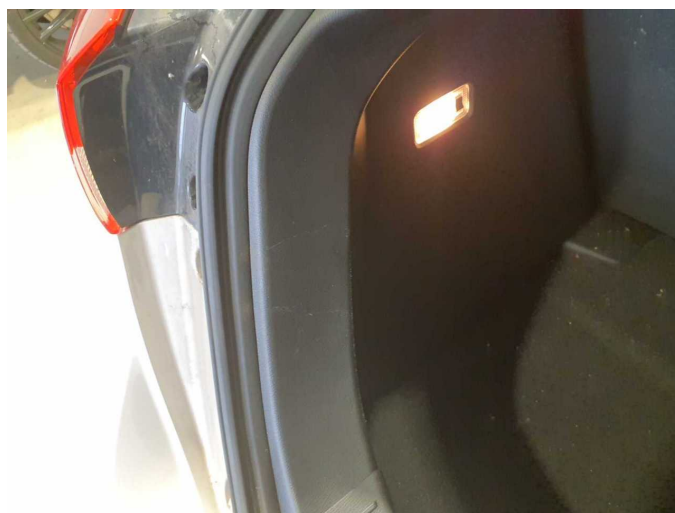
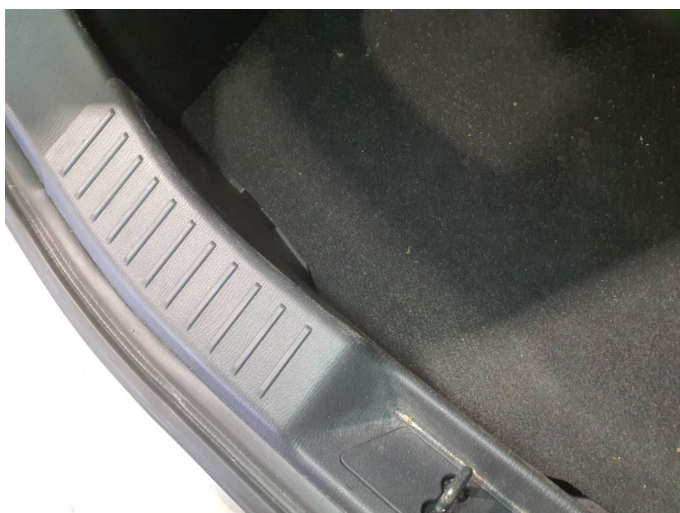
| No. | Component group | Description |
|---|---|---|
| 1 | Trim / covers | Boot lining - Scratch(es) - Loss in value |

**Damage 1:** Trim / covers: Boot lining - Scratch(es) - Loss in value

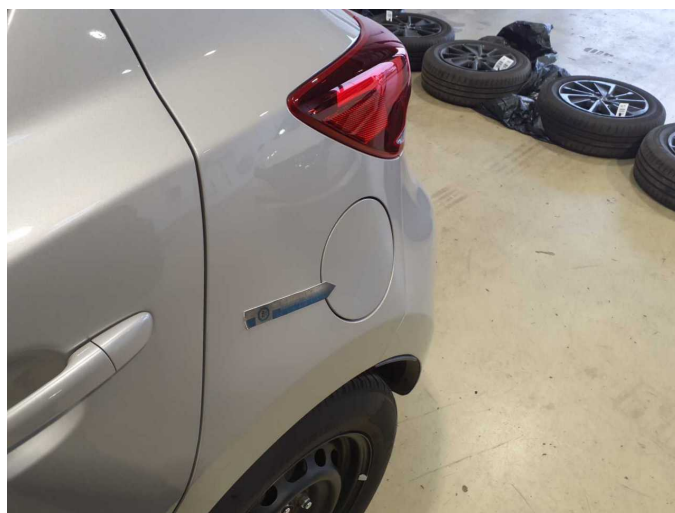
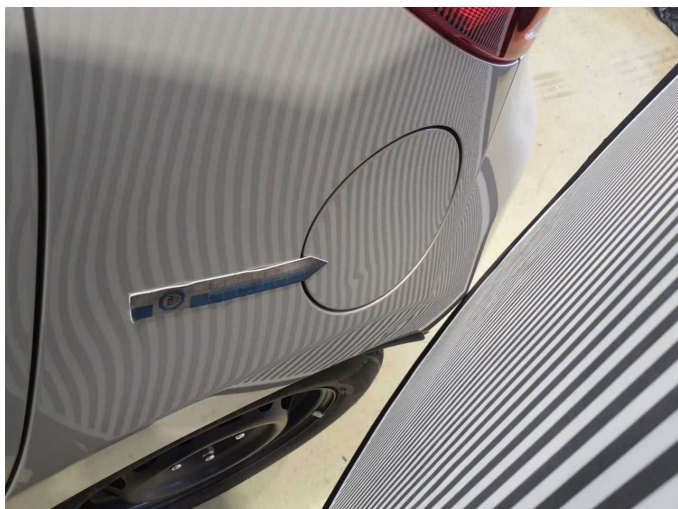
| No. | Component group | Description |
|---|---|---|
| 2 | Fuel system | Tank flap - dent(s) - Smooth repair work |

**Damage 2:** Fuel system: Tank flap - dent(s) - Smooth repair work

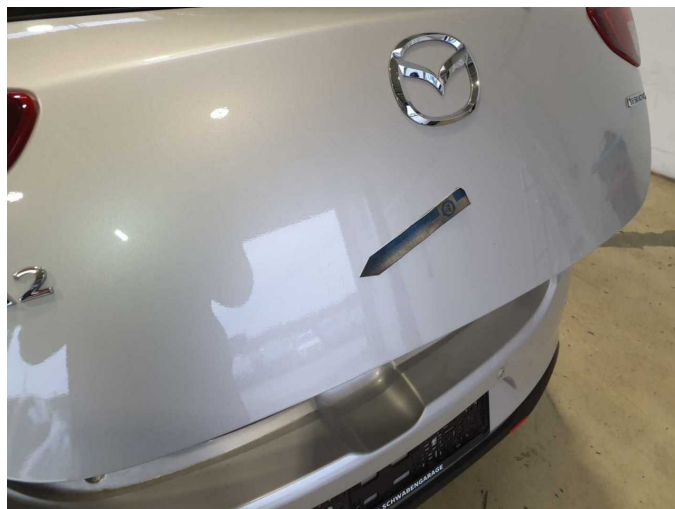
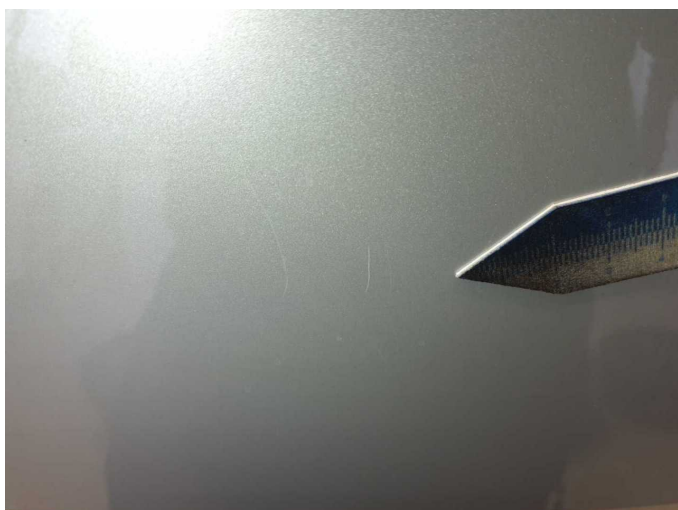
| No. | Component group | Description |
|---|---|---|
| 3 | Boot lid / rear door | Boot lid - Scratch(es) - Smart repair |

**Damage 3:** Boot lid / rear door: Boot lid - Scratch(es) - Smart repair

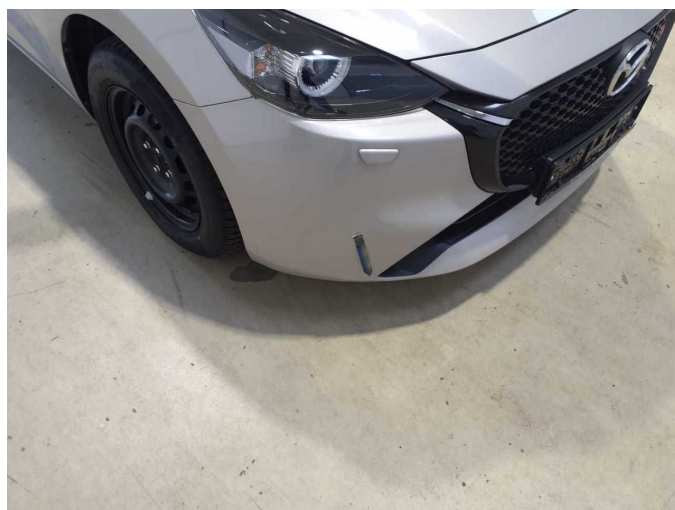
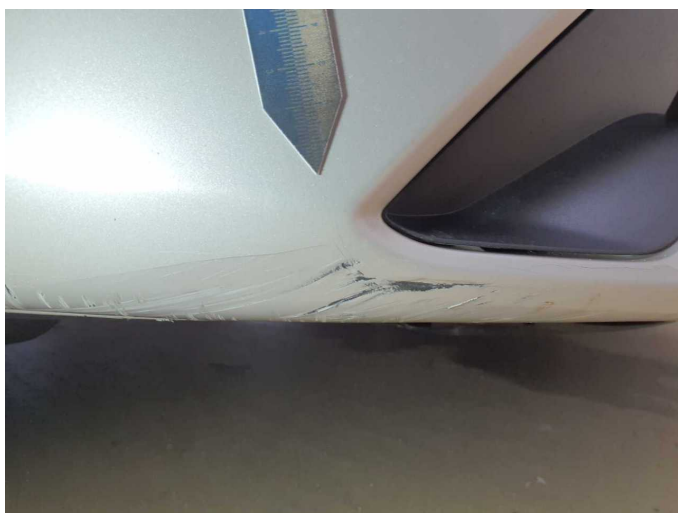
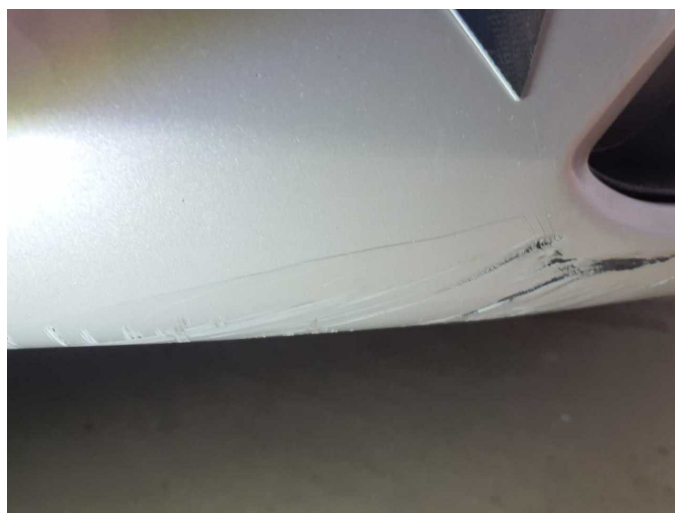
| No. | Component group | Description |
|---|---|---|
| 4 | Front bumper | Front bumper - Broken / torn - Replace |

**Damage 4:** Front bumper: Front bumper - Broken / torn - Replace

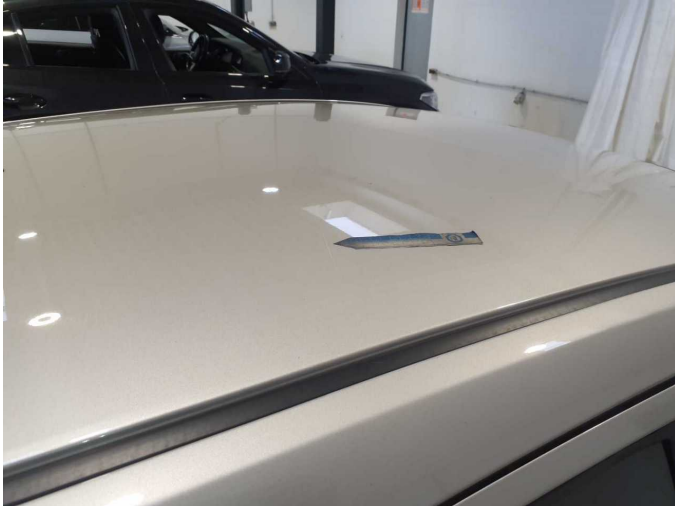
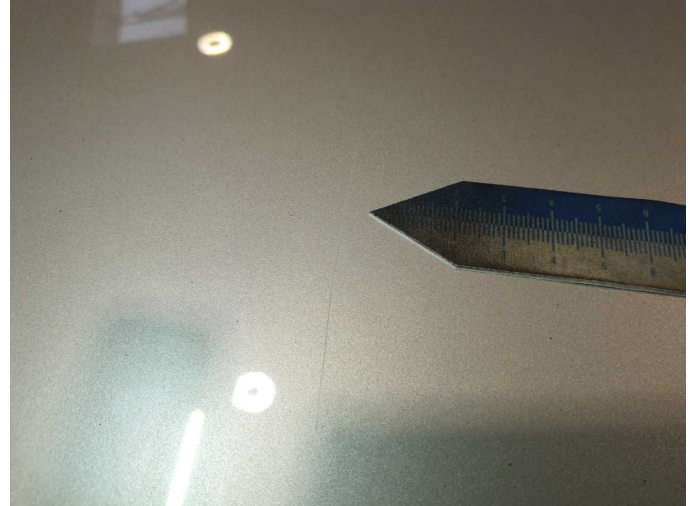
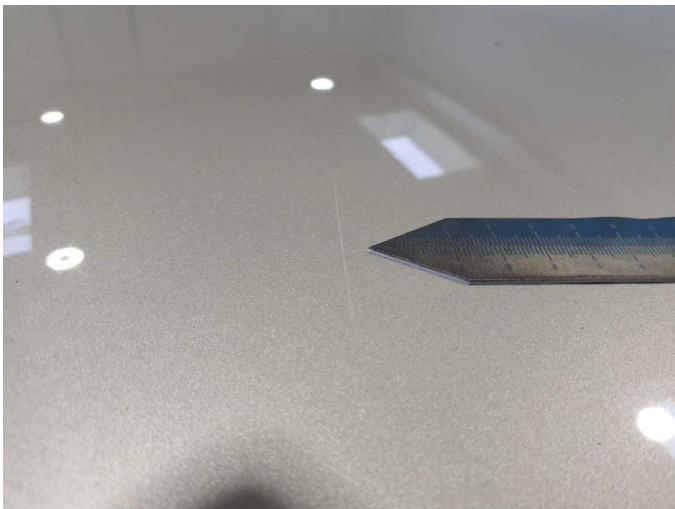
| No. | Component group | Description |
|---|---|---|
| 5 | Roof | Roof - Scratch(es) - Paint |

**Damage 5:** Roof: Roof - Scratch(es) - Paint
