Expertise

Protocol number: 46578865  
Order No. / Reference: 26587777  
Inspection date: 17 Jul 2026

Manufacturer: Volkswagen

Model: ID.4 Performance Upgrade Pro Tech

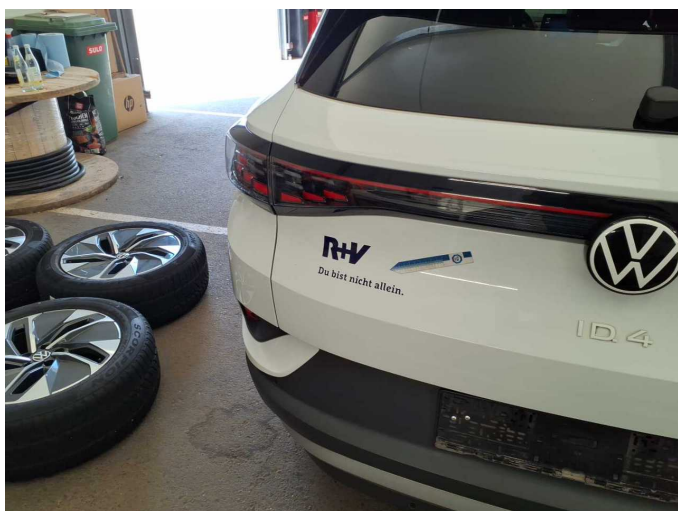
| No. | Component group | Description |
|---|---|---|
| 1 | Boot lid / rear door | Boot lid - Glued / labelled - De-glue / neutralise |

**Damage 1:** Boot lid / rear door: Boot lid - Glued / labelled - De-glue / neutralise

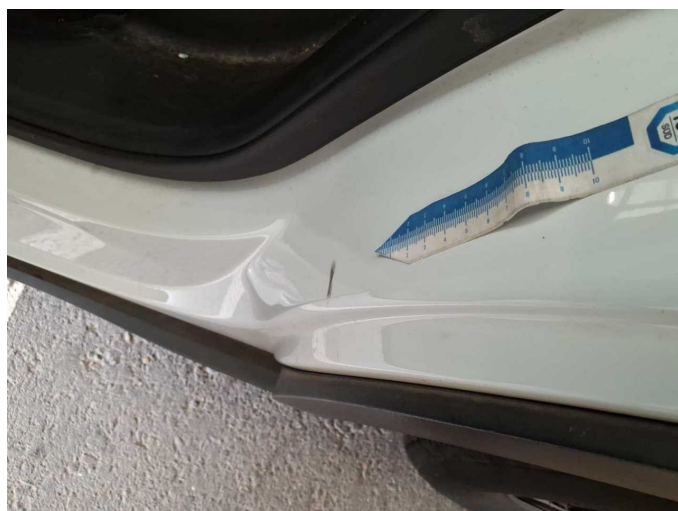
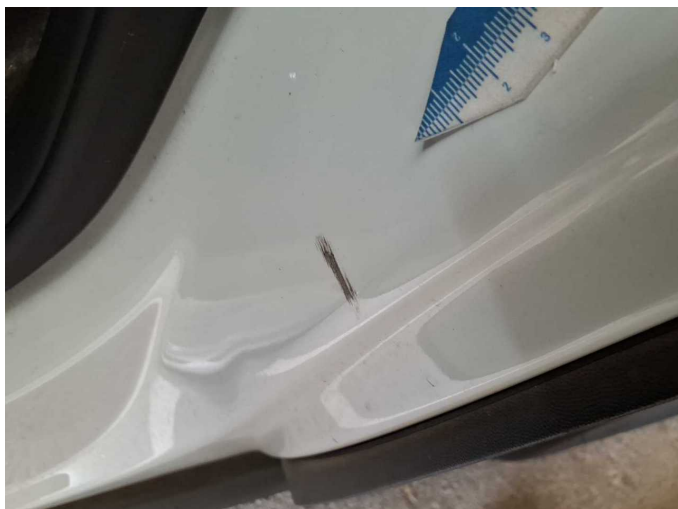
| No. | Component group | Description |
|---|---|---|
| 2 | Side panel - rear left side | Sill - Scratched - Smart repair |

**Damage 2:** Side panel - rear left side: Sill - Scratched - Smart repair

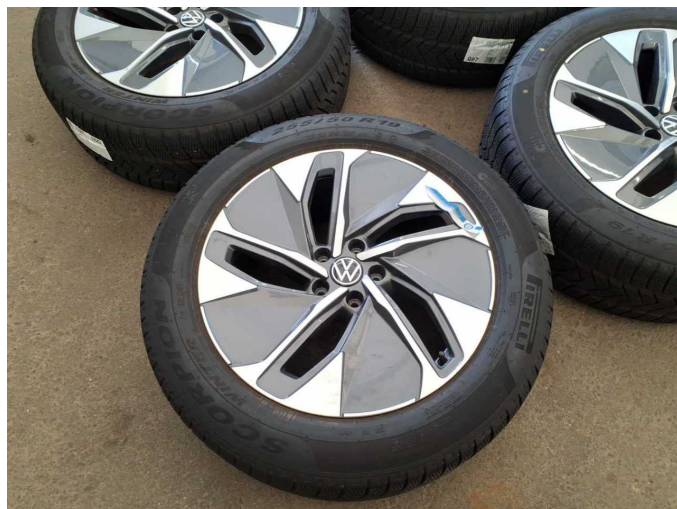
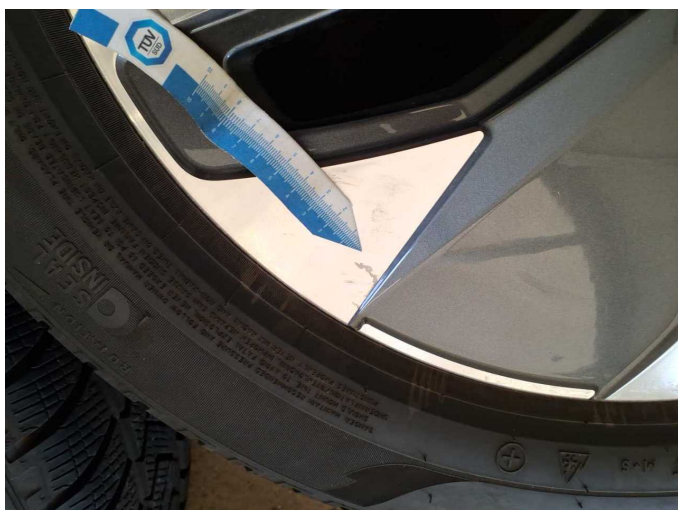
| No. | Component group | Description |
|---|---|---|
| 3 | 2nd wheel set | 1 alloy rim (Materialveränderung an Glanzgedrehter Stelle) - Corrosion - Loss in value |

**Damage 3:** 2nd wheel set: 1 alloy rim (Materialveränderung an Glanzgedrehter Stelle) - Corrosion - Loss in value

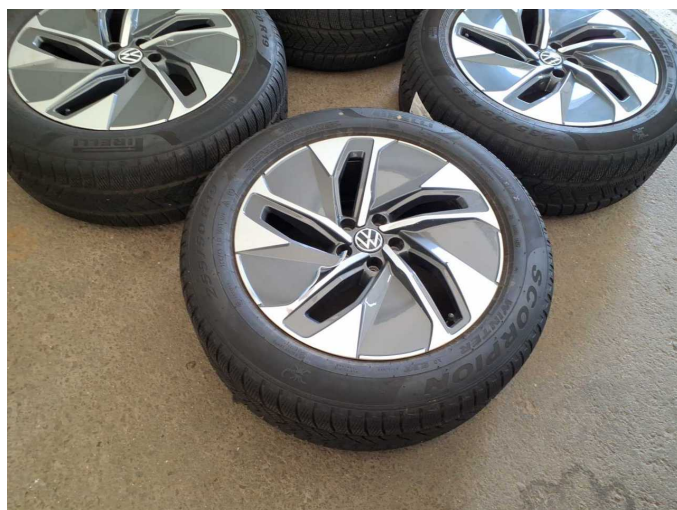
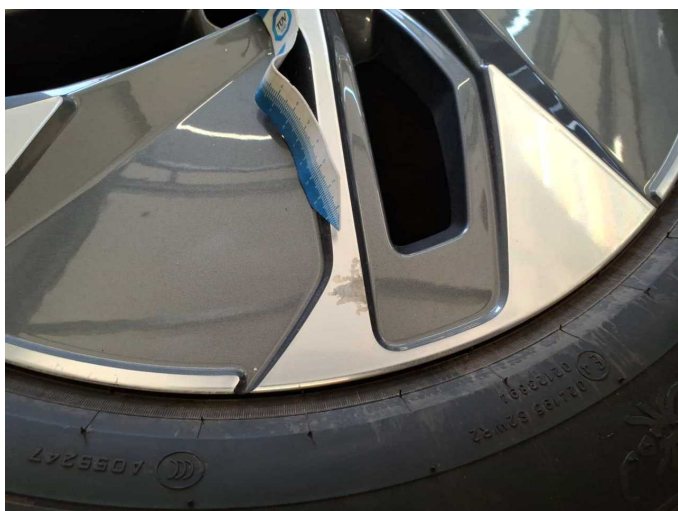
| No. | Component group | Description |
|---|---|---|
| 4 | 2nd wheel set | 1 alloy rim (Materialveränderung an Glanzgedrehter Stelle) - Corrosion - Loss in value |

**Damage 4:** 2nd wheel set: 1 alloy rim (Materialveränderung an Glanzgedrehter Stelle) - Corrosion - Loss in value

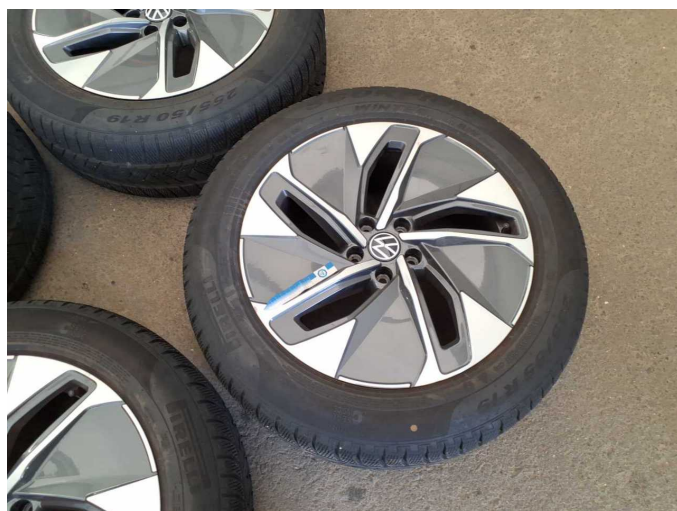
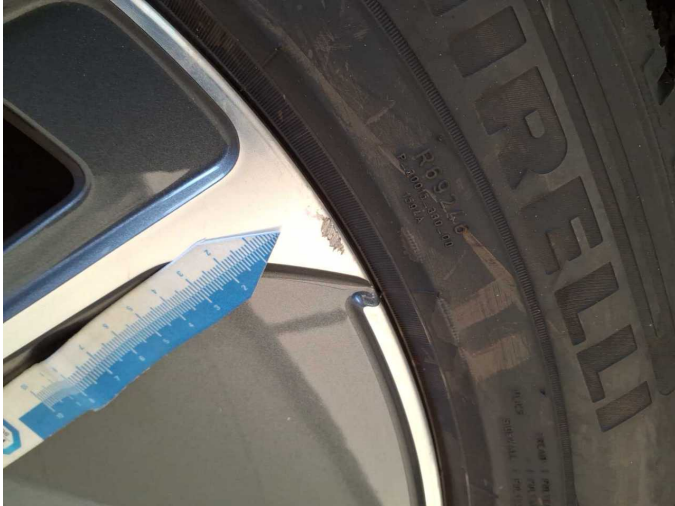
| No. | Component group | Description |
|---|---|---|
| 5 | 2nd wheel set | 1 alloy rim - Scratch(es) - Loss in value |

**Damage 5:** 2nd wheel set: 1 alloy rim - Scratch(es) - Loss in value

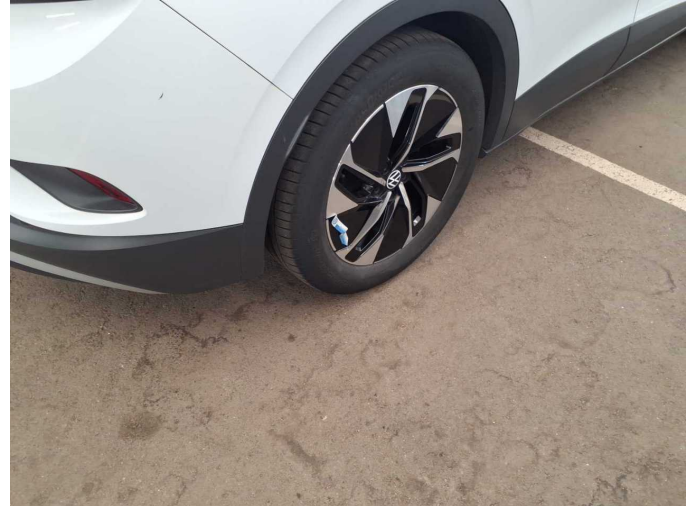
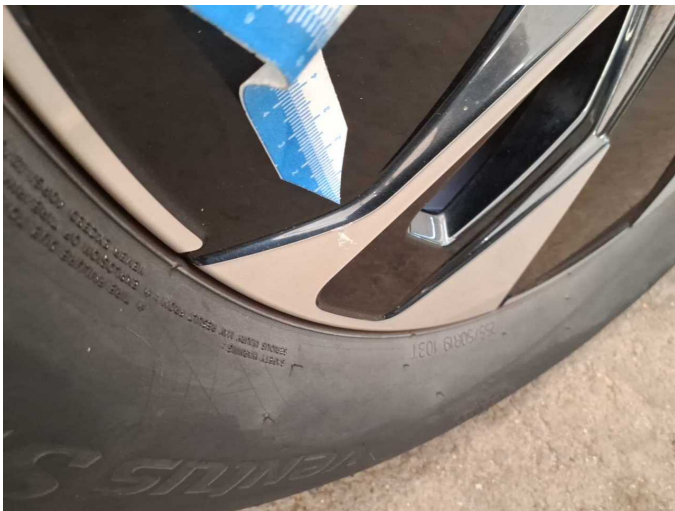
| No. | Component group | Description |
|---|---|---|
| 6 | Wheel / tyres | Alloy rim - rear right side - Scratch(es) - Loss in value |

**Damage 6:** Wheel / tyres: Alloy rim - rear right side - Scratch(es) - Loss in value

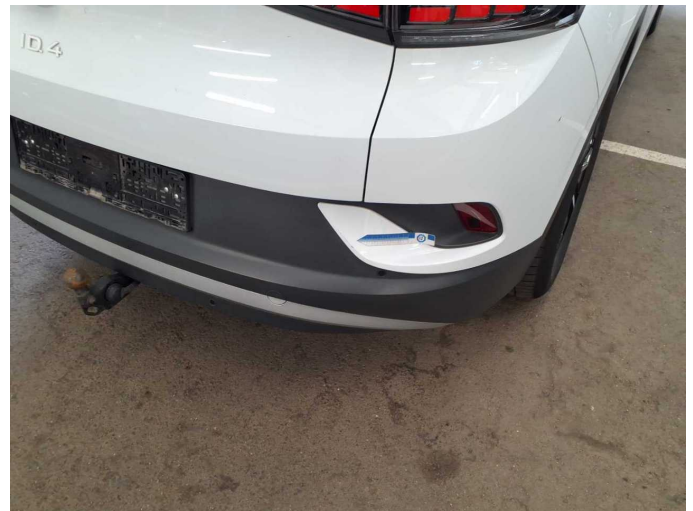
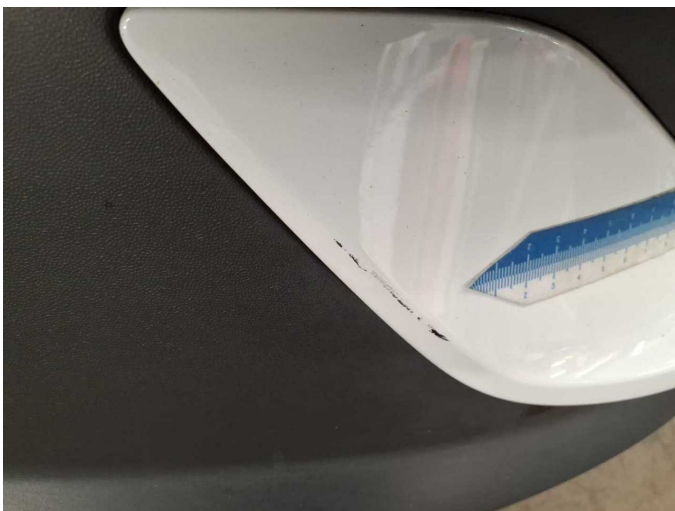
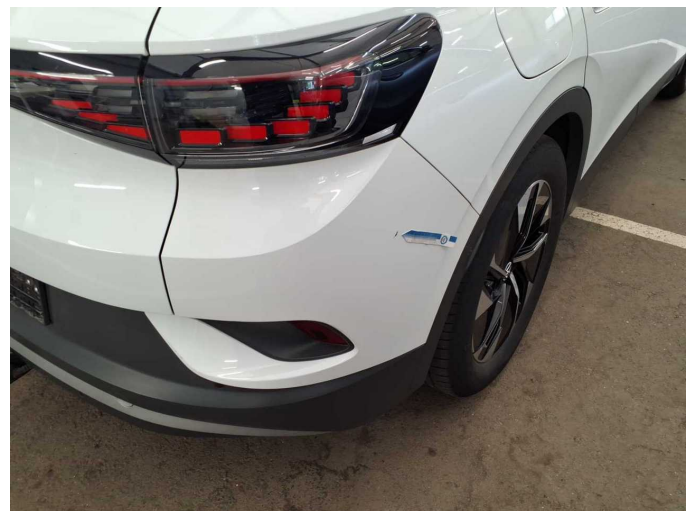
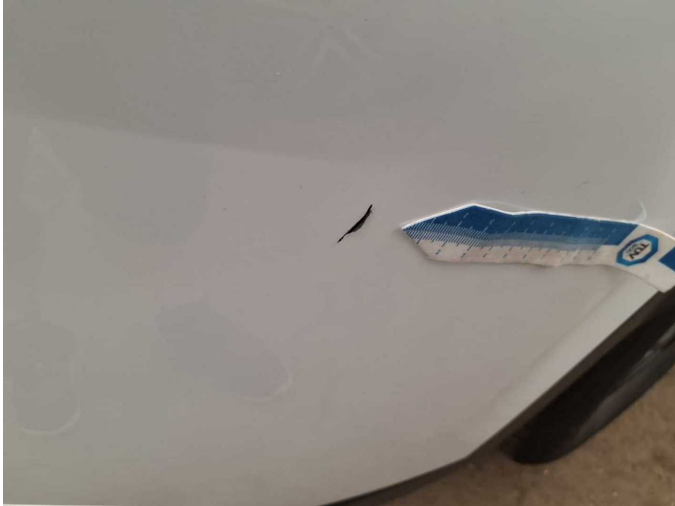
| No. | Component group | Description |
|---|---|---|
| 7 | Rear bumper | Bumper - rear right side - Scratched - Repair and paint |

**Damage 7:** Rear bumper: Bumper - rear right side - Scratched - Repair and paint

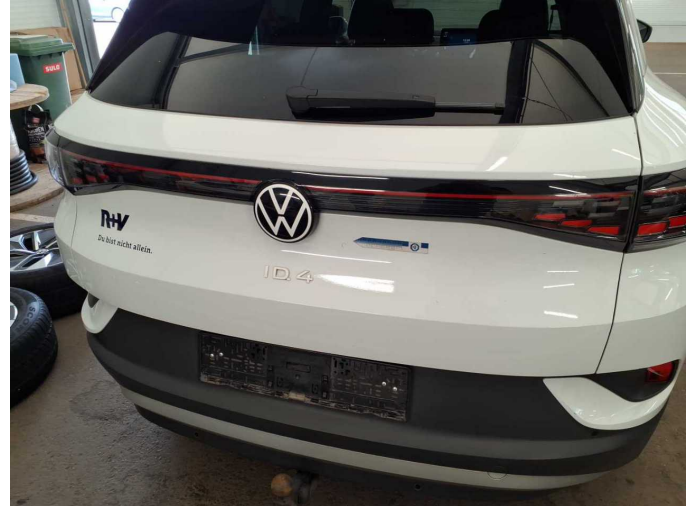
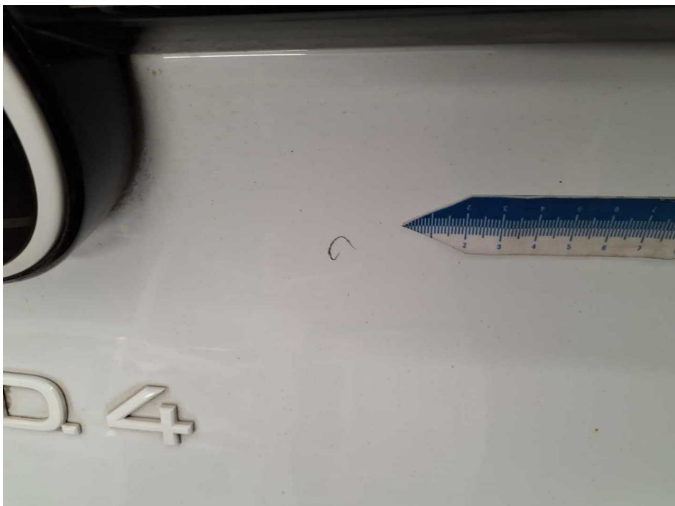
| No. | Component group | Description |
|---|---|---|
| 8 | Boot lid / rear door | Boot lid (Unterhalb) - Scratched - Paint |

**Damage 8:** Boot lid / rear door: Boot lid (Unterhalb) - Scratched - Paint

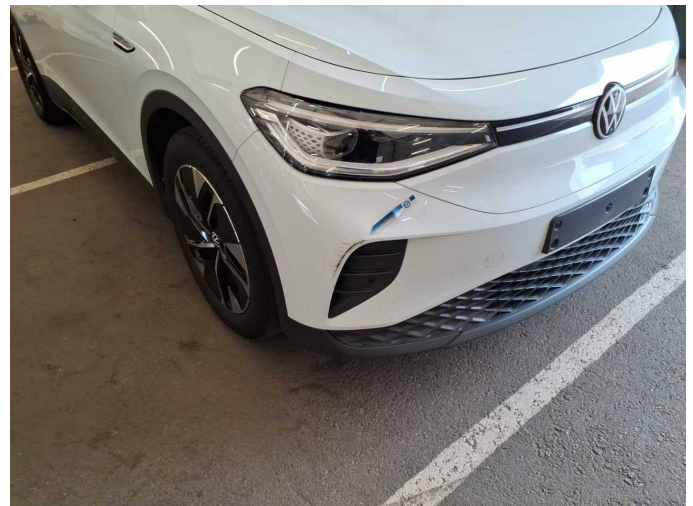
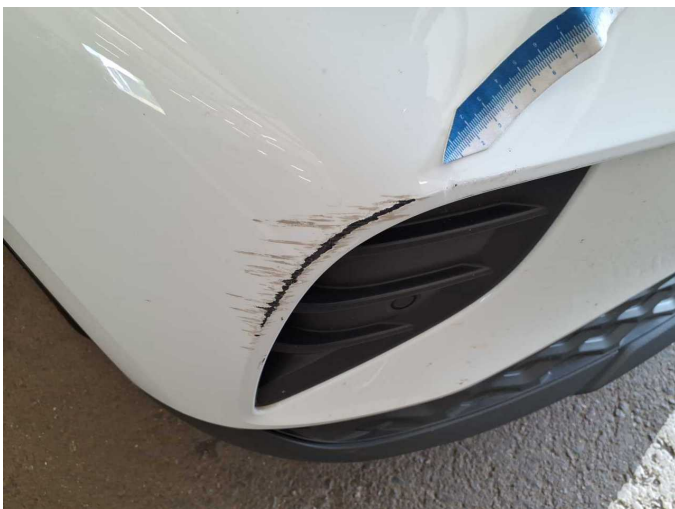
| No. | Component group | Description |
|---|---|---|
| 9 | Front bumper | Front bumper - Scratched - Repair and paint |

**Damage 9:** Front bumper: Front bumper - Scratched - Repair and paint

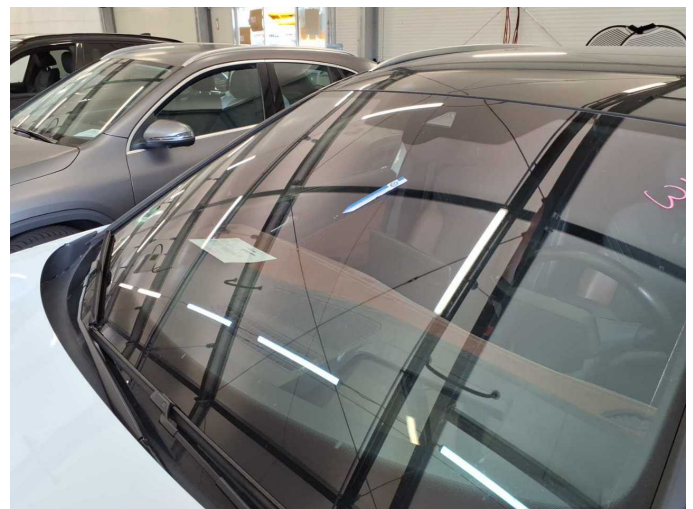
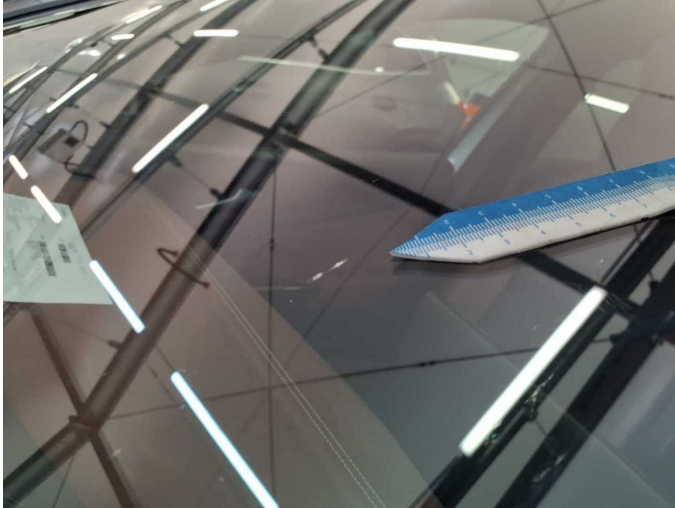
| No. | Component group | Description |
|---|---|---|
| 10 | Vehicle glazing | Windscreen (Größere Abplatzer im Fahrersichtfeld) - Stone chips - Replace |

**Damage 10:** Vehicle glazing: Windscreen (Größere Abplatzer im Fahrersichtfeld) - Stone chips - Replace
