Expertise

Protocol number: 46838950  
Order No. / Reference: 26601067  
Inspection date: 28 Jul 2026

Manufacturer: Mercedes-Benz

Model: GLC 300 e 4Matic 9G-TRONIC Avantgarde Advanced

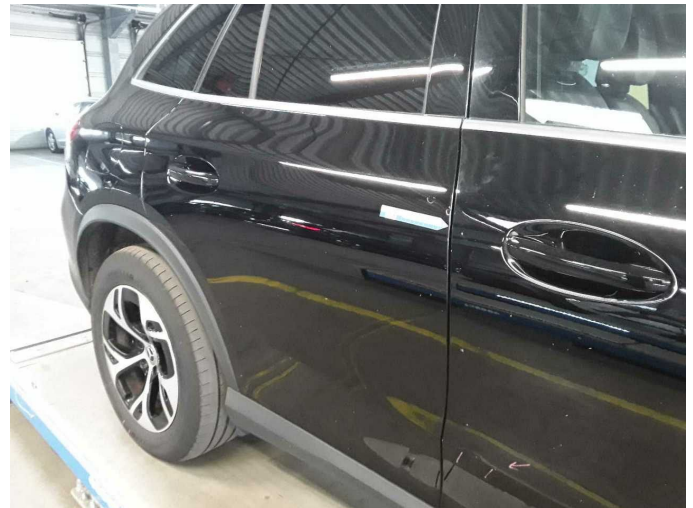
| No. | Component group | Description |
|---|---|---|
| 2 | Door - rear right side | Door - Scratch(es) - Smart repair |

**Damage 2:** Door - rear right side: Door - Scratch(es) - Smart repair

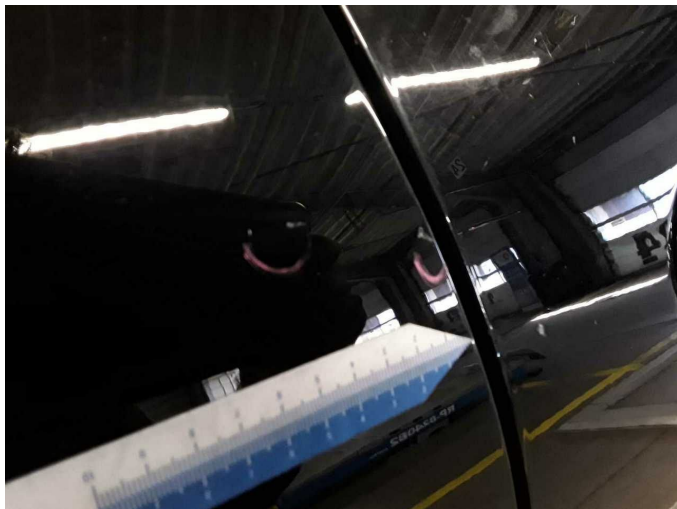
**Damage 2:** Door - rear right side: Door - Scratch(es) - Smart repair

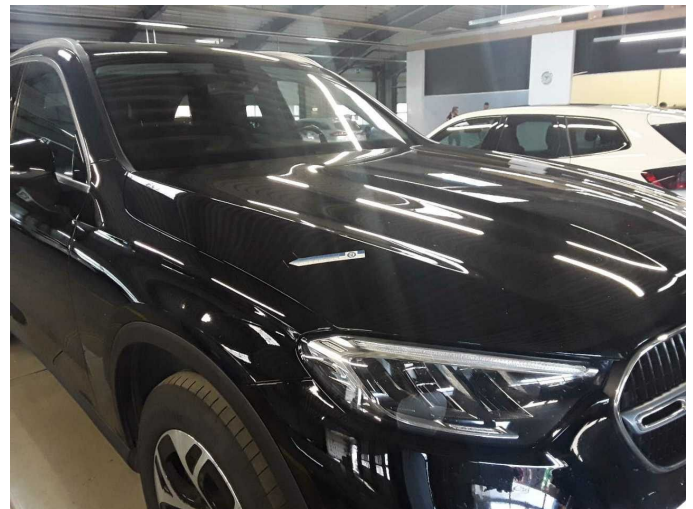
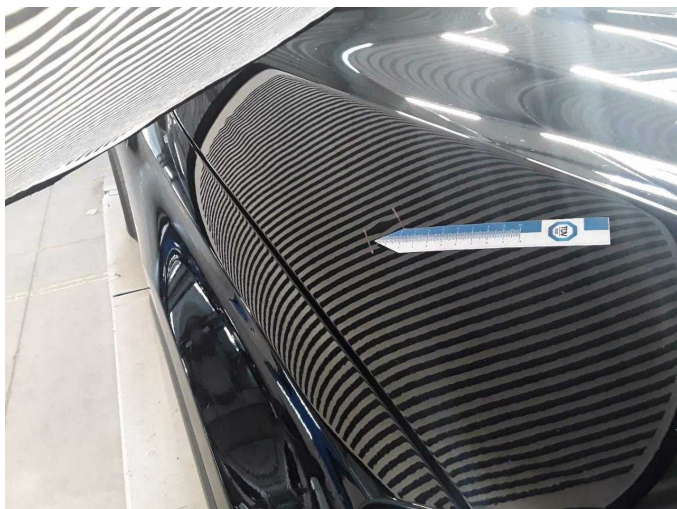
| No. | Component group | Description |
|---|---|---|
| 3 | Bonnet | Bonnet - dent(s) - Smooth repair work |

**Damage 3:** Bonnet: Bonnet - dent(s) - Smooth repair work

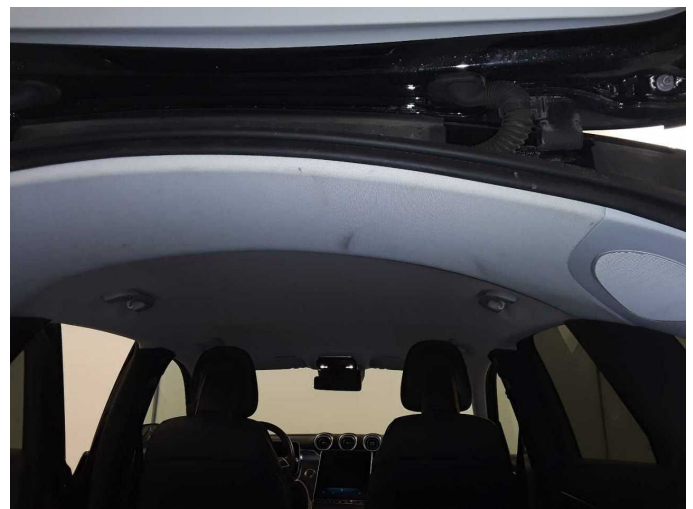
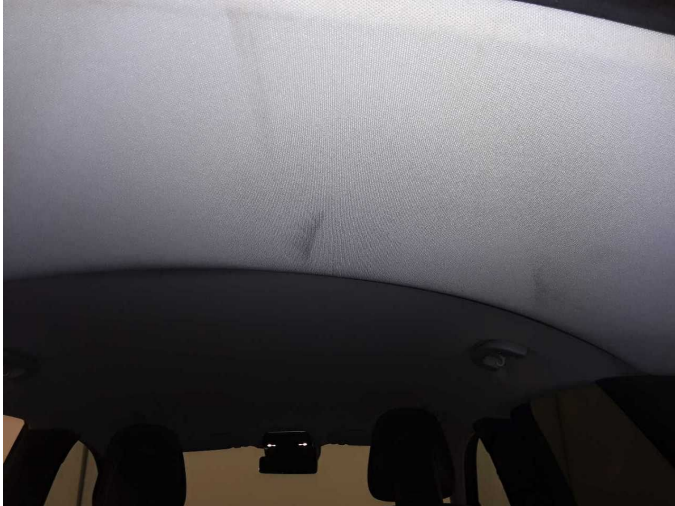
| No. | Component group | Description |
|---|---|---|
| 4 | Trim / covers | Roof lining - Soiled - Clean |

**Damage 4:** Trim / covers: Roof lining - Soiled - Clean

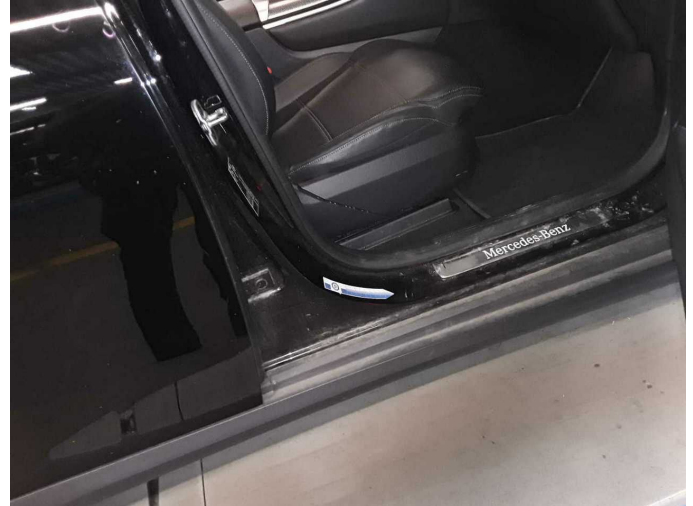
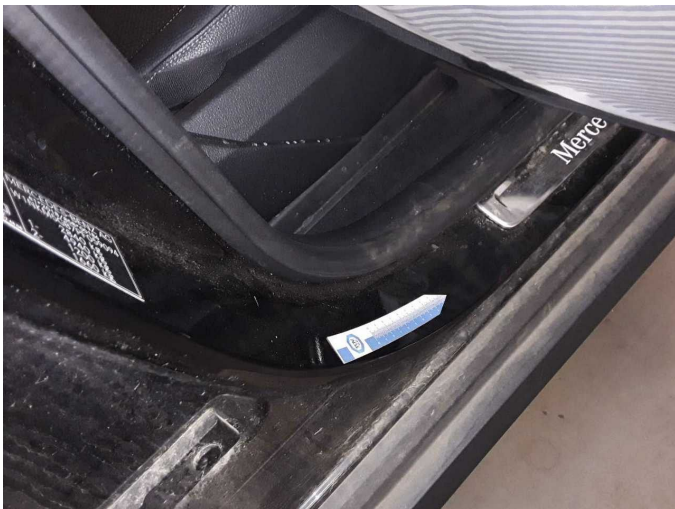
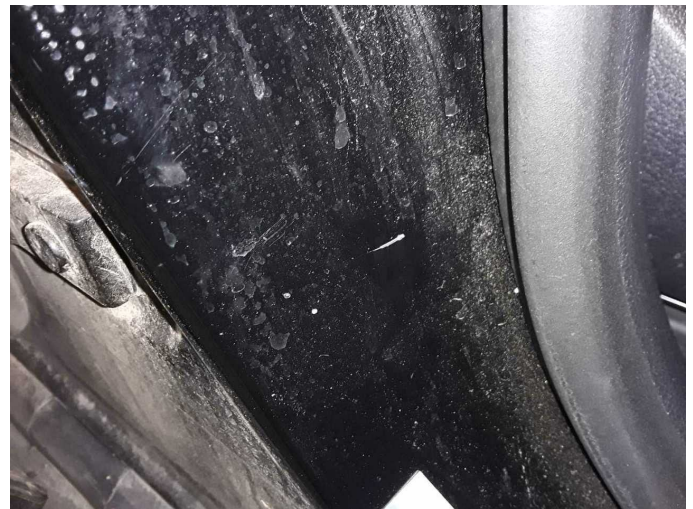
| No. | Component group | Description |
|---|---|---|
| 5 | Sill - right side | Sill - Dent / paintcoat damage - Smart repair |

**Damage 5:** Sill - right side: Sill - Dent / paintcoat damage - Smart repair

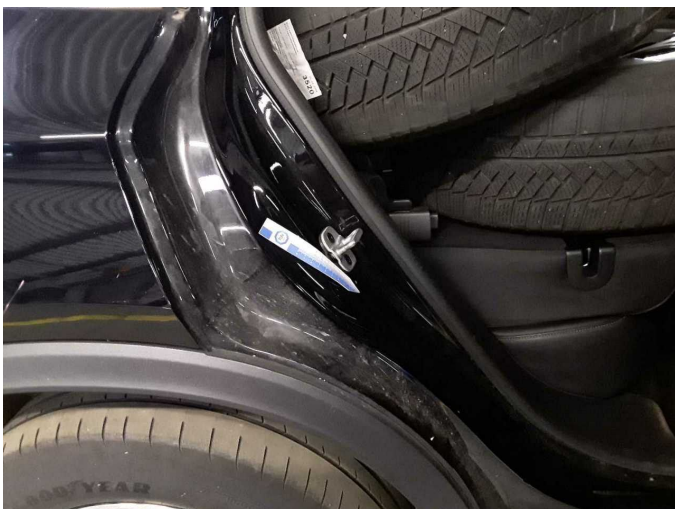
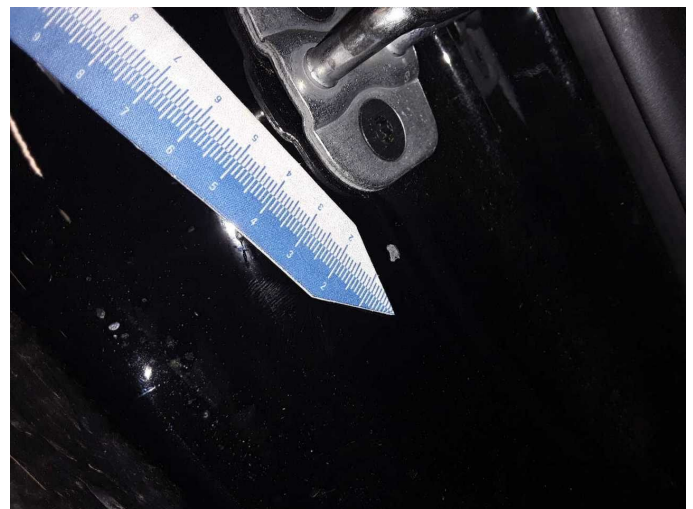
| No. | Component group | Description |
|---|---|---|
| 6 | Side panel - rear right side | Sill - Scratch(es) - Smart repair |

**Damage 6:** Side panel - rear right side: Sill - Scratch(es) - Smart repair

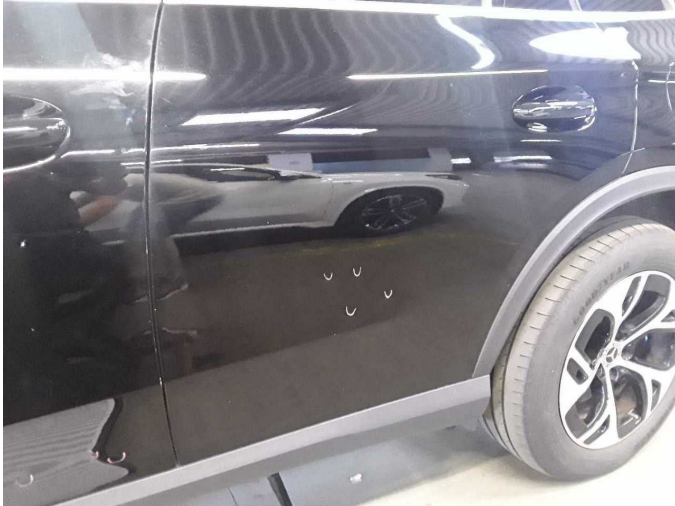
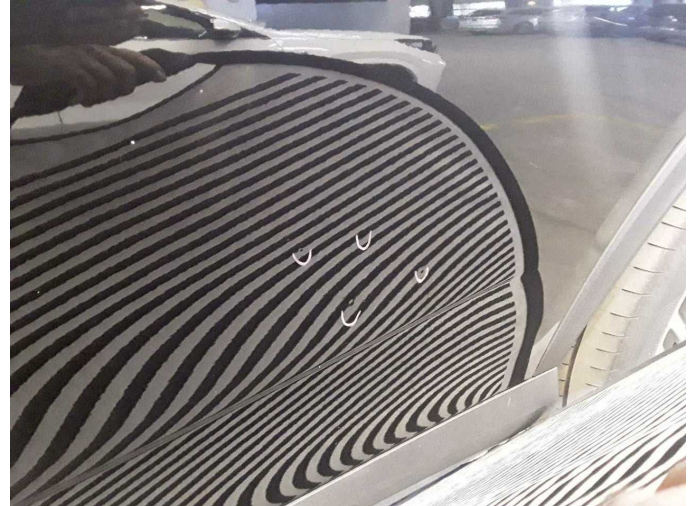
| No. | Component group | Description |
|---|---|---|
| 7 | Door - rear left side | Door (4x) - dent(s) - Smooth repair work |

**Damage 7:** Door - rear left side: Door (4x) - dent(s) - Smooth repair work

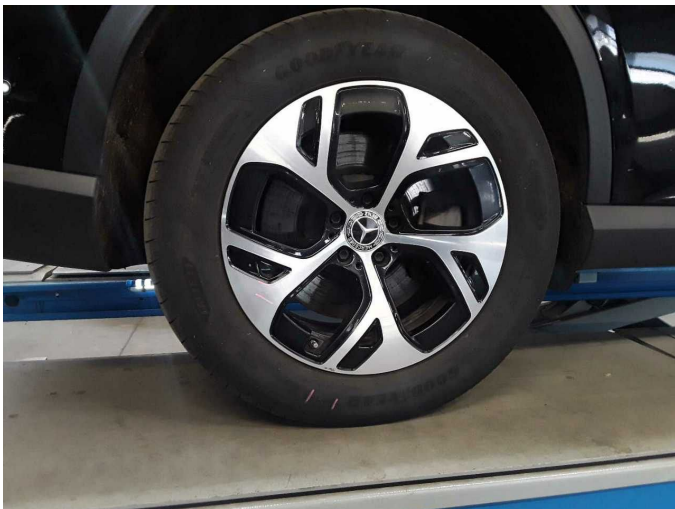
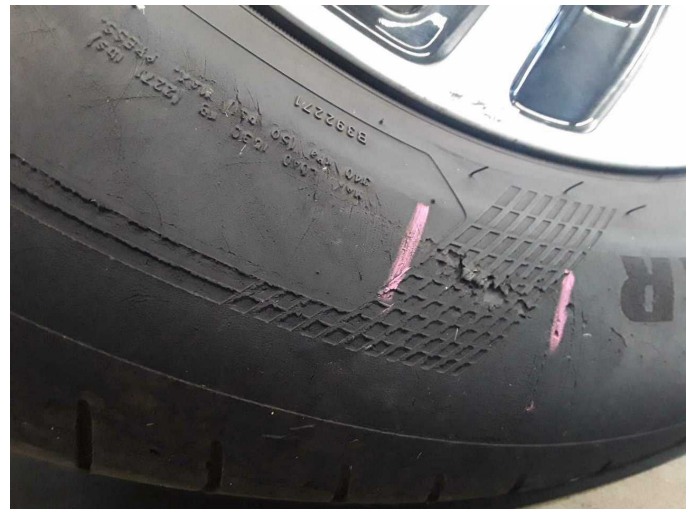
| No. | Component group | Description |
|---|---|---|
| 8 | Wheel / tyres | Tyre - rear right side (nicht fahrbereit) - Damaged - Replace |

**Damage 8:** Wheel / tyres: Tyre - rear right side (nicht fahrbereit) - Damaged - Replace

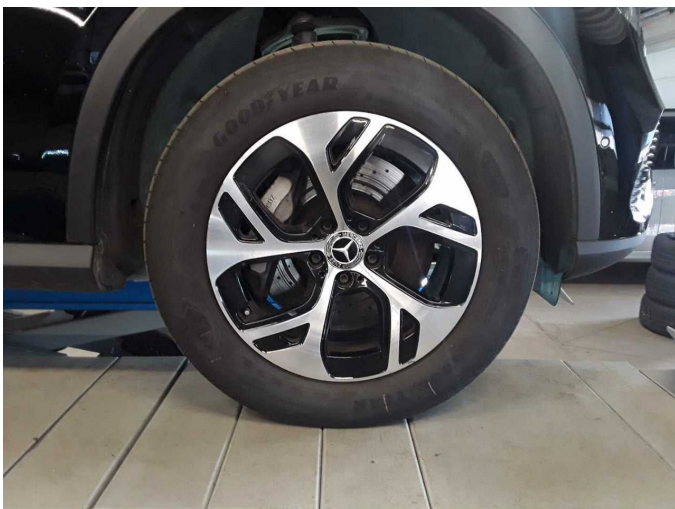
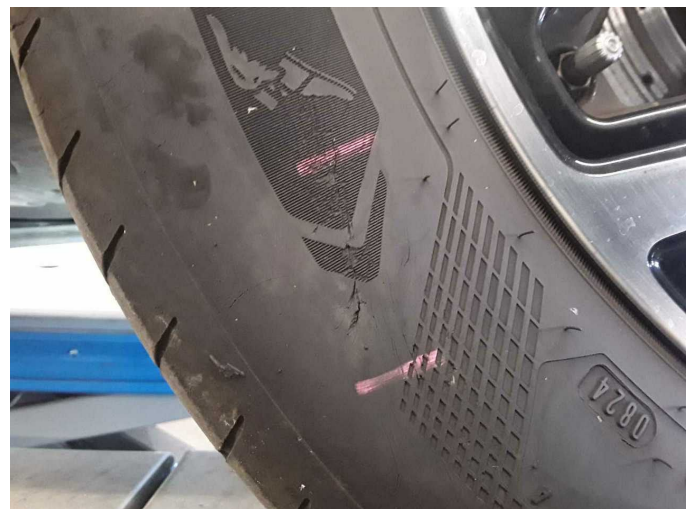
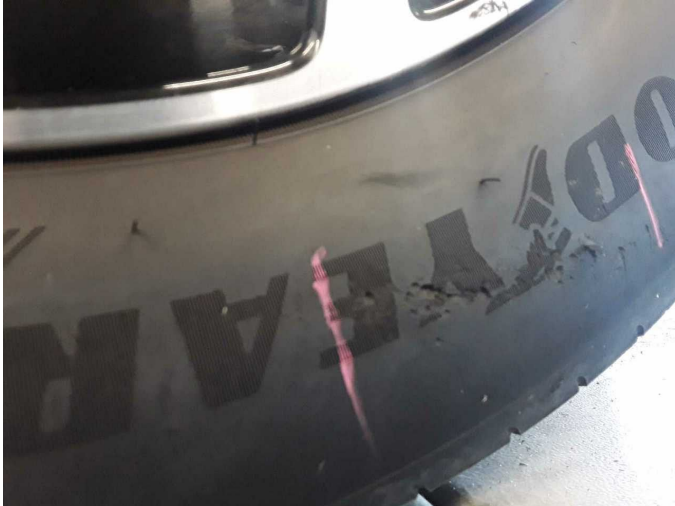
| No. | Component group | Description |
|---|---|---|
| 9 | Wheel / tyres | Tyre - front right side (nicht fahrbereit) - Damaged - Replace |

**Damage 9:** Wheel / tyres: Tyre - front right side (nicht fahrbereit) - Damaged - Replace

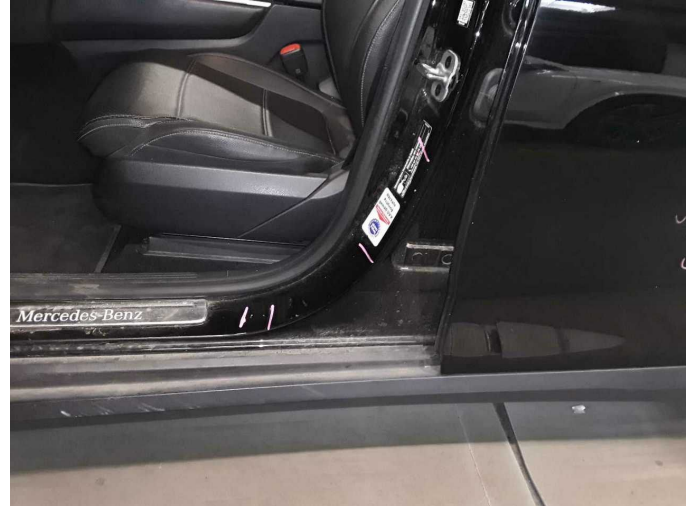
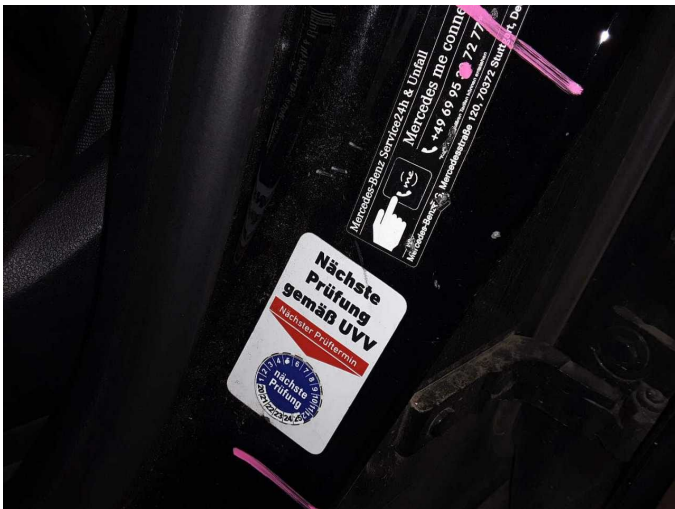
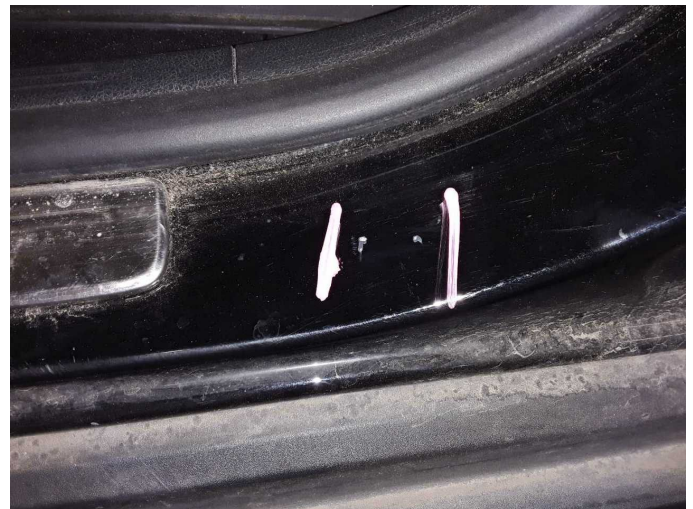
| No. | Component group | Description |
|---|---|---|
| 10 | Sill - left side | Sill (+ Aufkleber) - Dent / paintcoat damage - Smart repair |

**Damage 10:** Sill - left side: Sill (+ Aufkleber) - Dent / paintcoat damage - Smart repair

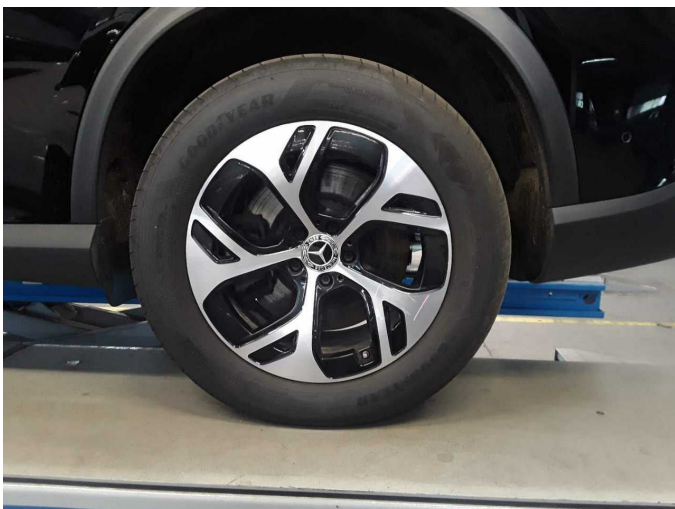
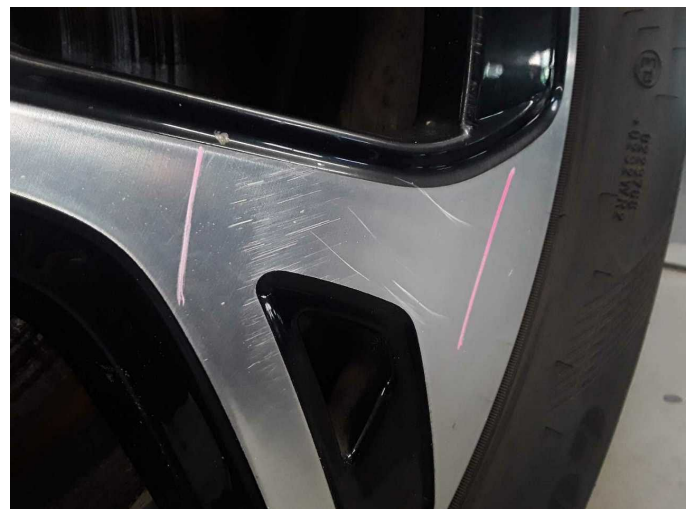
| No. | Component group | Description |
|---|---|---|
| 11 | Wheel / tyres | Alloy rim - rear left side - Scratch(es) - Loss in value |

**Damage 11:** Wheel / tyres: Alloy rim - rear left side - Scratch(es) - Loss in value

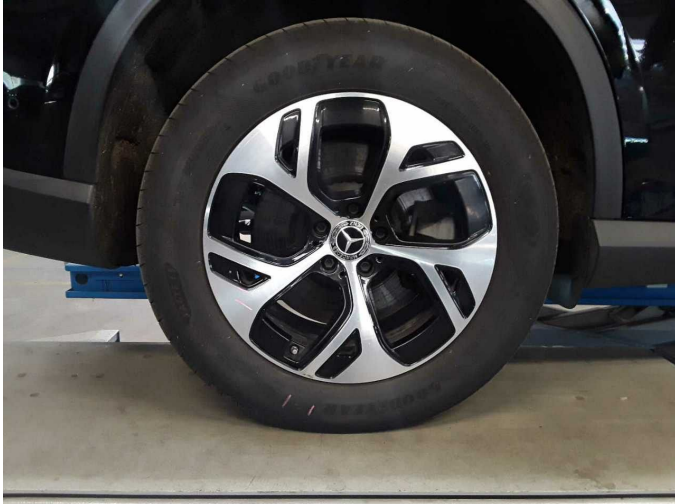
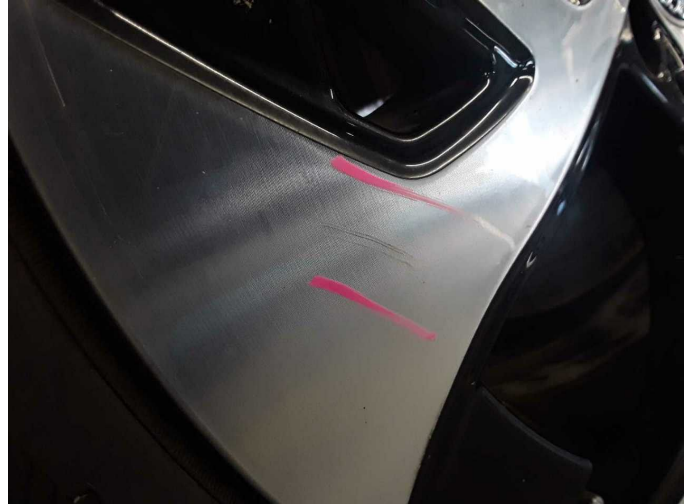
| No. | Component group | Description |
|---|---|---|
| 12 | Wheel / tyres | Alloy rim - rear right side - Scratch(es) - Loss in value |

**Damage 12:** Wheel / tyres: Alloy rim - rear right side - Scratch(es) - Loss in value

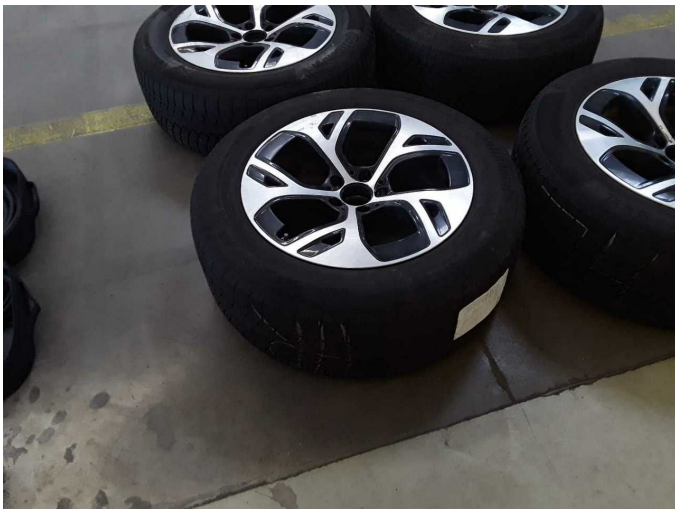
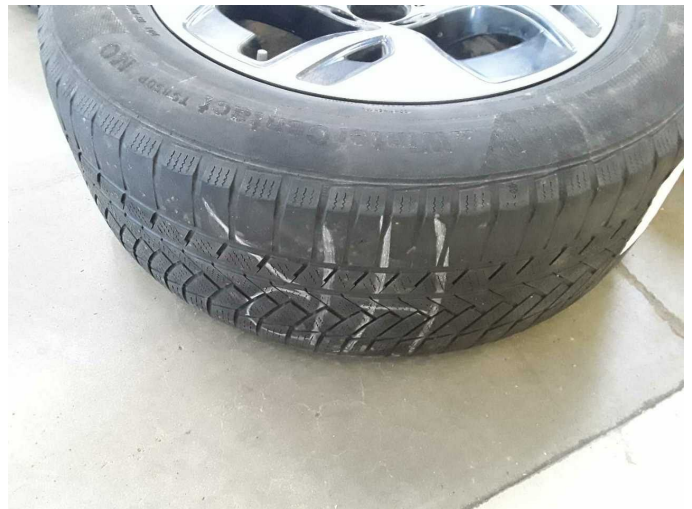
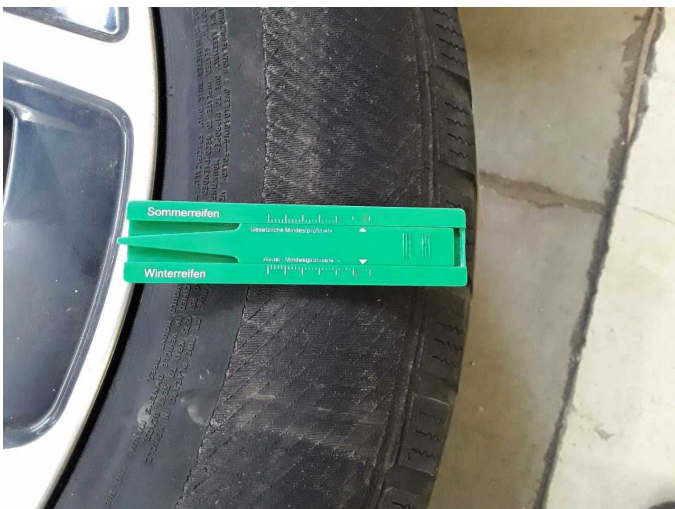
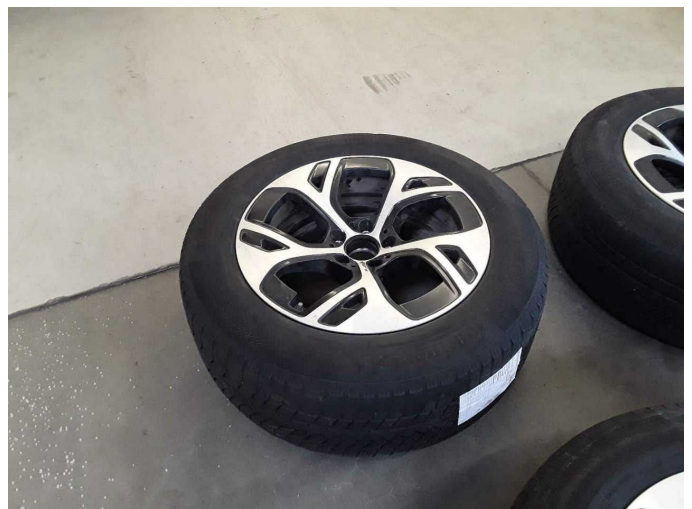
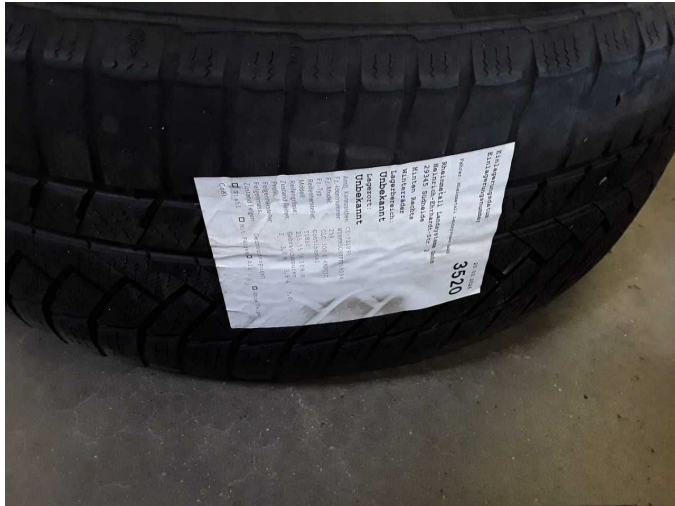
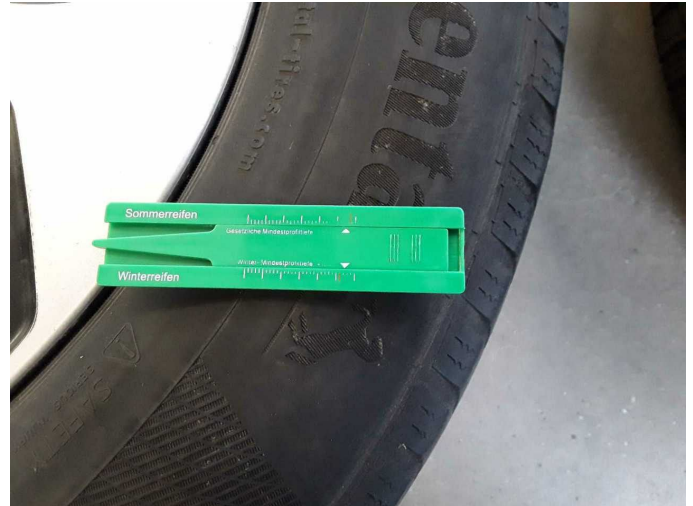
| No. | Component group | Description |
|---|---|---|
| 13 | 2nd wheel set | 2 tyres (3mm) - Does not meet the leasing specifications - Replace |

**Damage 13:** 2nd wheel set: 2 tyres (3mm) - Does not meet the leasing specifications - Replace

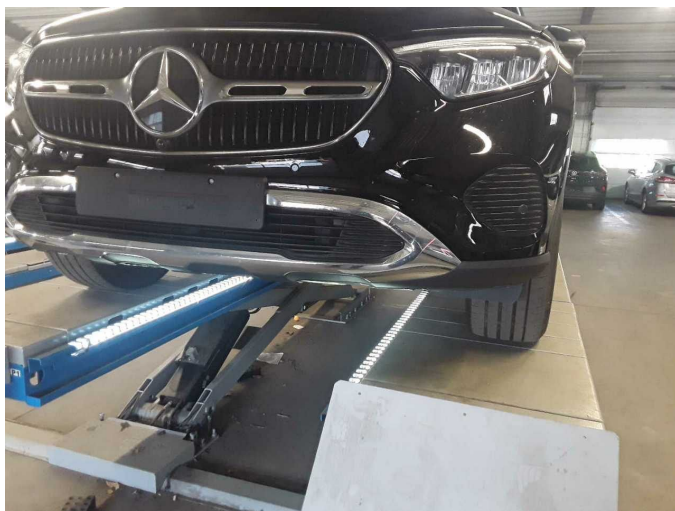
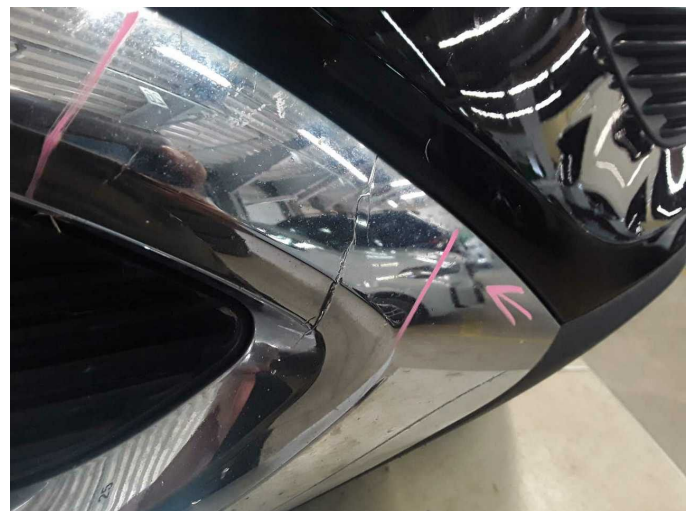
| No. | Component group | Description |
|---|---|---|
| 14 | Front bumper | Cover bumper - front - Damaged - Replace |

**Damage 14:** Front bumper: Cover bumper - front - Damaged - Replace

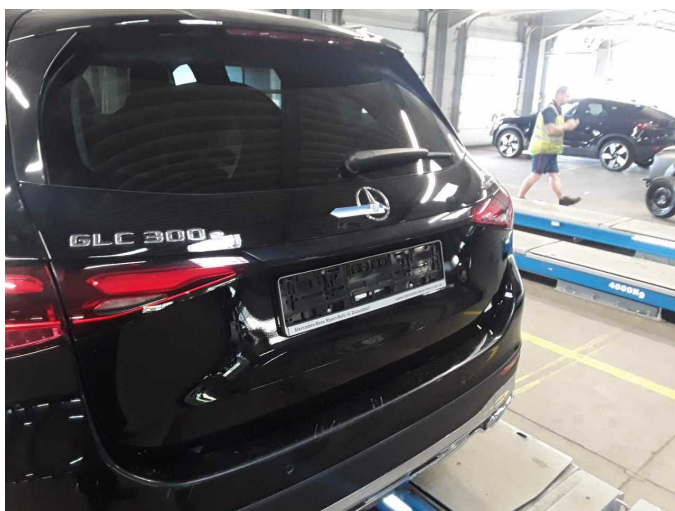
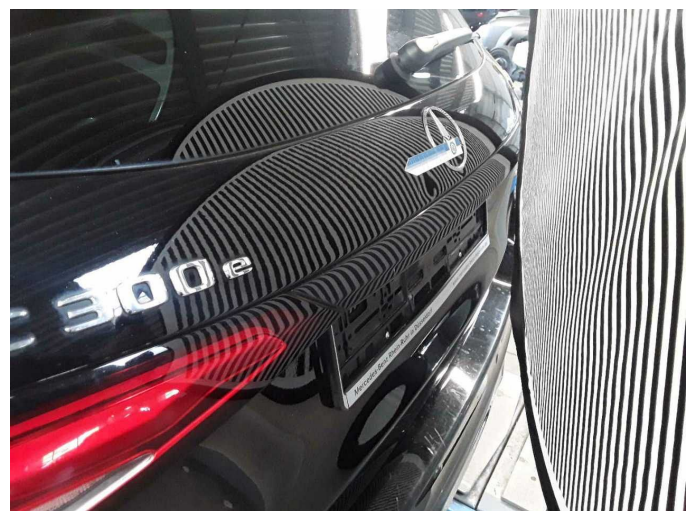
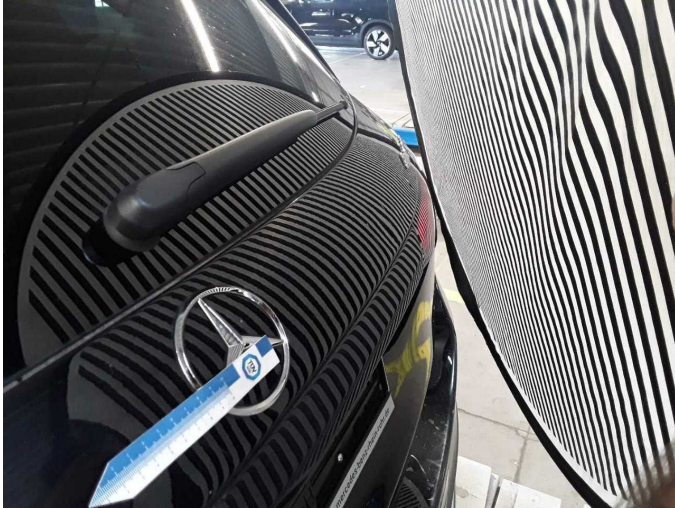
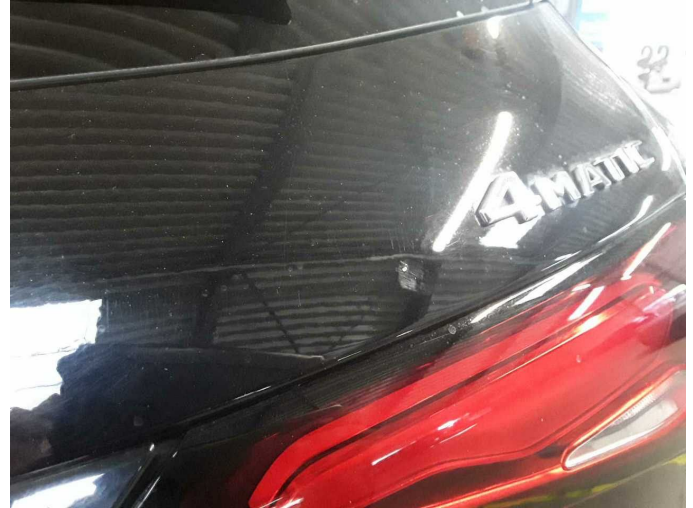
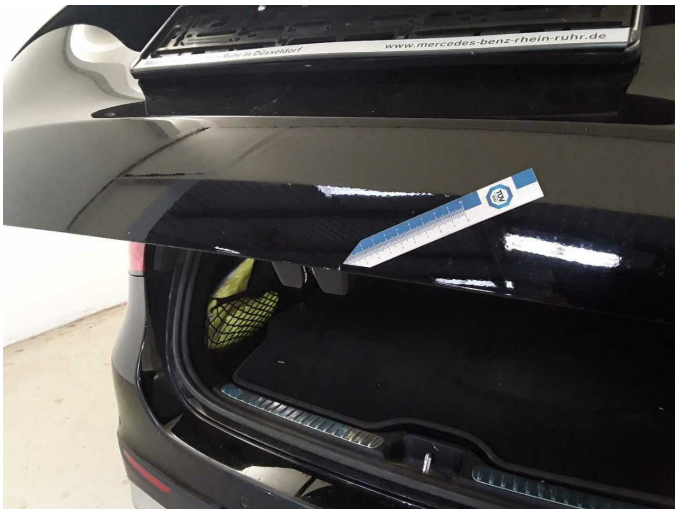
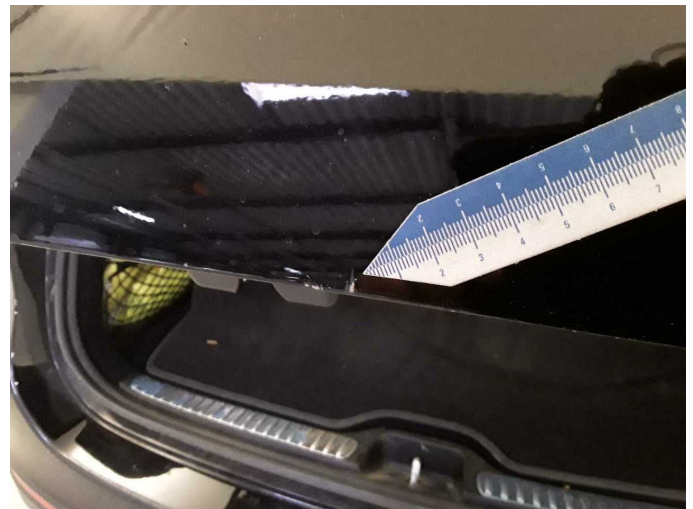
| No. | Component group | Description |
|---|---|---|
| 15 | Boot lid / rear door | Boot lid - Dent / paintcoat damage - Repair and paint |

**Damage 15:** Boot lid / rear door: Boot lid - Dent / paintcoat damage - Repair and paint

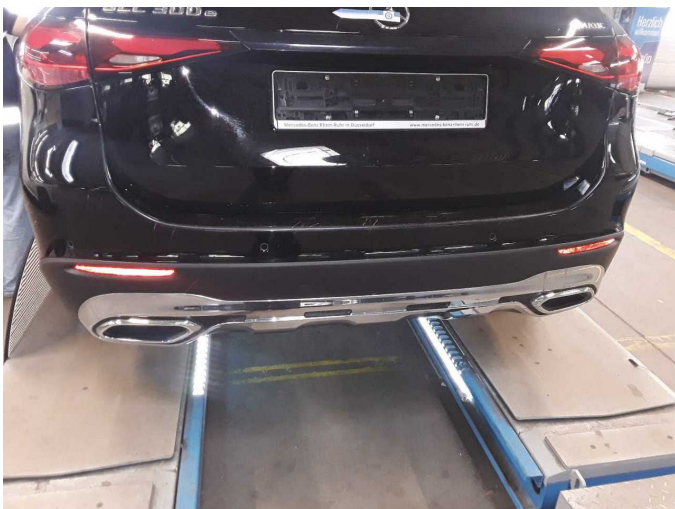
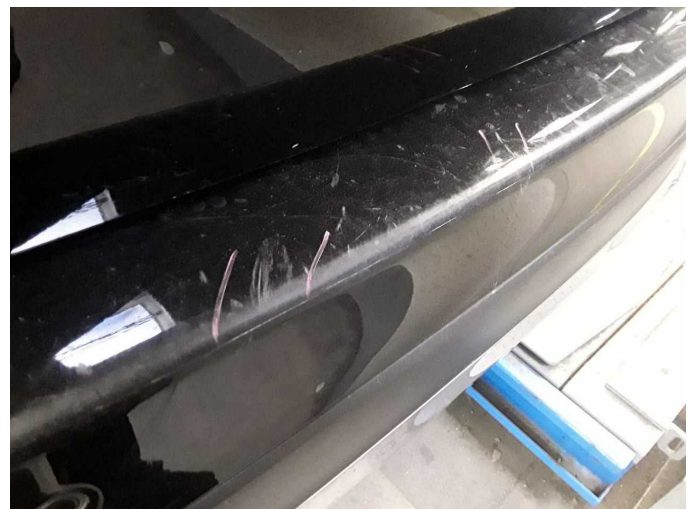
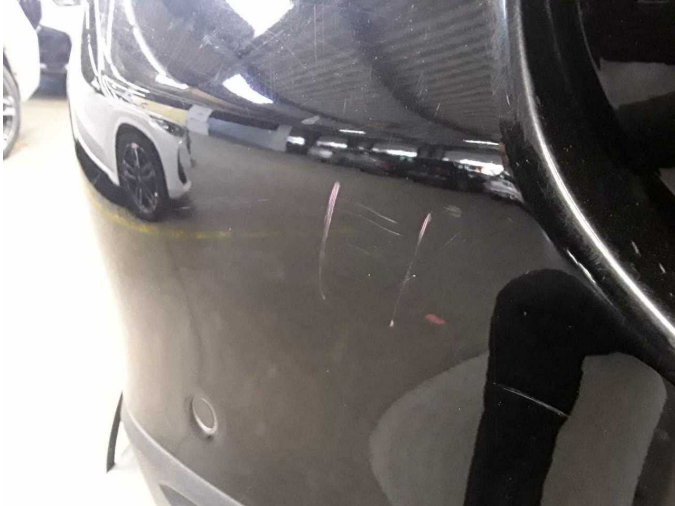
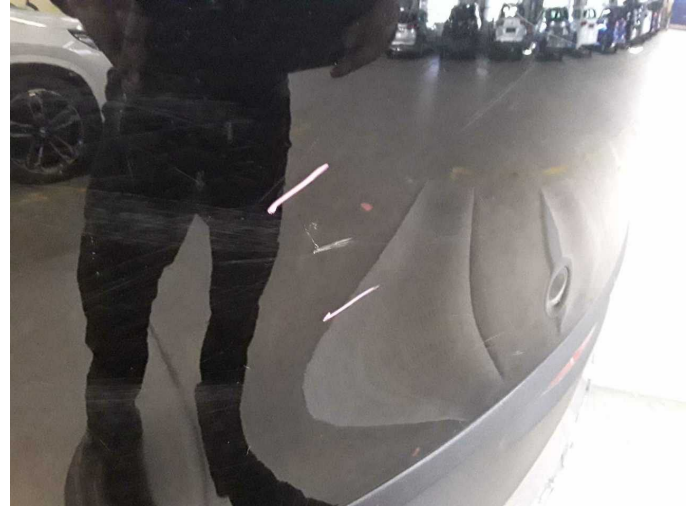
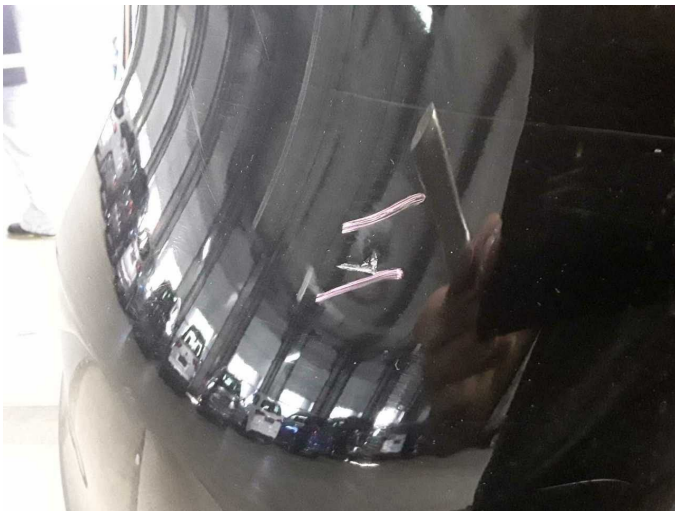
| No. | Component group | Description |
|---|---|---|
| 16 | Rear bumper | Rear bumper - Scratch(es) - Paint |

**Damage 16:** Rear bumper: Rear bumper - Scratch(es) - Paint

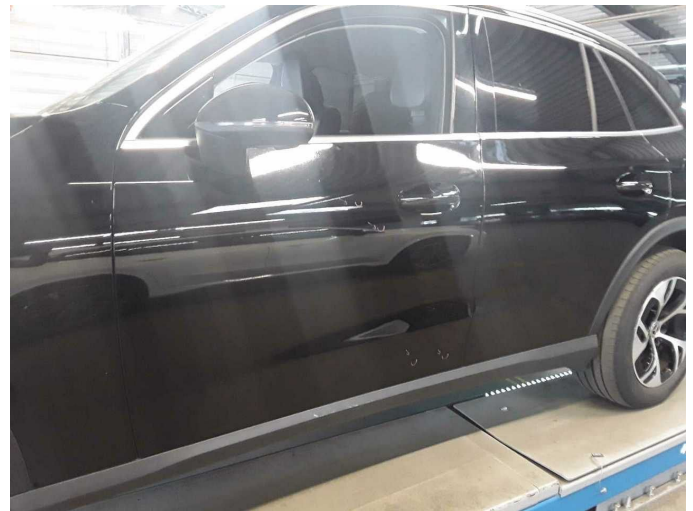
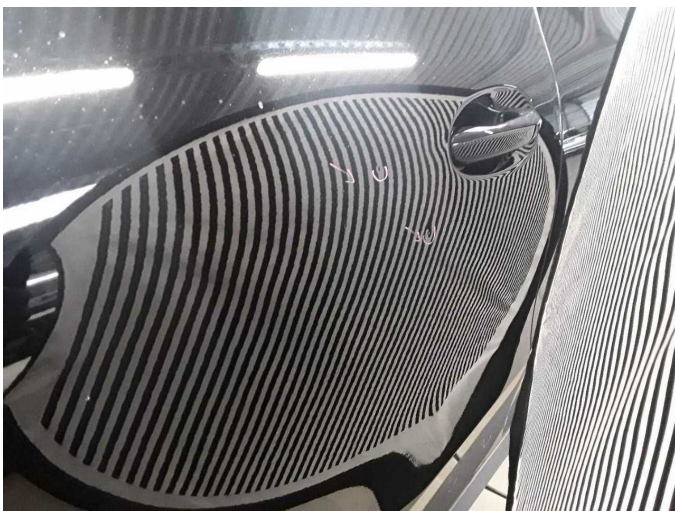
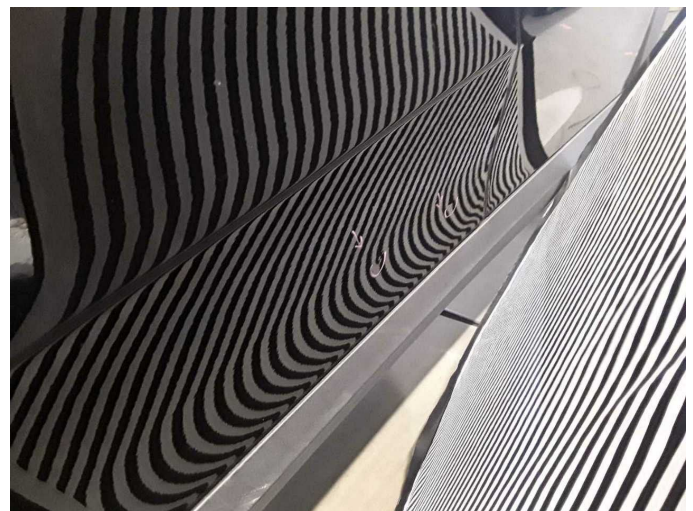
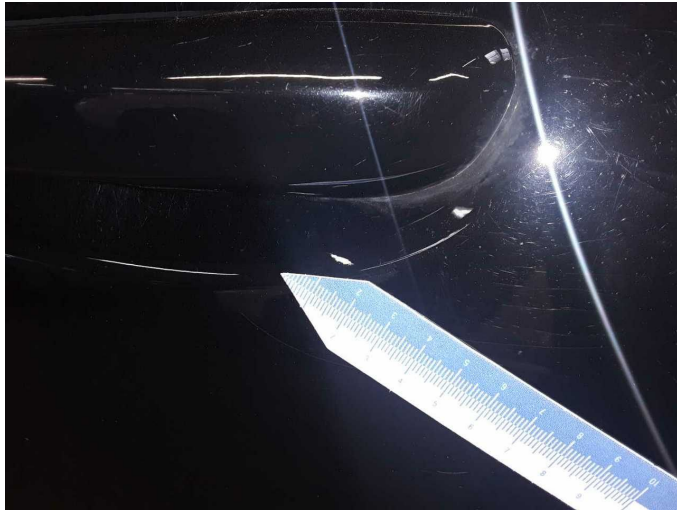
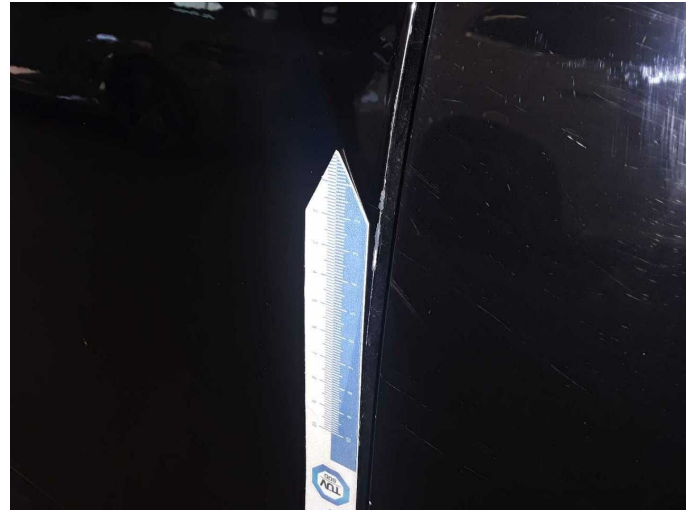
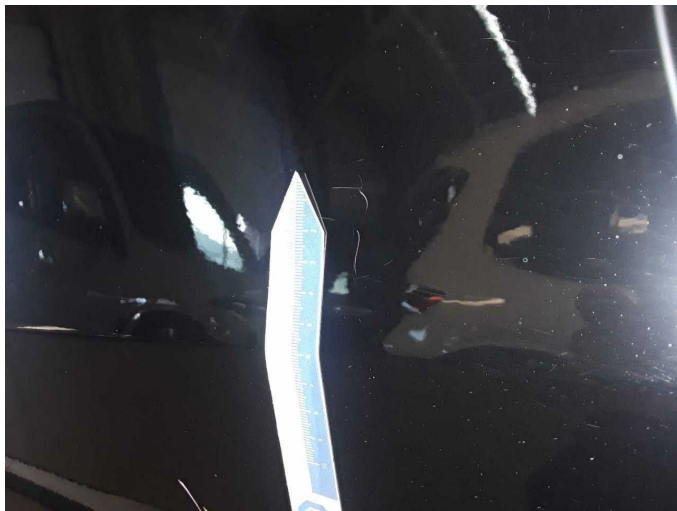
| No. | Component group | Description |
|---|---|---|
| 17 | Door - front left side | Door (4x) - Dent / paintcoat damage - Repair and paint |

**Damage 17:** Door - front left side: Door (4x) - Dent / paintcoat damage - Repair and paint

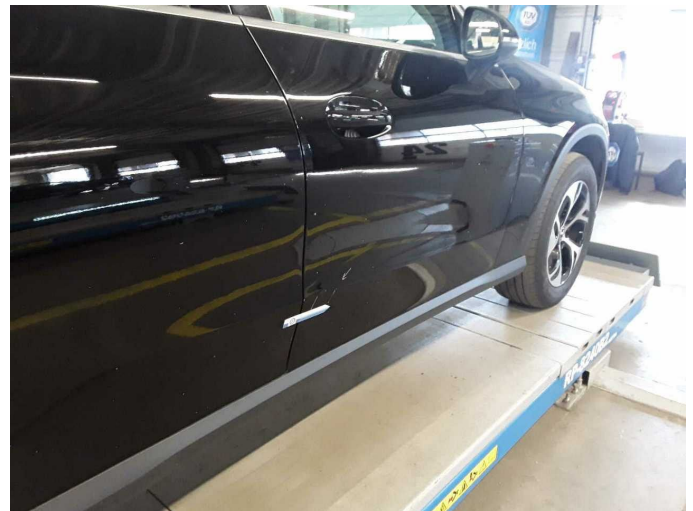
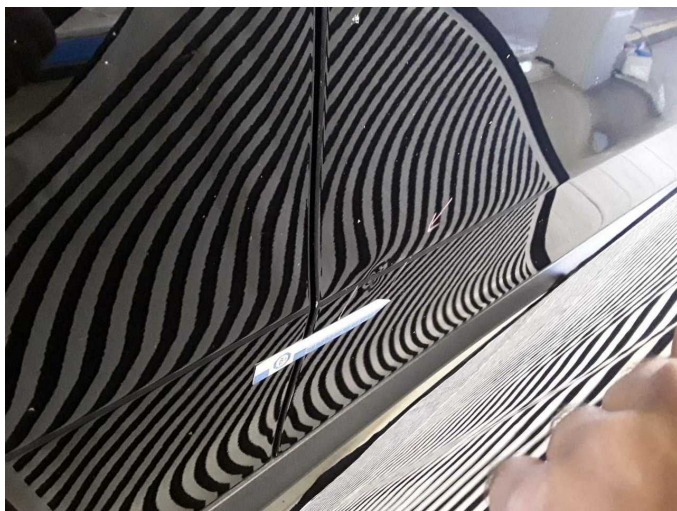
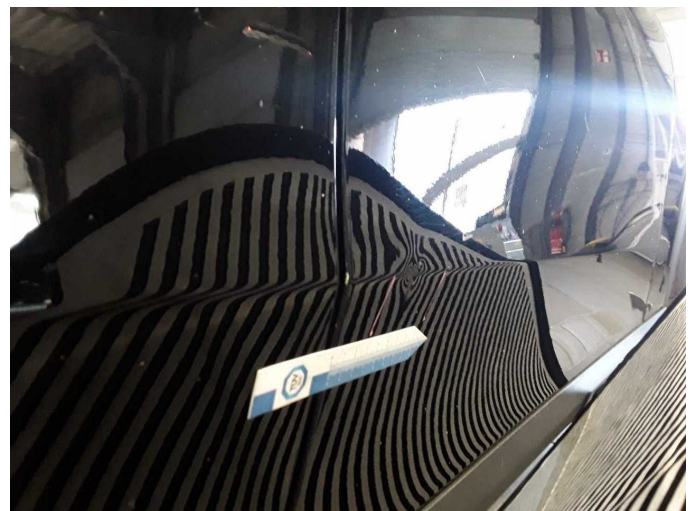
| No. | Component group | Description |
|---|---|---|
| 18 | Door - front right side | Door - Dent / paintcoat damage - Repair and paint |

**Damage 18:** Door - front right side: Door - Dent / paintcoat damage - Repair and paint

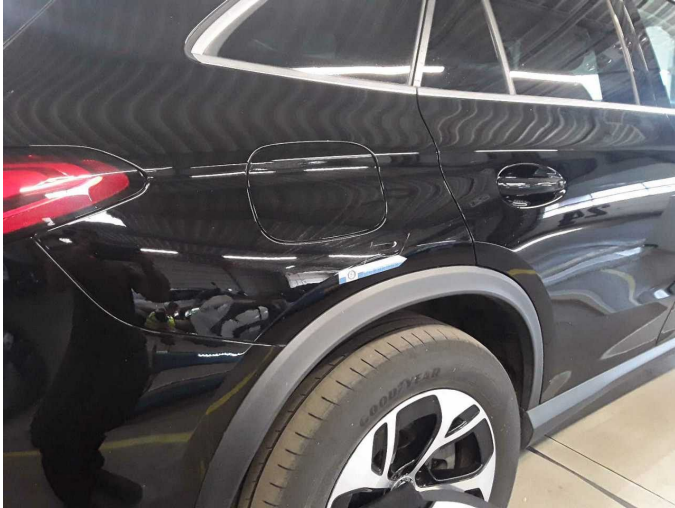
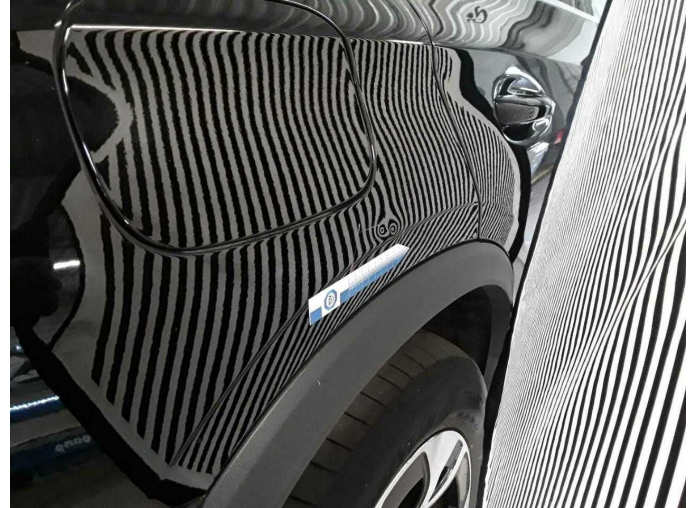
| No. | Component group | Description |
|---|---|---|
| 19 | Side panel - rear left side | Side panel - Dent / paintcoat damage - Repair and paint |

**Damage 19:** Side panel - rear left side: Side panel - Dent / paintcoat damage - Repair and paint
