Expertise

Protocol number: 46103055
Order No. / Reference: 26546880
Inspection date: 23 Jun 2026

Manufacturer: MAN

Model: TGE 3.140 4X2F SB

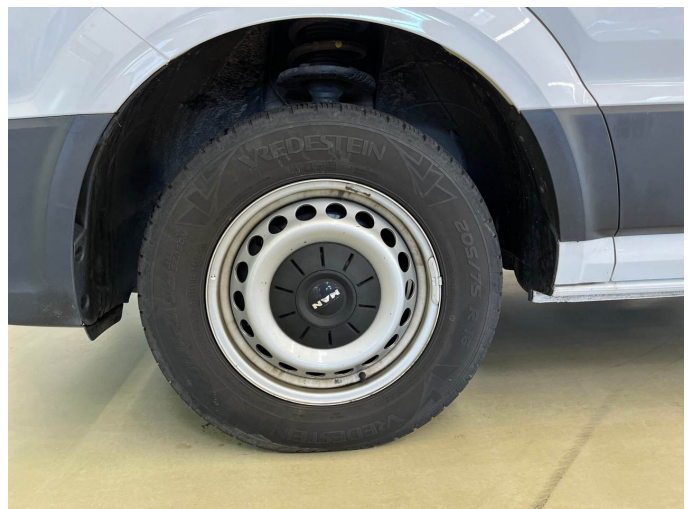
Figure 12: Mounted tyres

#	Tyre size	Type of tyre	Manufacturer	Tread depth
1)	205/75 R16 113R	All-season tyres on Steel rim with wheel cover	Vredestein	4mm / 4mm
2)	205/75 R16 113R	All-season tyres on Steel rim with wheel cover	Continental	6mm / 6mm

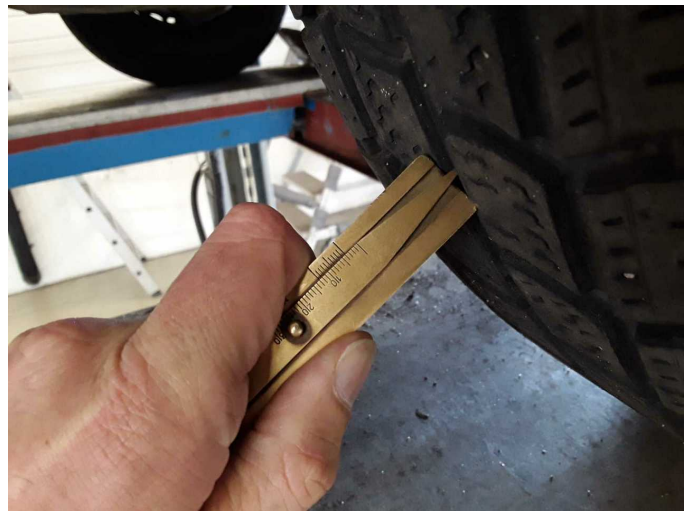
Damage 1: Wheel / tyres: Tyre - front - Does not meet the leasing specifications - Replace

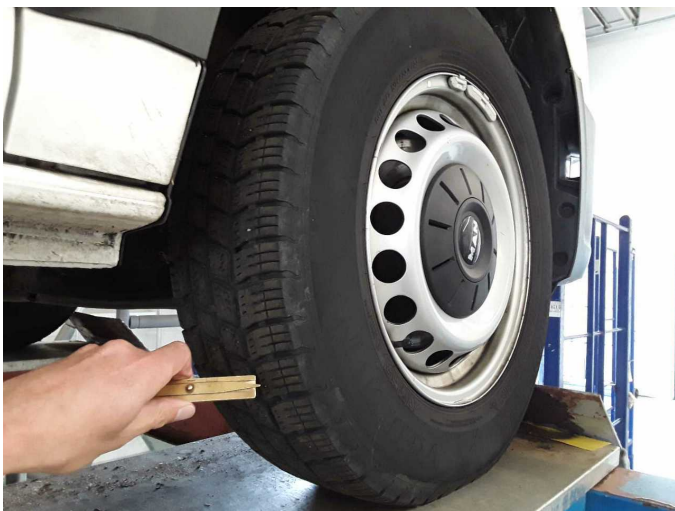
Damage 1: Wheel / tyres: Tyre - front - Does not meet the leasing specifications - Replace

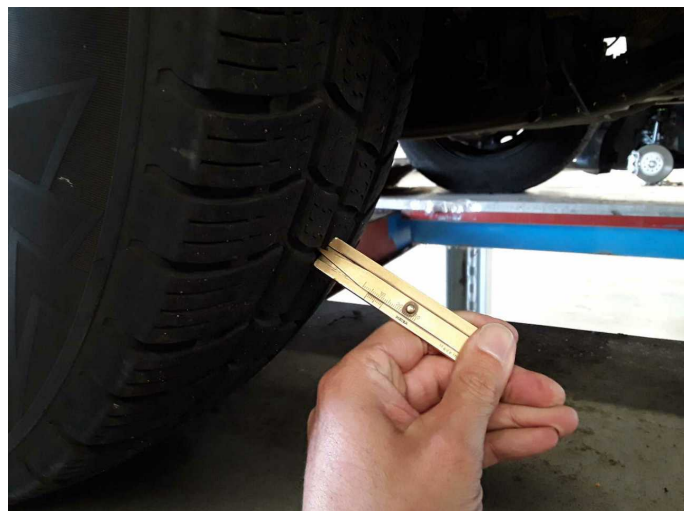
Damage 1: Wheel / tyres: Tyre - front - Does not meet the leasing specifications - Replace

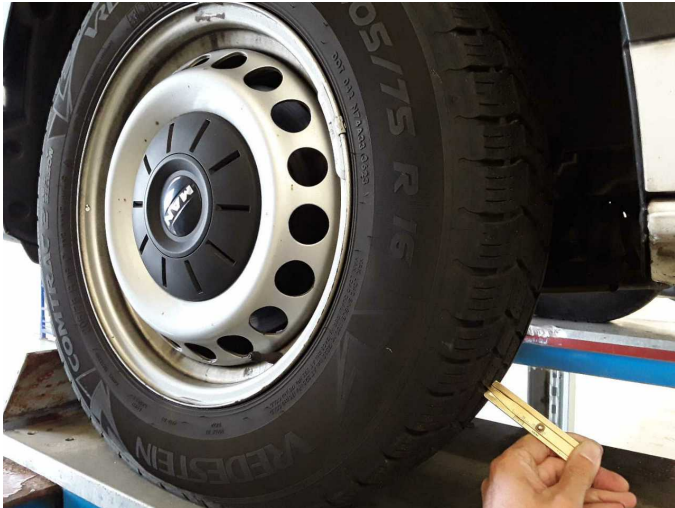
Damage 1: Wheel / tyres: Tyre - front - Does not meet the leasing specifications - Replace

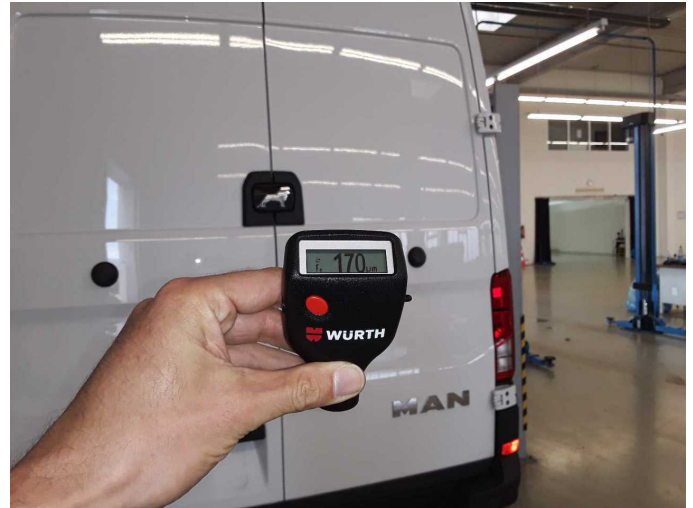
No.	Repainting
1	Boot lid / rear door, Side panel - rear right side, Door - front left side, Professionally carried out

Boot lid / rear door: 170 µm

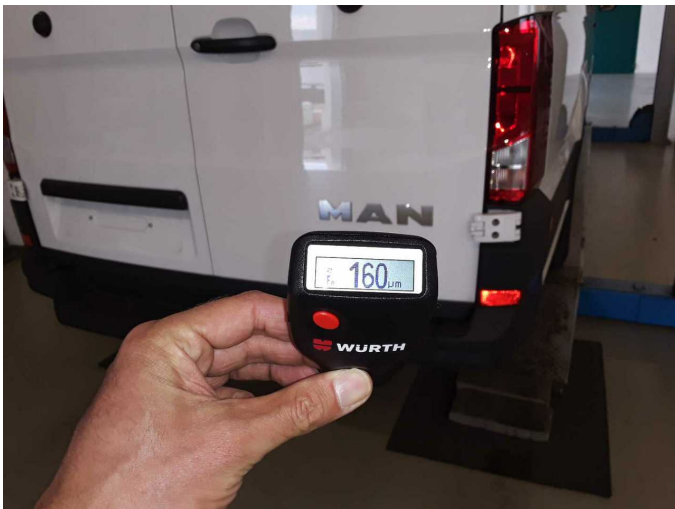
Boot lid / rear door: 170 µm

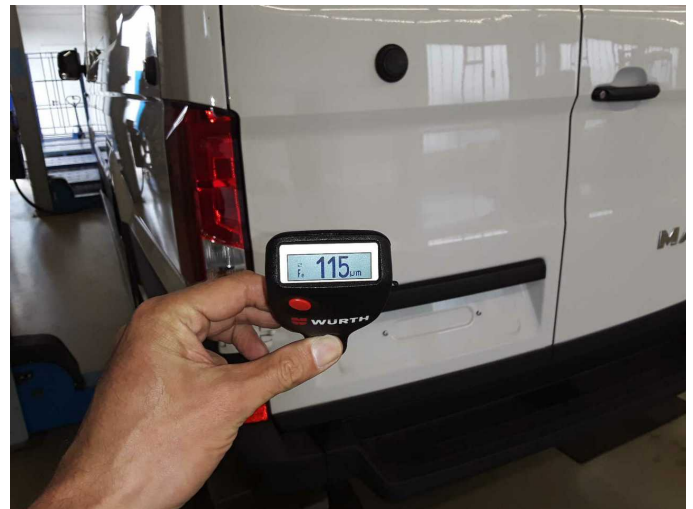
Boot lid / rear door: 170 µm

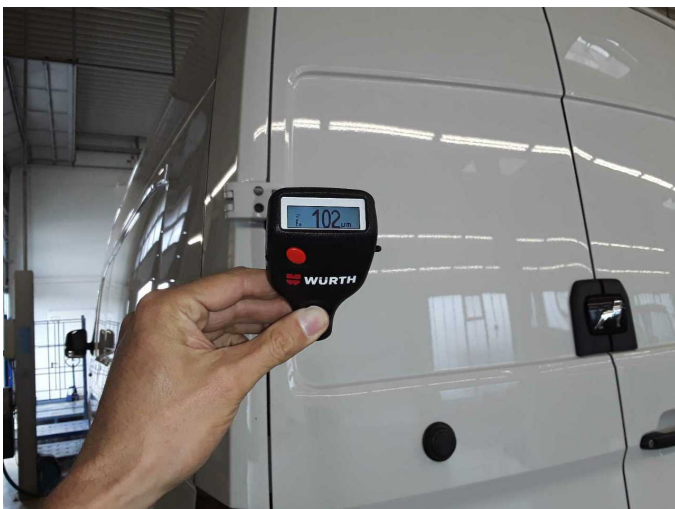
Boot lid / rear door: 170 µm

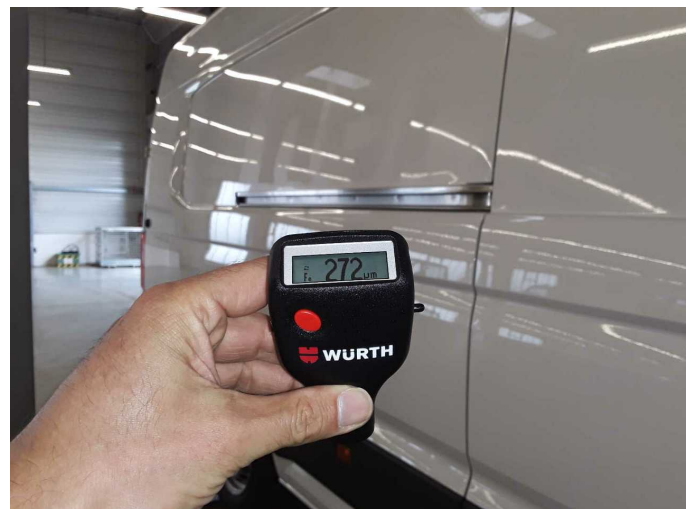
Side panel - rear right side: 272 µm

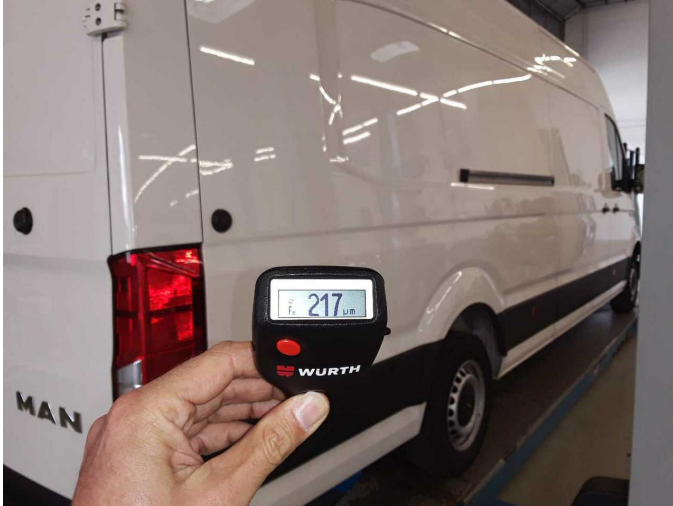
Side panel - rear right side: 272 µm

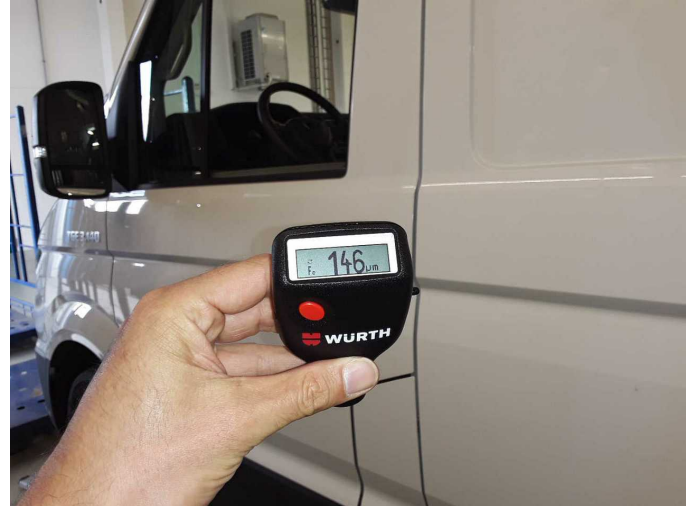
Door - front left side: 146 µm

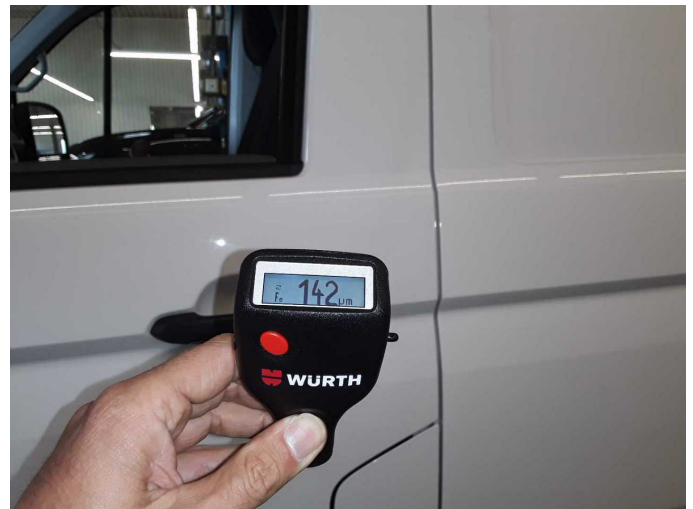
Door - front left side: 146 µm
