Expertise

Protocol number: 46499545  
Order No. / Reference: 26294464  
Inspection date: 10 Jul 2026

Manufacturer: Mercedes-Benz

Model: Vito 116 CDI Lang HA Aut. PRO

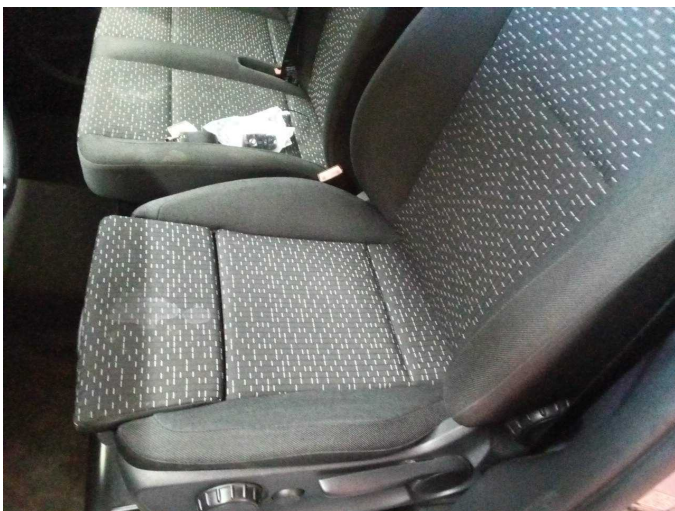
| No. | Component group | Description |
|---|---|---|
| 1 | Seat - front | Seat cover - left side (Verschmutzt) - Clean |

Damage 1: Seat - front: Seat cover - left side (Verschmutzt) - Clean

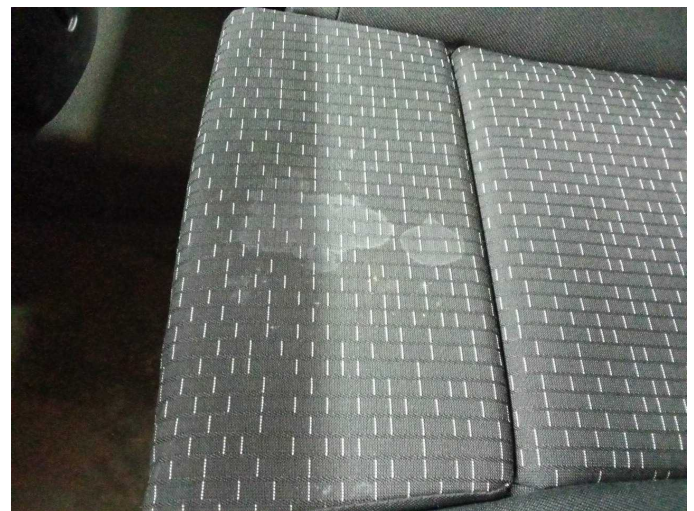
Damage 1: Seat - front: Seat cover - left side (Verschmutzt) - Clean

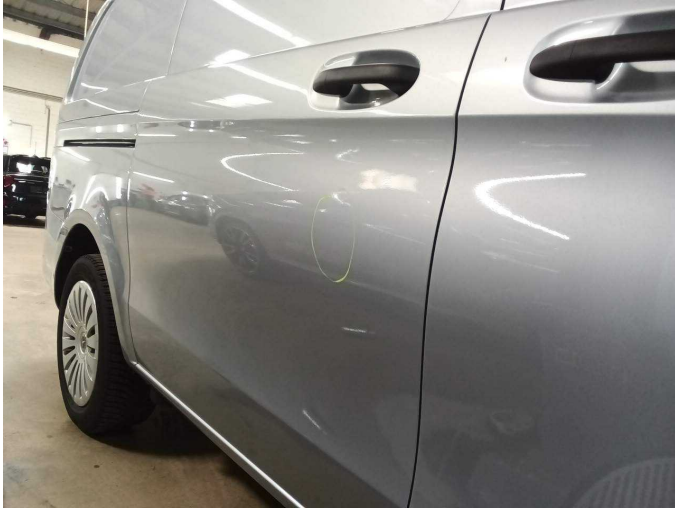
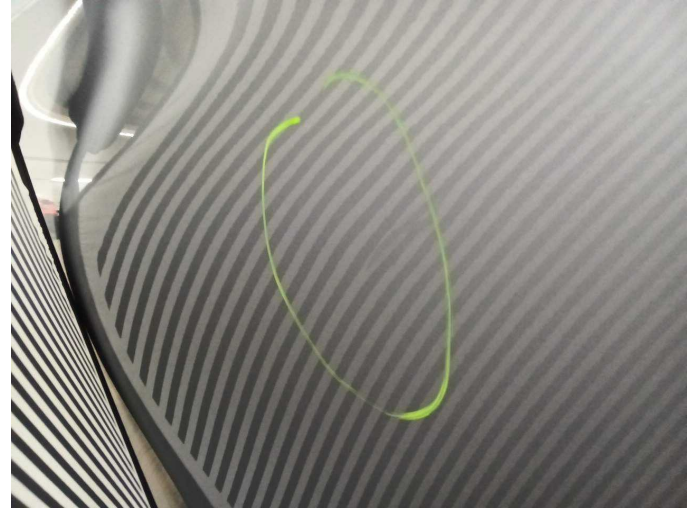
| No. | Component group | Description |
|---|---|---|
| 2 | Sliding door, right | Sliding door - dent(s) - Smooth repair work |

**Damage 2:** Sliding door, right: Sliding door - dent(s) - Smooth repair work

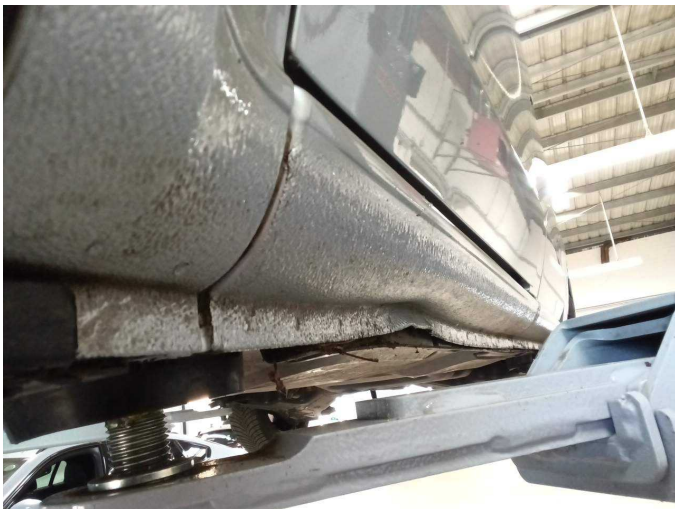
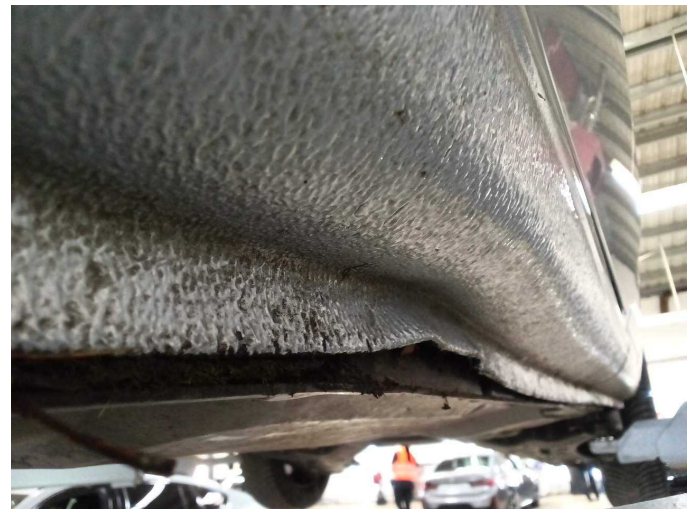
| No. | Component group | Description |
|---|---|---|
| 3 | Sill - left side | Sill - Deformed - Repair and paint |

**Damage 3:** Sill - left side: Sill - Deformed - Repair and paint

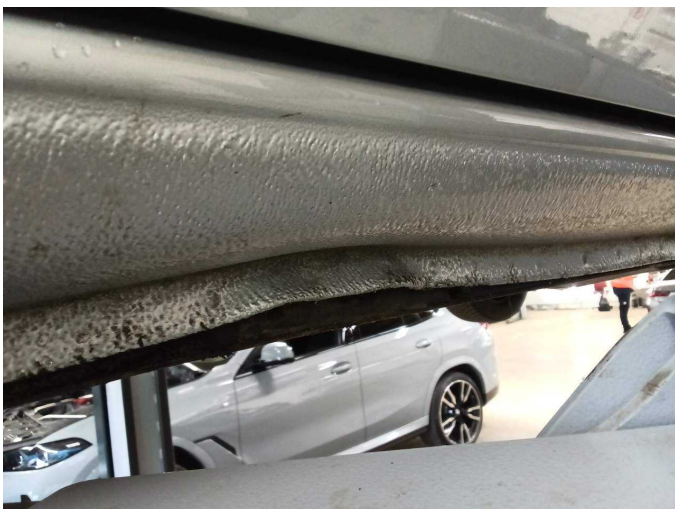
**Damage 3:** Sill - left side: Sill - Deformed - Repair and paint

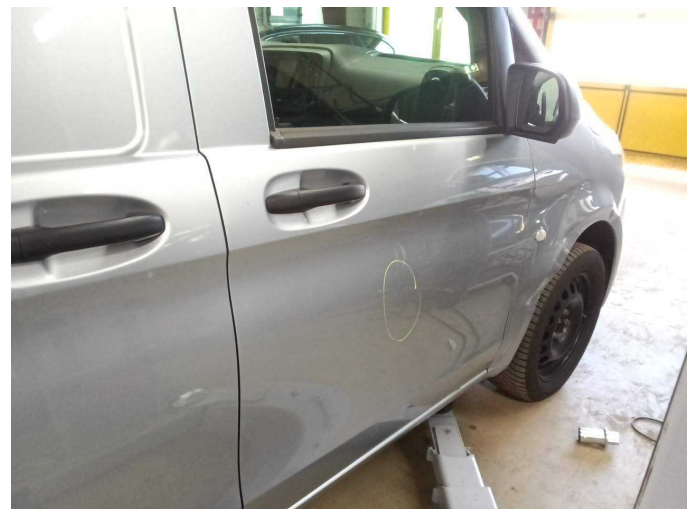
| No. | Component group | Description |
|---|---|---|
| 4 | Door - front right side | Door - Dent / paintcoat damage - Repair and paint |

**Damage 4:** Door - front right side: Door - Dent / paintcoat damage - Repair and paint

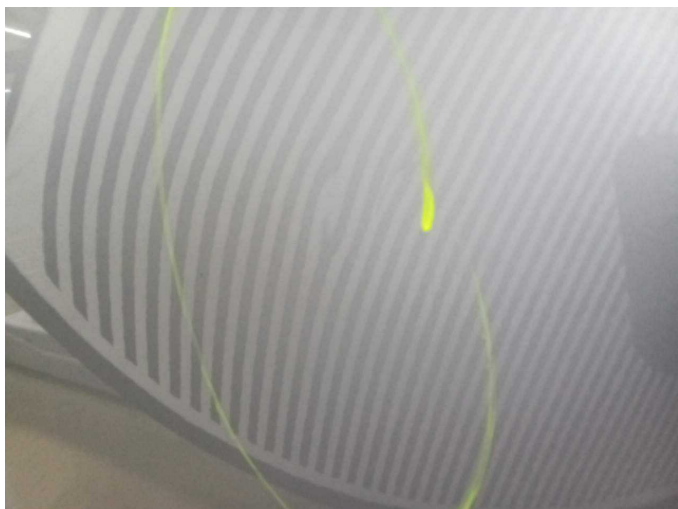
**Damage 4:** Door - front right side: Door - Dent / paintcoat damage - Repair and paint

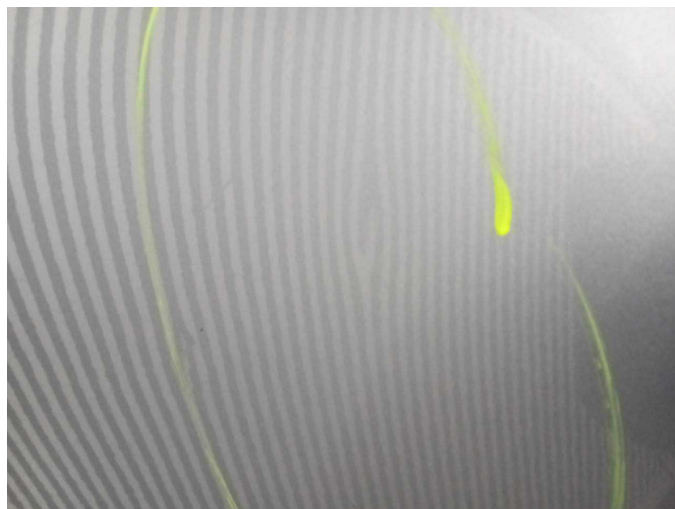
**Damage 4:** Door - front right side: Door - Dent / paintcoat damage - Repair and paint

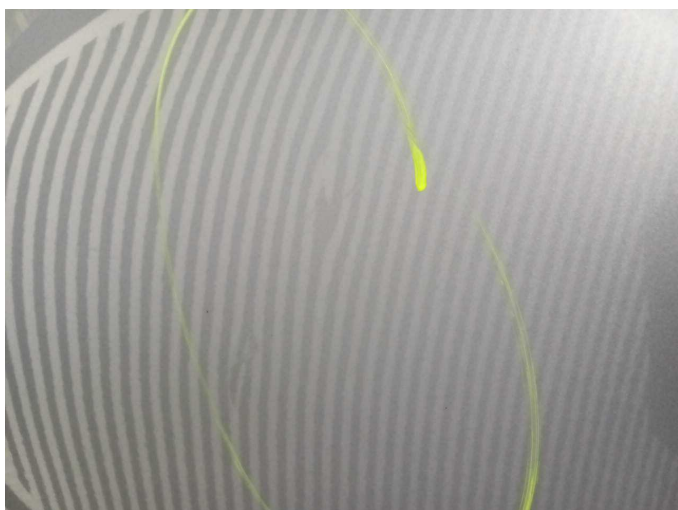
**Damage 4:** Door - front right side: Door - Dent / paintcoat damage - Repair and paint

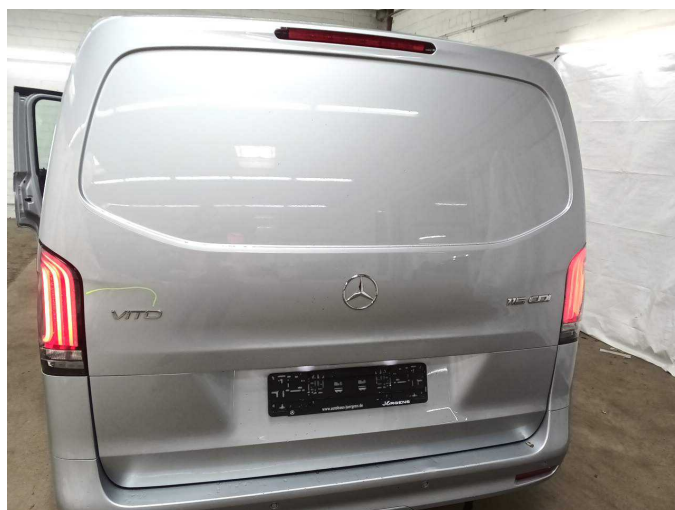
| No. | Component group | Description |
|---|---|---|
| 5 | Boot lid / rear door | Boot lid - Scratch(es) - Paint |

**Damage 5:** Boot lid / rear door: Boot lid - Scratch(es) - Paint

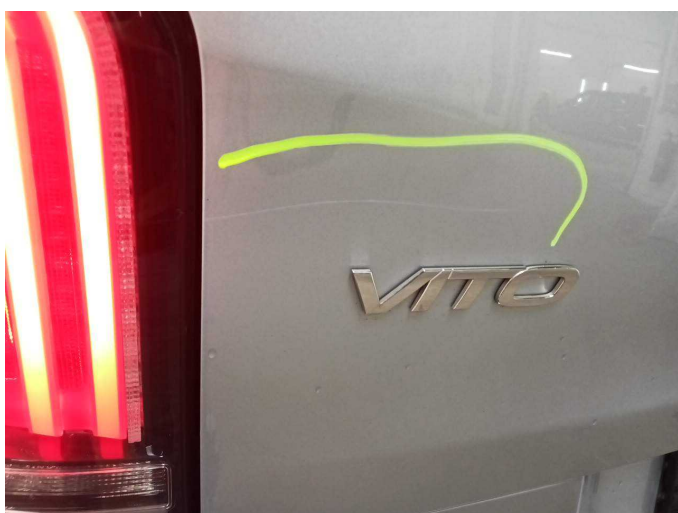
**Damage 5:** Boot lid / rear door: Boot lid - Scratch(es) - Paint

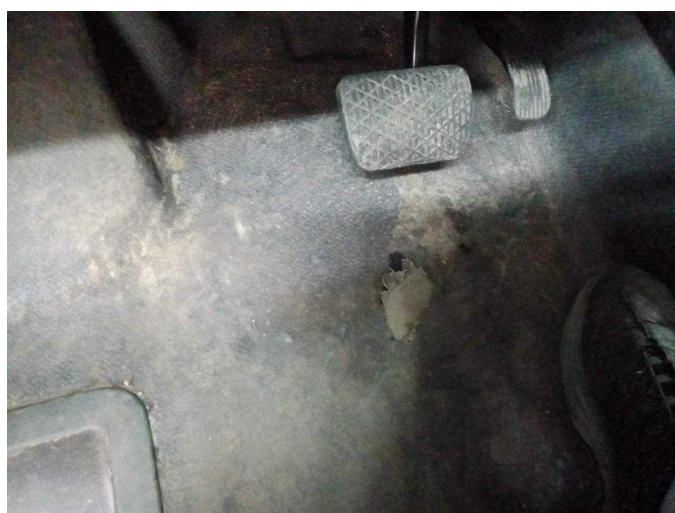
| No. | Component group | Description |
|---|---|---|
| 6 | Trim / covers | Carpet - front left side - Damaged - Replace |

**Damage 6:** Trim / covers: Carpet - front left side - Damaged - Replace

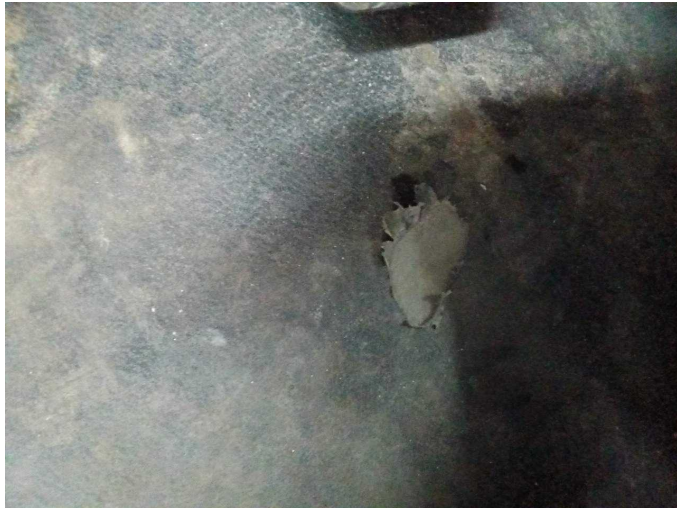
**Damage 6:** Trim / covers: Carpet - front left side - Damaged - Replace

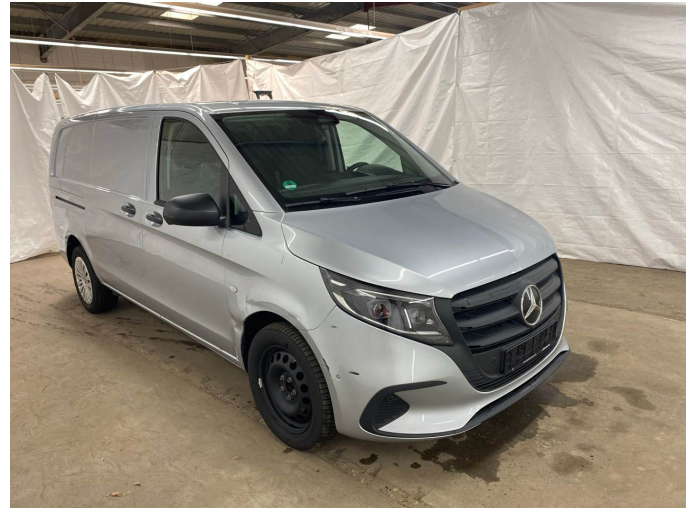
| No. | Accident |
|---|---|
| 1 | Side right |

**Accident 1:** Side right

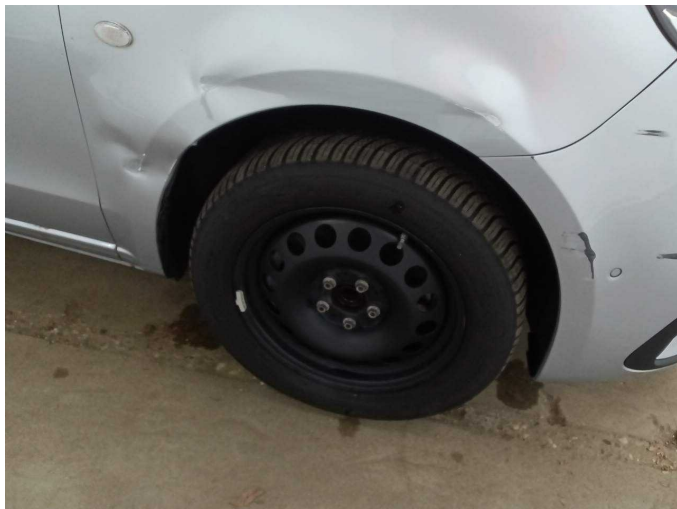
**Accident 1:** Side right

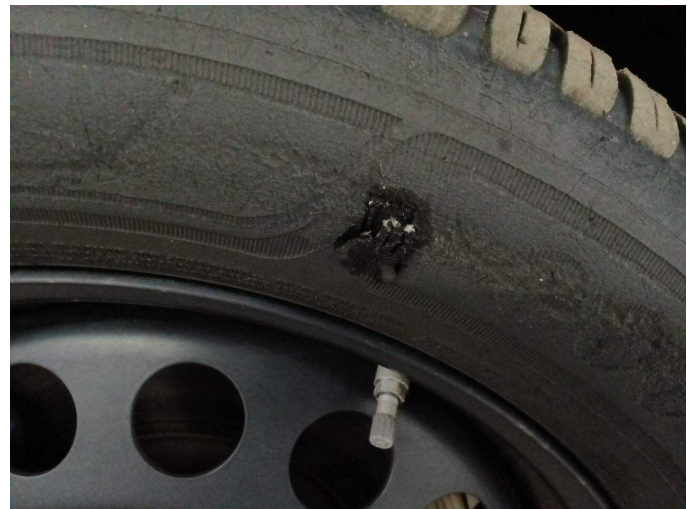
**Accident 1:** Side right

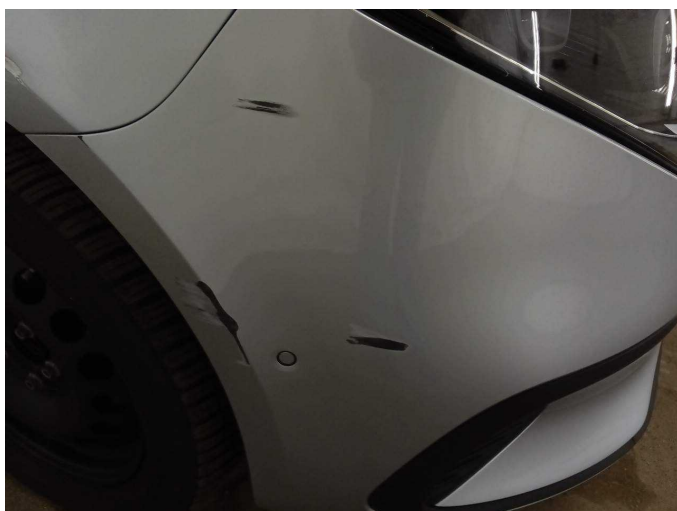
**Accident 1:** Side right

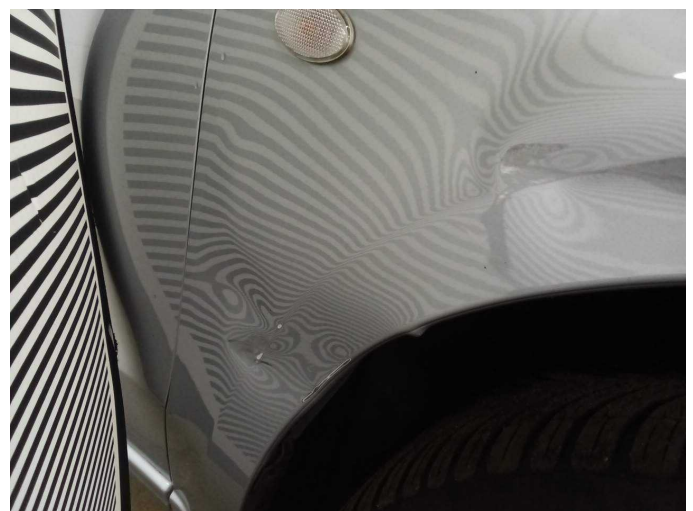
**Accident 1:** Side right

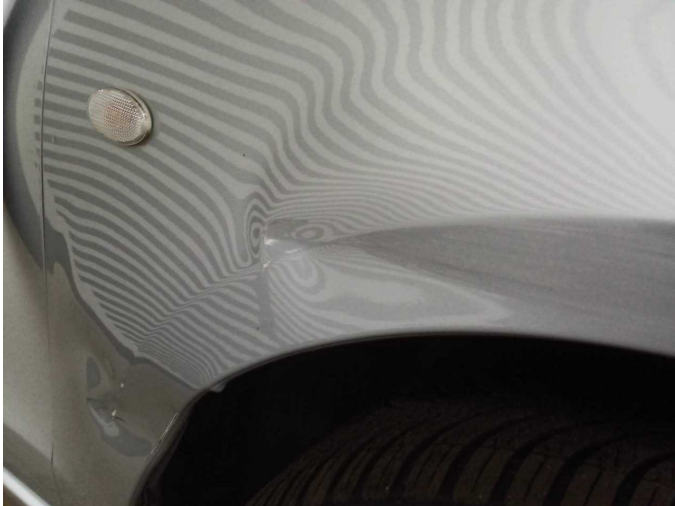
**Accident 1: Side right**

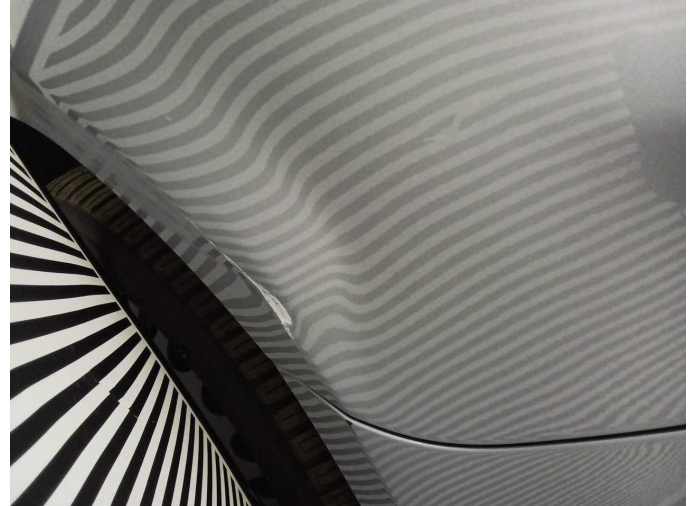
**Accident 1: Side right**

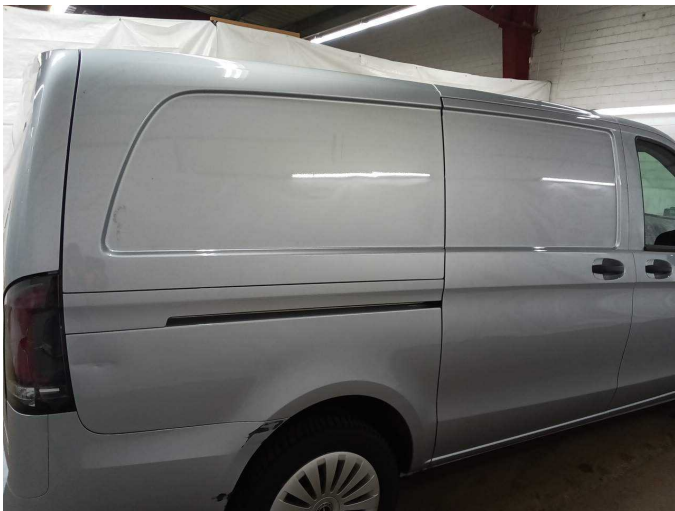
**Accident 1: Side right**

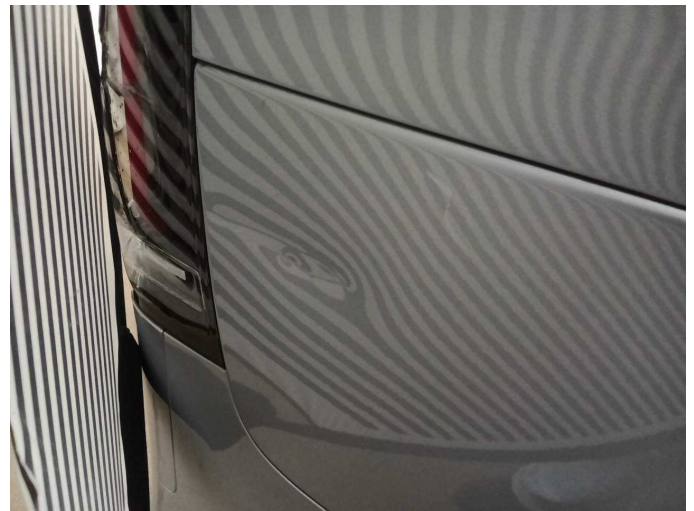
**Accident 1: Side right**

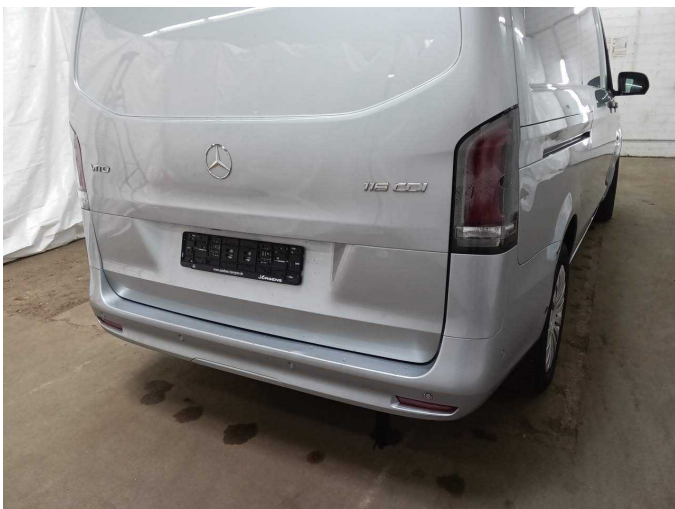
**Accident 1: Side right**

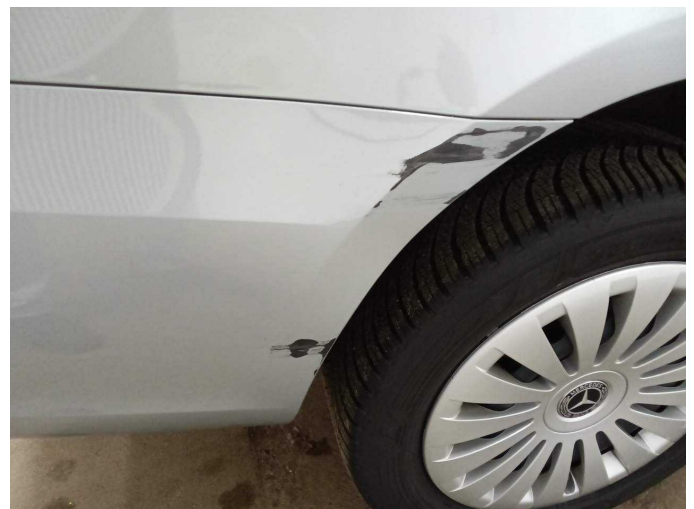
**Accident 1: Side right**

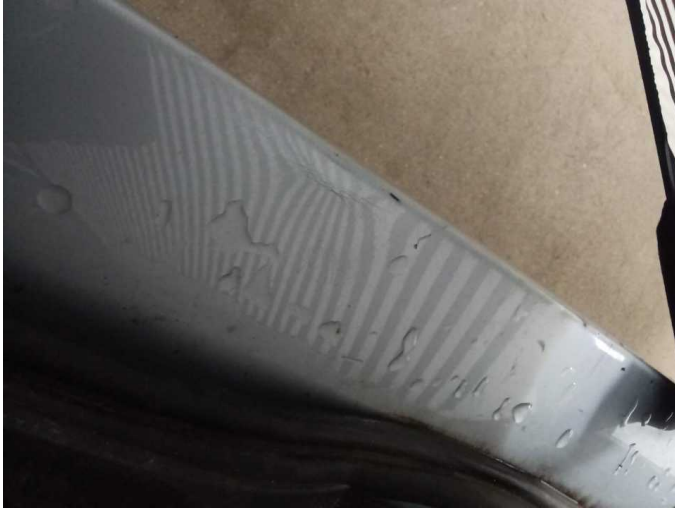
**Accident 1: Side right**

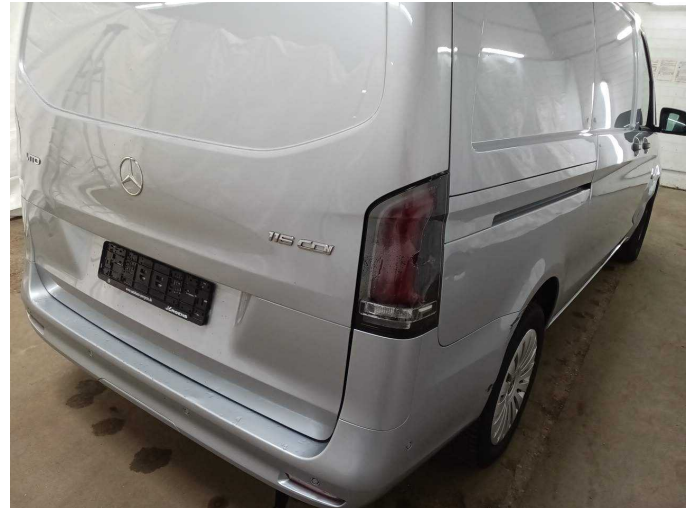
**Accident 1: Side right**

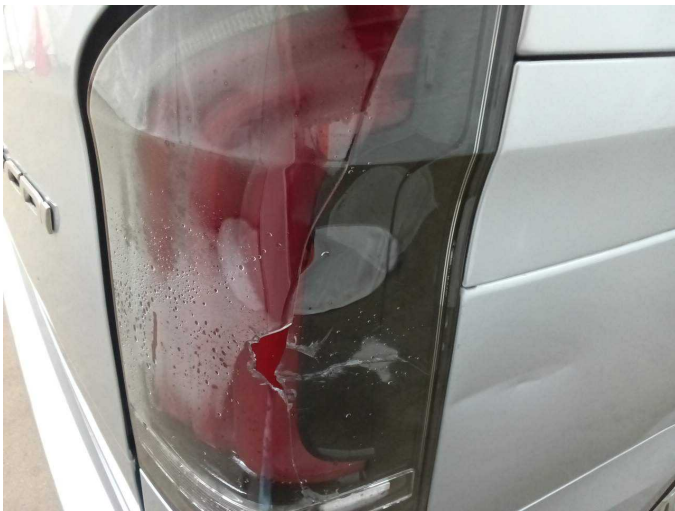
**Accident 1: Side right**
