Expertise

Protocol number: 46168770
Order No. / Reference: 26508941
Inspection date: 24 Jun 2026

Manufacturer: Volkswagen

Model: Caddy 2.0 TDI Trendline

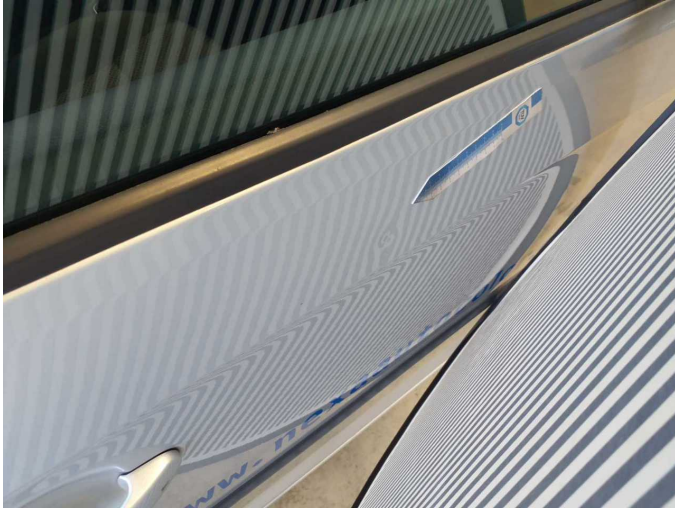
Damage 1: Door - front right side: Door - dent(s) - Smooth repair work

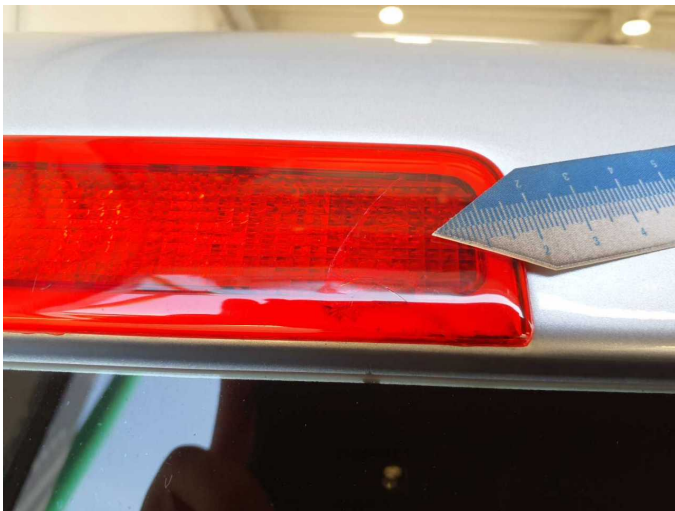
Damage 2: Tail light: Auxiliary brake light - Broken / torn - Replace

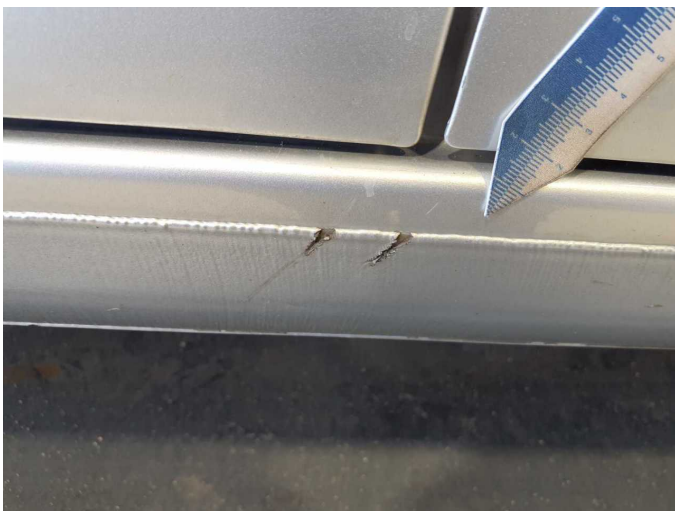
Damage 3: Sill - right side: Sill - Scratch(es) - Smart repair

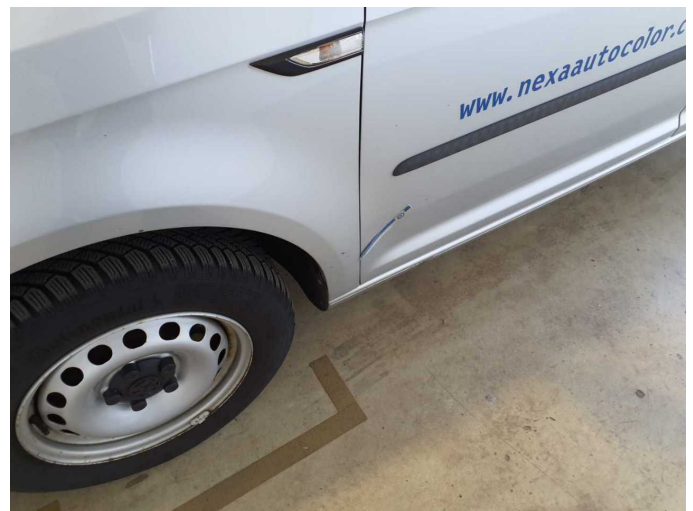
Damage 3: Sill - right side: Sill - Scratch(es) - Smart repair

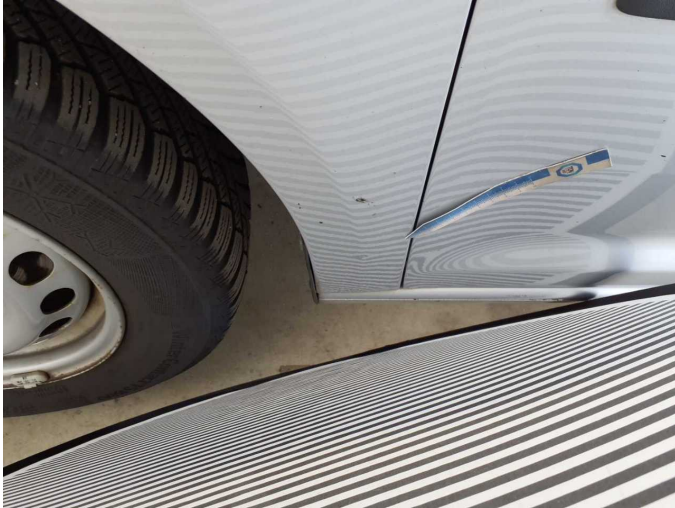
Damage 4: Mudguard - left side: Mudguard - left side - Dent / paintcoat damage - Smart repair

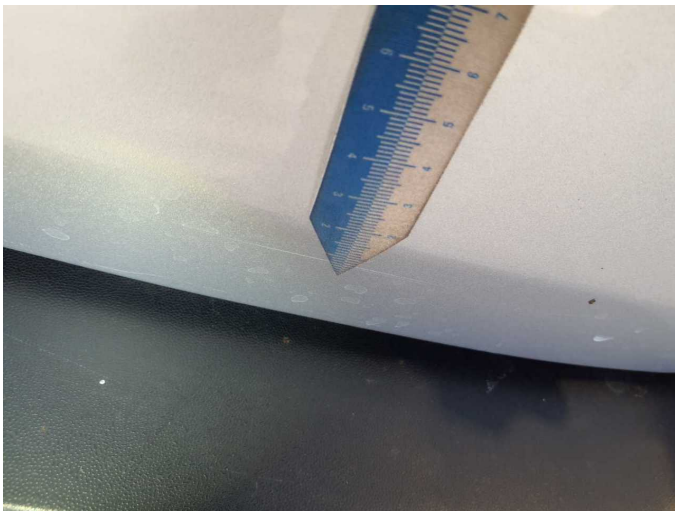
Damage 5: Boot lid / rear door: Rear door - right side - Scratch(es) - Smart repair

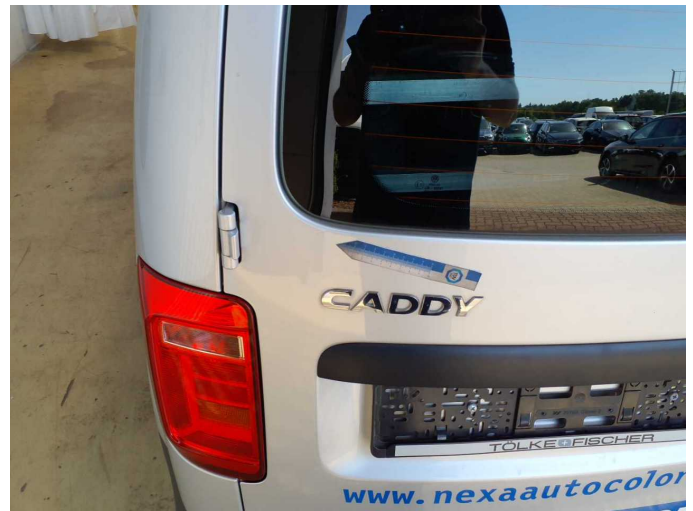
Damage 5: Boot lid / rear door: Rear door - right side - Scratch(es) - Smart repair

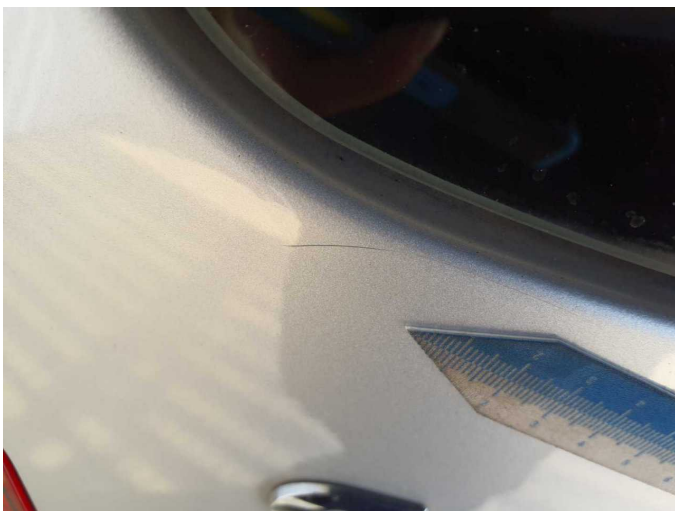
Damage 6: Boot lid / rear door: Rear door - left side - Scratch(es) - Smart repair

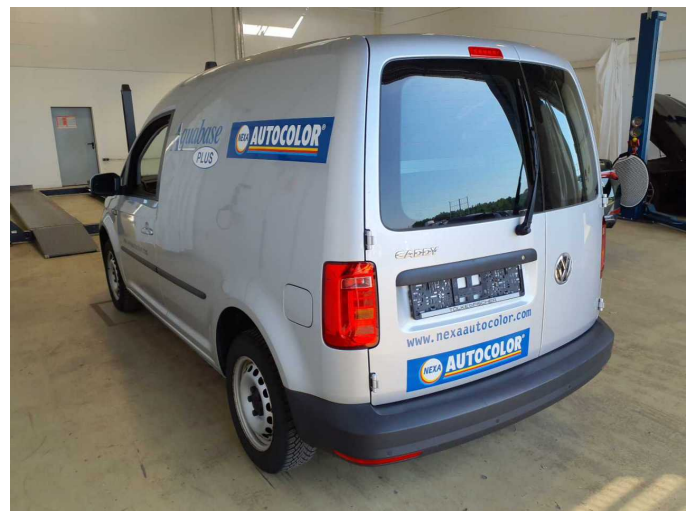
Damage 6: Boot lid / rear door: Rear door - left side - Scratch(es) - Smart repair

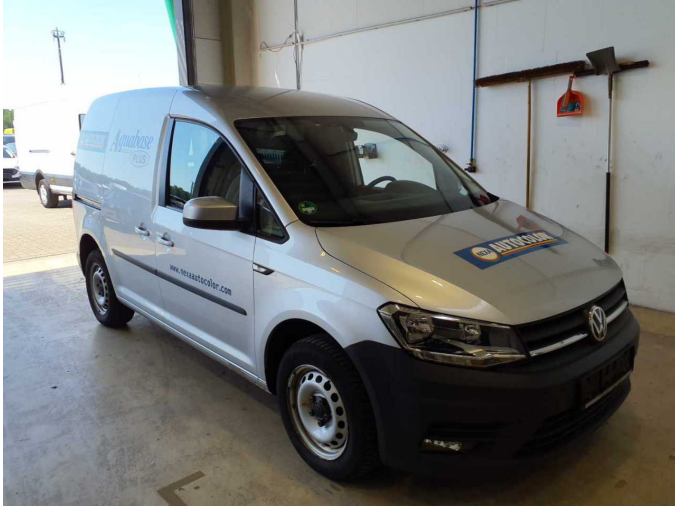
Damage 7: Body: Body - Glued / labelled - De-glude / neutralise

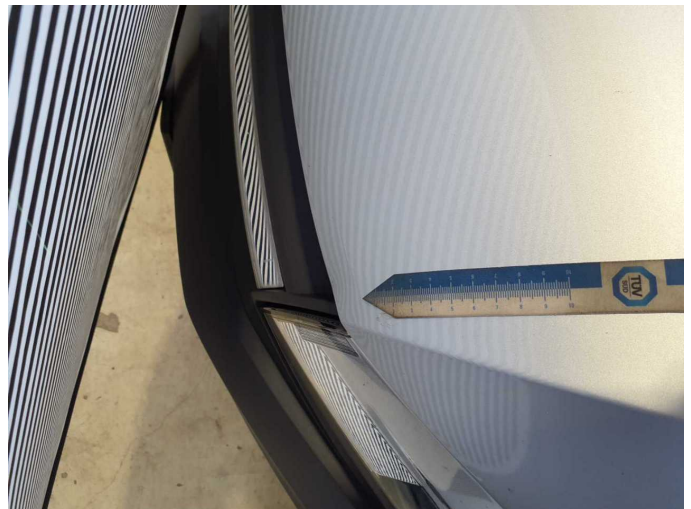
Damage 9: Bonnet: Bonnet - Deformed - Repair and paint

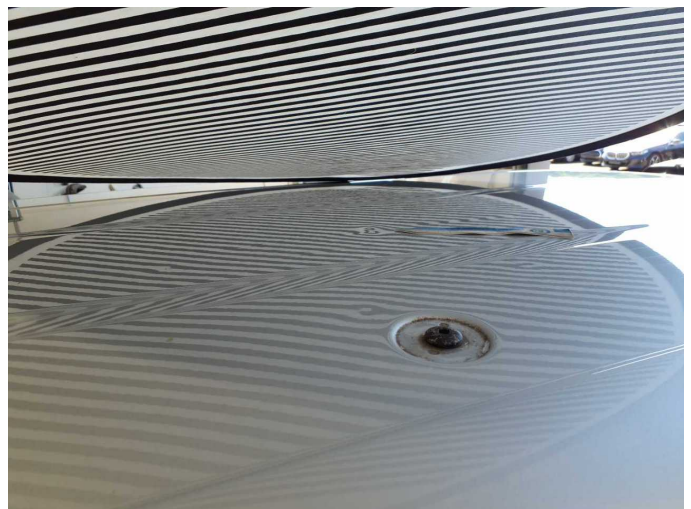
Damage 10: Roof: Roof - Corrosion - Repair and paint

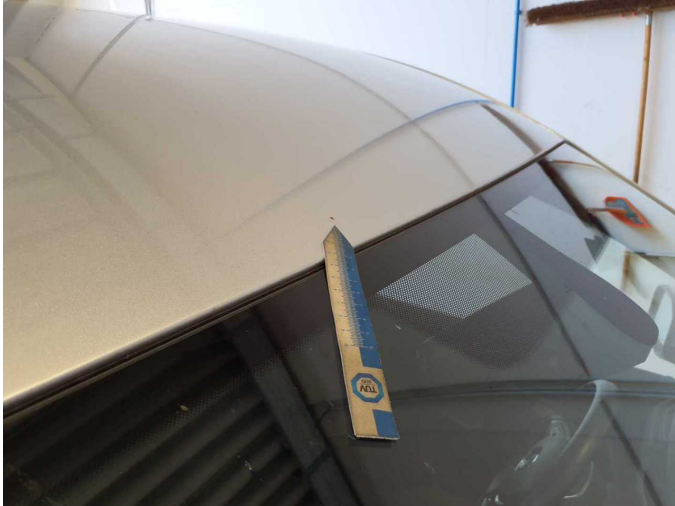
Damage 10: Roof: Roof - Corrosion - Repair and paint

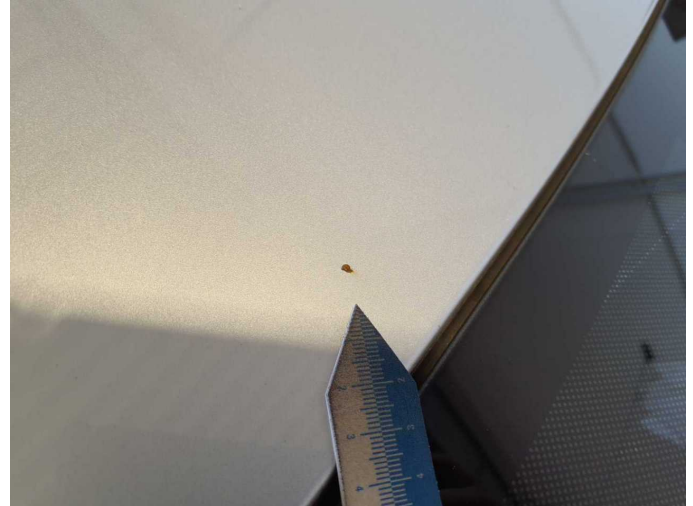
Damage 10: Roof: Roof - Corrosion - Repair and paint

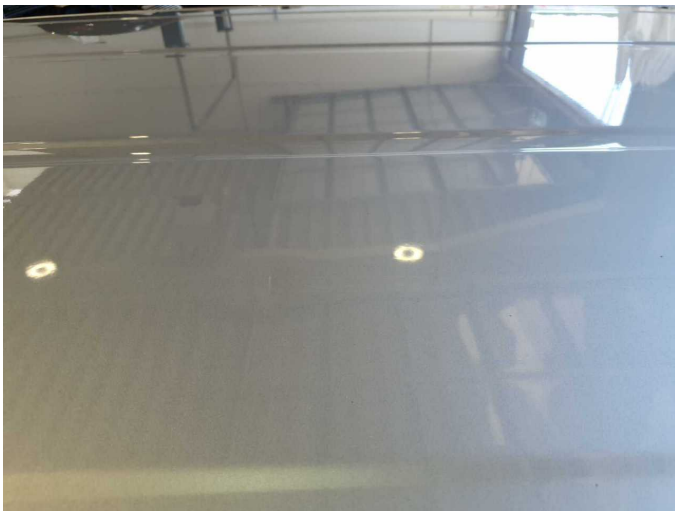
Damage 10: Roof: Roof - Corrosion - Repair and paint

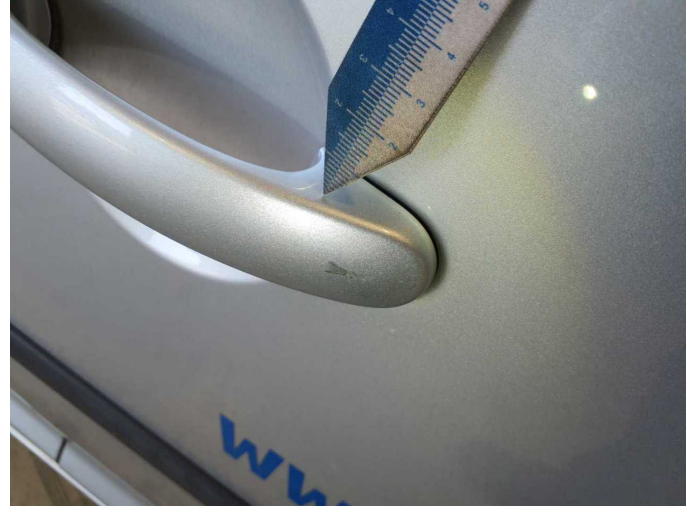
Wear and tear 4: Door - front right side: Door handle - outside - Scratch(es) - Cover / polish
