- Vehicle Inspection Report -

Number: 10326619
From: 30.03.2026

Order number: 1002380233
Order completed: 30.03.2026 11:47
Report number: 10326619
VIN: WVVZZZAAZND015158

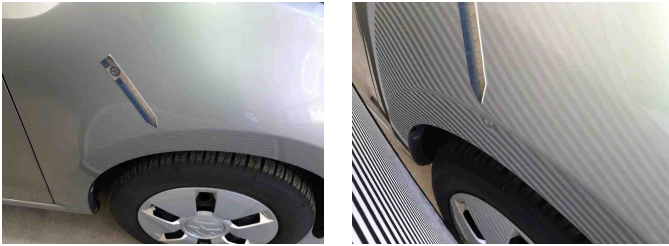
6 - Wing FR - Dent(s) - Paintless dent repair

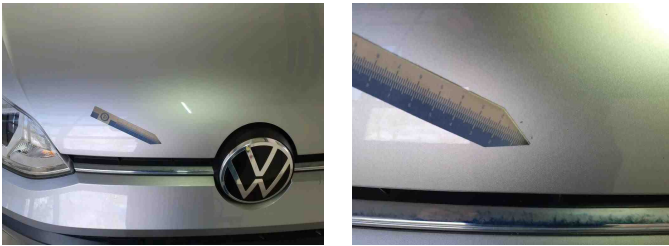
7 - Bonnet - Stone chip(s) - Touch up
