## Expertise

Protocol number: 45234562  
Order No. / Reference: 26292278  
Inspection date: 22 Apr 2026

Manufacturer: Mercedes-Benz

Model: 317 CDI Sprinter Standard HA 9G-TRONIC PRO

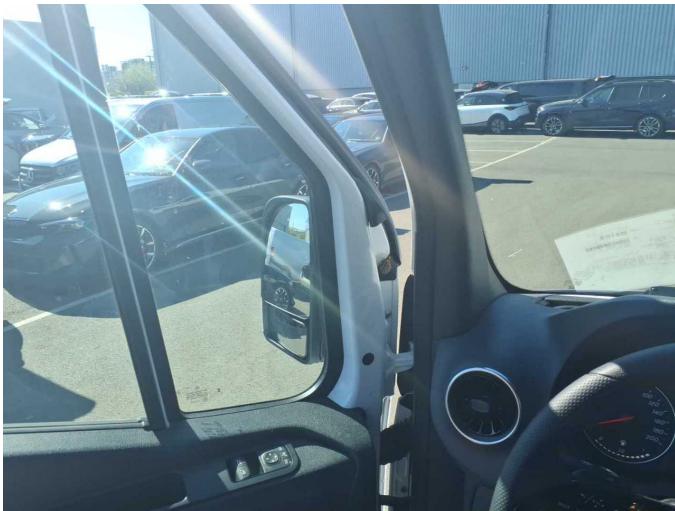
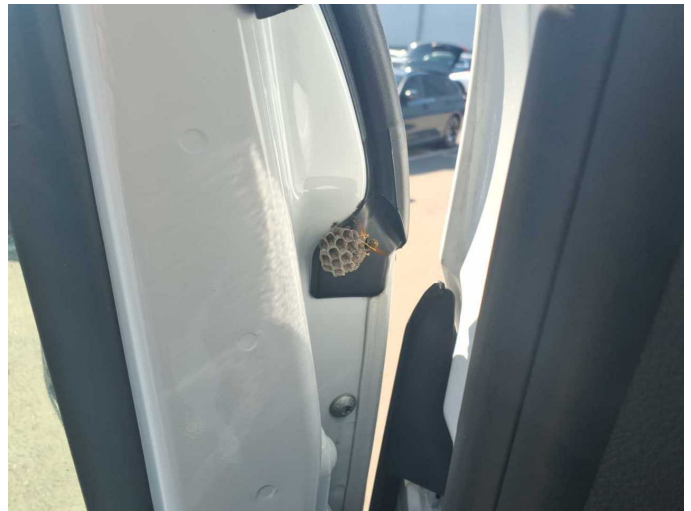
No.	Component group	Description
1	Door - front left side	Door (Wespennest Türinnenseite) - Remove

Damage 1: Door - front left side: Door (Wespennest Türinnenseite) - Remove

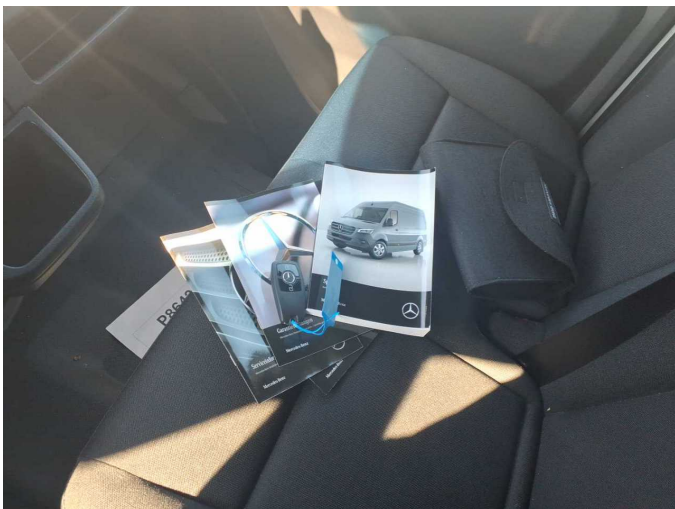
Equipment - Vehicle key

Missing part 1: Equipment: Vehicle key - Missing - Replace
