Expertise

Protocol number: 46600112  
Order No. / Reference: 26774292  
Inspection date: 20 Jul 2026

Manufacturer: Volkswagen

Model: Tiguan 2.0 TDI SCR DSG Life

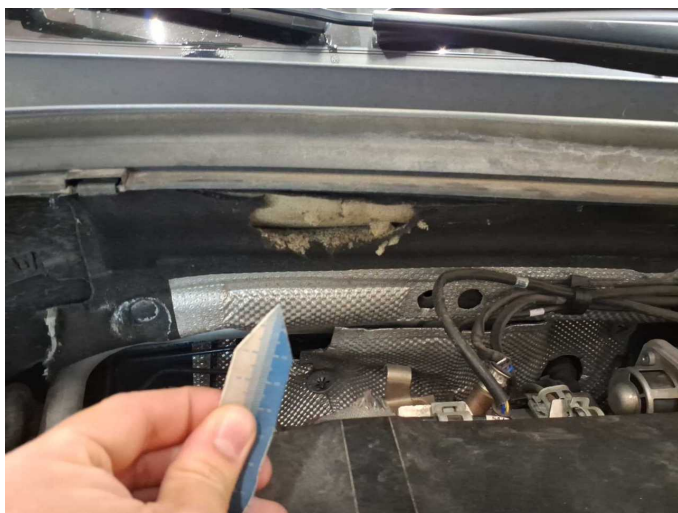
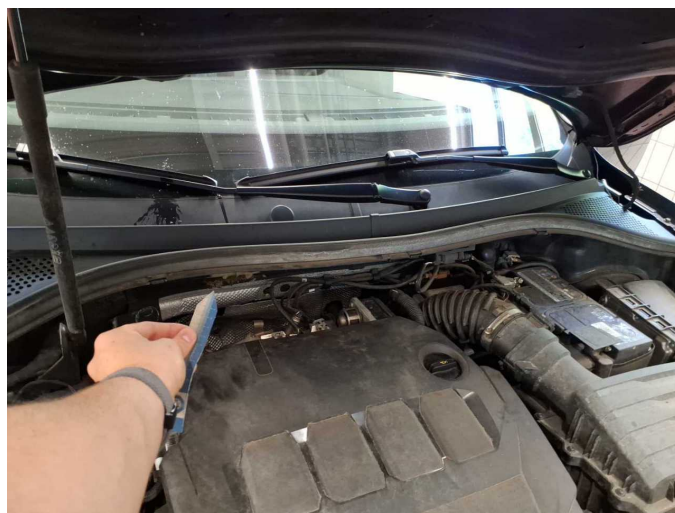
| No. | Component group | Description |
|---|---|---|
| 1 | Body | Firewall trim (Dämmmaterial) - Damage caused by marten / rodent - Replace |

**Damage 1:** Body: Firewall trim (Dämmmaterial) - Damage caused by marten / rodent - Replace

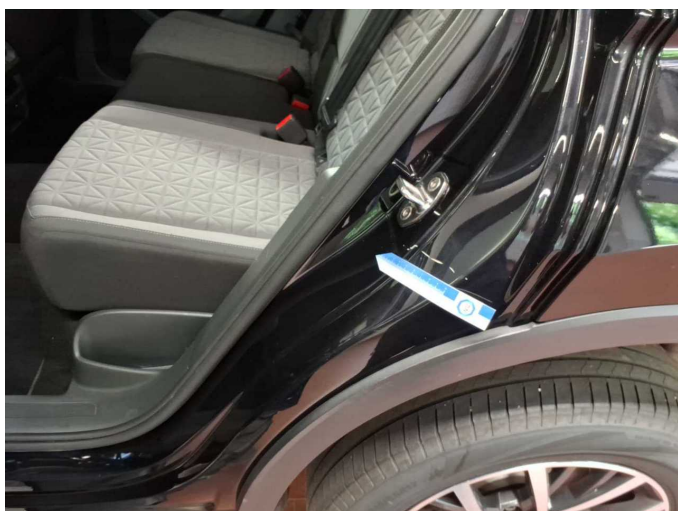
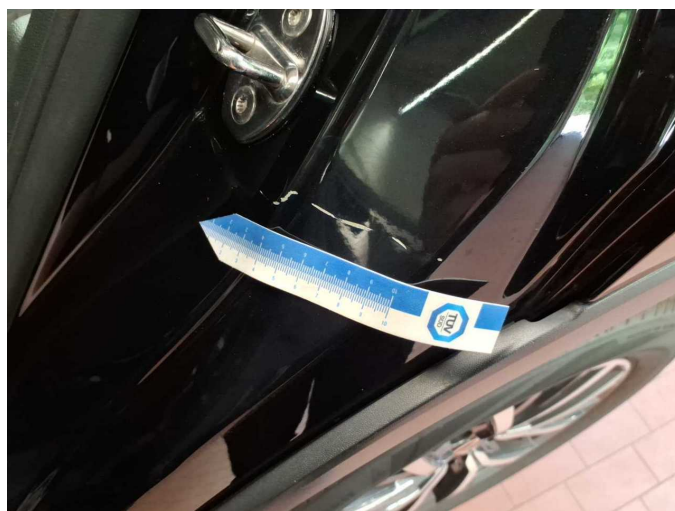
| No. | Component group | Description |
|---|---|---|
| 2 | Side panel - rear left side | Sill - Scratched - Smart repair |

**Damage 2:** Side panel - rear left side: Sill - Scratched - Smart repair

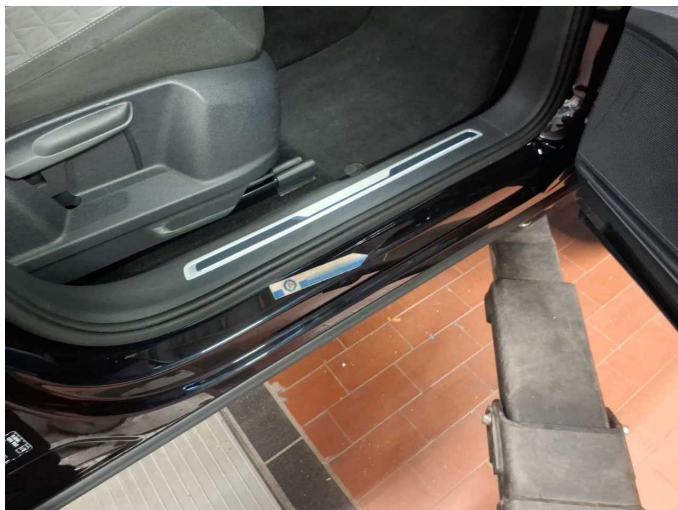
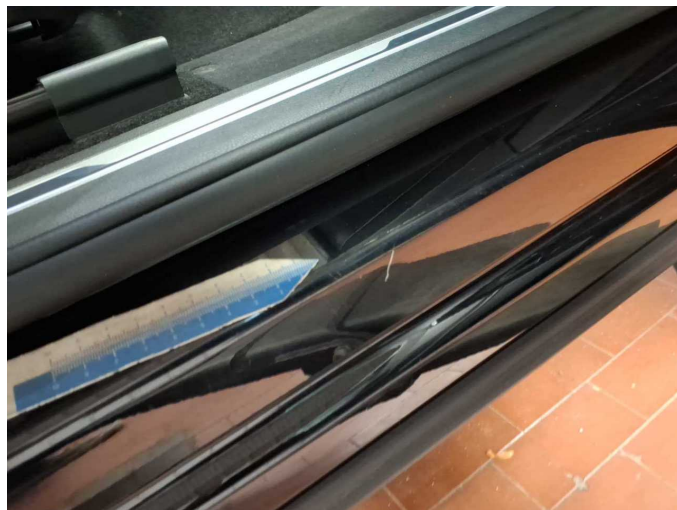
| No. | Component group | Description |
|---|---|---|
| 3 | Sill - right side | Sill - Scratch(es) - Smart repair |

**Damage 3:** Sill - right side: Sill - Scratch(es) - Smart repair

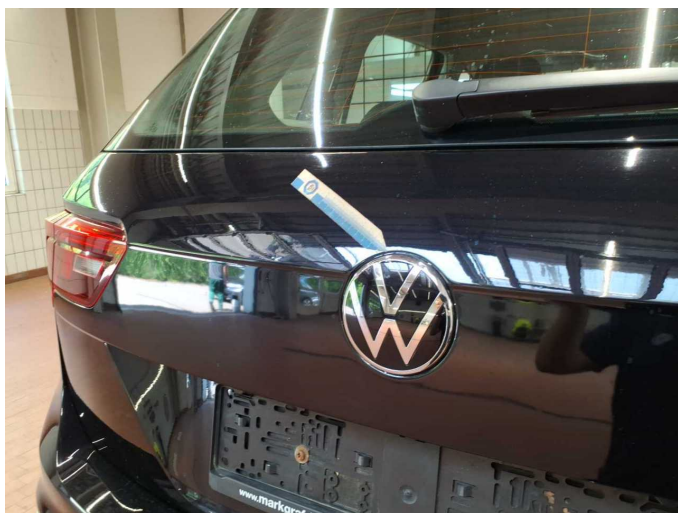
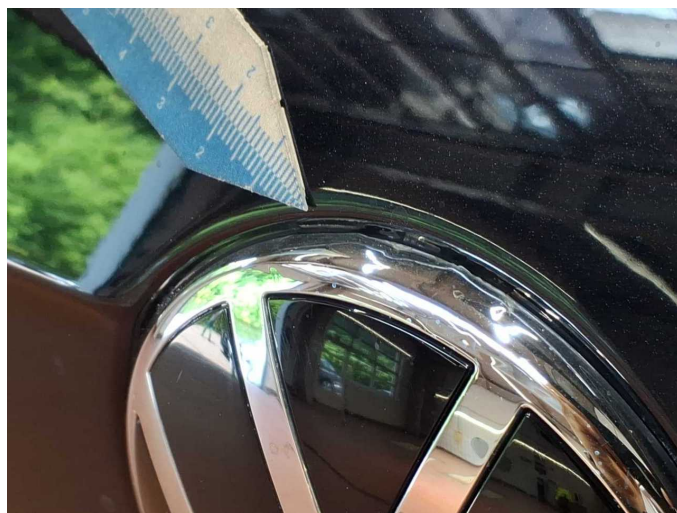
| No. | Component group | Description |
|---|---|---|
| 3 | Boot lid / rear door | Emblem - Paint defect - No deduction |

**Wear and tear 3:** Boot lid / rear door: Emblem - Paint defect - No deduction

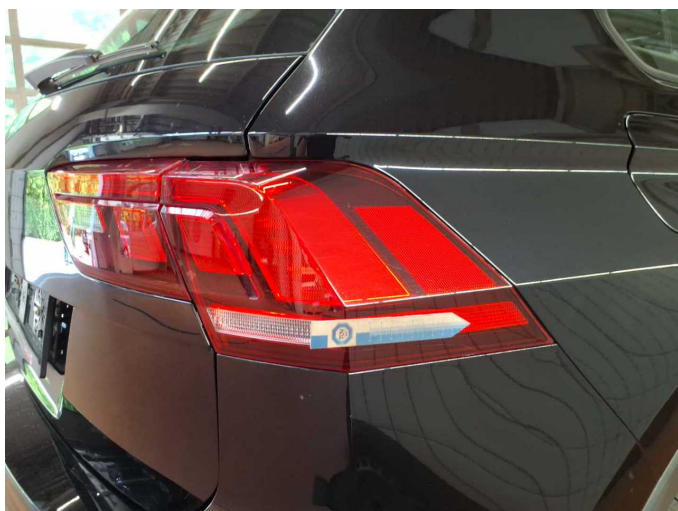
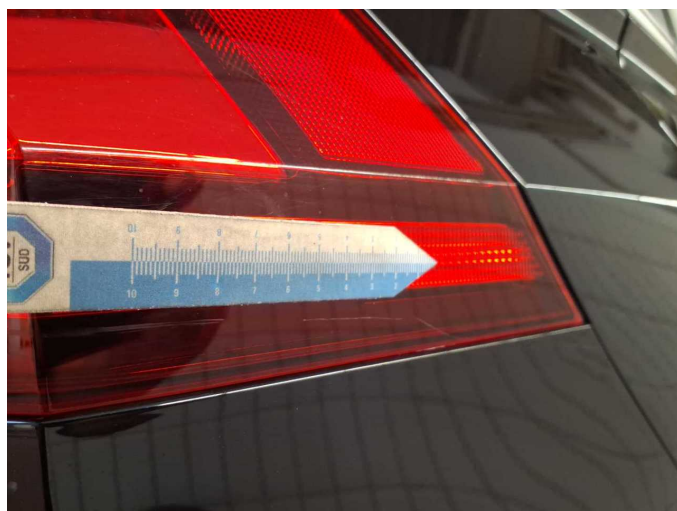
| No. | Component group | Description |
|---|---|---|
| 4 | Tail light | Tail lamp - right side - Scratched - No deduction |

**Wear and tear 4:** Tail light: Tail lamp - right side - Scratched - No deduction

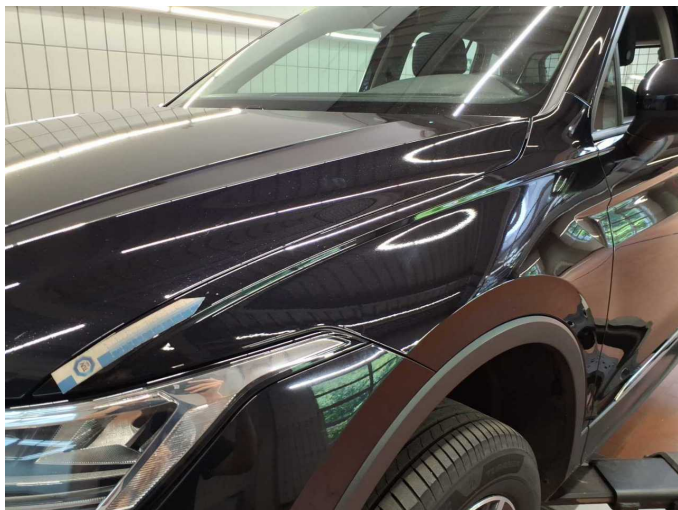
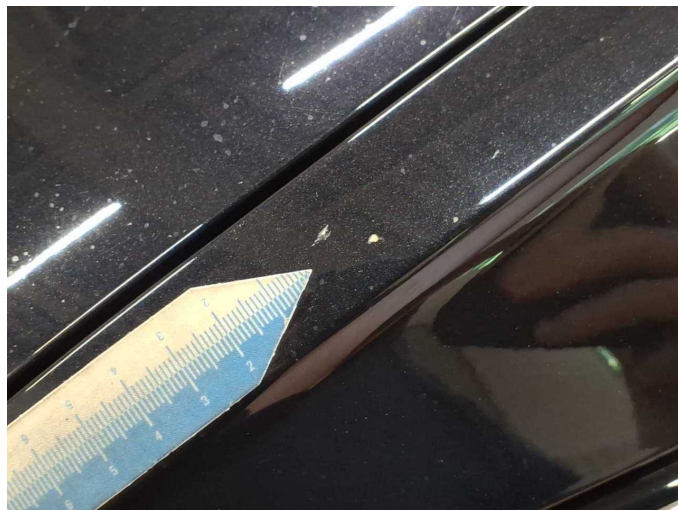
| No. | Component group | Description |
|---|---|---|
| 5 | Mudguard - left side | Mudguard - left side - Stone chips - No deduction |

**Wear and tear 5:** Mudguard - left side: Mudguard - left side - Stone chips  
- No deduction

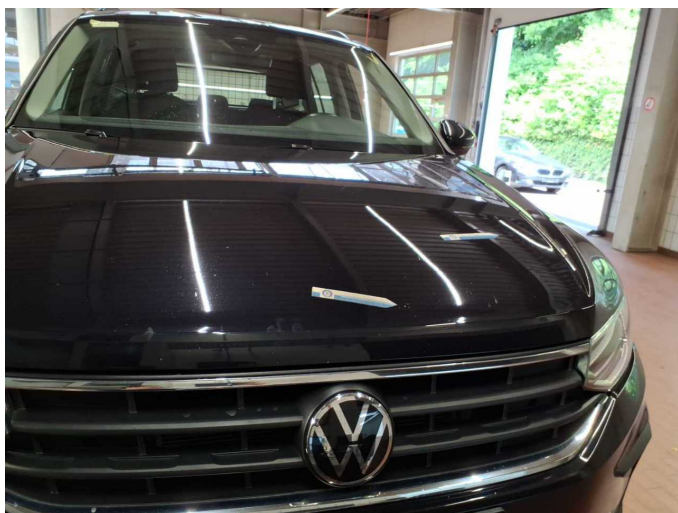
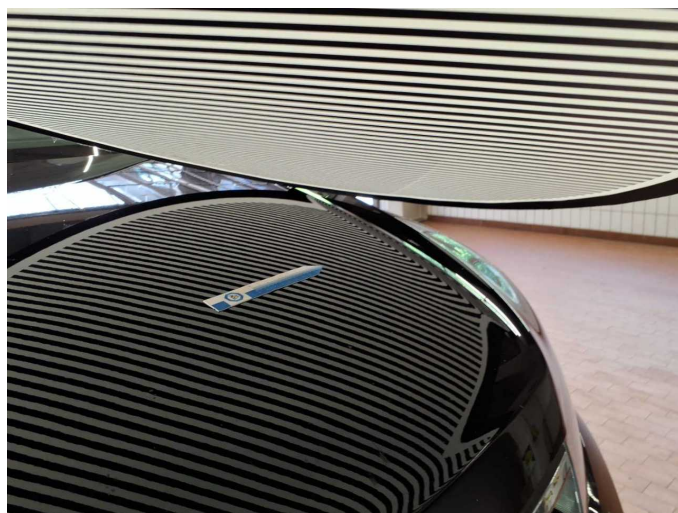
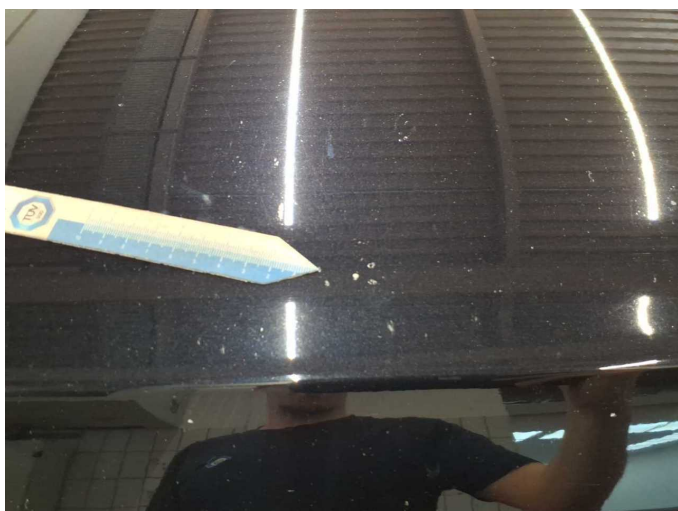
| No. | Component group | Description |
|---|---|---|
| 6 | Bonnet | Bonnet (Delle) - Stone chips - No deduction |

**Wear and tear 6:** Bonnet: Bonnet (Delle) - Stone chips - No deduction

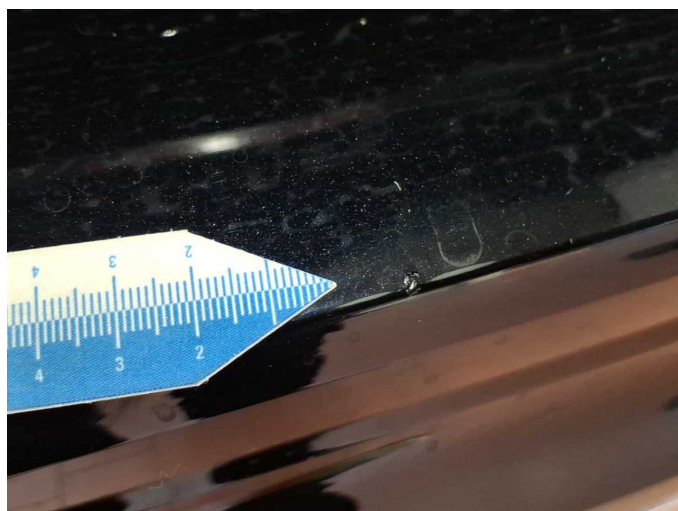
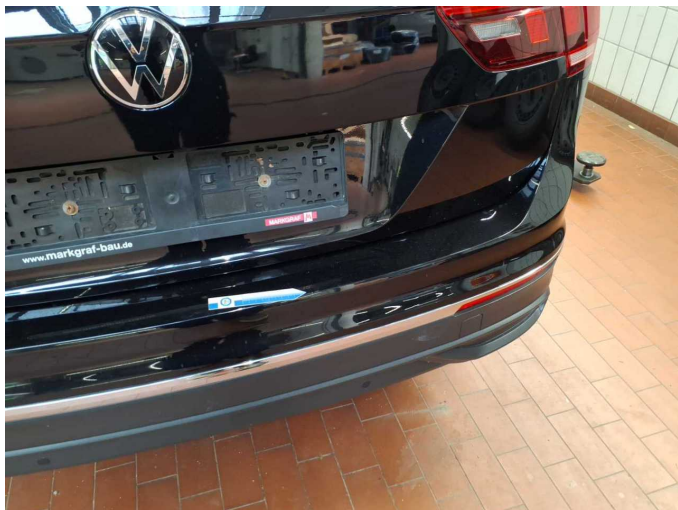
| No. | Component group | Description |
|---|---|---|
| 7 | Rear bumper | Rear bumper - Scratch(es) - No deduction |

**Wear and tear 7:** Rear bumper: Rear bumper - Scratch(es) - No deduction

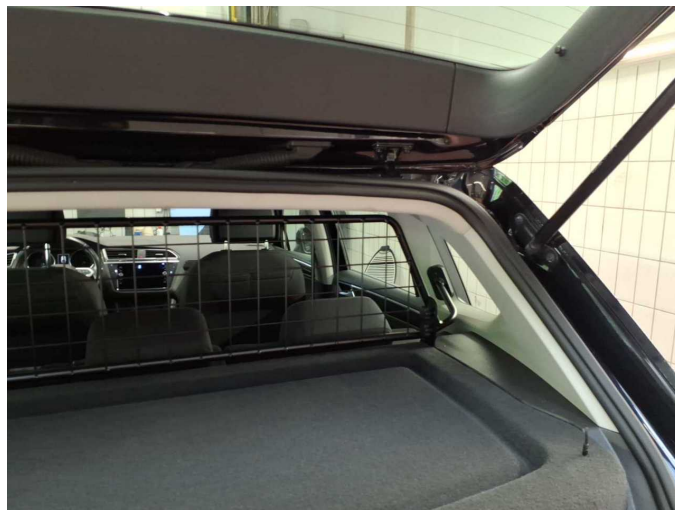
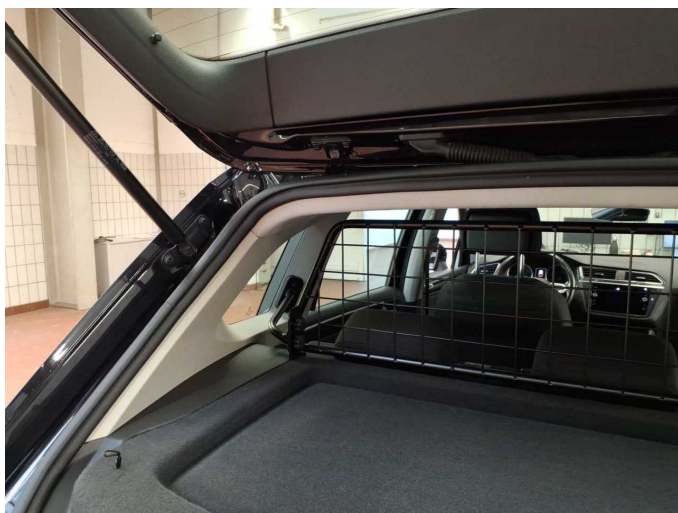
| No. | Component group | Description |
|---|---|---|
| 8 | Body | Partition wall - Differs from the original configuration - No deduction |

**Wear and tear 8:** Body: Partition wall - Differs from the original configuration - No deduction

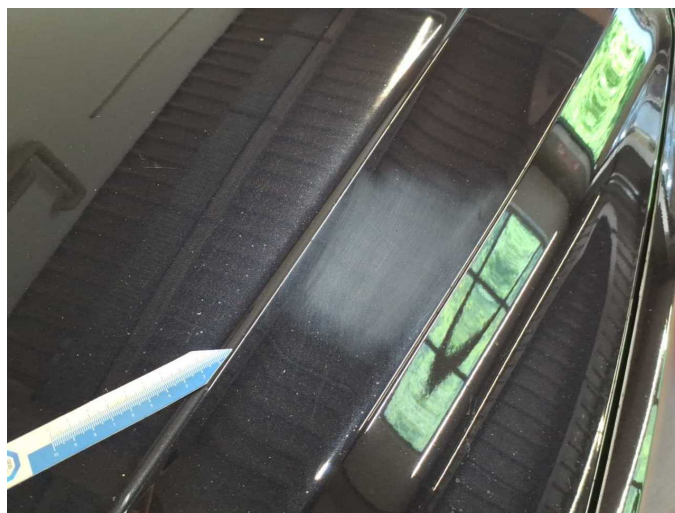
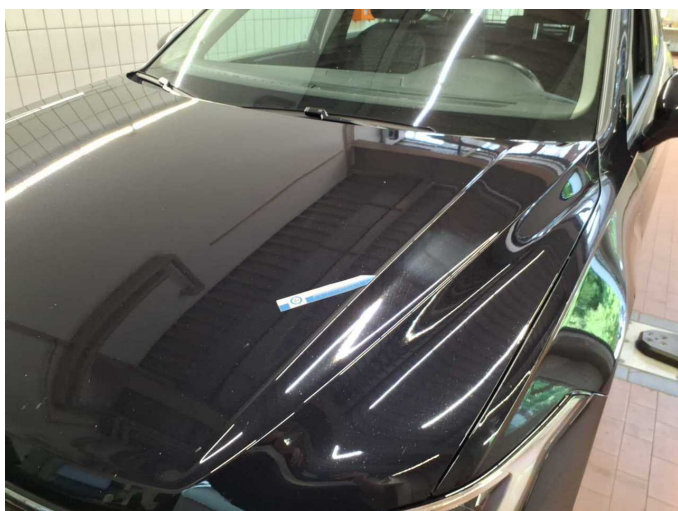
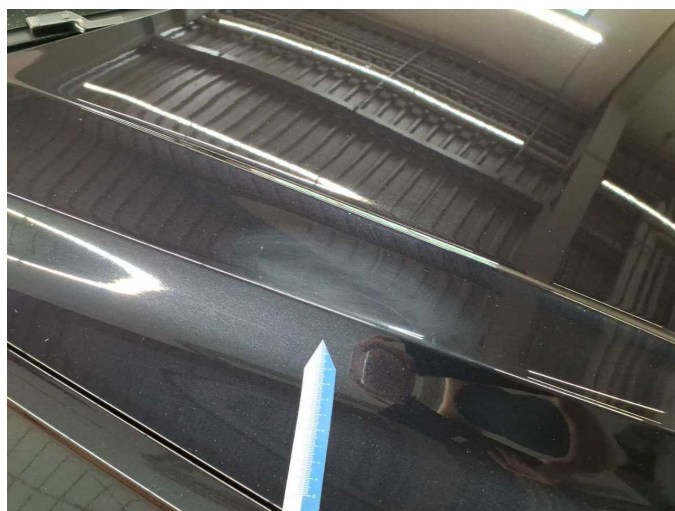
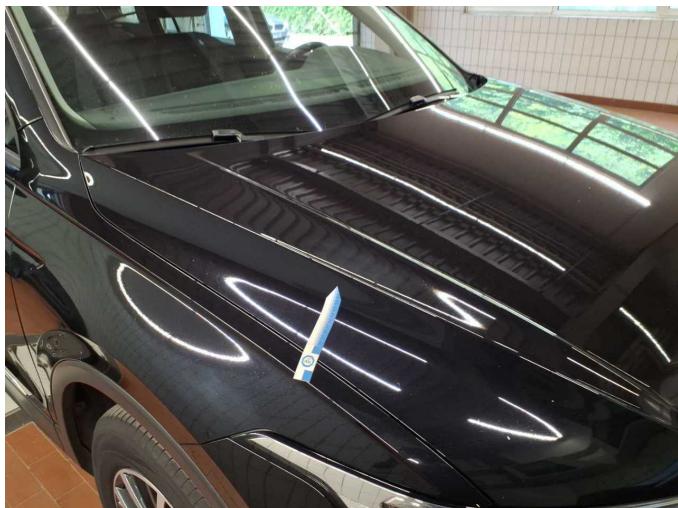
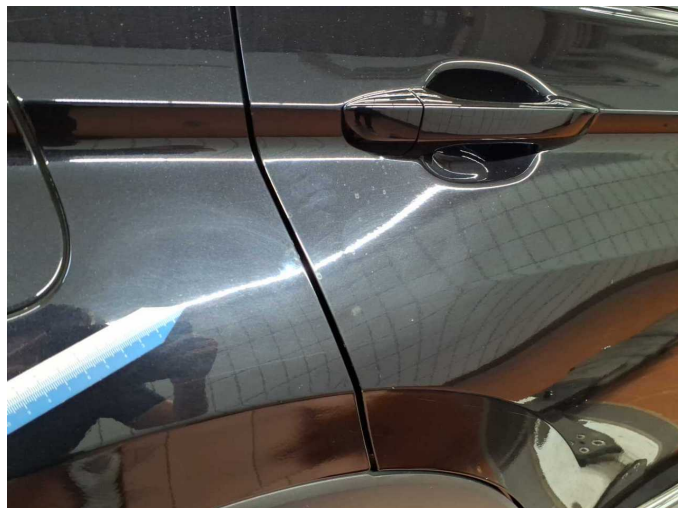
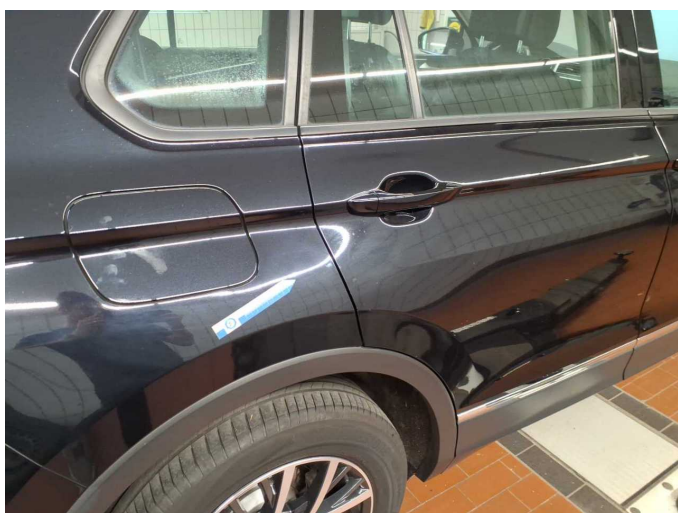
| No. | Component group | Description |
|---|---|---|
| 9 | Body | Body (Polierspuren) - Scratch(es) - No deduction |

**Wear and tear 9:** Body: Body (Polierspuren) - Scratch(es) - No deduction

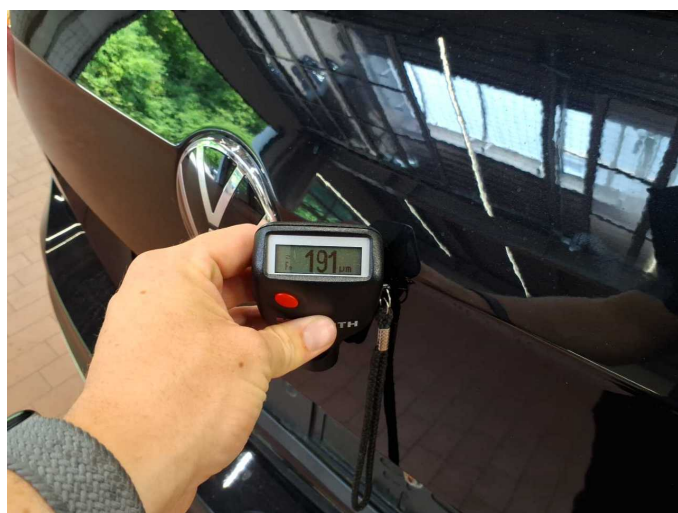
| No. | Repainting |
|---|---|
| 1 | Boot lid / rear door, Professionally carried out, Invoice of repair done Non-existent |

| Boot lid / rear door | 191 µm | Side panel - rear left side | 180 µm |

**Repainting 1:** Boot lid / rear door

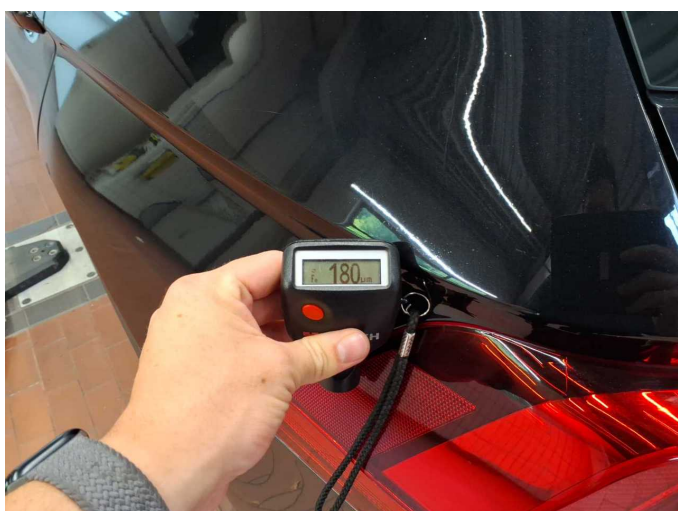
| No. | Repainting |
|---|---|
| 2 | Side panel - rear left side, Professionally carried out, Invoice of repair done Non-existent |

**Repainting 2:** Side panel - rear left side

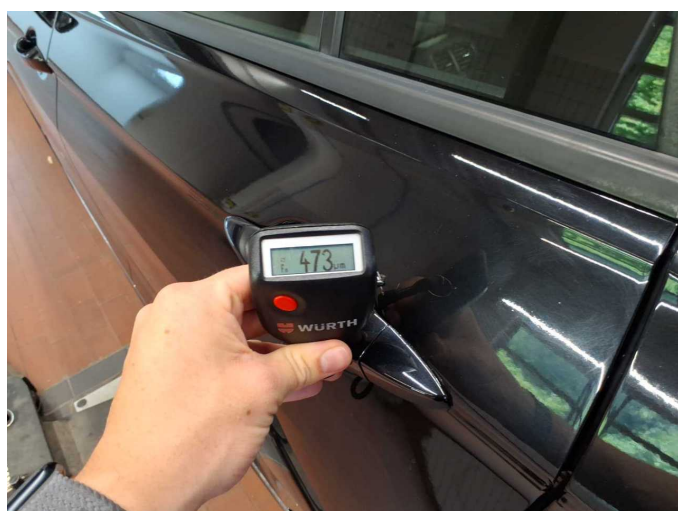
| No. | Repainting |
|---|---|
| 3 | Door - rear left side, Professionally carried out, Invoice of repair done Non-existent |

| Door - rear left side | 473 µm | Door - front left side | 201 µm |

**Repainting 3:** Door - rear left side

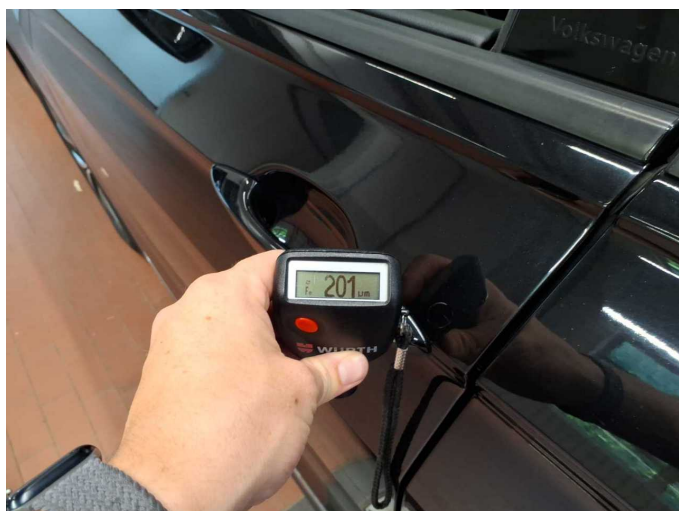
| No. | Repainting |
|---|---|
| 4 | Door - front left side, Professionally carried out, Invoice of repair done Non-existent |

**Repainting 4:** Door - front left side
