Expertise

Protocol number: 46064952
Order No. / Reference: 26546740
Inspection date: 22 Jun 2026

Manufacturer: MAN

Model: TGE 3.140 4X2F SB

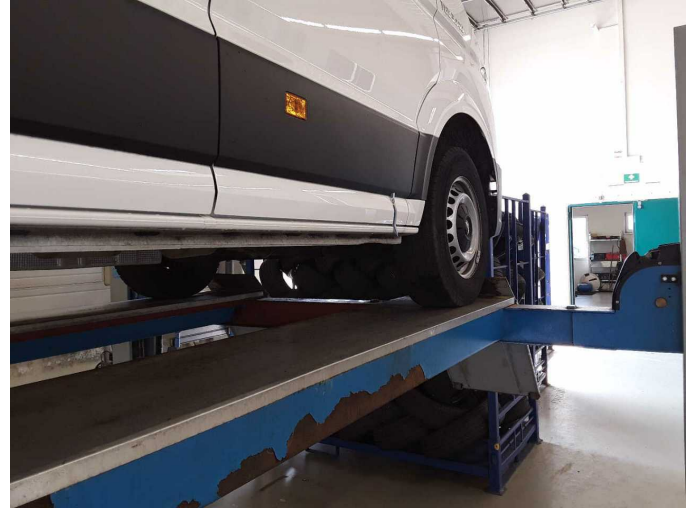
No.	Component group	Description
1	Sill - right side	Sill - Scratch(es) - Smart repair
2	Sill - left side	Sill - Scratch(es) - Smart repair
3	Side panel - rear left side	Interior trim - Broken / torn - Replace

Damage 1: Sill - right side: Sill - Scratch(es) - Smart repair

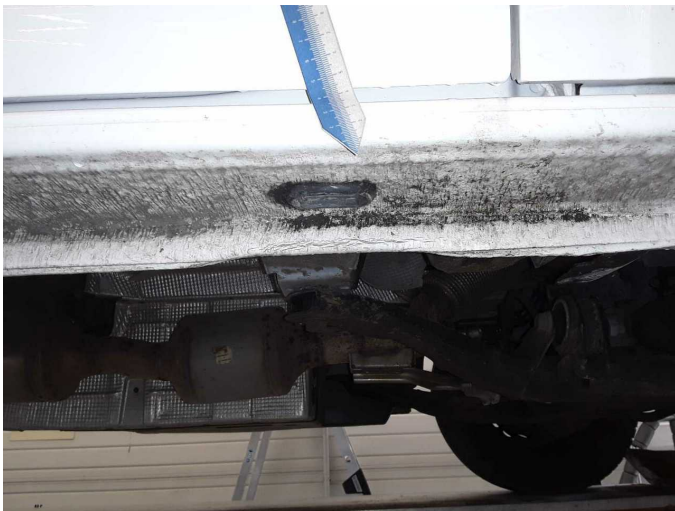
Damage 1: Sill - right side: Sill - Scratch(es) - Smart repair

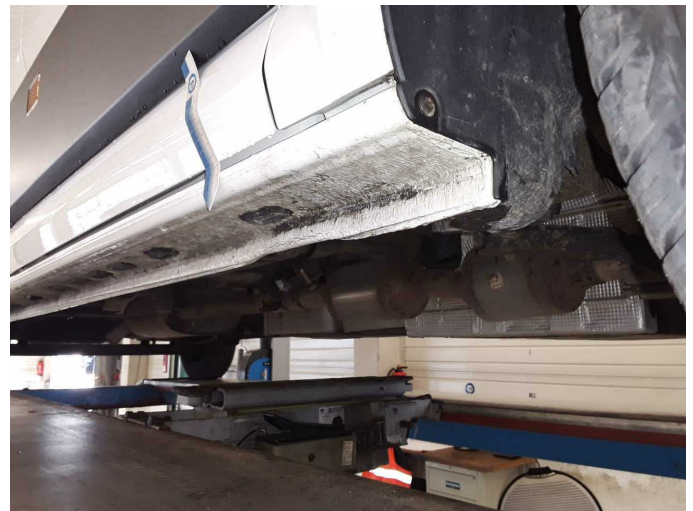
Damage 1: Sill - right side: Sill - Scratch(es) - Smart repair

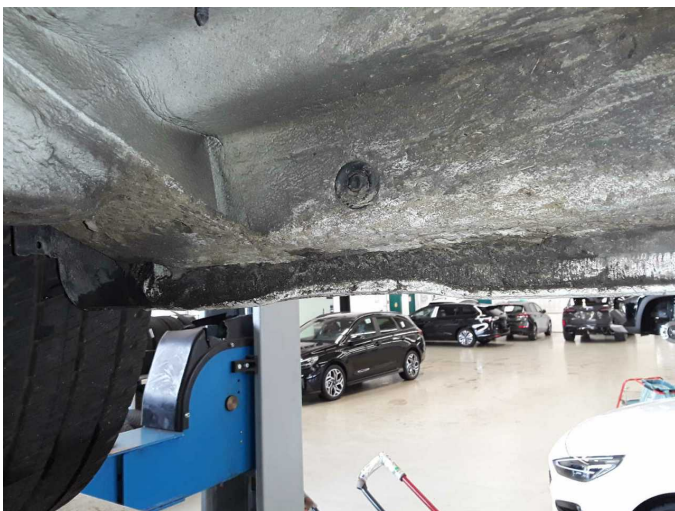
Damage 1: Sill - right side: Sill - Scratch(es) - Smart repair

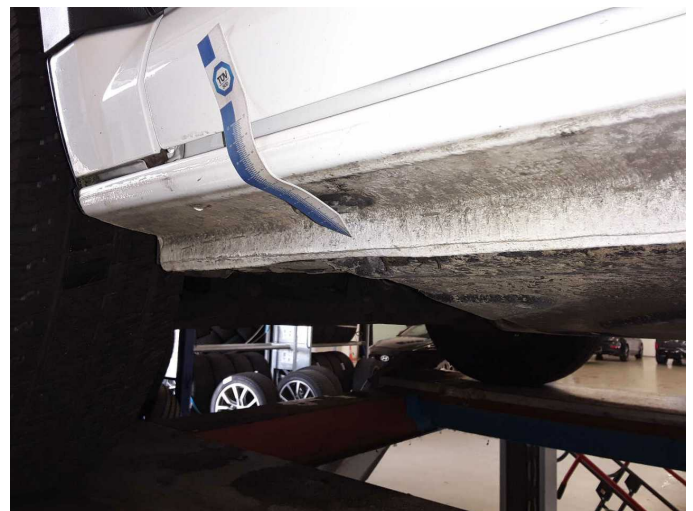
Damage 2: Sill - left side: Sill - Scratch(es) - Smart repair

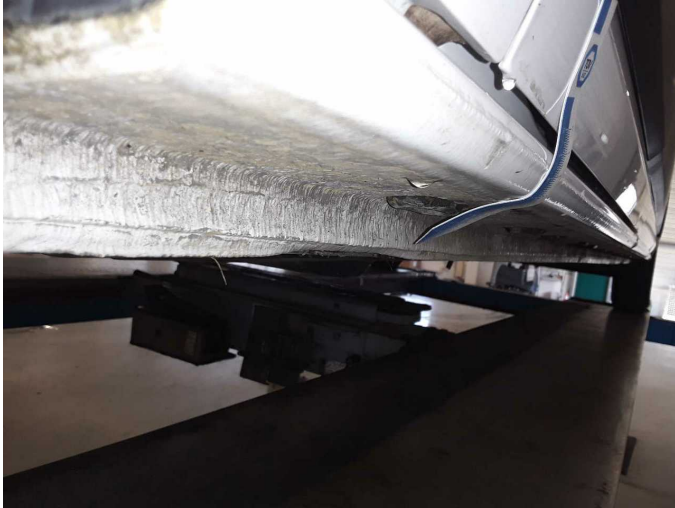
Damage 2: Sill - left side: Sill - Scratch(es) - Smart repair

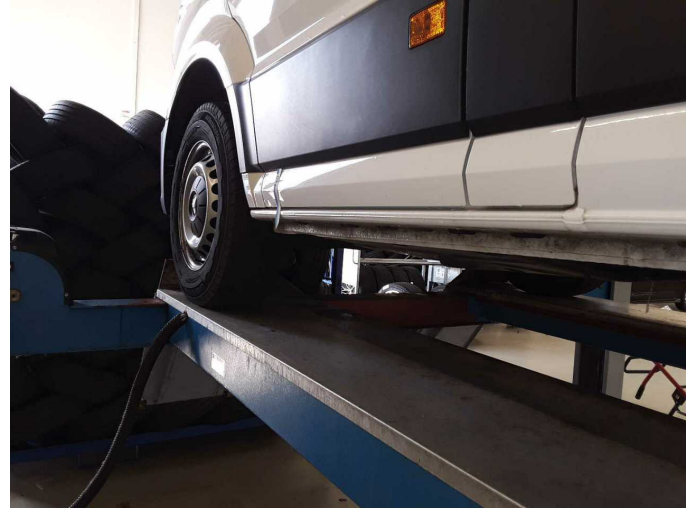
Damage 2: Sill - left side: Sill - Scratch(es) - Smart repair

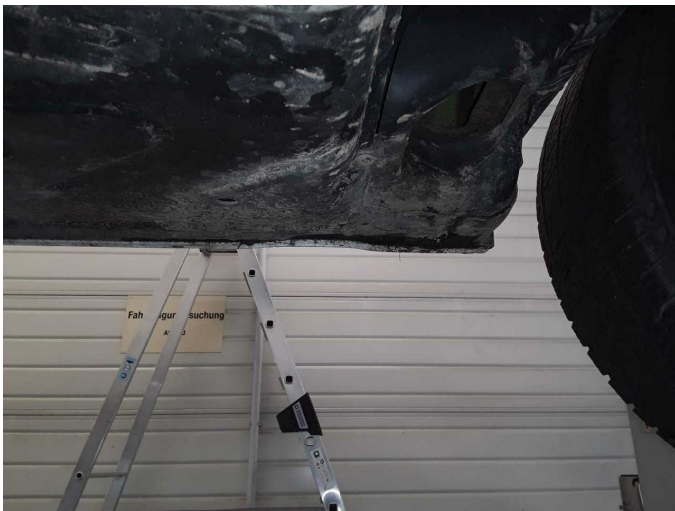
Damage 2: Sill - left side: Sill - Scratch(es) - Smart repair

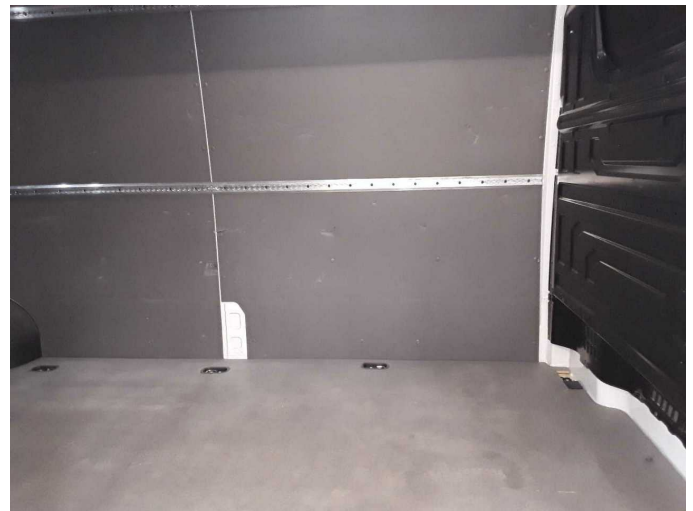
Damage 3: Side panel - rear left side: Interior trim - Broken / torn - Replace

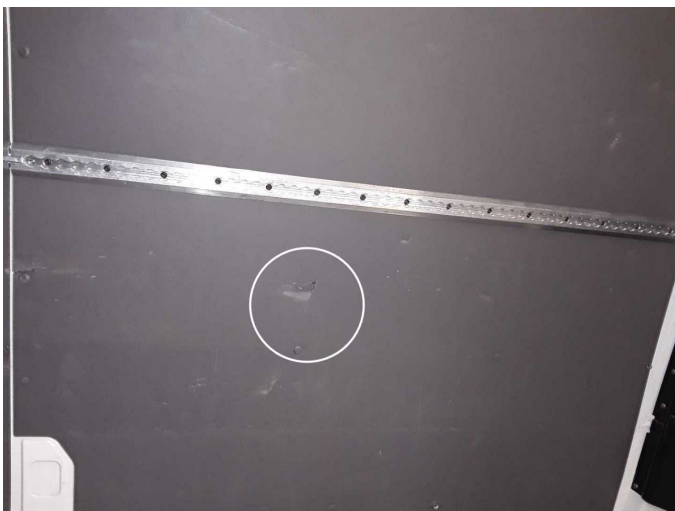
Damage 3: Side panel - rear left side: Interior trim - Broken / torn - Replace

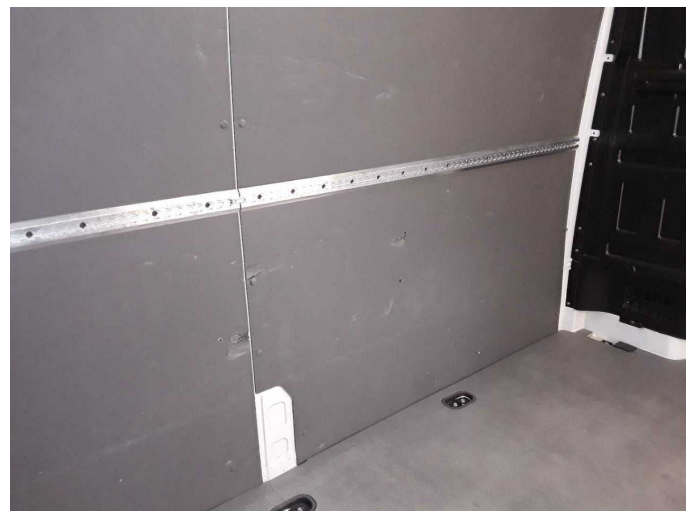
Damage 3: Side panel - rear left side: Interior trim - Broken / torn - Replace

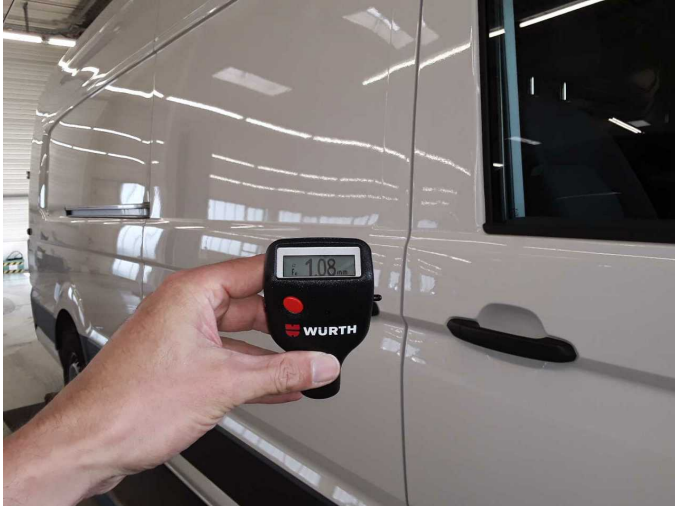
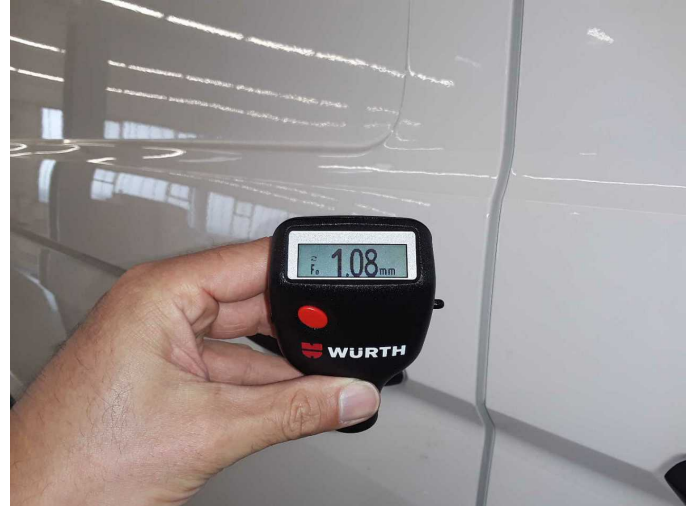
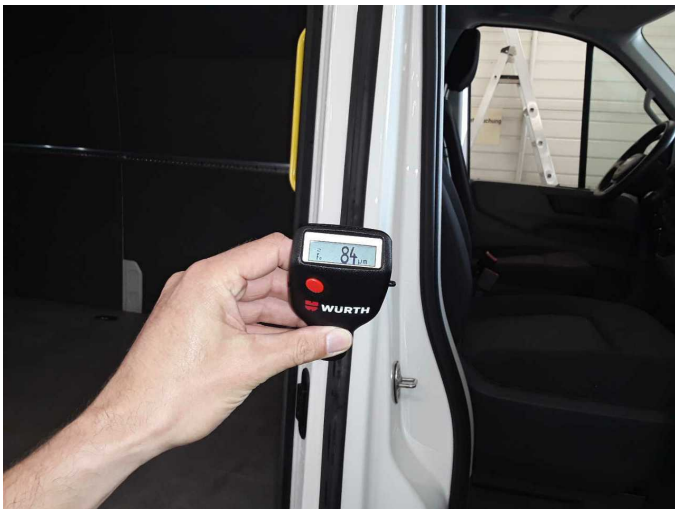
No.	Repainting
1	Door - rear right side, Door - front right side, Professionally carried out

Door - rear right side	1,080 µm	Door - front right side	661 µm
------------------------	-------------	-------------------------	--------

Door - rear right side: 1,080 μm

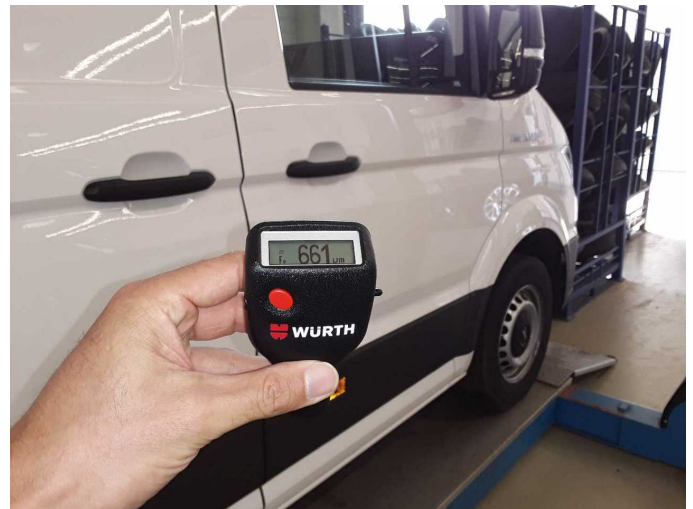
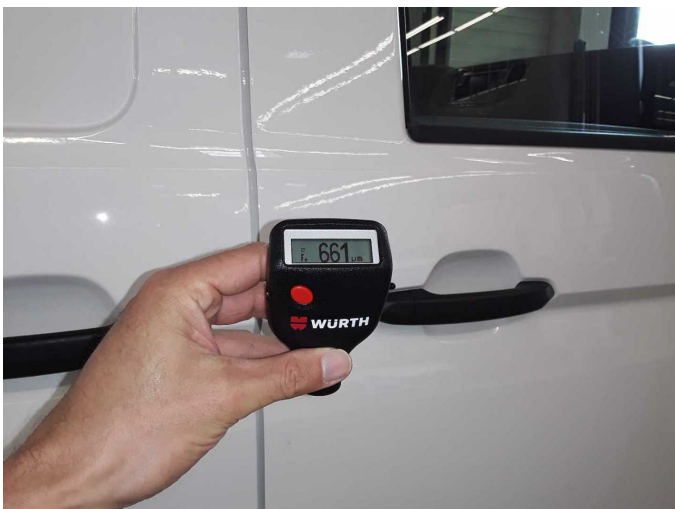
Door - front right side: 661 μm
